Application of Three-Dimensional Laser Scanning for the Identification, Evaluation, and Management of Unstable Highway Slopes

**Pooled Fund Study
Final Report TPF-5(166)
March 2015**

Prepared by:
John M. Kemeny, Ph.D.
Dept. of Mining and Geological Engineering
University of Arizona
1235 E. James E. Rogers Way, Room 229
Tucson, AZ 85721-0012

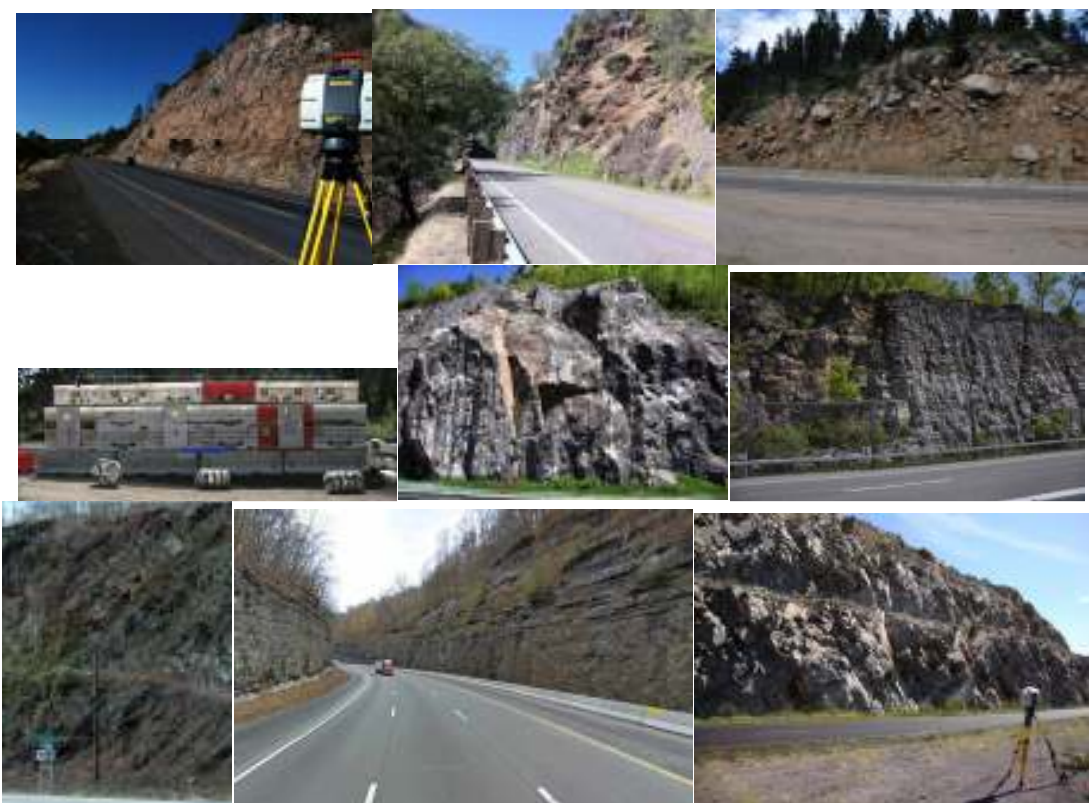
Figure 5. Nine sites were selected for the LIDAR pooled fund study. Top row, left to right: Arizona, California, and Colorado Site 1. Middle row: Colorado Site 2 (an artificial rock surface), New Hampshire, and New York. Bottom row: Pennsylvania, Tennessee, and Texas.

Table 3 and Figure 5 show that eight of the nine sites are highway rock slopes, and one site is an artificial “slope” consisting of jersey and plastic barriers. The eight rock slopes cover a wide variety of rock types and slope conditions. In general, the rock slopes were selected because of geotechnical issues. Some of these issues are apparent in the photos in Figure 5. For example, the New Hampshire site shows wedge and plane failures that have occurred, and the Tennessee site shows overhanging sandstone slabs posing a hazard to the interstate highway below. The Colorado site is an ancient landslide deposit and the large boulders are prone to toppling, as shown in Figure 6a.

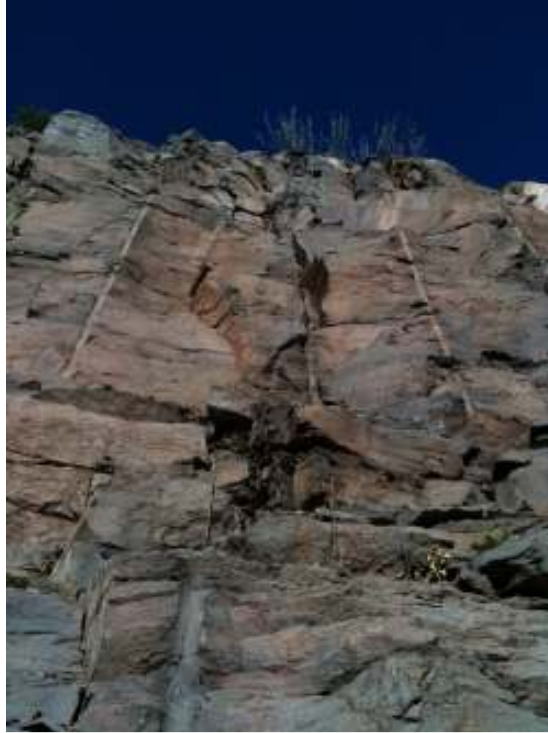
Figure 10. Rock slope in Scan 2 showing pre-split half-casts, blasting fractures, and natural fractures.

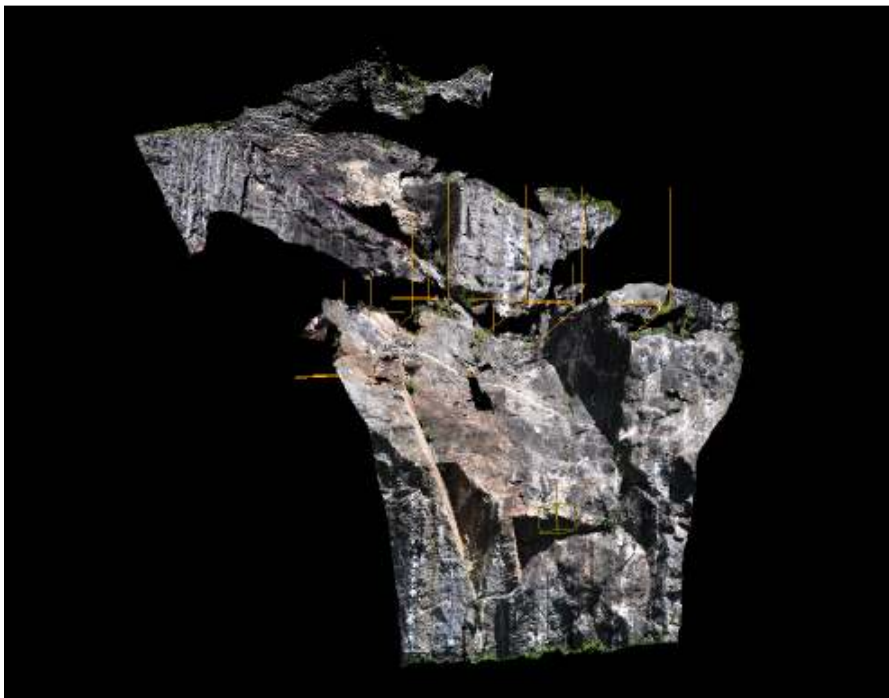
Figure 33. Color point cloud of the Woodstock6 LIDAR scan.

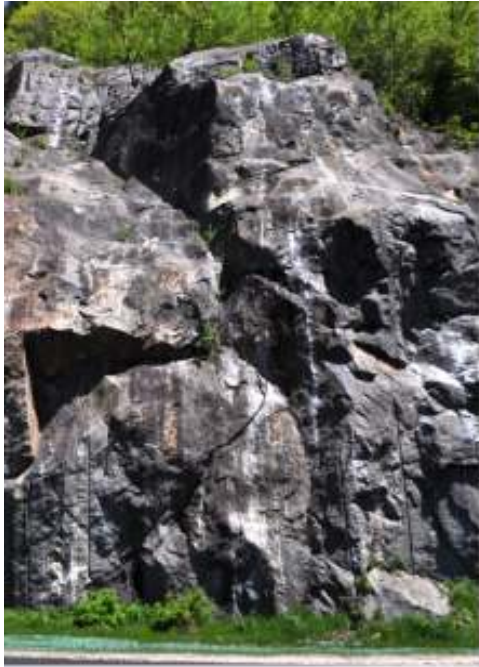
Figure 36. Left to right, a photograph of the Woodstock6 portion of the New Hampshire site, and a slope profile generated from the Woodstock6 scan.

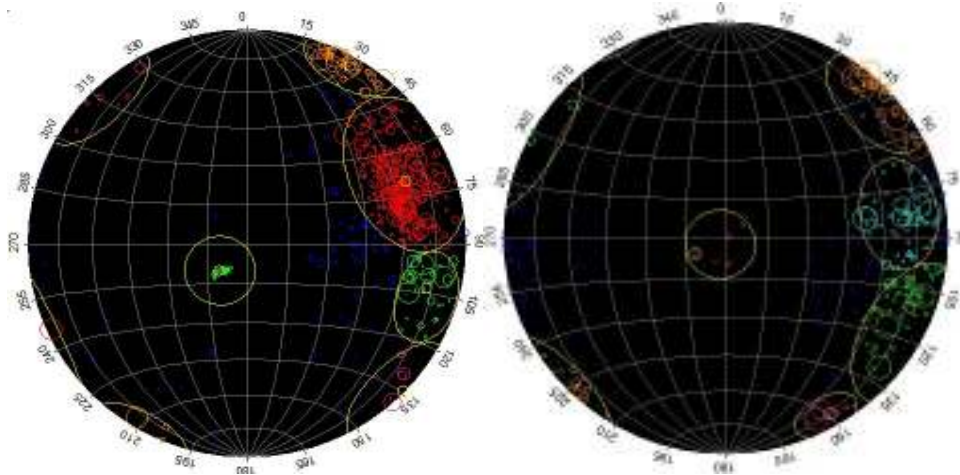
Figure 42a-b. Lower hemisphere stereonet plots for the discontinuity orientations extracted from LIDAR scans of, left to right, a) Mohawk1 and b) Mohawk2.

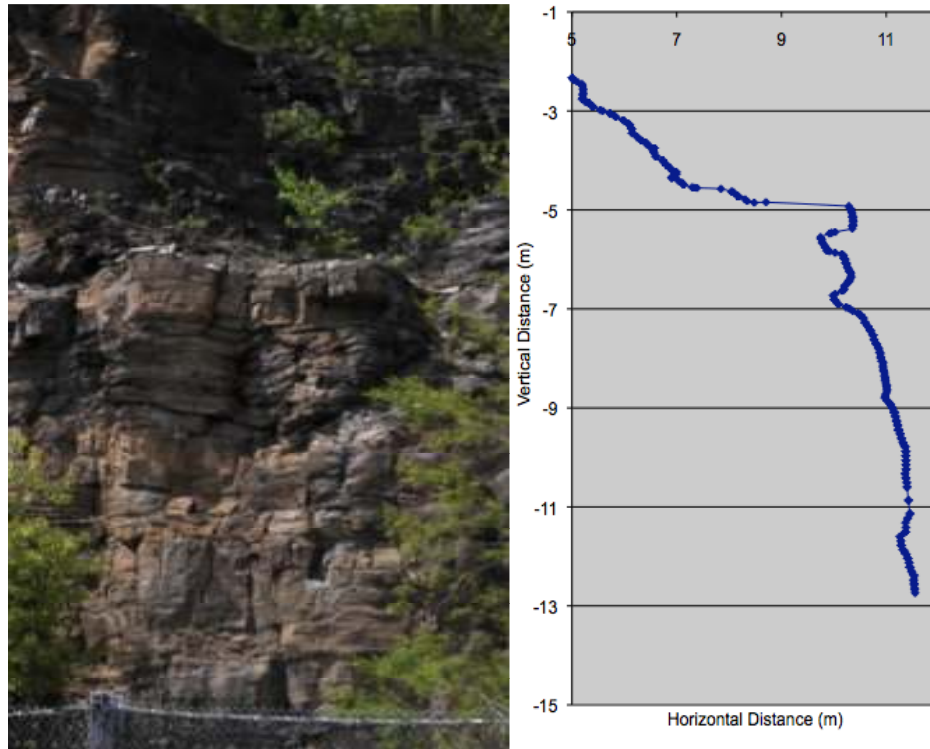
Figure 44. Left to right, a photo of a portion of the New York site, and a slope profile generated from the Mohawk2 scan.

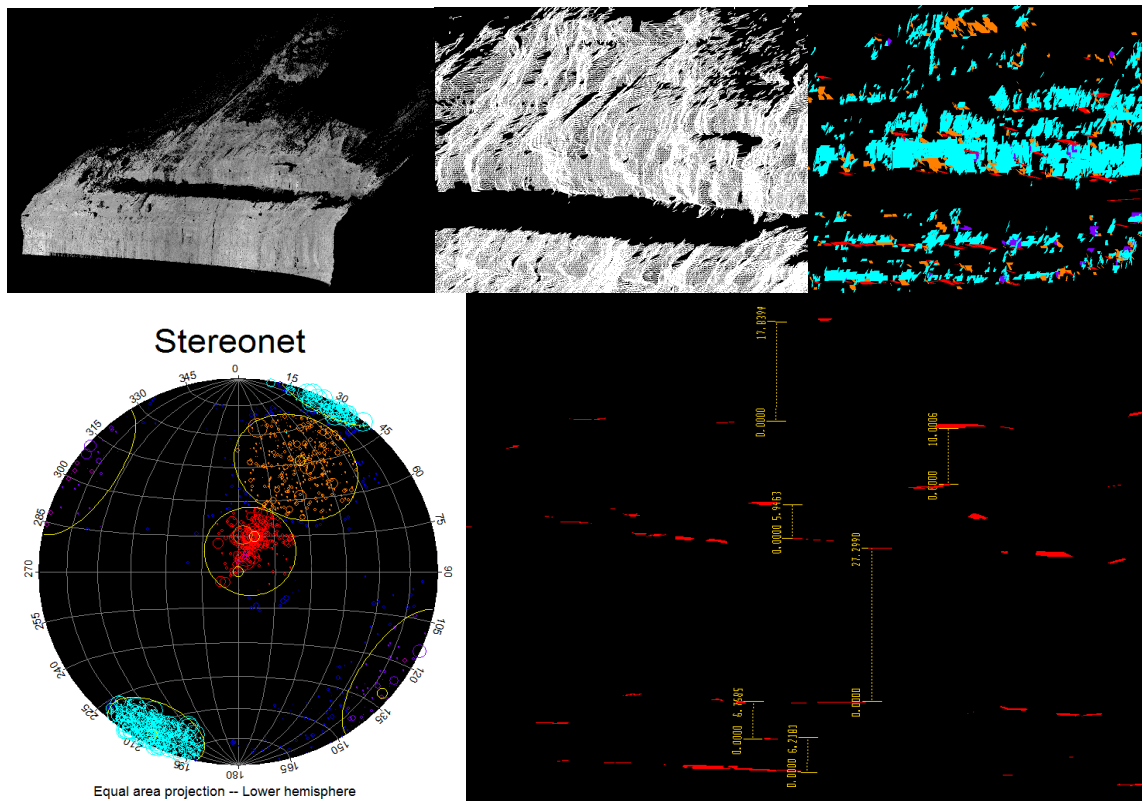
Figure 57. Basic steps using Split-FX for rock mass characterization using the Interstate 24 scan, at upper left, a) point cloud; at center, b) triangulated mesh (zoomed in), and, upper right, c) automatic fracture delineation (zoomed in); at bottom left, d) lower hemisphere stereonet of plot fracture poles, and, bottom right, e) measurement of average joint spacing for Joint Set 1 (red).

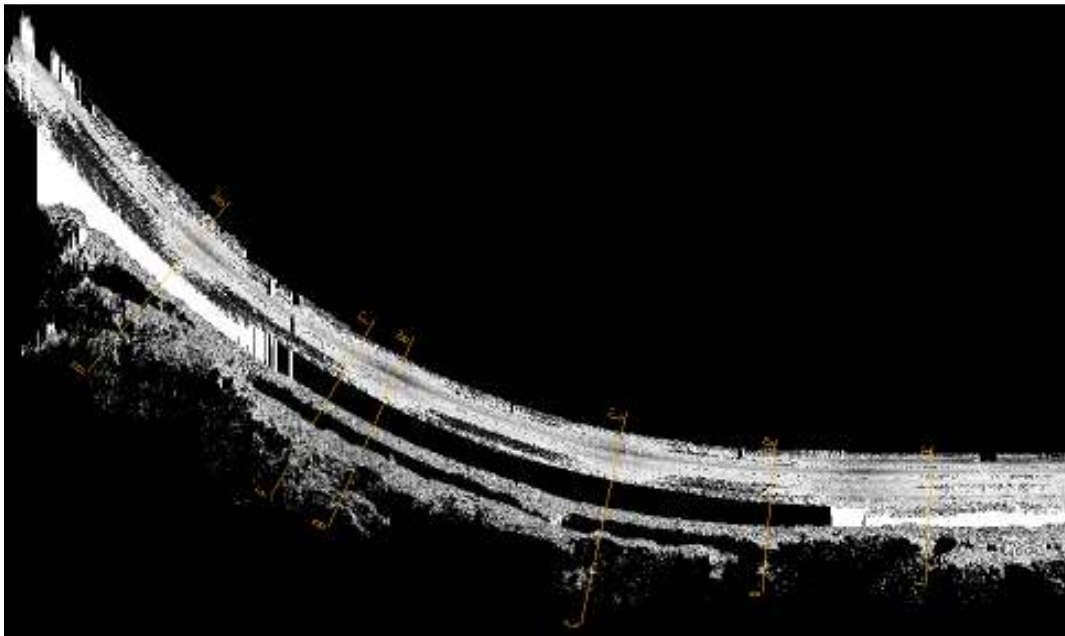
Figure 60. Aerial view (z direction) of I-24 with lanes scan, showing Sections A–F.

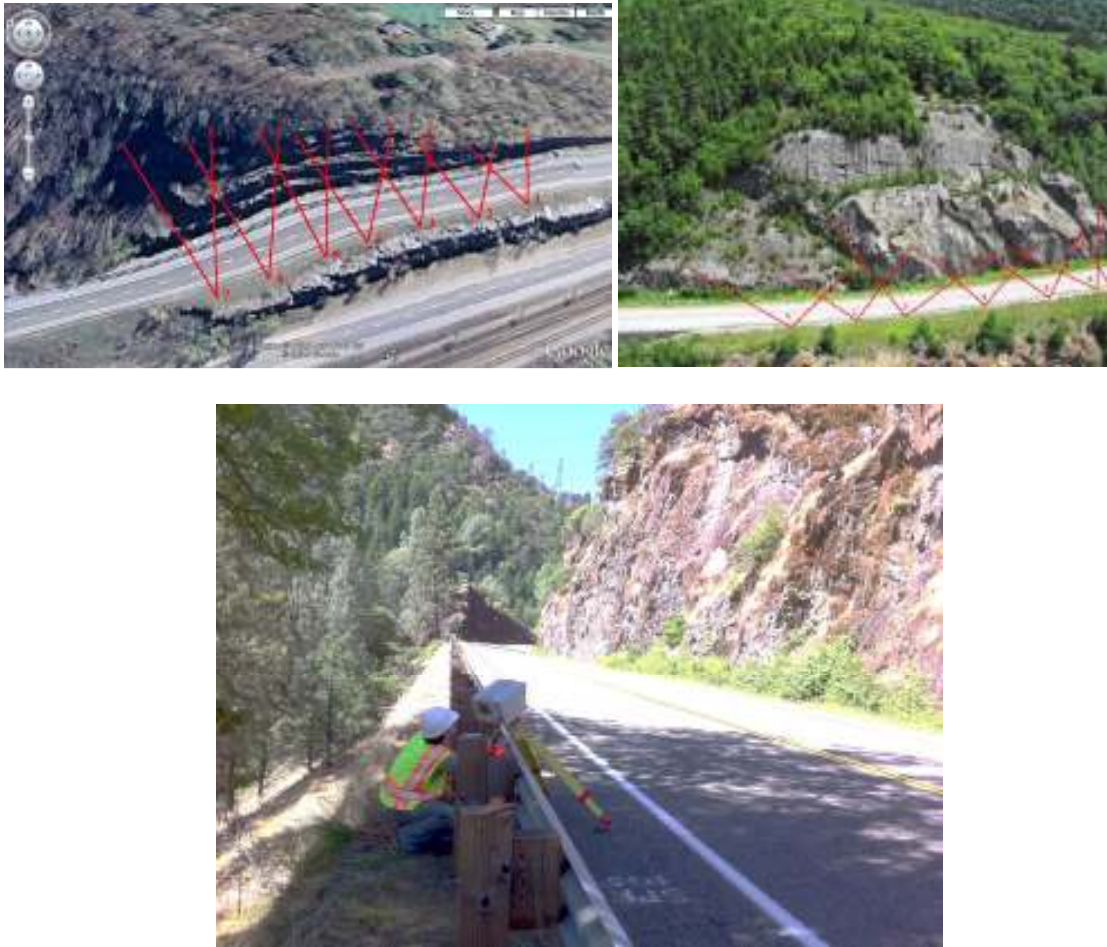
Figure 71. Top left, a) Scanning from the highway median at the New York site; top right, b) Scanning from the highway median at the New Hampshire site; and bottom, c) Difficult scanning from across a narrow highway at the California site.
