# Allowable Limit Contraction and Abutment Scour at Bridges: Technical Report

Technical Report 0-6935-R1

TEXAS A&M TRANSPORTATION INSTITUTE  
COLLEGE STATION, TEXAS

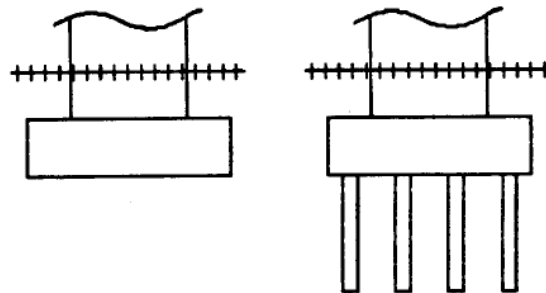
**Figure 1. Scour Depth above Foundation Top.**  
(FHWA, 1995)

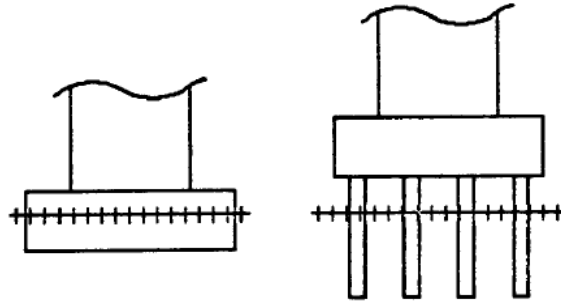
**Figure 2. Scour Depth within Foundation Limit.**  
(FHWA, 1995)

<b>Code</b>	<b>Description</b>
<b>N</b>	Bridge not over waterway.
<b>U</b>	Bridge with unknown foundation. Bridge not evaluated for scour. A plan of action and monitoring are required to reduce the risk of failure during a flood event.
<b>T</b>	Bridge over tidal waters. Bridge not evaluated for scour. Regular inspections and monitoring are required until bridge scour is evaluated.
<b>9</b>	Bridge foundation on dry land with no risk of scour.
<b>8</b>	Bridge with stable foundations for observed or calculated scour; scour depth is above the foundation top (Figure 1; the crossed line in Figure 1 refers to the estimated scour depth).
<b>7</b>	A previous scour problem was corrected, and bridge is no longer scour critical.
<b>6</b>	Scour has not been evaluated yet.
<b>5</b>	Bridge with stable foundations for observed or calculated scour; scour depth is within the foundation depth (Figure 2; the crossed line in Figure 2 refers to the estimated scour depth ).

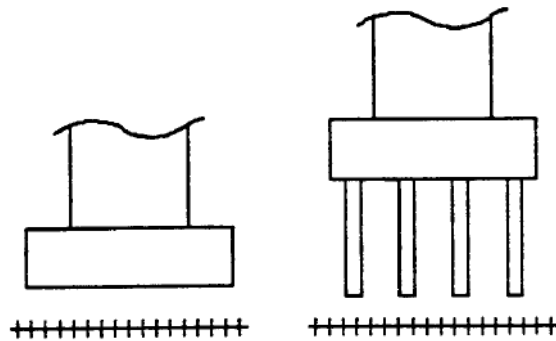
**Figure 3. Scour Depth below Foundation Bottom.**  
(FHWA, 1995)

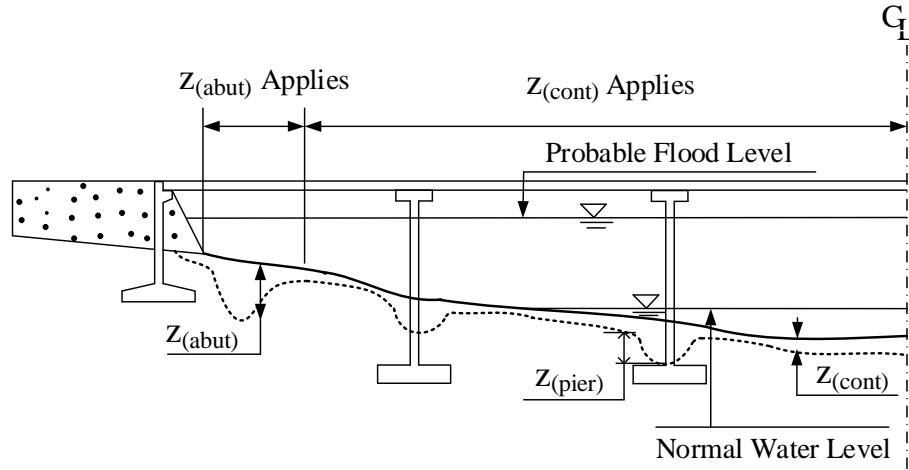
scour is caused by the presence of obstructions in the watercourse at the bridge section. Two types of local scour exist: pier scour and abutment scour. Figure 4 presents the contraction, pier, and abutment scour components. This figure indicates that abutment scour already includes contraction scour, but that pier scour and contraction scour are cumulative.

**Figure 4. Scour Components.**

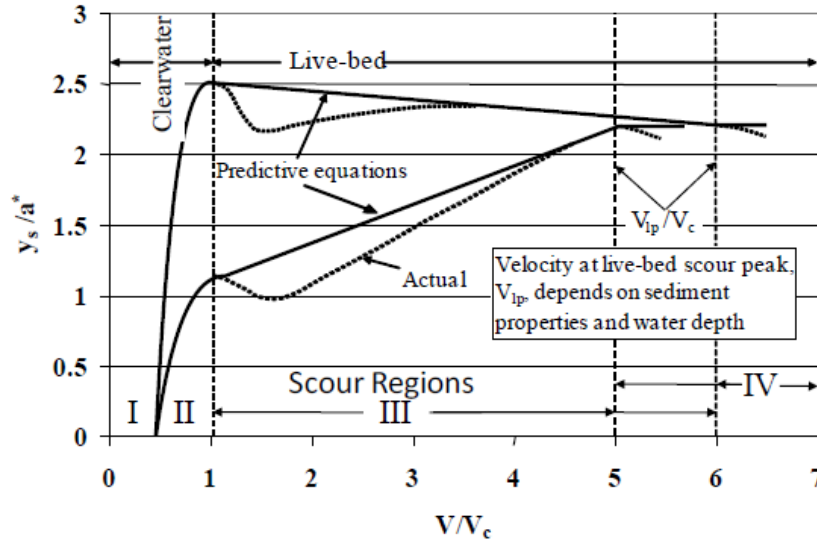
**Figure 5. FDOT Scour Analysis Methodology.**  
(FHWA, 2012)

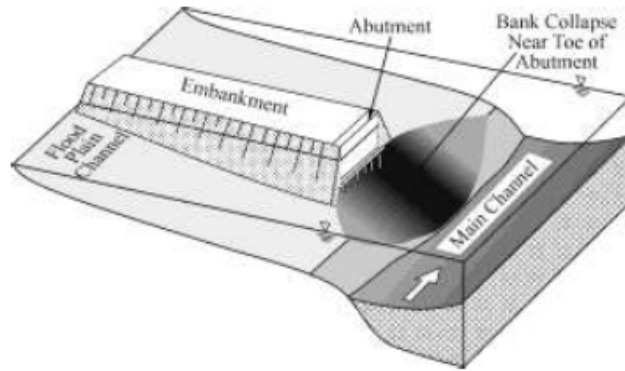
where  $y_{max}$  is the maximum flow depth including abutment scour,  $\alpha_A$  is the amplification factor for condition A,  $y_c$  is the flow depth after live-bed contraction scour,  $y_s$  is the abutment scour depth, and  $y_0$  is the flow depth before scour.

**Figure 6. Abutment Scour Condition A.**

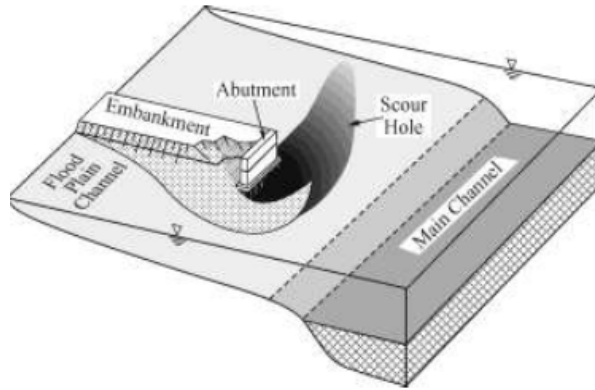
where  $y_{max}$  is the maximum flow depth including abutment scour,  $\alpha_B$  is the amplification factor for condition B,  $y_c$  is the flow depth after clear water contraction scour,  $y_s$  is the abutment scour depth, and  $y_0$  is the flow depth before scour.

**Figure 7. Abutment Scour Condition B.**

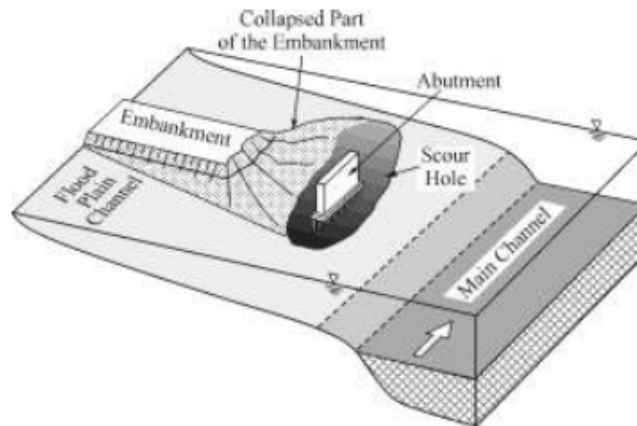
- The abutment approach embankment is breached.
- Local scour depth at the exposed abutment column is estimated similarly to pier scour.

**Figure 8. Abutment Scour Condition C.**

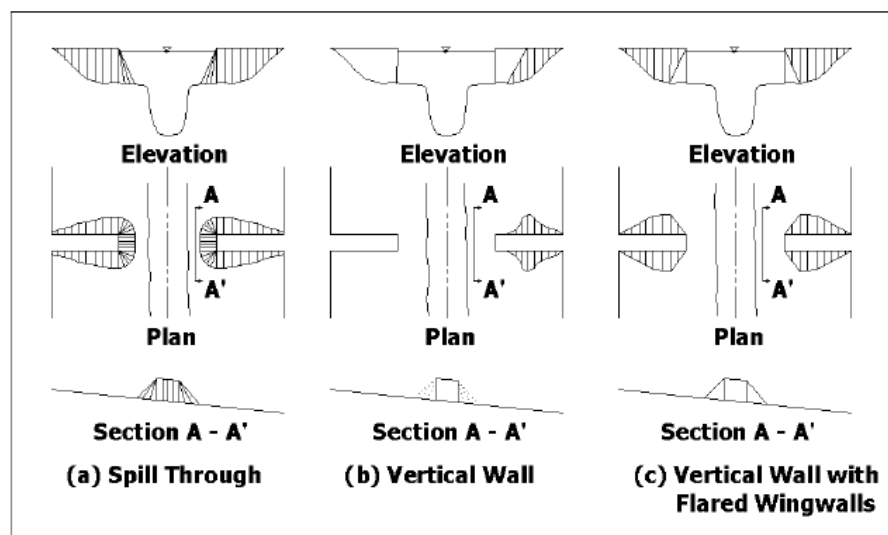
Two types of bridge abutments are commonly used in the United States. These are spill-through abutments and vertical wall abutments with or without wing walls (Figure 9).

**Figure 9. Abutment Types.**  
(FHWA, 2012)

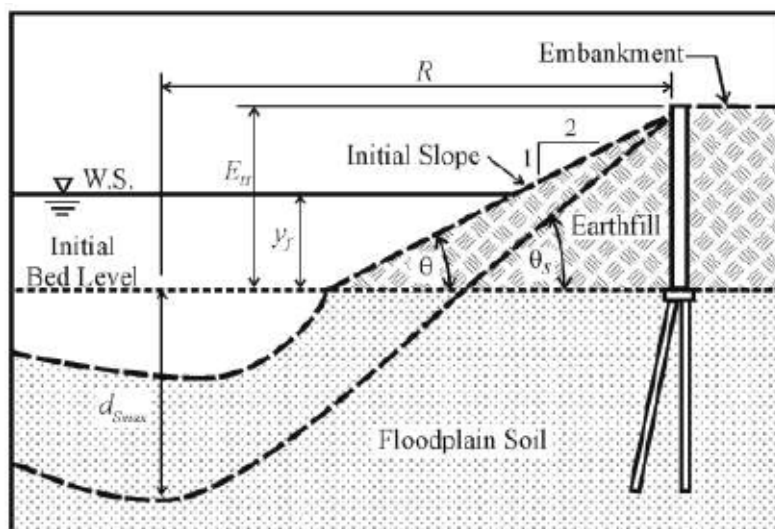
It has been recognized that scour at spill-through abutments eventually would reach a depth causing the failure of the embankment slope. This depth is defined as “geotechnical limit to scour” because the geotechnical slope failure of the approach embankment would increase the flow area and subsequently limit the extent and depth of scour. The geotechnical limit to scour also called the “limiting scour depth” is associated with the equilibrium slope  $\theta_s$  of the embankment material (Ettema et al., 2010). Figure 10 shows a sketch of a spill-through abutment at which the limiting scour depth,  $d_{smax}$ , is derived in Eq. 3-15.

**Figure 10. The Limiting Scour Depth.**

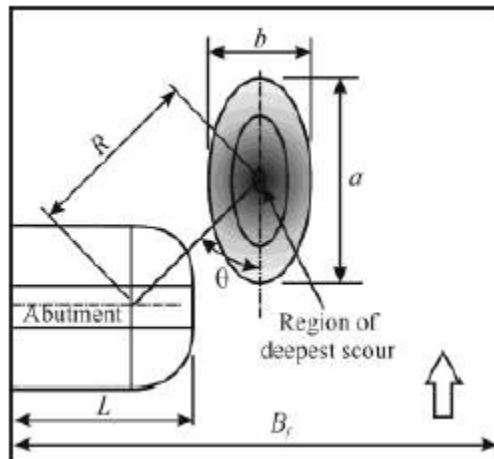
where  $Y_f$  is the flow depth in the floodplain.

**Figure 11. Scour Radial Distance.**

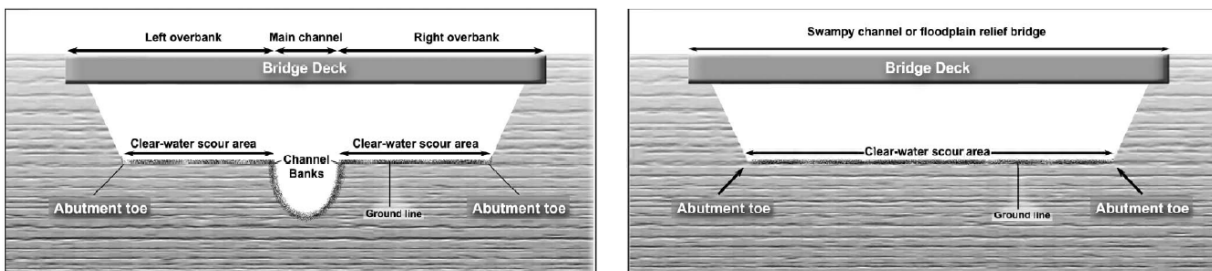
Measurements of abutment and contraction scour are collected by the USGS and the South Carolina Department of Transportation at 146 bridge sites in the Coastal Plain and Piedmont of South Carolina. Bridge sites in the Coastal Plain and Piedmont sites consist of either low flow main channels with set-back abutments in the floodplain or shallow swampy channel on the floodplain (Figure 13). In total, 209 abutment scour measurements and 76 contraction scour measurements were collected during this field study. These observations are used to verify the applicability of scour prediction equations and to develop an improved method to predict scour in South Carolina.

**Figure 13. Common Configuration of Abutments at Coastal Plain Bridge Sites in South Carolina.**

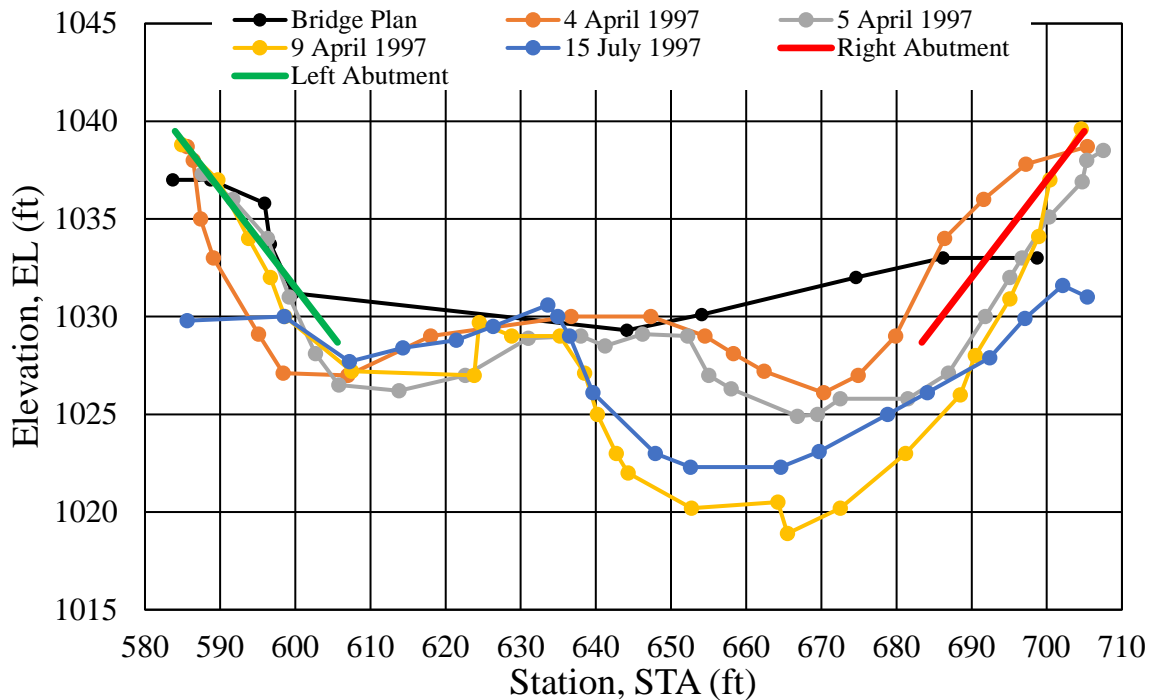
This case is retrieved from the NBSD. Supporting files for this case (Site ID 73) consist of a plot of the bridge plan, photos taken during the flood and various channel cross-sections measurements. The bridge is in a rural/agricultural area in Swift County, Minnesota. The bridge channel was surveyed on three days during a flood in April 1997 and then after the flood in July 1997. During the flooding event, scour progressed near the right abutment (Figure 15). During the visit on 9 April 1997, a slope failure of the right abutment (looking downstream) was observed.

**Figure 15. Channel Profiles for CR 22 over Pomme de Terre River.**

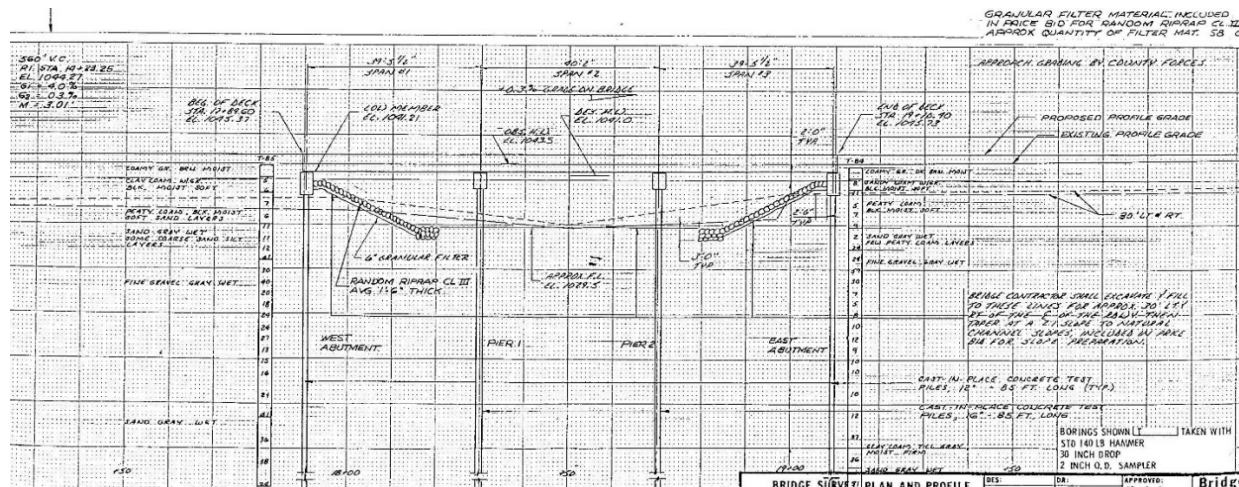
While no information is given about the embankment soil, the channel bed soil is classified as silty sand SM. The boring logs in Figure 16 indicate that the channel bed is mostly sand with few peaty loam layers. Soil samples collected from the upstream bridge face are comprised of non-cohesive fine sand and silt. Standard Penetration Test N results at the bottom of the abutment, reported on the boring logs (Figure 16), are used to estimate the channel bed friction angle  $\phi'_c$ , which is found to be  $30^\circ$ .

**Figure 16. Profile Plot of CR 22 over Pomme de Terre River from Bridge Plan.**

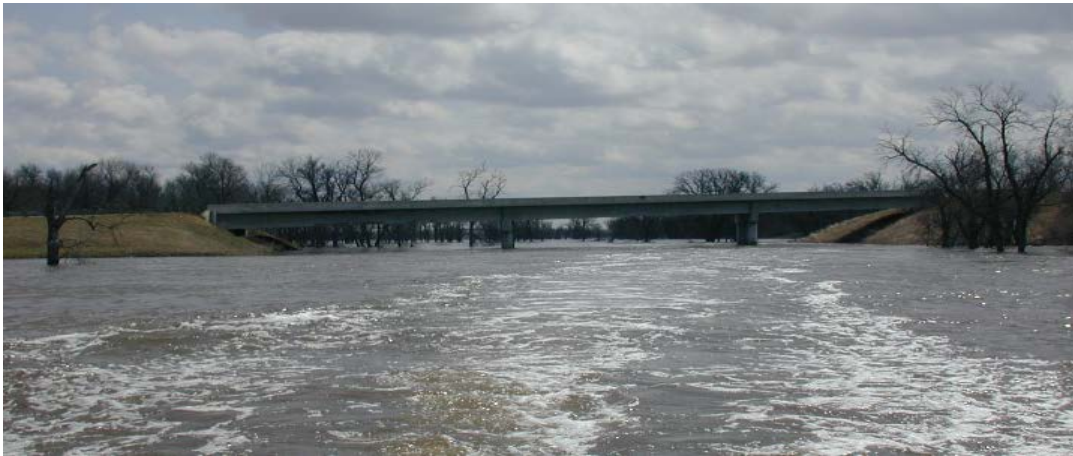
**Figure 17. SR 37 over James River during the Flood—Looking Downstream.**

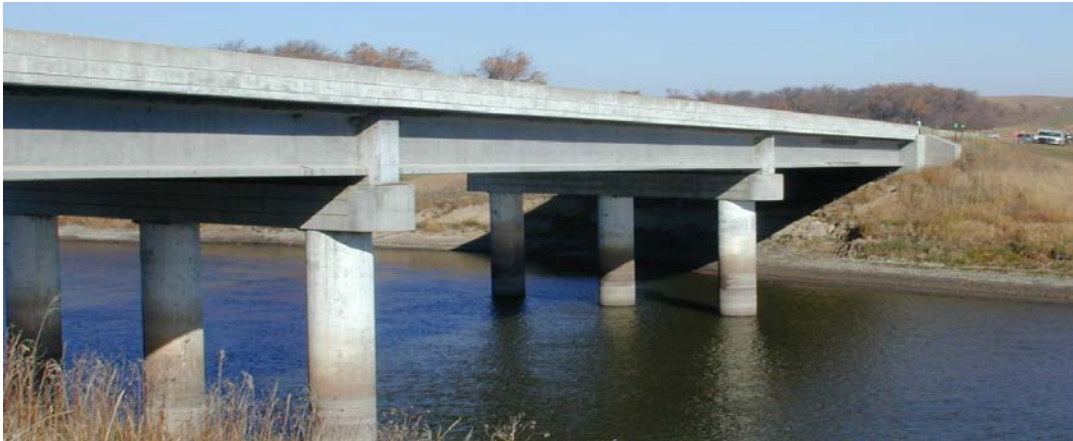
**Figure 18. SR 37 over James River after the Flood—Looking at the Left Abutment from the Downstream.**

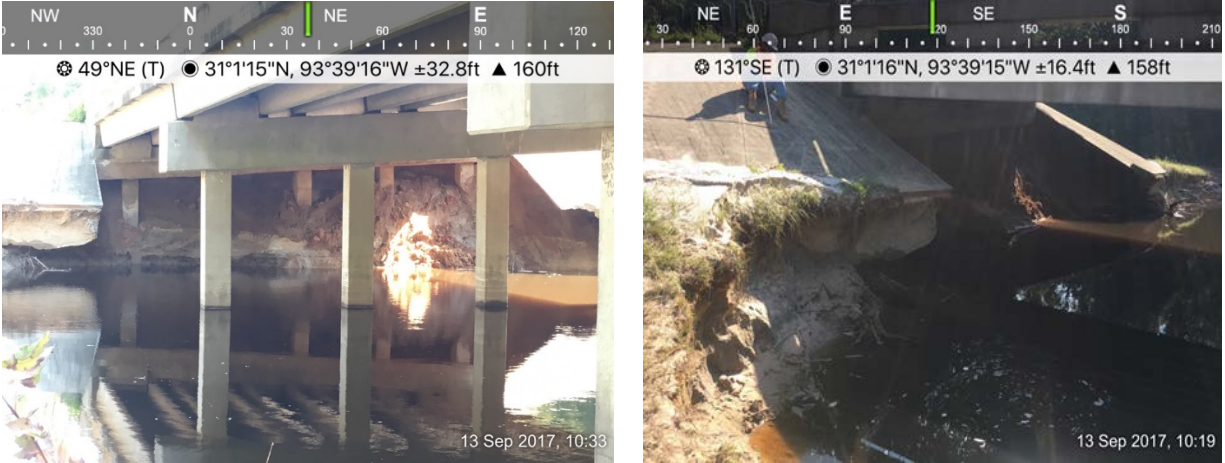
FM 692 over McGraw Creek is in Newton County, Texas. The bridge has been closed to traffic due to damage sustained during Hurricane Harvey (August–September 2017). The information needed to analyze the case is provided by the TxDOT office in Austin. The flooding caused significant scour in the bridge channel and caused the failure of the left abutment (Figure 21).

**Figure 21. Left Abutment Failure at FM 692 over McGraw Creek.**

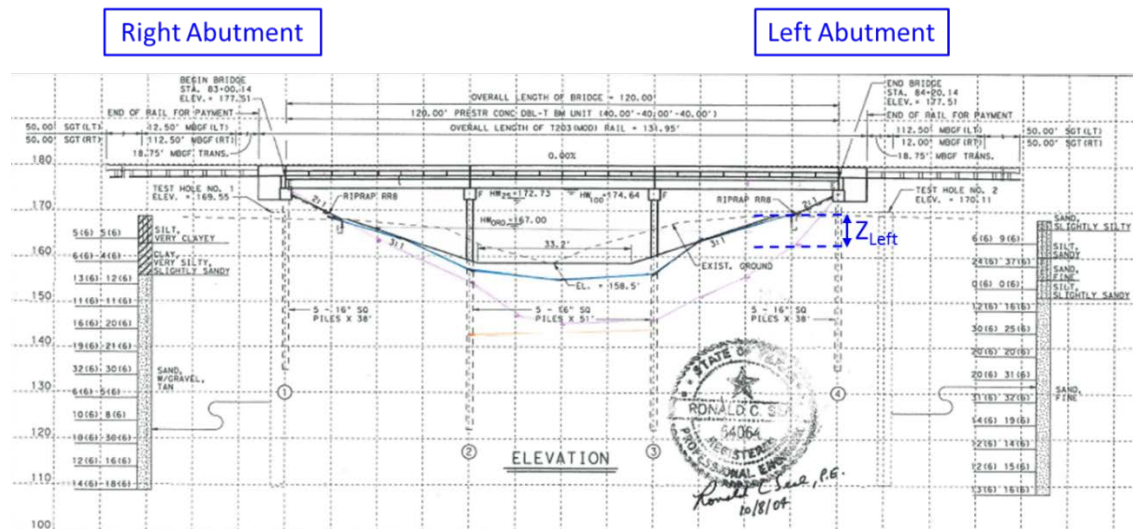
The borehole logs indicate that the bed soil is slightly silty sand at the left abutment and very clayey silt at the right abutment. The borehole logs also show the results of TCP test. The TCP blow counts,  $N_{TCP}$ , at the bottom of the left and right embankments are 15 and 10, respectively. The undrained shear strength  $S_u$  values are calculated using  $N_{TCP}$  values and the linear relationship  $S_u$  (tsf) =  $N_{TCP}/40$  (TxDOT, 2018). It follows that the undrained shear strength of the channel bed soil at the left abutment is  $S_{uLeft} = 750$  psf and at the right abutment is  $S_{uRight} = 500$  psf. No information is given on the soil type of the embankments nor on the water elevation at the time of the failure.

**Figure 22. Bridge Layout of FM 692 over McGraw Creek Showing the Channel Profiles before and after Harvey.**

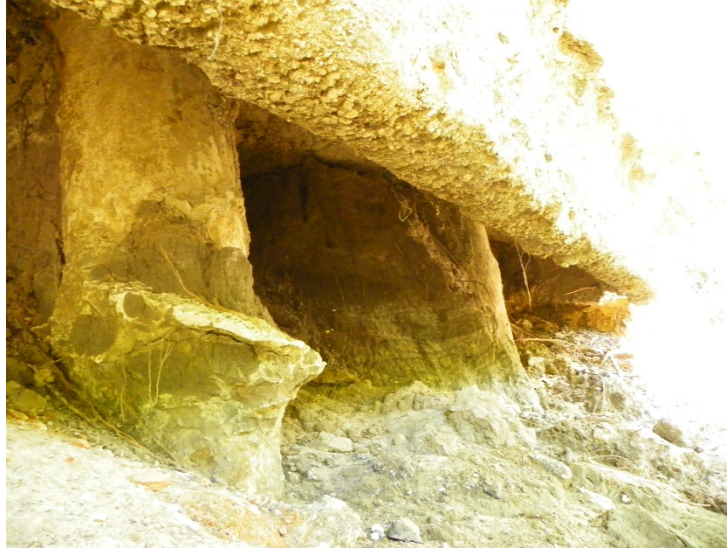
**Figure 26. Voids under the Left Abutment Concrete Riprap of CR 309 over Rocky Creek.**

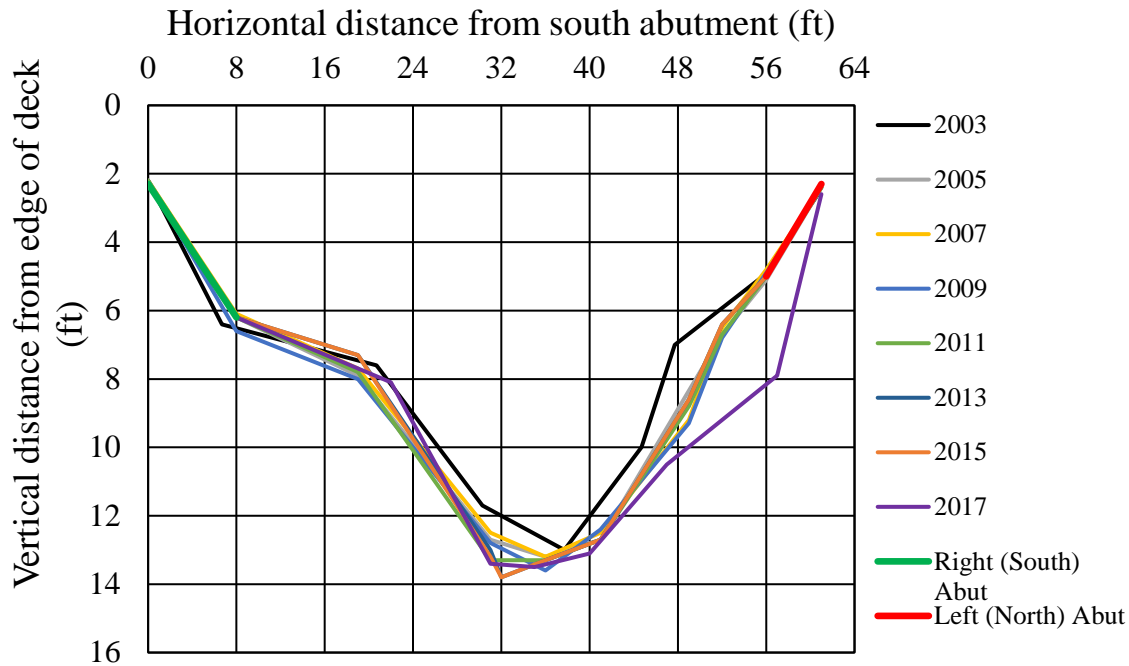
The borehole logs presented on the bridge layout plan indicate that the channel soil directly under the abutment embankment is tan sandy clay. TCP blow counts,  $N_{TCP}$ , are reported on the borehole logs. The  $N_{TCP}$  values at the bottom of the left and right embankments are 9 and 13, respectively. The linear relationship between the undrained shear strength  $S_u$  and  $N_{TCP}$  for low plasticity clay (CL) soils,  $S_u$  (tsf) =  $N_{TCP}/30$  (TxDOT, 2018) is used to estimate the undrained shear strengths of the channel bed at the left and right abutments. Table 9 presents these geotechnical parameters, in addition to the geometry and scour parameters.

**Figure 27. Channel Profiles at CR 309 over Rocky Creek from 2003 to 2017.**

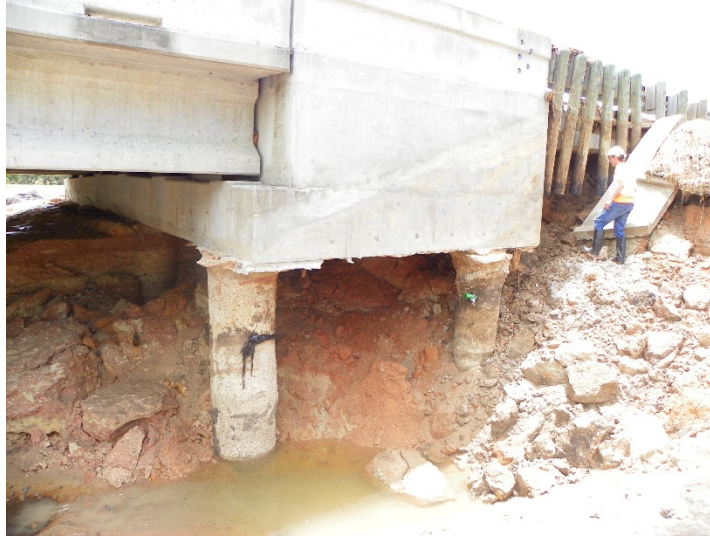
SH 105 over Rocky Creek is also located in Washington County, Texas. The bridge was closed to traffic in April 2017 due to Tax Day Flooding. Large scour holes formed during the flooding and caused the failure of the right abutment (Figure 28). Pictures from the inspection of the bridge site after the flood showed that the right abutment, where the failure occurred, was not protected against scour while the left abutment was protected by a gabion mattress.

**Figure 28. Right Abutment Failure at SH 105 over Rocky Creek.**

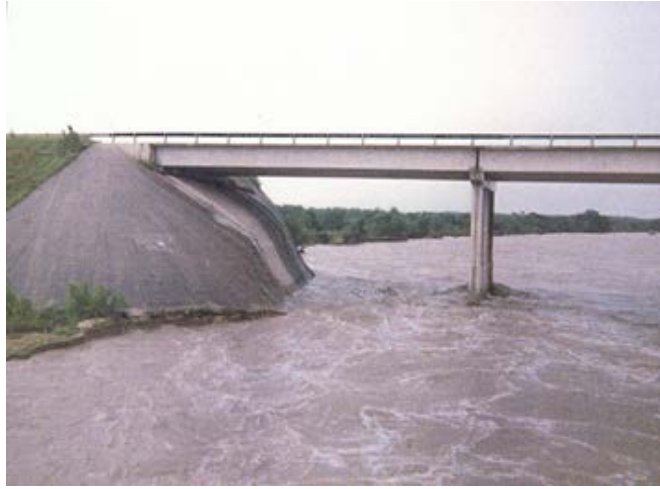
**Figure 29. Right Abutment Failure at US 90 over Nueces River.**

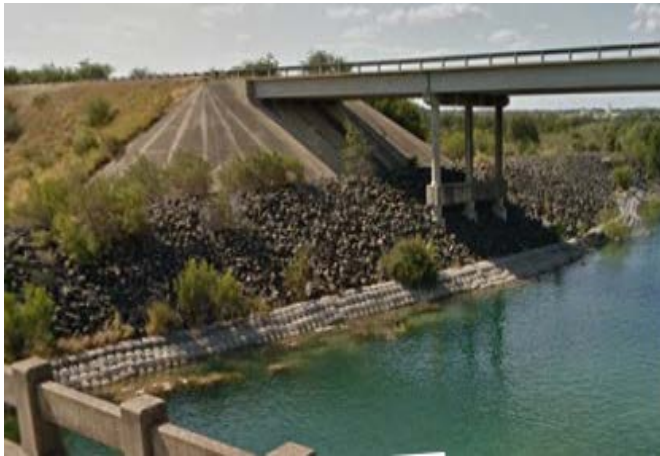
promptly repaired, and stone riprap was placed at the end of the embankment to prevent future failure due to scour (Figure 30).

**Figure 30. Right Abutment Repair at US 90 over Nueces River.**

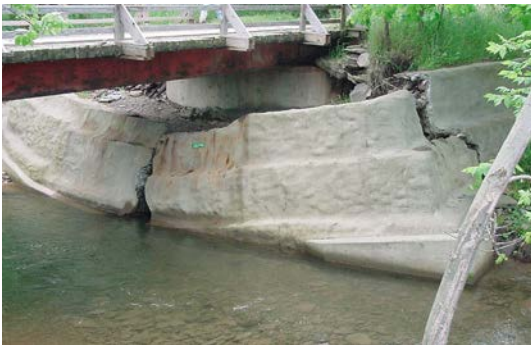
**Figure 32. Abutment Foundation Failure by Vertical Loading.**

- **Failure mode 1:** Abutment foundation failure by vertical loading (Figure 32).
- **Failure mode 2:** Abutment foundation failure by horizontal loading (Figure 33).
- **Failure mode 3:** Slope stability failure of the abutment embankment (Figure 34).
- **Failure mode 4:** Lateral channel migration and erosion of the embankment soil (Figure 35).

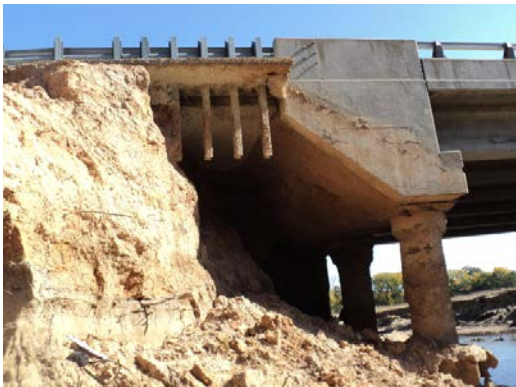
**Figure 34. Slope Stability Failure of the Abutment Embankment.**

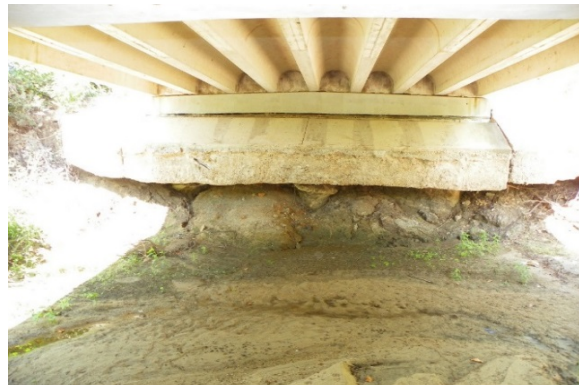
**Figure 35. Erosion of the Embankment Soil.**

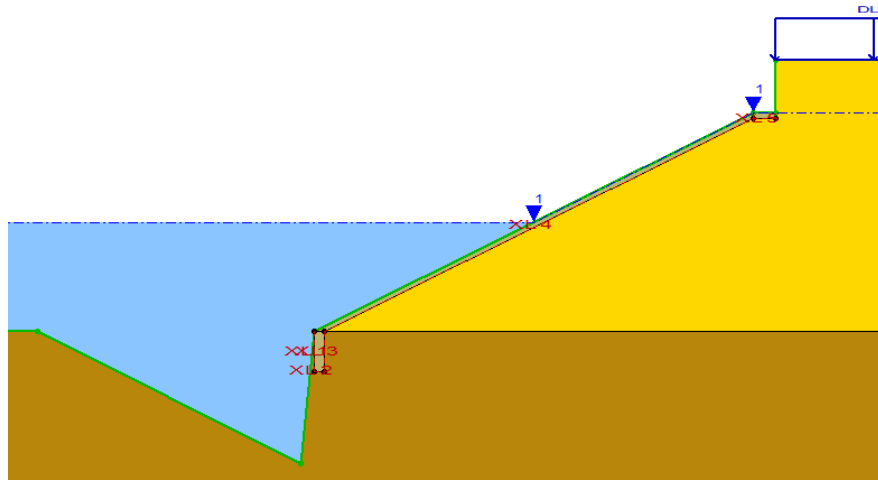
failure surface is prevented from intersecting the concrete layer using exclude lines (Figure 36). In this way, the presence of the concrete protection layer does not enhance geotechnical stability. On the other hand, this layer helps simulating realistic deep-seated slip surfaces going beyond the abutment cap and prevents shallow raveling failures.

**Figure 36. XCLUDE Lines around the Concrete Protection.**

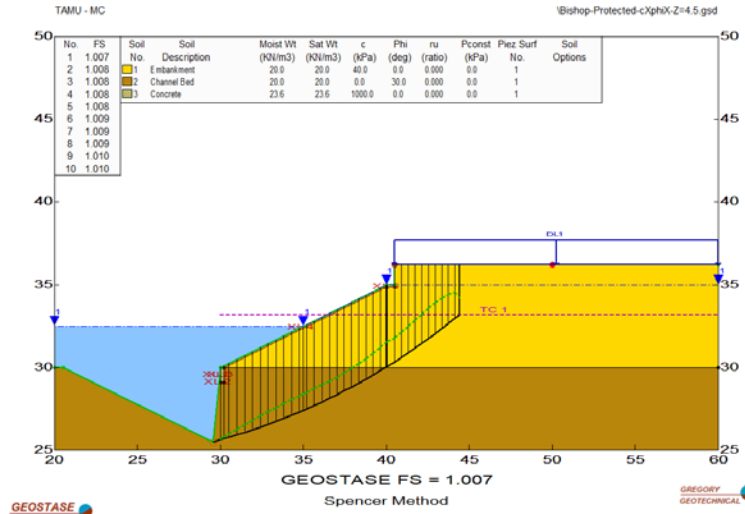
$$z_c = \frac{2c'}{\gamma \tan(45^\circ - \frac{\phi'}{2})} \quad (\text{Eq. 5-1})$$

**Figure 37. Tension Crack Used to Suppress the Tension in a Medium Stiff Embankment.**

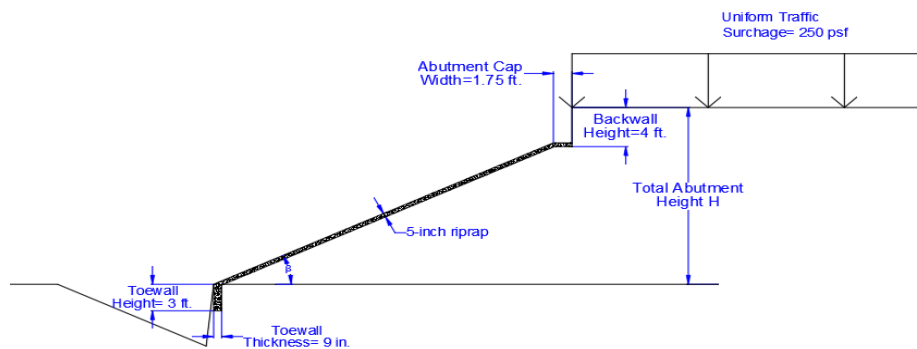
Figure 38 illustrates the abutment cross-section used in the slope stability analyses. The abutment embankment is protected by concrete riprap of type RR8 including a 5-inch thick facing and a 3-ft deep toe-wall. The abutment slope is set to 2H:1V, which gives a slope angle  $\beta$  of 26.6°. This is representative of a typical slope of riprap in Texas. The abutment cap and back-wall dimensions are those corresponding to TxDOT pre-stressed concrete I girder, Tx34 or Tx40, typically used with a 28 ft roadway. A slope height of 16.4 ft (5 m) is first considered. To cover the range of possible embankment heights, the stability analyses are repeated with a smaller slope height of 6.5 ft (2 m) and a larger slope height of 24.5 ft (7.5 m). Adding the back-wall height of 4 ft results in three total height H values of 10.5 ft, 20.4 ft, and 28.5 ft. A uniform traffic surcharge of 250 psf is placed on the approach roadway.

**Figure 38. Abutment Model.**

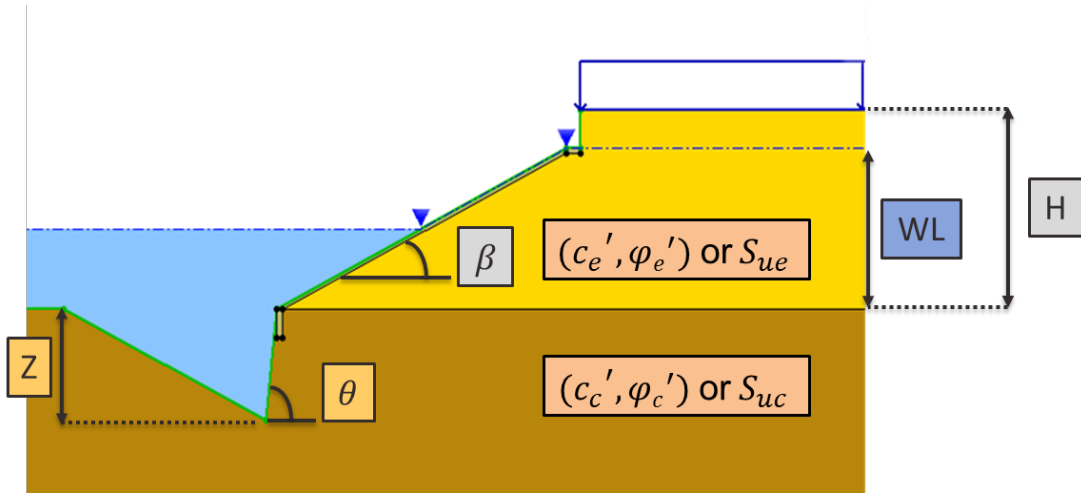
The abutment model variables can be divided into four categories (Figure 39).

**Figure 39. Abutment Model Variables.**

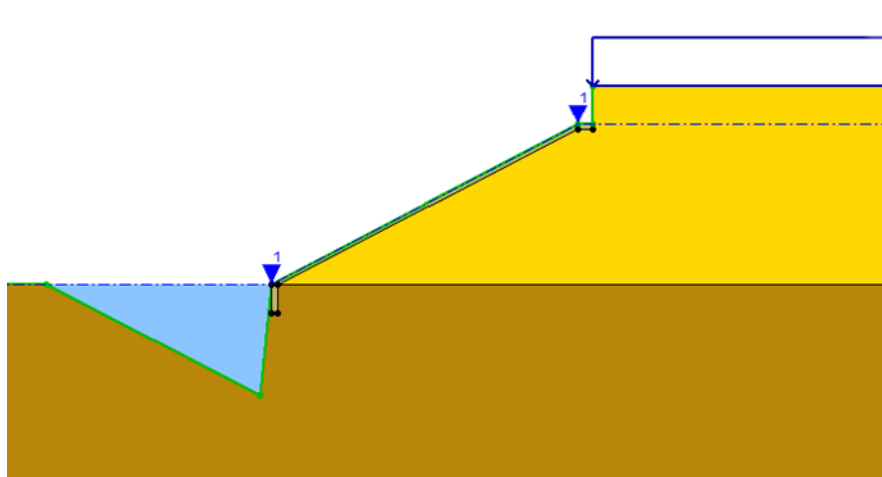
condition would be dry, the slope stability of the abutment embankment should be analyzed using a long-term effective analysis. It has been proven that the effective analysis of dry conditions results in a higher FS against slope stability than that of the rapid drawdown condition. Although the dry condition (no water) and other steady state conditions with WL=100 percent and WL=50 percent were simulated, the determination of the failure scour depth  $Z_{Fail}$  at or near the abutment is based on the rapid drawdown condition.

**Figure 40. Complete Rapid Drawdown.**

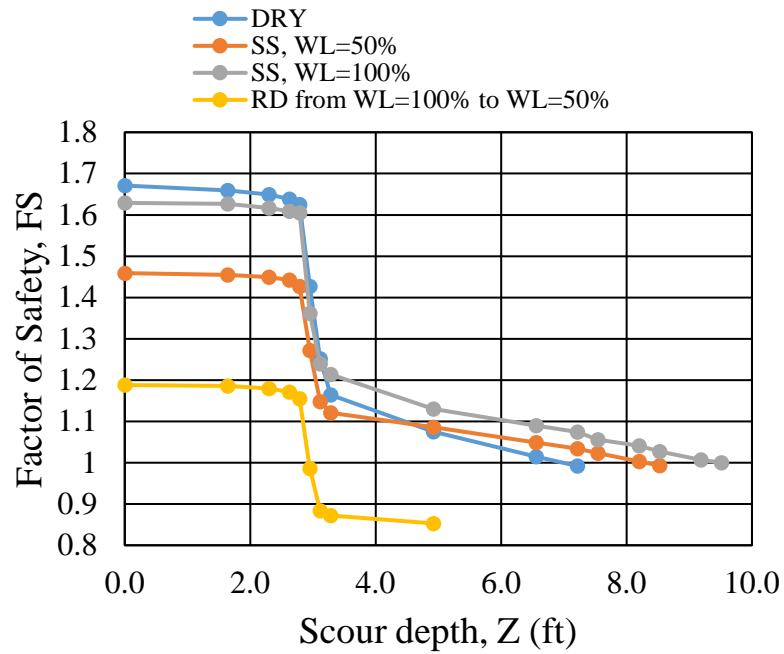
seen in Figure 41 and Table 16, rapid drawdown is the most critical water condition and is therefore used to determine the failure scour depth  $Z_{Fail}$ .

**Figure 41. FS vs. Z Using Effective Stress Analysis.**

Water Condition	DRY	SS, WL=50%	SS, WL=100%	RD from WL=100% to WL=50%
Failure Scour Depth, $Z_{Fail}$ (ft)	7.0	8.3	9.5	2.9
$Z_{Fail}/H$	0.34	0.40	0.46	0.14

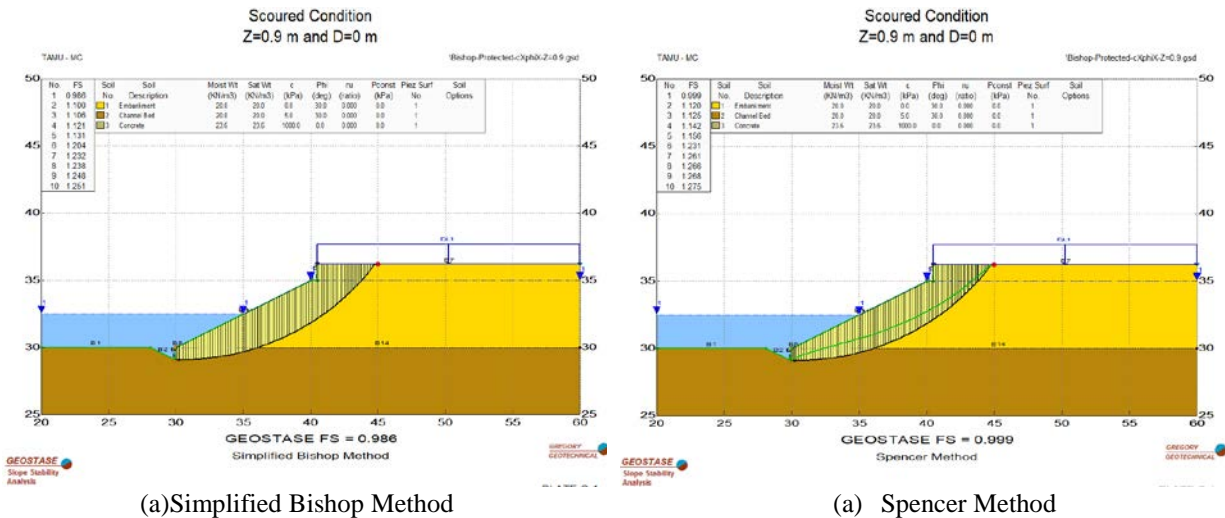
**Figure 42. Failure Surface Location at Z Equal to the Toe-Wall Depth.**

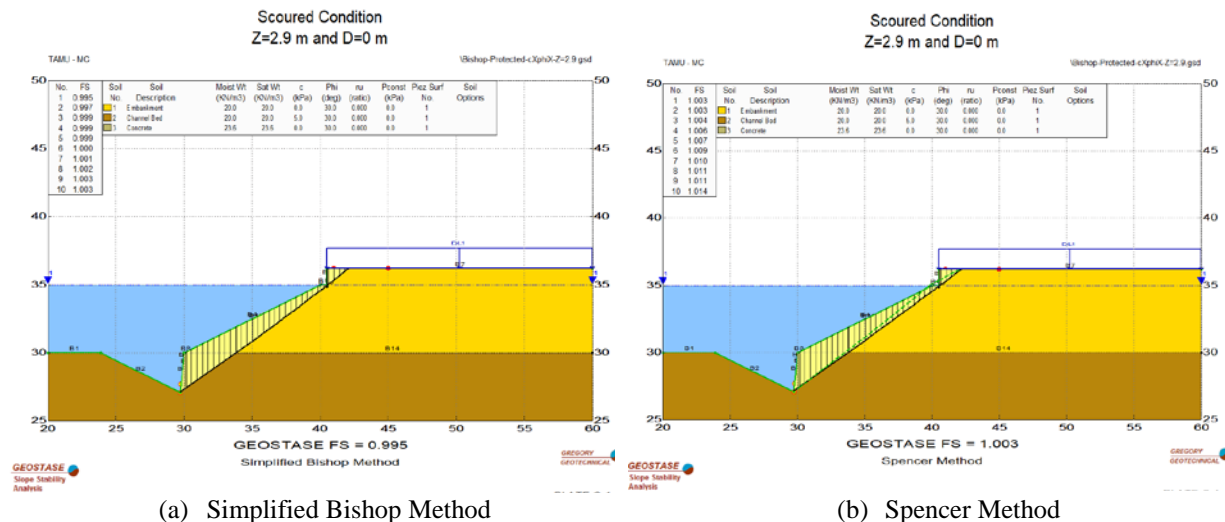
**Figure 43. Failure Surface Location at Z Greater than the Toe-Wall Depth.**

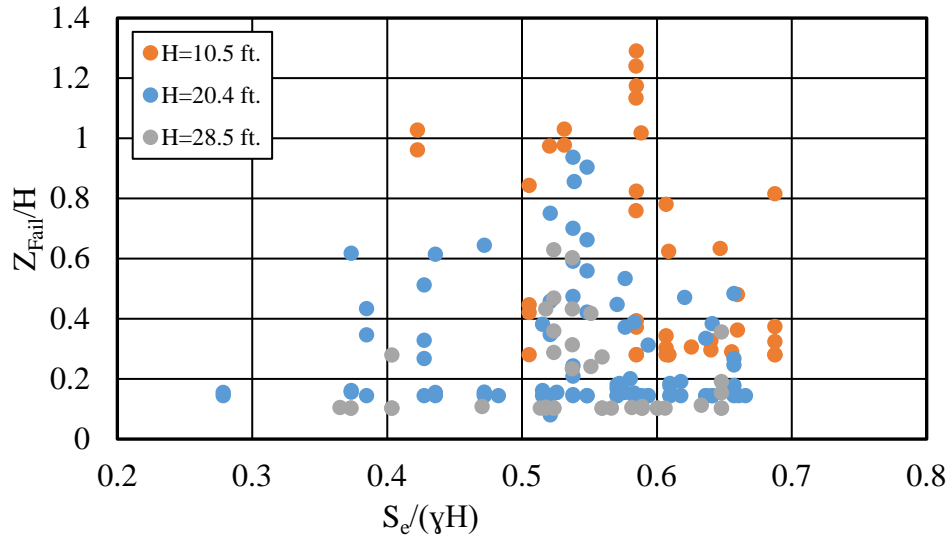
At first,  $S$  was taken to be the bulk shear strength of the embankment  $S_e$  with  $S_e = c'_e + \gamma H \tan \phi'_e$ , which results in  $\frac{S_e}{\gamma H} = \frac{c'_e}{\gamma H} + \tan \phi'_e$ . Figure 44 shows that no correlation exists between  $Z_{\text{Fail}}/H$  and  $S_e/\gamma H$ . It was thought that including the channel bed shear strength parameters in the expression of  $S$  would improve the relationship between  $Z_{\text{Fail}}/H$  and  $S/\gamma H$ . Consequently,  $S_e$  was replaced by  $S_{\text{avg}}$  with  $S_{\text{avg}} = c'_{\text{avg}} + \gamma H (\tan \phi')_{\text{avg}}$  where  $c'_{\text{avg}} = \frac{c'_e + c'_c}{2}$  and  $(\tan \phi')_{\text{avg}} = \frac{\tan \phi'_e + \tan \phi'_c}{2}$ . However, no correlation is observed between  $Z_{\text{Fail}}/H$  and  $S_{\text{avg}}/\gamma H$  neither (Figure 45).

**Figure 44.  $Z_{\text{Fail}}/H$  vs.  $S_e/\gamma H$ .**

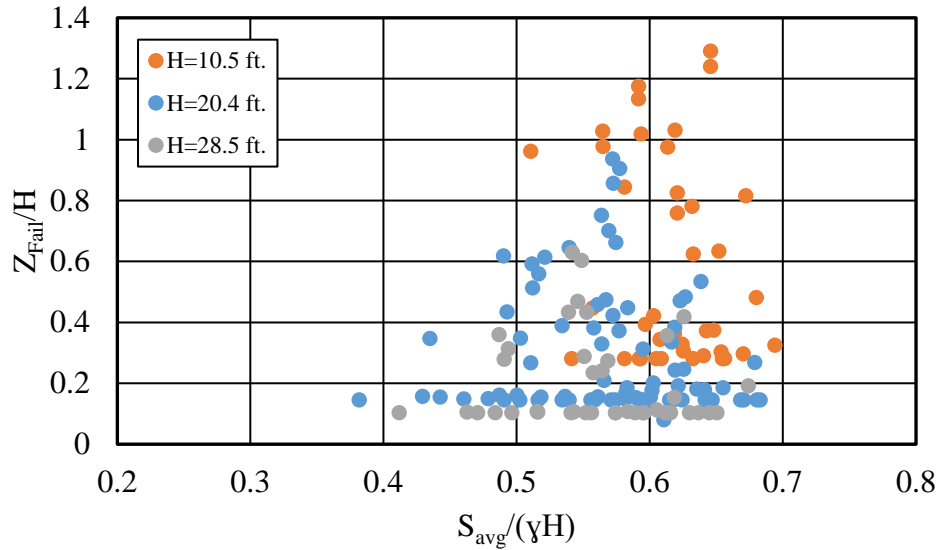
**Figure 45.  $Z_{\text{Fail}}/H$  vs.  $S_{\text{avg}}/\gamma H$ .**

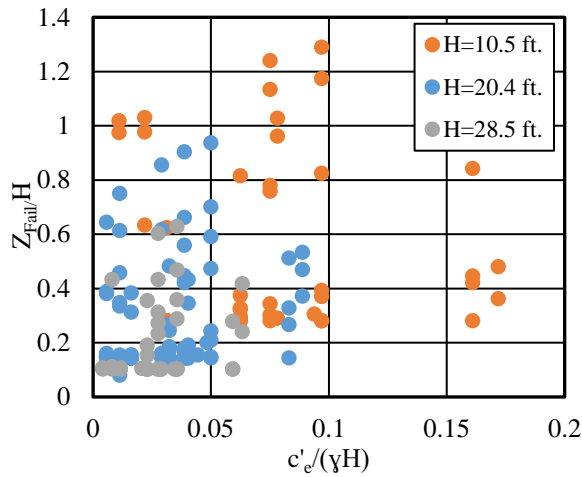
**Figure 46.  $Z_{\text{Fail}}/H$  vs.  $c'/\gamma H$ .**

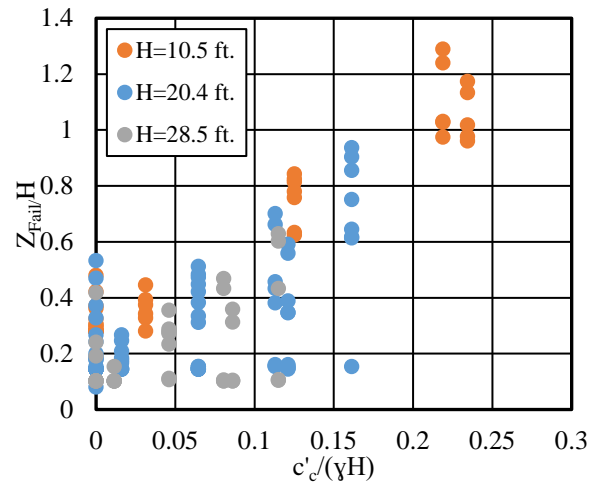
**Figure 47.  $Z_{\text{Fail}}/H$  vs.  $c'/\gamma H$ .**

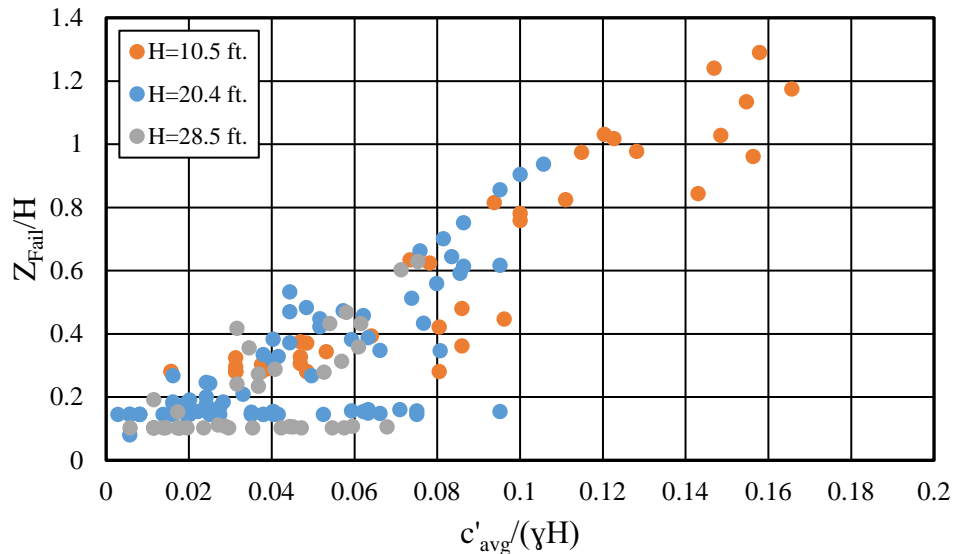
**Figure 48.  $Z_{\text{Fail}}/H$  vs.  $c'_{\text{avg}}/\gamma H$ .**

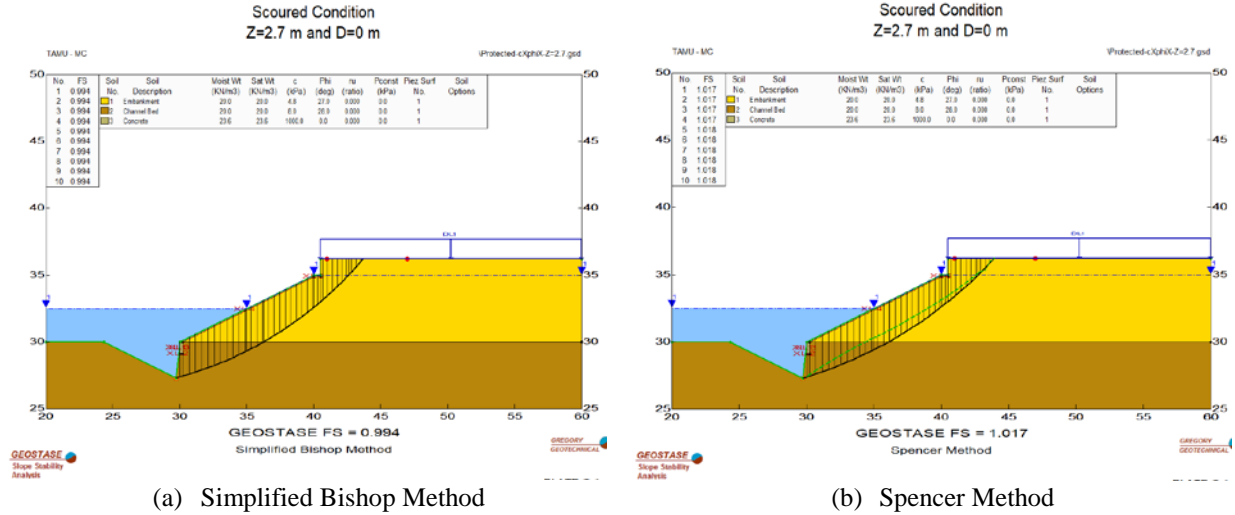
**Figure 49. Failure Surface Shape under Rapid Drawdown Condition.**

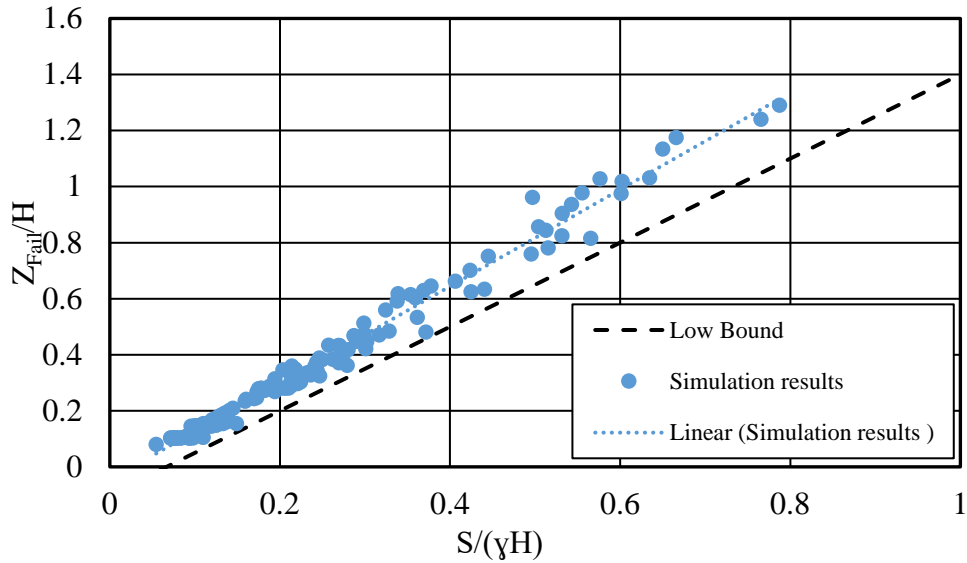
**Figure 50.  $Z_{Fail}/H$  vs.  $S/\gamma H$ .**

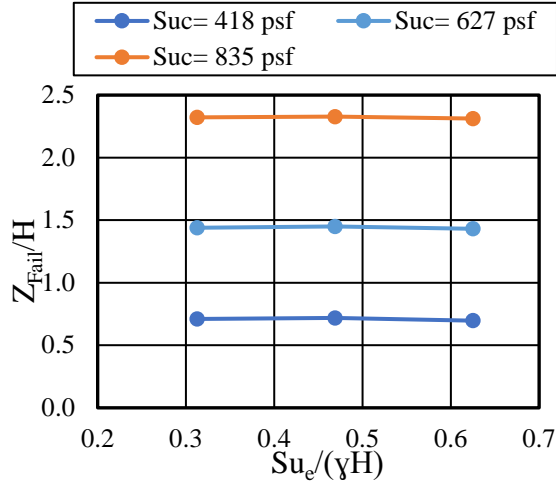
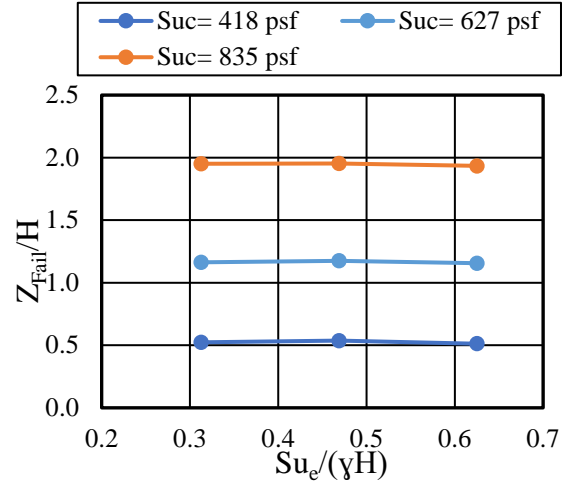
(a) Rapid Drawdown from WL=100% to WL=50%

(b) Rapid Drawdown from WL=100% to WL=0%

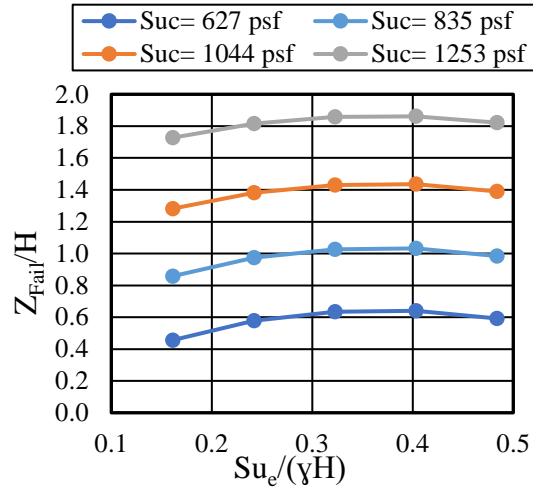
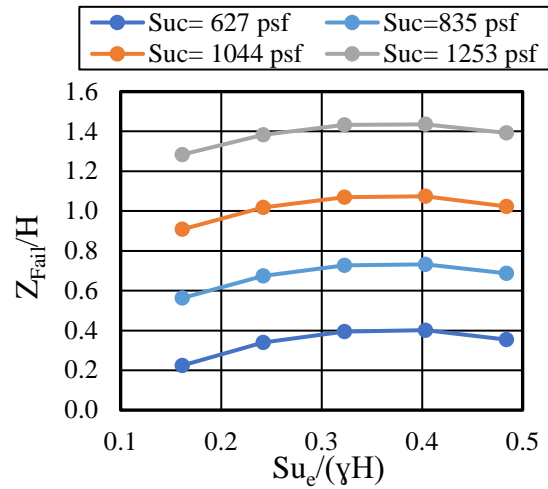
(a) Rapid Drawdown from WL=100% to WL=50%

(b) Rapid Drawdown from WL=100% to WL=0%

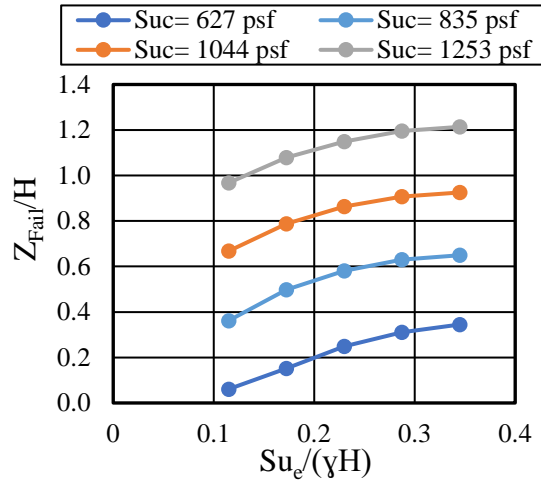
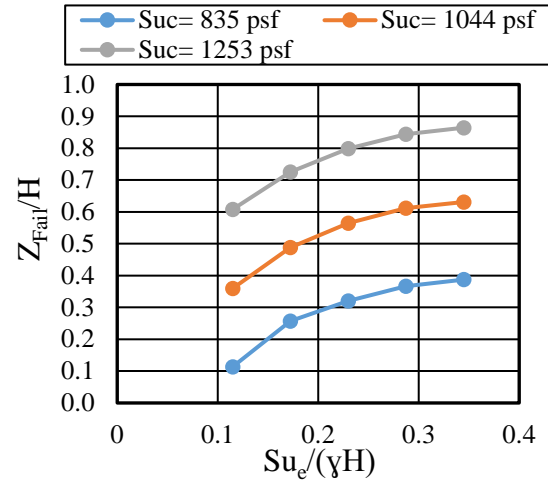
(a) Rapid Drawdown from WL=100% to WL=50%

(b) Rapid Drawdown from WL=100% to WL=0%

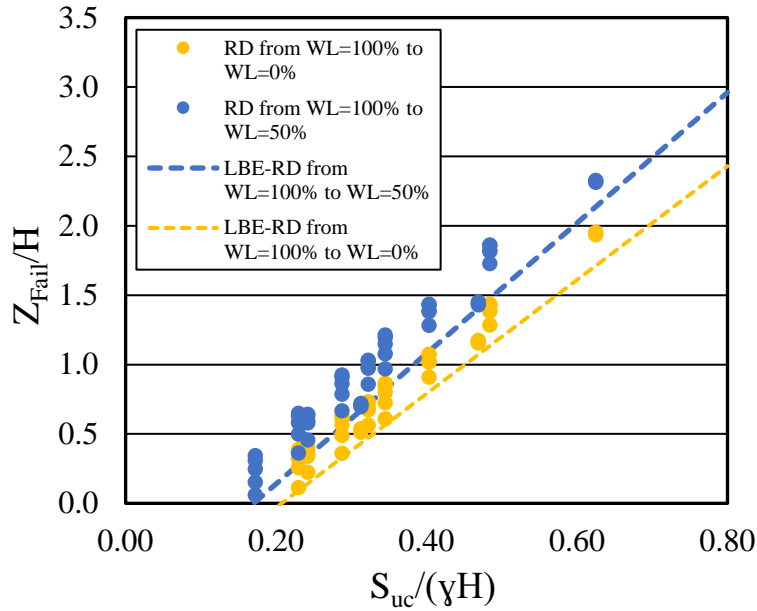
**Figure 55.  $Z_{Fail}/H$  vs.  $S_{uc}/\gamma H$ .**
