# Allowable Limit Contraction and Abutment Scour at Bridges: Technical Report

Technical Report 0-6935-R1

TEXAS A&M TRANSPORTATION INSTITUTE  
COLLEGE STATION, TEXAS

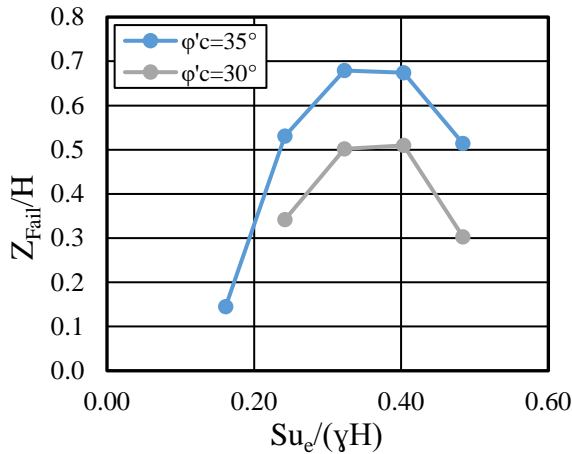
**Figure 56.  $Z_{Fail}/H$  vs.  $S_{uc}/\gamma H$  for Rapid Drawdown to Half Slope Height with  $H = 20.4$  ft.**

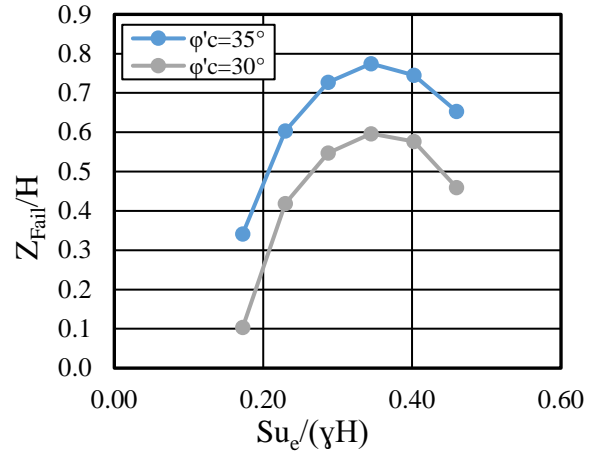
**Figure 57.  $Z_{Fail}/H$  vs.  $S_{uc}/\gamma H$  for Rapid Drawdown to Half Slope Height with  $H = 28.5$  ft.**

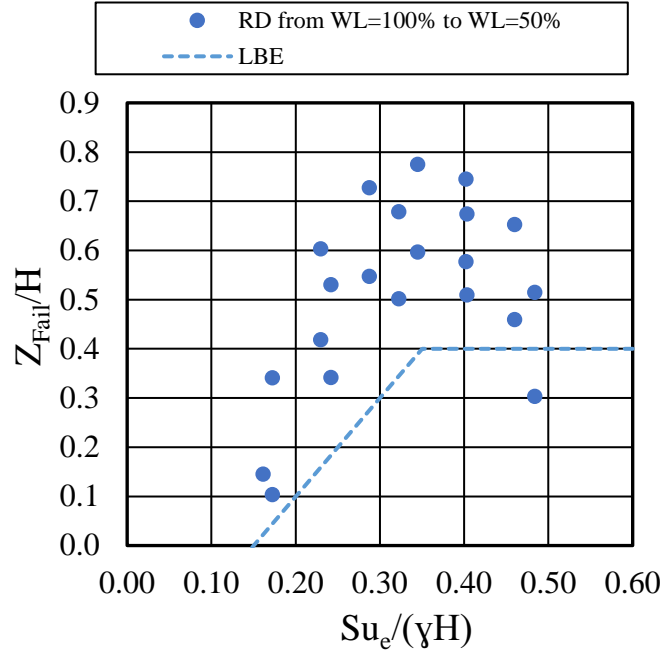
**Figure 58.  $Z_{Fail}/H$  vs.  $S_{ue}/\gamma H$  for Rapid Drawdown to Half Slope Height.**

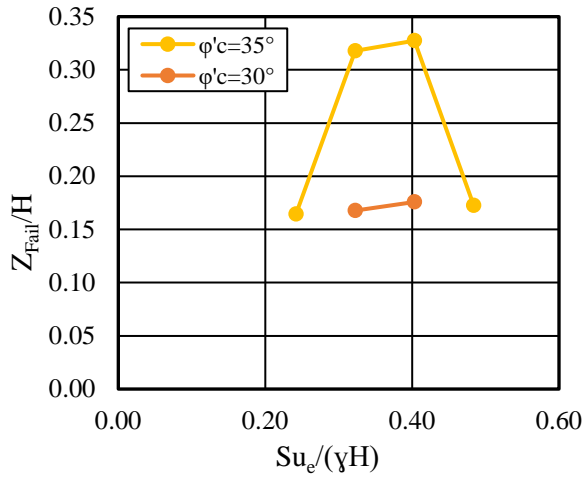
**Figure 59.  $Z_{Fail}/H$  vs.  $S_{ue}/\gamma H$  for Complete Rapid Drawdown with  $H=20.4$  ft.**

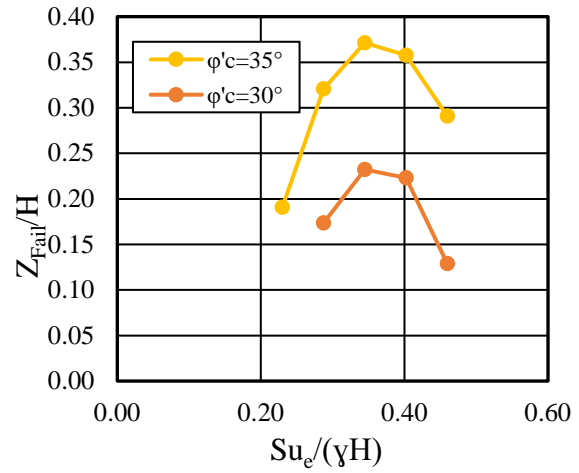
**Figure 60.  $Z_{Fail}/H$  vs.  $S_{ue}/\gamma H$  for Complete Rapid Drawdown with  $H=28.5$  ft.**

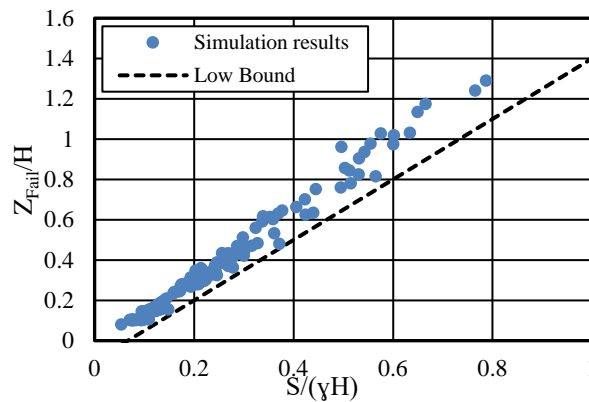
**Figure 61. Effective Stress Analysis Results.**

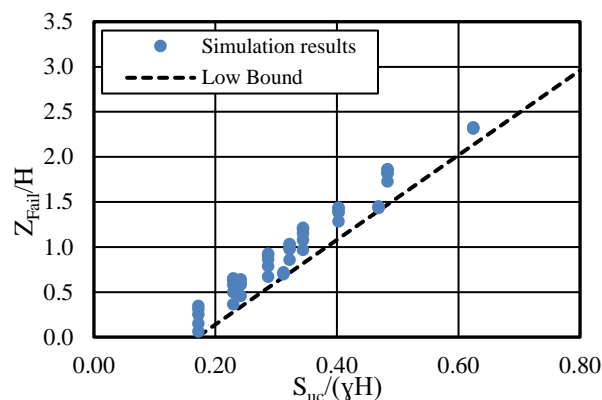
**Figure 62. Total Stress Analysis Results.**

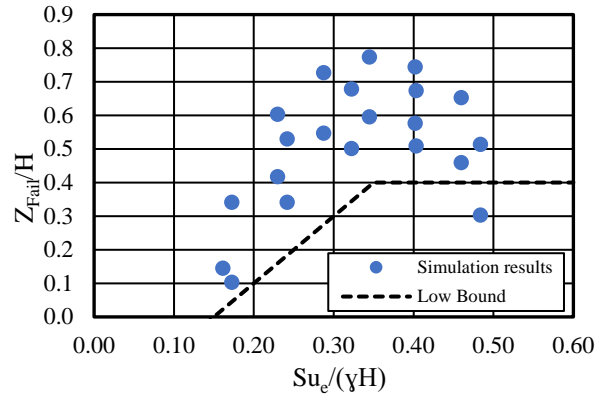
**Figure 63. Total Stress Analysis Results with Cohesionless Channel Bed.**
