MASH TL-4 TESTING AND EVALUATION OF FREE-STANDING SINGLE SLOPE CONCRETE BARRIER WITH CROSS-BOLT CONNECTION

Test Report 0-6968-R5

TEXAS A&M TRANSPORTATION INSTITUTE

Report 0-6968-R5
Project 0-6968
Project Title: Roadside Safety Device Analysis, Testing, and Evaluation Program

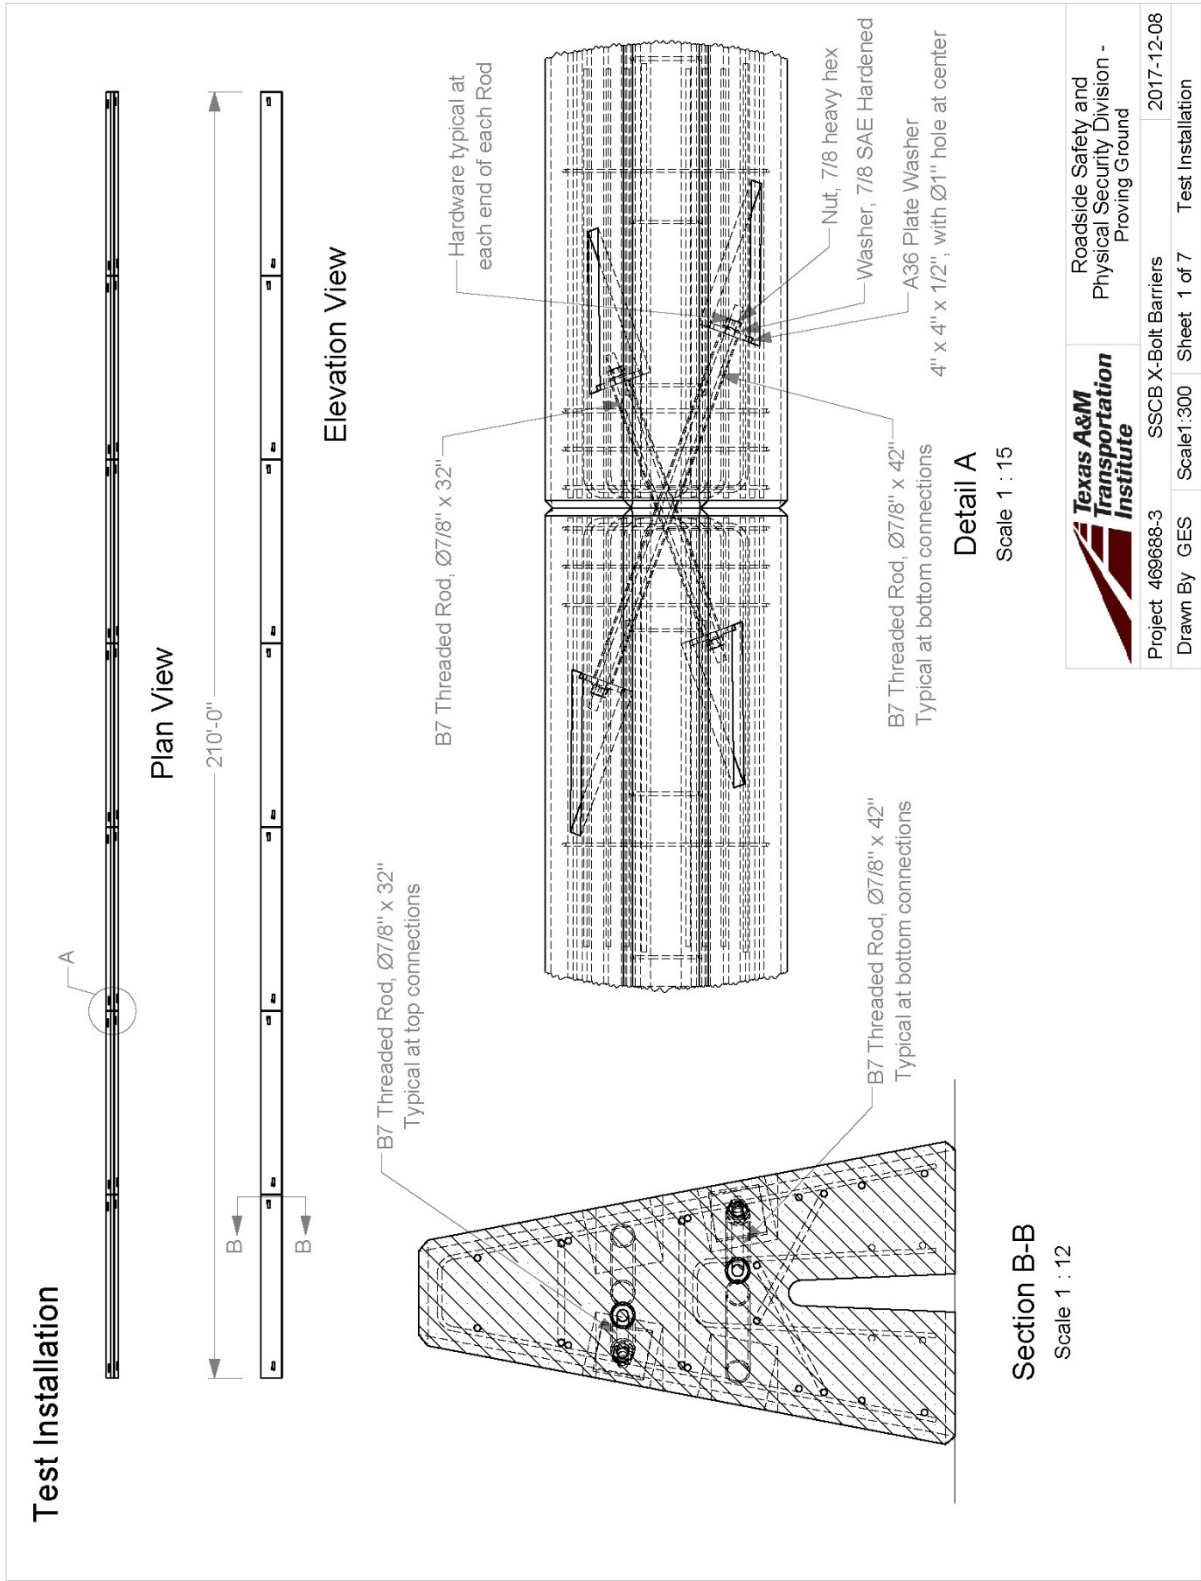
Figure 2.1. Overall Details of the Free-Standing SSCB with Cross-Bolt Connection.

The installation consisted of seven 30-ft long by 42-inch tall reinforced concrete barrier segments, each 8 inches wide at top and tapering on each side to 24 inches wide at the bottom. The total installation length of the barrier test installation was 210 ft. These barrier segments were placed free-standing on an existing concrete apron without any restraints. Adjacent barrier segments were connected to each other using the cross-bolt connection, which was comprised of two $\frac{7}{8}$ -inch diameter threaded rods that passed through each segment in an X pattern, restrained on each end with hex nuts and plate washers.

Figure 2.1 presents overall details on the free-standing SSCB with cross-bolt connection, and Figure 2.2 provides photographs of the installation. Appendix A provides further details of the free-standing SSCB with cross-bolt connection.

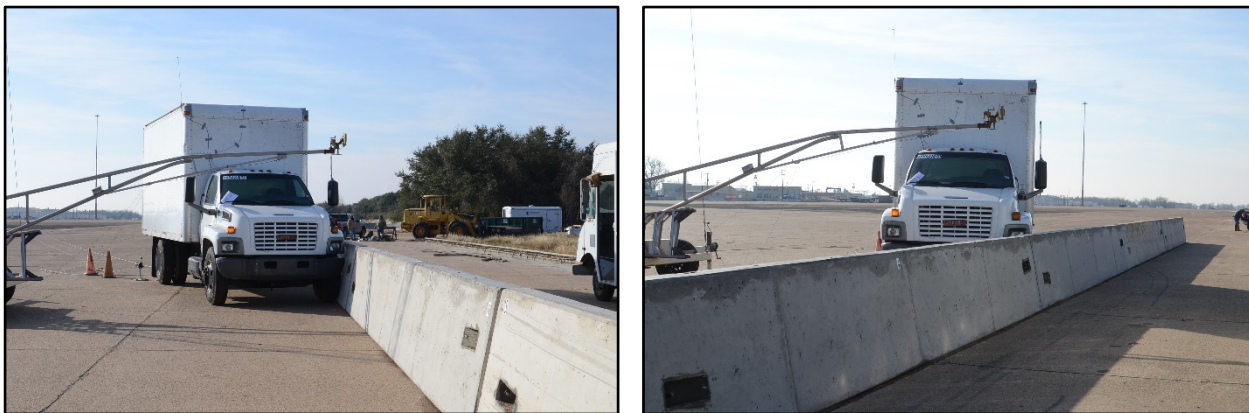
Figure 5.1. Barrier/Test Vehicle Geometrics for Test No. 469688-3-1.

Figures 5.1 and 5.2 show the 2006 GMC C7500 single-unit box-van truck used for the crash test. The vehicle's test inertia weight was 22,290 lb, and its gross static weight was 22,290 lb. The height to the lower edge of the vehicle bumper was 18.5 inches, and height to the upper edge of the bumper was 33.5 inches. The height to the ballast's center of gravity was 64.0 inches. Table C.1 in Appendix C1 gives additional dimensions and information on the vehicle. The vehicle was directed into the installation using a cable reverse tow and guidance system, and was released to be freewheeling and unrestrained just prior to impact.

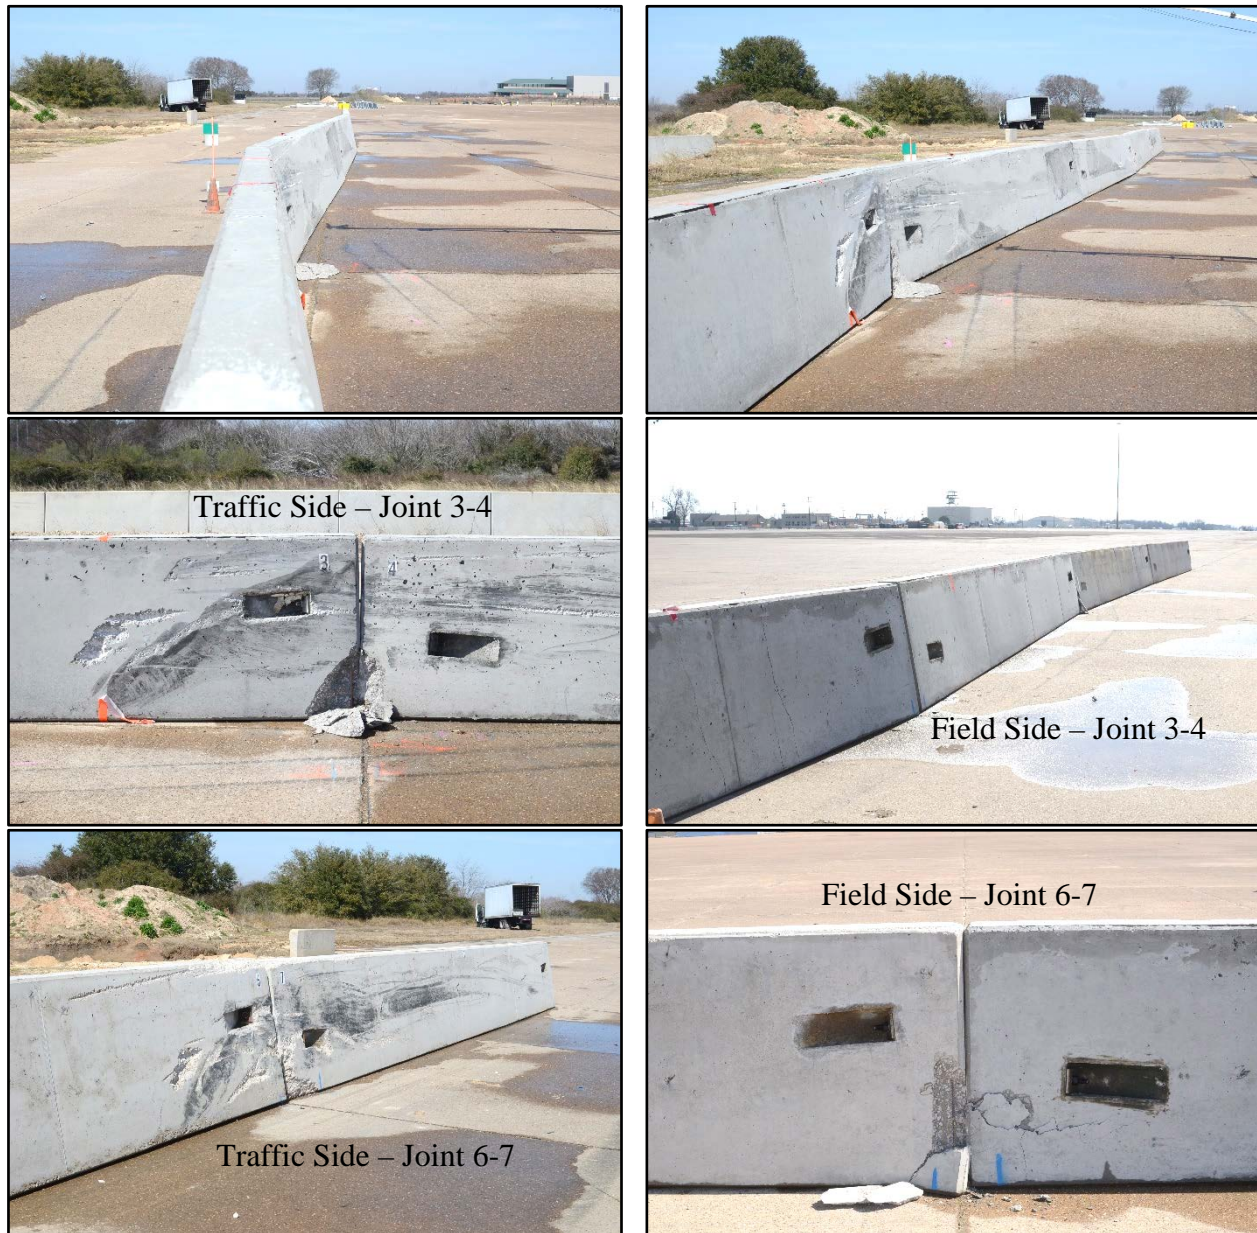
Figure 5.3. Barrier after Test No. 469688-3-1.

Figures 5.3 and 5.4 show the damage to the barrier. Segment 1 and the upstream end of segment 2 were pulled downstream 0.5 inch, and the joint between segments 2 and 3 deflected 2.0 inches toward the field side and 2.5 inches downstream. The segments at joint 3–4 deflected

toward the field side 33.0 inches, and the segments at joint 4–5 deflected 14.0 inches toward the field side. No movement was noted at segments 5 and 6. Segment 4 developed vertically oriented hairline cracks in several places near its center. Working width for the test was 47.0 inches, and the height of the working width was 119.8 inches, both attributable to the top of the cargo box. Maximum dynamic deflection during the test was 33.0 inches, and maximum permanent deformation was 33.0 inches.

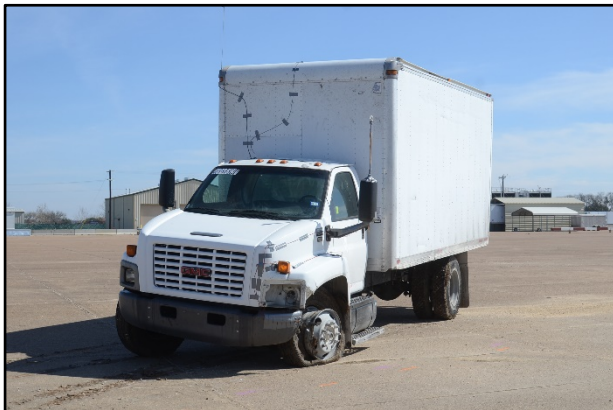
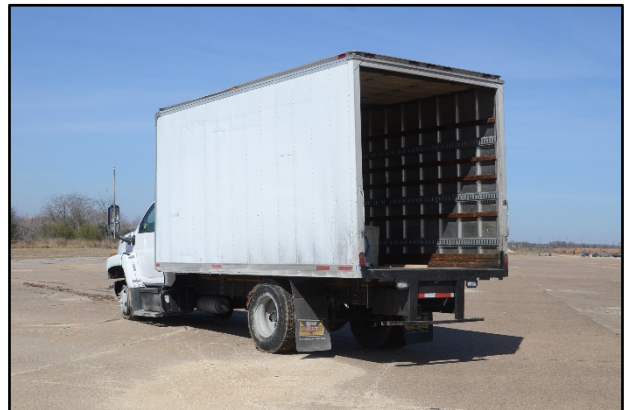
Figure 5.5. Test Vehicle after Test No. 469688-3-1.

Figure 5.5 shows the damage sustained by the vehicle. The front bumper, hood, left front spring, left front tire and rim, and left front corner of the box were damaged. Maximum exterior crush to the vehicle was 7.0 inches in the side plane at the left front corner at bumper height. Maximum occupant compartment deformation was 4.0 inches in the left kick panel/firewall area. Figure 5.6 shows the interior of the vehicle.

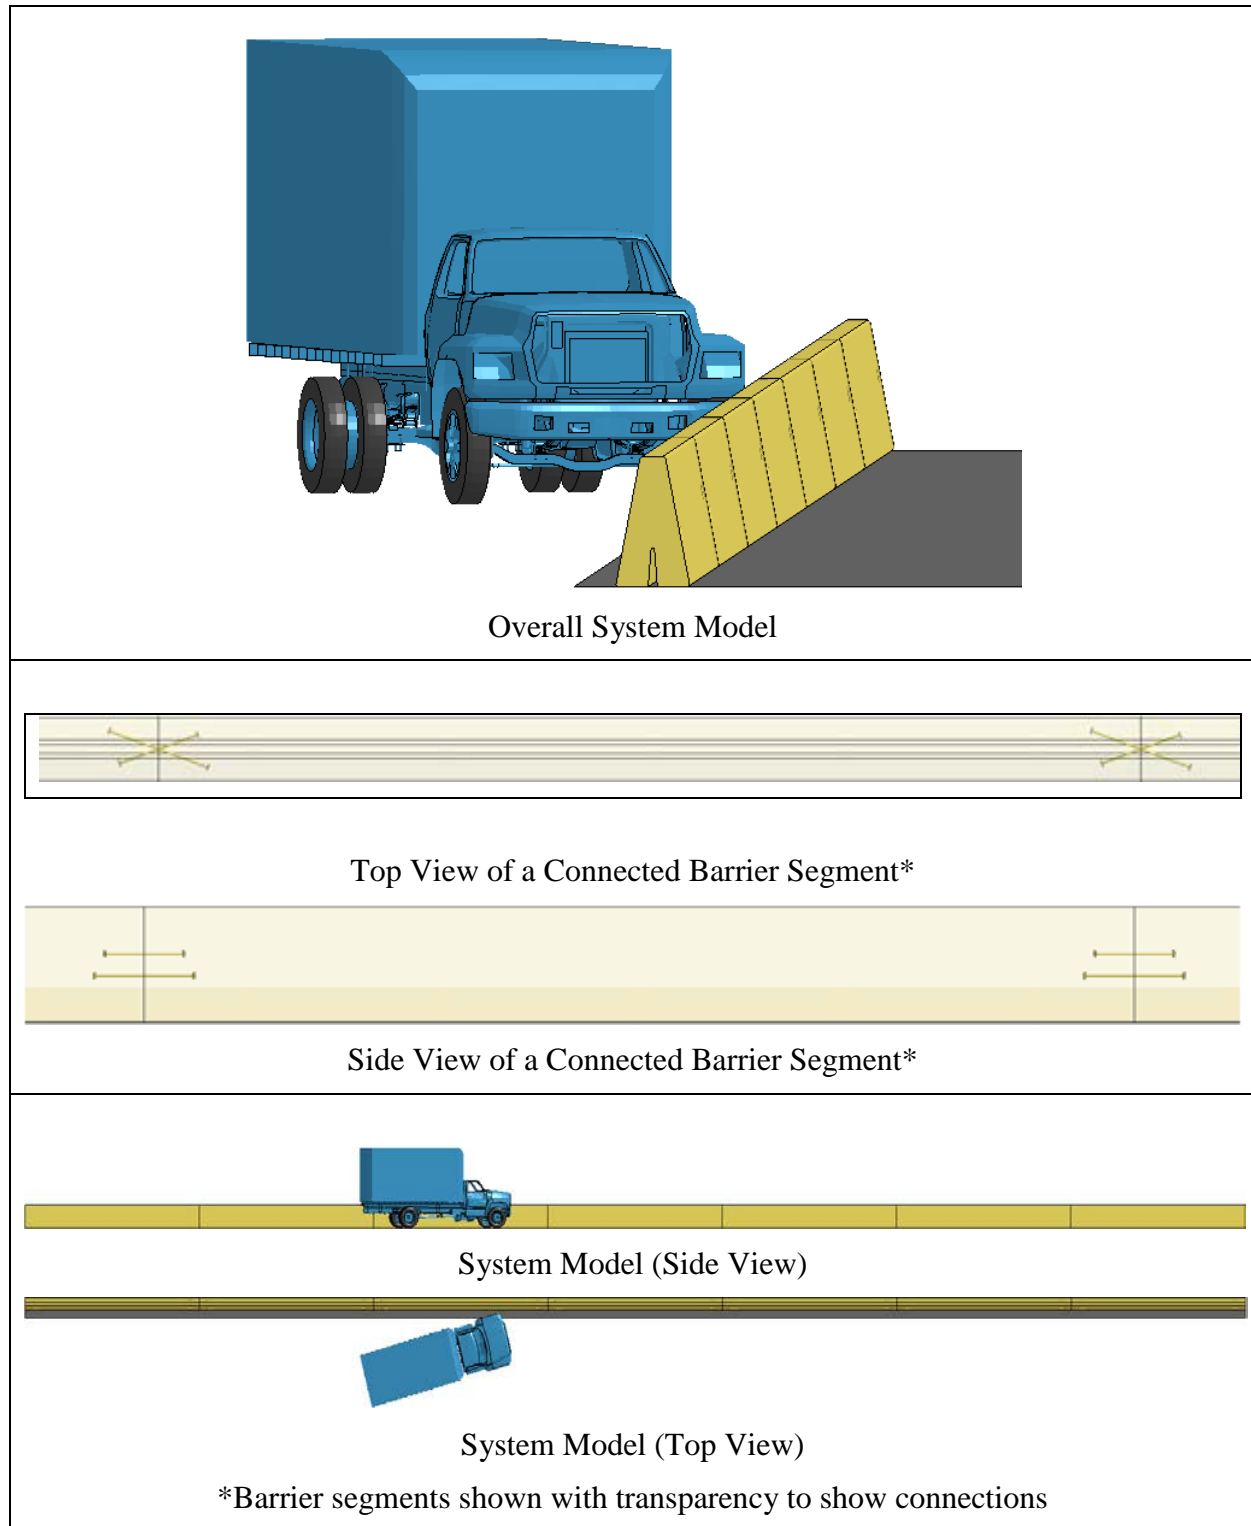
Figure 6.1. Simulation Model Details of Tested Design.

The single-unit truck simulations were performed for *MASH* Test 4-12 impact conditions, which involve the vehicle impacting the barrier at 56 mi/h and 15 degrees. The vehicle model used in the simulations was originally developed by National Crash Analysis Center and Battelle under sponsorship from the Federal Highway Administration. This model has subsequently been modified to meet *MASH* 10000S specifications and improved for greater accuracy and robustness by Texas A&M Transportation Institute (TTI) over the course of many research projects involving simulation and testing with the single unit truck.

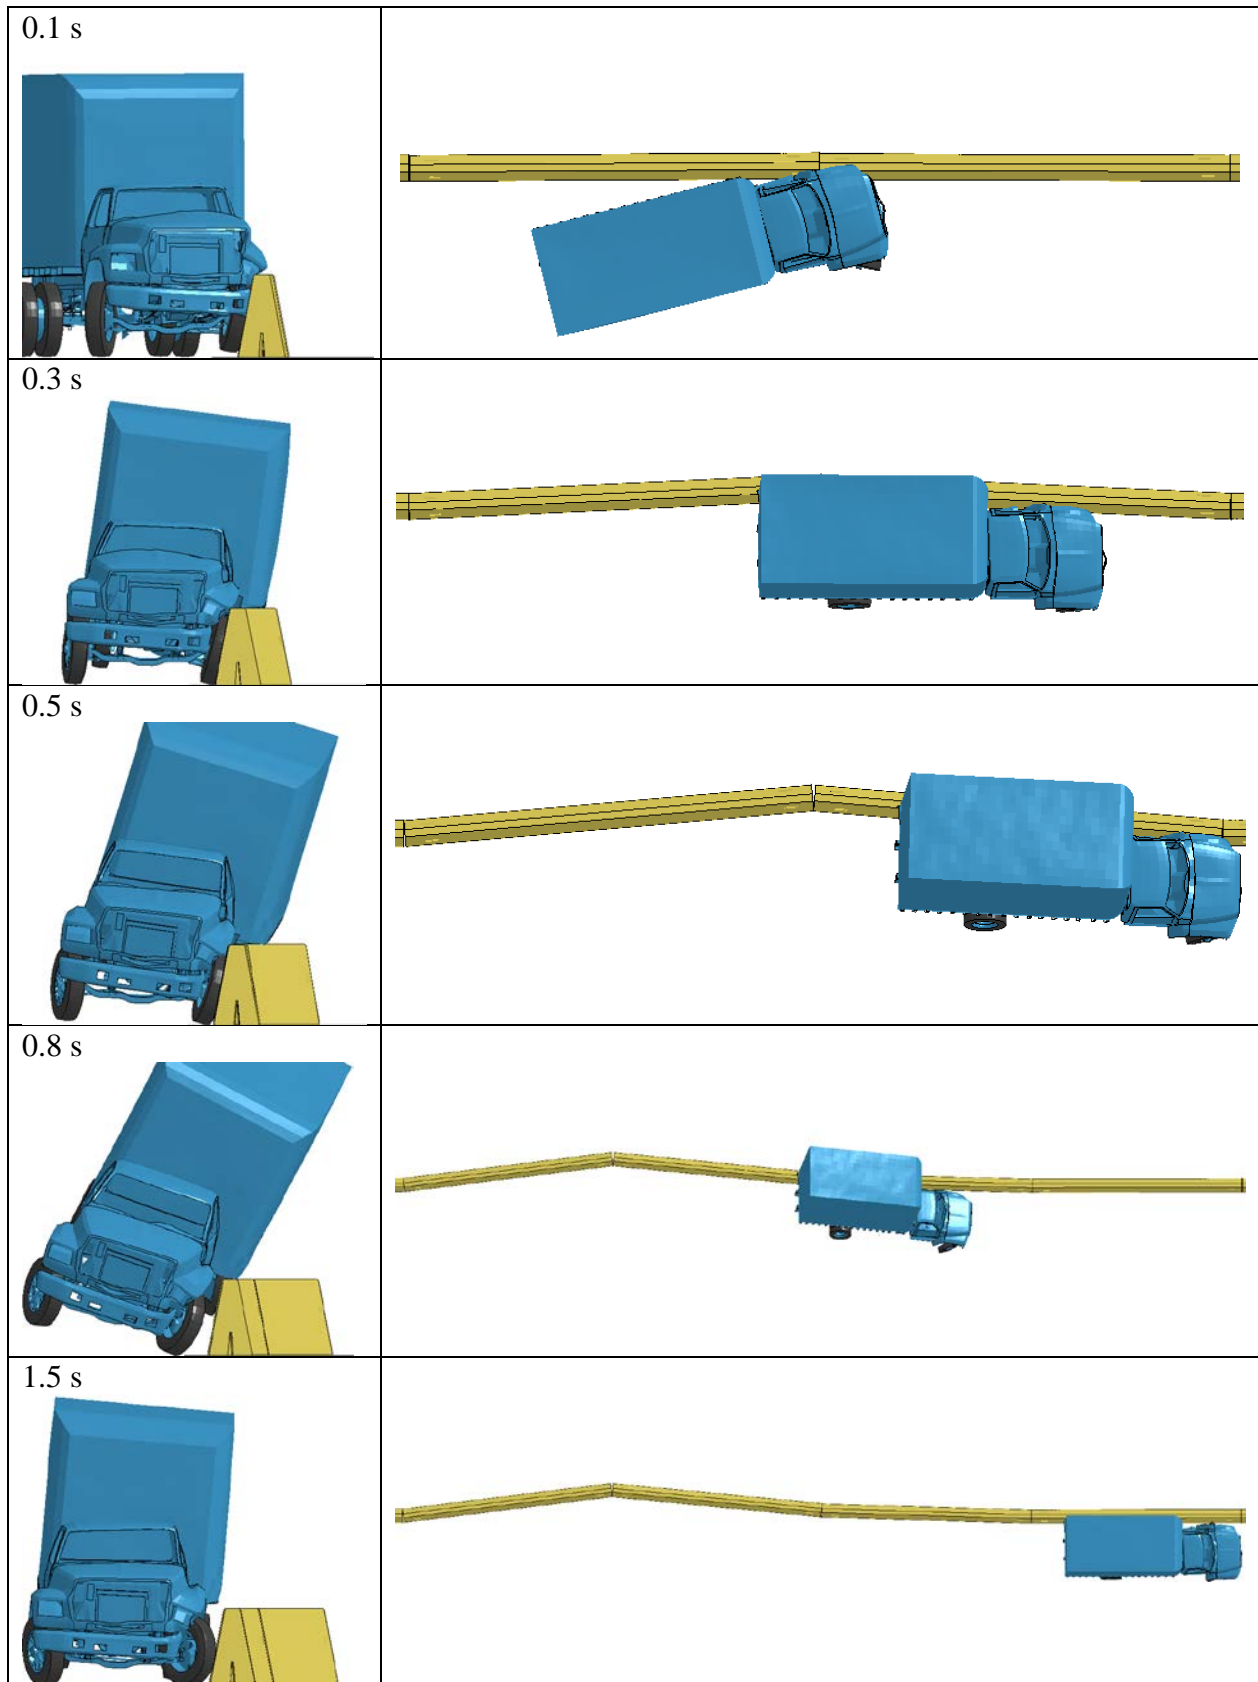
Figure 6.2. Sequential Images of the Simulation for *MASH* Test 4-12.

Figure 6.2 shows the results of the simulation analysis for *MASH* Test 4-12 with the single-unit truck. The free-standing barrier successfully contained and redirected the vehicle as in the full-scale test. The permanent deflection of the barrier was 44.6 inches in the simulation, which is 1.35 times greater than the 33-inch maximum deflection observed in the full-scale crash test. Some of the differences in the test and simulation deflection can be attributed to the failure and cracking of the barrier concrete during the impact, which dissipates some of the impact energy and reduces the bending load on the threaded rods comprising the barrier's cross-bolt connections. The barrier segments in the simulations were modeled with rigid material representation for simplicity. This resulted in greater load being transferred to the cross-bolt connections, resulting in greater bending of the threaded rods and, therefore, a larger deflection in the simulation compared to the test.

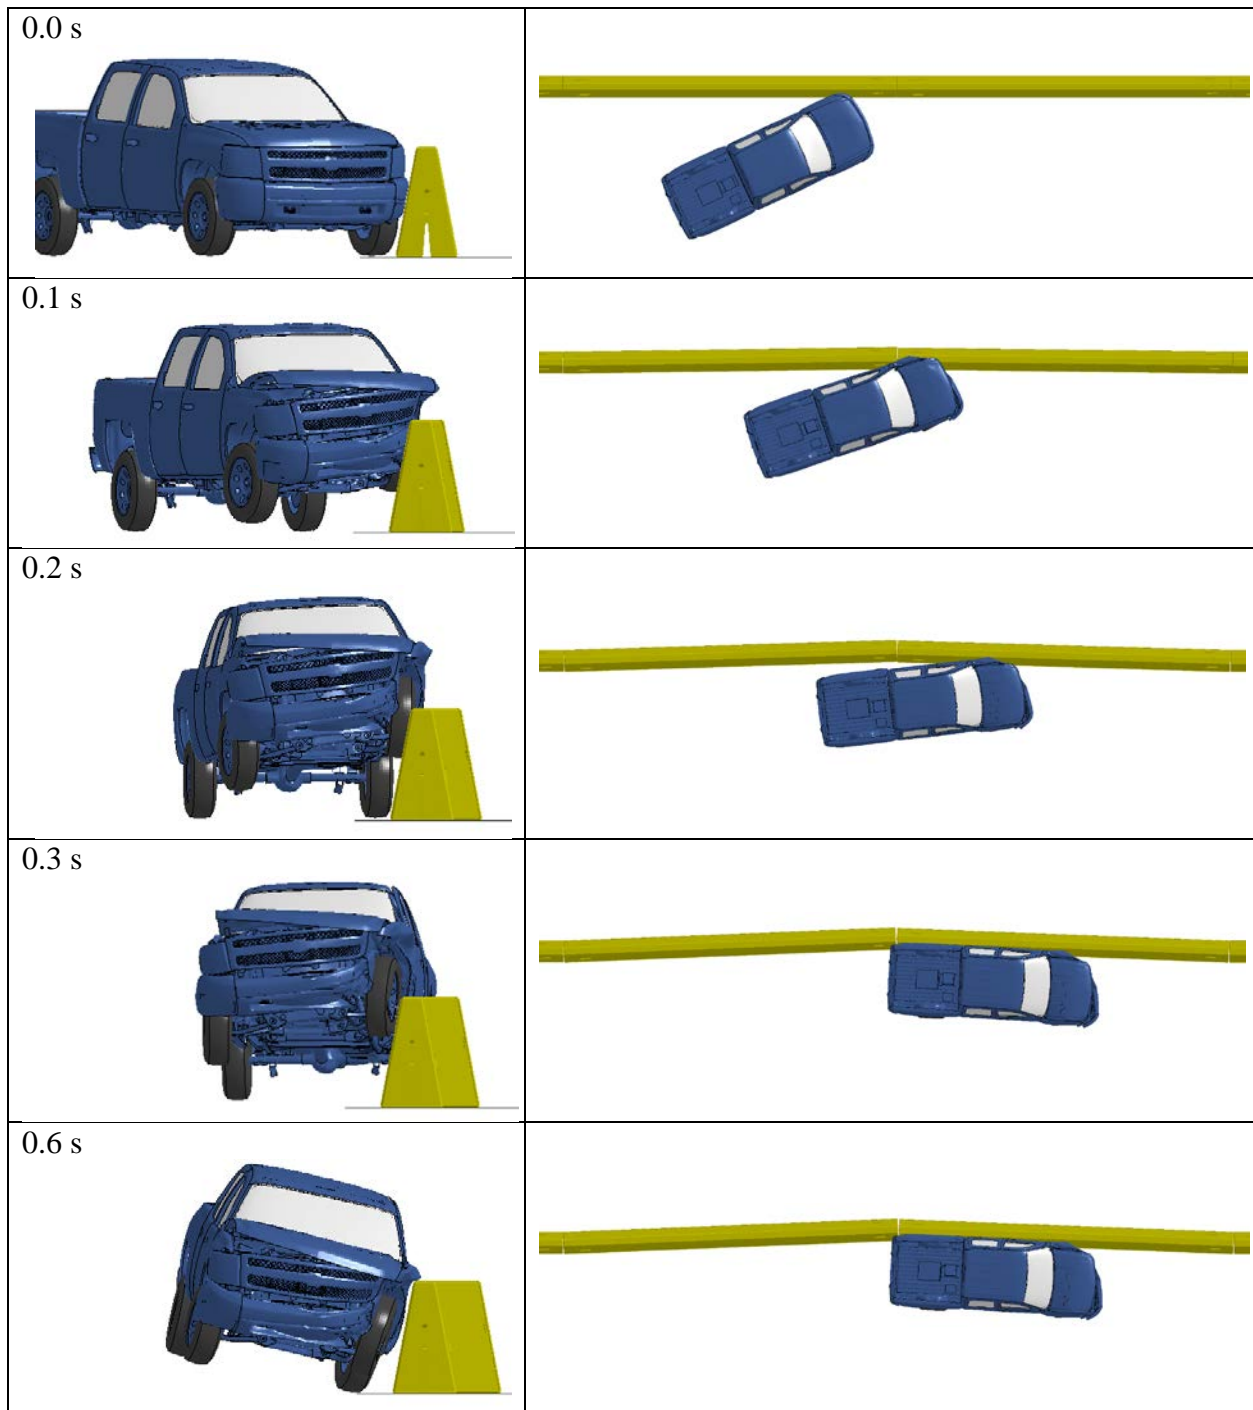
Figure 6.3. Sequential Images of the Simulation for *MASH* Test 4-11.

Figure 6.3 shows results of the impact simulation with the pickup truck model under *MASH* Test 4-11 conditions. The vehicle impacted the barrier 4.3 ft upstream of the connection between the third and fourth barrier segment. The impact point was selected using the CIP recommendations provided in the Section 2.2 and 2.3 of *MASH*. The barrier successfully contained and redirected the vehicle in the simulation. The maximum permanent lateral deflection of the barrier was 16.8 inches. This deflection was scaled using the ratio observed for the single unit truck impact to arrive at the expected pickup truck deflection of 12.5 inches.

Thus, using the results of the simulations, the estimated lateral deflection of the free-standing single slope barrier with cross-bolt connections ranges between 12.5 and 16.8 inches.

Based on the simulation analysis performed under this project, the barrier is expected to have a deflection range of 12.5 to 16.8 inches for pickup truck impact under *MASH* Test 4-11 (which is an equivalent test condition to *MASH* Test Level 3, Test 3-11). This low deflection makes this TL-4 barrier suitable for use as a work zone barrier.

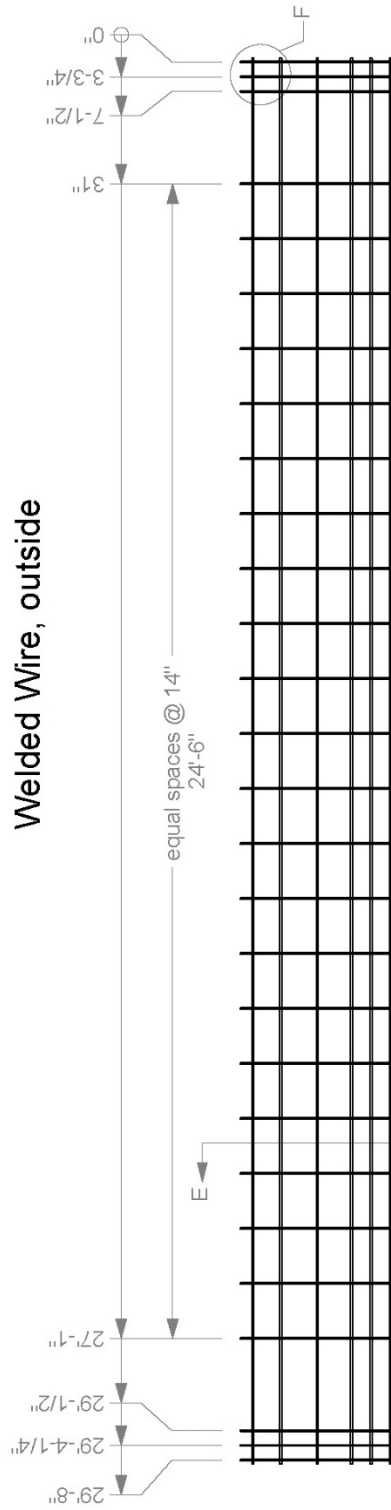
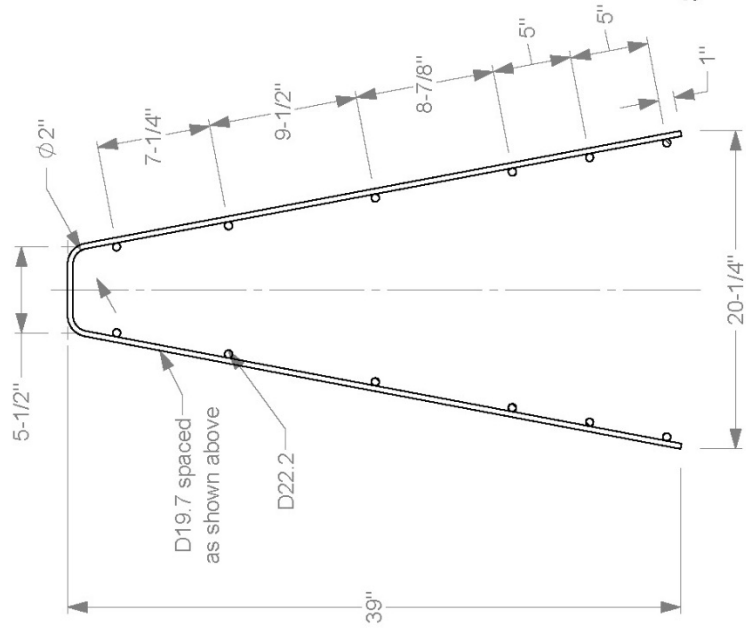
Roadside Safety and Physical Security Division - Proving Ground	
	SSCB X-Bolt Barriers	2017-12-08
Project 469688-3	Scale 1:40	Sheet 5 of 7
Drawn By GES	Scale 1:40	Welded Wire, outside

Elevation View

Section E-E

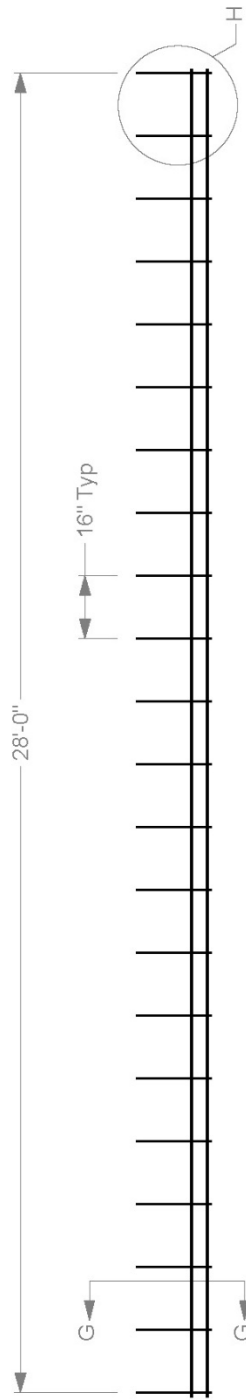
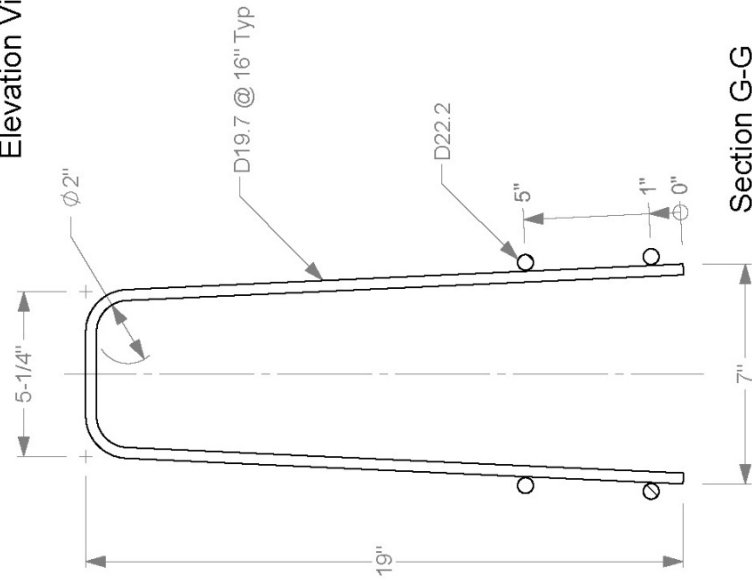
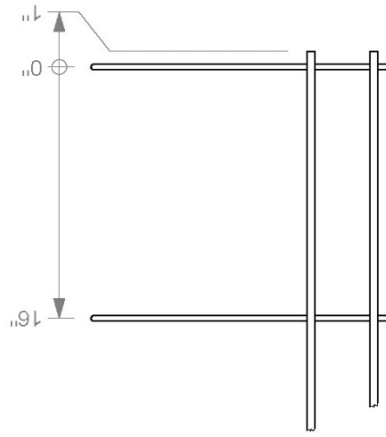
Roadside Safety and Physical Security Division - Proving Ground		
	Project 469688-3	SSCB X-Bolt Barriers	2017-12-08
Drawn By	GES	Scale 1:40	Sheet 6 of 7
			Welded Wire, inside

Elevation View

Section G-G

Detail H

6a. All welded wire components are grade 70.

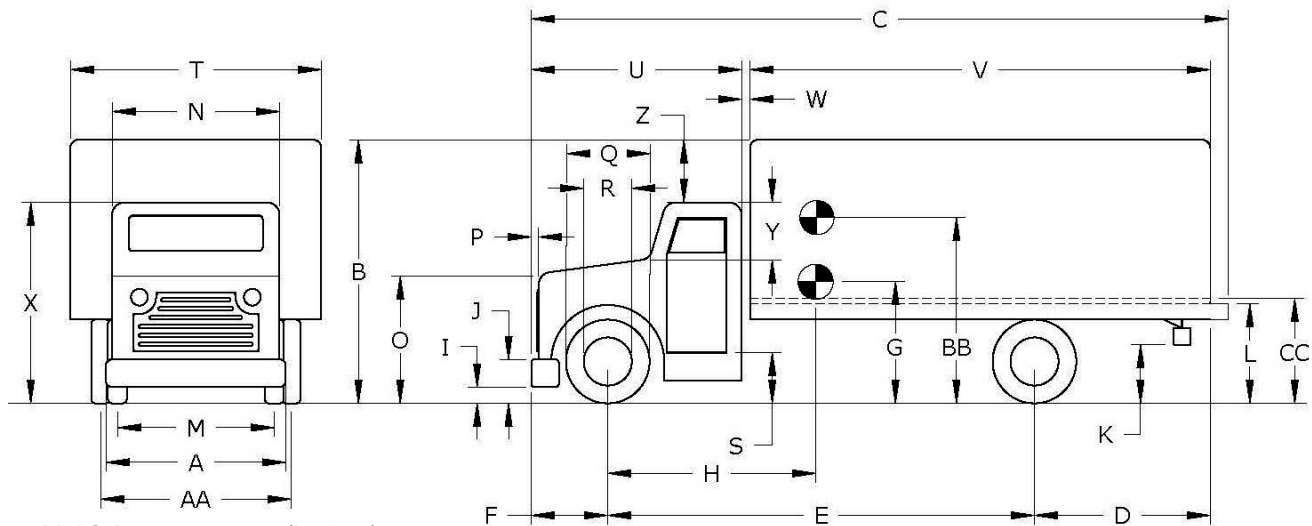
Table C.1. Vehicle Properties for Test No. 469688-3-1.

A Front Bumper Width:	<u>93.50</u>	K Rear Bumper Bottom:	<u> </u>	U Cab Length:	<u>102.00</u>
B Overall Height:	<u>150.00</u>	L Rear Frame Top:	<u>39.00</u>	V Trailer/Box Length:	<u>222.50</u>
C Overall Length:	<u>329.50</u>	M Front Track Width:	<u>82.00</u>	W Gap Width:	<u>3.00</u>
D Rear Overhang:	<u>86.50</u>	N Roof Width:	<u>60.00</u>	X Overall Front Height:	<u>99.50</u>
E Wheel Base:	<u>206.00</u>	O Hood Height:	<u>61.00</u>	Y Roof-Hood Distance:	<u>26.00</u>
F Front Overhang:	<u>37.00</u>	P Bumper Extension:	<u>2.00</u>	Z Roof-Box Height Difference:	<u>49.00</u>
G C.G. Height:	<u> </u>	Q Front Tire Width:	<u>41.50</u>	AA Rear Track Width:	<u>72.00</u>
H C.G. Horizontal Dist. w/Ballast:	<u>131.70</u>	R Front Wheel Width:	<u>23.00</u>	BB Ballast Center of Mass:	<u>64.00</u>
I Front Bumper Bottom:	<u>18.50</u>	S Bottom Door Height:	<u>35.50</u>	CC Cargo Bed Height:	<u>50.50</u>
J Front Bumper Top:	<u>33.50</u>	T Overall Width:	<u>101.75</u>

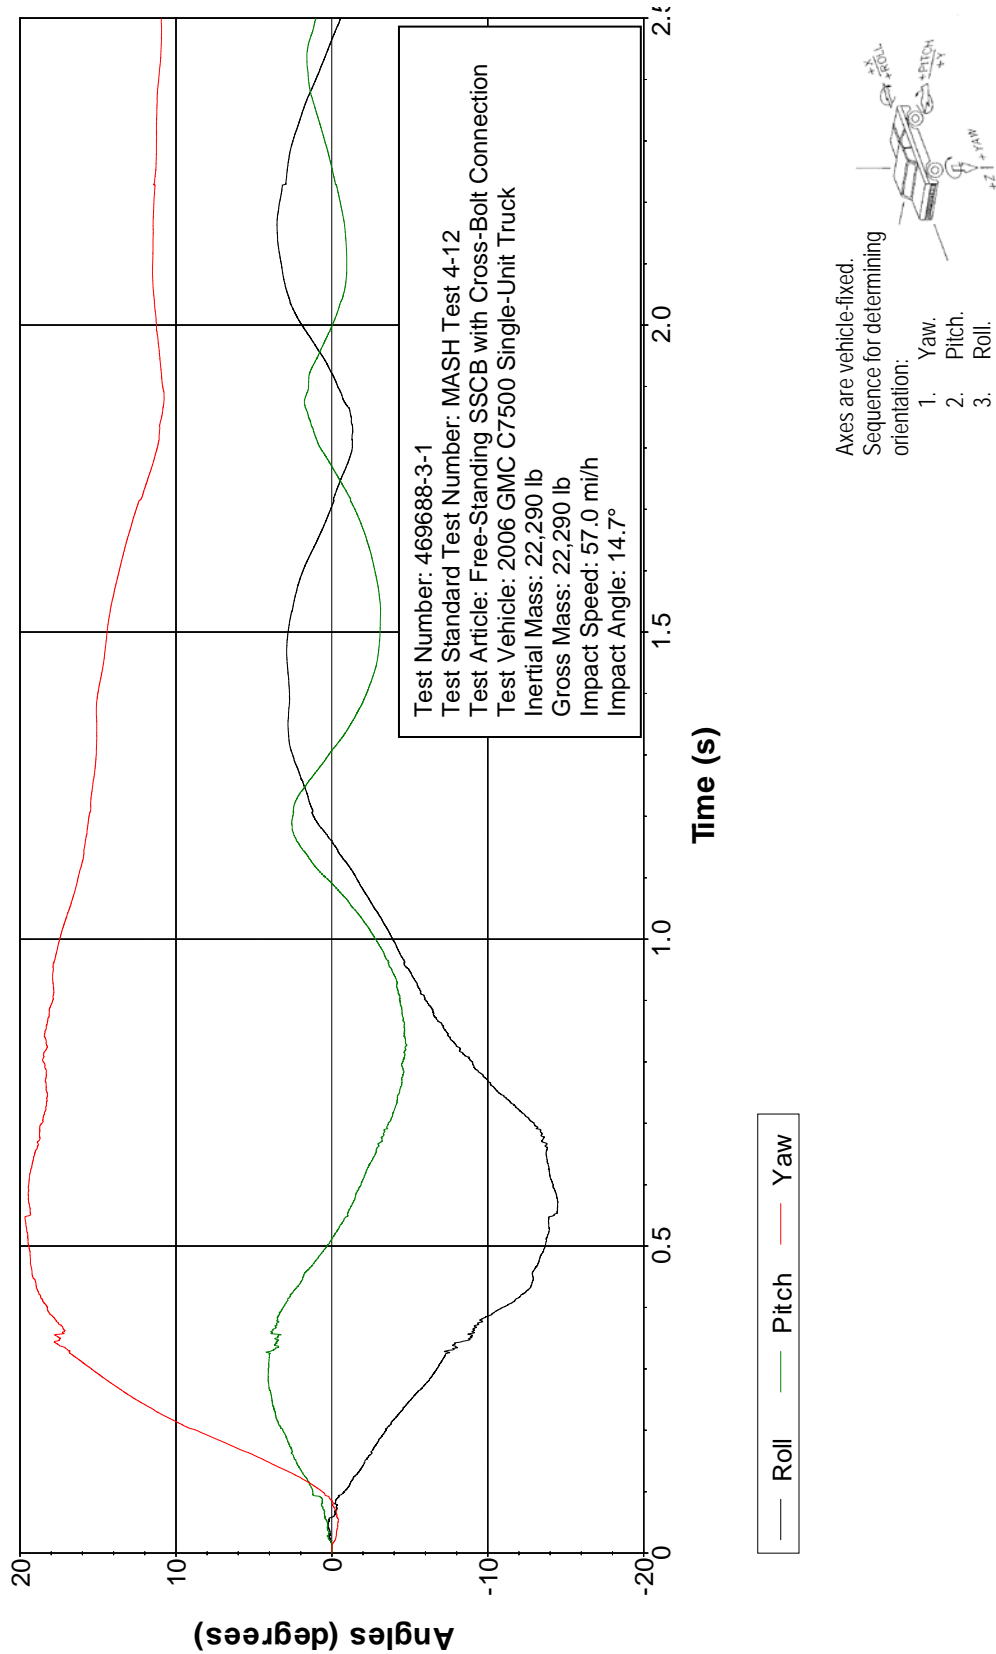
Figure C.3. Vehicle Angular Displacements for Test No. 469688-3-1.

Roll, Pitch, and Yaw Angles

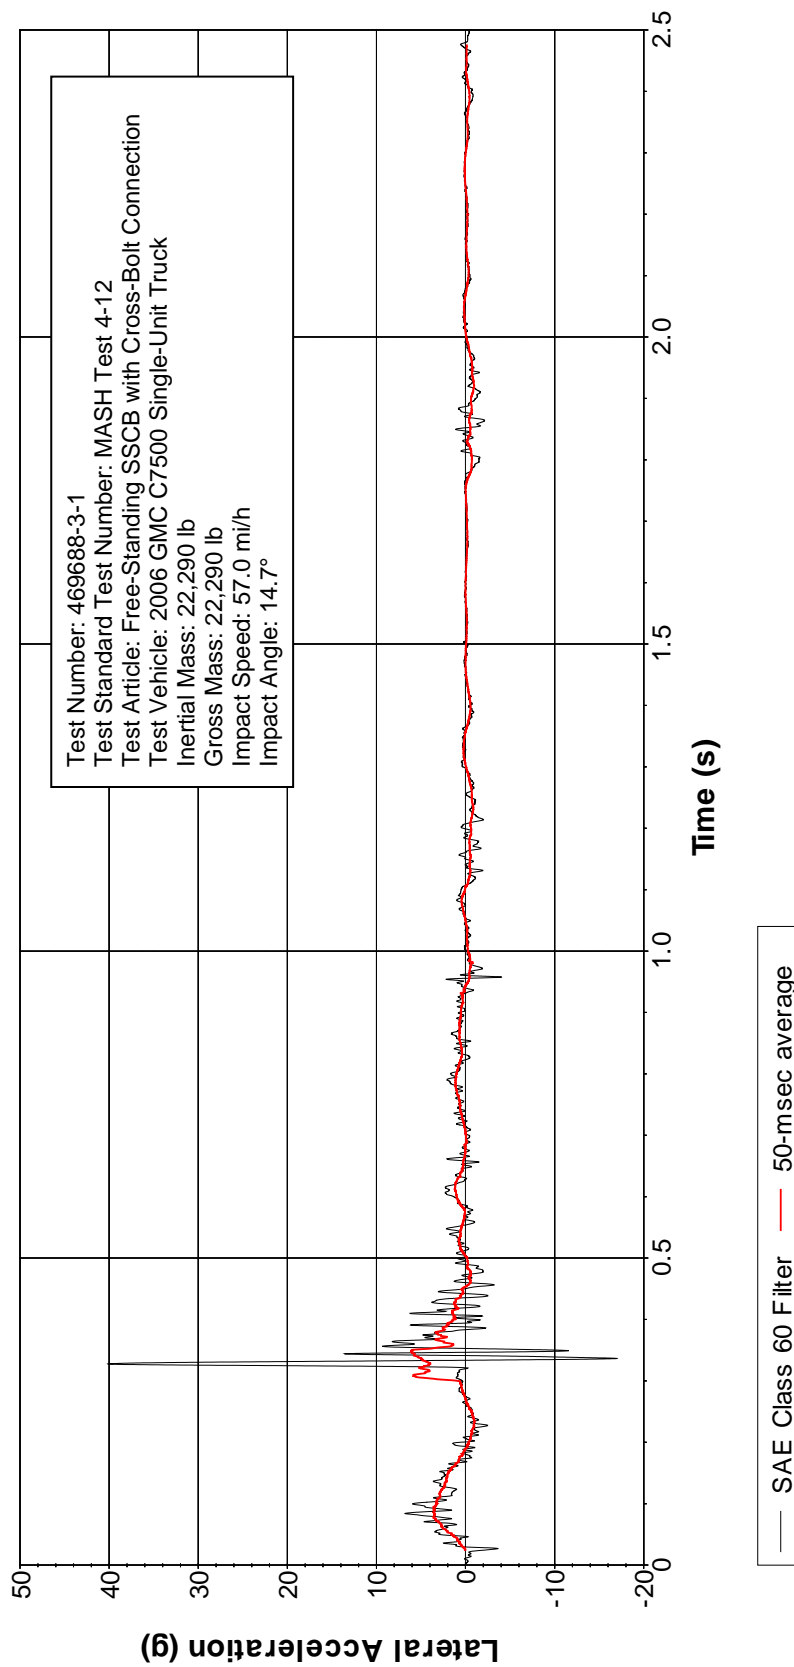
Figure C.5. Vehicle Lateral Accelerometer Trace for Test No. 469688-3-1
 (Accelerometer Located at Center of Gravity).

Y Acceleration at CG

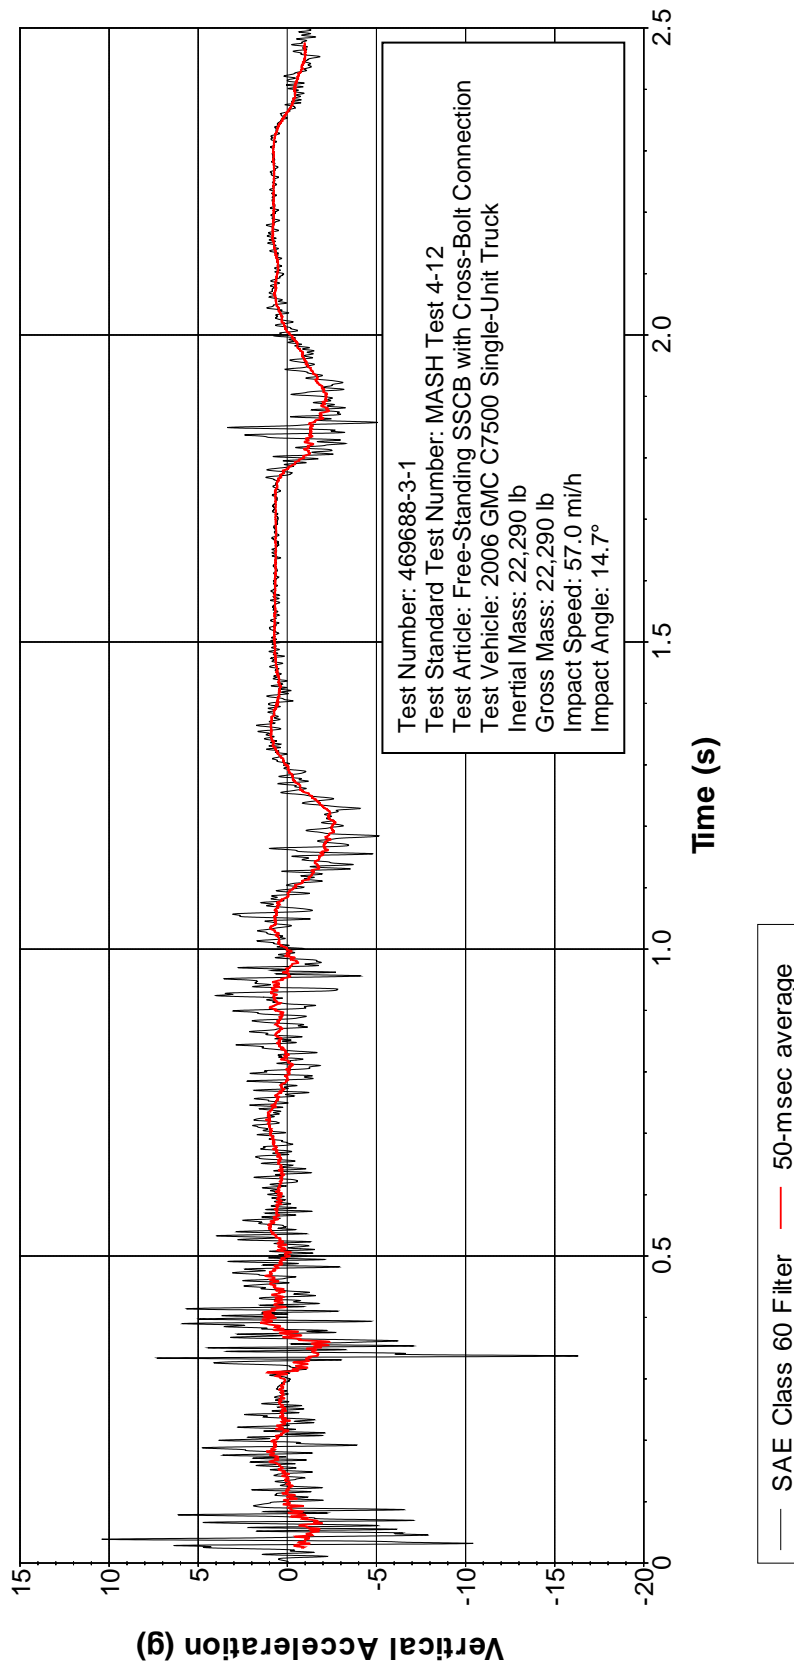
Figure C.6. Vehicle Vertical Accelerometer Trace for Test No. 469688-3-1
(Accelerometer Located at Center of Gravity).

Z Acceleration at CG

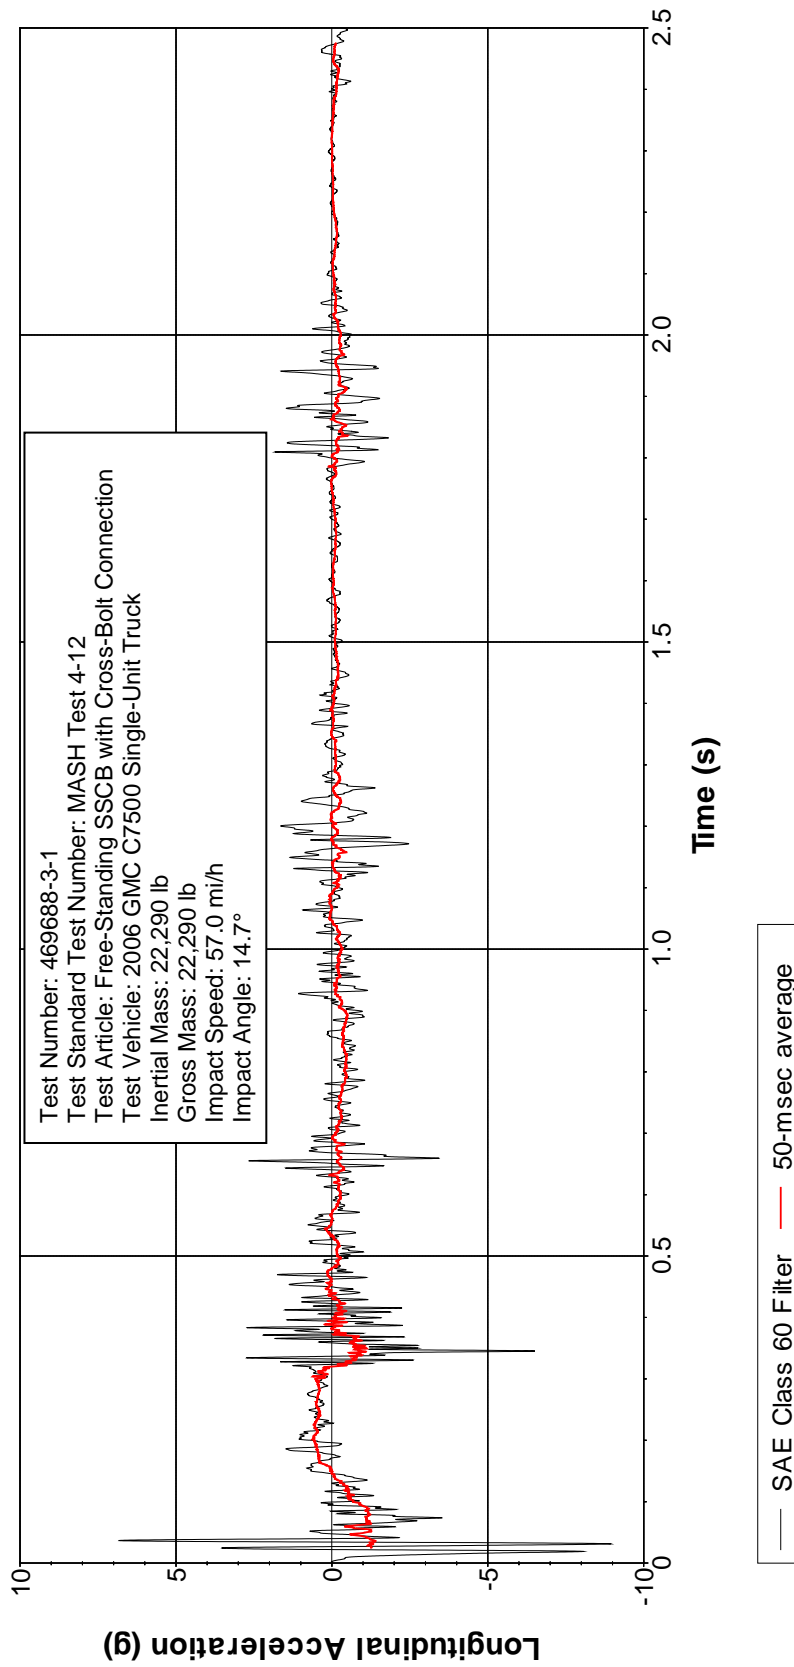
**Figure C.7. Vehicle Longitudinal Accelerometer Trace for Test No. 469688-3-1
(Accelerometer Located Rear of Center of Gravity).**

X Acceleration Rear of CG

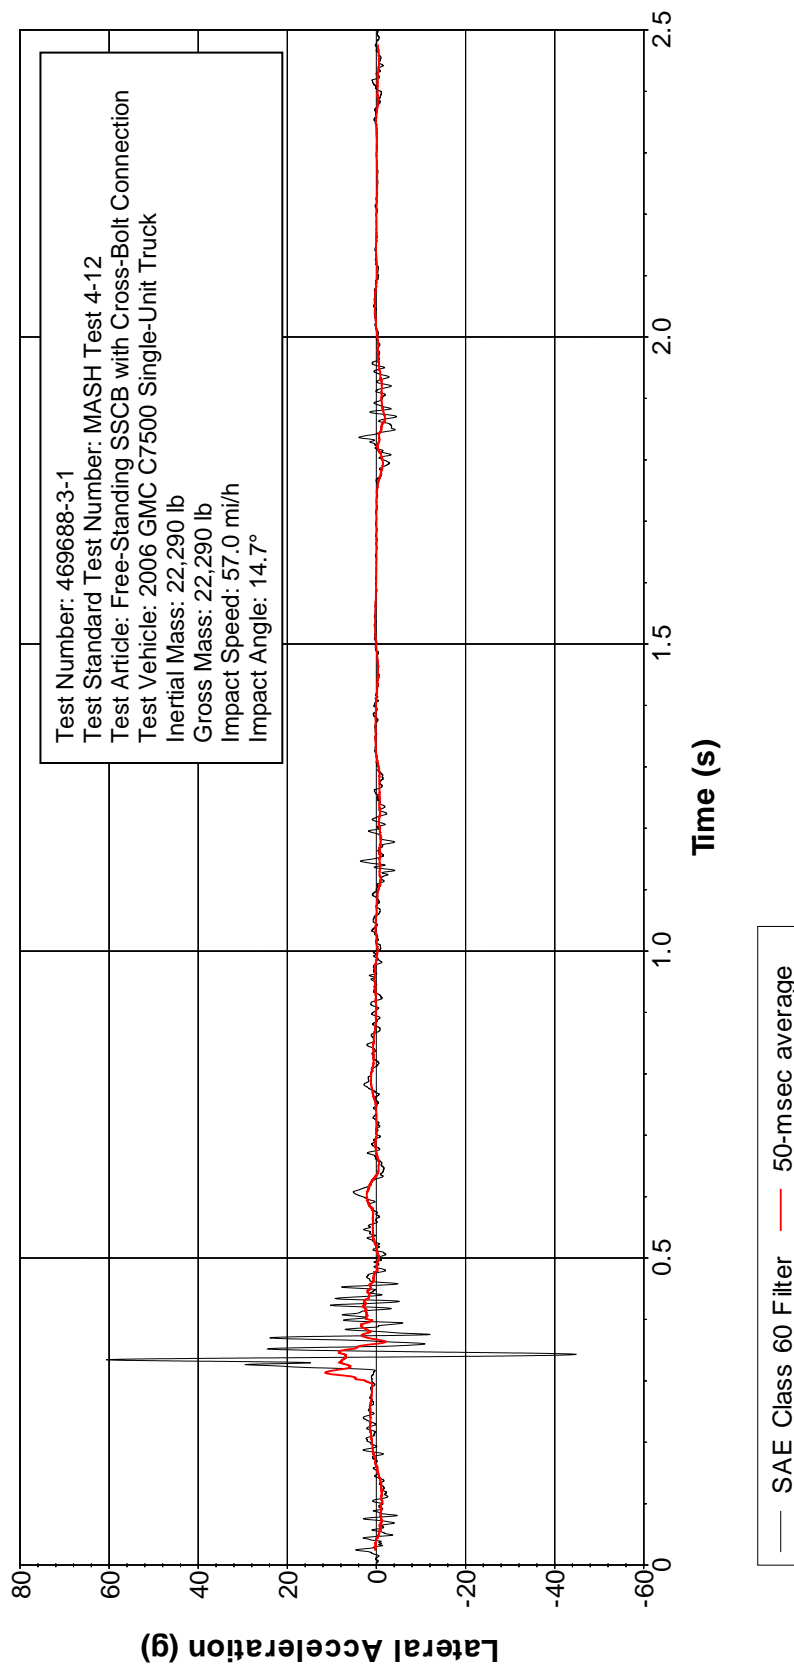
**Figure C.8. Vehicle Lateral Accelerometer Trace for Test No. 469688-3-1
 (Accelerometer Located Rear of Center of Gravity).**

Y Acceleration Rear of CG
