MASH TL-4 TESTING AND EVALUATION OF FREE-STANDING SINGLE SLOPE CONCRETE BARRIER WITH CROSS-BOLT CONNECTION

Test Report 0-6968-R5

TEXAS A&M TRANSPORTATION INSTITUTE

Report 0-6968-R5
Project 0-6968
Project Title: Roadside Safety Device Analysis, Testing, and Evaluation Program

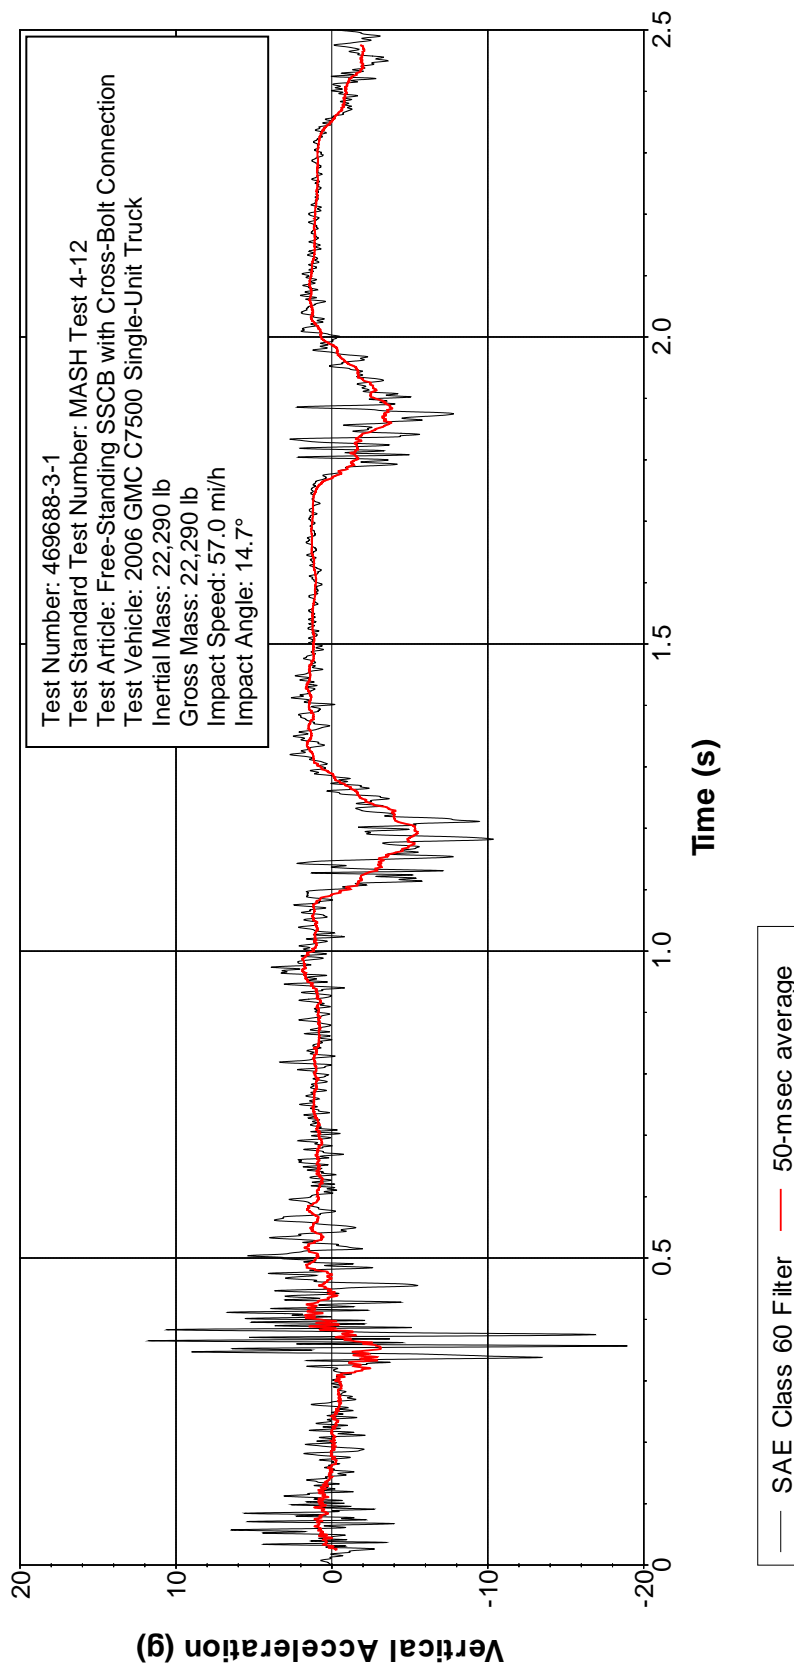
**Figure C.9. Vehicle Vertical Accelerometer Trace for Test No. 469688-3-1
 (Accelerometer Located Rear of Center of Gravity).**

Z Acceleration Rear of CG
