US 31W Jefferson County Pavement Surface Treatment Evaluation

Report Number: KTC-18-14/FRT209 SHRP II

**US 31W Jefferson County
Pavement Surface Treatment Evaluation**

July 2018

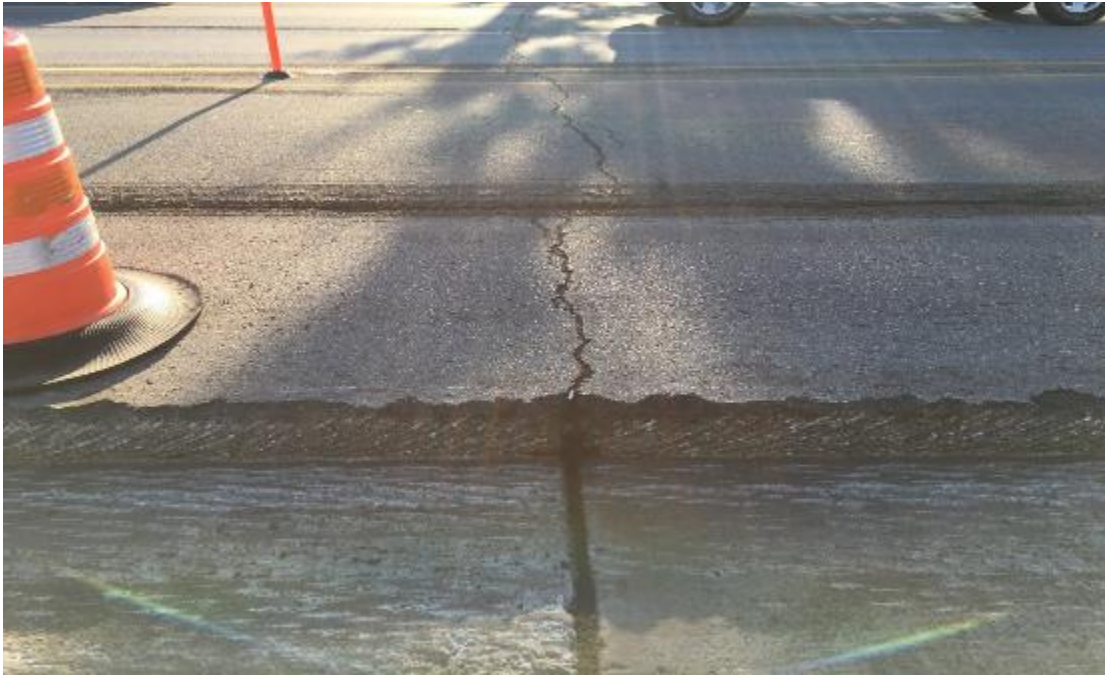
Figure 1 Example of Reflective Cracking

Reflective cracking inevitably occurs when asphaltic concrete (AC) is placed over an existing unfractured Portland cement concrete (PCC) pavement. However, manufacturers state their products will mitigate reflective cracking, therefore extending the pavement life cycle.

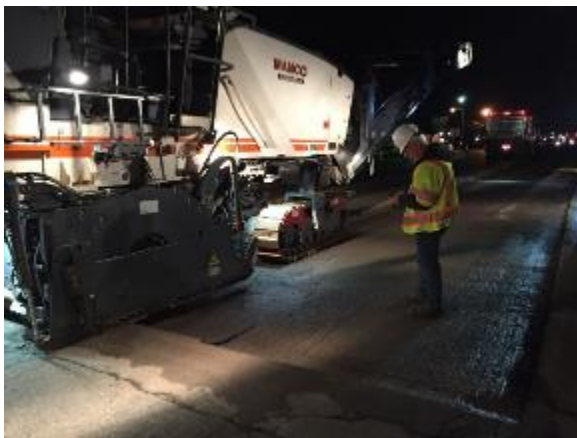
Figure 6 Pavement Milling Process

KTC technicians were onsite at Section 3 at the time of installation to monitor and document any problems. There were no problems associated with placement of RCRI at time of KTC’s visit. Although this section was also to receive joint sealing before installation, no joint sealer was applied. Several pictures were taken as RCRI was placed atop existing PCC pavement. See RCRI installation photographs in Figures 5-8.

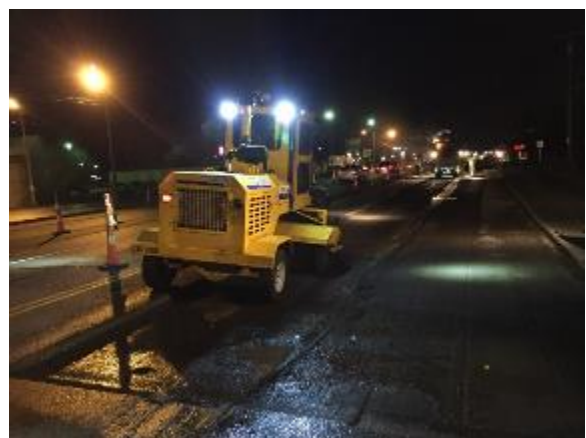
Figure 5 Pavement Prep For RCRI

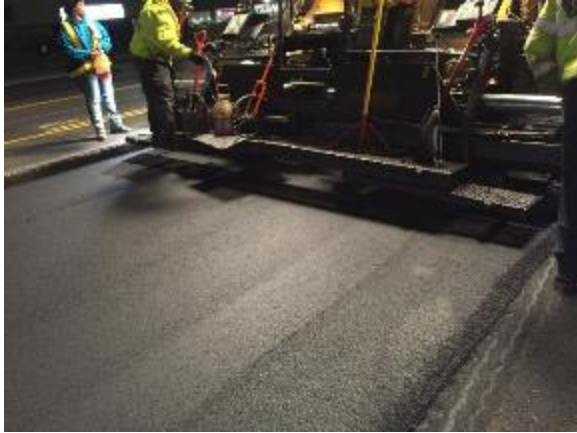
Figure 7 Placement of RCRI

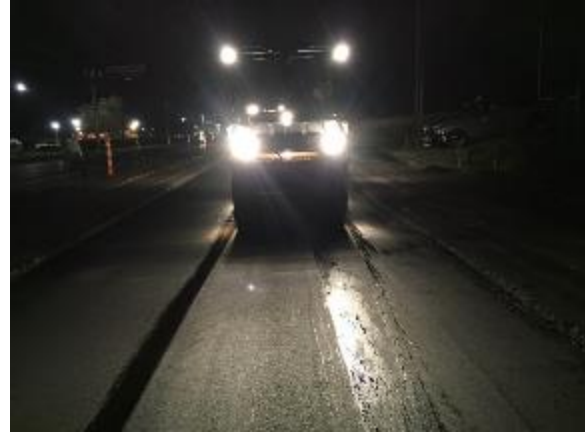
Figure 8 Compaction of RCRI

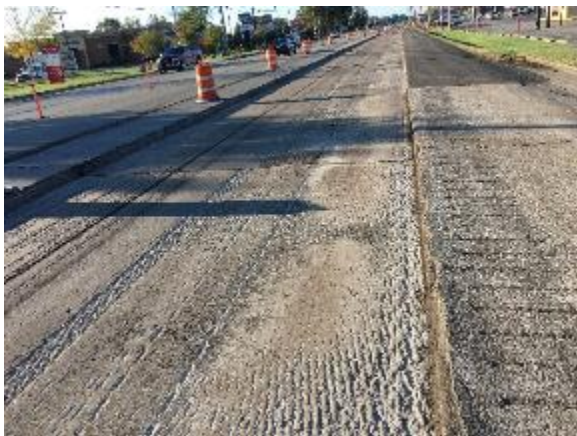
Figure 10 Pavement Prepped for Fabric

Section 2 utilized a Multi-Axial Fiberglass Paving Mat. The paving mat is constructed of a non-woven material consisting of at least 60% fiberglass (by weight), with the remainder comprised of polyester and binder. The material has a minimum average roll value (MARV) unit weight of 3.69 oz./yd². It is also resistant to chemicals, mildew and rot, and does not have any tears or holes that will adversely affect the material’s in-situ performance and physical properties. At the time of installation there were no problems associated with the placement of paving mat. Details of the installation can be seen Figures 10-15.

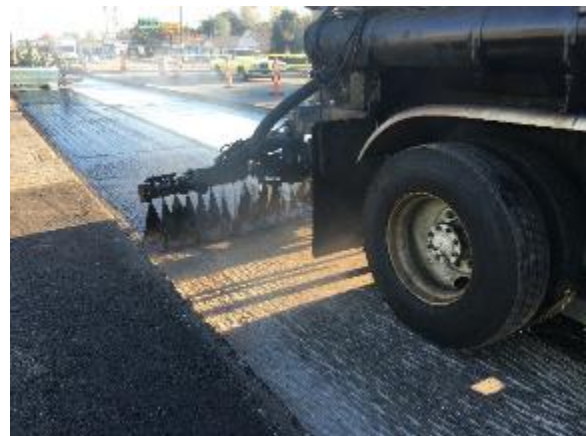
Figure 11 Applying Tack Coat as Adhesive

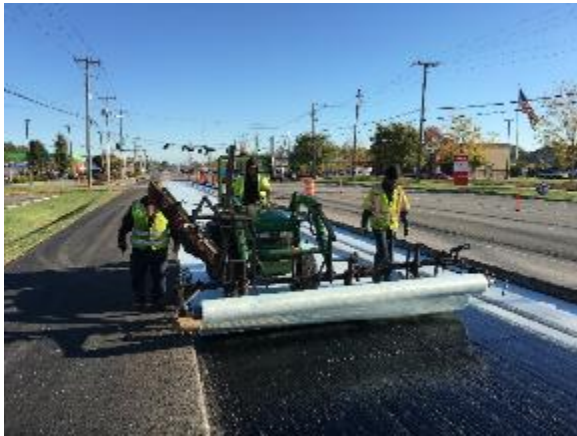
Figure 12 Fabric Placement

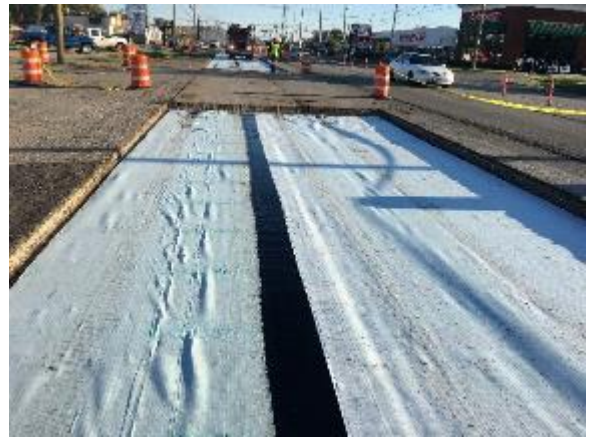
Figure 13 Piecemeal Installation

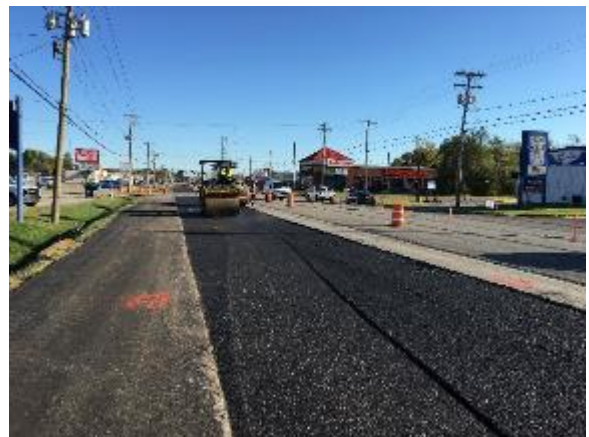
Figure 14 Compaction of Base Course

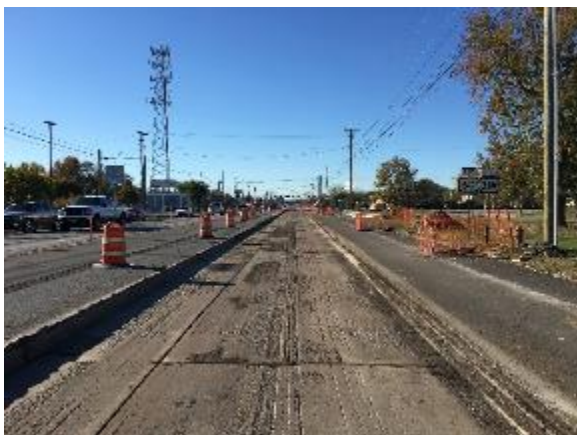
Figure 17 Pavement Prepped for Fabric

Section 3 southbound utilized a Multi-Axial Composite Paving Grid. The paving grid is an engineered multi-axial composite paving grid interlayer constructed of uncoated, multi-directional, continuous strand, high strength fiberglass fibers, bound to a carrier that when properly saturated with hot asphalt binder forms a moisture barrier and provides multidirectional tensile strength. At the time of installation there were no problems associated with the placement of paving grid. Photographs of installation can be seen Figures 17-22.

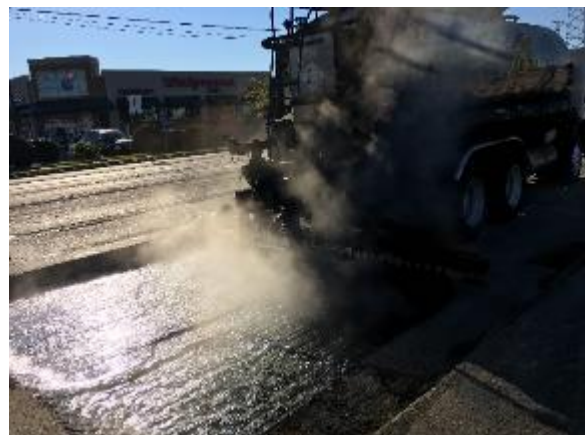
Figure 18 Applying Tack Coat as Adhesive

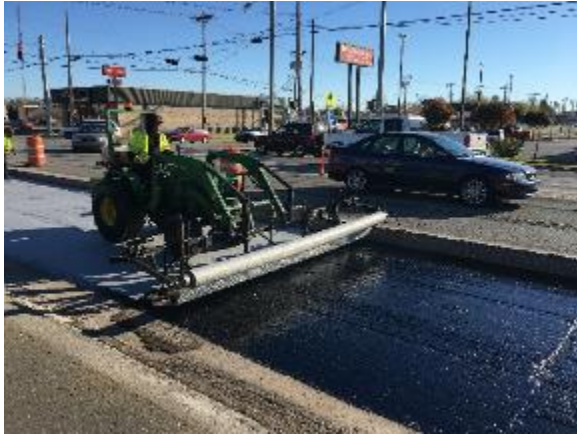
Figure 19 Fabric Placement

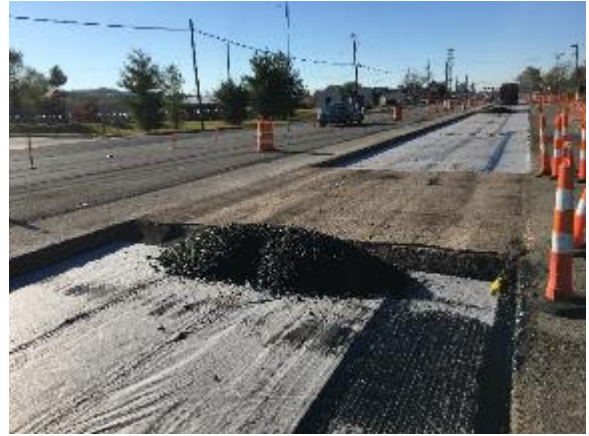
Figure 20 Piecemeal Installation

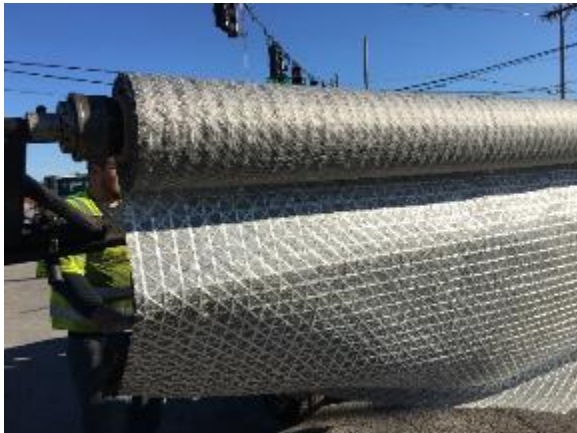
Figure 21 Close-Up of Paving Grid

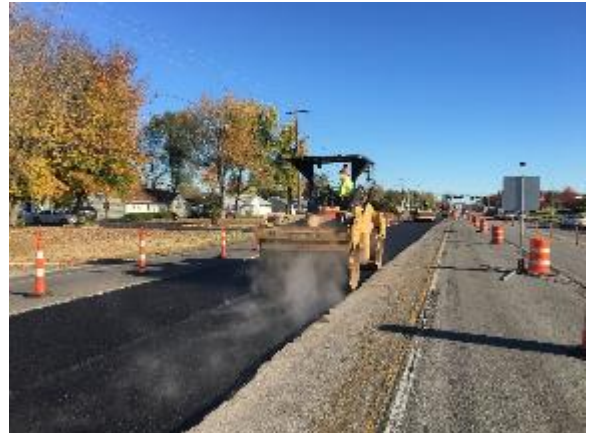
Figure 22 Compaction of Base Course

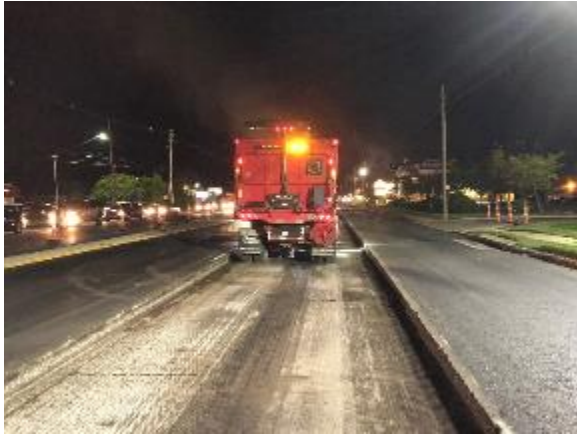
Figure 23 Pavement Prep for Paving Grid

Section 4 southbound utilized a Bi-Axial Composite Paving Grid. The paving grid used for this location is a bi-axial composite paving grid interlayer consisting of a fiberglass grid and a nonwoven paving fabric that acts as a moisture barrier. At the time of installation there were no problems associated with the placement of paving grid. No FWD data were collected at this location due to a scheduling conflict. Figures 23-26 are photographs of the installation.

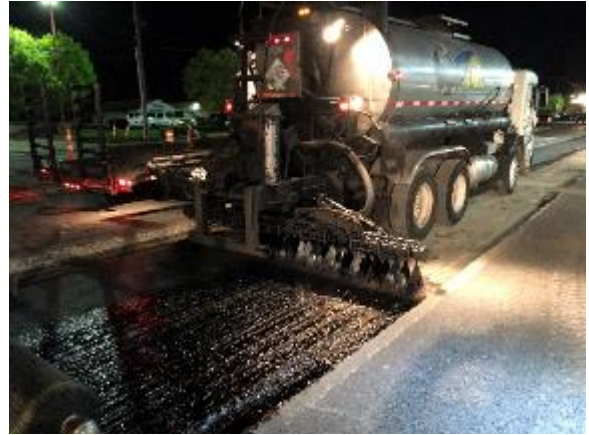
Figure 24 Applying Tack Coat as Adhesive

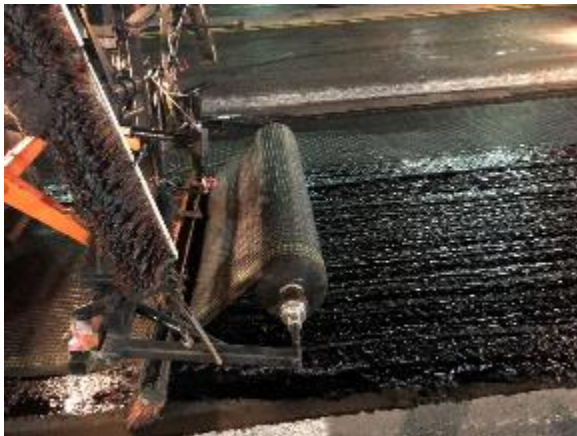
Figure 25 Fabric Placement

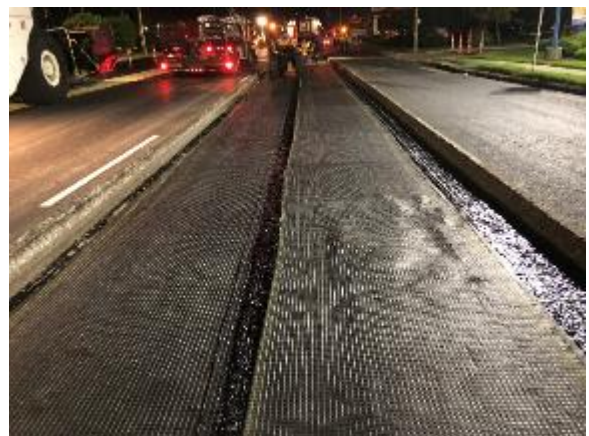
Figure 26 View of Installed Fabric
