Rapid Repair of Bridge Decks in Cold Weather

Report Number: KTC-19-18/SPR12-436-1F

Research Report
KTC-19-18/SPR12-436-1F

July 2019

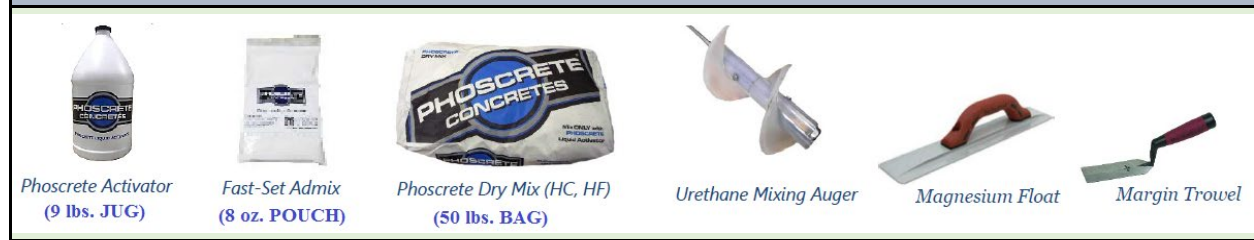
Cold Weather Pothole Repair With Phoscrete¹

(Apply when Surface Temperatures are above -5 °F)

Step 1:	Wear proper safety gear (goggles, gloves, mask, etc.)
Step 2:	Concrete surface in pothole must be dry (use hot or warm air blower), clean, and sound (no dirt, loose aggregates, oil contamination, etc.). Exposed steel bars in the pothole, if any, must be clean.
Step 3:	Pour entire content of the Phoscrete Activator (9 lbs. JUG) into a clean bucket. Note: The freezing point of the Liquid Activator is -20°F
Step 4:	Add the Fast-Set Admix to Activator when temperatures are at or below 50 °F. Note 1: For temperatures between -5 °F and 30 °F, use one pouch (8 oz.) Note 2: For temperatures between 30 °F and 50 °F, use half a pouch (4 oz.)
Step 5:	Add the Phoscrete Dry Mix (50 lbs. BAG) to the bucket. Note 1: DO NOT use water when mixing Phoscrete Note 2: DO NOT extend with sand or gravel.
Step 6:	Mix for 45 seconds or until no dry powder remains. Use a heavy duty Mixing Auger with a minimum 7 amp drill with side handle. Dual or variable speed drill is recommended.

Step 7:	Quickly Place Phoscrete mix onto to dry and sound concrete, and around clean rebars. Work fast to finish surface of each pour. Phoscrete sets up within 15 minutes, so form up large repairs in smaller segments and work across a repair. For potholes deeper than 3 inches, place Phoscrete in 3 inch layers. Note 1: DO NOT use water when placing Phoscrete
Step 8:	Finish Phoscrete using a Magnesium Float, Margin Trowel , or screed. Rinse tools with water and wipe off excess water before contact with Phoscrete. Once material develops a “skin,” leave it alone for the best finish. Note 1: DO NOT use water when finishing Phoscrete
Step 9:	Clean hands, tools and buckets with water when finished.

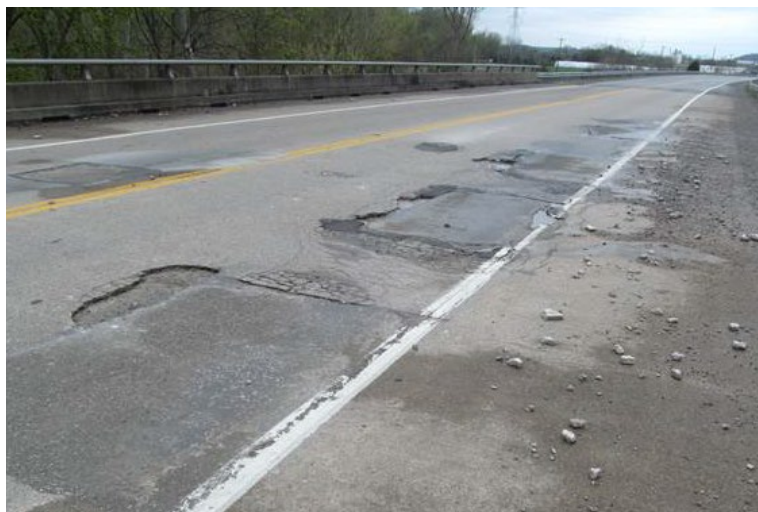
Figure 1 Damage Observed on Bridge Decks

This research study focused on small-scale partial-depth patches on bridge decks. Results are also applicable to other types of structures requiring partial-depth patches (e.g., concrete pavement). Deterioration around cracks, scaling, pop outs, and blow-ups damage concrete but can be addressed through patching (NCHRP 463, 2014). As seen in several locations in Fig. 1, patching may also be required around earlier patches that did not inhibit bridge deck deterioration.

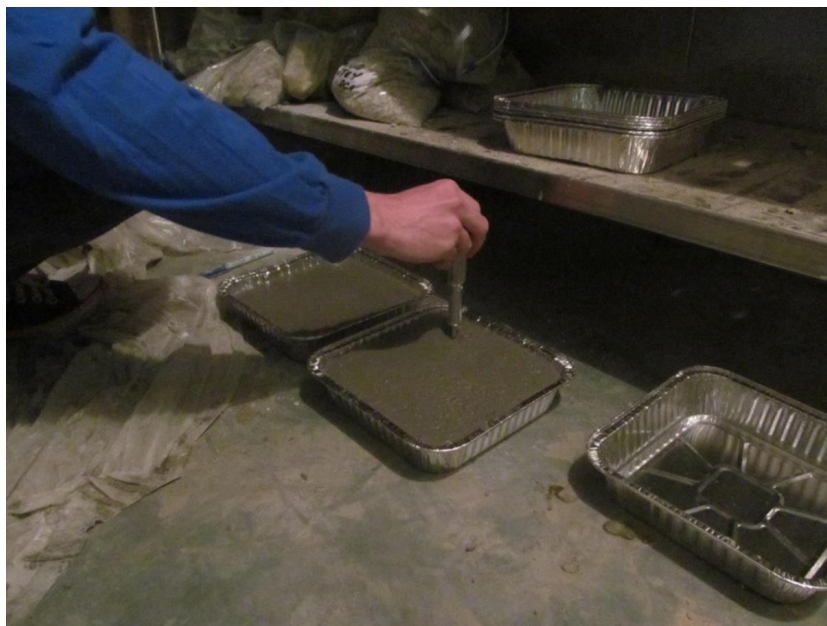
Figure 2 Penetrometer used to evaluate set time

The penetrometer provided analog readings up to 640 psi. The penetrometer’s plunger was inserted to the marker on the penetrometer (1” depth) and the corresponding resistance read from the spring-reaction scale. The penetration resistance was measured at 5-minute intervals until the material set (at which point the plunger would not penetrate the mix). Penetrations were made at least 1” away from the sides of the container, with each penetration made at least an 1” away from previous test spots.

For set time tests, only the repair material was used — aggregate was not added. There was one exception. For Roadware, the set time was evaluated when it was mixed with sand. For materials with accelerants (Phoscrete and MG-Krete), initial pan tests were conducted to determine the accelerant ratio needed to achieve initial set within 30 minutes. Based on the results obtained at 35 °F, (see Chapter 3) Duracal was not tested at 0°F or 15°F. Figure 2 illustrates the penetrometer being used on a mix.

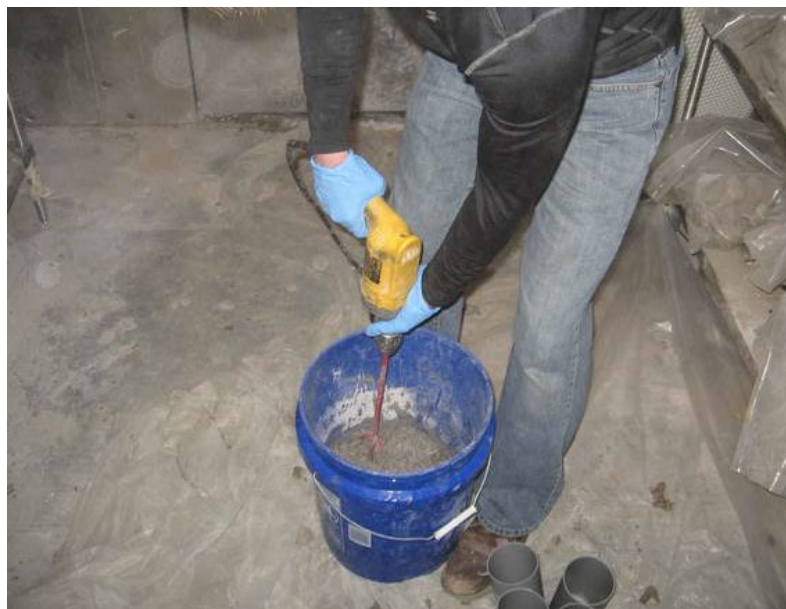
Figure 3 Mixing of MG-Krete at 35 °F for Cylinder Preparation

When products without aggregate were mixed (except Roadware), components were measured and placed in a mixing container (the liquid activator or water followed by the dry mix). If an accelerant was used, it was added to the liquid activator and mixed for a few seconds before it was added to the dry mix (Figure 3). Once the mix was ready, it was scooped into the cylinders using a trowel; cylinders were filled to the half-way point. Half-filled cylinders were rodded with a metal rod (3/8 in. diameter). The sides of the cylinders were then tapped with a mallet as per ASTM C192 (ASTM C192, 2018). Cylinders were then filled the rest of the way and the rodding and tapping repeated. A trowel was used to strike off the top surface, and then the cylinders were left in the cold room to cure until testing.

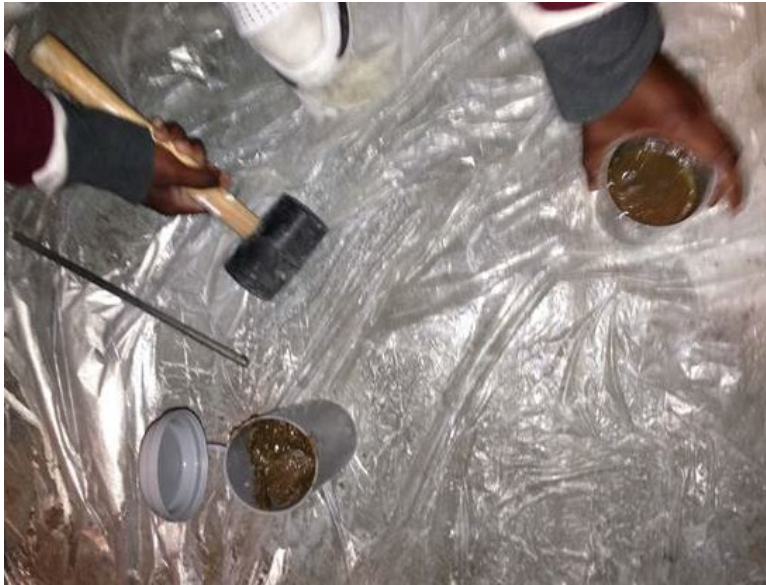
Figure 4 Preparation of Roadware Compression Cylinder Specimens at 35°F

For mixes with aggregate, the same basic mixing process was used. However, after mixing the accelerator aggregate was added and the two thoroughly combined. Cylinder preparation occurred in the same manner as for mixes without aggregate. The only exception was Roadware — as per manufacturer instructions the two liquid parts were mixed and then sand was added into the mixture (Figure 4). Once fully mixed, test cylinders were prepared using the same steps described above. For each product, proportions of each mixture component were determined based on manufacturer specifications. The amount of accelerant used for Phoscrete and MG-Krete was based on the values used in the set-time tests.

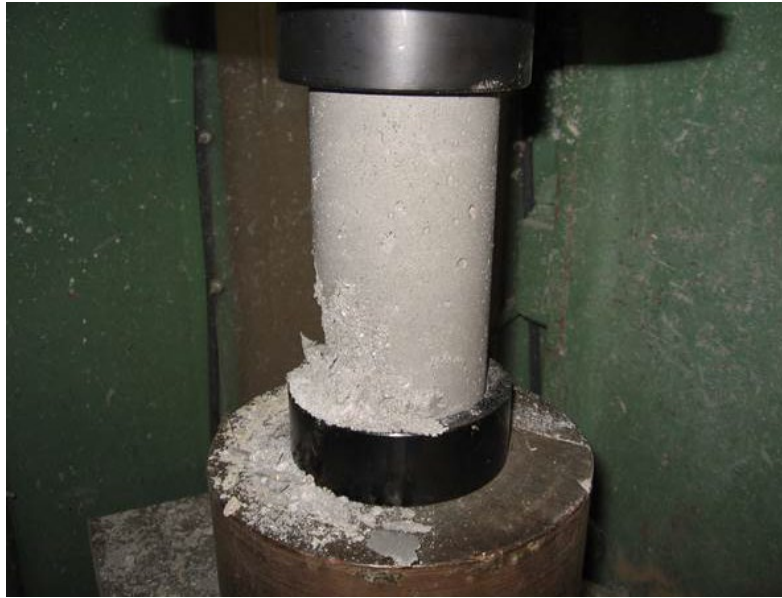
Figure 5 Phoscrete compression test 1 hour after mixing at 0 °F

Prepared cylinders were tested in compressions at the four specified time intervals (Figure 5). Based on the set-time results at 35 °F, Duracal was excluded from testing at 15 °F and 0 °F. While the manufacturer does not recommend using aggregate with Phoscrete, this was carried out to evaluate the performance of the material at 35 °F and 15 °F. Due to the large difference observed in the strength results between cylinders with and without aggregate, cylinders of Phoscrete with aggregate were tested at 0 °F.

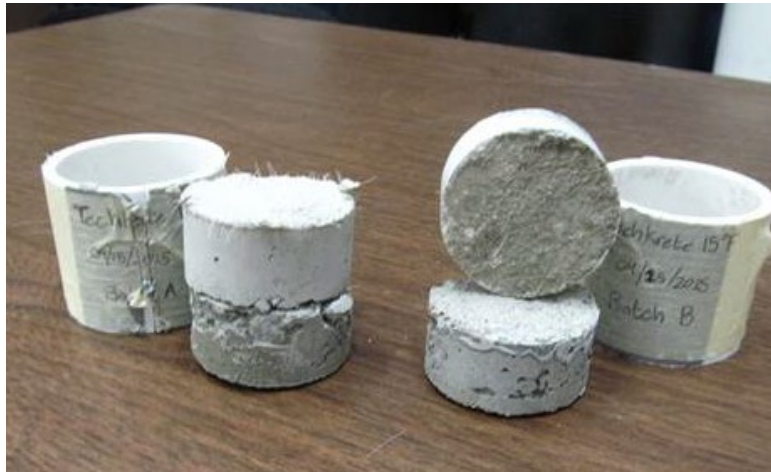
Figure 7 Tekrete Bond Shear Specimens After Failure

Table 4 is a test matrix showing the sample count for the bond test. The material for each bond shear test specimen was part of the mix for the four concrete cylinders cast as a batch for the compressive strength gain testing. Repair material extended with aggregate was excluded from the bond shear test matrix. Specimens cured for a minimum of 28 days and were then tested in direct shear. The failure of two of the Tekcrete bond shear specimens mixed and cured at 15 °F is shown in Figure 7.

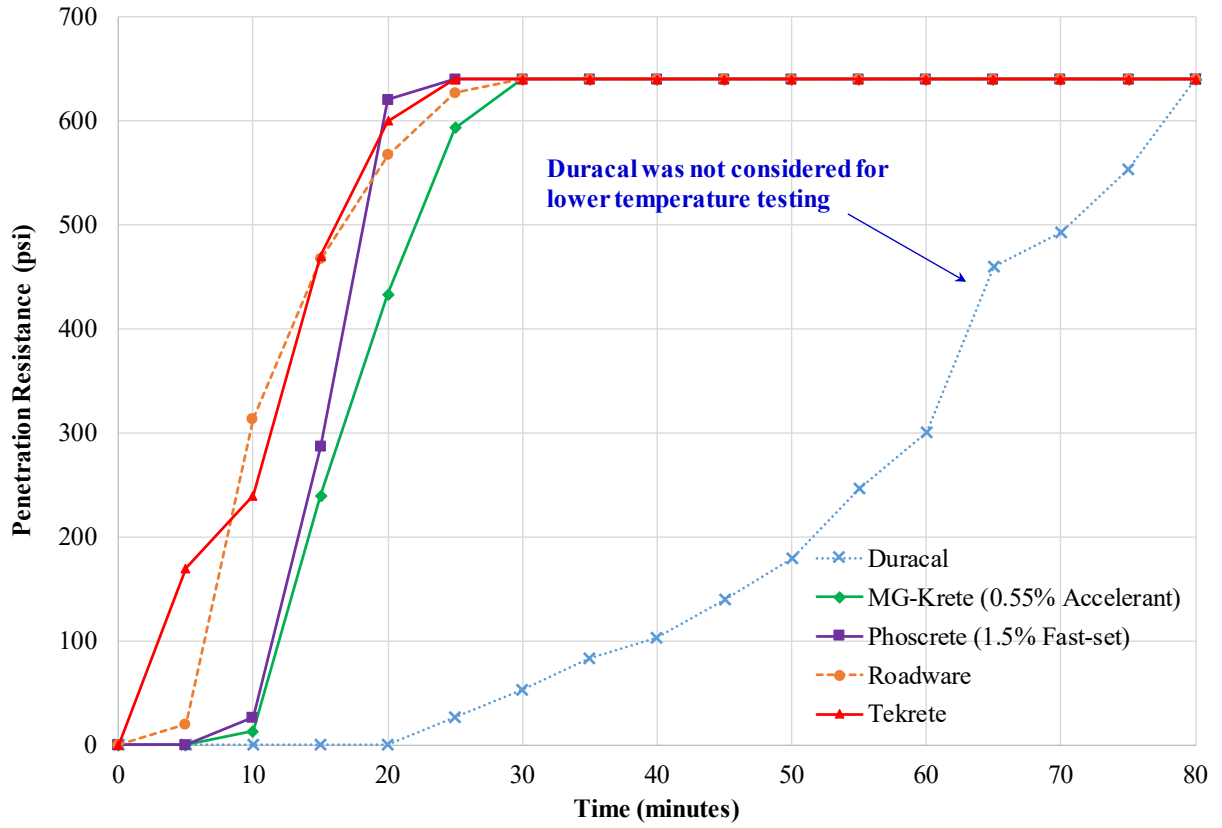
Figure 8 35 °F Set Time Results

Test results for set times at 35 °F, 15 °F, and 0 °F are presented in Figures 8, 9, and 10, respectively. Each data point represents the average of three test specimens. As noted previously, the accelerants for both Phoscrete and MG-Krete were based on additional testing carried out prior to the set-time tests, where the quantity of accelerant was varied to achieve a set time of approximately 30 minutes. While the amount of accelerant was sufficient for the quantities mixed for laboratory testing, these values may not be viable when mixing large batches of material in the field. Typical repair materials, such as epoxy or polymer-modified mortars, tend to set up faster when the volume of the mix is greater. Water for both Tekcrete and Duracal was kept at room temperature (approximately 72 °F) outside the climate-controlled room prior to mixing.

As Figure 8 demonstrates, for the specimens mixed and cured at 35 °F, all material except Duracal set up within 30 minutes following placement. Initial set was almost instantaneous with Tekcrete and Roadware. Both showed penetration resistance at 5 minutes; both MG-Krete and Phoscrete took 10 minutes. Duracal did not begin to set up until after 20 minutes and did not fully set up until the 80-minute mark. Due to the delay in set time, Duracal was not tested at 15 °F and 0 °F. It was also dropped from the compressive strength gain and bond shear tests at those temperatures.

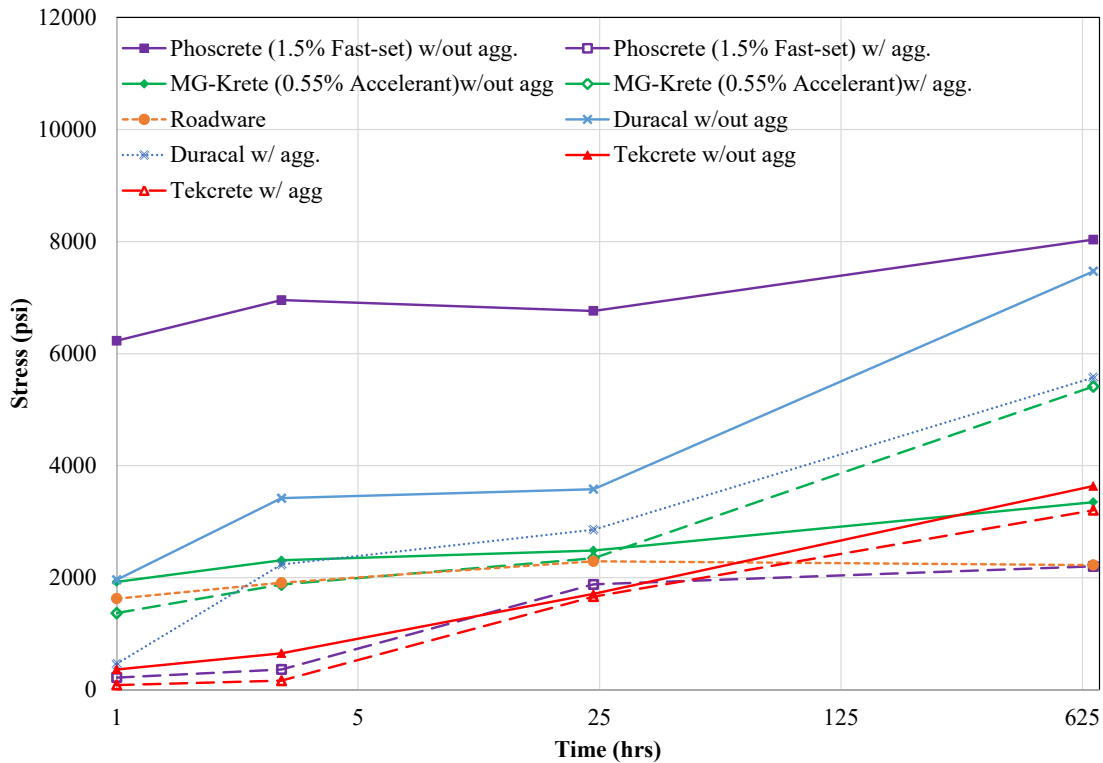
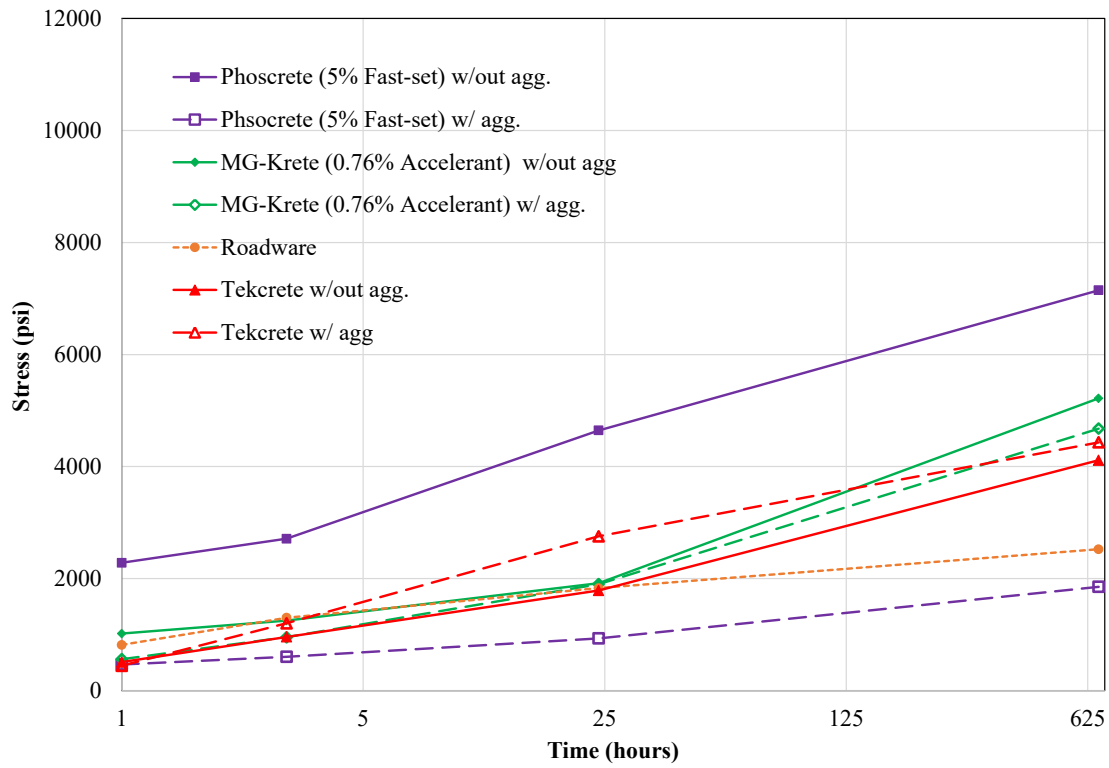
For the three test temperatures, the rate of compressive strength gain was evaluated according to ASTM C39 (ASTM C39, 2018) at 1 hour, 3 hours, 24 hour, and 672 hours (28 days). Results from compressive strength test are presented in Figures 11, 12, and 13. Each data point in the figures represents the average of the tests for three cylinders. Individual compressive cylinder test data are tabulated in Appendix A. Due to the widening time intervals between the four tests at each temperature from 1 hour to 672 hours [(5⁴ + 47) hours or 28 days], the time axes in Figures 11–13 are plotted in a base 5 log scale.

At the three test temperatures, all specimens reached a compressive strength of at least 1,800 psi. Incorporating aggregate reduced the compressive strength of Phoscrete at both 35 °F and 15 °F. For this reason, Phoscrete with aggregate extension was not tested at 0 °F. As the manufacturer does not recommend using aggregate with Phoscrete, the results of Phoscrete with aggregate extension were not considered a viable material. The compressive strength of Tekcrete was unaffected by aggregate extension. Aggregate extension increased the 28-day strength of MG-Krete at both 35 °F and 0 °F, while the 15°F strength was slightly higher for cylinders without the aggregate. At the three temperatures, the MG-Krete without aggregate had a higher strength when compared to MG-Krete with aggregate extension up to 24 hours after placement. Phoscrete without aggregate extension was the strongest material at all temperatures at every test period.

For the three test temperatures, Roadware consistently had a compressive strength of slightly over 2,000 psi at 28 days. It would be the weakest material if Phoscrete with aggregate extension is discounted. However, Roadware was considered for the test matrix primarily as a material for filling large cracks and openings in temperatures near or below freezing — not primarily as a deck patching material.

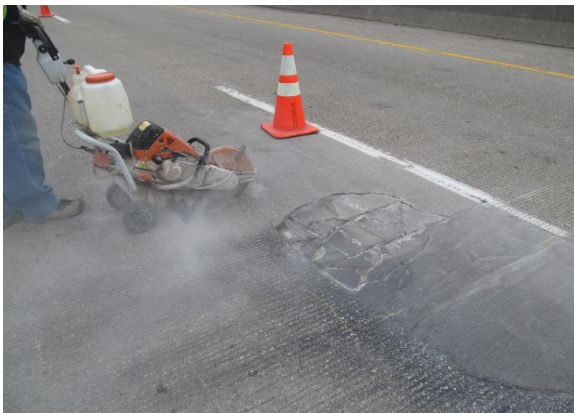
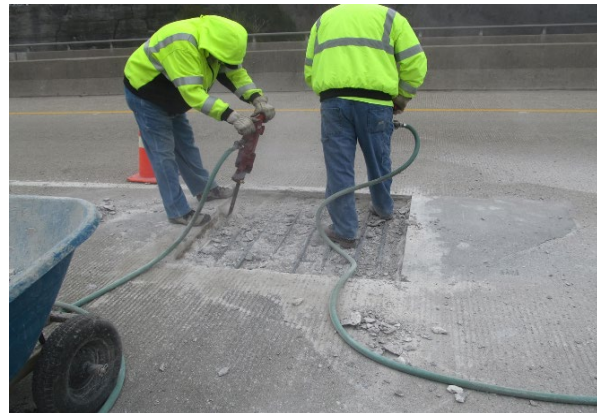
Figure 15 Preparing Repair Area

Concrete sounding around the crumbling patch identified a rectangular 54" × 48" repair area. The area extended a minimum of 4" beyond the delaminated areas. A concrete saw was used to cut 2" deep vertical edges around the repair area (Figure 15). Using pneumatic hammers, all deteriorated concrete was removed from the repair area to a depth of approximately 6.5", exposing the top layer of rebar. Workers used compressed air to remove debris and clear the surface for Phoscrete application.

(a) Saw cutting repair edge

(b) Chipping Concrete

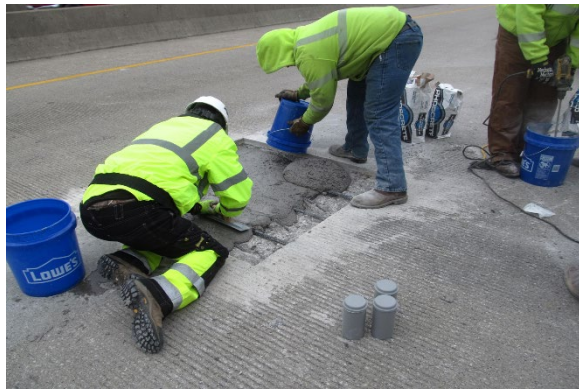
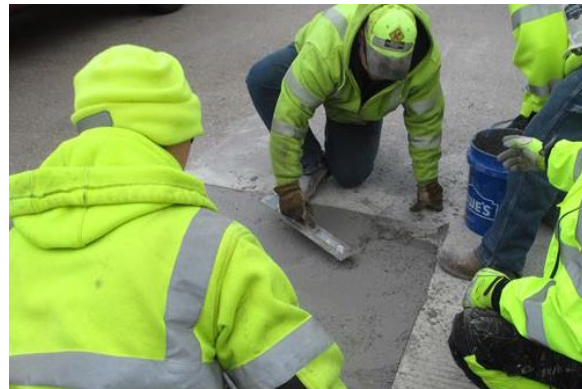
Figure 16 Phoscrete Repair

of 40°F. One bag of the Phoscrete dry mix was then poured into the bucket. The mixture was blended for at least 45 seconds using a drill-powered spiral auger. The repair area was filled in two layers; the first layer was approximately 3” deep. Total application time was roughly 20 minutes. Finishing was done using magnesium floats — as recommended by the manufacturer — to prevent Phoscrete from sticking to the float. Figure 16 depicts the placement and finishing of Phoscrete.

(a) Placing Phoscrete

(b) Finishing Phoscrete

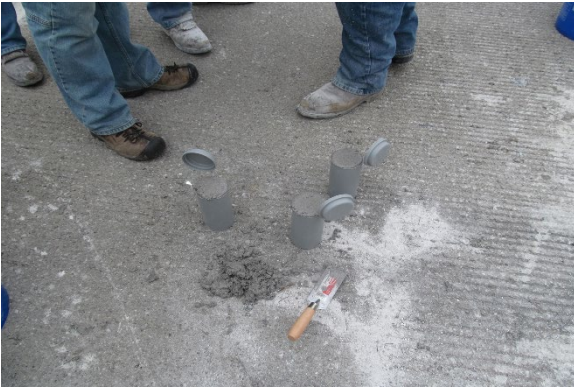
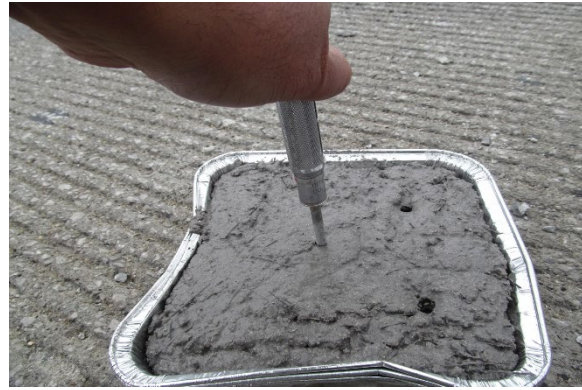
Figure 17 In Situ Material Tests

Three concrete cylinders (3” diameter × 6” height) were prepared with three batches of the mix used to repair the patch. Only two cylinders were tested in compression; one cylinder could not be capped because the Phoscrete set up before the top surface was leveled. After 28 days, average compressive strength of the two cylinders was 9,450 psi. Cylinders remained at the bridge site for approximately 3 hours at temperatures between 34 °F and 40 °F. Once removed from the site, they were stored indoors at a temperature of 72°F prior to testing.

Part of the Phoscrete mix produced for the deck repair was placed in a pan (9” × 9” × 2”) to measure the set time. The same penetrometer used for laboratory testing was used to measure the penetration resistance. Compared to laboratory testing, the mix was more cohesive, preventing any smoothing of the surface within the pan. Final set was reached within 11 minutes of casting — also faster than what was observed in the laboratory. The cast cylinders and set-time measurement are shown in Figure 17.

(a) Phoscrete test cylinders

(b) Set time measurement

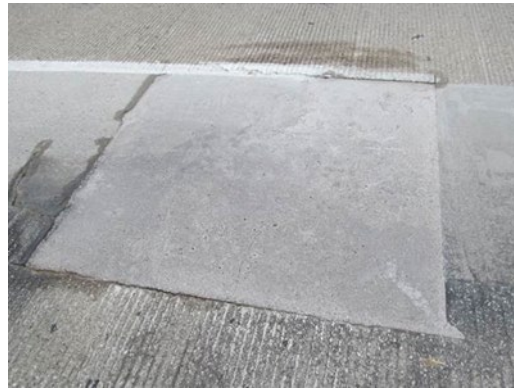
Figure 18 Repaired Patch One Year Later

The Phoscrete deck patch was inspected during several field visits. As seen in Figure 18, the inspection carried out on Feb. 12, 2017 (one year after construction) revealed no distress to the repair patch. Some small surface cracks were detected, while the previous repair material on one

side of the Phoscrete patch was failing (Figure 18). To measure durability, the repaired patch should undergo annual monitoring for several years.
