SEMI-ANNUAL EVALUATION REPORT

**FIBER-REINFORCED POLYMER
(FRP) PULTRUDED DECKING MATERIAL AND HELICAL ANCHORING SYSTEM FOR
USE IN SNOW FENCE APPLICATIONS**

Project No.: IM90-7(63)33, Interstate 90, MP-332

Description: Ninth semi-annual analysis of remaining test section of snow fence using proprietary EZ-Deck Fiber-Reinforced Polymer (FRP).

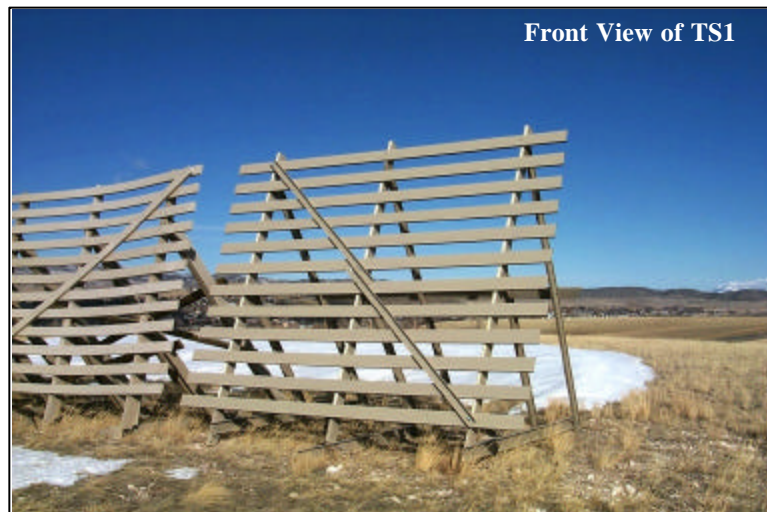
state of Montana. In addition, this experiment was to compare a new design as submitted by the contractor. The modified design deleted the interior rear supports (Test Section 1 [TS1] vs. Test Section 2 [TS2]), as explained in the November 1999 construction report (document address located at the end of this report). As noted in the May 2001 report, TS2 was found collapsed, which was assumed a structural-related failure due to the three rear (sole) supports buckling or snapping in high winds.

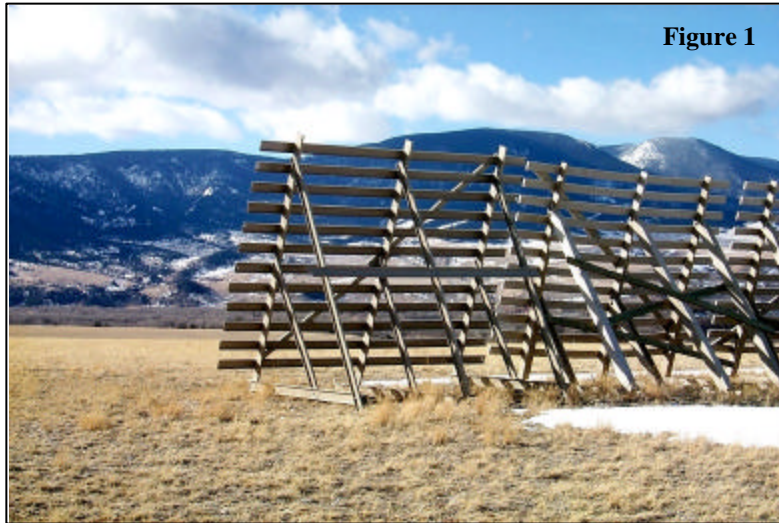
Site visits are held in late winter or early spring and late fall to document the environmental effects of seasonal extremes to the FRP material as well as stability of design. Figure 1 shows the remaining fence TS1, as seen on February 11.

No additional deterioration of the attachment hardware and planking material was observed since the last inspection. No deflection of supports have been noticed. TS1 is rated as performing well. February 2005 is the next scheduled evaluation. This will be the project's final report.
