**SEMI-ANNUAL EVALUATION REPORT**

**FIBER-REINFORCED POLYMER  
(FRP) PULTRUDED DECKING MATERIAL AND HELICAL ANCHORING SYSTEM FOR  
USE IN SNOW FENCE APPLICATIONS**

Location: Livingston, Montana. Interstate 90, MP-332, Park County

Description: Eighth semi-annual evaluation of remaining test section of snow fence using proprietary EZ-Deck Fiber-Reinforced Polymer (FRP).

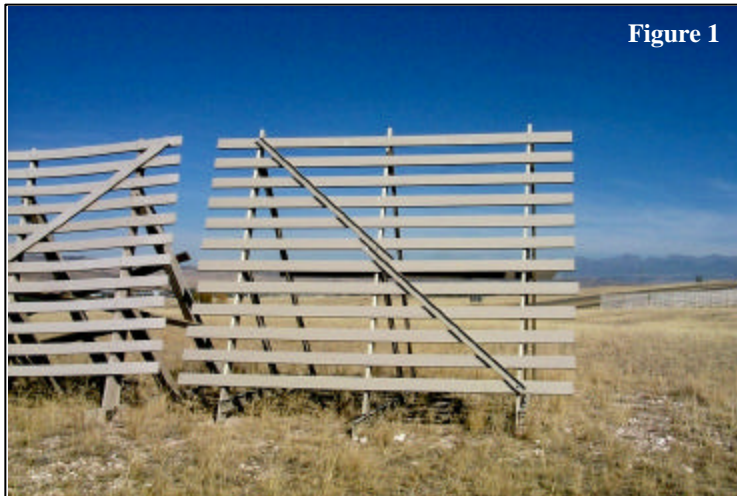
Inspections are held in late winter or early spring and late fall to document the environmental effects of seasonal extremes to the FRP material as well as stability of design. Figure 1 shows the remaining TS1 as seen on October 3, 2003.

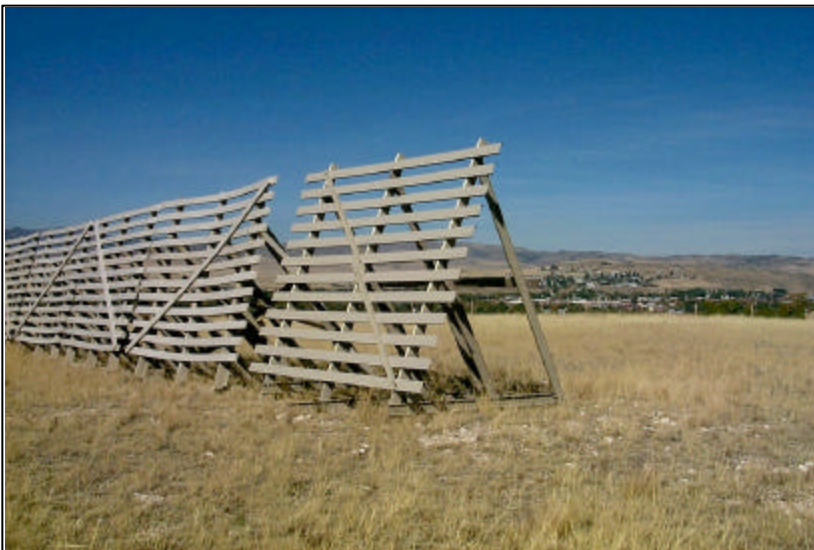
The evaluation consisted of a visual inspection of the FRP material and the structural supports. Special attention was given to the attachments of the FRP planks, (setting screws, bolts, FRP clips).

No additional deterioration of the attachment hardware and planking material was observed since the last inspection. The TS1 has been rated as performing well. The next evaluation will be conducted in March 2004.
