EXPERIMENTAL PROJECTS CONSTRUCTION REPORT AND ANNUAL EVALUATION

T15 Base One Soil Stabilization

Project Name: Milk River – North

Experimental Project: MT-18-05

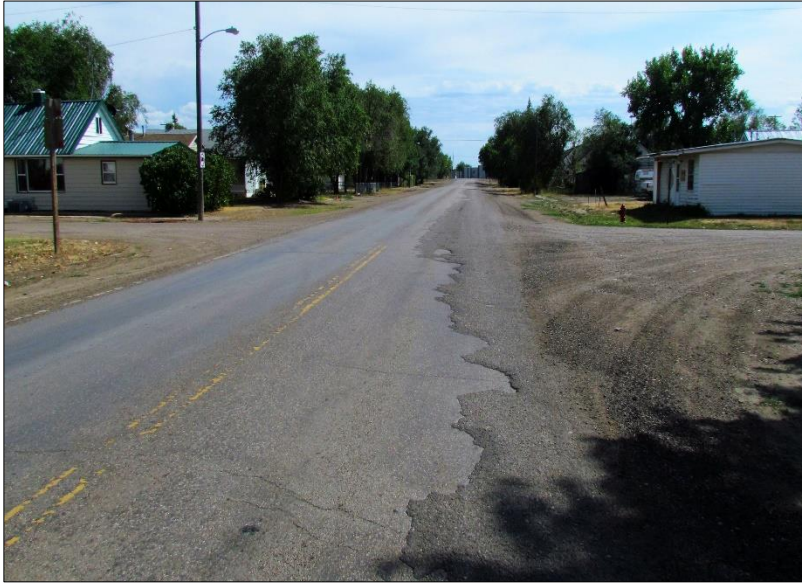
← Representative images of pavement condition prior to reclamation. Areas of visible fatigue, distress, and excessive patching evident.

Area is north end (near US2) of Sargent St. view south towards downtown area.

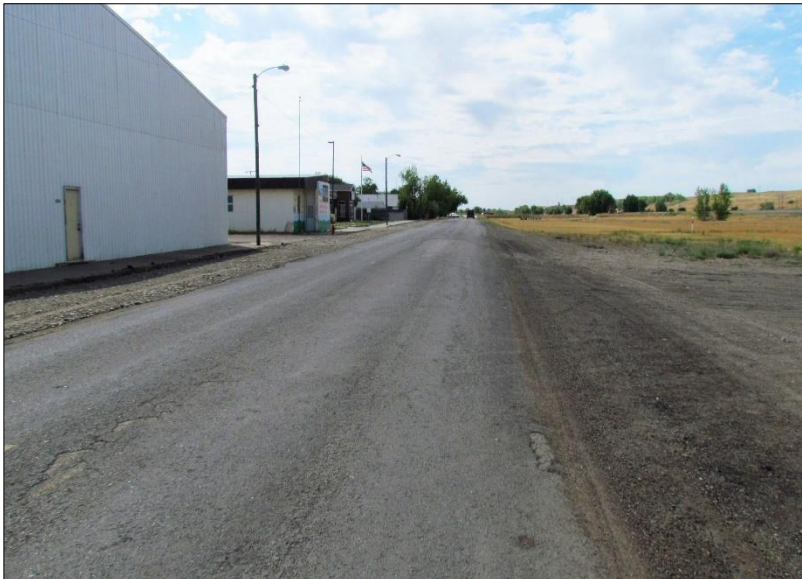
← Front St.; View west.

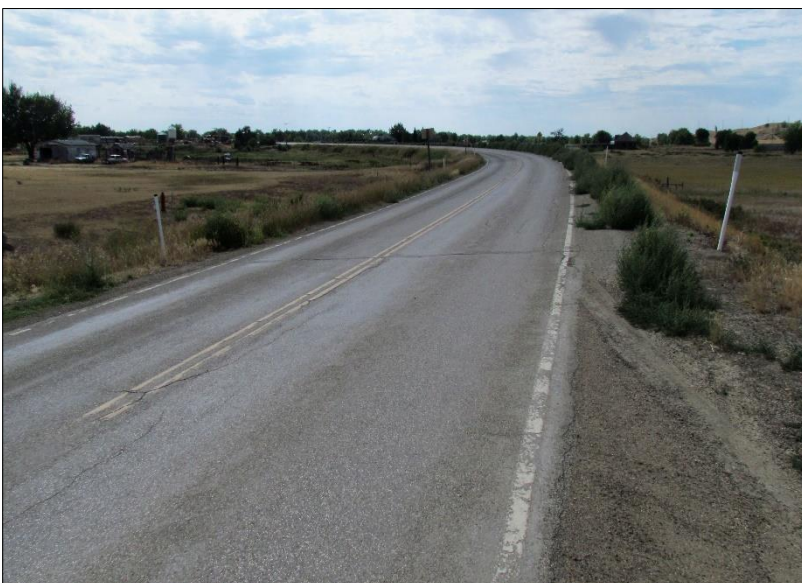
← Front St. merge to MT 117:
View west.

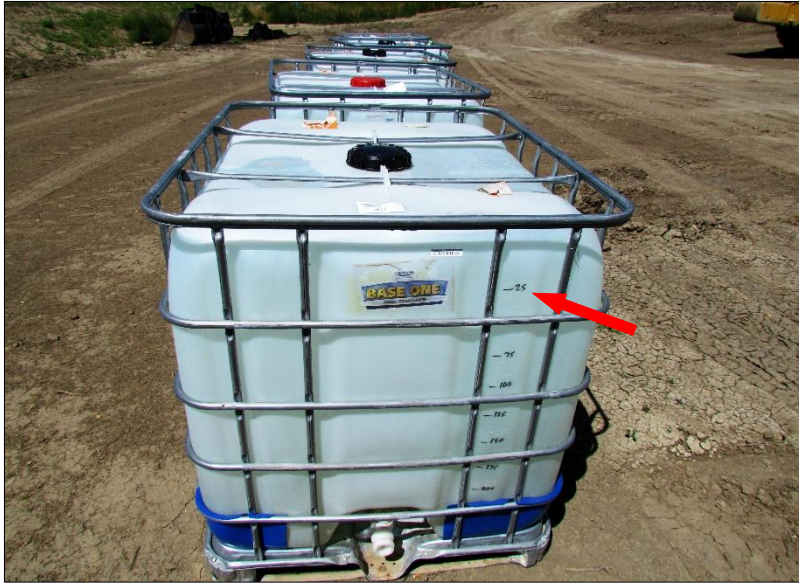
← The T15 Base One was stored on-site in 275 gal. (1041 L) totes.

Note (red arrow), the totes were marked off in 25 gal. increments starting at the top to allow visual reference for the required amount of product to be added to the mixing truck.

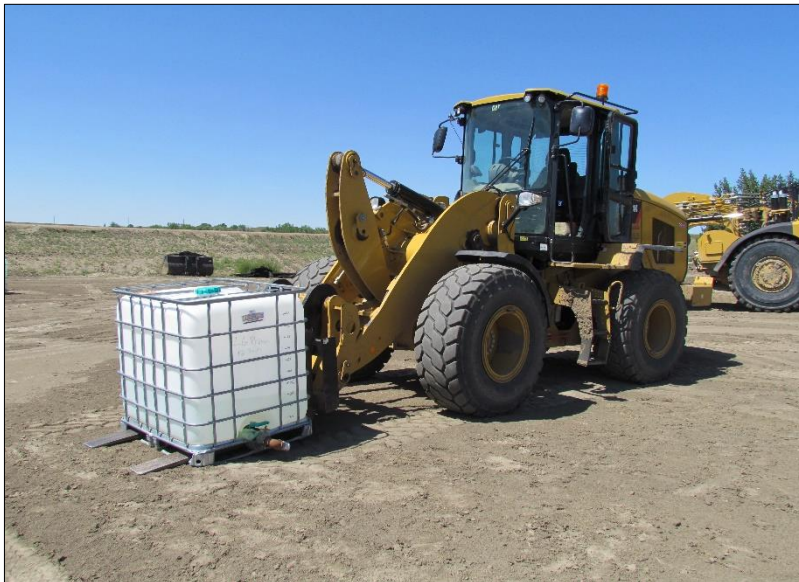
← Totes were lifted to the mixer using a payloader fitted with a fork lift.

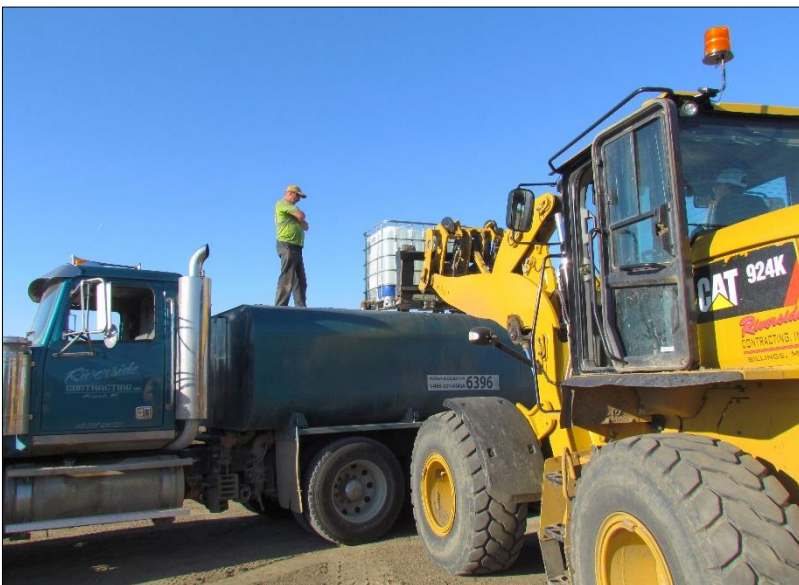
← The workman monitors the correct proportion of Base One to the water tank truck.

The Base One is added first to the tank. Then water is added, this insures adequate blending of the stabilizer to water.

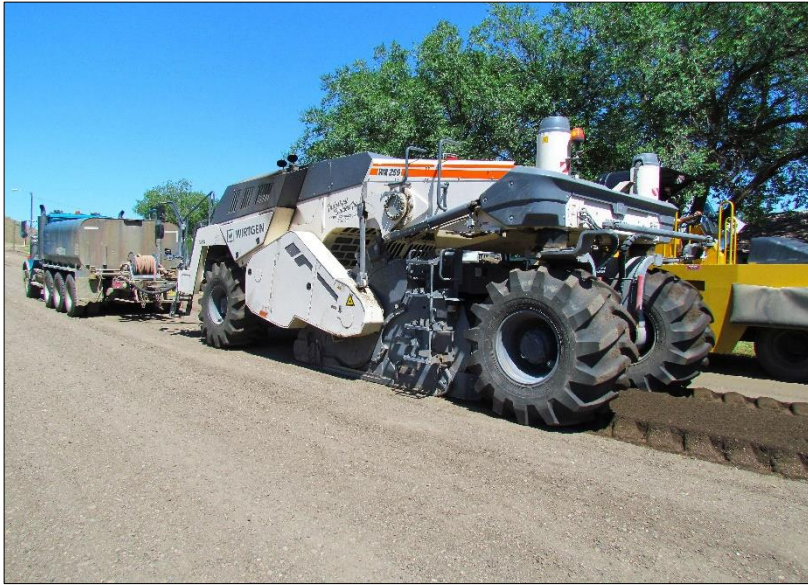
◀ A high-performance Wirtgen wr250 was utilized on the project for both reclamation of the existing pavement as well as the soil stabilization mixing phase.

This image shows the mixing phase in progress (Sargent St.).

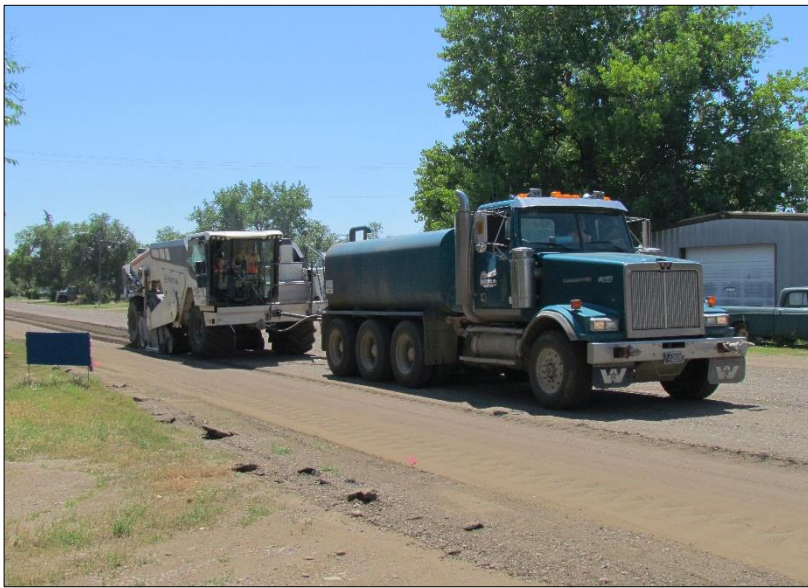
◀ Additional view of the Base One soil binder mixture in progress.

The wr250 uses a computer-controlled metering system to insure a homogeneous mix based on project specifications.

The Wirtgen wr250 is connected to the tank truck which doubles as the tow unit. If the tow speed varies the wr250 metering systems automatically adjust the stabilizer quantity for blending.

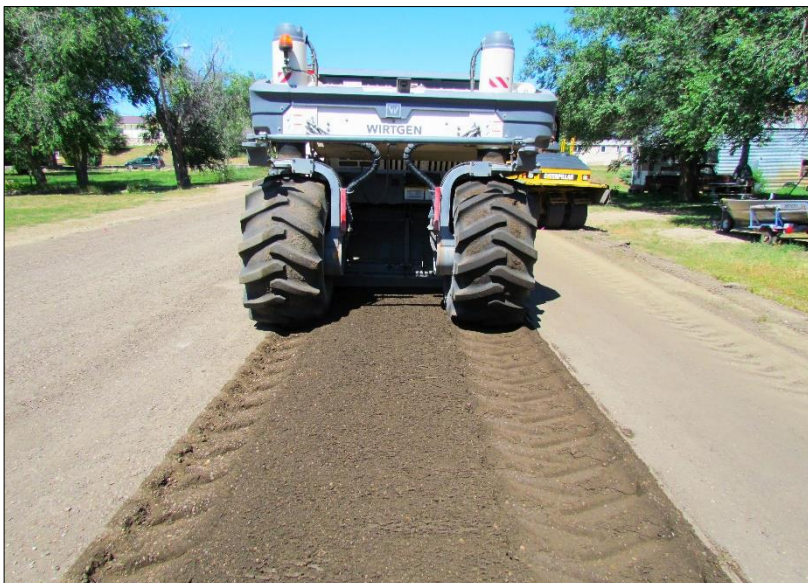
◀ Rear view of the Wirtgen unit and blended base.

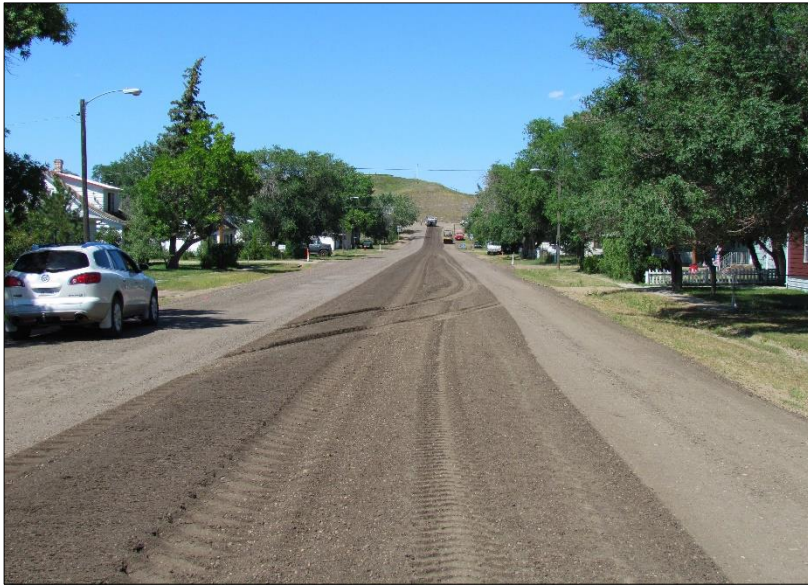
← Completed pass (Sargent St.-view north).

Although not documented in this report; base compaction was accomplished using a nine-wheel pneumatic roller and drum roller sequentially.

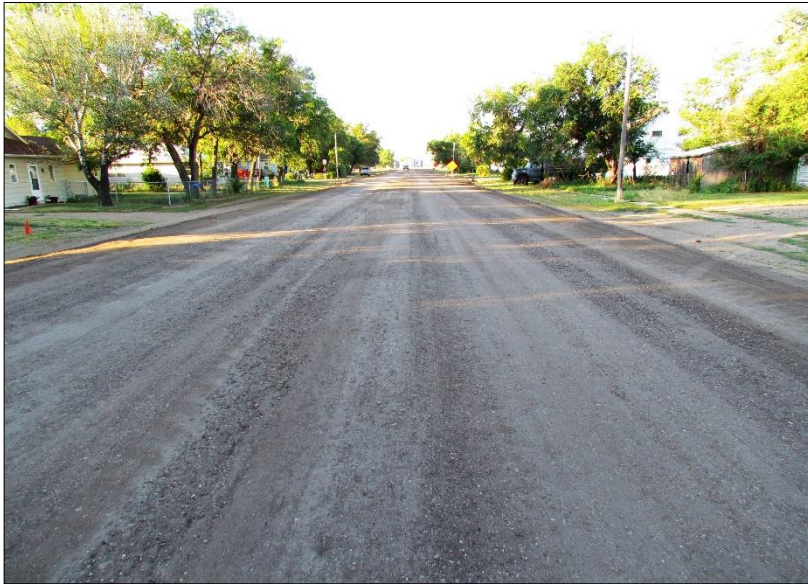
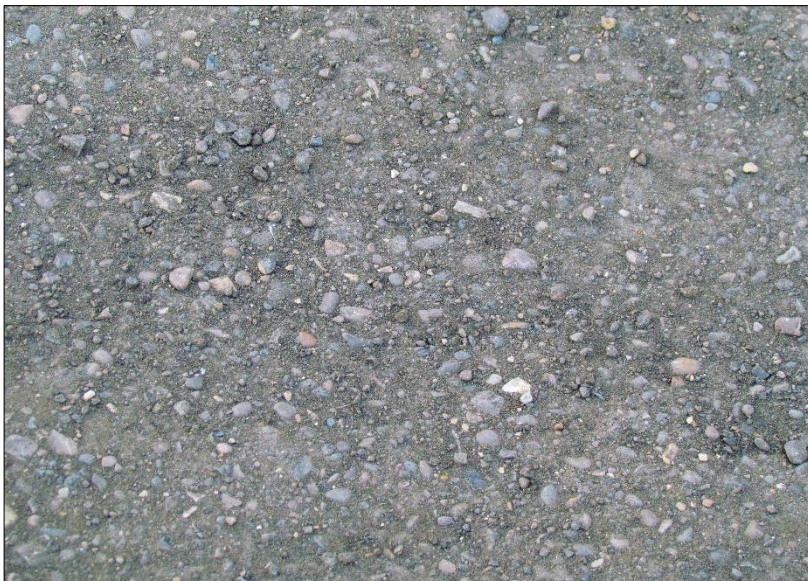
←↓ Representative images were taken several days after the stabilization phase was completed.

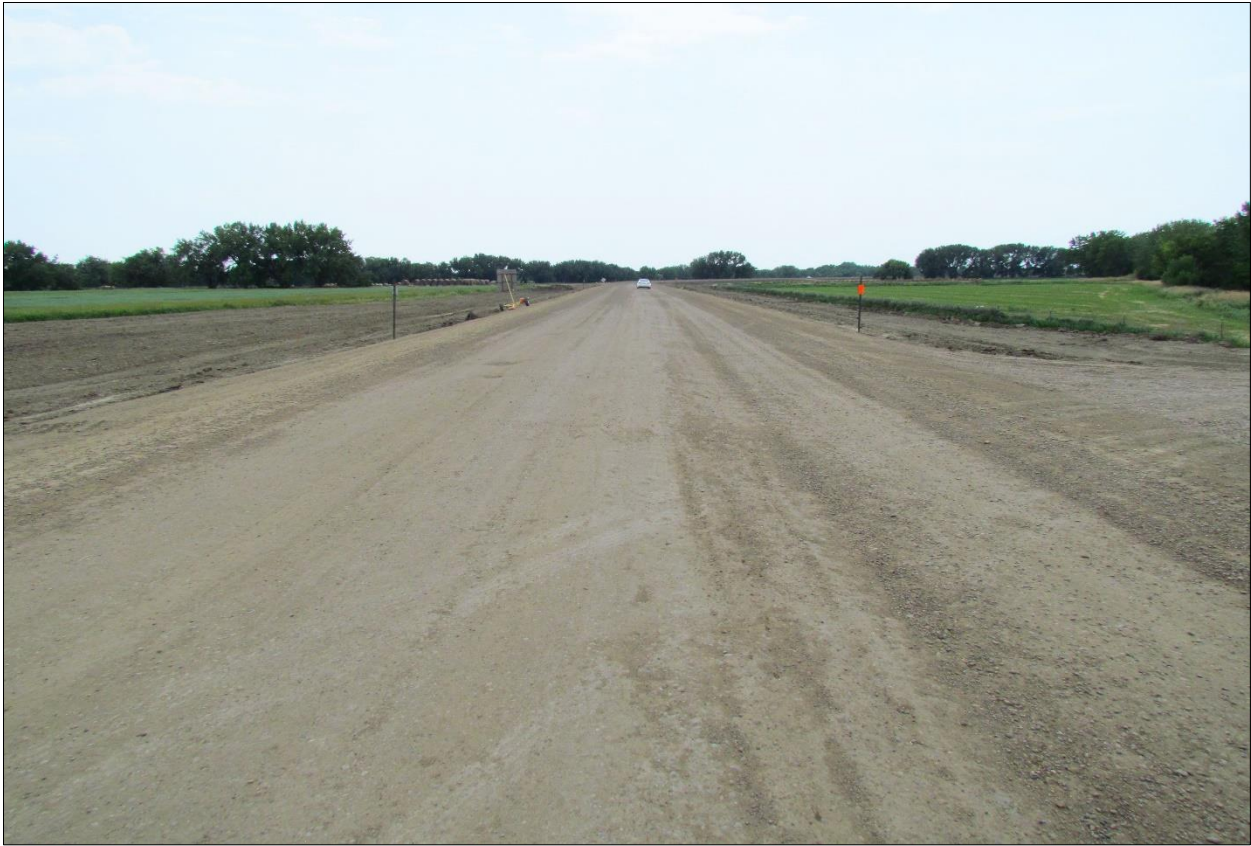
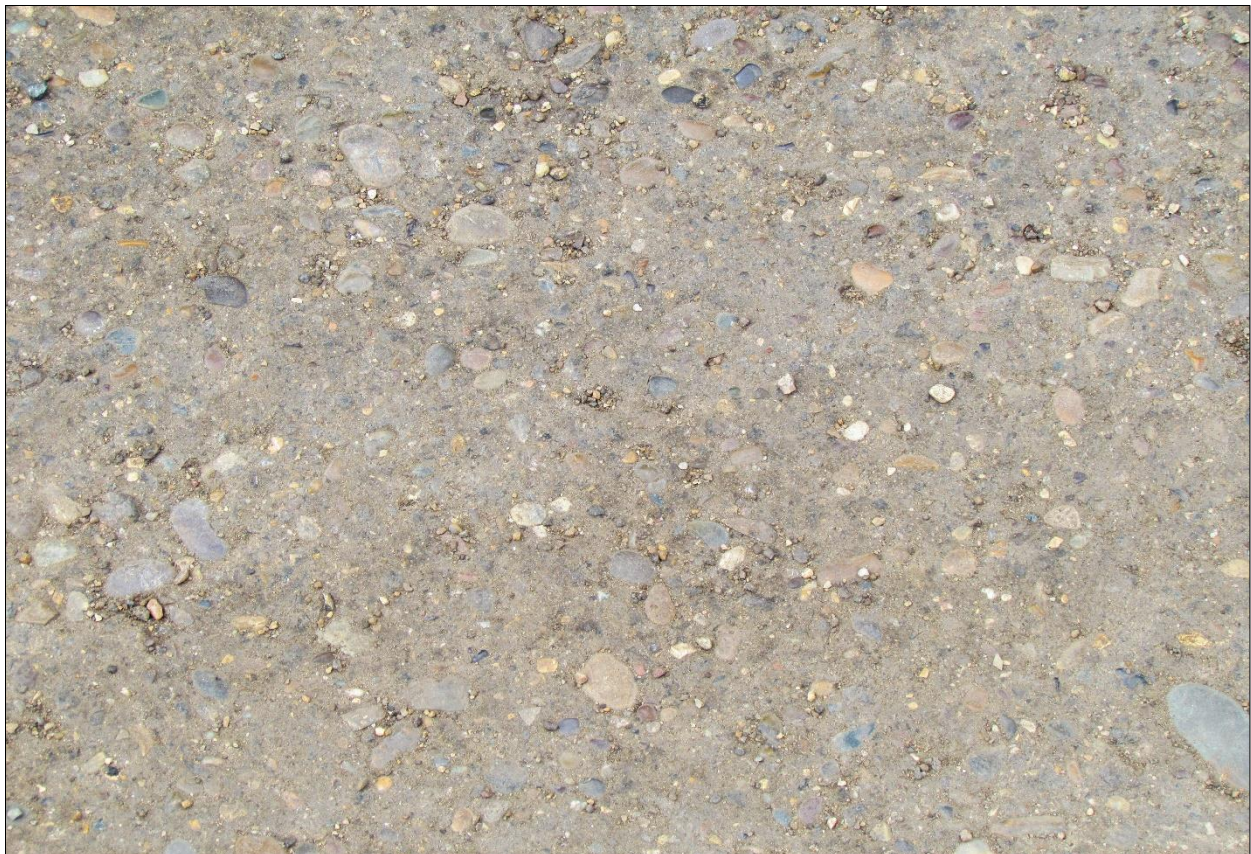
- ↑ View of treated base approximately two weeks after compaction (Section 1, view south towards Milk River bridge).
- ↓ Close-up of compacted base.

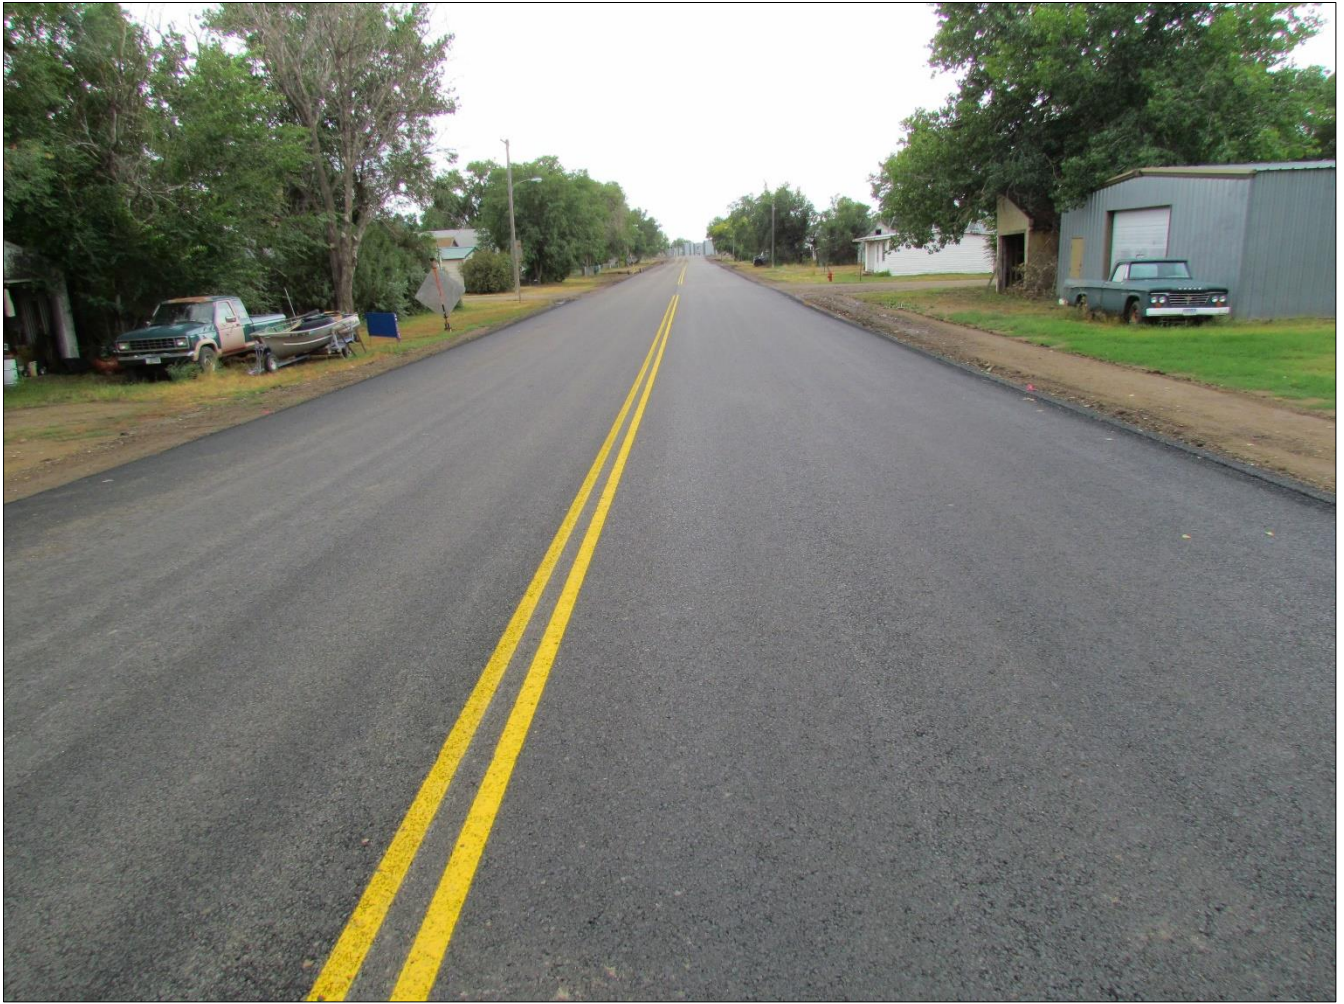
↑ Representative image of completed paving phase of project (Section 6 - Sargent St.) view south.

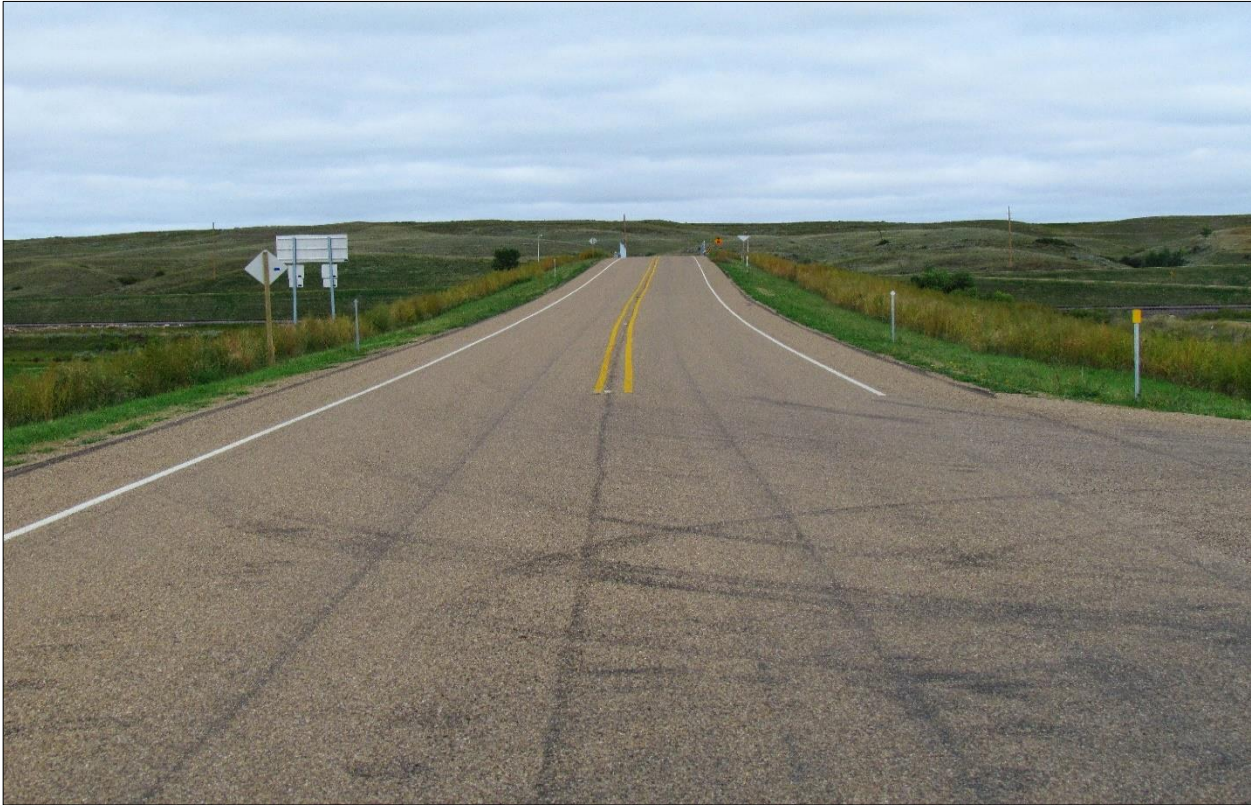
↑ Representative view of AC pavement after chip seal (Section 2, view north).

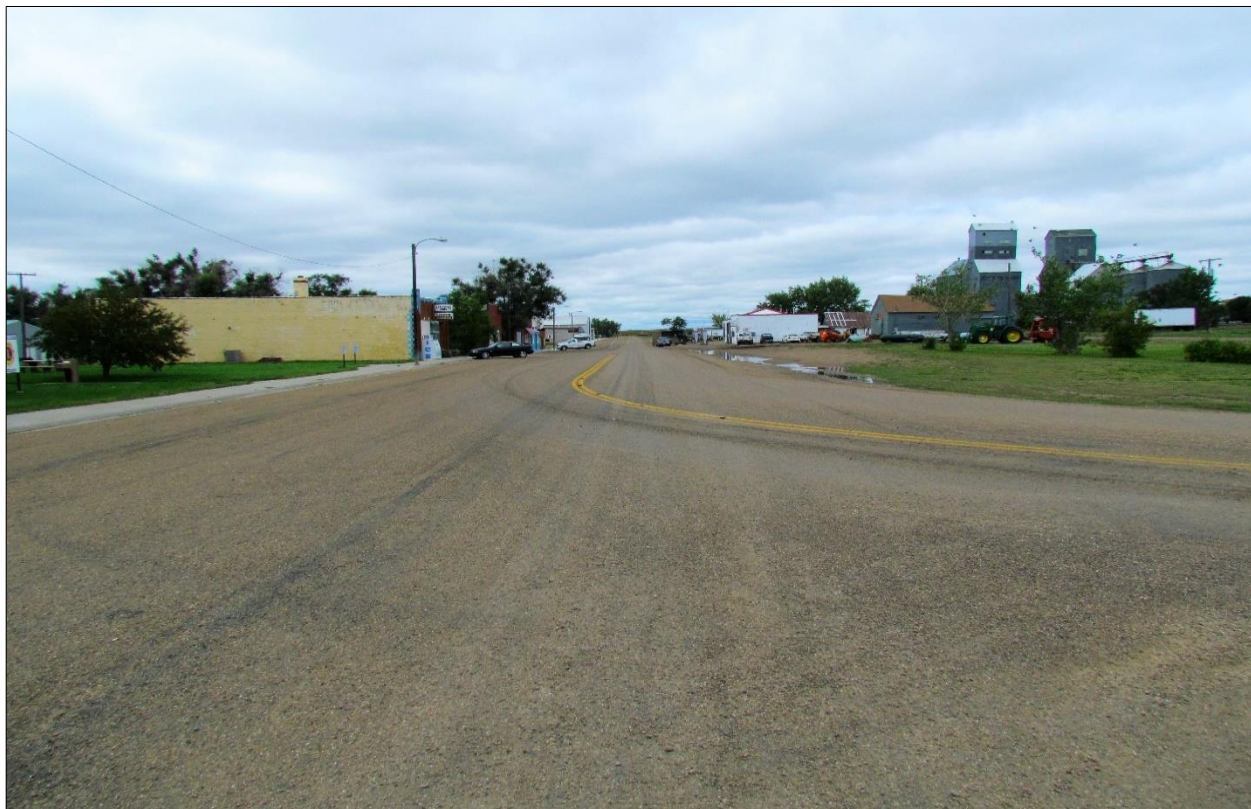
The project has received a standard seal and cover (chip seal) since construction. To date no visible distress on any of the project sections was observed. The next inspection will take place in the spring of 2020.

↓ Section 6; view west, no project distress to report.

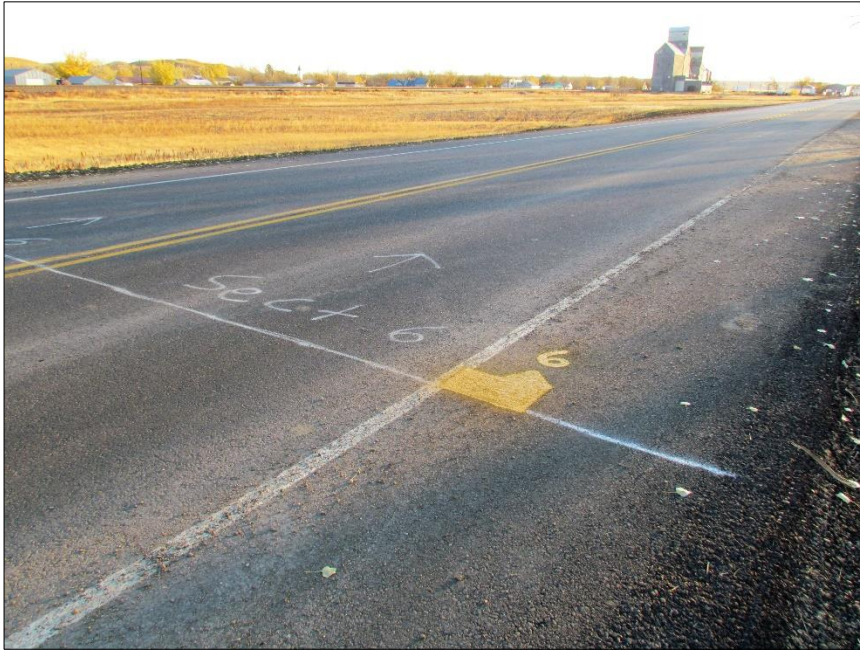
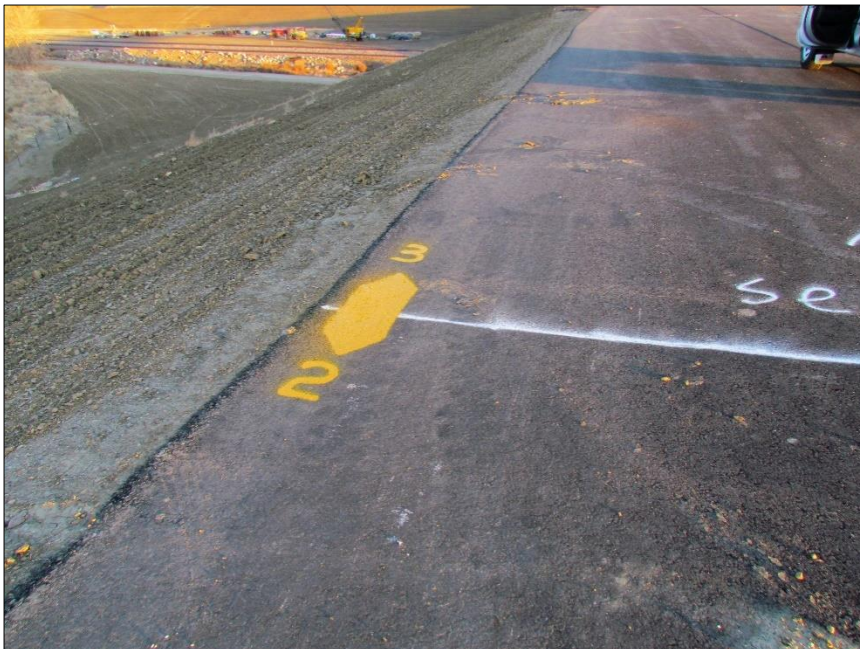
← Each section is delineated by yellow markings as seen in these images.

They will be reapplied as necessary.
