U.S. Department of  
Transportation

**Federal Railroad  
Administration**

# Laser Triangulation for Track Change and Defect Detection

1. AGENCY USE ONLY (Leave blank)		2. REPORT DATE March 2020		3. REPORT TYPE AND DATES COVERED Technical Report, March 2017 – December 2017
4. TITLE AND SUBTITLE Laser Triangulation for Track Change and Defect Detection			5. FUNDING NUMBERS DTFR53-17-C-00005

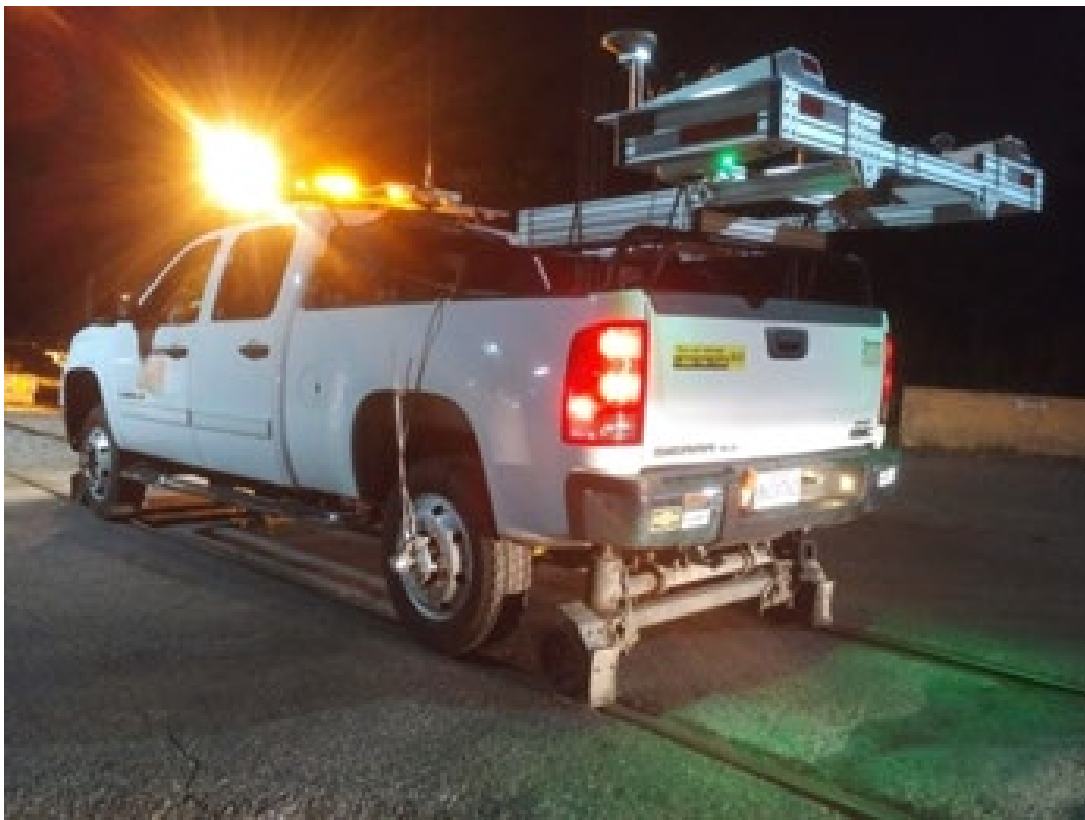
**Figure 1 – Primary Sensor Configuration**

During the data collection phase, Pavemetrics brought a hi-rail vehicle equipped with LRAIL sensors and associated hardware to Amtrak's facility for testing. The hardware package included a wheel-mounted encoder (for distance measurement), a GPS receiver, a DC to AC power inverter, and an industrial computer. Two different sensor mounting configurations were utilized; a top-down setup, (Figure 1) with one sensor directly over each rail and a two-sensor setup with one sensor above one rail and another sensor scanning the gauge-side face of that same rail (Figure 2).

The top-down setup was the primary configuration used for the project and for all change detection tasks. The side-scanning setup was specifically used to capture rail stamping on the side of the rail, and was not used for change detection.

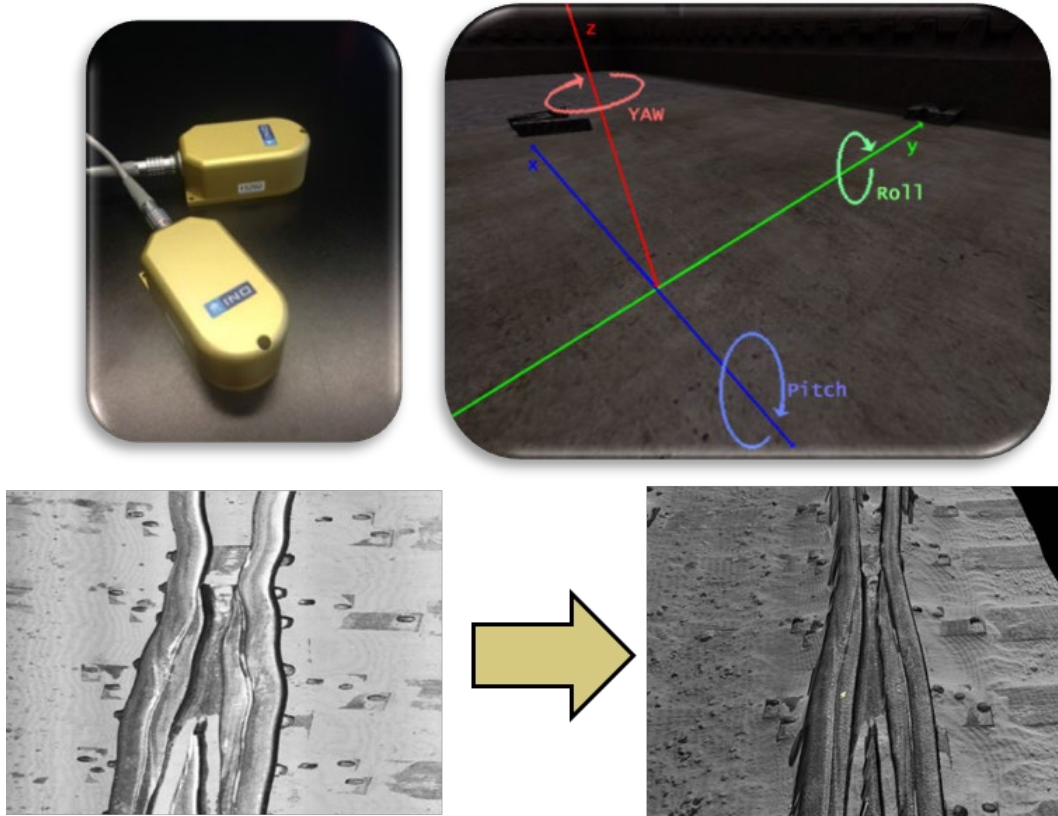
**Figure 3 – Correction for Vehicle Motion**

An inertial measurement unit is enclosed in each sensor head and used to track small changes in the pitch, roll and heading for each sensor. These orientation data were later used by a computer algorithm to remove vehicle motion artifacts from 2-dimensional and 3-dimensional data ([Figure 3](#)).

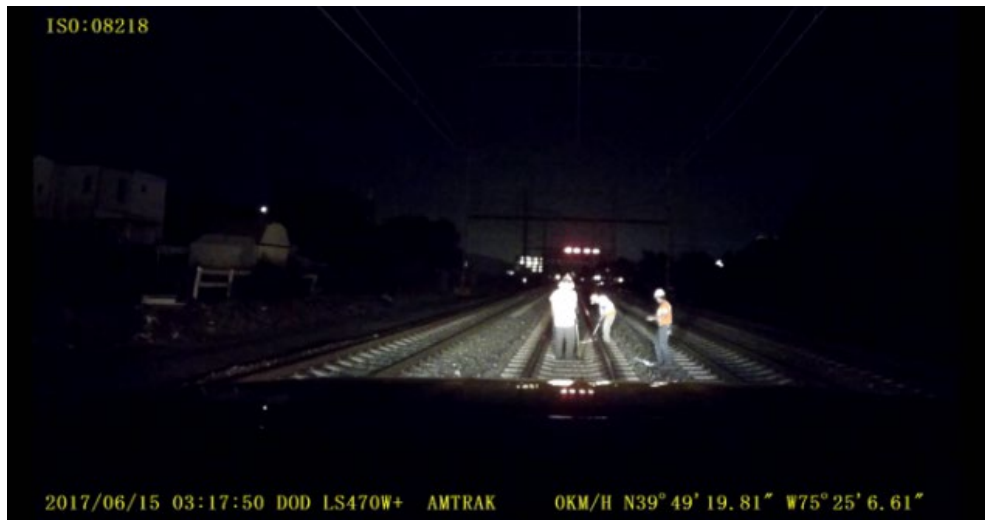
**Figure 7 – Dash-cam View of Mainline Testing**

Testing was also performed on the mainline near the Wilmington Maintenance Facility, also in Delaware, during off hours to minimize impact to the network.

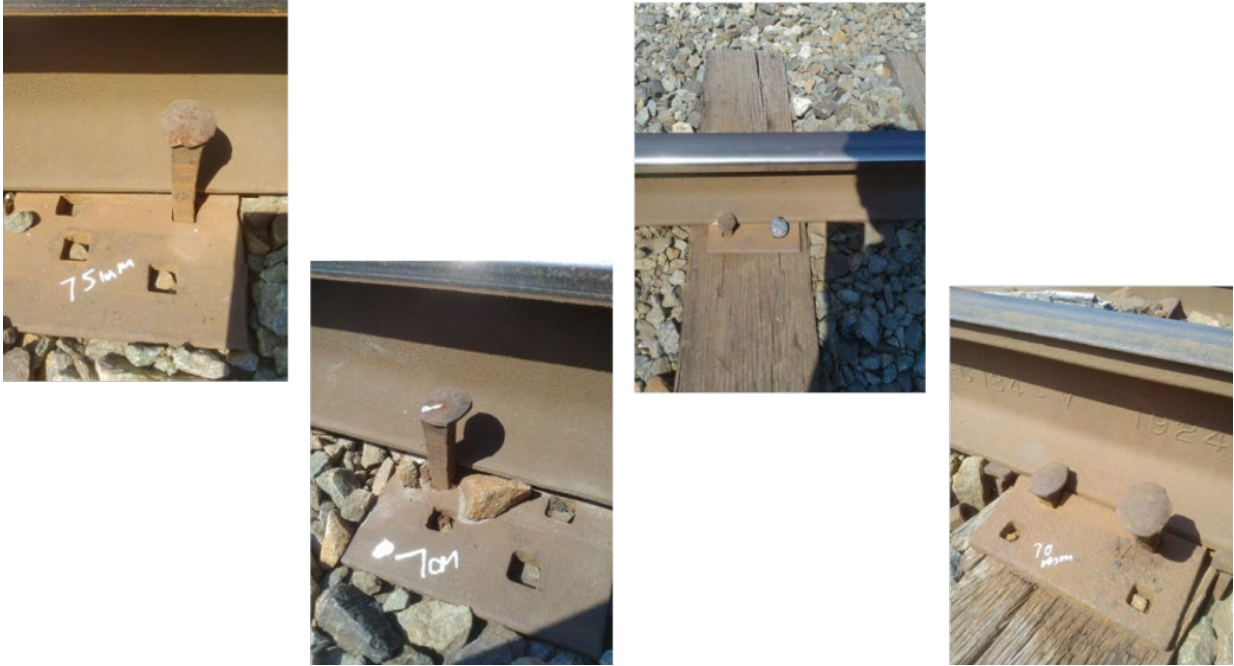
**Figure 8 – Spike Changes**

To test the detection sensitivity of the LRAIL system, a variety of changes were made to assets in the field, including spikes, anchors, fasteners, ballast, tie-skew, and joints. These changes are shown in the following figures.

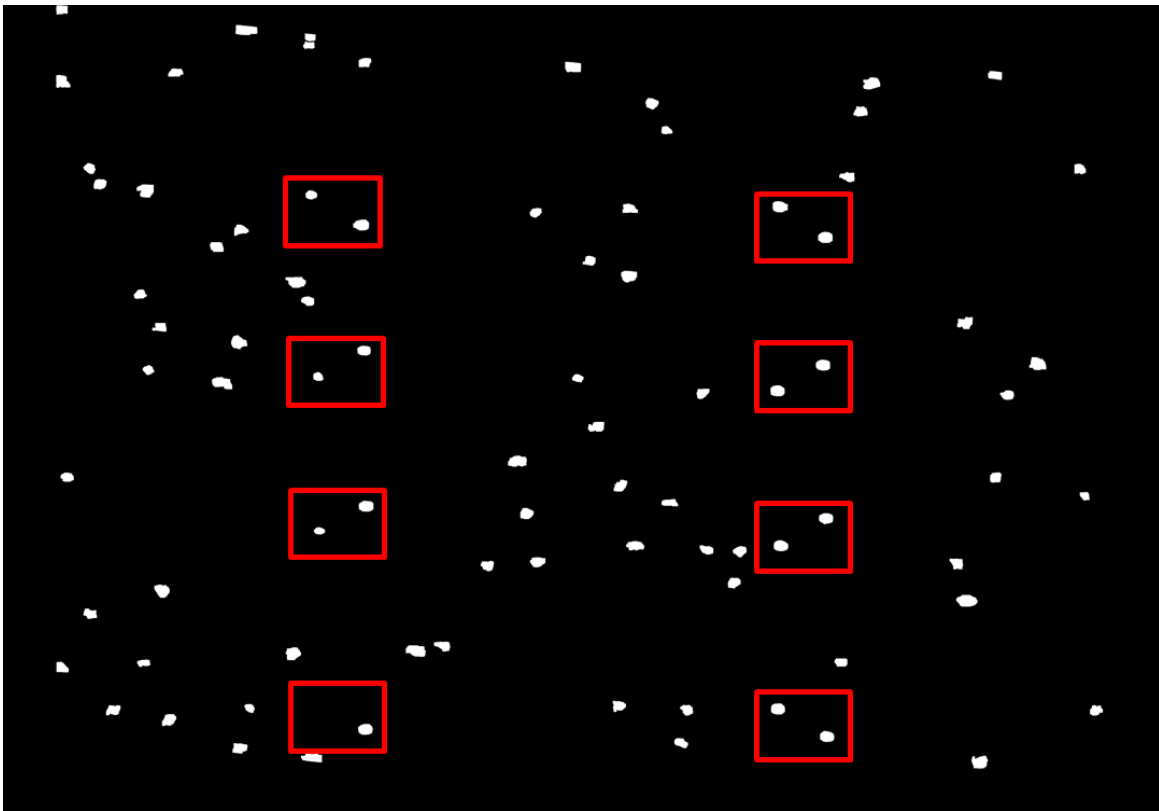
**Figure 14 – Regions of Interest Containing Heads of Spikes**

The change detection process involves first detecting the ties and rails, and then defining four regions of interest (ROI) at each intersection point (two on the gauge side and two on the field side). Each ROI was then inspected for the presence of spike heads using a 3-dimensional model (Figure 14). Spike count and average spike height was reported for each ROI and run-to-run comparison was performed on those same metrics.

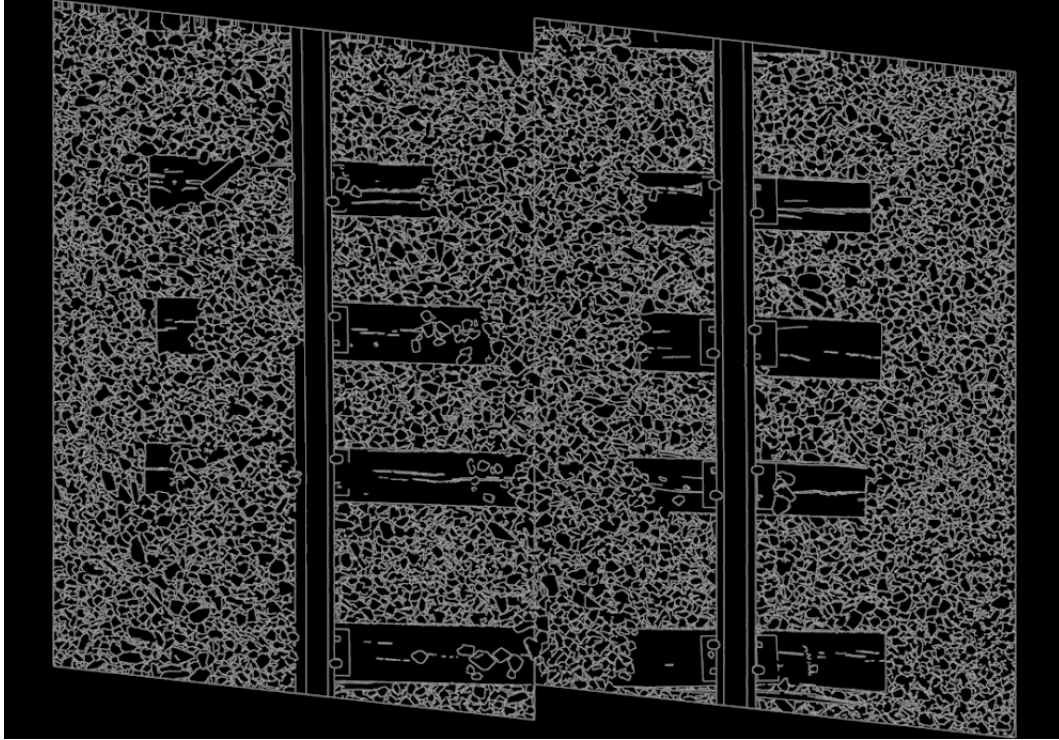
**Figure 15 – Similarity Between Ballast Particles and Spike Heads**

There was a similarity in size and shape between ballast particles and spike heads (Figure 15) that required the use of a high threshold for comparing candidate spikes against the 3-dimensional model for a genuine spike—to avoid erroneously labeling ballast particles in the ROI as spikes.

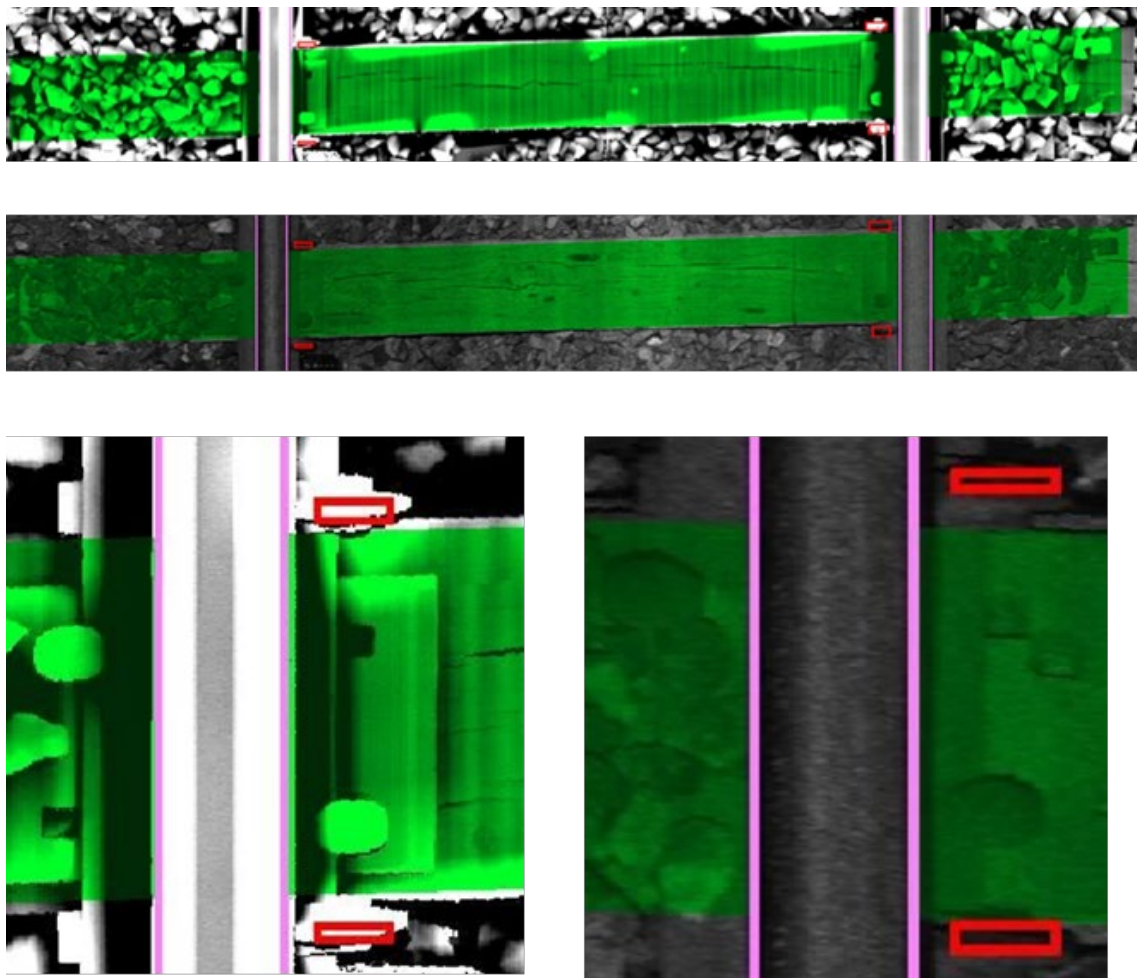
**Figure 17 – Anchor Change Detection**

For change detection of anchors, each ROI was inspected for the presence of anchors using a 3-dimensional model before a run-to-run comparison was completed to detect changes (Figure 17).

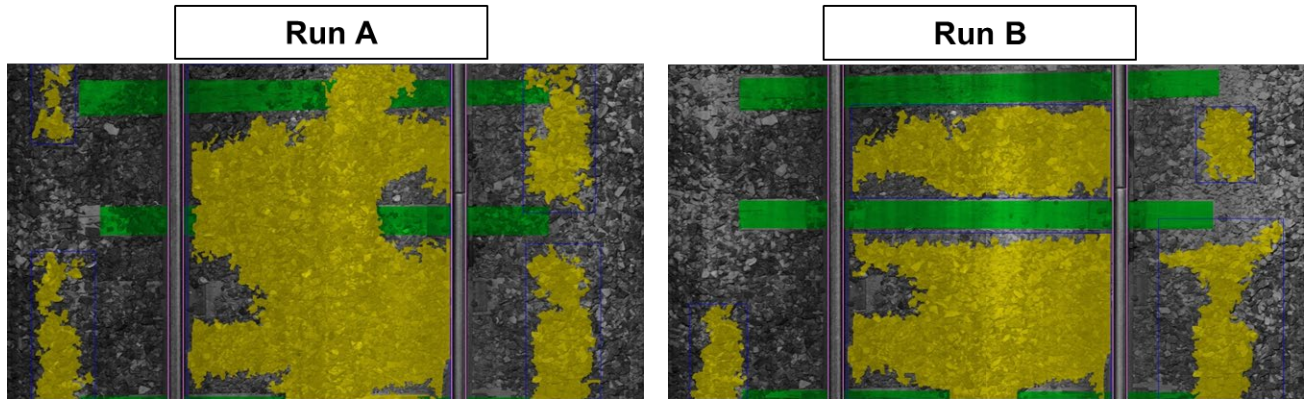
**Figure 18 – Ballast Change Detection Algorithm**

The ballast change detection process involved first detecting the rails to use as a reference point and then measuring ballast volume in relation to the position of the rails. Run-to-run comparison was then performed to flag changes. The program included a user-definable ballast volume threshold (Figure 18).

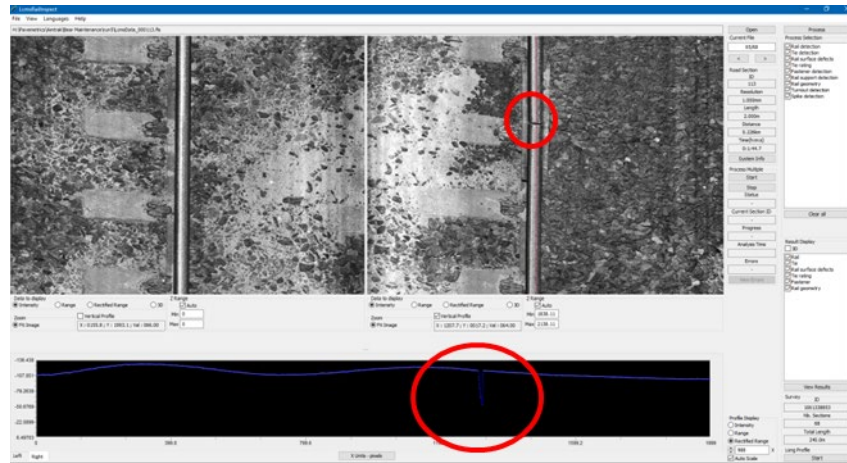
**Figure 20 – Rail Joint Range Image and Change Detection**

The joint change detection process involved first detecting the rails. The longitudinal profile of each rail was analyzed to locate gaps in the rail and joint-gap range images were produced for each location. Finally, a run-to-run comparison was then used to detect changes between runs ([Figure 20](#)).

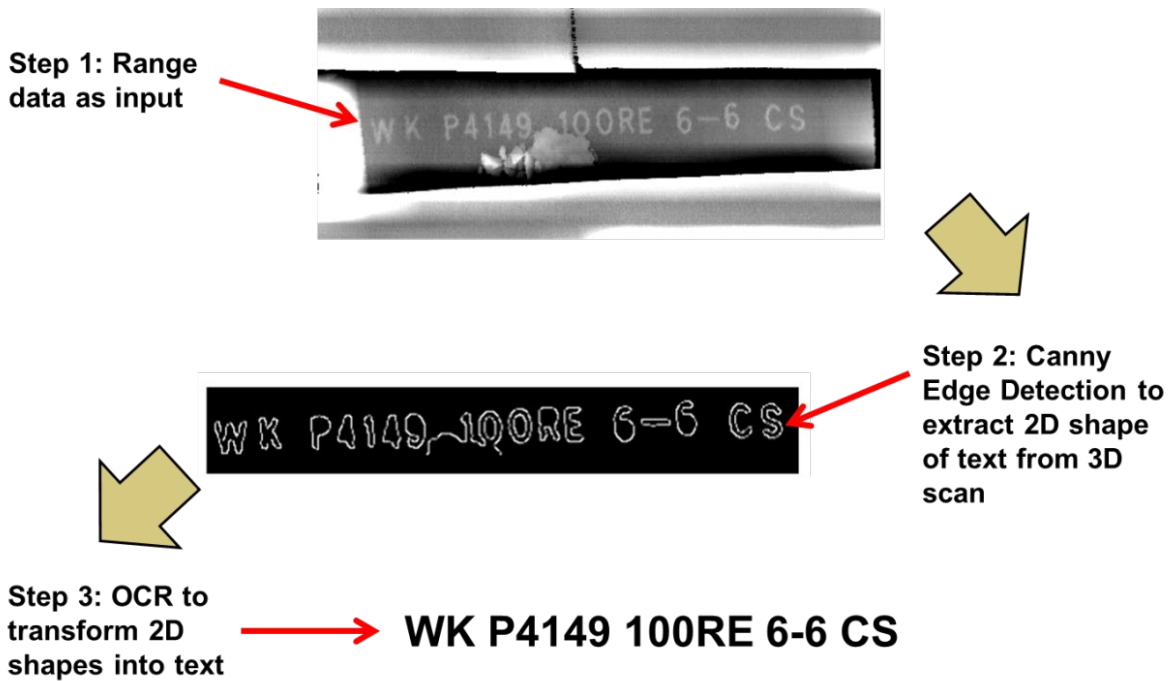
**Figure 21 – Rail Stamping Information Detection**

For rail stamping detection, Canny edge detection was used to extract the outline of rail stamping information from range data and an optical character recognition (OCR) algorithm is used to transform shapes into letters and numbers (Figure 21).

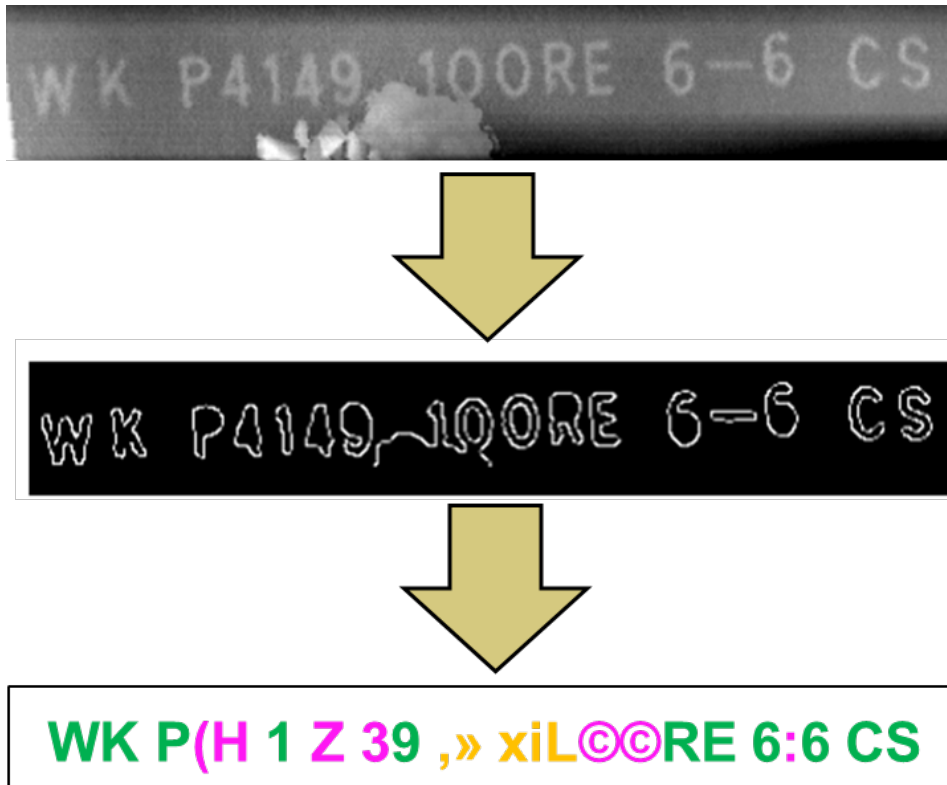
**Figure 22 – Impact of Corrosion and Surface Contamination on OCR Results**

Range data from both the top-down and side-scan sensor configurations were analyzed. In general, the results showed promise. It was possible to extract reasonable shapes from range data and to translate shapes into characters using OCR. However, surface corrosion and contamination affected the system’s accuracy. Both conditions contributed poor edge detection as well as poor OCR results (Figure 22).

Good edges and good OCR  
 Good edges but poor OCR  
 Poor edges and poor OCR (contaminants)

These results could be improved by filtering the Canny edge detection image to remove the outline of contaminants and by using an improved OCR algorithm. Researchers determined that the side-facing sensor setup was not ideally positioned to capture high-quality range data. The top-scanning equipment performed better. The stamping was clearly visible in range and intensity data from the top-scanning equipment and could be processed by OCR, while the side-scan data sets were poorly resolved.
