Federal Railroad
Administration

Fire Performance of a UN-T75 Portable Tank Phase 1: Loaded with Liquid Nitrogen

1. AGENCY USE ONLY (Leave blank)		2. REPORT DATE January 2020		3. REPORT TYPE AND DATES COVERED Technical Report, September 2016– August 2017
4. TITLE AND SUBTITLE Fire Performance of a UN-T75 Portable Tank Phase 1: Loaded with Liquid Nitrogen			5. FUNDING NUMBERS Contract DTFR53-16-C-00017

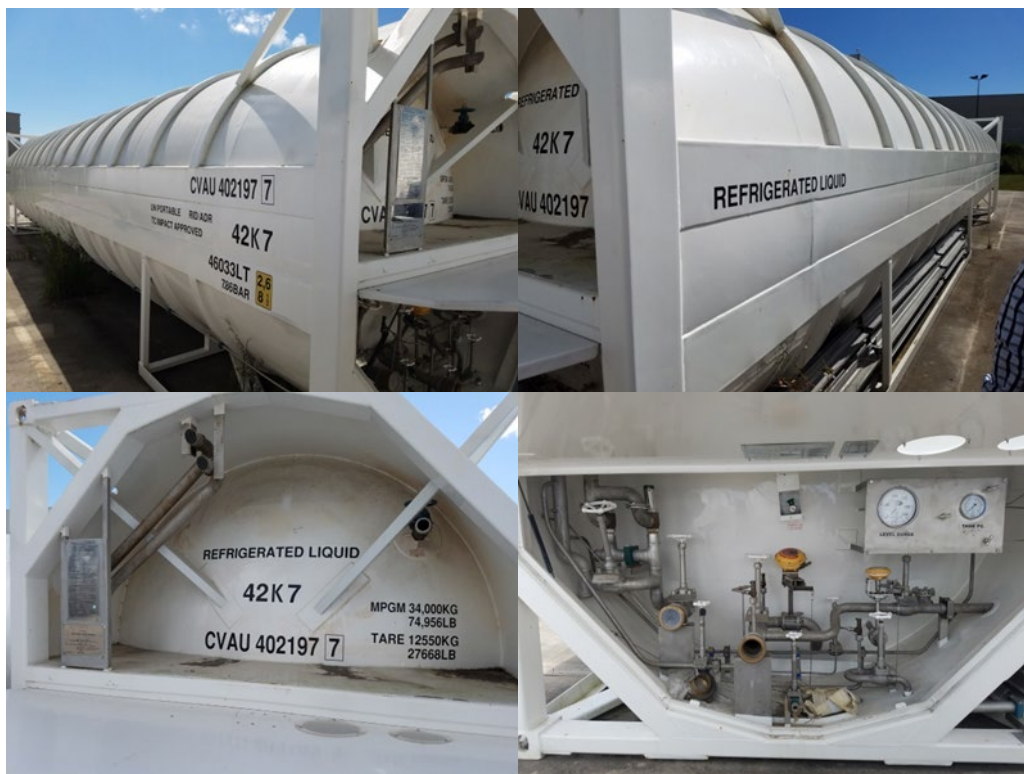
An ISO UN-T75 storage tank, outfitted for LNG service, was procured from Cryogenic Vessel Alternatives, Inc. (CVA). The model number of the tank is CVA-12K-114-ISO and measures 40 feet long, 8.5 feet high and 8 feet wide. [Figure 1](#) provides selected photographs of the tank that was used in this experiment. Additional figures can be referenced in [Appendix A](#) of this report.

Figure 1. ISO Test Tank Photographs

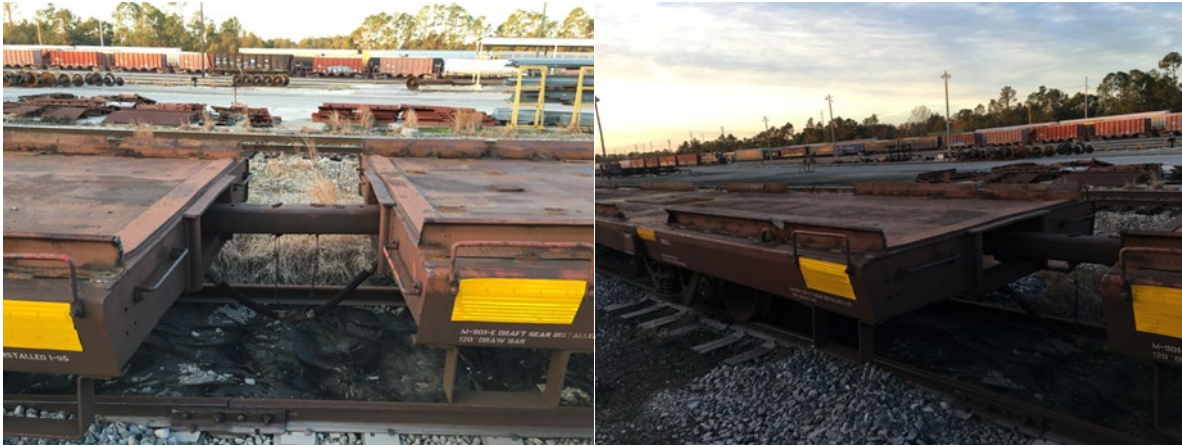
FRA identified a project partner in the Florida East Coast Railway (FECR), that donated two flatcars connected together, in order to safely travel across the country by rail. Only one of these cars was utilized for the fire testing. The car was taken off the rail line at the Transload Operations location for Hondo Railway. The cars were disconnected and transported by truck to the remote test site, located in Sabinal, TX. [Figure 2](#) shows two photographs of the flatcar prior to arrival at the remote site.

Figure 2. Flatcar Photographs (provided by FECR)

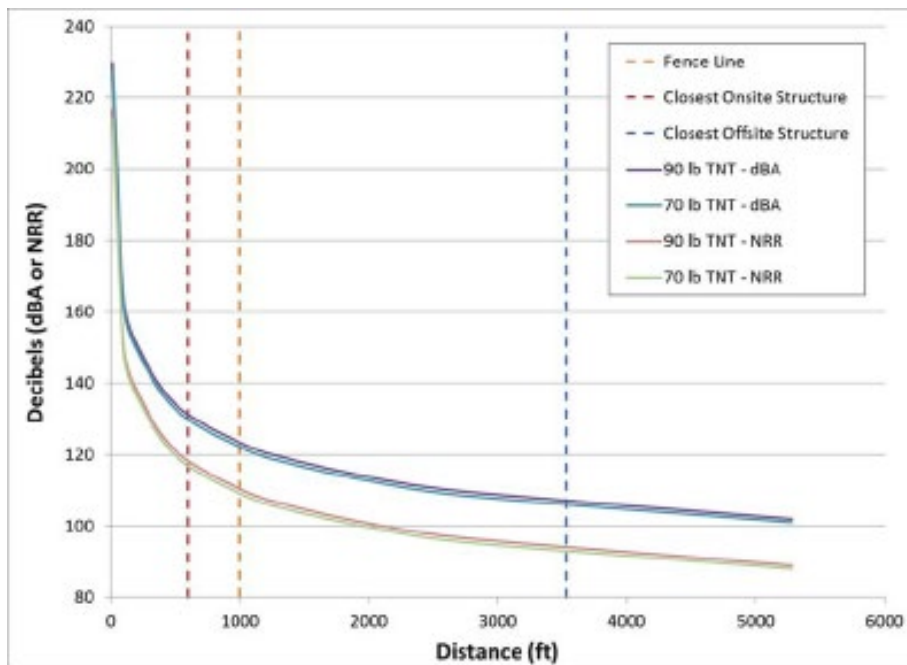
Figure 3 shows a curve for 70- and 90-lb. TNT equivalent and the dBA and noise reduction rating (NRR), or dBA after accounting for hearing protection. It can be seen that onsite structures and personnel were able to be protected to a safe level in the event of a tank failure.

Figure 3. Calculated Sound Pressure Levels for Varying Overpressures

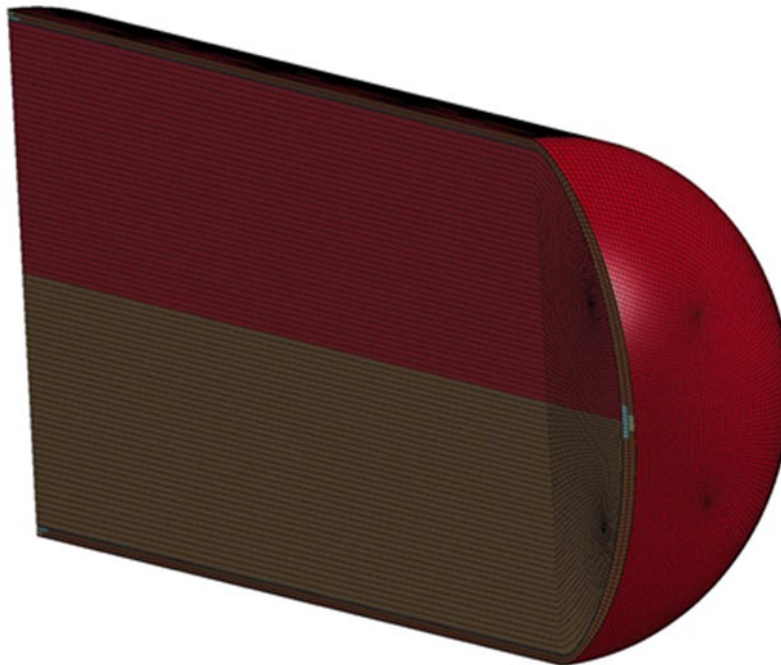
FE analysis was used to support the development of the safety plan. The objectives of the modeling efforts included validating the model against known burst pressure performance data and to assess the temperature versus pressure time histories due to representative pool fire heat transfer rates. A quarter-scale model of a 12,164-gallon insulated LNG, based on a currently available and in-service product, was generated for use in the LS-DYNA (i.e., developed by the Livermore Software Technology Corporation [LSTC] in Livermore, CA) solver environment. See Figure 6 for a rendering of this quarter-scale model.

Figure 6. Quarter-Scale FE Model of Tank

The FE model consisted of eight parts representing the actual tank. These included the outer and inner walls, a multilayer insulation between the inner and outer walls, pipe connections between the walls, cylindrical supports, ring supports, LNG, and an air cavity. The model was meshed with 882,636 nodes, 766,800 solid (hexagonal) elements, and 58,800 shell (thick) elements. The use of thick shell elements versus standard 4-node shells facilitated surface temperature assignment to the model.

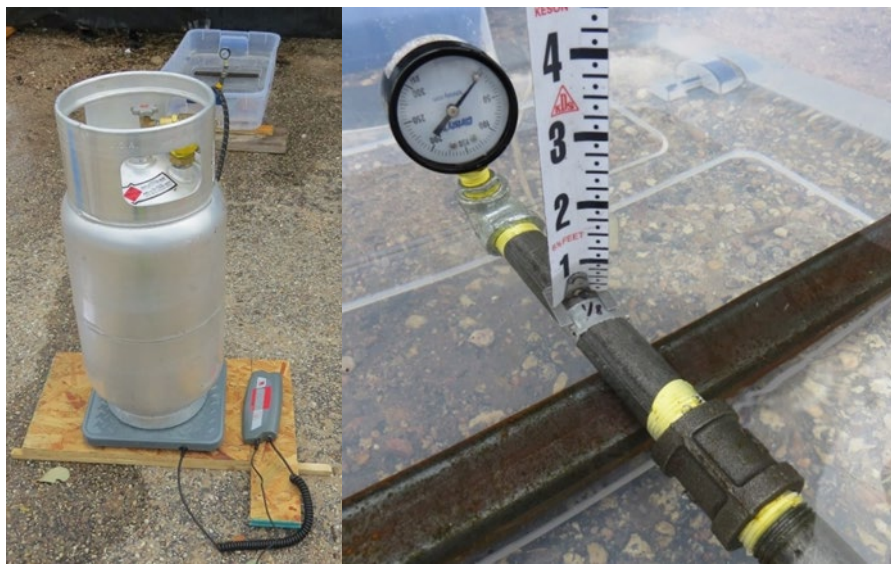
A small-scale test was set up to investigate the effects of flowing LPG through a representative burner system and to identify unforeseen issues with this burner design. Liquid propane flowed through variations of small-scale burner assemblies that consisted of 12-inch to 36-inch lengths of 1/2-inch, 1-inch and 2-inch diameter, schedule 40 black pipe. A 33-lb (8-gal.) “forklift cylinder” propane tank with a dip tube was used to supply the flow of liquid propane into the burner assembly via a 6-foot long hose. The burner assembly was made with several 1/16-inch, 1/8-inch, and 1/4-inch diameter holes as shown in [Figure 13](#) and summarized in [Table 1](#). The burner was submerged in under a depth 1 inch to 4 inches of water for each test. A digital scale (i.e., model No. SD35, Ohaus Corporation in the U.S.) was used to provide a time-history of the propane mass from which a flow rate could be calculated. [Figure 14](#) depicts a typical test.

Figure 13. Small-Scale LPG Burner Test Setup

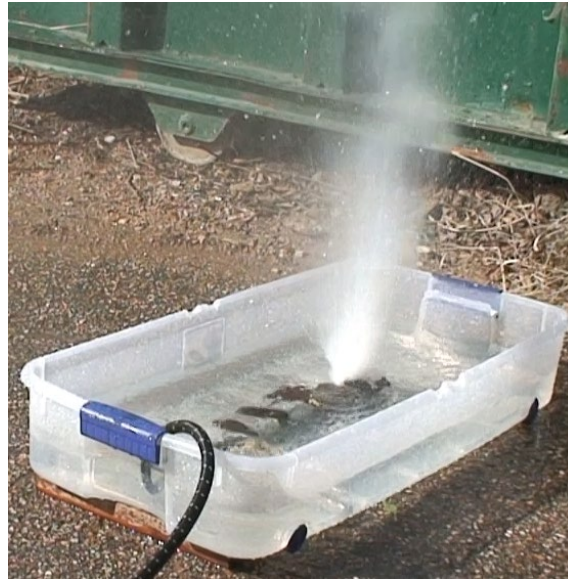
Figure 14. (3) × 1/8-in. Diameter Holes, 2-in. Diameter Pipe, 1.5 gpm

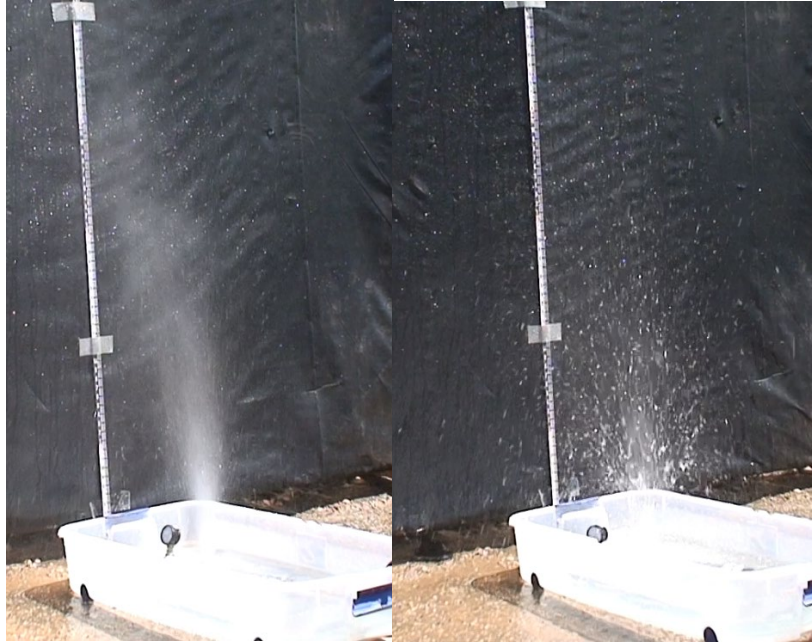
For each test, the pipe was initially submerged in and filled with water. As the flow of propane was initiated, the water was quickly expelled through the pre-drilled orifices. In all tests, the propane appeared to remain liquid until escaping through the orifices at which point it quickly changed phase and expanded rapidly. The rapid phase change and expansion into a gas had two negative effects. The interaction between the LPG and the water surrounding the orifices resulted in the formation of ice around the orifices under certain situations, which discussed below. Additionally, the rapid expansion of the LPG liquid as it vaporized into gas resulted in jets of LPG/water that reached as high as 5-feet and produced a large amount of spray. The height of the jets decreased with increasing orifice size. Two examples of jet height are shown in [Figure 15](#).

**Figure 15. Left: Height of Spray from Single 1/8-in. Hole (~4-5-ft. tall);
Right: Height of Spray from Single 1/4-in. Hole (~3-ft. tall)**

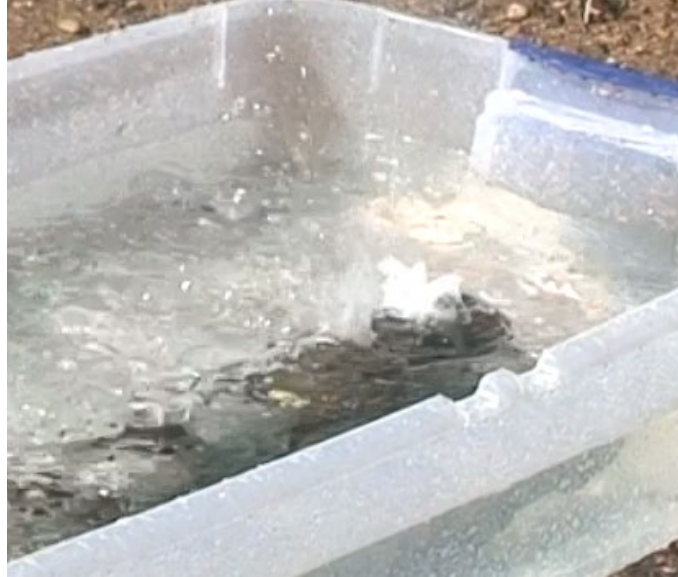
The most important effect related to hole size was the generation of ice on the orifice. The 1/4-in. diameter holes always produced ice at flow rates up to 1.25 gpm. Ice occasionally occurred at the 1/4-in. diameter orifices at 1.5 gpm. Ice formation was reduced with the use of smaller holes. Ice always formed at the hydraulically most remote hole first and then propagated toward the pressure source if the overall flow rate was not high enough to prevent ice buildup. When ice did form, it generally fully covered or significantly restricted the flow through an orifice within 30 seconds of initiating the flow. An example of the resulting flow after ice buildup is shown in [Figure 16](#).

Figure 16. Ice Buildup: $(2) \times 1/4$ -in. Diameter Hole in 2-in. Diameter Pipe at 1.5 gpm

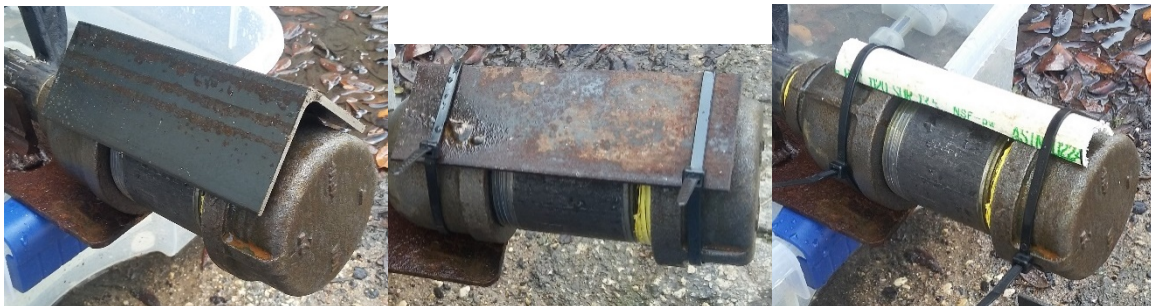
To reduce the height of the jets produced by the vaporization of the LPG three cover designs were implemented as shown in Figure 17. All the covers prevented jets from occurring, as shown in Figure 18, however, they also increased the generation of ice. A flat plate (2-in. wide) mounted 1.75 inches above the $3 \times 1/8$ -inch diameter holes provided adequate dissipation of the jet while also limited ice formation; some amount of ice still formed, but did not appear to affect the flow rate out of the orifices.

Figure 17. Select Covering Methods to Reduce Spray; 2-in. Angle Iron, 2-in. Wide Plate, 1-in. Diameter PVC Tubing Split Lengthwise

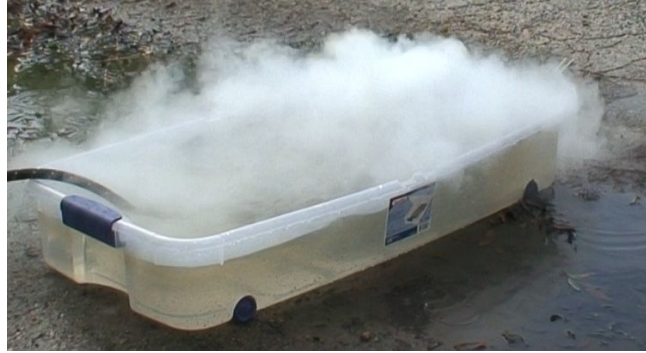
Figure 18. (3) × 1/8-in. Diameter Holes in 2-in. Diameter Pipe with 2-in. Wide Plate Cover, 1-in. Gap Between Steel Plate and Pipe Holes, 1.5 gpm

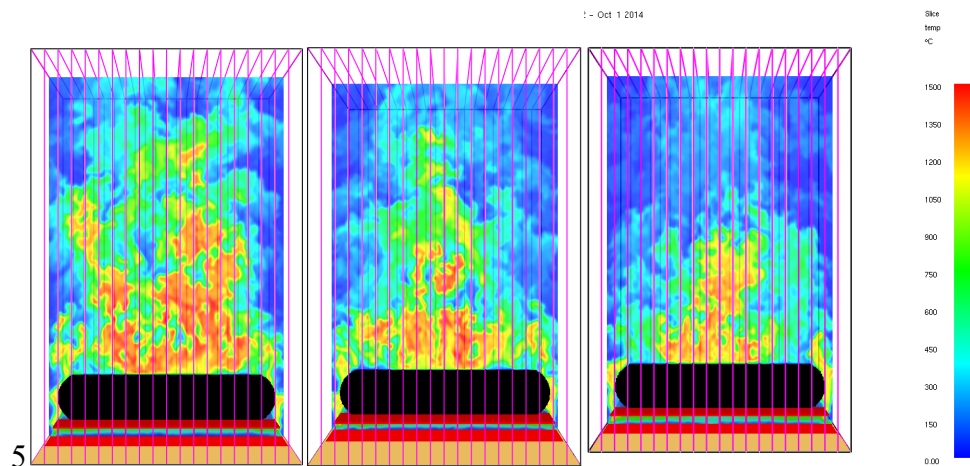
Finally, the ability to fully combust the amount of propane required to produce the desired HRRPUA was evaluated. A maximum HRRPUA of 4,564 kW/m² was identified by SwRI as approximately equivalent to the LPG exposure fire planned for testing. The density of propane reactants for the Full and Half HRRPUA simulations was calculated at two heights: 1.5-feet and 11.5 feet above the ground to determine how much propane was combusted. Note that the combustion parameters were defined to simulate ideal conditions. As depicted in [Figure 25](#), 97–99 percent of all propane was able to be combusted by the time it reached 11.5 feet. On the other hand, about 25 percent and 50 percent of the propane in the Full and Half HRRPUA simulations, respectively, had yet to combust at 1.5 feet above the ground.

Figure 20. Flame Height Comparison for Full, Three-quarter, and Half HRRPUA FDS Simulations, NB: Total Mesh Height Is 20 m

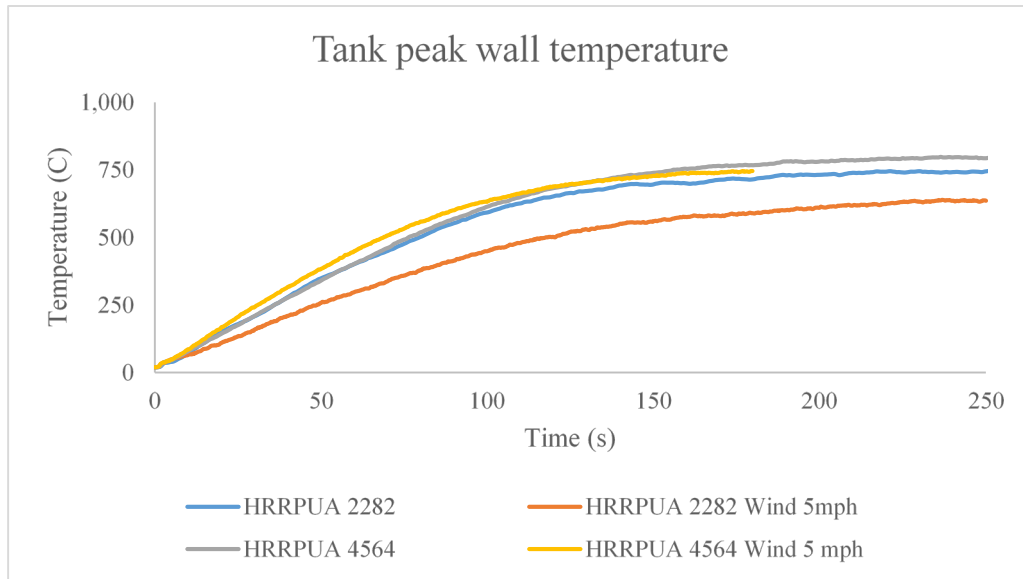
Figure 23. Effect of 5-mph Wind on Peak Outer Wall Tank Temperature

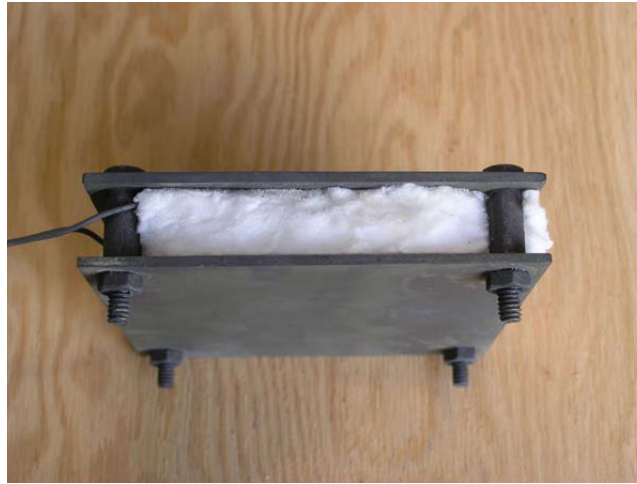
An advantage of the DFT over the plate thermometer is that the heat transfer through a DFT can be calculated with an inverse heat transfer code such as IHCP1D.¹³ The use of these devices in fire experiments has been recently standardized in ASTM E3057.¹⁴

Figure 29. Directional Flame Thermometer

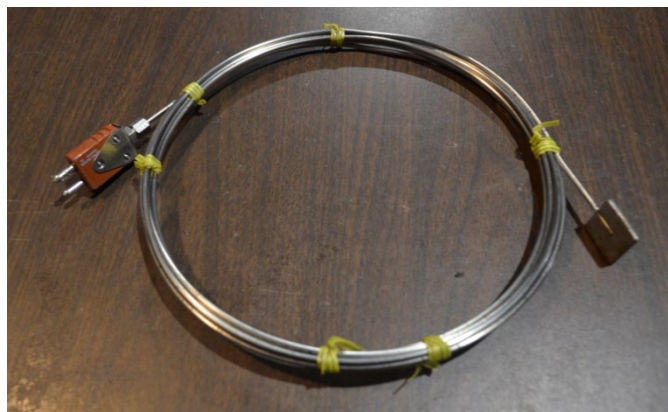
The weld-pad surface temperature thermocouple probe is designed for use in industrial applications to measure surface temperature by way of attachment via weld, braze, or clamp. The pad is flexible to easily form to the contour of a flat or curved surface. The pad material is 304 stainless steel and measures $1.0 \times 1.0 \times 0.01$ inch (25 mm \times 25 mm \times 0.25 mm) and the thermocouple is type K. Figure 30 shows a photograph of one of SwRI's weld-pad thermocouples.

Figure 30. Weld-Pad Surface Temperature Thermocouple Probe

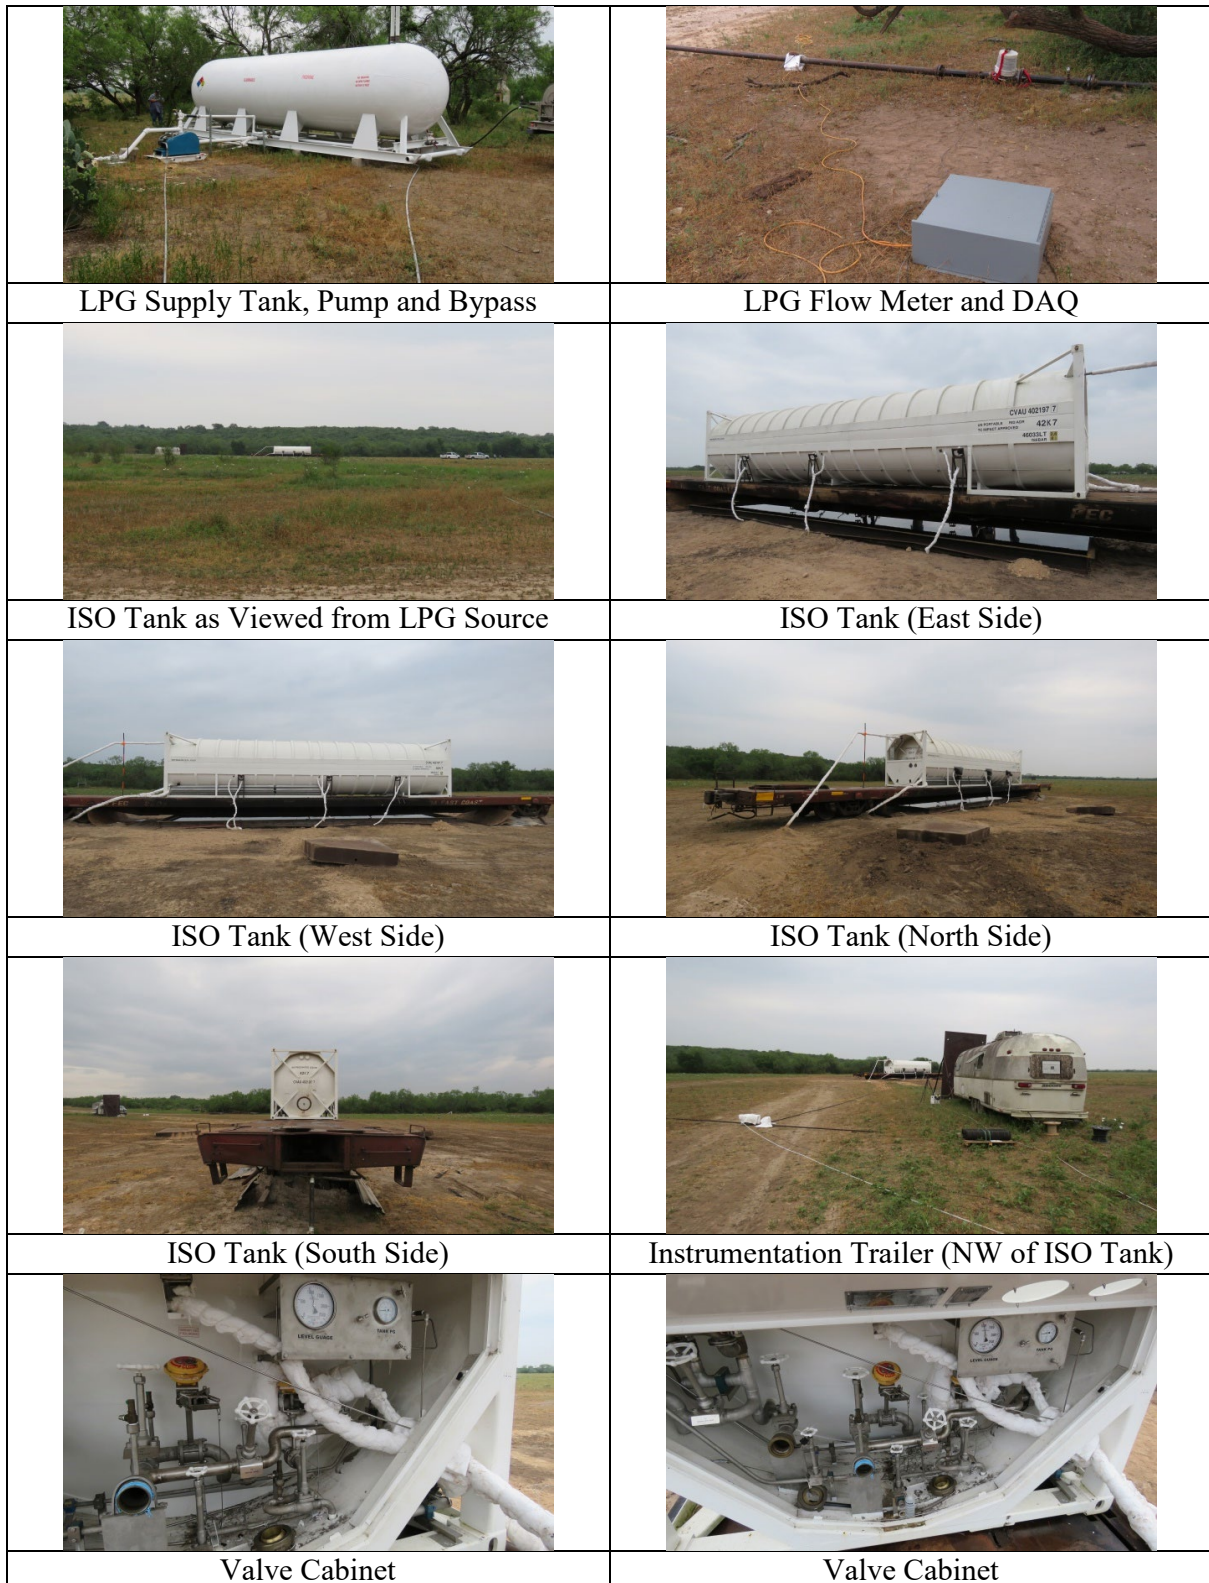
[Figure 36](#) through [Figure 39](#) show the test setup, pre- and post-test condition of the tank. Additional photographs and processed video of the test from each of the three camera angles have been sent to FRA.

Figure 36. Selected Setup and Pre-Test Photographs

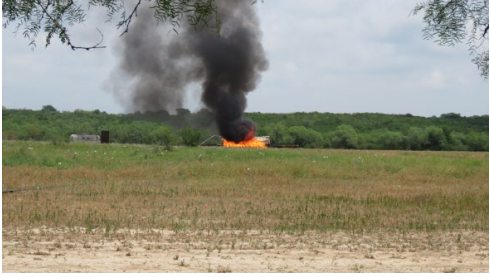
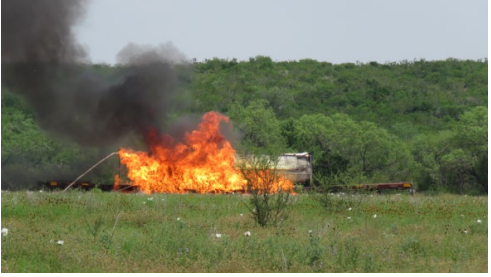
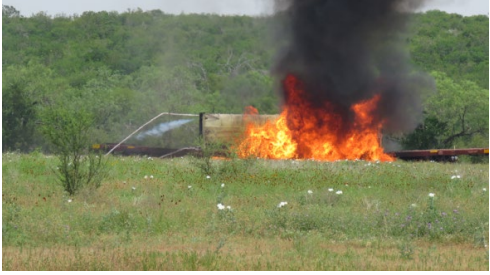
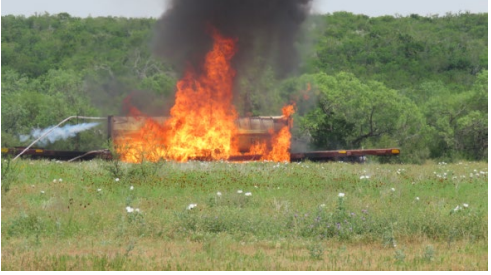
Test in Progress (View from LPG Supply Tank)	Test in Progress (Close-Up View)

Test in Progress (PRV Operating)	Test in Progress (PRV Operating)

Figure 37. Selected Testing Photographs

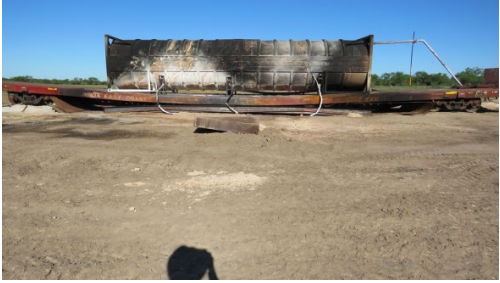
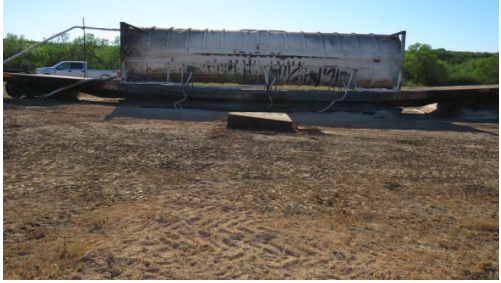
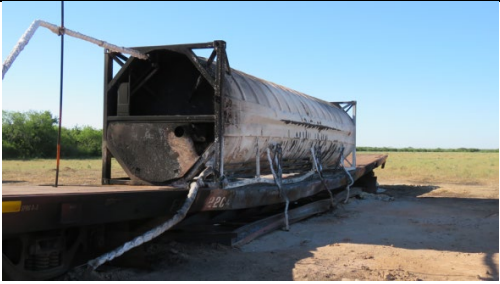
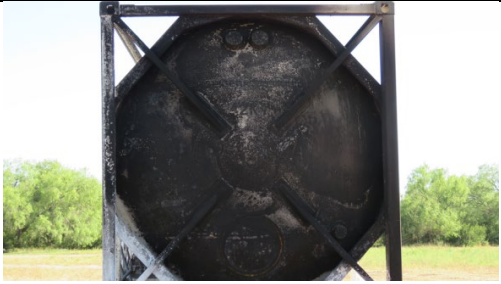
Post-Test: ISO Tank (East Side)	Post-Test: ISO Tank (West Side)

Post-Test: ISO Tank (North Side)	Post-Test: ISO Tank (South Side)

Figure 38. Selected Post-Test Photographs

- A portable tank, filled with LN₂, was exposed to a liquefied petroleum gas (LPG) fire for 2 hours, 35 minutes.
- There was no rupture or BLEVE of either the inner or outer tank.
- The steel in the flatcar exceeded its softening temperature. The flatcar sagged downward until it was supported by the fire pan.

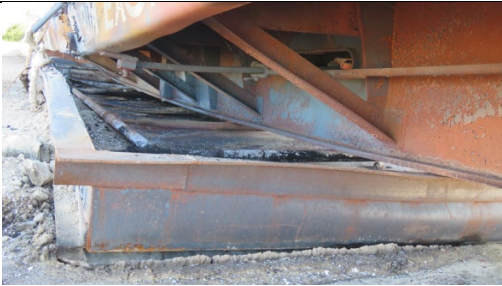
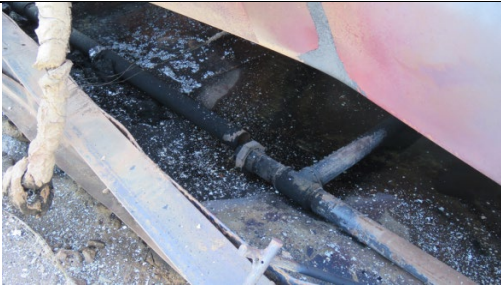
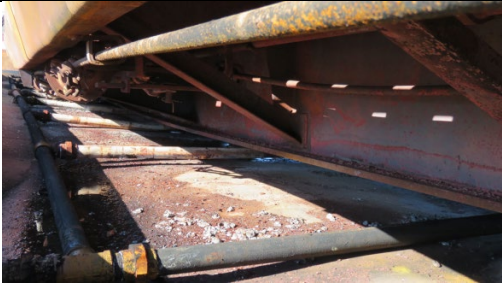
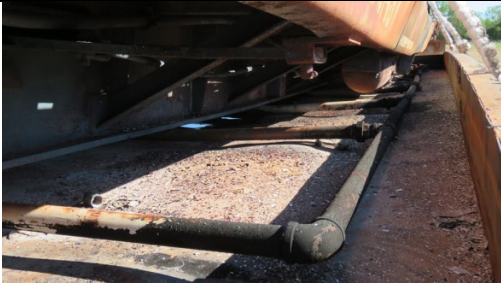
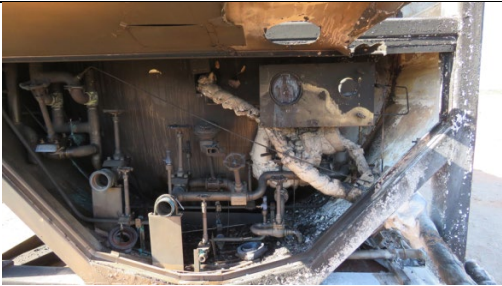
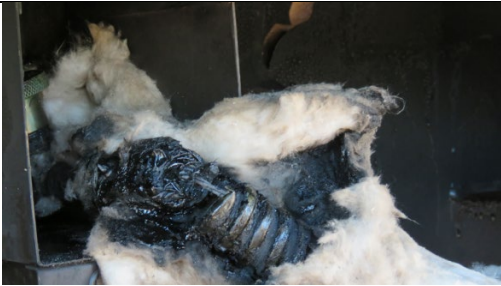
Flatcar Buckling into Burner	Damage in Burner Piping Array

Flatcar Buckling into Burner	Flatcar Buckling into Burner

Post-Test: Valve Cabinet	Post-Test: Vacuum Pressure Damaged Connection
