# Maintenance-Free Corrosion-Resistant Steel Plate for Bridges

Final Report VTRC 19-R21

**MAINTENANCE-FREE CORROSION-RESISTANT STEEL PLATE FOR BRIDGES**

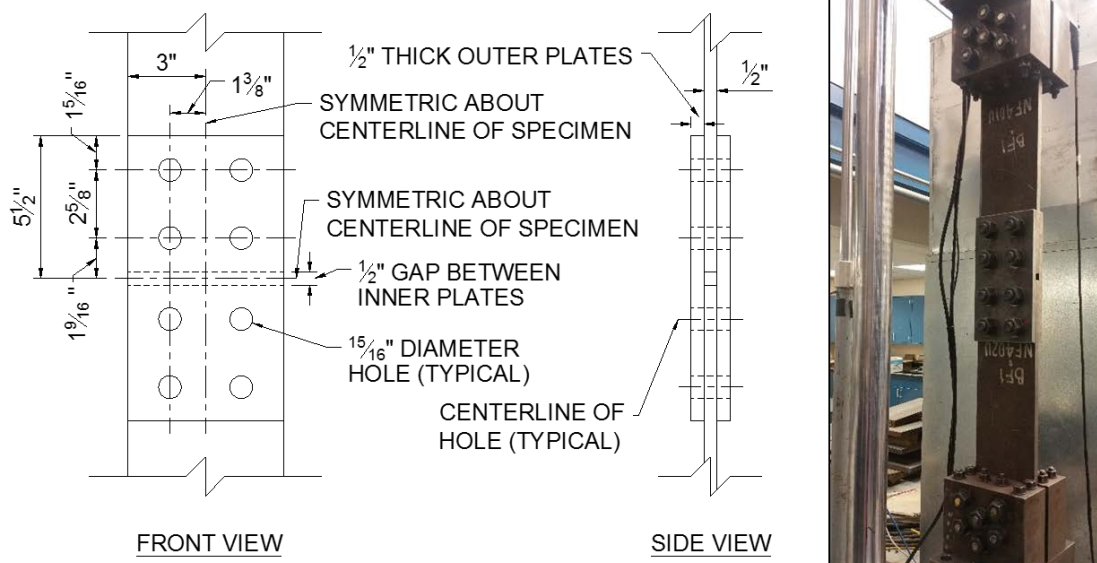
**Figure 4. Geometry and Fatigue Test Setup of ASTM A709 Grade 50CR Steel Bolted Connections: left, geometry; right, test setup**

During testing, it was common for one of the two splice plates to fail in fatigue before the other did. When this occurred, the plate that did not fail was matched with an untested splice plate and testing was resumed. Conducting the tests in this manner allowed for one stress range–number of cycles (S-N) data point to be produced per splice plate tested. The load and number of cycles were recorded until failure or until the test was stopped and was declared a runout. Figure 4 shows the geometry and test setup of the fatigue test of the 50CR steel bolted connection.

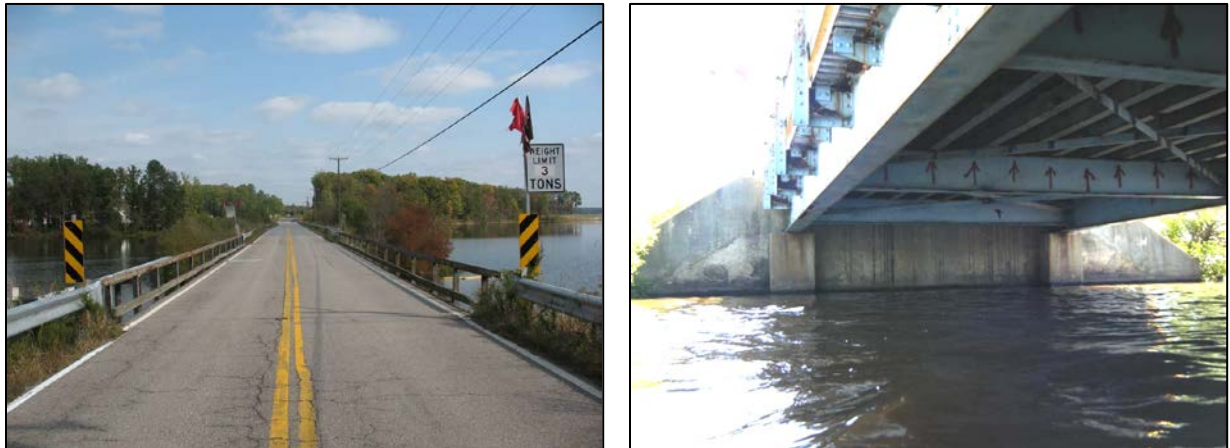
Figure 6. Original Bridge Over Swift Creek: left, 3 ton posting in spring 2010; right, underside of bridge

After an inspection in the spring of 2010, deterioration of the structure led the bridge to be load rated for a capacity of 3 tons, which necessitated that all school and emergency vehicles be detoured around the bridge. Although the original bridge had provided access across Swift Creek for 72 years, new physical and construction constraints required changes in the bridge design.

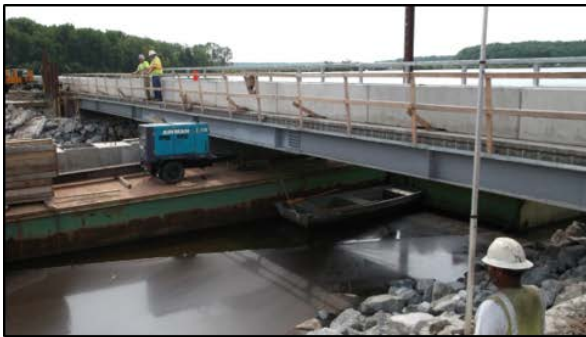
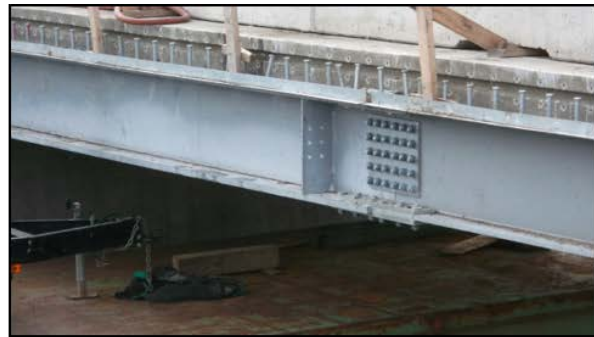
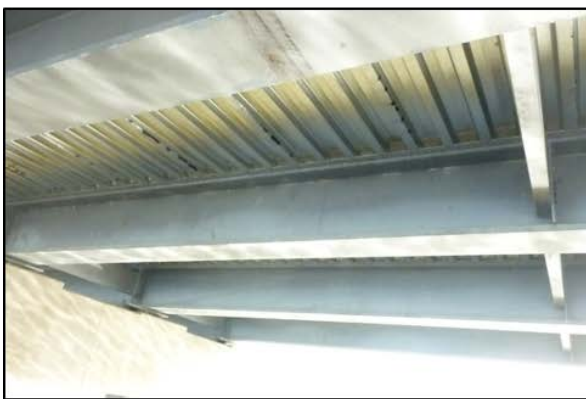
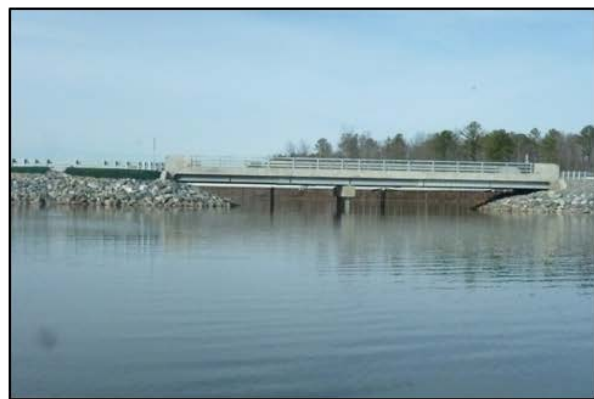
Figure 8. The New Genito Road Bridge Over the Swift Creek Reservoir: (a) during construction; (b) showing the studs and splice; (c) underside of the bridge; (d) after completion of construction

Construction of the bridge using the GWS girders was consistent with standard construction practices. Figure 8 shows the exposed studs before placement of the concrete on the deck and the girder splice that was used. In the figure showing the splice, a variation in the color can be seen; however, the galvaning was tightly adherent. This figure also shows the underside of the bridge and a side view of the finished bridge.

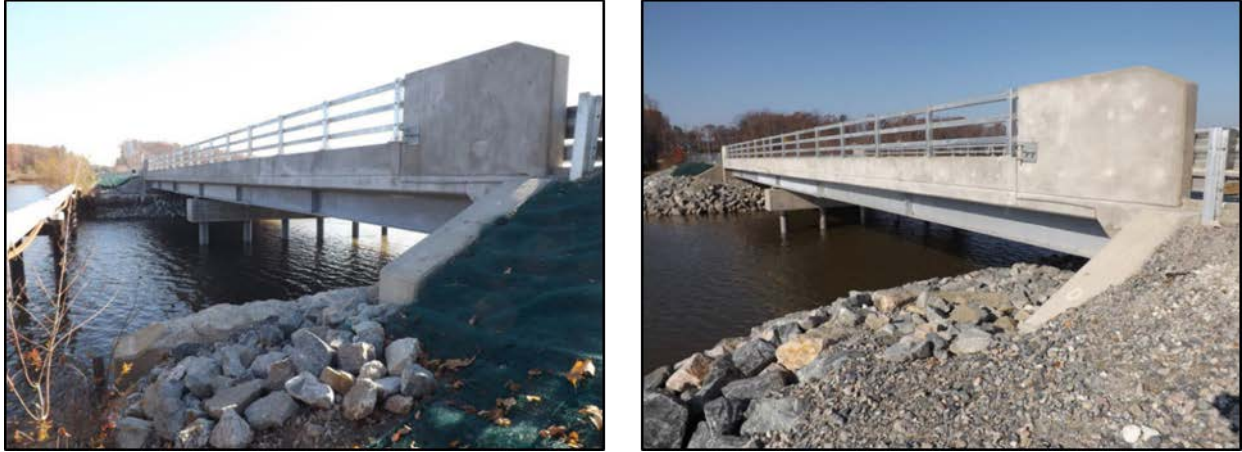
**Figure 9. Images of the Genito Road Bridge From the Initial VDOT Inspection Report in 2012: left, upstream (north) elevation; right, downstream (south) elevation**

After completion of the bridge, an initial inspection was performed in October 2012. Images from this inspection are shown in Figure 9. The overall condition of the structure was reported as “Good,” and there were no indications of any noteworthy deficiencies with the GWS girders. Regular inspection reports from October 2014 and 2016 also indicated that the overall condition of the structure was “Good” and there were still no indications of any noteworthy deficiencies with the GWS girders.

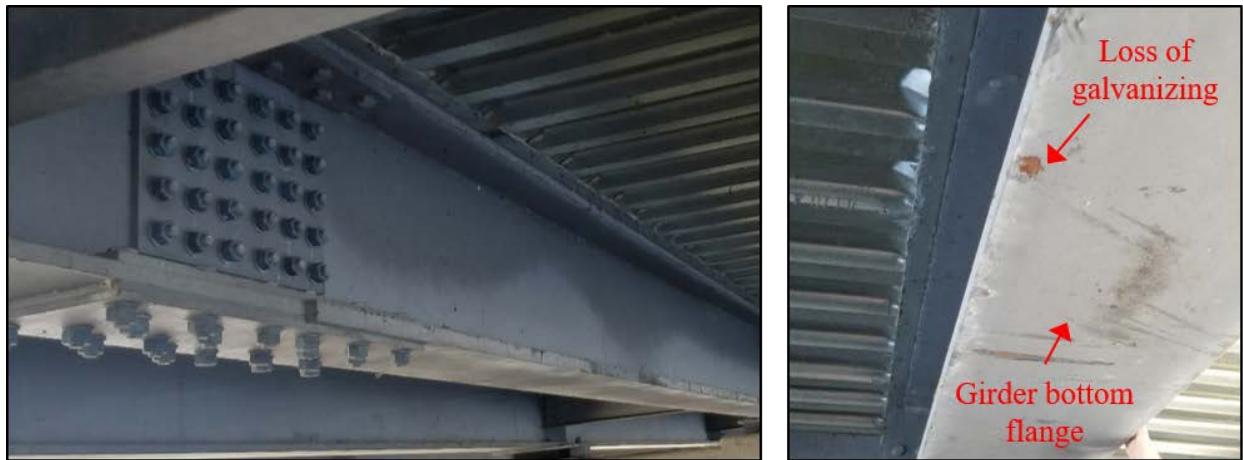
**Figure 10. Visual Condition of Galvanized Weathering Steel Girder in March 2018: left, an example of the general condition; right, the only location exhibiting loss of galvanizing coating and showing the underlying weathering steel girder**

In March 2018, a field visit by VTRC and VDOT staff was arranged for a visual assessment of the condition of the GWS girders. Most of the surface appeared to be in acceptable condition and corrosion was not evident, as shown in Figure 10. However, a small circular area was found along the bottom of a girder where the galvanizing was no longer present. It will be important to monitor this site as the bridge continues to age and to understand better the corrosion resistance of a galvanized Grade 50W steel girder in this environment.

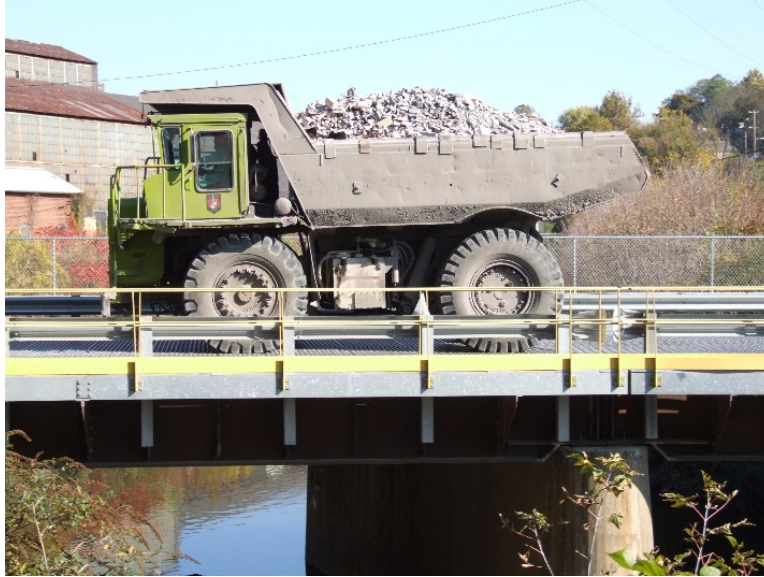
**Figure 12. William G. Taylor Memorial Bridge Constructed Using ASTM A709 Grade 50CR Steel Plate Girders**

In October 2013, the producer of the 50CR steel gave a small group of personnel from VTRC and VDOT the opportunity to visit the William G. Taylor Memorial Bridge, which was constructed using 50CR steel plate and is located in Coatesville, Pennsylvania. Since its dedication in 2012, the bridge has been subjected to low volume, heavy loads because of its location between the steel belt shop and the rolling mill at the steel producer. A photograph of one of these heavy loads is shown in Figure 12.

The bridge was constructed using a galvanized steel open grid deck supported by 50CR steel plate girders. As shown in Figure 13, the bridge hardware, including fastener assemblies, is also galvanized. The 309L filler metal used when welding is evident, which is why the weld beads have a shiny metallic luster and the 50CR steel plate has a darker rustic patina. As may be seen, the patina formed on the 50CR steel plate except for the region around the galvanized bolt head.

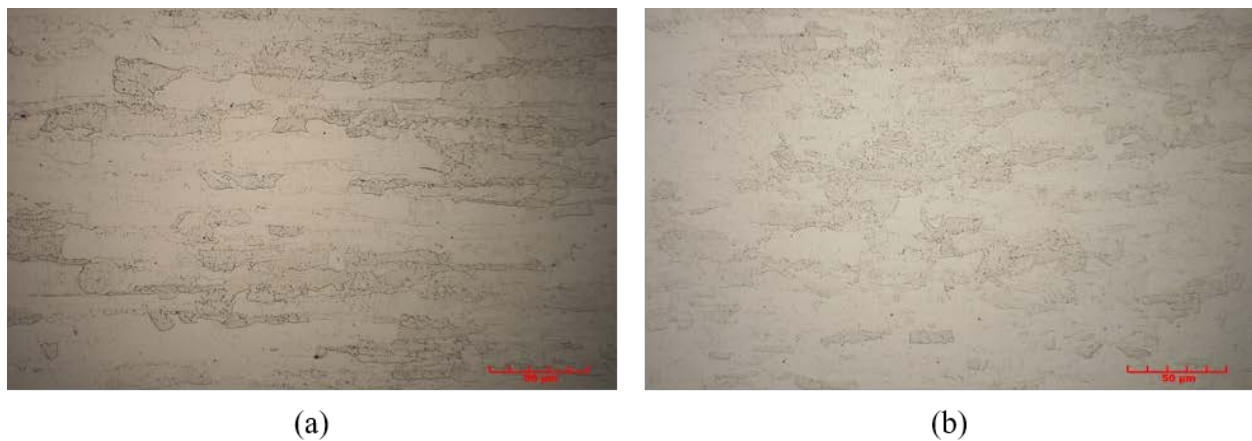
**Figure 18. Micrographs From an ASTM A709 Grade 50CR Steel Plate Etched With Vilella's Reagent: (a) longitudinal sample at 1000X magnification; (b) transverse sample at 1000X magnification**

All of the samples etched with Vilella's reagent exhibited similar features upon comparison with different samples that had been rolled in same direction. A comparison between two samples rolled in different directions appeared to show different features; this was expected because of the influence of rolling. However, when Figures 17 and 18 are compared, it is easy to see the thicker horizontal martensitic structure with thinner ferritic grains between the bands of martensite in Figure 18.

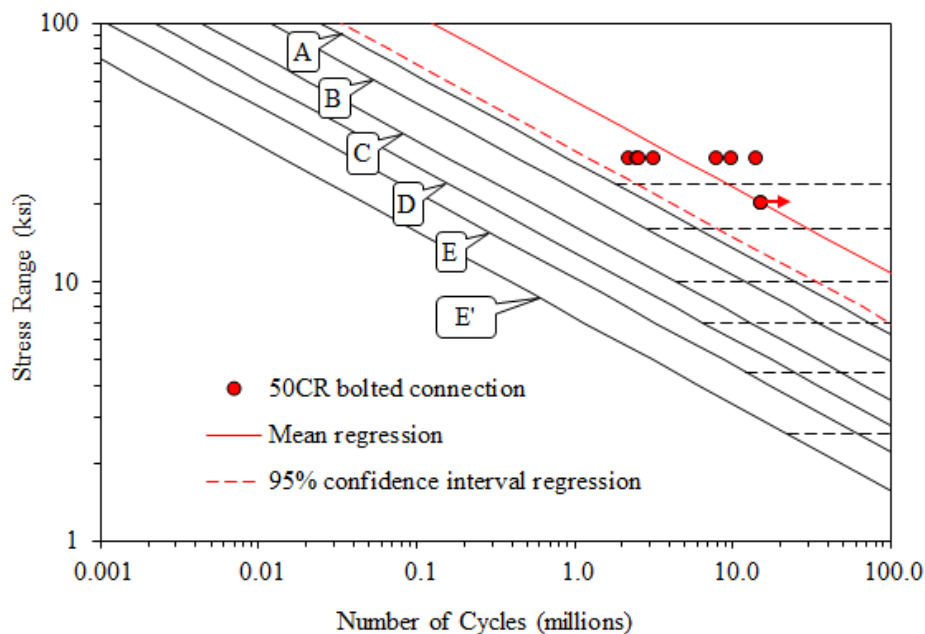
Figure 22. Fatigue Results for ASTM A709 Grade 50CR Steel Bolted Connections Compared to AASHTO Design Curves

From examination of the figure, it is clear that the lower 95% confidence interval regression line exceeds the AASHTO fatigue design Category B curve, which is the detail category for slip-critical bolted connections. This shows that when a slip-critical bolted connection with 50CR steel is designed, it can be treated the same as a typical Grade 50 or 50W steel. Further research is ongoing at VTRC regarding other aspects of 50CR steel bolted connections, including the slip coefficient and fastener assembly mechanical properties.

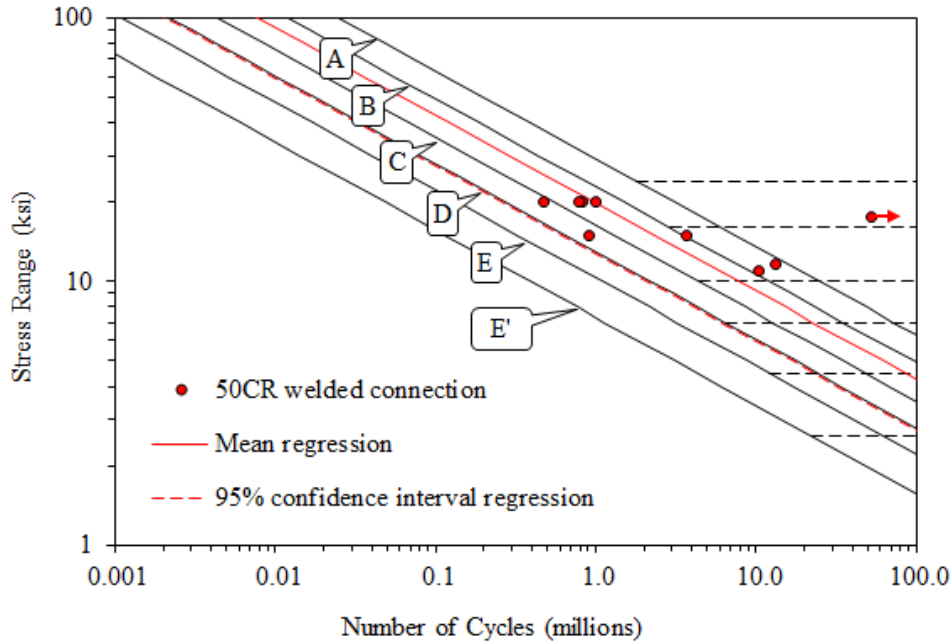
**Figure 23. S-N Test Results of Welded ASTM A709 Grade 50CR Steel Connections**

The presence of undercuts in some of the welded samples indicates that when the samples were ordered from the fabricator, the order specifications had not stated that the welds be ground smooth or pass any NDT requirements, including visual inspection. For all steel bridges, including the Route 340 Bridge, CJP welds, such as those in these specimens, would have to be ground smooth and pass NDT requirements. Therefore, it was concluded that the welds tested in this study did not comprise a representative sample of 50CR steel bridge welds. It is recommended that additional research be conducted on 50CR steel welded samples that meet the fatigue detail Category B requirements (i.e., weld reinforcement ground smooth and NDT requirements passed) since these details are commonly used for steel bridges.

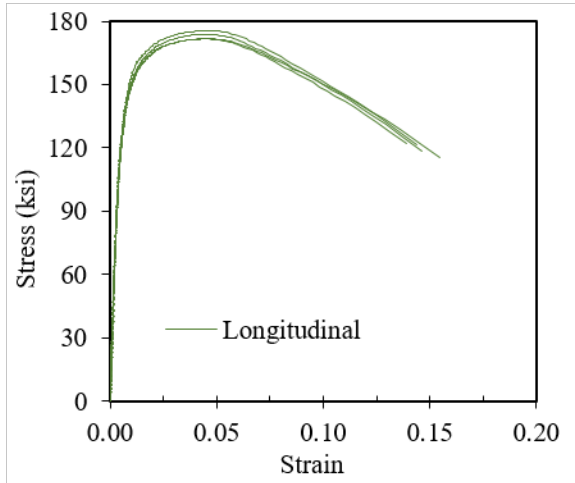
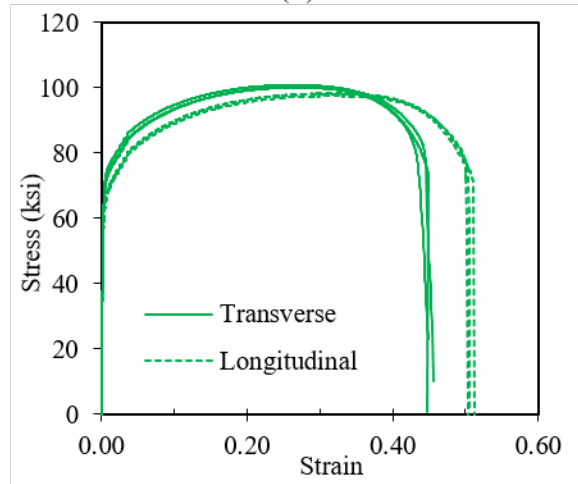
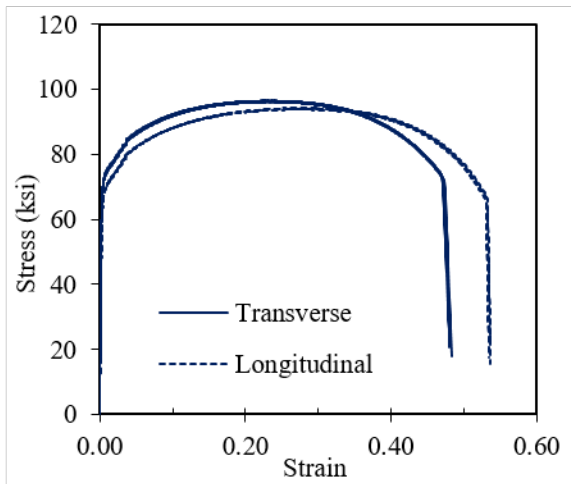
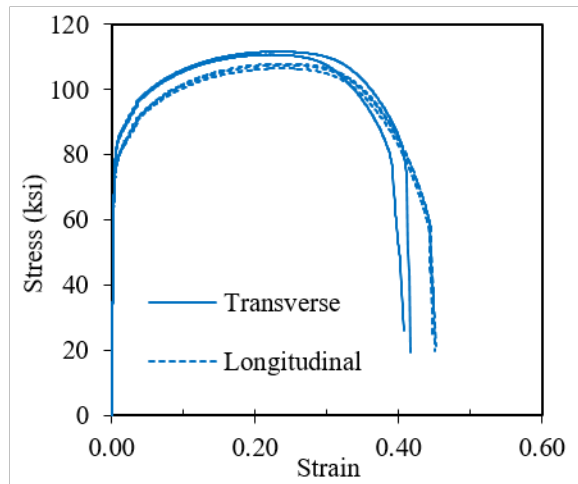
**Figure 24. Tensile Test Results: (a) 1/2-in-thick A1035CS steel plate, (b) 1/2-in-thick Grade 2101; (c) 1/2-in-thick Grade 2202; (d) 1/2-in-thick Grade 2304; (e) 3/4-in-thick Grade 2304; (f) 1/2-in-thick Grade 2205**

The results of the tensile tests on the remaining stainless steels, including duplex and A1035CS steel plate, are shown in Figure 24. As previously mentioned, the steels tested included Grades 2101, 2202, 2304, and 2205 and A1035CS steel plate. All tests were conducted on 1/2-in-thick samples except for a second group of Grade 2304 samples from another steel producer, which were conducted on 3/4-in-thick samples.

Overall, the stress-strain behavior of the stainless steels was relatively similar to that of carbon steel. Similar to the 50CR steel, there was no discontinuous yielding or yield point elongation. The stress-strain curve of the stainless steels transitioned gradually from elastic to plastic behavior. There were some slight differences between the longitudinal and transverse samples of each steel type, such as the longitudinal samples tended to produce slightly smaller yield stress values and slightly greater elongations. Overall, however, the differences between the two orientations were not significant. The A1035CS steel plate exhibited similar behavior to that of the duplex steels, although the transition from elastic to plastic behavior occurred more rapidly. In order to provide a more clear comparison among all of the A1035CS steel plate and duplex stainless steels, Figure 25 shows a plot with a representative curve for each steel type. For the duplex steels, a representative longitudinal curve was selected since the A1035CS steel consisted of only longitudinal samples. For comparison purposes, plots of Grade 50 and Grade 50CR steels were also included in the figure. Table 11 also provides a numerical summary of the tensile test results for A1035CS and duplex stainless steels.

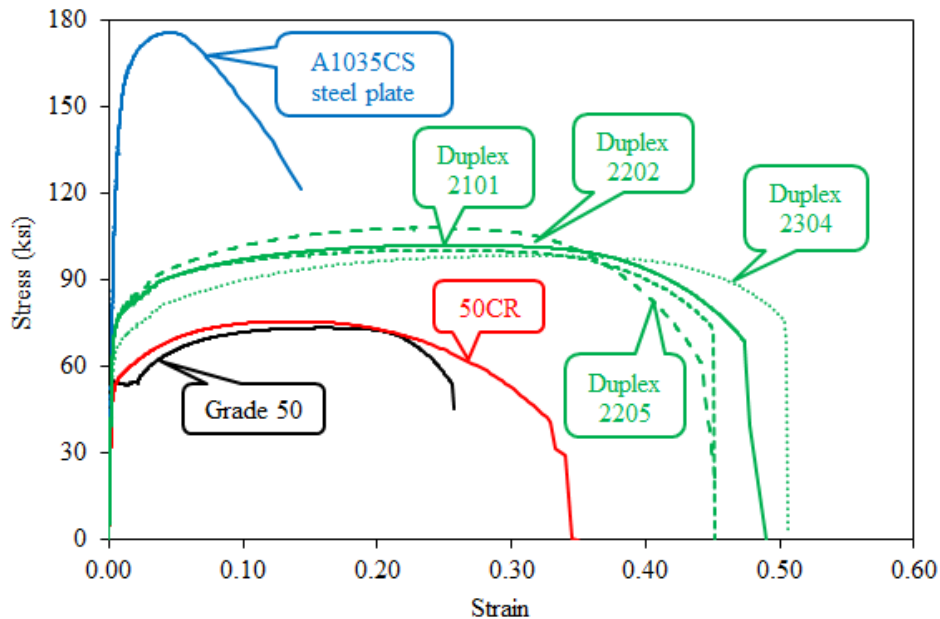
Figure 25. Comparison of Tensile Test Results for Corrosion-Resistant Steels

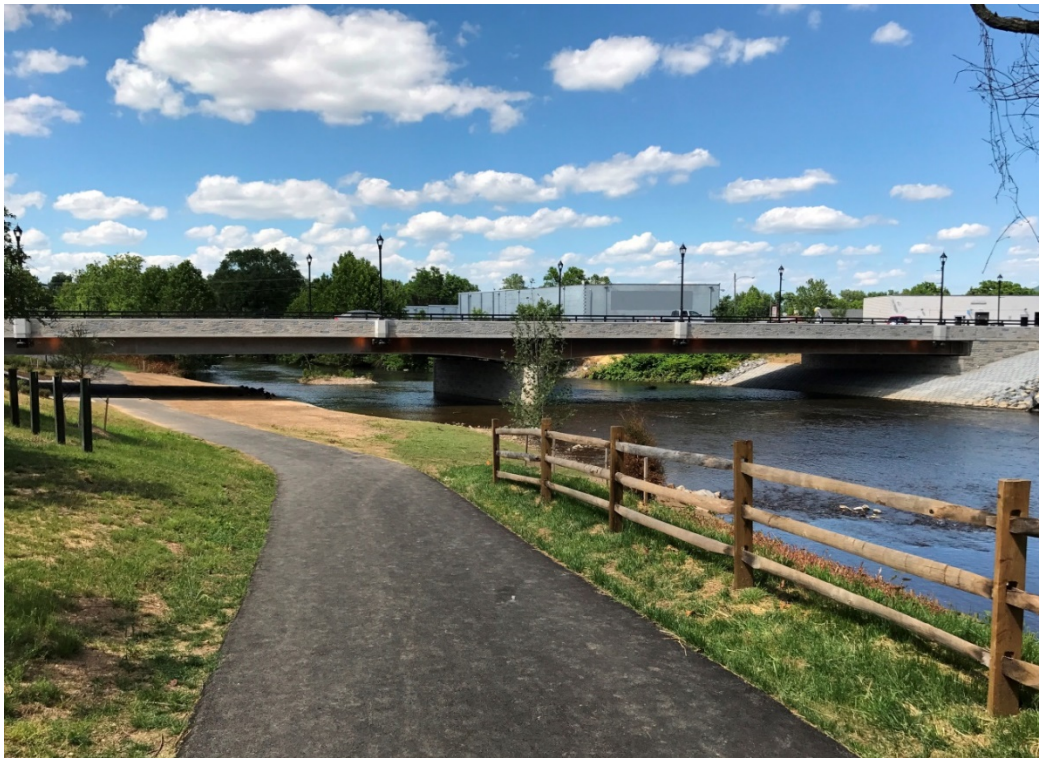
**Figure 26. Route 340 Bridge With ASTM A709 Grade 50CR Steel Girders**

The Route 340 Bridge carries Route 340 (Main Street) over the South River in Waynesboro, Virginia. The previous structure was a coated steel girder bridge. Grade 50CR steel was chosen as the material for the new bridge for three reasons. First, there was an industrial site upstream of the bridge. Second, the bridge is in close proximity to standing water and can be inundated after storms. Third, Waynesboro desired an aesthetically pleasing, rustic look for the bridge because it is located in a park near downtown. Aside from the aesthetics, these are areas in which FHWA does not recommend the use of uncoated weathering steel (Sharp et al., 2018).

The new girders were successfully designed, fabricated, and constructed by January 2017. The Route 340 Bridge was the first 50CR steel bridge to include haunched girders, a bolted field splice with stainless steel fasteners, 50CR steel cross frames and diaphragms, and the use of a non-metallic blast cleaning media. The entire project was a success and provided the public with access across the river and trails connecting a park-like setting, shown in Figure 26. The bridge also received the 2018 Prize Bridge Award given by the National Steel Bridge Alliance (AISC, 2018).
