Louisiana Transportation Research Center

Final Report 608

Impact of Inundation on Roadway Pavements: Case Study – LA 493

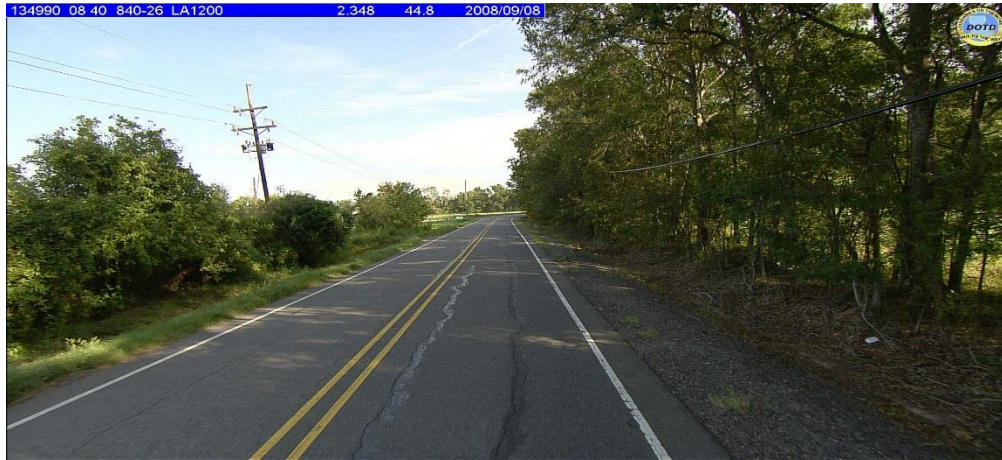
Figure 1
Longitudinal cracks: LA 1200: CSLM 2.348

stress exceed the tensile strength of the soil, a crack will form as shown in Figure 5 [39-41]. When this occurs beneath the pavement, it is possible for the crack to propagate through the pavement structure as presented in Figures 1 to 3.

When the yearly rainfall is insufficient to return the active zone (the depth of soil layer(s) impacted by evapotranspiration) to its field capacity (equilibrium saturation), a zone of permanent desiccation is created as presented in Figure 6 [36-38, 47,48]. If permanent desiccation occurs either near the pavement edge or beneath it, permanent settlement (dynamic settlement) at that location may be the culprit of both multiple longitudinal cracks and subsidence as shown in Figures 1, 2, 6, 7, and 8 [47].

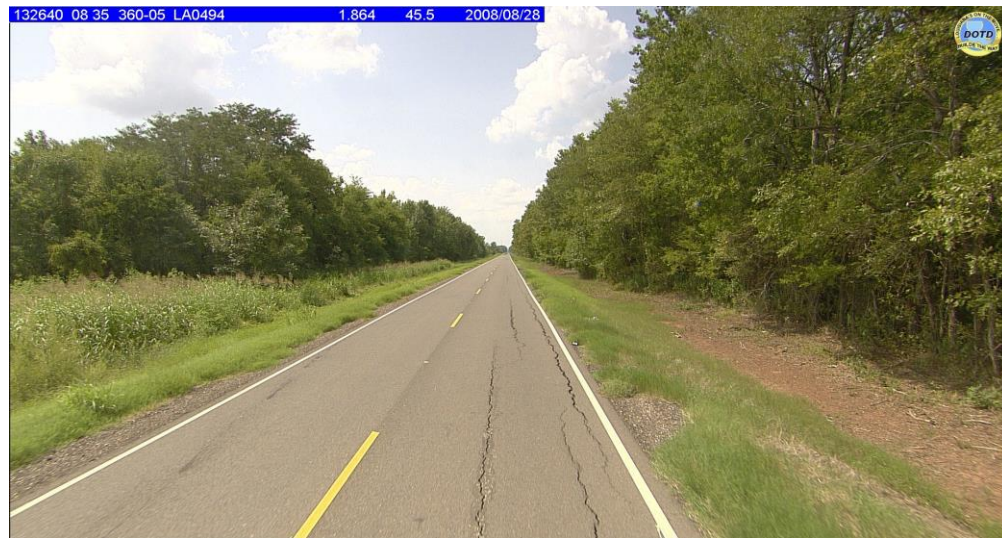
Figure 2
Multiple longitudinal cracks: La 494: CSLM 1.864

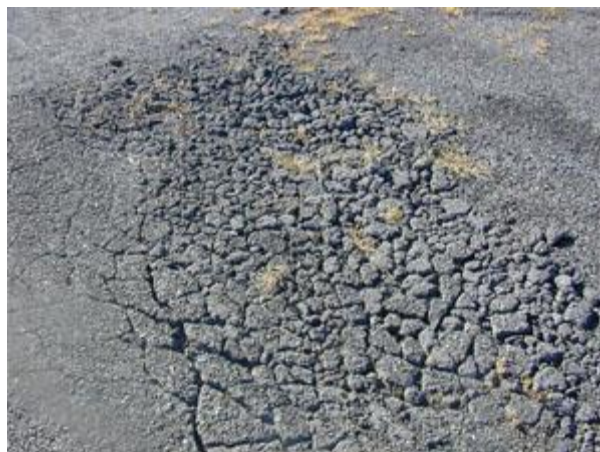
Figure 4
Alligator cracking in AC surface

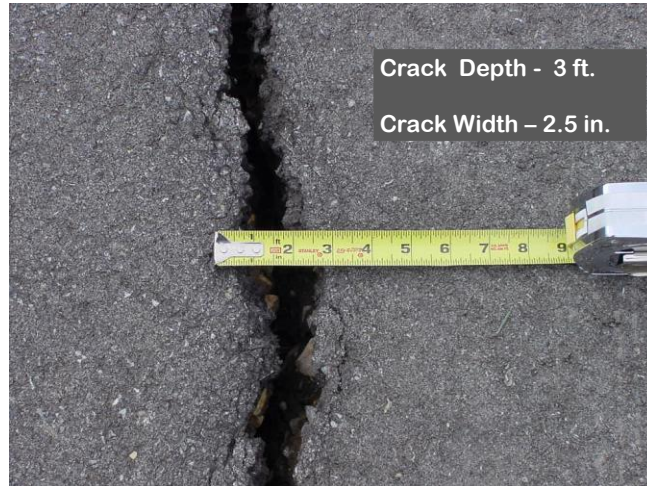
Longitudinal cracks in the pavement may also be caused by desiccation in the expansive clay subgrade. When the soil suction stresses induced by desiccation coupled with net normal

Figure 5
Parish road: St. Martin Parish

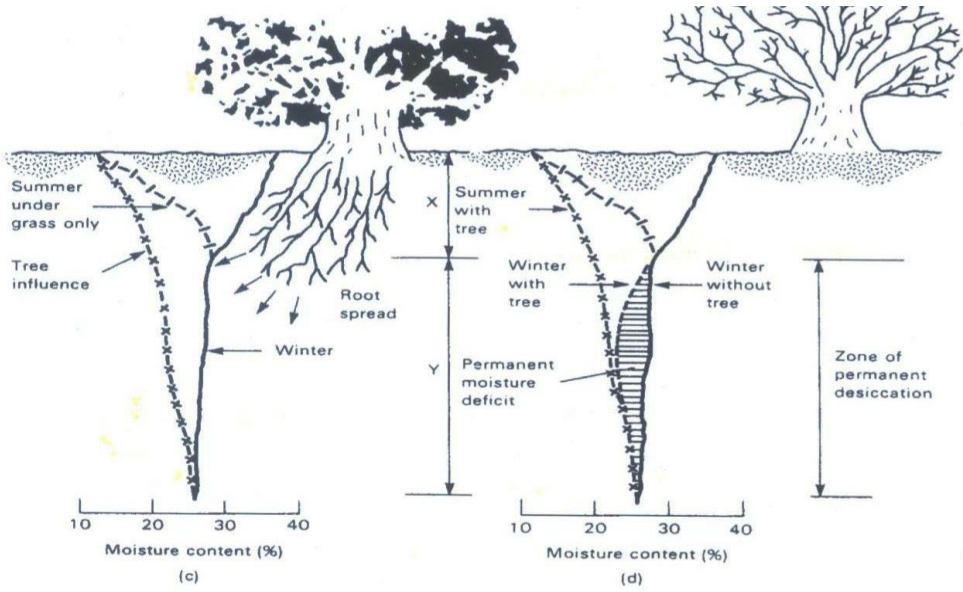
Figure 6
Permanent desiccation: Source Roberts [48]

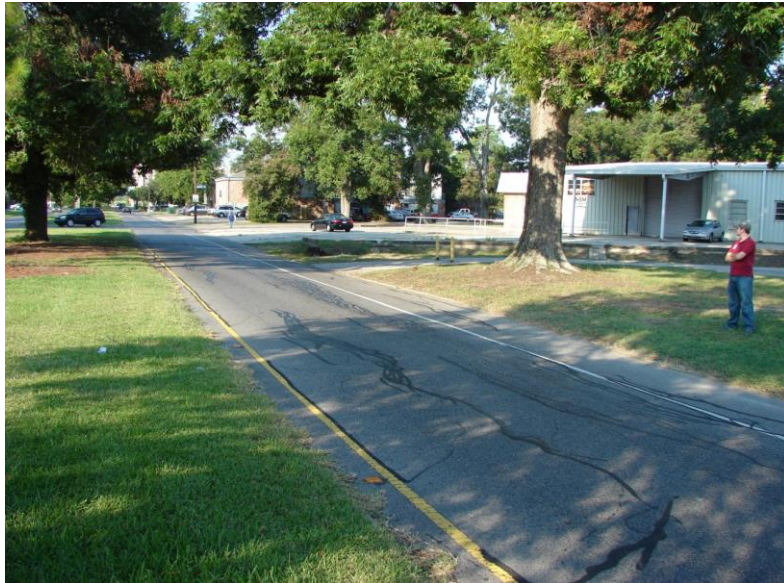
Figure 7
Multiple longitudinal cracks and subsidence: West Parker Ave. near LTRC

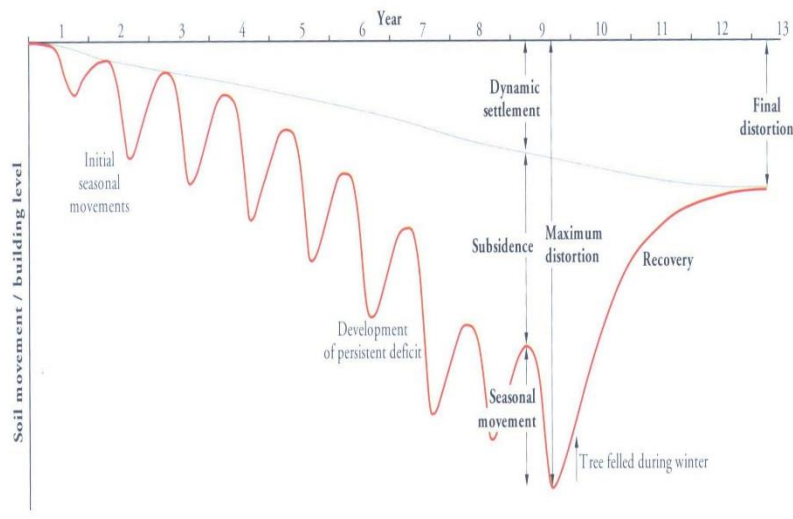
Figure 8
Dynamic settlement: Source Biddle [47]

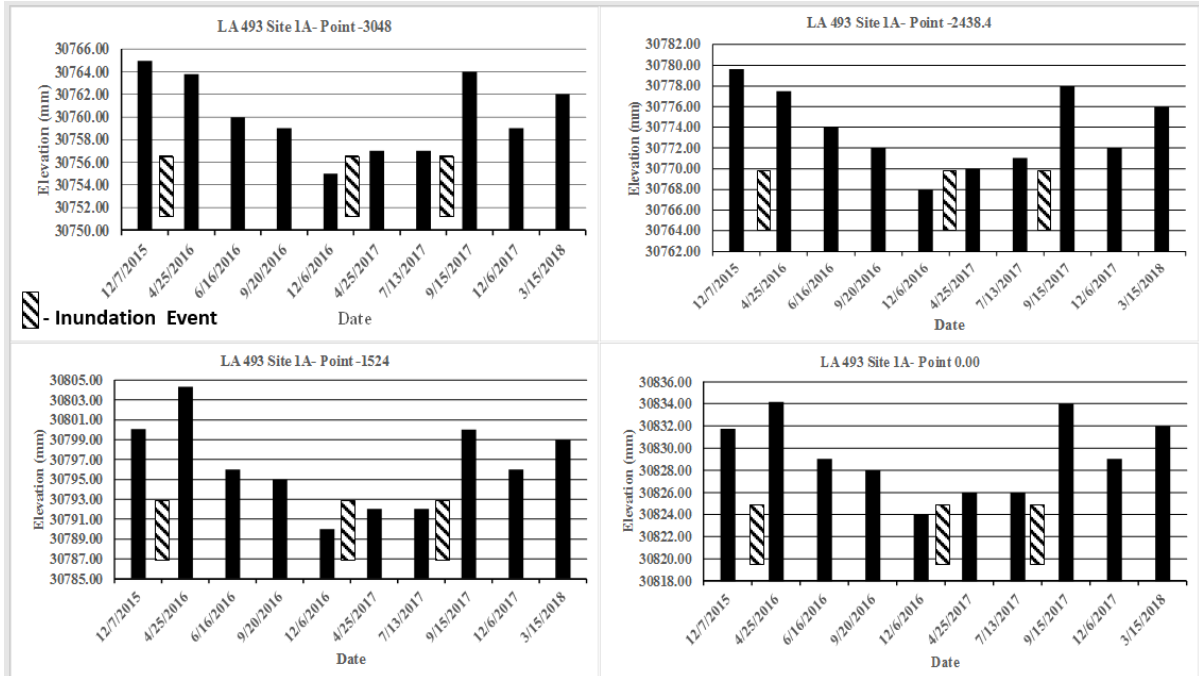
Figure 12
Charts of cross-section points for Site 1A

Figure 13
Charts of cross-section points for Site 1A

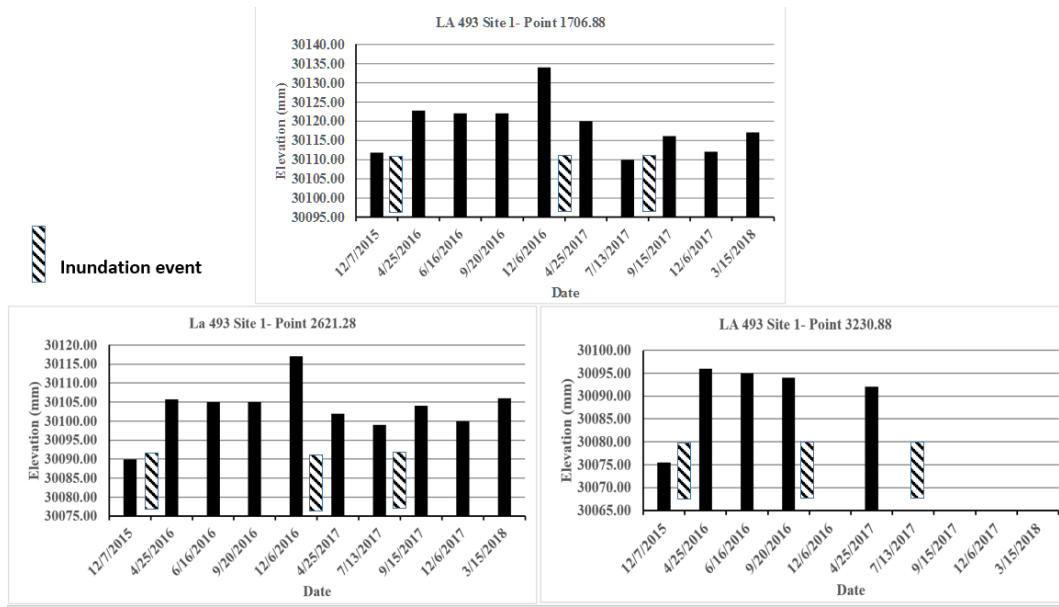
Figure 14
Charts of cross-section points for Site 1

Figure 15
Charts of cross-section points for Site 1

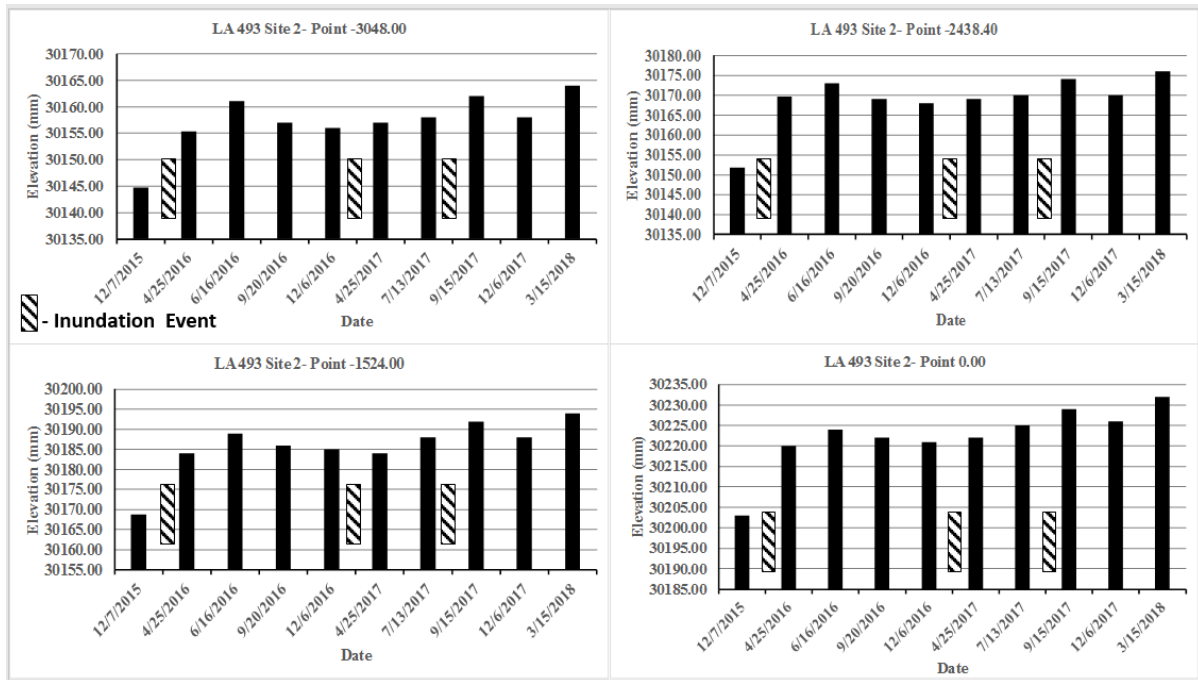
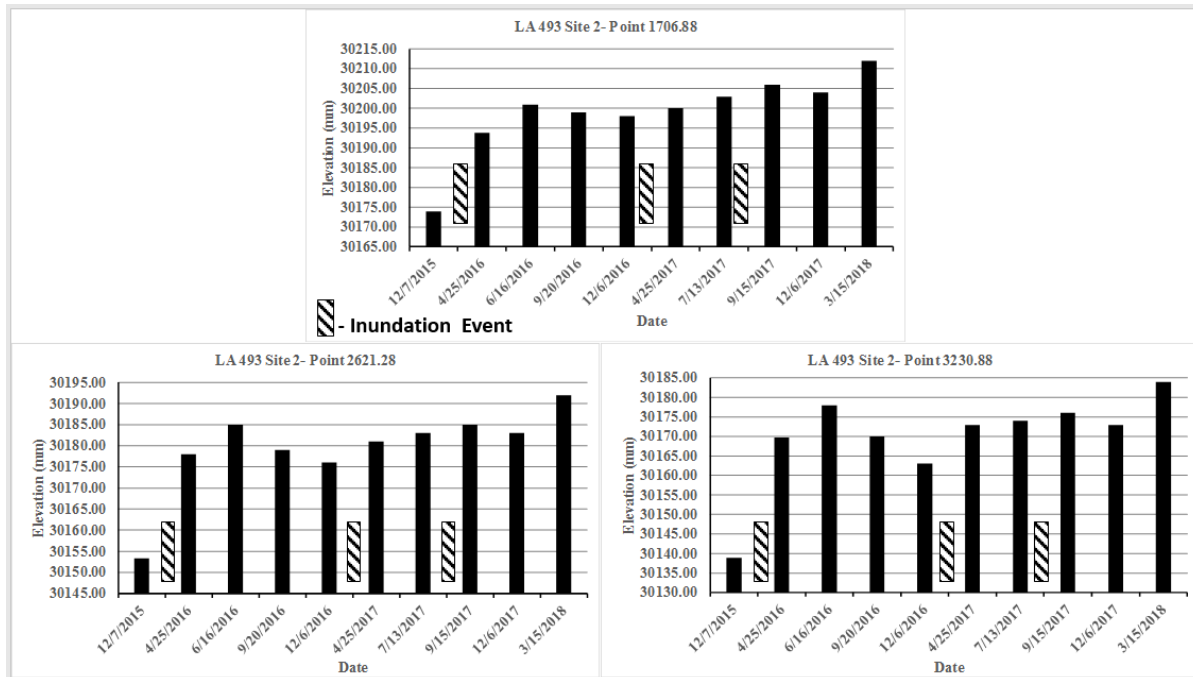
Figure 16
Charts of cross-sections for Site 2

Figure 17
Charts of cross-sections elevations from 12/7/2015 for Site 2

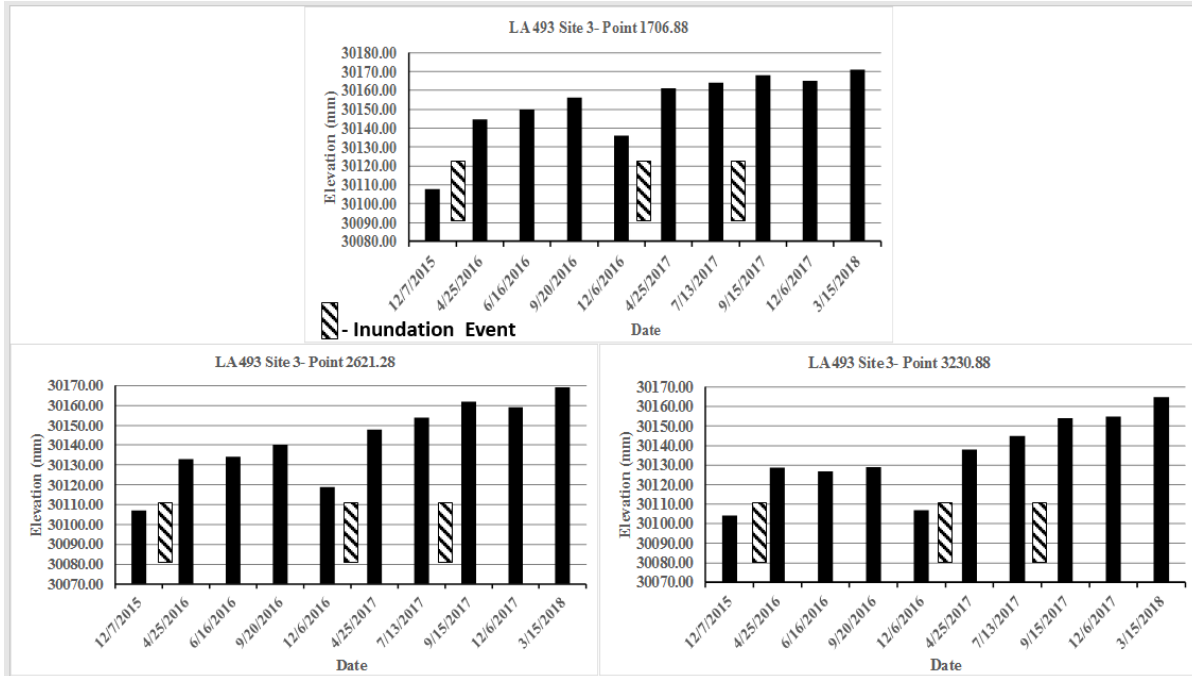
Figure 18
Charts of cross-section points for Site 3

Figure 19
Charts of cross-section points for Site 3

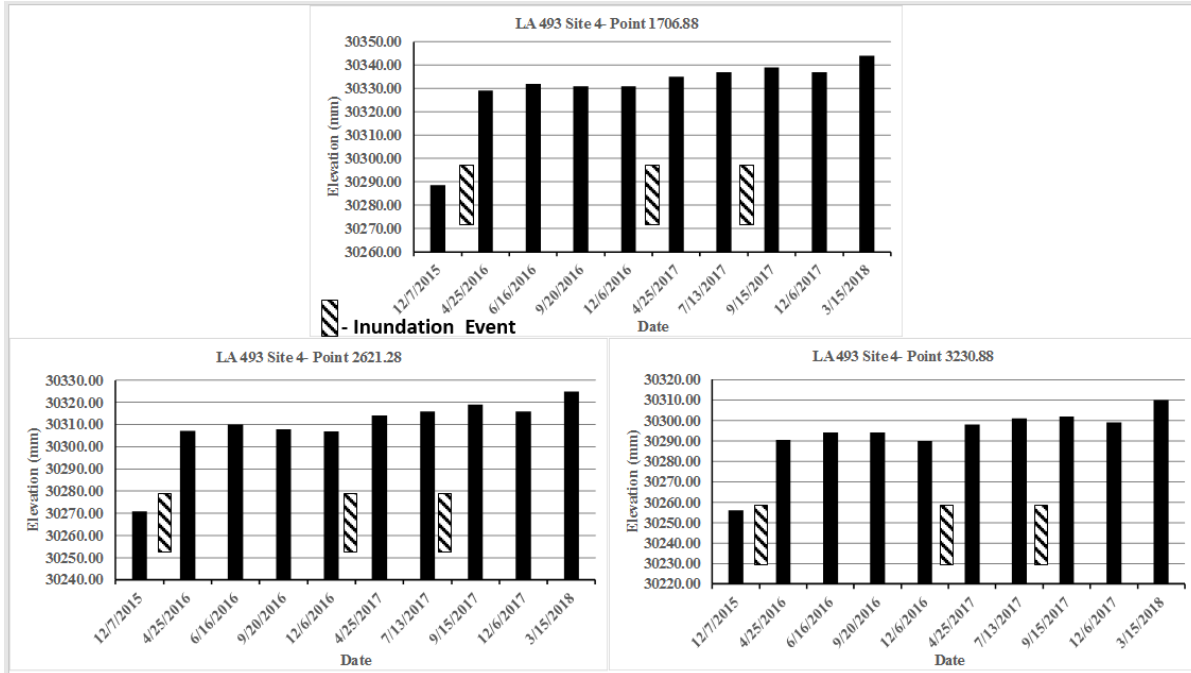
Figure 20
Charts of cross-section points for Site 4

Figure 21
Charts of cross-section points for Site 4

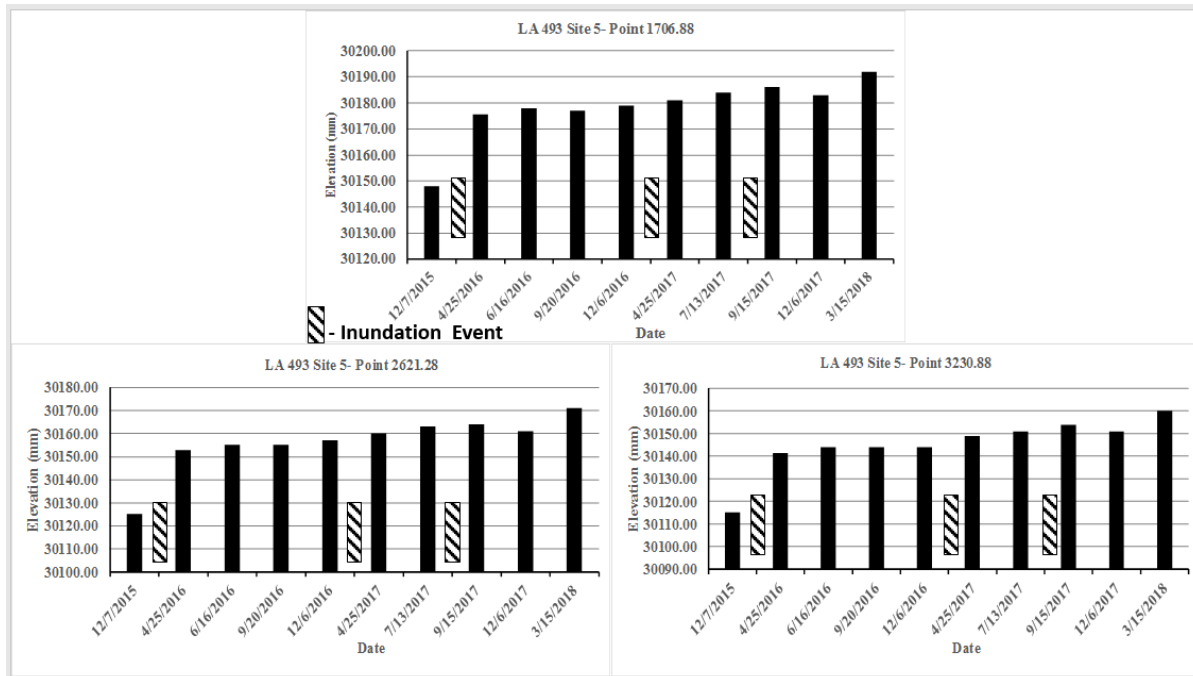
Figure 22
Charts of cross-section points for Site 5

Figure 23
Charts of cross-section points for Site 5

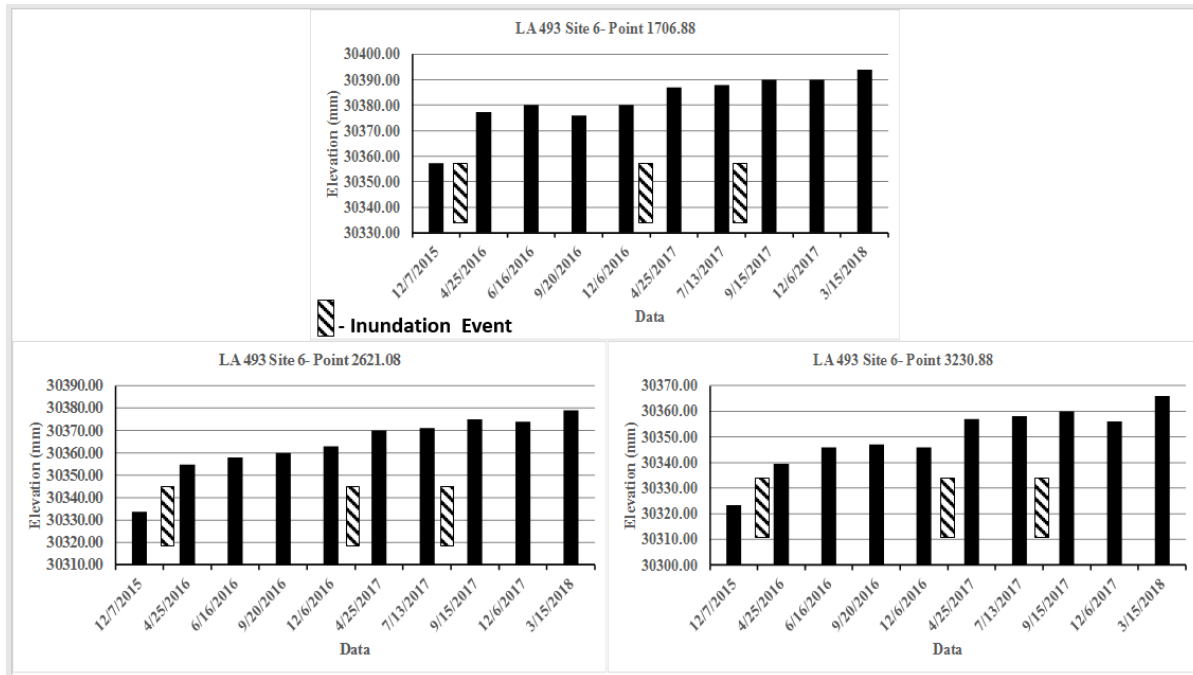
Figure 24
Charts of cross-section points for Site 6

Figure 25
Charts of cross-section points for Site 6

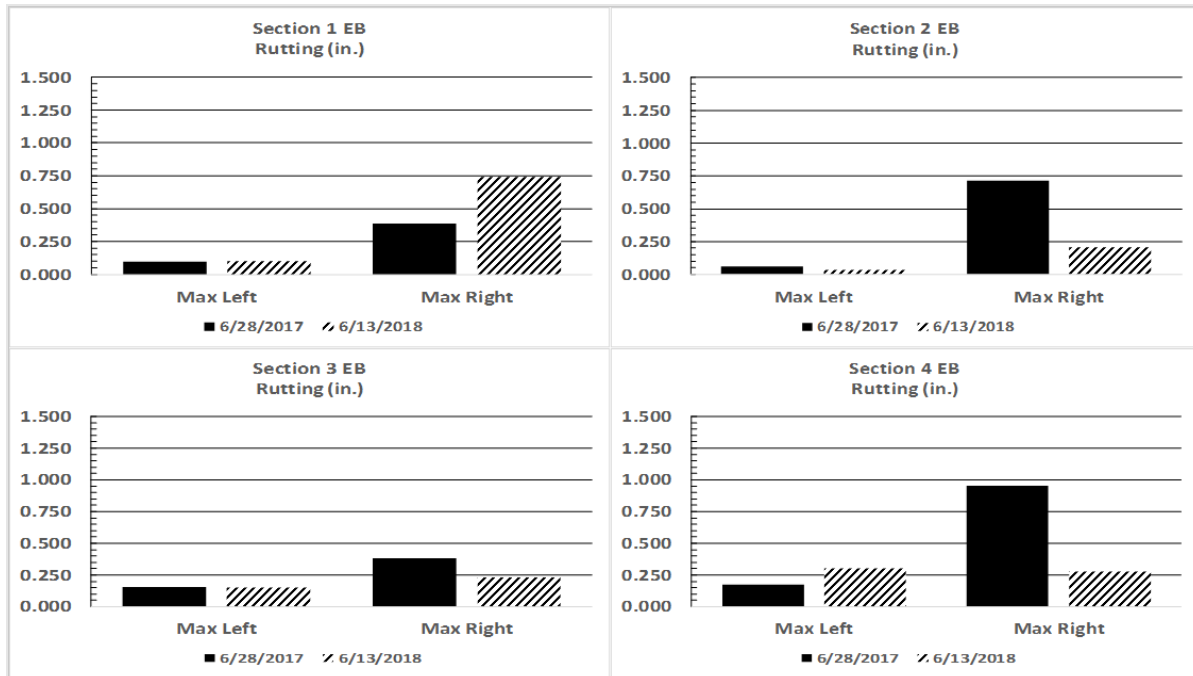
Figures 28 and 29 present the rutting measurements for Sites 1 to 6 on the assessment dates of June 2017 and June 2018. DOTD considers rutting values greater than 0.5 in. to be significant and in need of mitigation. It is probable that the significant rutting at some locations were due to weakening of the pavement structure due to volumetric changes in the embankment as well as depressions caused by movements in the embankment. For Site 1, the maximum rutting in June 2017 in the RWP was 0.386 in. and 0.74 in. a year later in June 2018 indicating that rutting in those locations are increasing. Site 2 showed a similar pattern with the maximum rutting in the RWP being 0.713 in. in June 2017 and 0.205 in. on June 2018. The reason for the decrease in the maximum rutting between June 2017 and June 2018 is unknown. The maximum rutting values for Site 3 in the RWP were 0.382 in. on June 2017 and 0.232 in. on June 2018. Site 4 had maximum rutting values in the RWP of 0.953 in. on June 2017 and 0.28 in. on June 2018. As with Site 2, the authors are uncertain of the decrease in maximum rutting between June 2017 and June 2018. The maximum rutting values in the RWP for Site 5 were 0.673 in. and 1.2 in. on June 2017 and June 2018, respectively. Site 6 had maximum rutting values in the RWP of 0.953 in. and 1.685 in. on June 2017 and June 2018, respectively. Site 6 had the highest maximum rut depth in the EB direction.

Figure 28
EB maximum rutting for Sites 1 to 4

Figure 29
EB maximum rutting for Sites 5 and 6

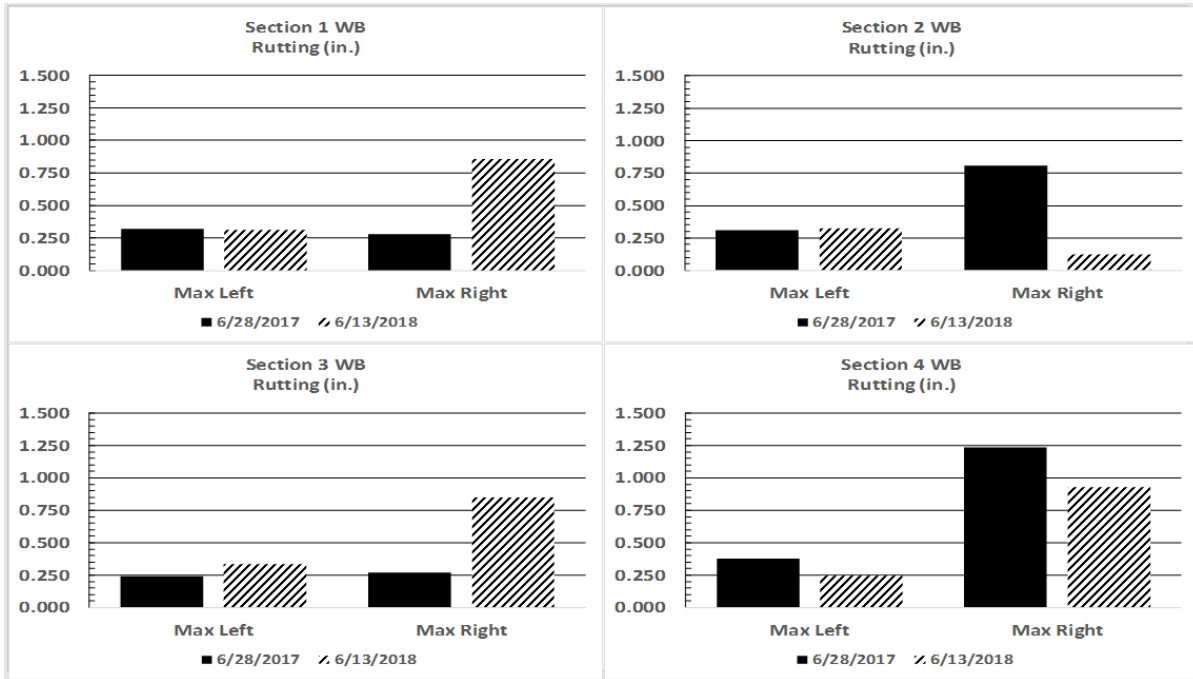
Figures 30 and 31 present the rutting measurements for Sites 1 to 6 on the assessment dates of June 2017 and June 2018. On Site 1, the maximum rutting depth in the RWP was 0.276 in. and 0.858 in. on June 2017 and June 2018 respectively. Site 2 had maximum rutting depths in the RWP of 0.807 in. for June 2017 and 0.122 in. for June 2018. The reason for the decrease in the rutting depths between June 2017 and June 2018 is unknown but may be due to volumetric changes in the embankment. The maximum rutting depth in the RWP for Site 3 was 0.268 in. and 0.850 in. on June 2017 and June 2018. respectively. Site 4 had maximum

rutting depths on the RWP of 1.236 in. and 0.929 in. in June 2017 and June 2018, respectively. Regarding Site 5, the maximum rutting depth in the RWP in June 2017 was 0.824 in. and in June 2018 it was 0.965 in. On Site 6, the maximum rutting depth on the RWP was 1.118 in. in June 2017 and 0.118 in. in June 2018.

Figure 30
WB maximum rutting for Sites 1 to 4

Figure 31
WB maximum rutting for Sites 5 and 6

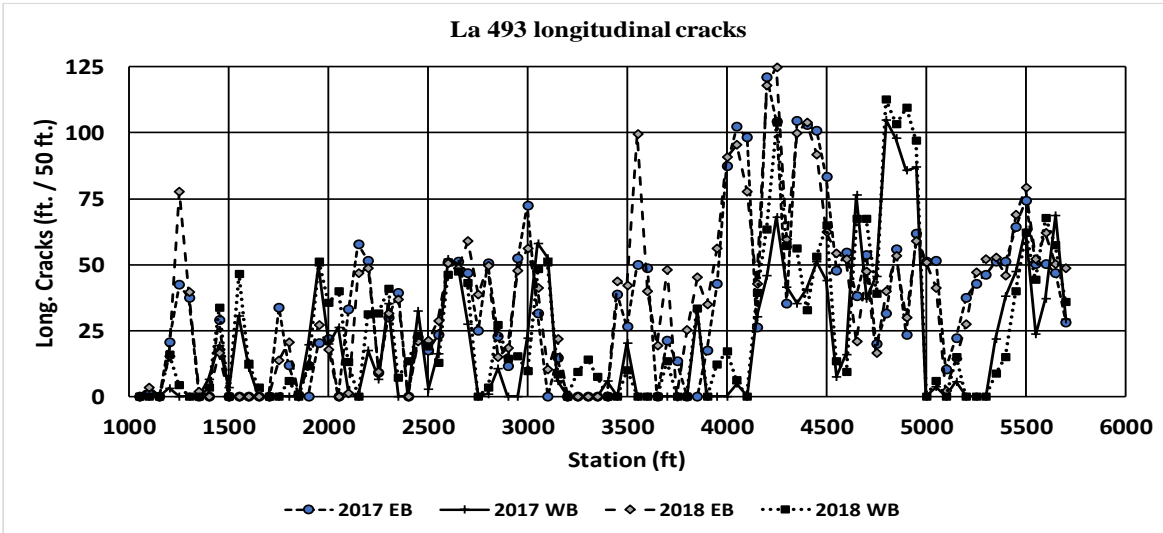
Figure 32

Longitudinal cracks for the EB and WB directions for the June 2017 and June 2018 assessments
