INTERSTATE COMMERCE COMMISSION

REPORT OF THE CHIEF OF THE DIVISION OF SAFETY COVERING THE INVESTIGATION OF AN ACCIDENT WHICH OCCURRED ON THE GALVESTON, HARRISBURG & SAN ANTONIO RAILWAY NEAR ISER, TEX , JANUARY 31, 1916

FEBRUARY 12, 1917

REPORT OF THE ENGINEER-PHYSICIST

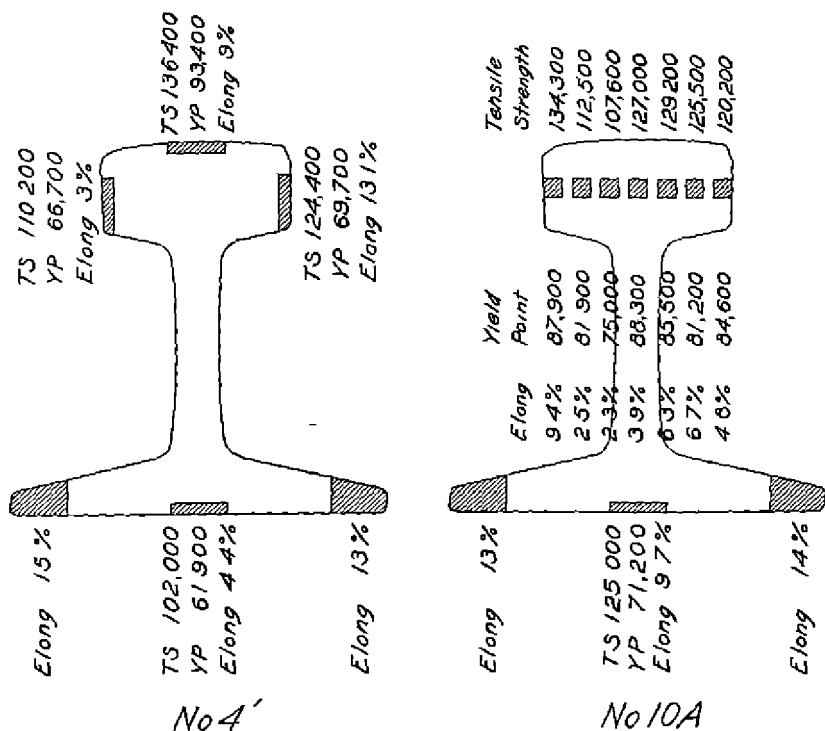
FIG 5 — Tensile and bending tests of the metal of the rail, using strips on which internal strains were measured. Strips from flanges used for bending tests only

The results of tensile and bending tests are entered on two cross sections of the rail and shown on figure No 5. The tensile strength was found to range from 102,000 to 134,000 pounds per square inch. The maximum strength was displayed by the strip from the top of the head. The minimum strength was in the metal at the middle of the bottom of the base. Tests of the metal from the interior of the head showed intermediate results.

The yield points, which may be taken as values somewhat above the elastic limit of the steel, ranged from 61,900 to 93,400 pounds per square inch. The cold rolling of the metal at the top of the head gave increased rigidity to the steel, as it had also affected the tensile strength, and the highest yield point was recorded in that part of the rail. It is not held that the usual tests defining the yield point suffice to indicate the real condition of the metal affected by cold rolling, or the effect of repeated alternate stresses which the rail had endured. Tests of greater refinement than the usual laboratory tests are necessary for such a purpose. The metal of the rail would be expected to fail ultimately under stresses of much lower magnitude than the yield points recorded in these tests, although these values represent loads at which decided permanent sets were first observed.

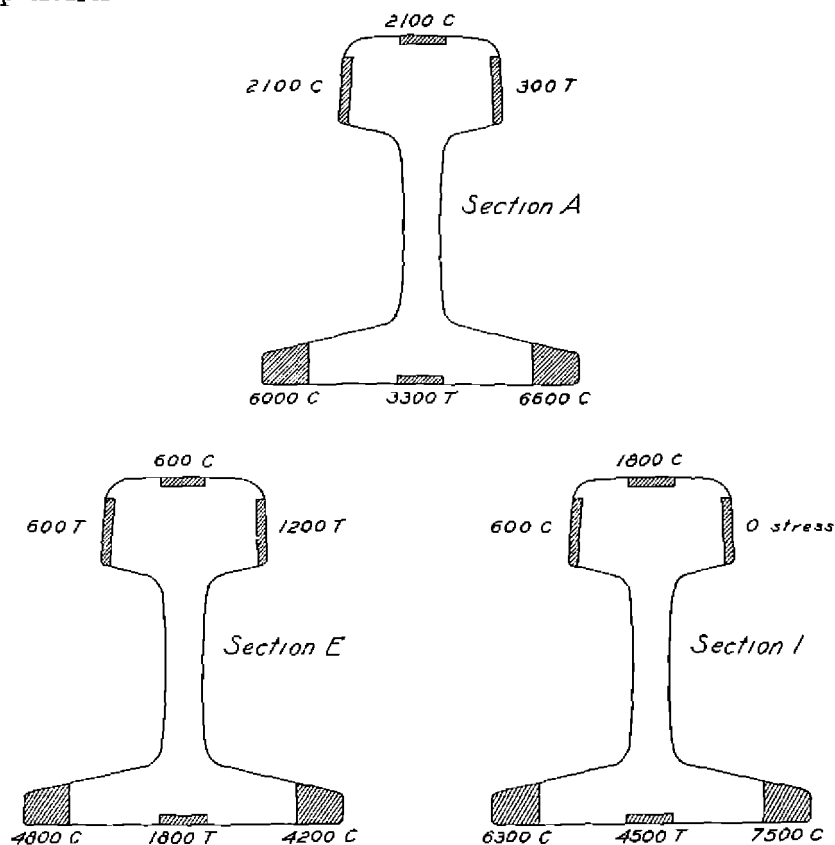
FIG 7—Initial stresses in sections of new 100 pound rail, which had not been subjected to wheel loads in reciprocating machine

Figures Nos 7 and 8 show the internal strains which were present, respectively, in the 1-foot sections and those of the 5-foot sections which were cold rolled. There was a fairly uniform state of initial strains throughout the base, indicating that the cooling strains are substantially the same in different parts of the length of the rail. The greatest departure from uniformity was found in the 1-foot pieces particularly in section E, taken from the middle of the length of the rail. It is believed that the internal strains were here modified by the cold sawing of the rails into short lengths for testing, that the cold sawing, which left the ends very hard, changed the state of

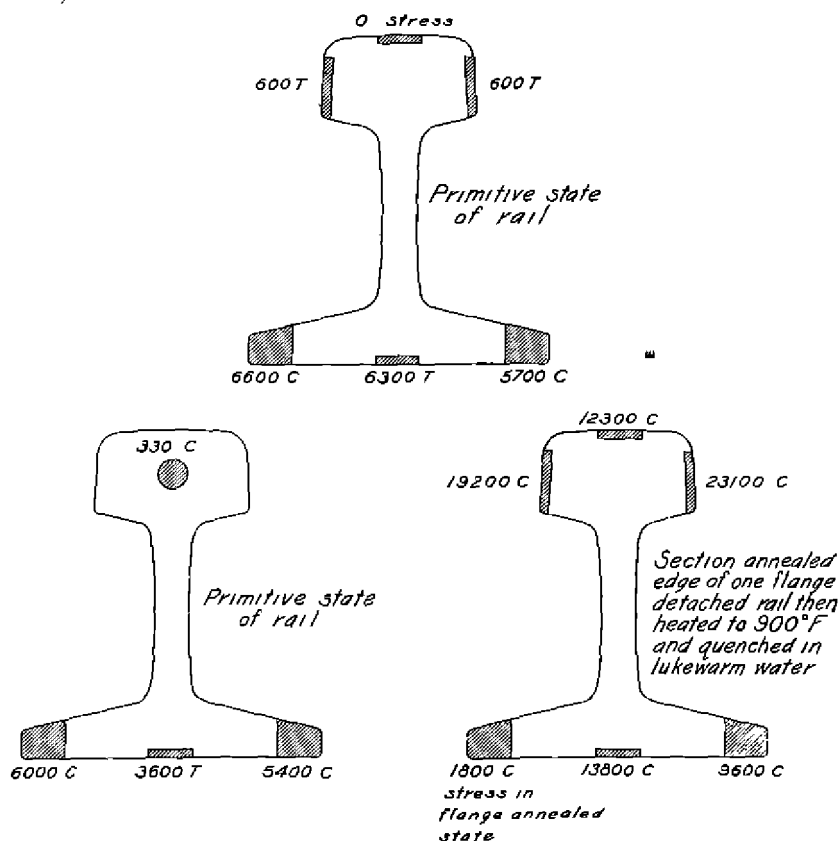
FIG 10—Internal stresses in new 100-pound rail, type A R A-B in primitive state also stress in flange of an annealed section, and stresses introduced by quenching the annealed section from a temperature of 900° F

The temperature to which this rail section was raised at the time of quenching was much below the zone of critical temperature. Transformations at the recalcitrant periods of temperature are not involved in the introduction of these strains. They were introduced by sudden cooling from a temperature several hundred degrees below the critical points. In other examples it has also been found

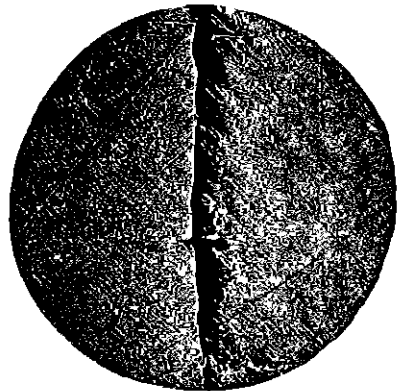
Still further information was acquired upon the microstructure of this rail at another incipient transverse fissure, one which also showed the opposite faces of the fissure to be in close proximity to each other, and illustrated by figure No 25 The location of the fissure having been predetermined, the specimen was polished and etched with picric acid No trace of the transverse fissure appeared on the etched surface, as indicated by photomicrograph 10-A The metal was repolished, removing the structural shapes which the picric acid had brought into view, the fissure still remaining unrevealed, as indicated by photomicrograph 10-B

The specimen was then treated with a boiling solution of ammonium oxalate, which brought into view the transverse fissure, as shown by photomicrograph 11-A The location of the fissure remained visible when again repolished, as shown by 11-B Photomicrograph 10-C, not here reproduced, was taken at 300 diameters magnification, the results being the same as with the lower magnification

FIG. 25.—Microstructure, at an incipient transverse fissure, of rail which caused present derailment: longitudinal section 10 A, area containing transverse fissure, but not revealed by polishing and etching with picric acid; 10 B, same area repolished; 11 A, same area treated with ammonium oxalate, revealing the presence of the transverse fissure; 11 B, same area repolished after treatment with ammonium oxalate. Magnification, 100 diameters.
