Minnesota Road Research Project Forensic Investigation 199701

MnROAD
Office of Minnesota Road Research

FORENSIC INVESTIGATION 199701

Final Report

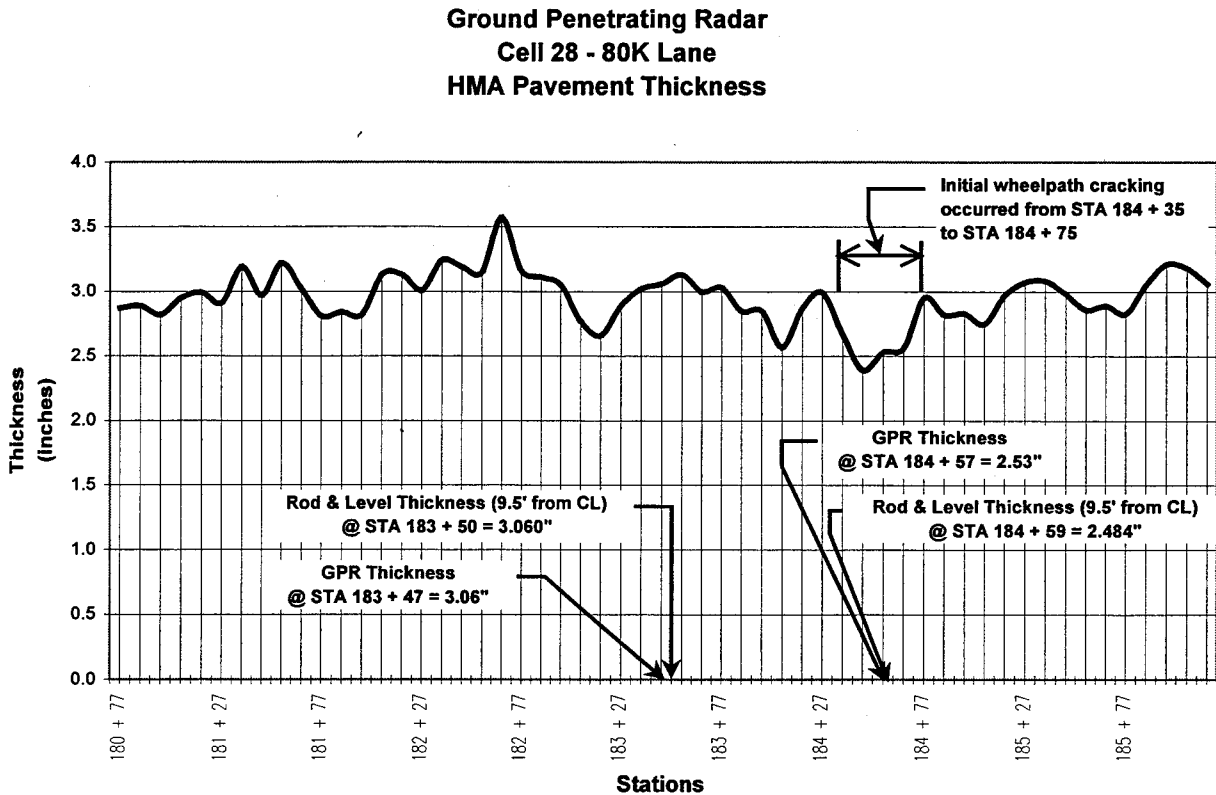
Figure 1.5 - HMA Pavement Thickness

Ground Penetrating Radar (GPR) tests were performed at Mn/ROAD in July of 1994. Due to construction variability, the pavement of Cell 28 ranges in thickness from 2.39 inches to 3.57 inches. Figure 1.5 illustrates the range of pavement thickness in the right wheel path of the 80K lane of Cell 28. The thinnest portion of pavement, from Station 184 + 47 to Station 184 + 67 (2.39 inches to 2.56 inches), corresponds to the area of initial wheel path cracking. The pavement thickness in the remaining portion of the cell was generally greater than 3.0 inches.

The Forensic Team confirmed GPR data by measuring the HMA course during the forensic investigation. Calculations made using rod and level data established that the pavement at Station 184 + 59 was on average 2.64 inches. This is 0.36 inches less than the initial design thickness of 3 inches. The average pavement thickness at Station 183 + 50 was 3.10 inches. Appendix C contains the rod and level data taken during the forensic excavation and includes the pavement thickness from centerline to shoulder of both trenches and a cross-section of each trench. The

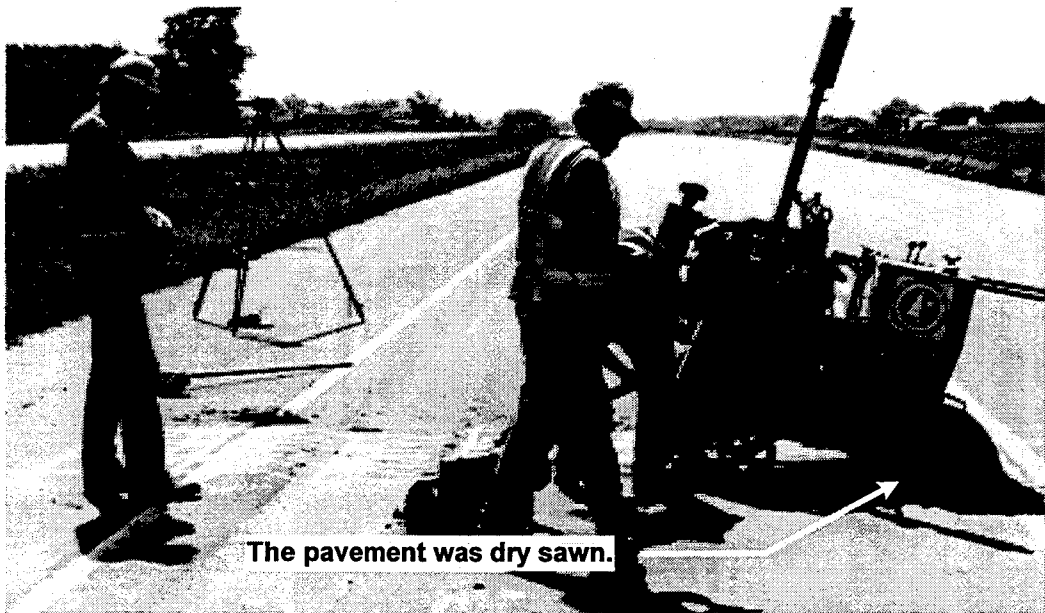
Figure 2.2 - Dry Sawing of Pavement

Sawing of the pavement commenced at 9:00 AM on Tuesday July 1, 1997. A diamond circle saw was used to dry saw the pavement from the centerline across the 80K lane and into the shoulder as seen in Figure 2.2. A dry saw was used to prevent the introduction of moisture into the aggregate

base that could effect test results. The sawing went quickly, taking approximately 60 minutes per trench to cut the pavement in the layout illustrated in Figure 2.1. After sawing, the Forensic Team removed the HMA pavement using hand tools as seen in Figure 2.3.

If sampling and testing of aggregate base materials is part of a forensic excavation, care must be taken to preserve the in situ moisture conditions of the aggregate base. The use of a dry pavement saw instead of a wet saw is recommended. The sawing will have to progress a little more slowly to prevent the saw blade from overheating. However, samples that are more representative of field conditions can then be taken. To reduce evaporation, tarps can be placed over the open trench when tests are not being performed.

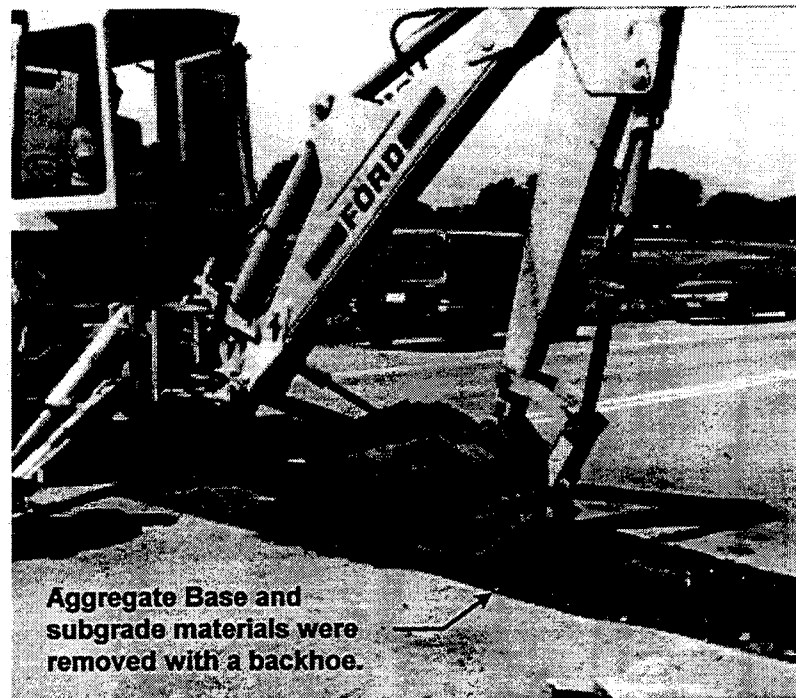
Figure 2.4 - Removal of Aggregate Base

After removal of the HMA pavement, the backhoe operator removed the layer of CL 5S and 6 to 12 inches of subgrade in both trenches. A distinct separation between the subgrade and aggregate base layers was observed on the vertical faces of the trenches. Aggregate base was gently removed by hand from a vertical face in each trench to uncover a ledge of subgrade. Figure 2.4 shows the removal of the aggregate base.

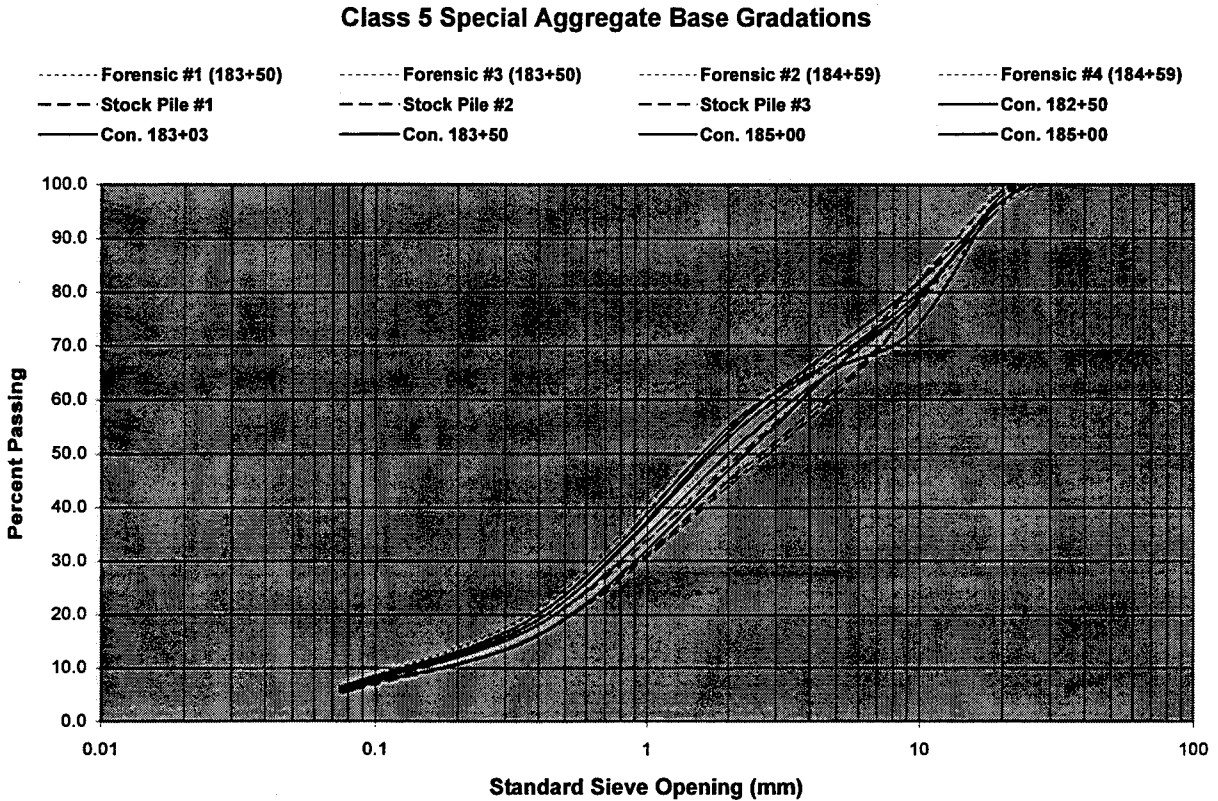
Unbound samples of the CL 5S were taken to determine the in situ moisture content and gradation. During construction, the aggregate base was stockpiled for use in future testing. Six hundred pounds of CL 5S was obtained from stockpiles and used for resilient modulus and triaxial tests. The gradation of the CL 5S removed from the stockpile was determined and compared to the gradation

of samples removed from the trenches. The gradations comparable and thus the stockpiled CL 5S was used for triaxial testing. Construction, stockpile, and forensic sample gradations are illustrated in Figure 2.8.

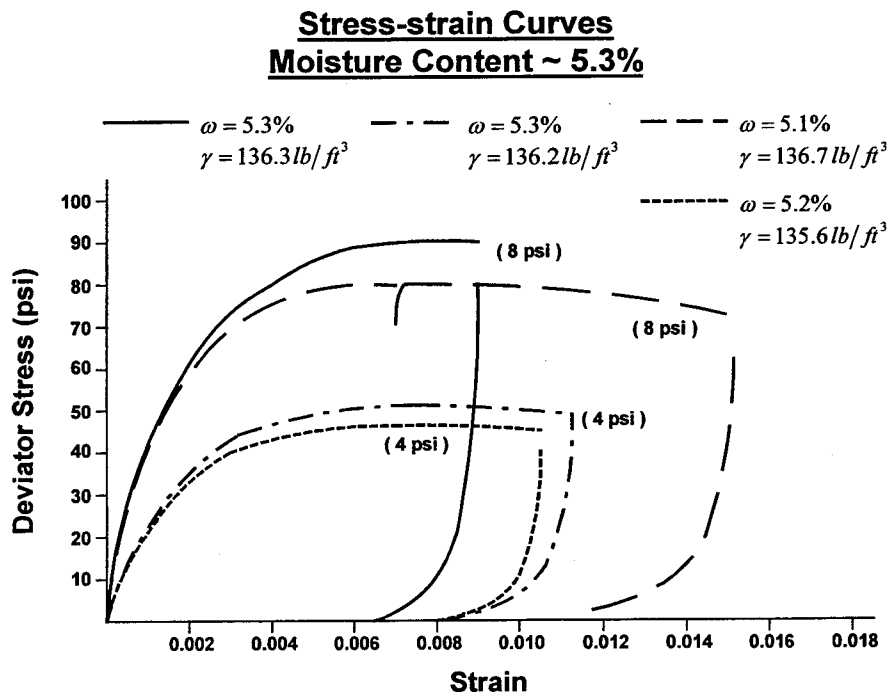
Figure 3.1 - Stress-Strain Curves

The laboratory tests performed illustrated that the moisture content of the aggregate base is an important factor in controlling strength. The shear strength decreased as the moisture content increased. In Cell 28, moisture content increased with depth. Another factor influencing strength is confining pressure. As the confining pressure increased, the strength of the material increased. The stress-strain curves are shown in Figures 3.1 and 3.2. After obtaining the stress-strain curves the Mohr's circles were constructed and can be found in Appendix D. The Mohr-coulomb failure envelopes (assuming a linear failure criteria), 5.3% and 8.2%, are shown in Figure 3.3.

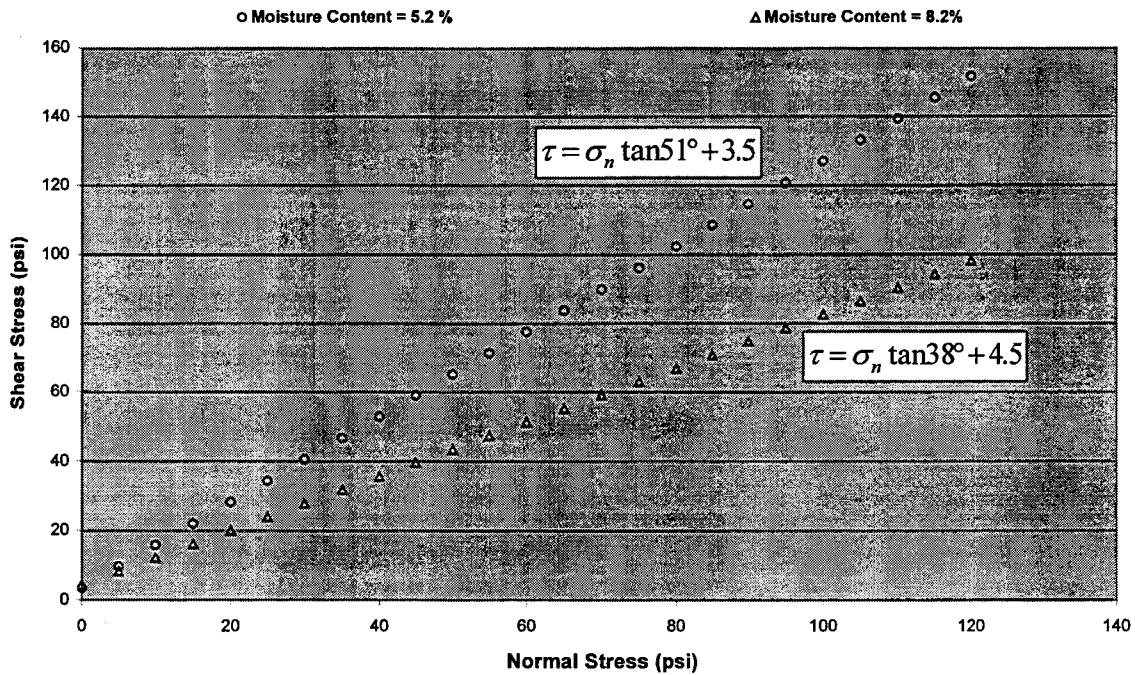
Figure 3.3 - Mohr-Coulomb Failure Envelope

Mohr-Coulomb Failure Envelope
Class 5 Special Aggregate Base

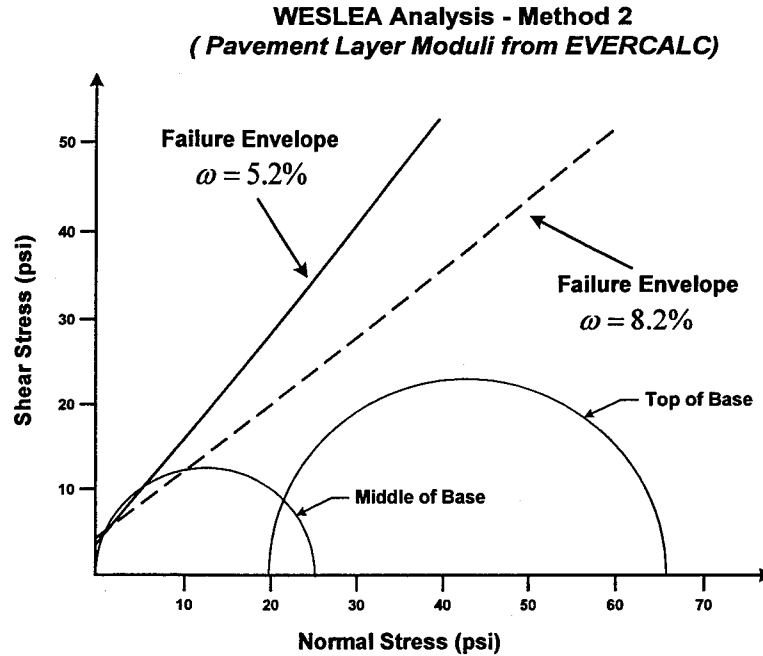
Figure 3.5 – Method 2

The second method used the pavement layer moduli calculated using EVERCALC (Washington DOT). The stress in the middle of the aggregate base layer was again above the failure envelope suggesting failure in the middle of the aggregate base layer.

Analytical and numerical analyses were performed in order to examine the stress state and failure criterion. Figures 3.4 and 3.5 show comparisons between the laboratory developed failure envelopes and the calculated stresses in the aggregate base. The software WESLEA (Corp of Engineers) was utilized for the analytical calculations. Two different methods for pavement layer moduli determination were used.
