U.S. Department of  
Transportation

**Federal Railroad  
Administration**

## **Extended Field Trials of LRAIL for Automated Track Change Detection**

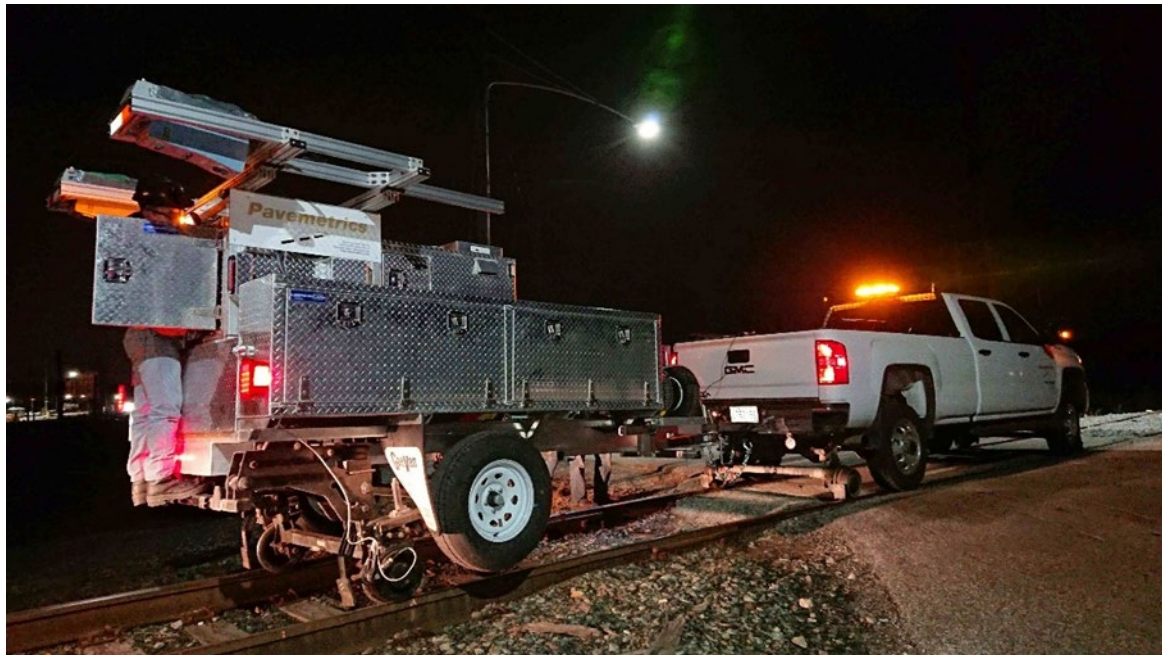
For this project, a specialized hi-rail trailer was constructed and fitted with the LRAIL sensor technology, battery-bank power supply, data storage computers, GPS receivers, and related hardware ([Figure 1](#) and [Figure 2](#)).

**Figure 1 – LRAIL Trailer**

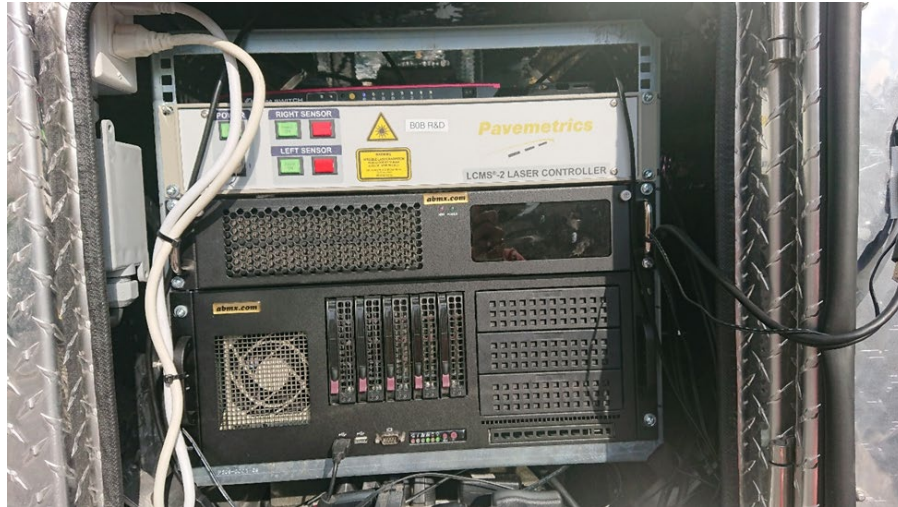
**Figure 2 – Onboard Computing and Power Supply**

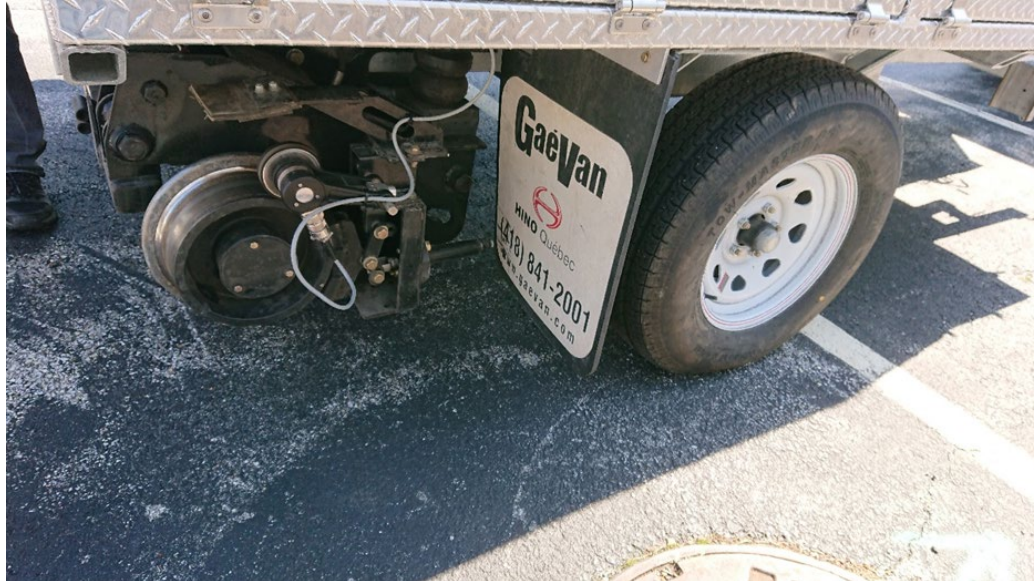
An optical encoder ([Figure 3](#)) was used to trigger image capture and images were sent to a frame grabber to be digitized and then processed by the CPU. Image compression was performed on-the-fly using lossless algorithms to minimize data storage without compromising the usefulness of the data.

**Figure 3 – Optical Encoder (attached to rail wheel)**

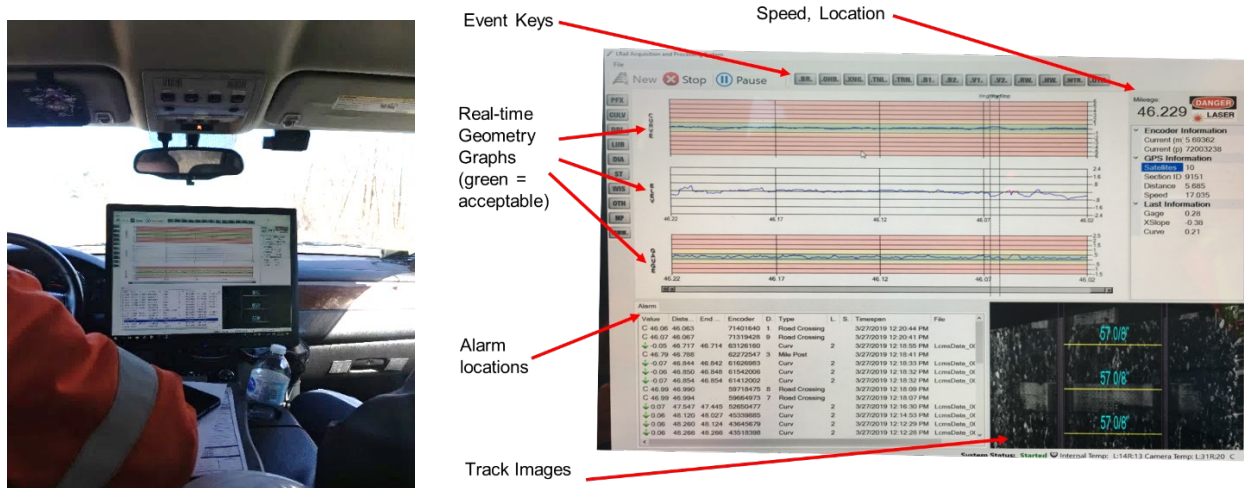
To streamline data collection in the field, a real-time software interface was developed. On-screen readouts include mile post and speed, real-time graphs for geometry, and display of track images ([Figure 4](#)).

**Figure 4 – Real-time User Interface**

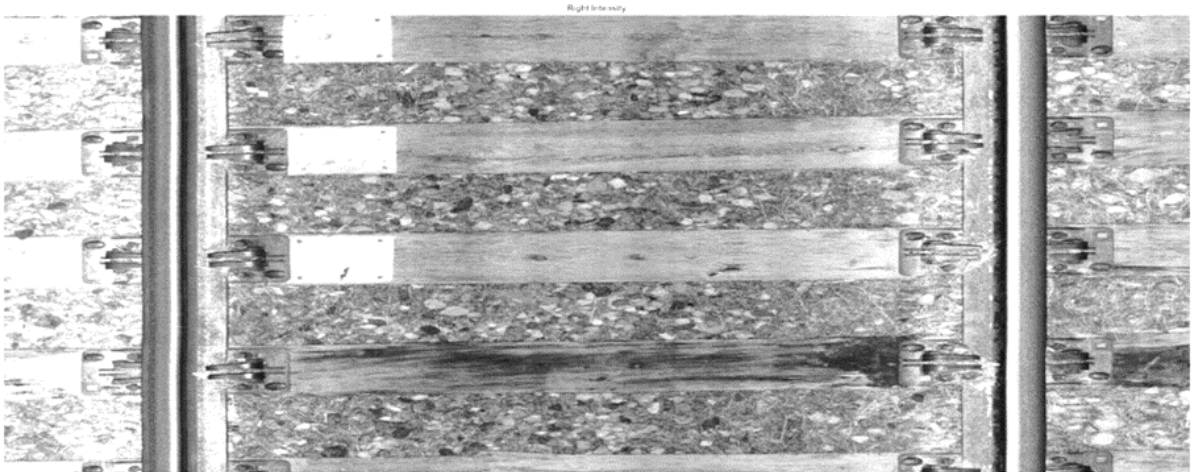
The LRAIL simultaneously captured both intensity and range images of railway assets. Intensity images (Figure 5) are produced by mapping the intensity of the reflected laser light, and range images (Figure 6) are produced by mapping the elevation of each measurement point.

**Figure 5 – Intensity Image**

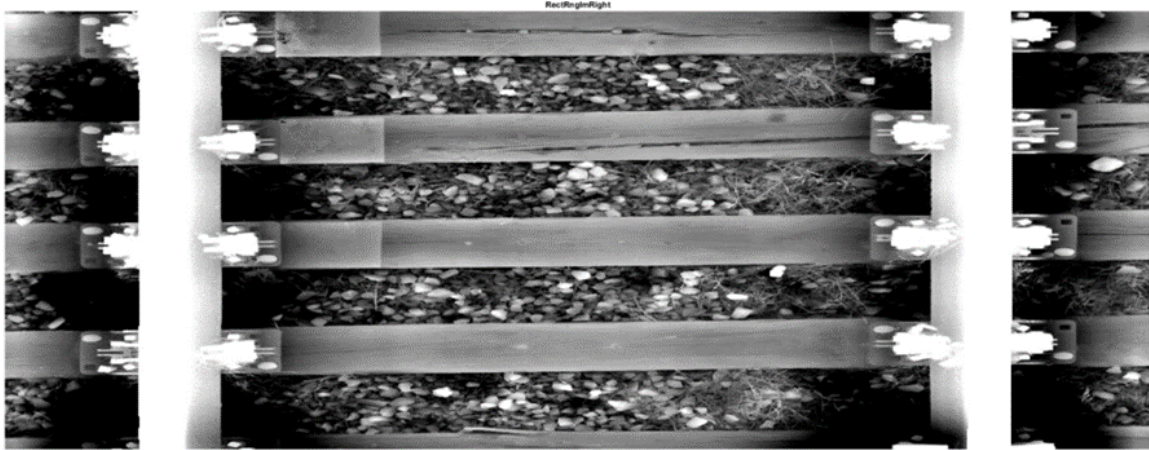
**Figure 6 – Range Image**

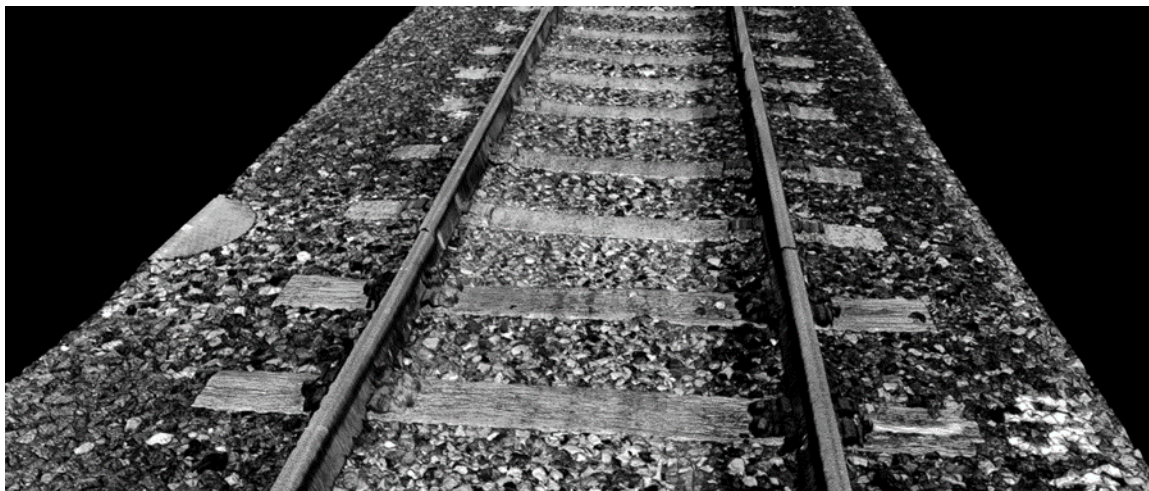
The resulting images are approximately 4,000 pixels wide with a lateral resolution of one point per millimeter and a longitudinal scan interval (as the inspection vehicle travels along the track) of one scan per millimeter. The result is a 1 mm by 1 mm scan of the railway ([Figure 7](#)).

**Figure 7 – 1 mm by 1 mm Scan of Railway**

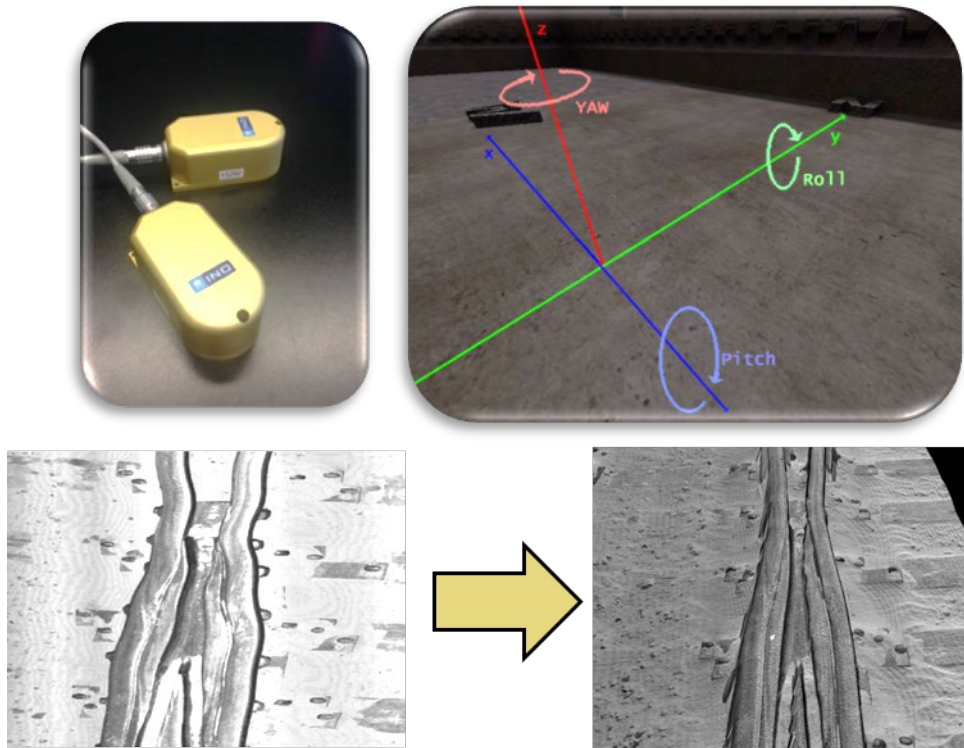
An inertial measurement unit is enclosed in each sensor head and used to track minute changes in the pitch, roll, heading, and acceleration of each sensor. These orientation data are used by a computer algorithm to remove vehicle motion artifacts from 2-dimensional and 3-dimensional data ([Figure 8](#)).

**Figure 8 – Correction for Vehicle Motion**

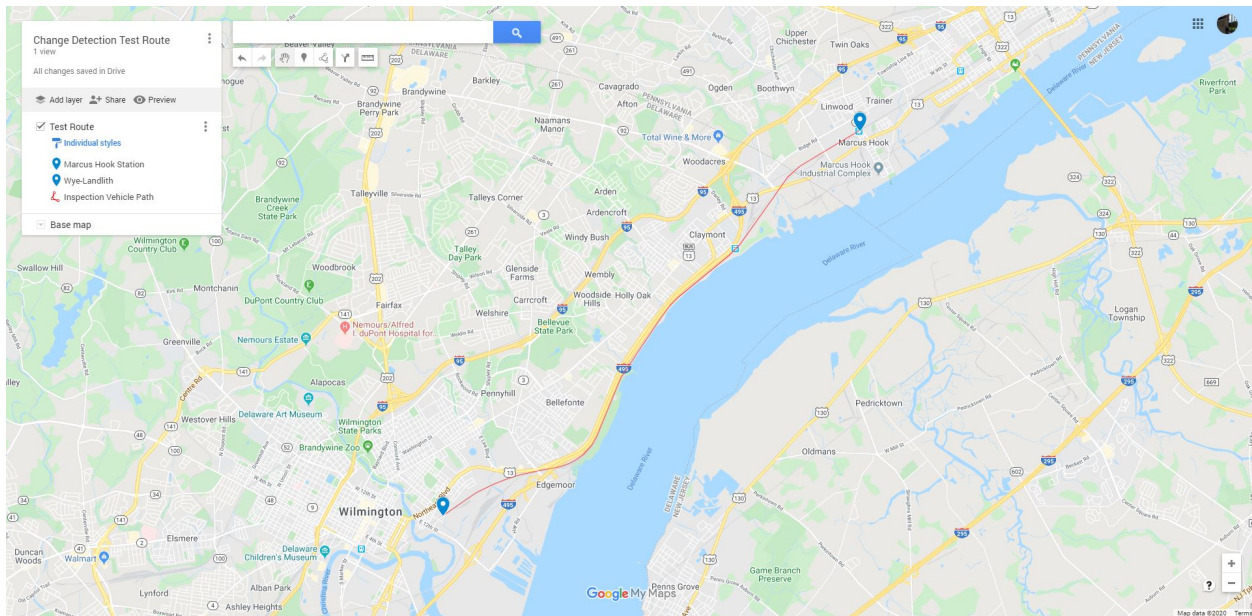
For this project, data was collected on Amtrak starting at approximately MP 25 on the south leg of Wye-Landlith until approximately MP 17 at the Hook Interlocking (Figure 9, the data collection “loop”). The test zone runs north of Wilmington, DE to Marcus Hook, PA, through the towns of Bellefonte, DE and Claymont, DE.

**Figure 9 – Test Loop (MP 25 at Wye-Landlith to MP 17 at the Hook Interlocking)**

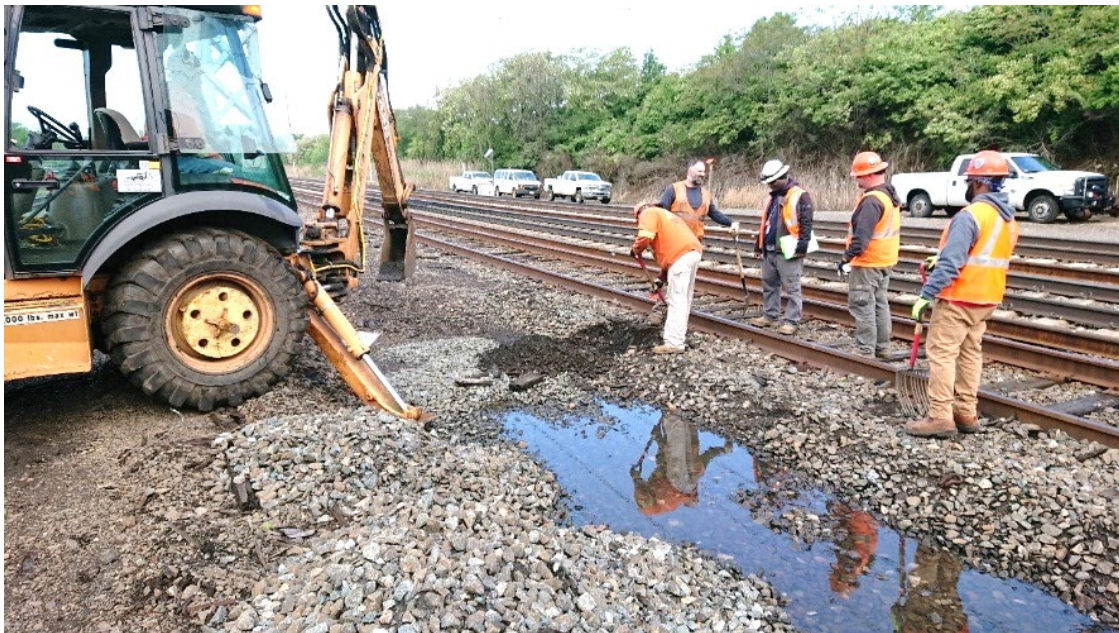
A series of deliberate changes ([Figure 10](#)) were made during the first field deployment between test runs to safeguard against insufficient organic changes to track conditions over the project timeframe. Changes were made to the ballast level in the crib area as well as at the end of ties, tie skew, fastener installation, and joint bar bolting.

**Figure 10 – Deliberate Changes to Ballast Level**

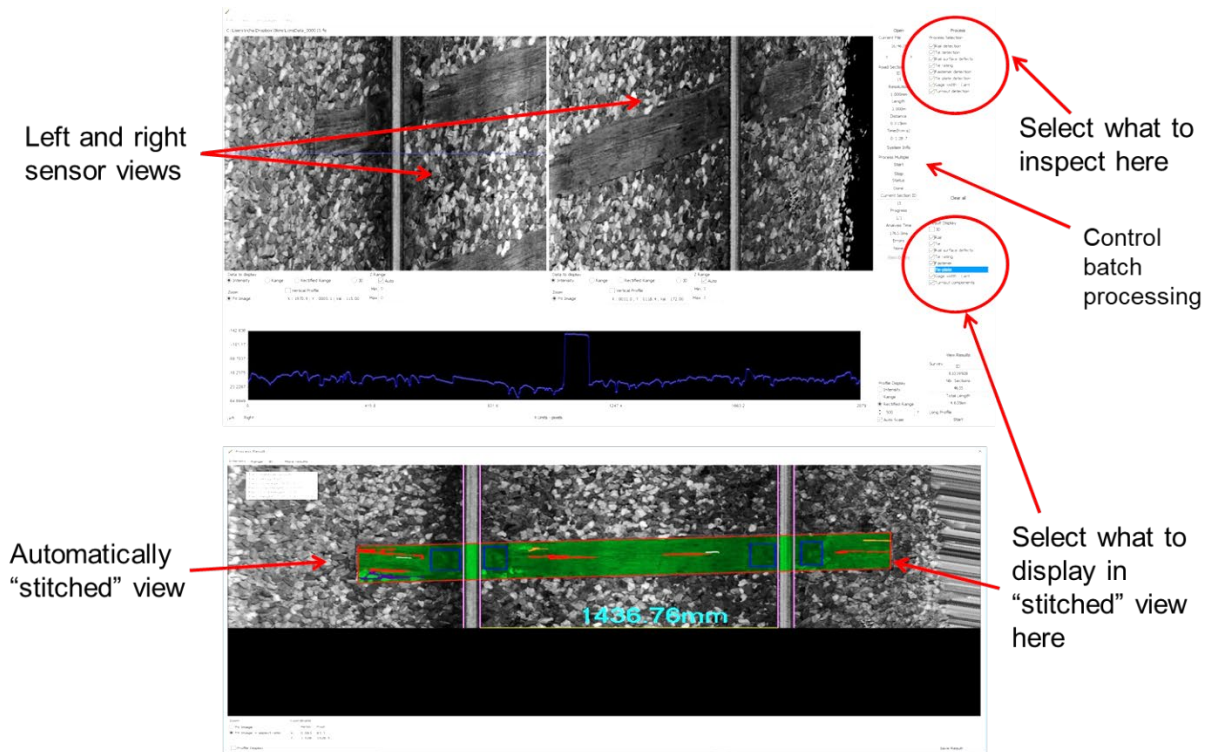
Intensity and range data scans captured in the field are analyzed by the LRAIL's proprietary processing library which combines artificial intelligence (a deep neural network) and traditional image processing to automatically detect railway features and assess their condition (Figure 13). These results, including detect fasteners, joint bar bolts, ballast fouling levels, and tie skew angles, serve as inputs to a proprietary change detection algorithm described in Section 3.3.

Figure 13 – LRAIL Inspection Software Interface

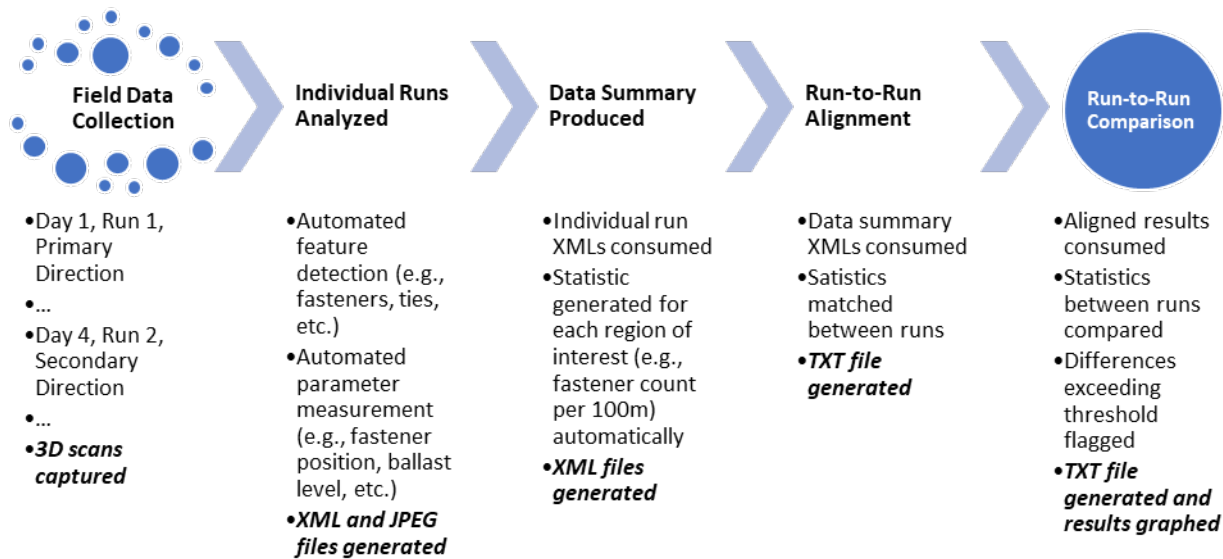
The process flow for change detection is presented in Figure 14.

**Figure 14 – Change Detection Process Flow Summary**

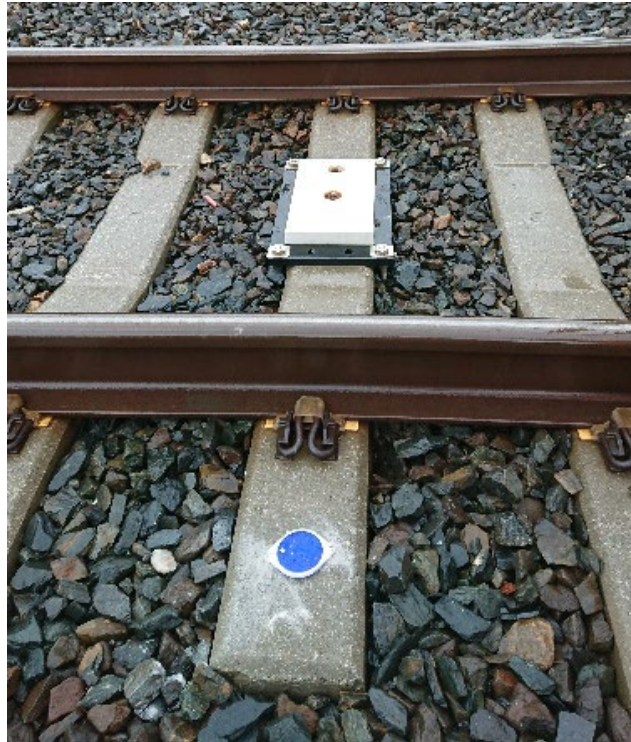
This method is useful when GPS data are not available (e.g., in remote locations or tunnel environments). The semi-automated method utilizes the linear position of a single physical reflector target (Figure 15) at the start of the test run to align the two runs. To develop this approach, reflector targets were installed at the start, end, and midpoint of the test route. Although, ultimately, only a single target was required.

**Figure 15 – Reflector Target**

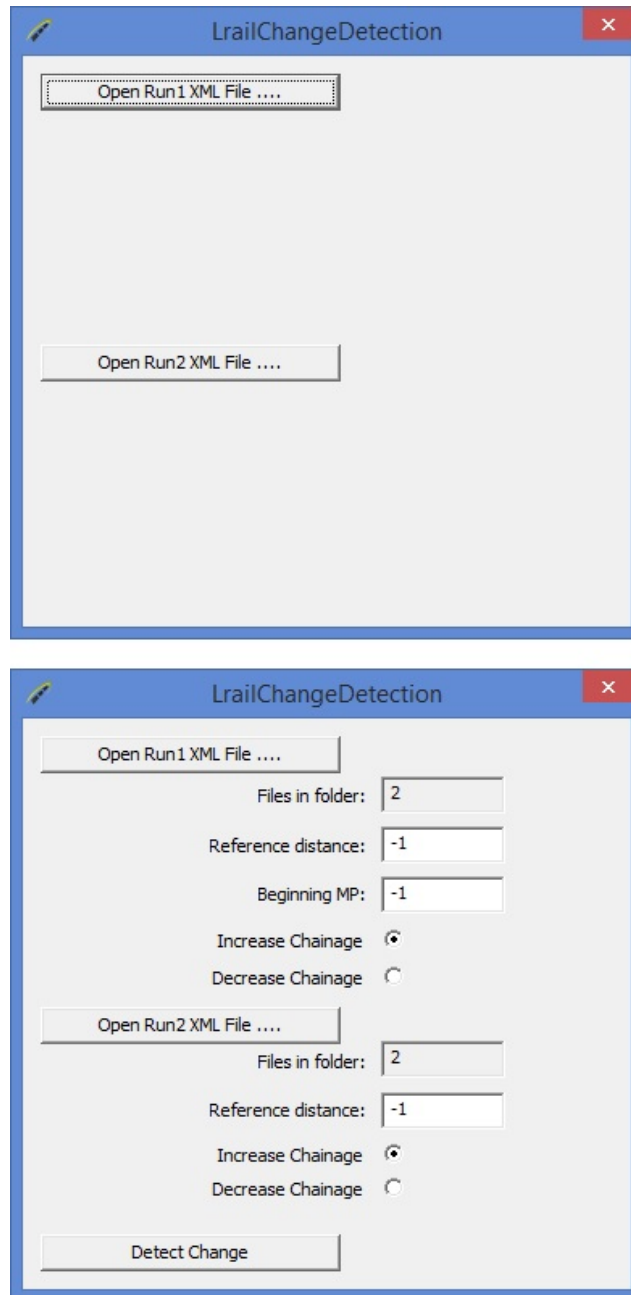
This algorithm compares the GPS position of all ties in each run and selects a single tie location in each run closest to a tie in the other run. The algorithm then moves outward to adjacent ties and compares automatically reported tie parameters, such as skew angle, fastener count, and ballast cover, to validate the initial match. Once validated, data streams from each run are aligned with one another on a tie-by-tie basis.

**Figure 16 – Automated Run-to-Run Alignment Software**

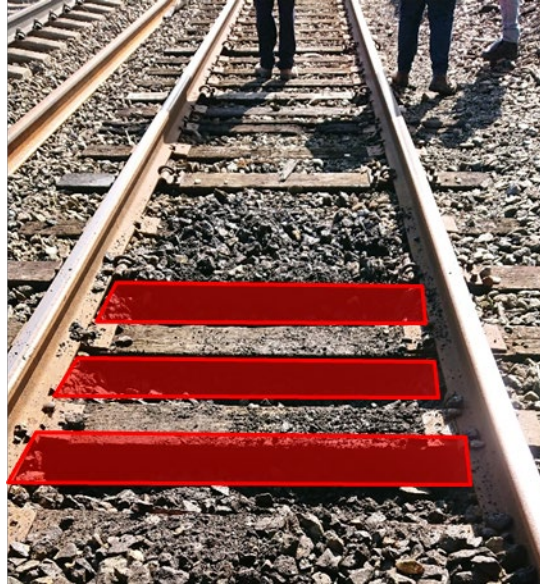
This task involved run-to-run comparisons regarding the mean level of ballast material present in the crib area of the same crib between repeat runs ([Figure 17](#)).

**Figure 17 – Ballast-in-Crib Height Measurements**

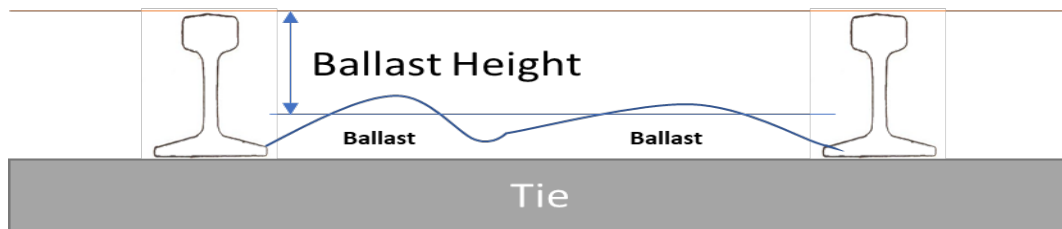
Ballast level is measured as the absolute distance between the planer surface of the top-most point on each rail and the mean height of the ballast surface (Figure 18).

**Figure 18 – Ballast Height Measurement**

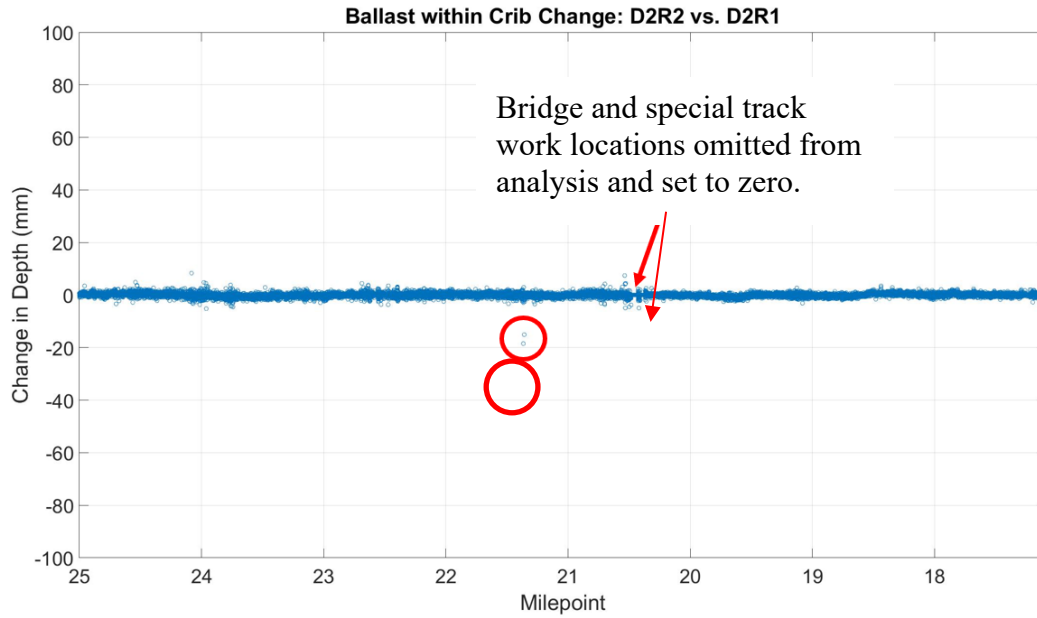
Figure 19 presents the run-to-run comparison with the difference in measurements plotted along the Y-axis and the location for each comparison plotted along the X-axis. Each circle in the plot represents a height comparison between runs for a given crib. Note that a negative value implies an increase in ballast level, since the absolute distance between the rails and the ballast surface decreased while a positive value implies a decrease in ballast height. Note that special trackwork and bridge installation locations were deliberately omitted from analysis. These areas are located by arrows in the figure.

**Figure 19 – Modeling Ballast-in-Crib Height Noise Floor (D2R2 vs. D2R1)**

As can be seen in [Figure 19](#), there were two significant outliers near MP 21.25 (circled in red) that approached 20 mm in magnitude. Upon investigation of the 3-dimensional scans ([Figure 20](#)) a utility box mounted in the crib area was discovered as the source of error.

In future development, the researchers believe that this error can be eliminated (e.g., through the deliberate detection of such boxes); however, for the time being a noise floor of 20 mm is recommended to avoid change detection false positives.

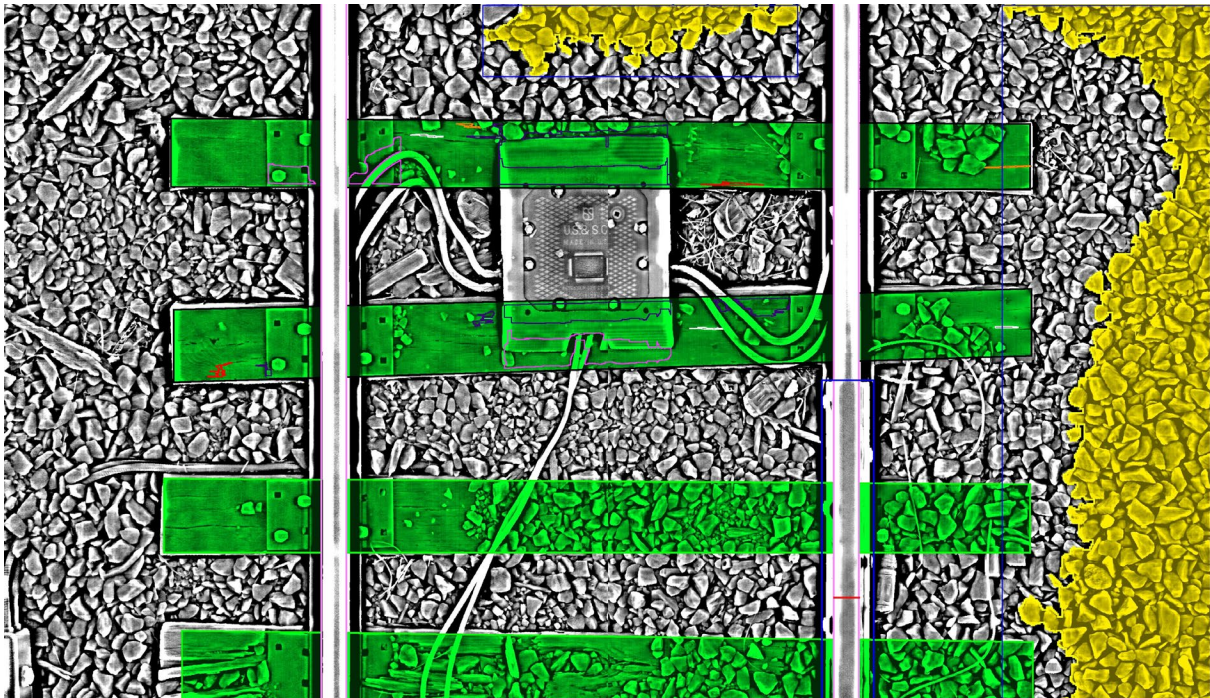
**Figure 20 – Utility Box that Led to False Change Detection**

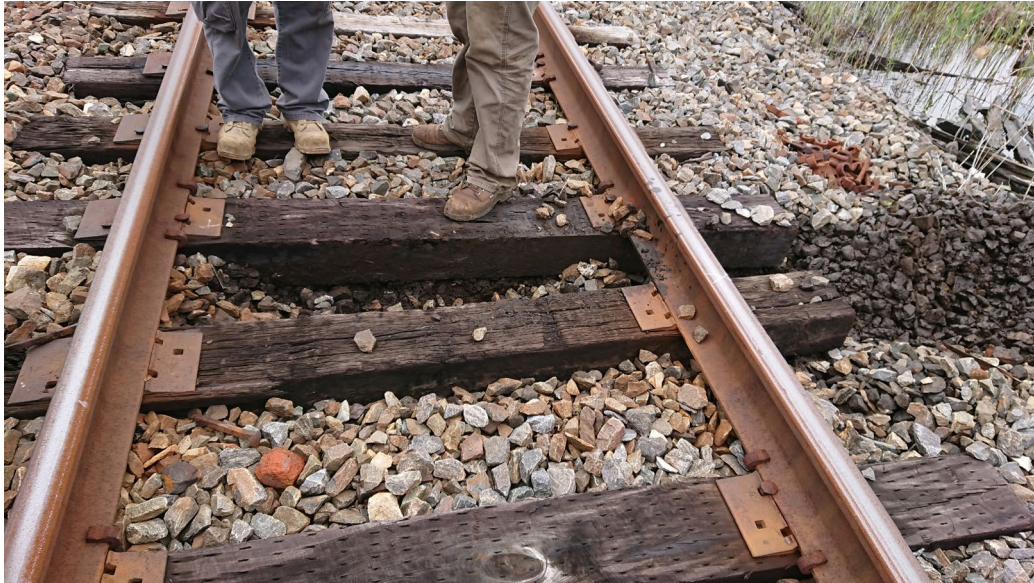
Deliberate changes were made to ballast-in-crib height ([Figure 21](#)) to validate the performance of this algorithm.

**Figure 21 – Deliberate Ballast-in-Crib Height Change**

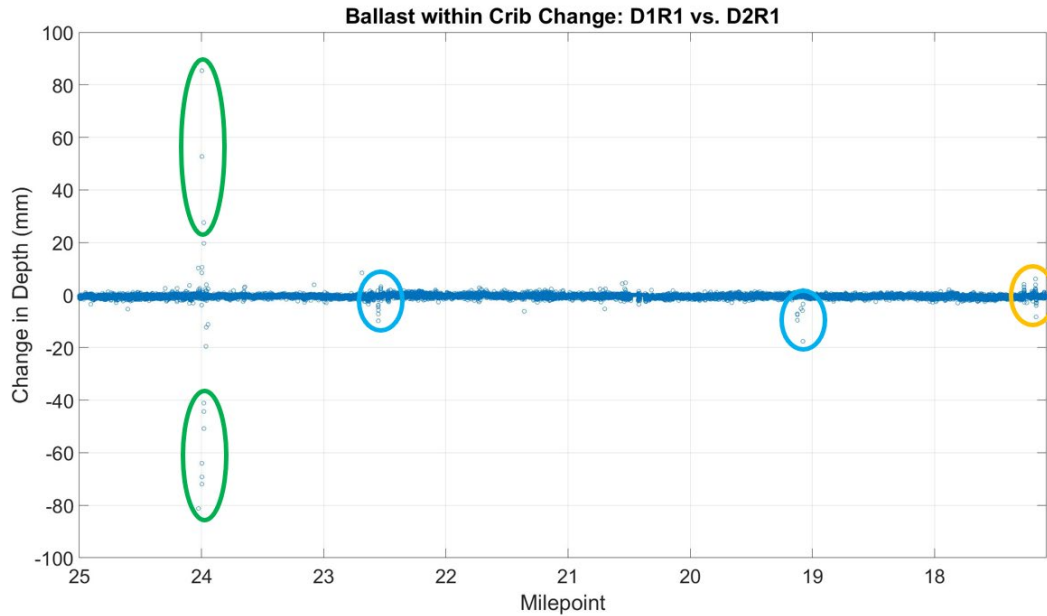
Consequently, when plotting the difference in ballast-in-crib height from any of the scans captured on Day 1 to those captured on Day 2, researchers expected that a number of data points around MP24 would exceed the 20-mm (0.87 inches) noise floor. [Figure 22](#) presents this comparison (D1R1 vs. D2R1).

**Figure 22 – Detecting Deliberate Ballast-in-Crib Change (D1R1 and D2R1)**

Also of note in [Figure 22](#) were some small responses near MP 22.5 and MP 19 (circled in blue) and two near MP 17 (circled in orange). Although these signals were below the 20-mm noise floor, upon investigation of the 3-dimensional scans there are some interesting things learned. The points near MP 22.5 and MP 19 were simply due to excessive changes in surface moisture between D1R1 and D2R1; the ballast material was clearly saturated on D1R1 (which was collected following very heavy rain). By D2R1, the surface was much drier here. However, the two responses near MP 17 told a different story. When the 3-dimensional scans ([Figure 23](#) and [Figure 24](#)) were reviewed for this location, small, unplanned, and unrecorded changes (about 10 mm) to a track sensor installation could be found.

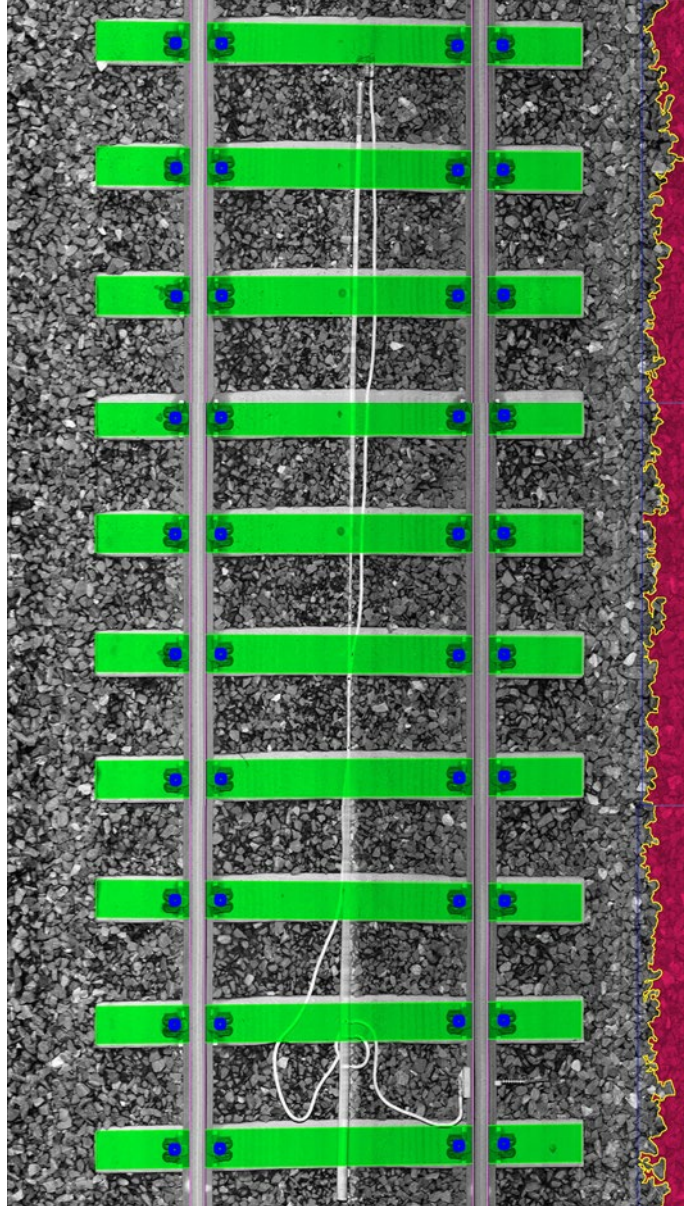
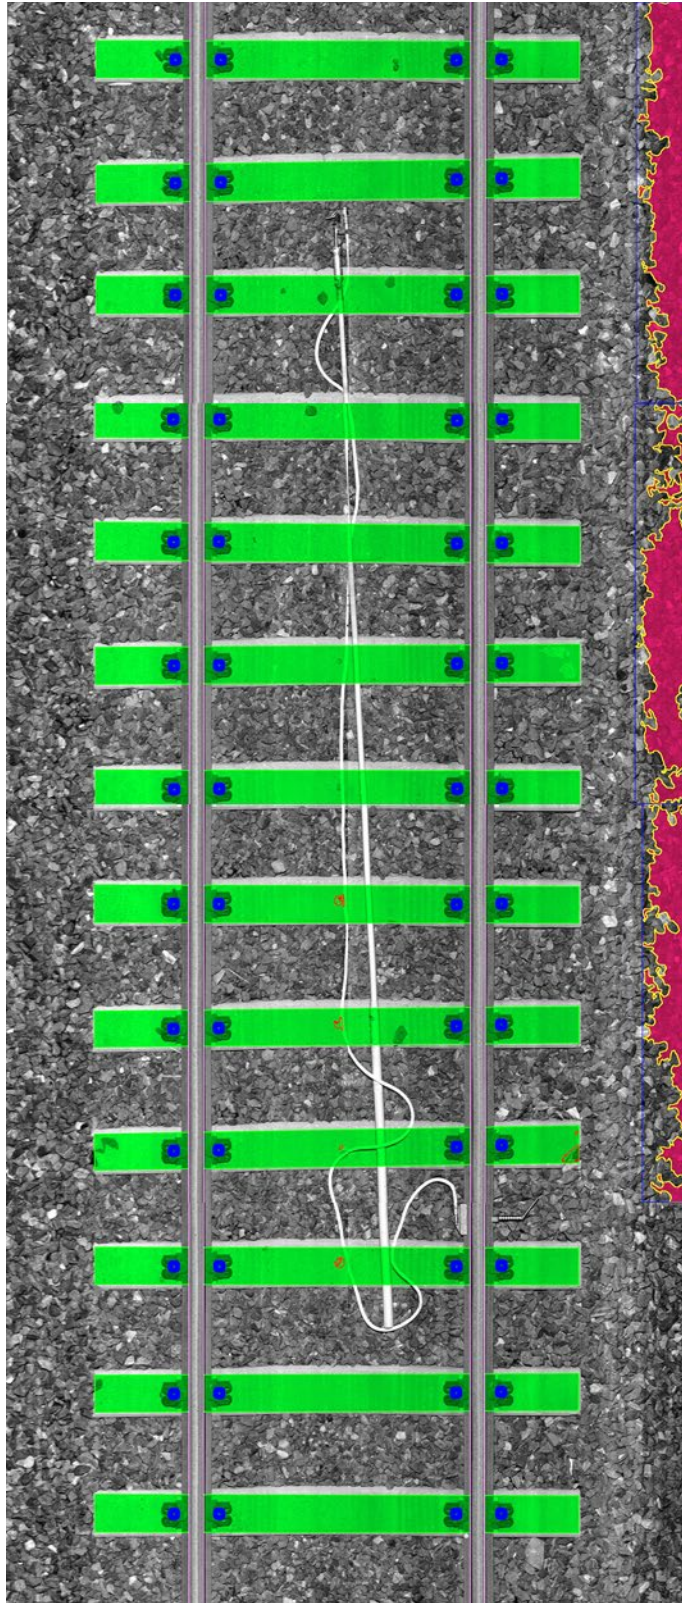
**Figure 23 – Unknown Sensor Installation in Crib Area (D1R1)**

**Figure 24 – Unknown Sensor Installation in Crib Area (D2R1)**

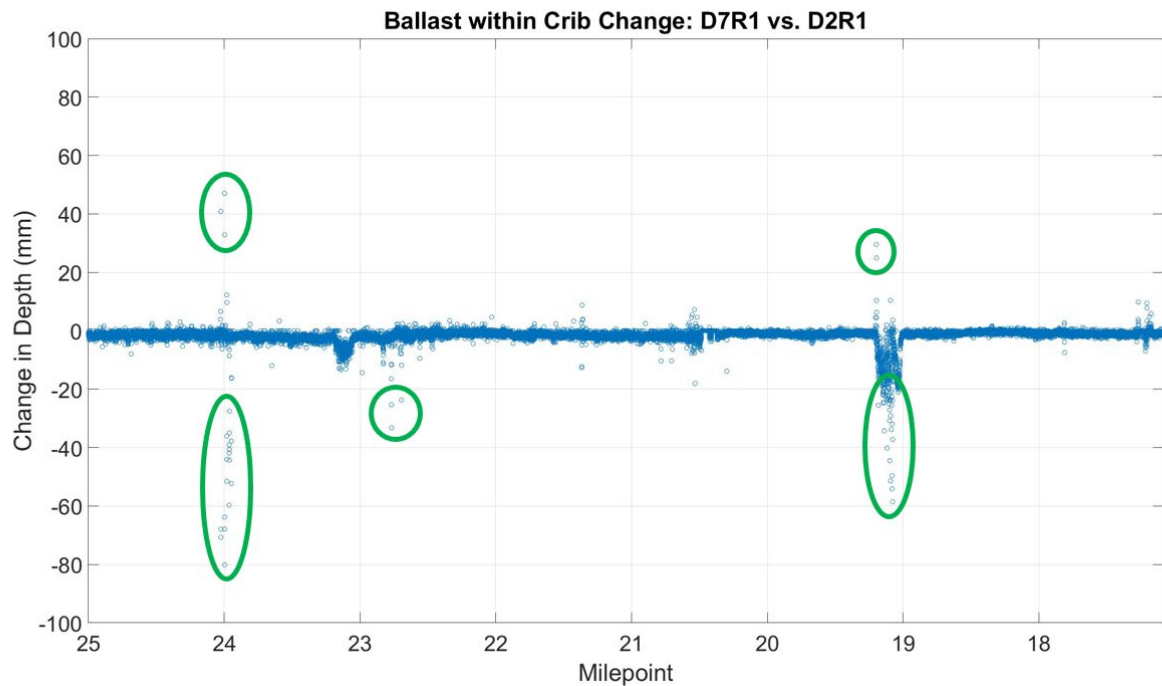
Organic changes to ballast-in-crib height occurred over the test period and were automatically detected. An example of this can be seen when comparing ballast-in-crib heights measured in September 2019 (D7R1) versus those measured in May (D2R1), presented in [Figure 25](#).

**Figure 25 – Ballast-in-Crib Changes between May and September**

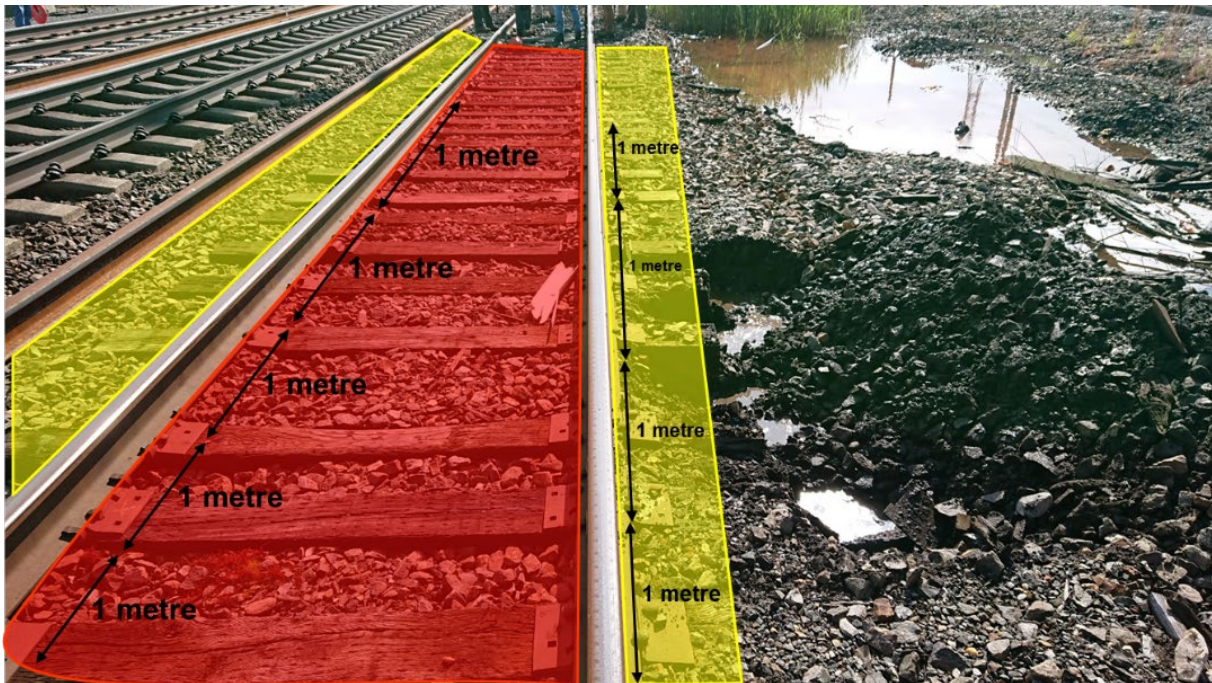
This task involved run-to-run comparisons of ballast height at the end of each tie and in the gauge area along a track segments ([Figure 26](#)).

**Figure 26 – Running Meter Ballast Height Measurements**

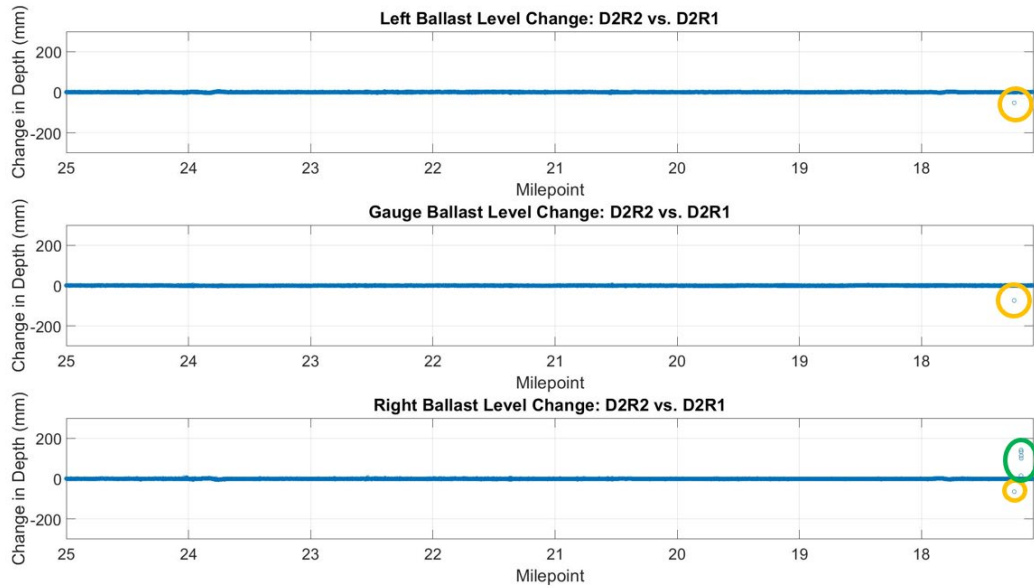
Upon review of the back-to-back runs, the comparison between the second and first runs of Day 2 (D2R2 and D2R1) were determined to contain the largest outliers for this parameter. No deliberate changes were made to track conditions between these runs, and they were captured within approximately 2 hours of one another. [Figure 27](#) presents the run-to-run comparison with the difference in measurements plotted along the y-axis and the location for each comparison plotted along the x-axis. A negative value indicates a decrease in ballast level between scans, and a positive value denotes an increase. The three graphs present changes located in the left field side (when scanned in decreasing chainage), gauge side, and the right field side. Each circle in the plot represents a comparison between runs of average ballast height per meter of track.

**Figure 27 – Modeling Ballast Height at Gauge and End-of-Tie Noise Floor (D2R2 vs. D2R1)**

- The removal of wooden planks adjacent to the right rail (circled in green on middle graph in Figure 27 and in 3-dimensional scans in Figure 28)
- The removal of a long cylindrical object in the gauge area (circled in green on bottom graph in Figure 27 and in 3-dimensional scans in Figure 29)

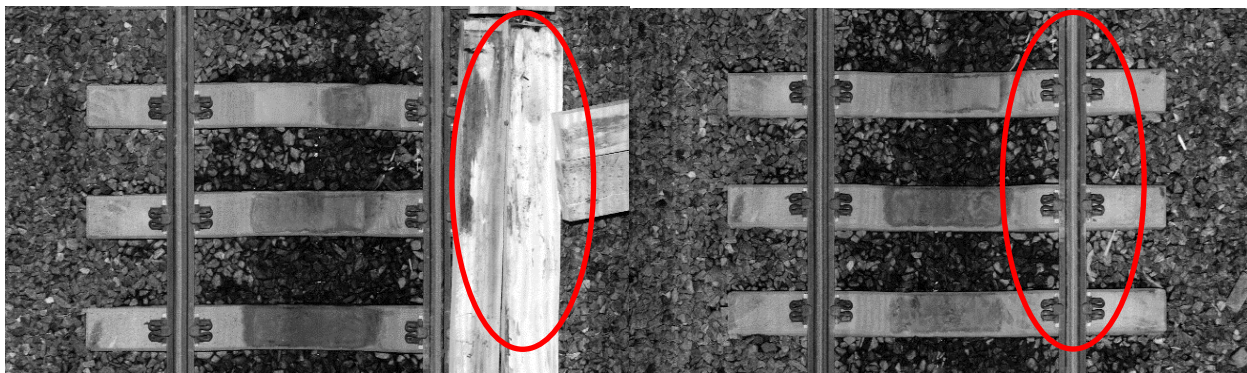
**Figure 28 – Unplanned Removal of Wooden Planks (D2R1 on left and D2R2 on right)**

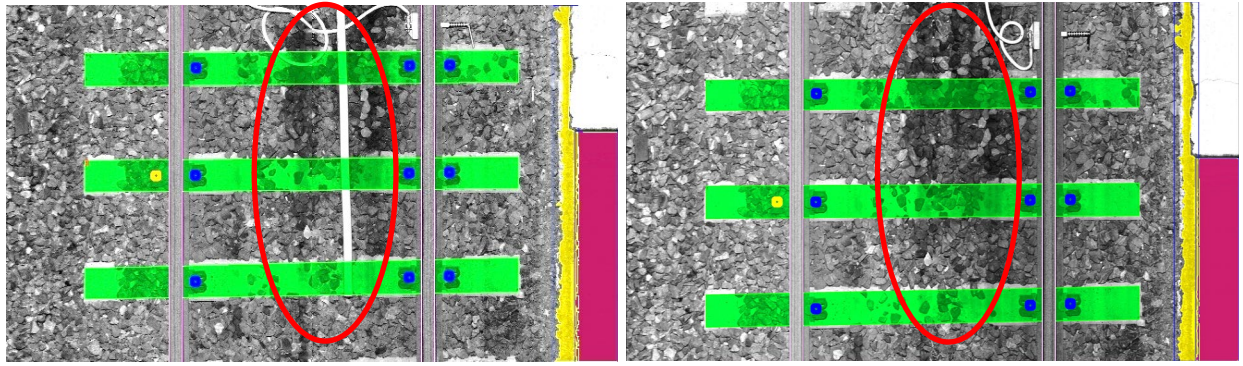
**Figure 29 – Unplanned Removal of Pole (D2R1 left and D3R1 right)**

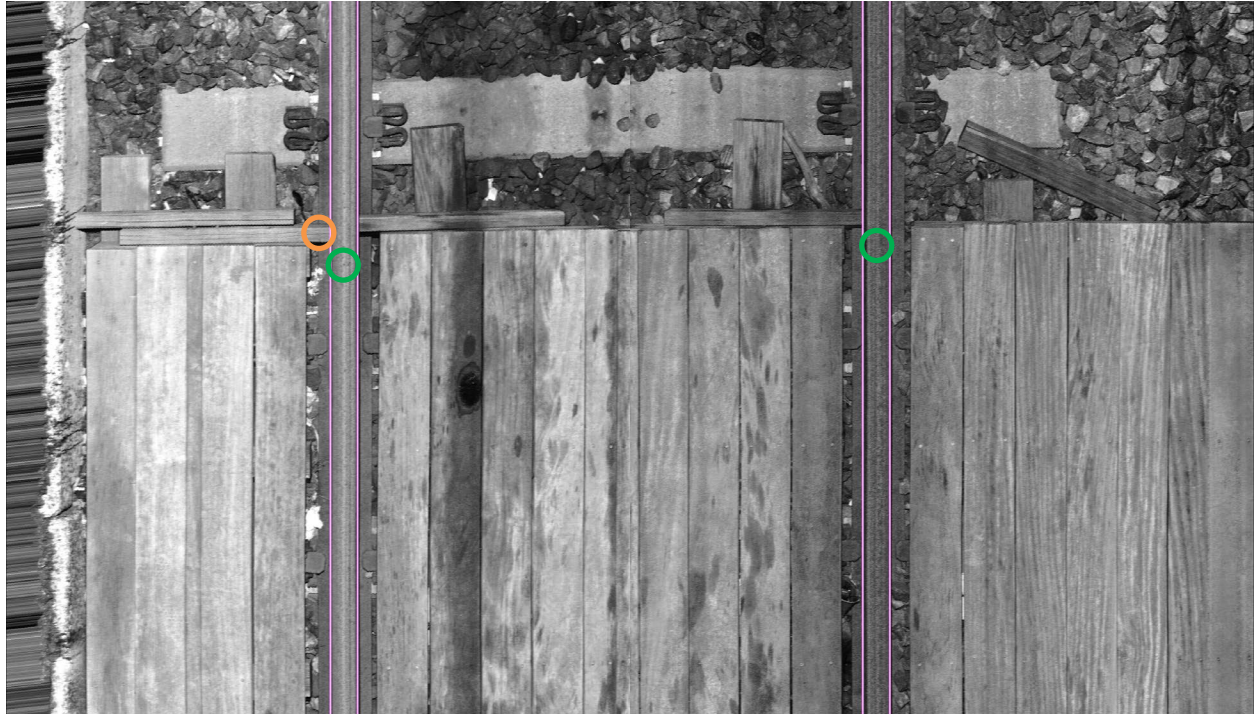
There were also changes detected in the ballast adjacent to the left rail, ballast in the crib, and ballast adjacent to the right rail – all at the same location near MP 17 (circled in orange in the top graph of [Figure 27](#)). However, upon review of the 3-dimensional scans ([Figure 30](#)) these reported changes were determined to be the result of variability between scans related to top-of-rail detection (used as a point of reference for ballast height measurements). In one run, the highest points on the two rails (green circles in [Figure 30](#)) were used to define the frame of reference for ballast height measurements on the left side, while in the second run an adjacent wooden plank was selected (orange circle in [Figure 30](#)) in error by the algorithm and combined with the other rail to form the reference plane.

**Figure 30 – Road Crossing Leads to False Change**

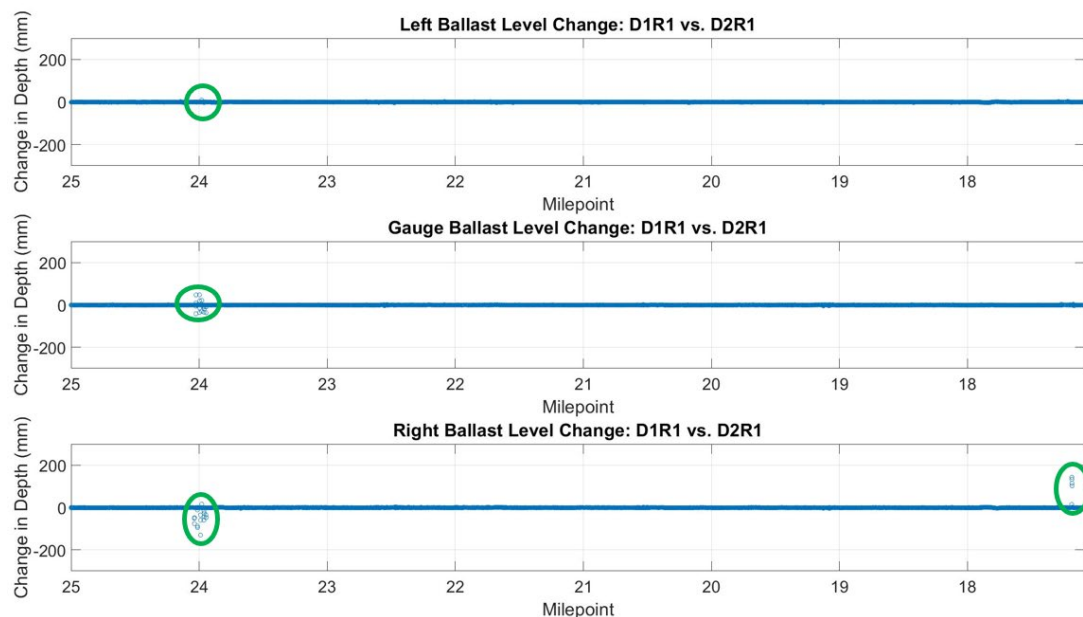
Consequently, when comparing the average ballast height per meter for any of the scans captured on Day 1 to those captured on Day 2, a number of data points that exceeded the 5 mm noise floor were expected near MP 24 (and MP17 due to the legitimate changes noted prior). Figure 31 presents this comparison (D1R1 vs. D2R1).

**Figure 31 – Detecting Deliberate Ballast in Gauge and End-of-Tie Change (D1R1 and D2R1)**

Researchers reviewed additional data and found this error to be intermittent; this can be seen in [Figure 31](#), below, where the false changes do not appear in the left rail ballast graph (top graph) nor in the crib ballast graph (middle graph).

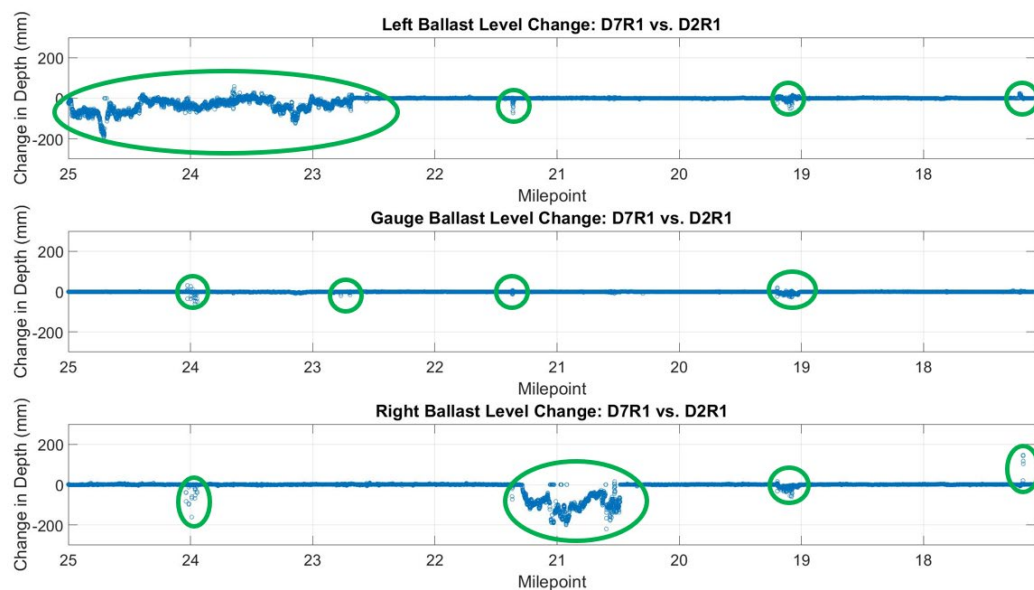
Organic changes to ballast-height-per-meter-of-travel occurred over the test period and were automatically detected. An example of this can be seen when comparing ballast-in-crib heights measured in September 2019 (D7R1) versus those measured in May 2019 (D2R1) and presented in Figure 25.

**Figure 32 – Height of Changes in Ballast per Meter of Travel between May and September**
