U.S. Department of  
Transportation

**Federal Railroad  
Administration**

## **Extended Field Trials of LRAIL for Automated Track Change Detection**

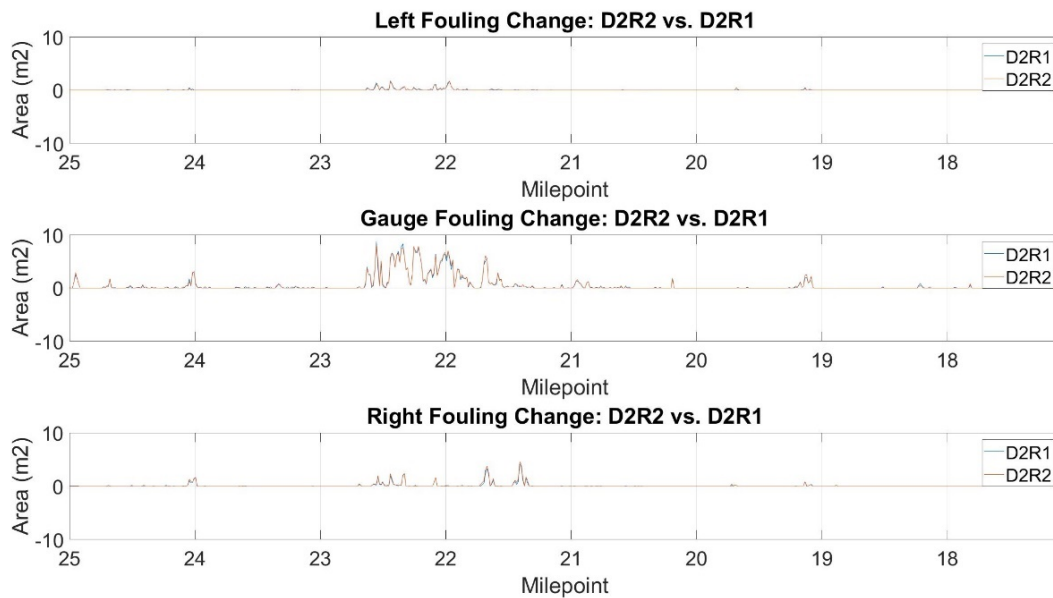
Upon review of the back-to-back runs, the comparison between the second and first runs of Day 2 (D2R2 and D2R1) contained the largest outliers. No deliberate changes were made to track conditions between these runs, and they were captured within approximately 2 hours of one another. Figure 33 presents the measurement results from each run overlaid on top of one another (D2R1 in blue and D2R2 in orange).

**Figure 33 – Modeling Ballast Fouling Noise Floor (D2R2 vs. D2R1)**

Figure 33 shows that these measurements are highly repeatable. As well, if the mathematical difference in these measurements is plotted (Figure 34), one can see that the typical variation per measurement is quite low as it is less than 1 m<sup>2</sup> over a 20-meter length of track.

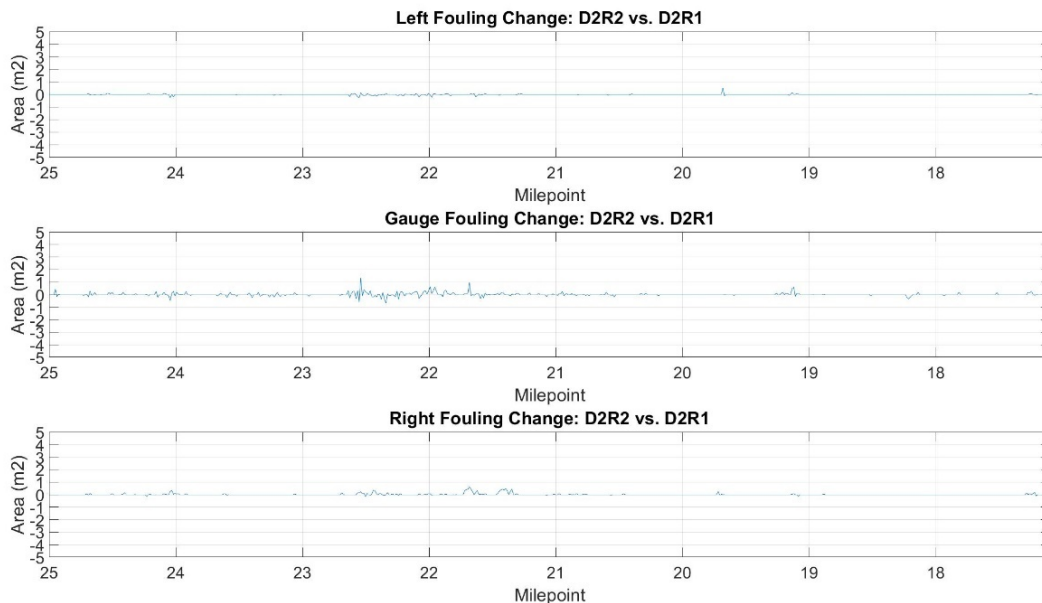
**Figure 34 – Difference in Area of Fouling between Runs (D2R2 vs. D2R1)**

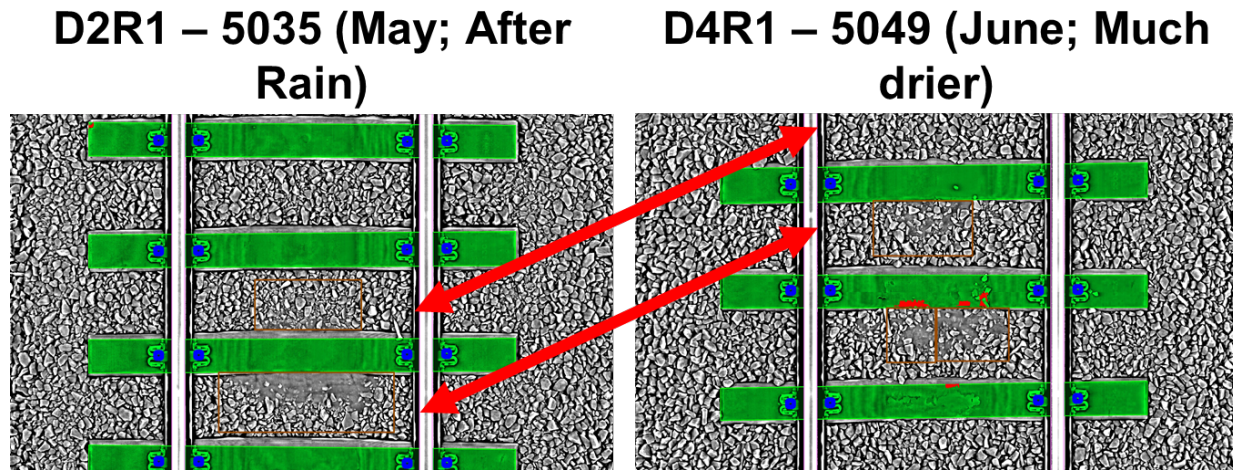
Deliberate changes were not made to ballast fouling. Organic changes to fouling occurred over the test period and were automatically detected. For example, the reduction in surface fouling between May and June is visible in the range data (Figure 35).

**Figure 35 – Reduction in Surface Fouling between May and June**

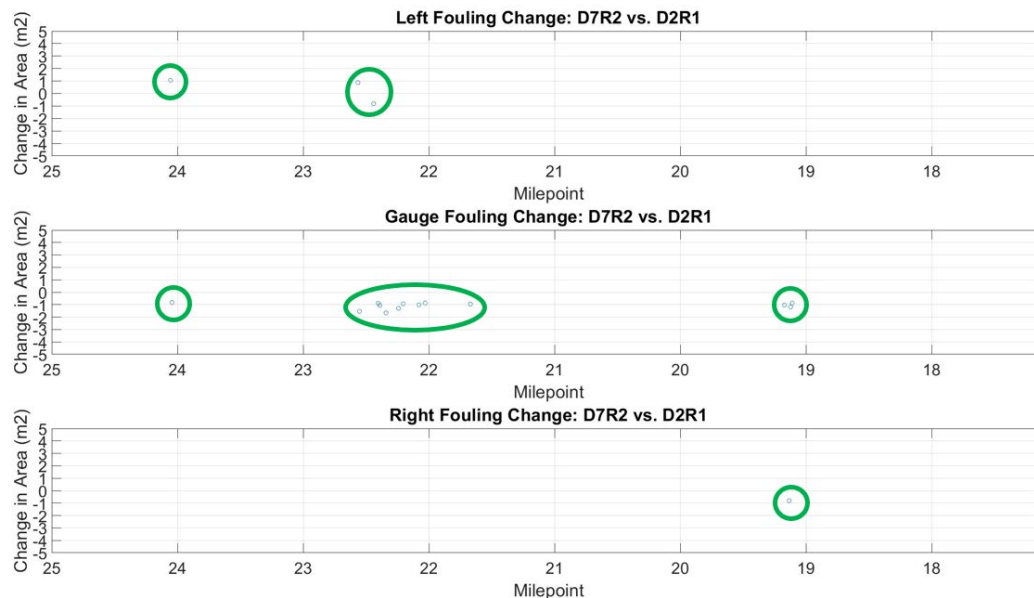
This same trend can be seen when plotting the detected changes in surface fouling between September 2019 (D7R2) and May (D2R1) (Figure 36, circled in green).

**Figure 36 – Organic Changes in Ballast Fouling over the Test Period (D7R2 vs. D2R1)**

The majority of organic change observed between May and September was related to a decrease in the level of fouling. This was likely because the test conditions in May were very wet (i.e.,

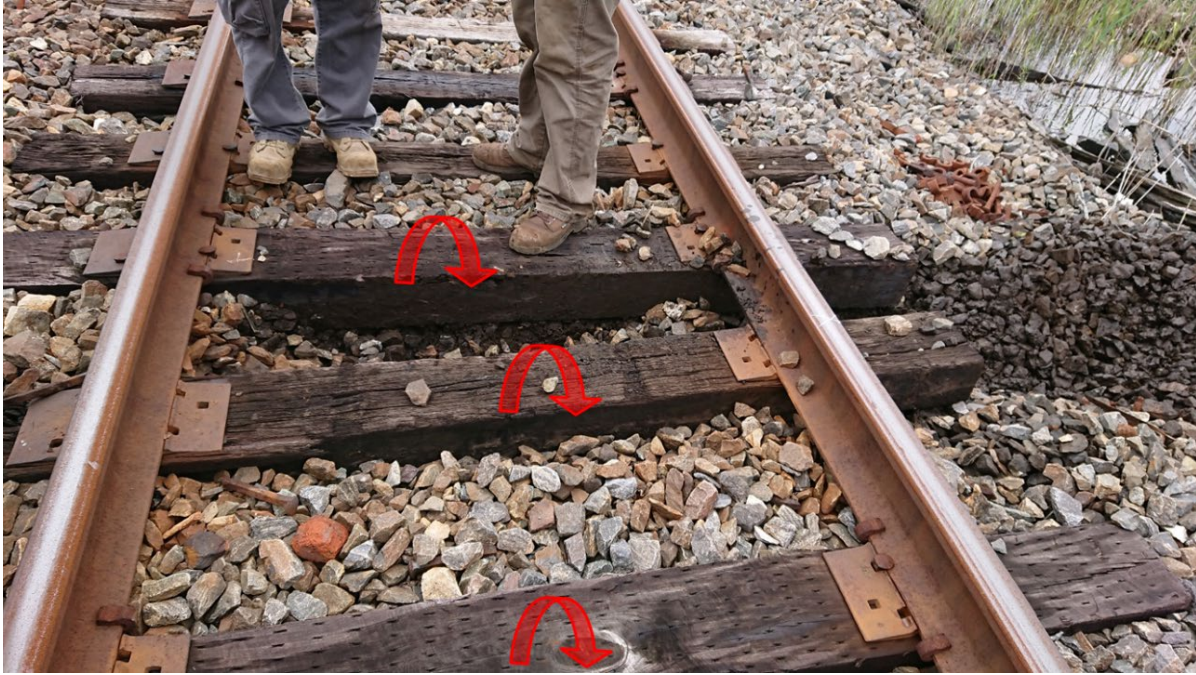
**Figure 37 – Tie Skew Change Detection**

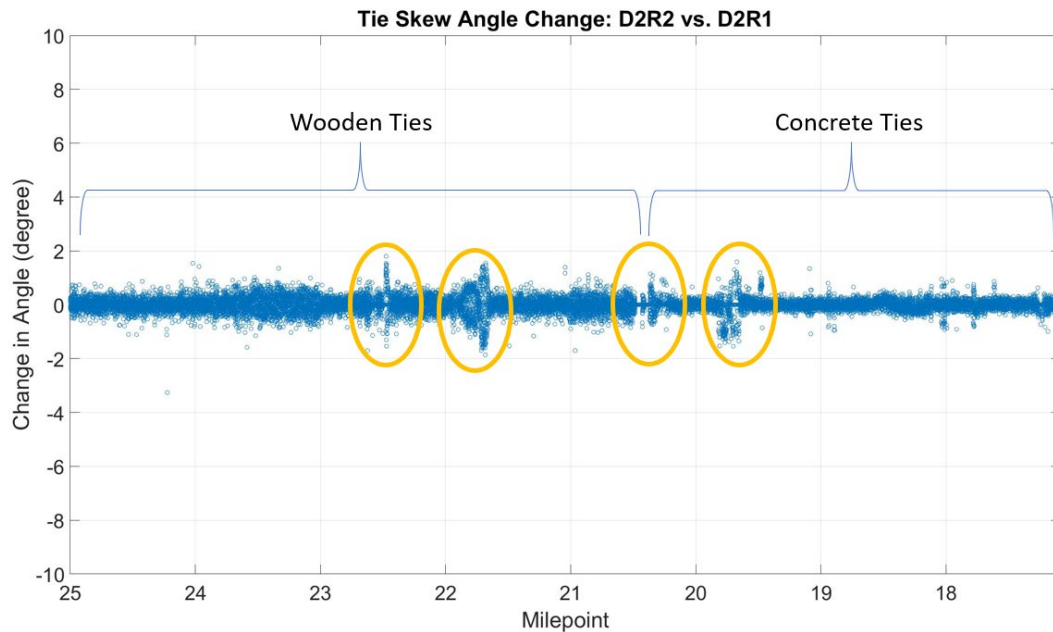
**Figure 38 – Modeling Tie Skew Noise Floor (D2R2 vs. D2R1)**

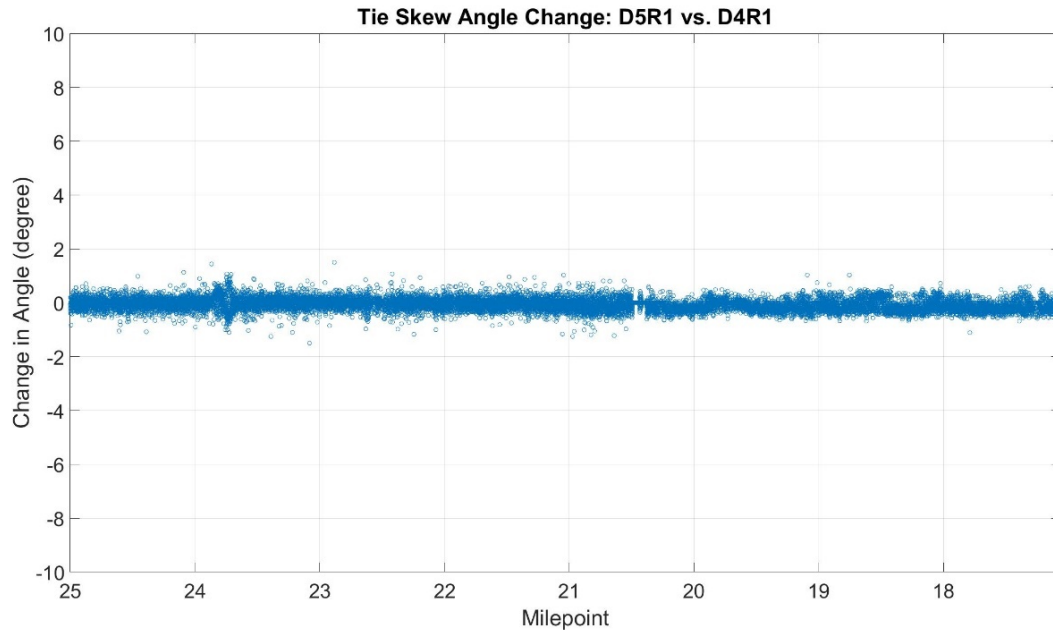
**Figure 39 – Same Direction Runs Produce More Consistent Skew Angle Measurements**

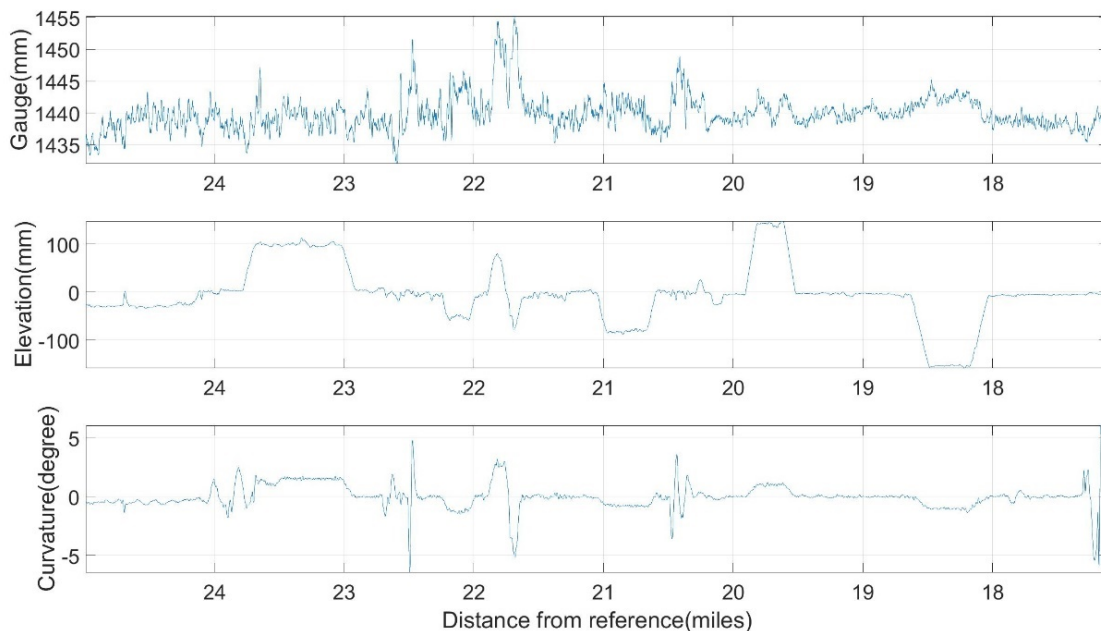
Initially, there was no logical explanation why skew angle measurements from opposite-direction repeat runs would be noisier than same-direction runs at specific track locations. To better understand potentially unique conditions encountered at these locations, additional LRAIL algorithms were used to calculate geometry parameters for the test loop (Figure 40).

**Figure 40 – Track Geometry for Test Section**

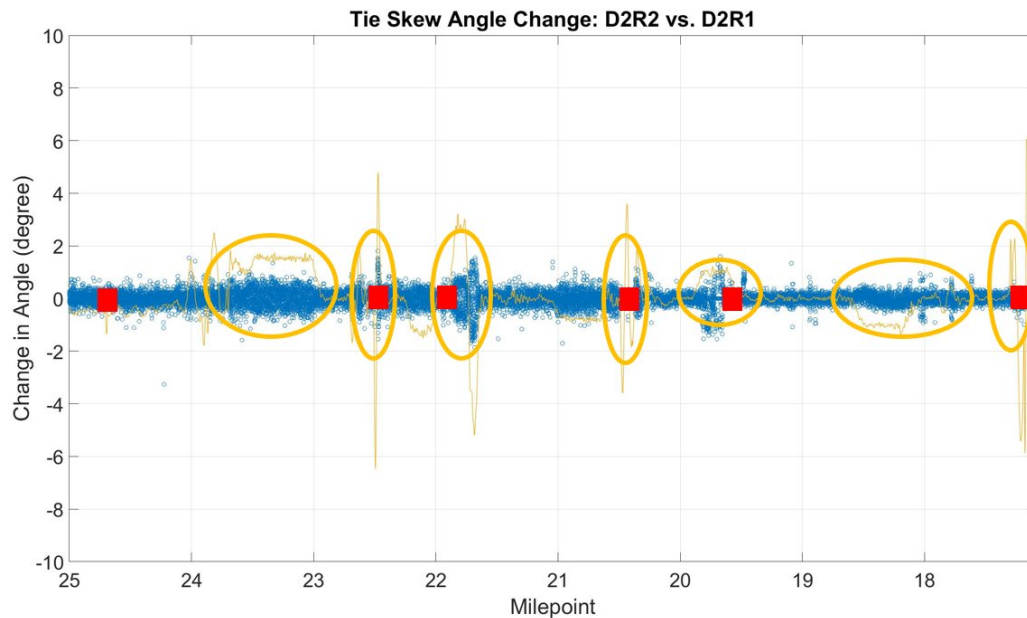
corresponded to the track locations where there was a rapid change in horizontal track alignment and in crosslevel (yellow circles in Figure 41). Adding the locations of special track work to Figure 41 (red squares) helps to further corroborate this hypothesis. Multiple turnouts can be found at MP 22.5 and MP 20.46, two bridges at MP 24.69 and MP 21.92, and multiple road crossings at MP 19.68 and MP 17.23.

**Figure 41 – Track Alignment (yellow line) Overlaid on Plot of Tie Skew Angle Change**

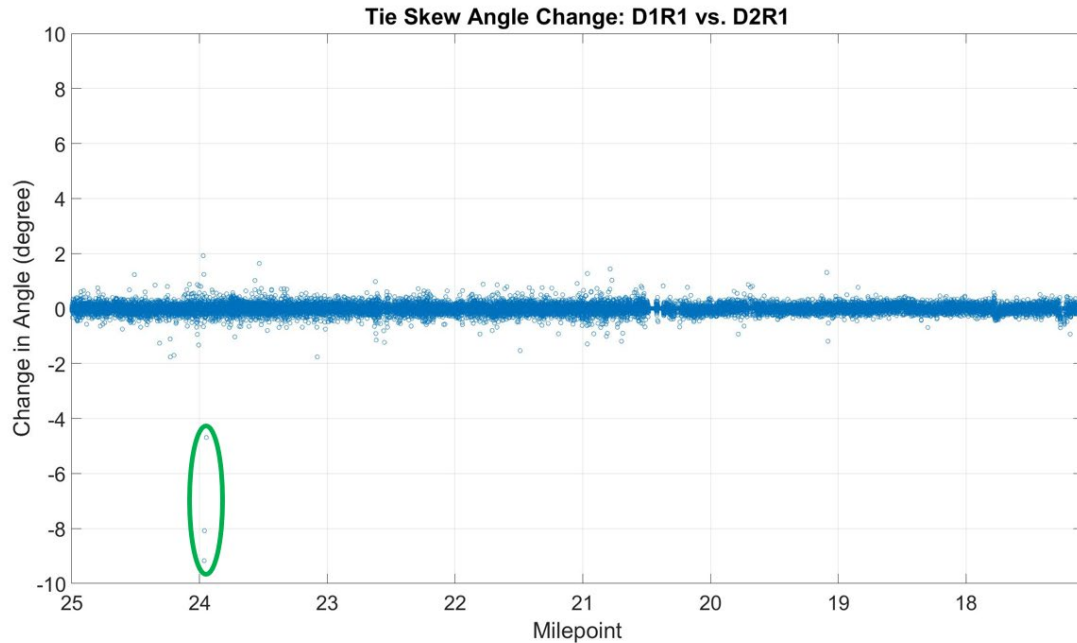
**Figure 43 – Detecting Deliberate Tie Skew Change (D1R1 and D2R1)**

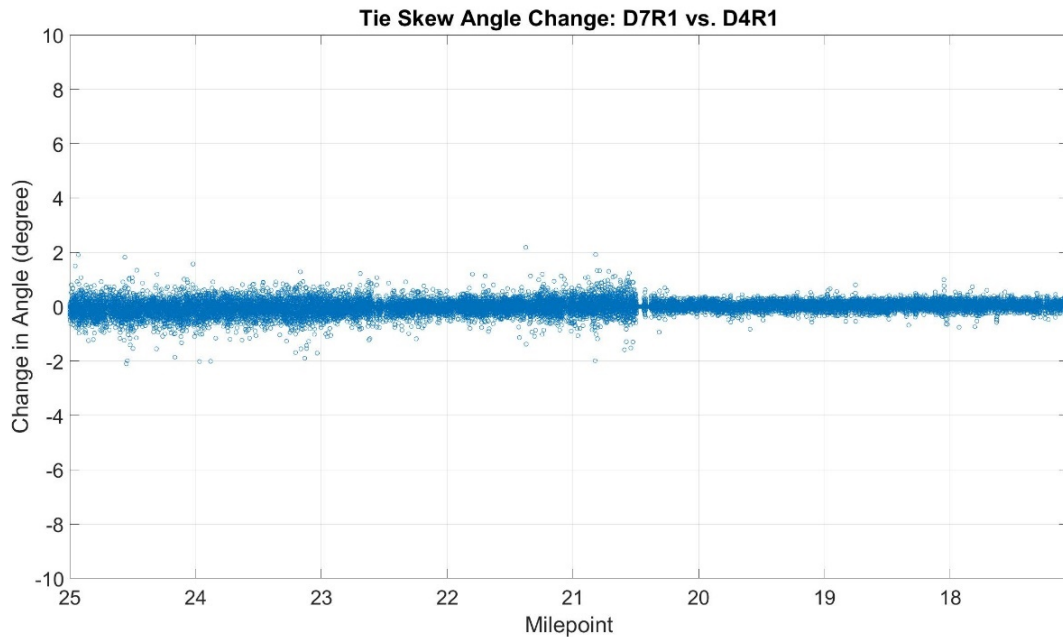
**Figure 44 – Organic Changes to Tie Skew (D7R1 vs. D2R1)**

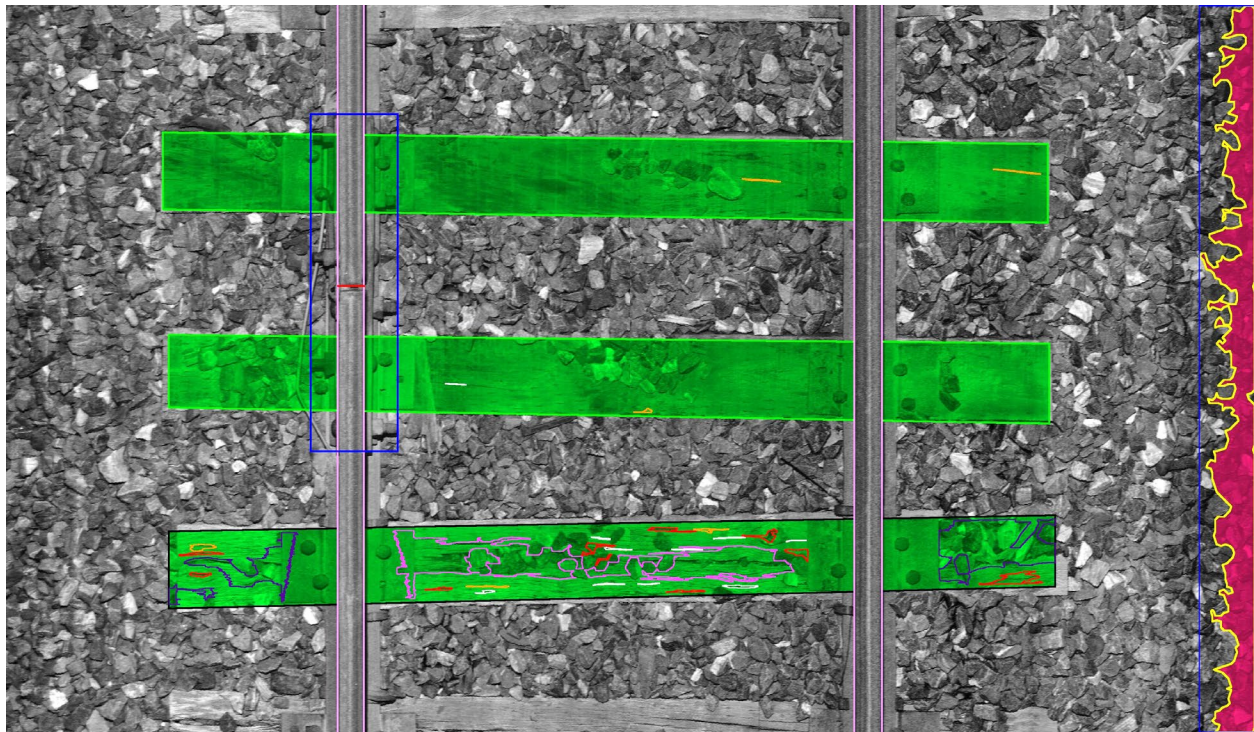
Figure 45 – Wooden Tie Showing Color-coded Defects

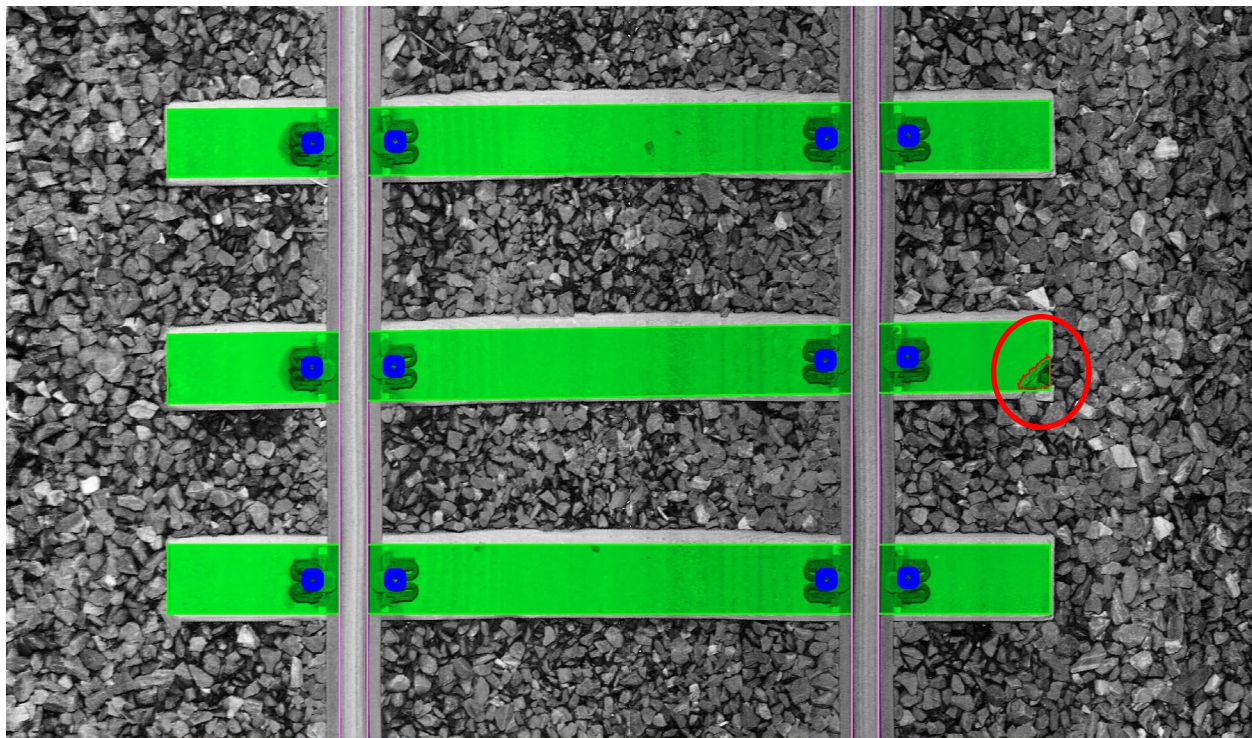
**Figure 48 – Intensity Image Showing Automatically Detected Chipping on Concrete Tie**

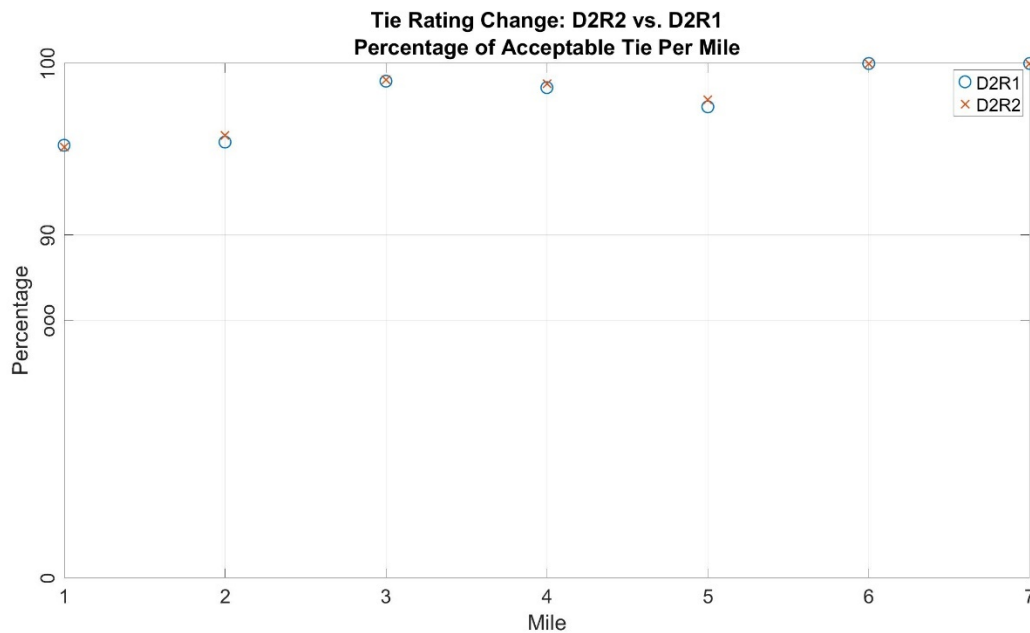
**Figure 49 – Modeling Tie Condition Rating Noise Floor (D2R2 vs. D2R1)**

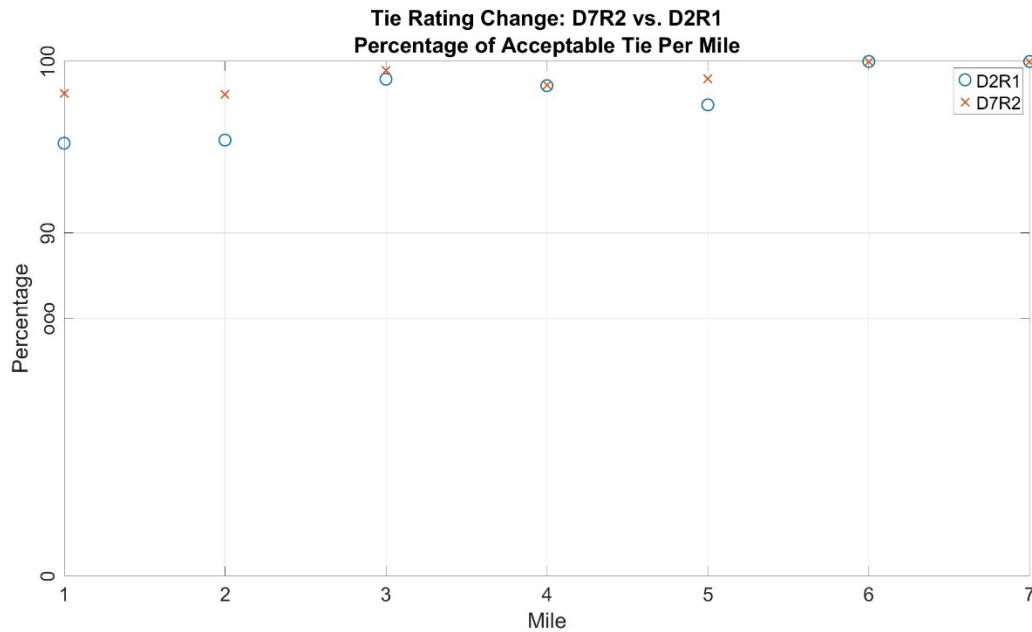
**Figure 50 – Organic Changes to Tie Condition Between May 2019 and September 2019 (D7R2 vs. D2R1)**

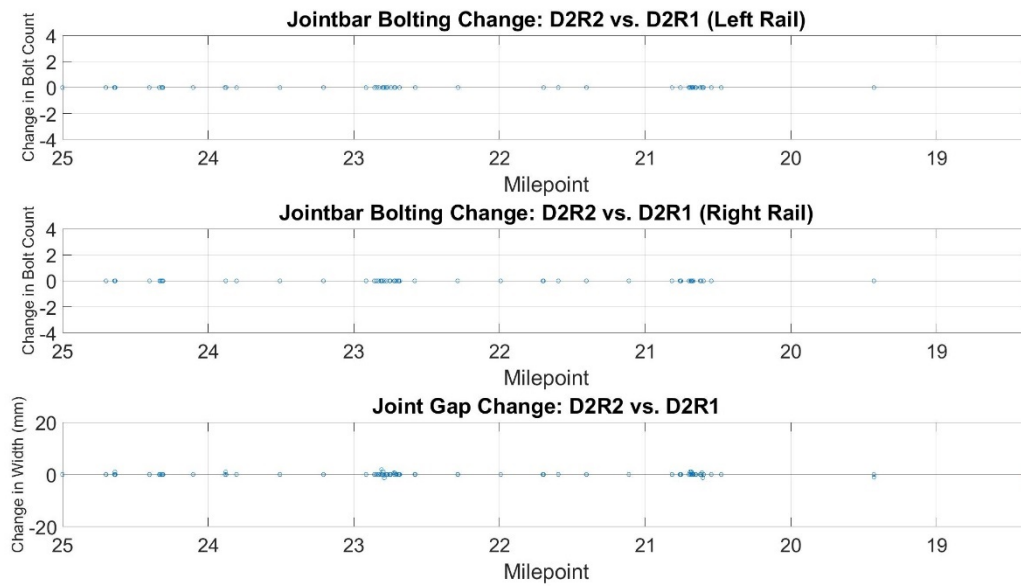
**Figure 51 – Modeling Joint Bar Bolting Noise Floor (D2R2 vs. D2R1)**

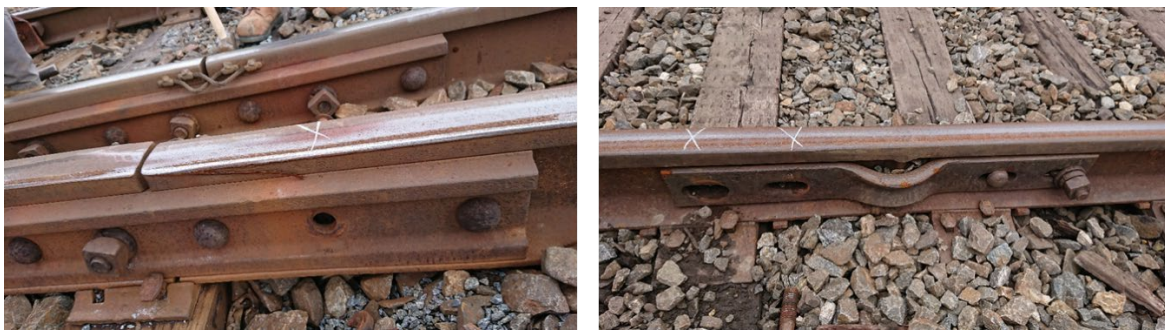
**Figure 52 – Deliberate Changes to Joint Bar Bolting**

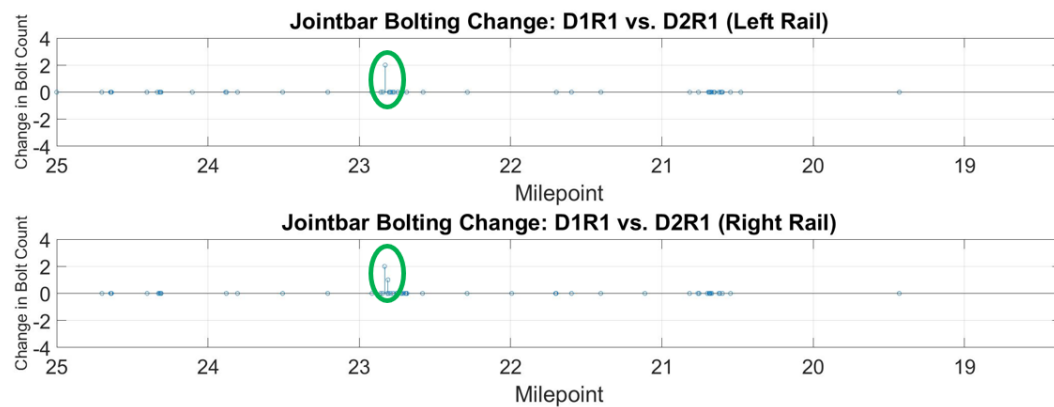
**Figure 53 – Detecting Deliberate Joint Bar Bolting Change (D1R1 and D2R1)**

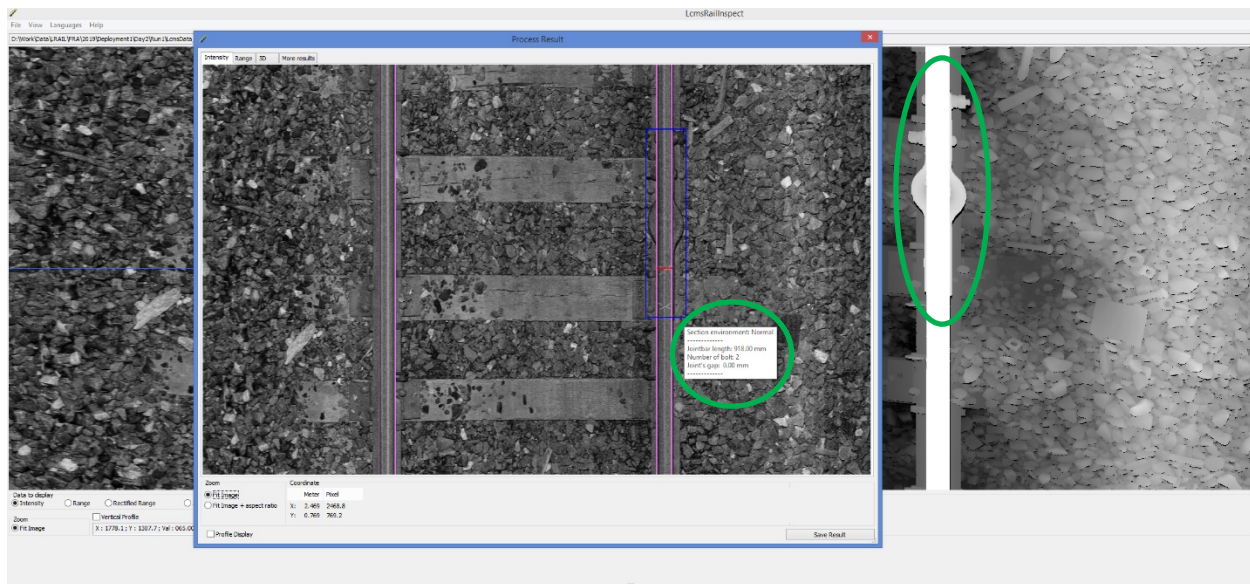
**Figure 54 – Right Rail at MP 22+3076 with Two Bolts (D1R1)**

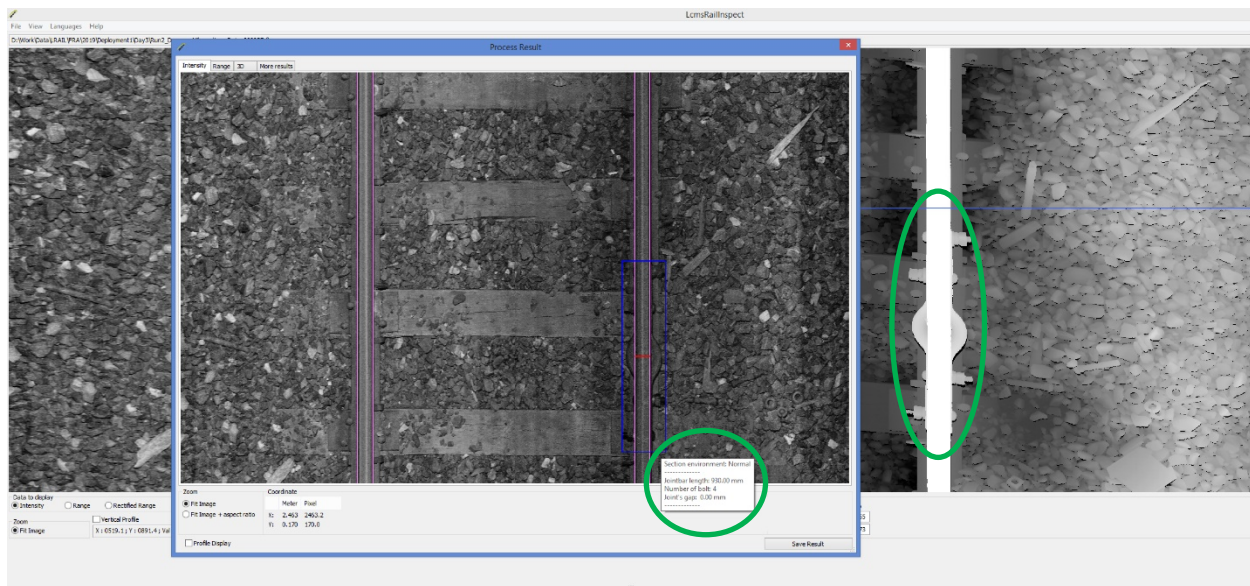
**Figure 55 – Right Rail at MP 22+3076 with Four Bolts (D2R1)**

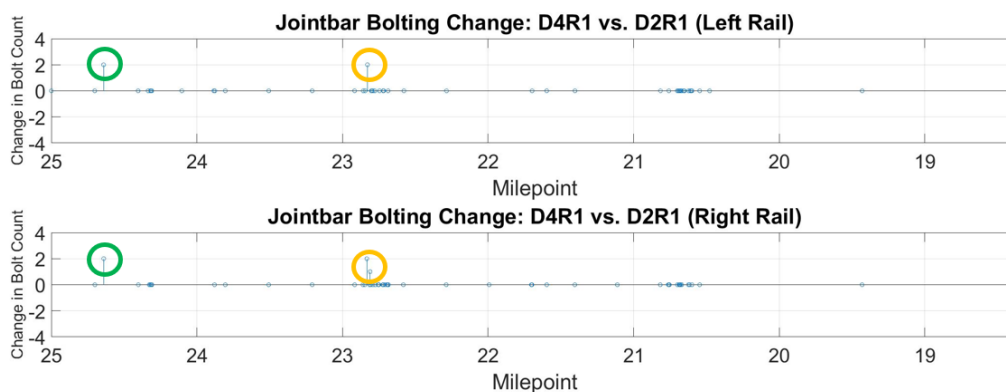
**Figure 56 – Joint Bar Bolting Changes between May and June (D4R1 vs. D2R1)**

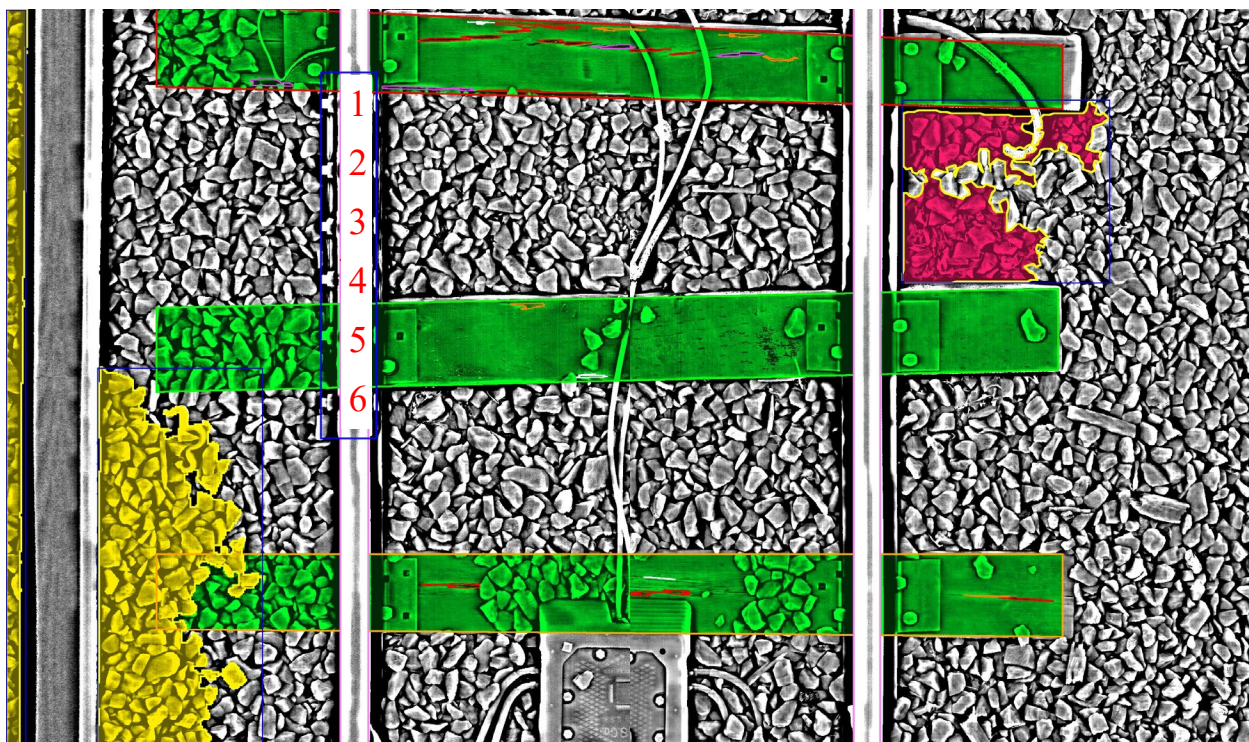
**Figure 57 – Left Rail Joint Bar in May Showing Six Bolts with Heads on Gauge Side**

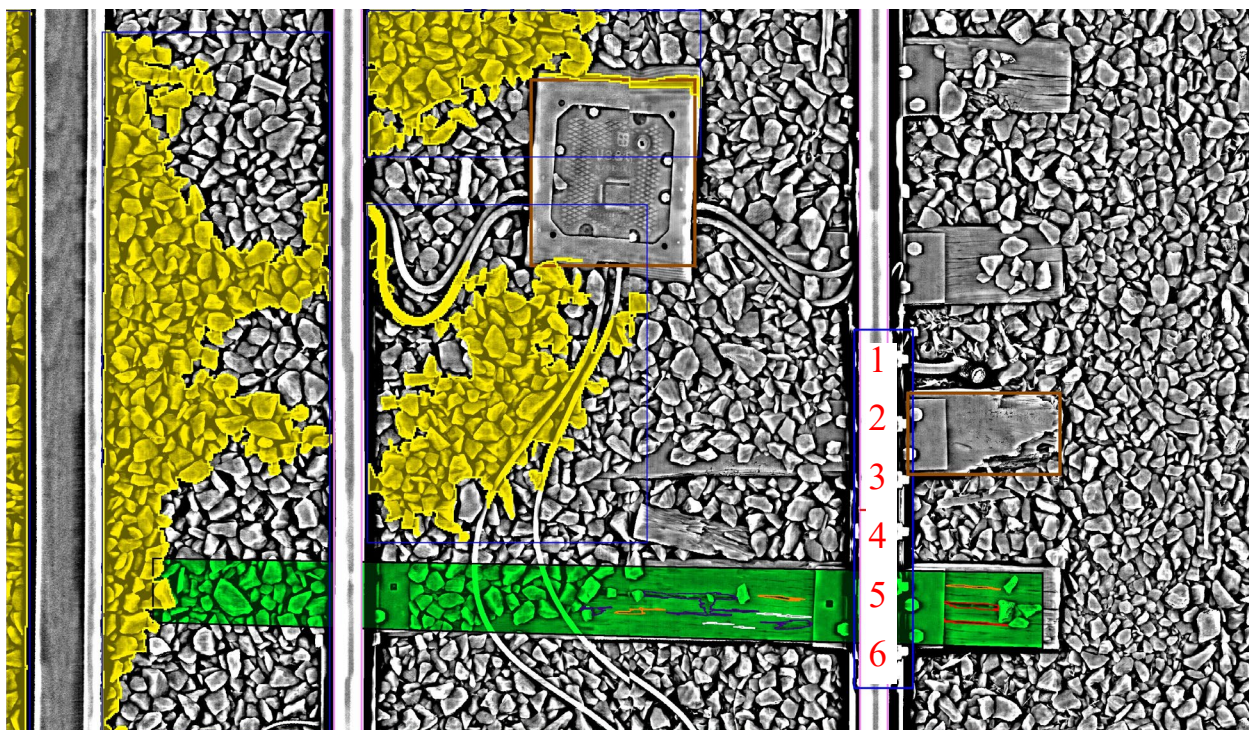
**Figure 58 – Right Rail Joint Bar in May Showing Six Bolts with 100 percent of Heads on the Gauge Side of the Rail**

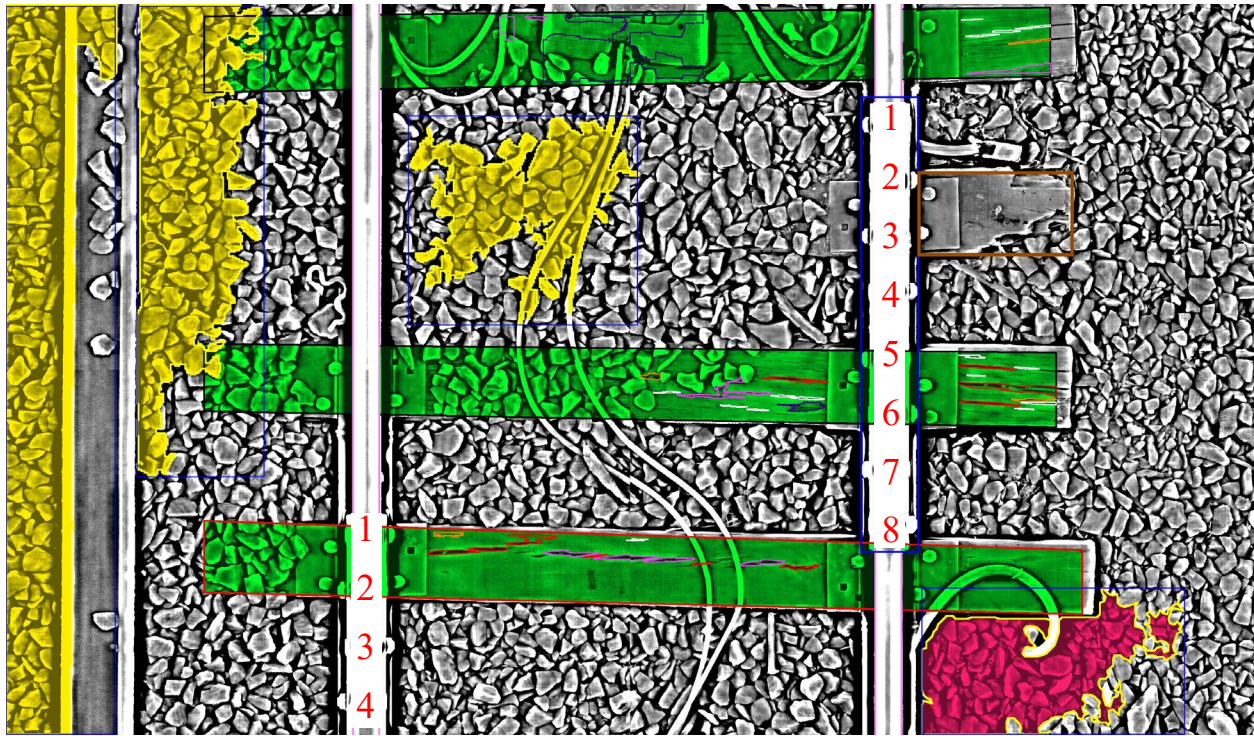
**Figure 59 – Part 1 of Left and Right Rail Joints in June Showing Eight Bolts (four on either side of the joint) with Staggered Heads**

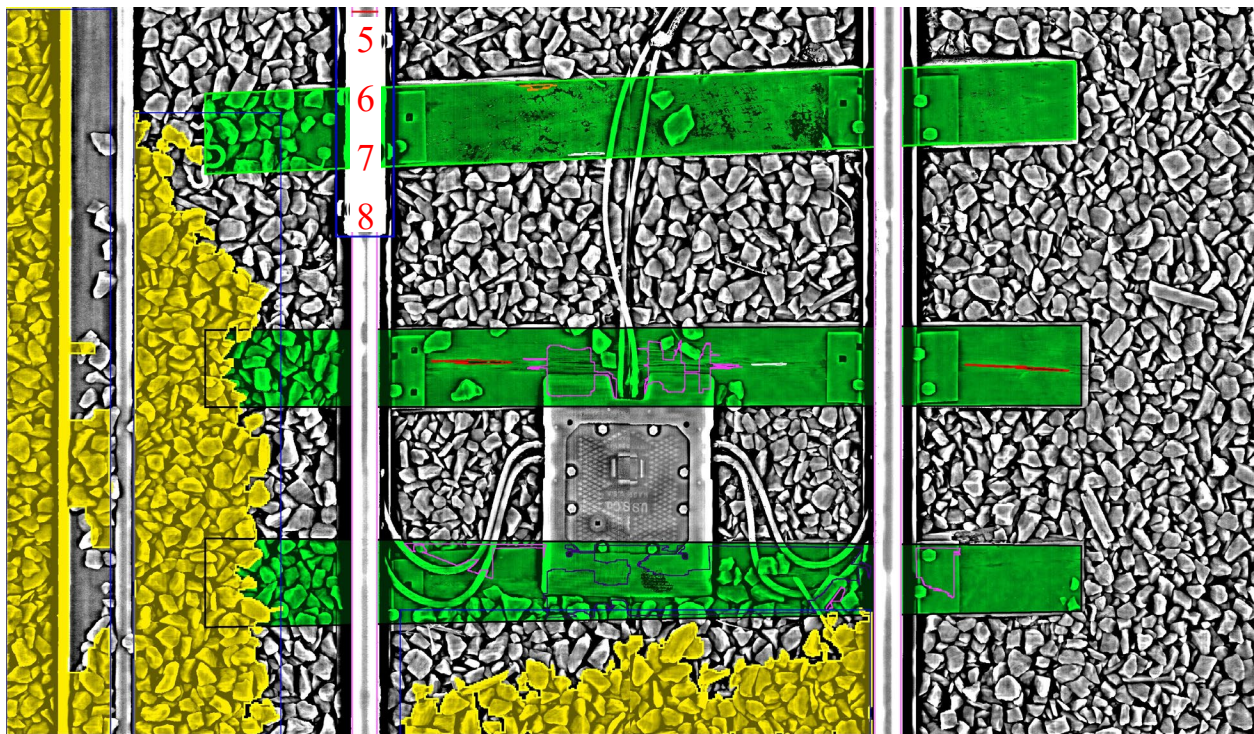
**Figure 60 – Part 2 of Left and Right Rail Joints in June Showing Eight Bolts (four on either side of the joint) with Heads Alternating between Gauge and Field Sides**

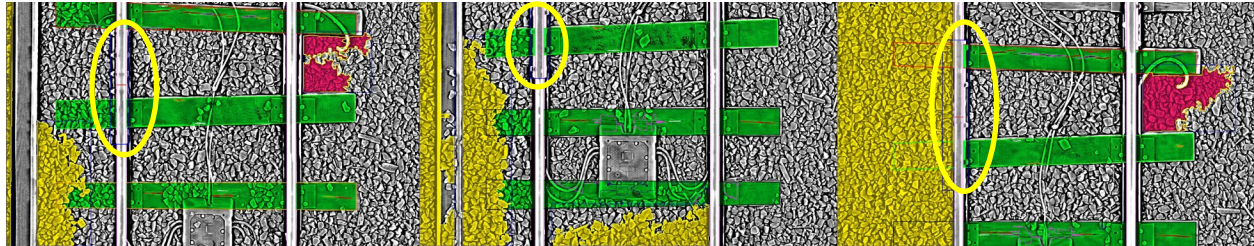
**Figure 61 – Ends of Joint Bar Bolts Buried by Ballast (from left to right: May, June, and September)**

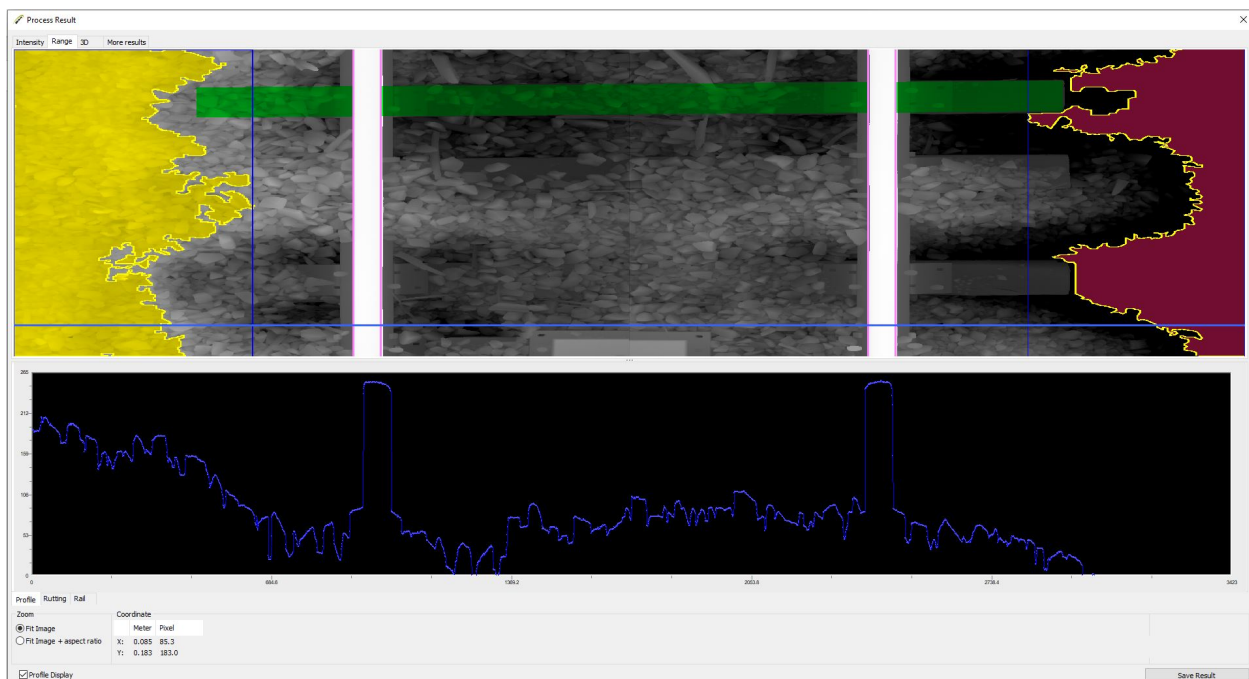
**Figure 62 – 3-Dimensional Range Data Showing Height Profile of Ballast**

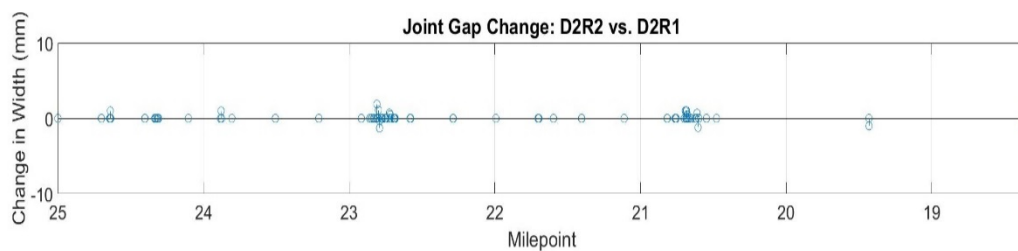
**Figure 63 – Modeling Joint Gap Noise Floor (D2R2 vs. D2R1)**

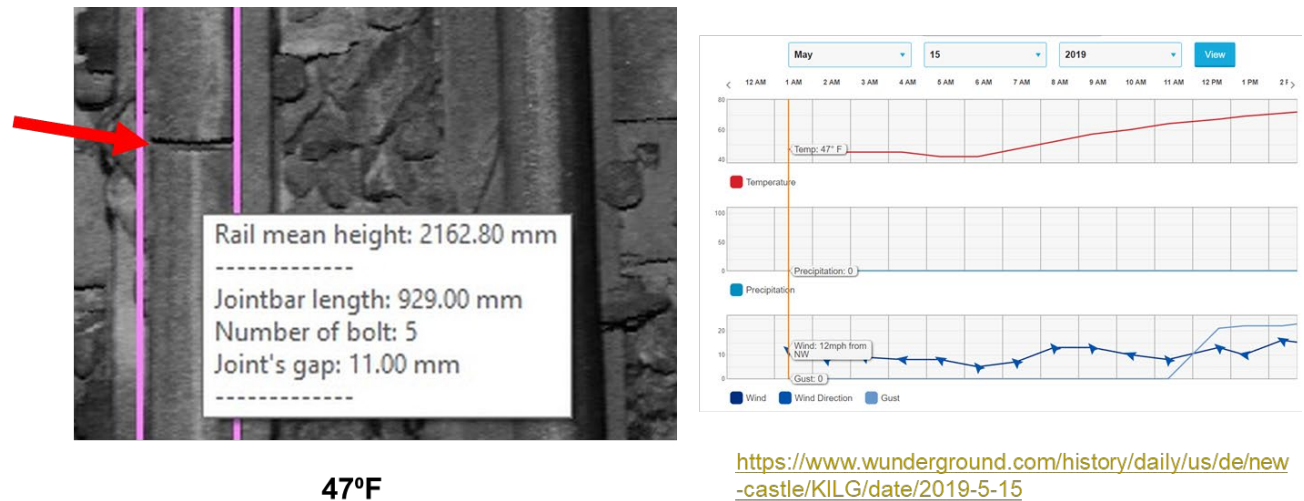
**Figure 64 – Organic Joint Gap Change; Joint 1 at 11 mm in May**

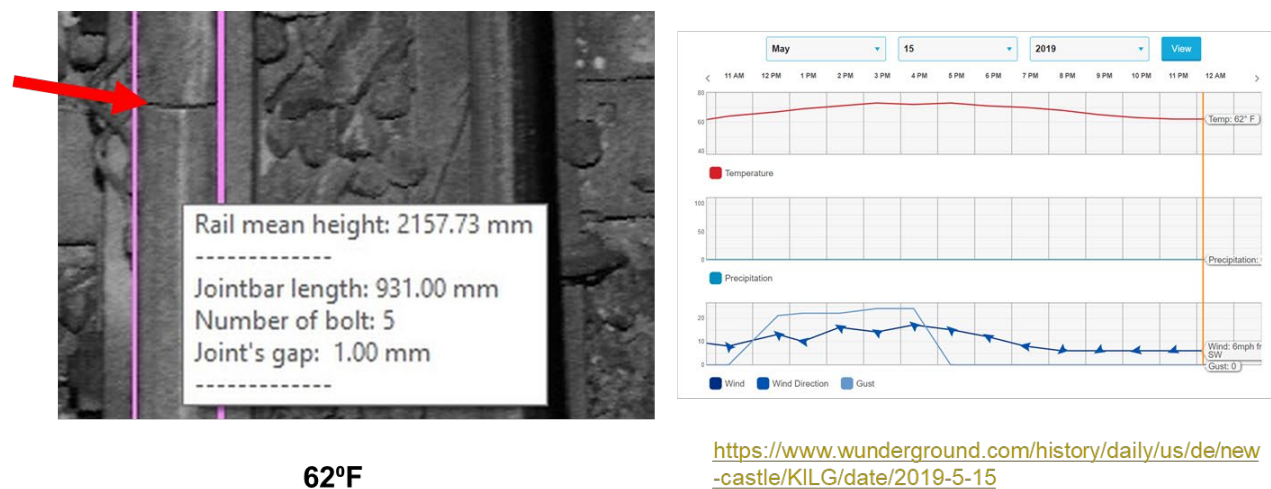
**Figure 65 – Organic Joint Gap Change; Joint 1 at 1 mm in June**

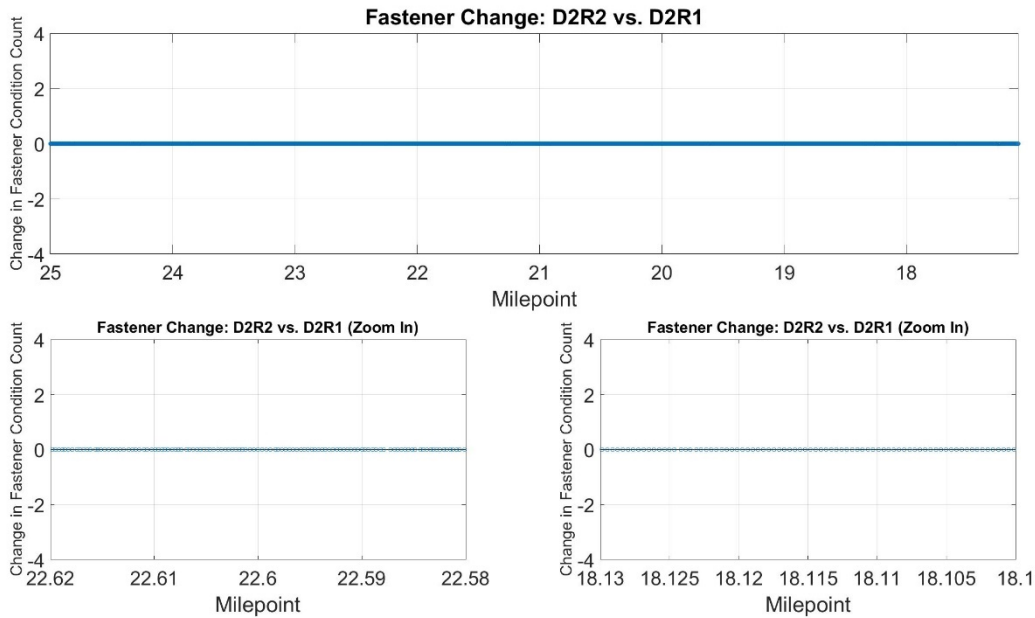
**Figure 66 – Modeling Fastener Status Noise Floor (D2R2 vs. D2R1)**

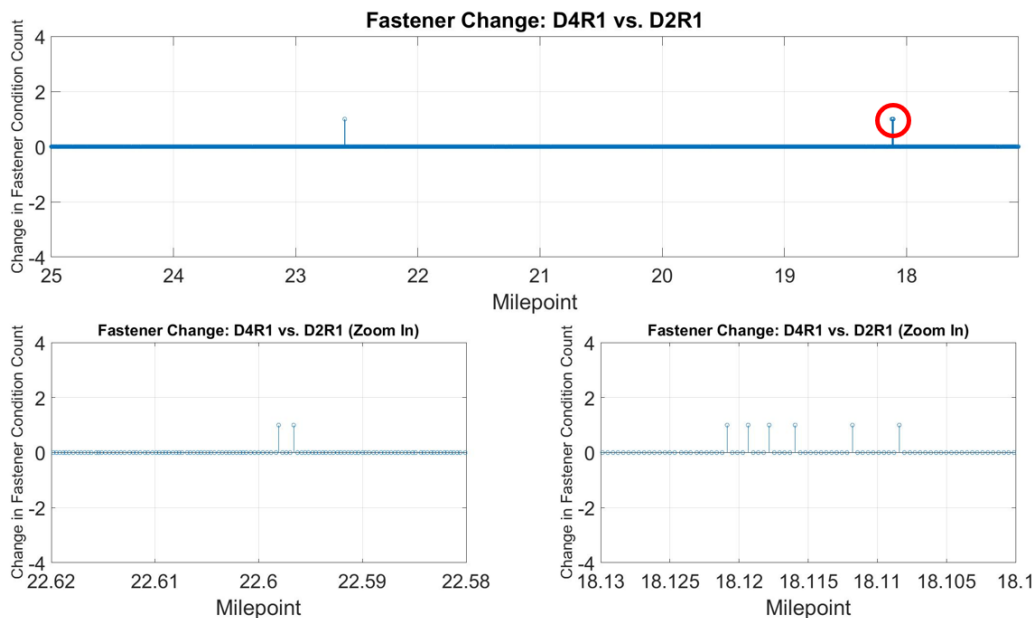
**Figure 67 – Modeling Fastener Status Noise Floor (D4R1 vs. D2R1)**

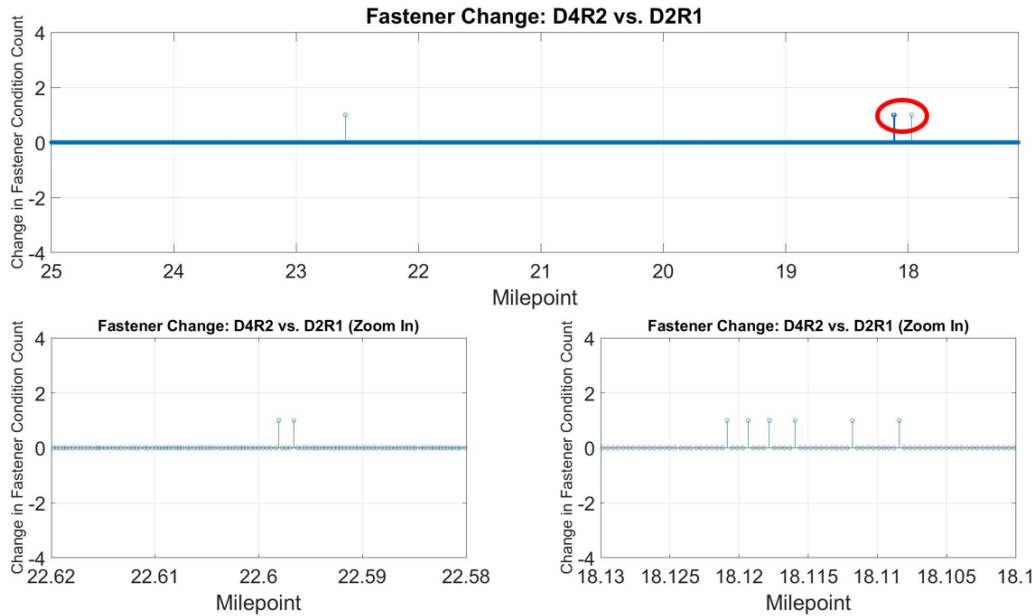
**Figure 68 – Modeling Fastener Status Noise Floor (D4R2 vs. D2R1)**
