U.S. Department of  
Transportation

**Federal Railroad  
Administration**

## **Extended Field Trials of LRAIL for Automated Track Change Detection**

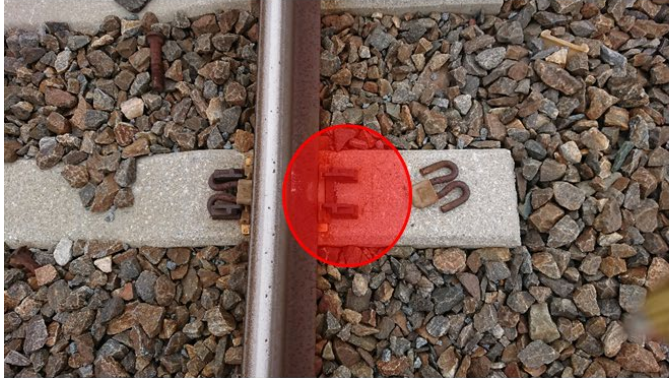
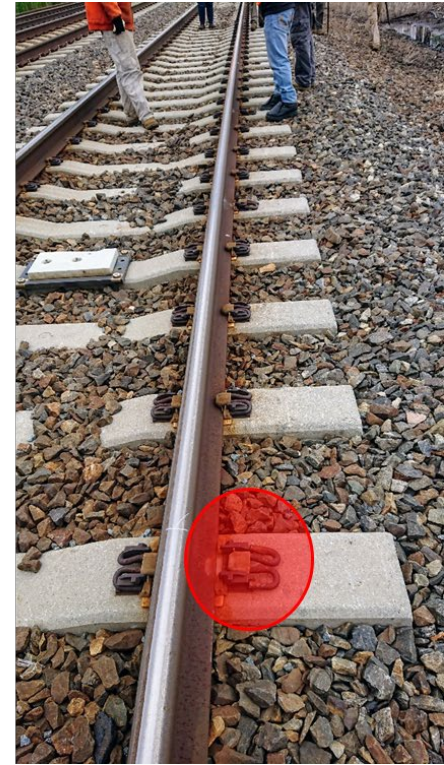
**Figure 69 – Deliberate Changes to Fastener Conditions in the Field (missing on the left and loose on the right)**

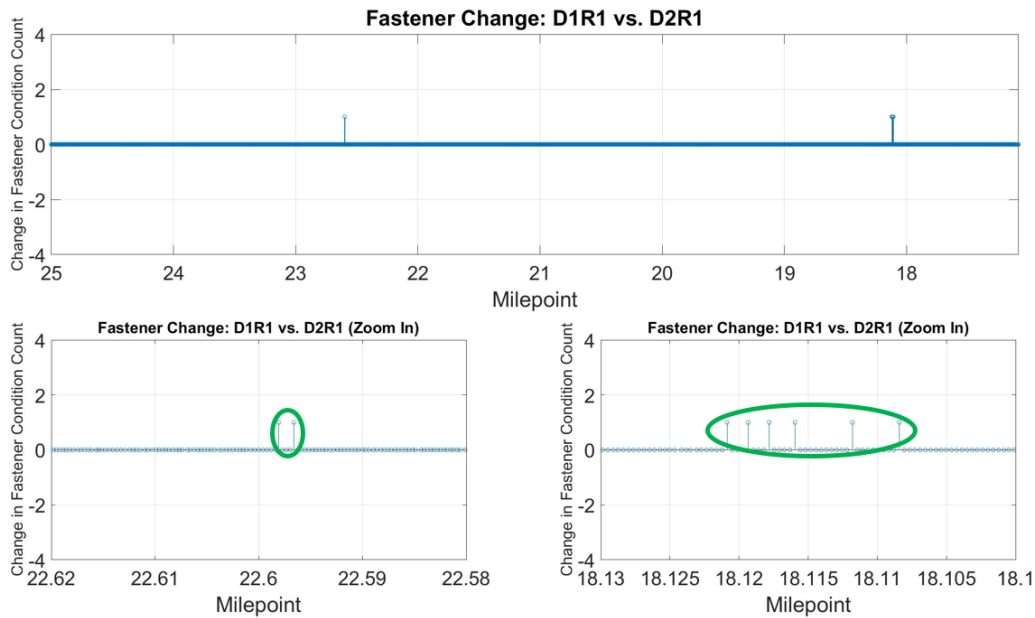
**Figure 70 – Detecting Deliberate Fastener Change (D1R1 and D2R1)**
