**December 2019**

**Report No. 19-010**

# **The Application of Unmanned Aerial Systems in Surface Transportation - Volume II-B: Assessment of Roadway Pavement Condition with UAS**

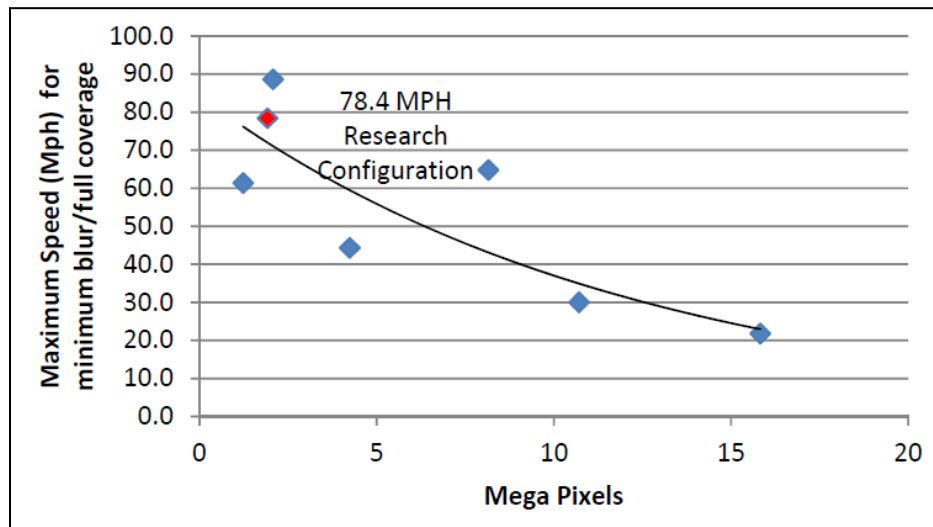
**Figure 2.1: Maximum speed of image capture characterized by megapixels of camera**

The U.S. Air Force Institute of Technology prepared an extensive report in 2015, which discussed the viability of UAS paired with high-resolution cameras to assess pavement condition. The test area was a 2,000-foot-long airbase runway that displayed a wide range of various types and severities of pavement distresses (7). The size, type and resolution of camera used in this study were all taken into consideration, since higher megapixel cameras operate at slower maximum frame capture rates (7). This means that the UAS must fly slower to capture adequate data if a higher resolution camera is used (7). Furthermore, smaller capacity cameras must take more pictures to equalize the decrease in frame exposure time, which plays a role in determining optimal velocity (7). Another design constraint is battery life, which is directly related to flight time, velocity and quality and quantity of data collected (7). During the course of this study, a graph was created (shown in Figure 2.1) which shows the relationship between maximum flight velocity (while still attaining full coverage) and number of megapixels in a given camera (7). The software interprets the intensity of light values given off by pictures of the pavement and characterizes it within certain thresholds (7). Once these threshold values can be paired with corresponding distress types and severity, a reliable UAS Pavement Condition Index will be more attainable. The software has the capability of identifying pixels that correspond to a crack in the pavement and then assess whether there are any similar pixels within a certain range of pixels next to the already identified "crack-pixel" (7). This feature essentially maps the pixels of interest together, which can be used to identify alligator-cracking and longitudinal cracking (7). The software completes this task by "choosing the smallest distance edge and retaining it only if it connects a new node. Edges connecting already visited nodes are removed. Once all nodes are connected, the algorithm is completed" (7). Unfortunately, when a success rate for this method was graded by the F-Measure method, it displayed only 40 percent accuracy (7). The F-Measure method is a function of the recall and precision rates (both functions of the true positives and false positives and negatives captured by the algorithm) as compared to the

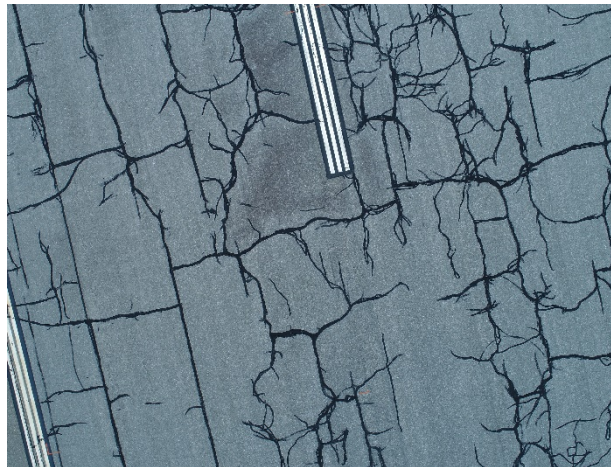
**Figure 4.1: Drone image from the initial data set**

The team obtained two sets of data from FMA. The first set of data was collected from an altitude of 120 ft and provided by the MassDOT Aeronautics Division. A sample image is presented in Figure 4.1. The team applied CrackIT and a deep learning method to this initial data set. However, the results were unsatisfactory. The team then visited the FMA and took some pictures of the pavement using a cell phone (see Figure 4.2). Clearly, the cell phone image covers a smaller area but is much clearer than the drone photo taken at 120 ft above the ground. The previous unsatisfactory crack detection results may likely be attributed to the

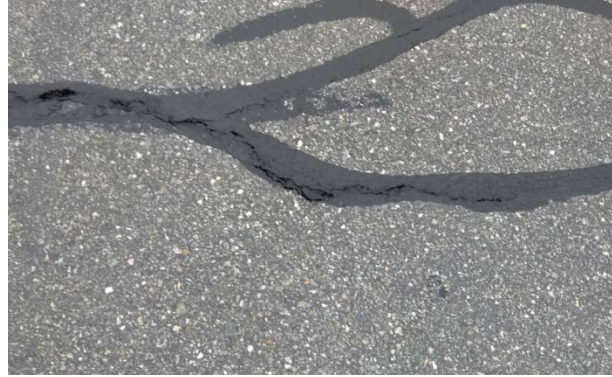
**Figure 4.2: Pavement image taken by a cell phone**

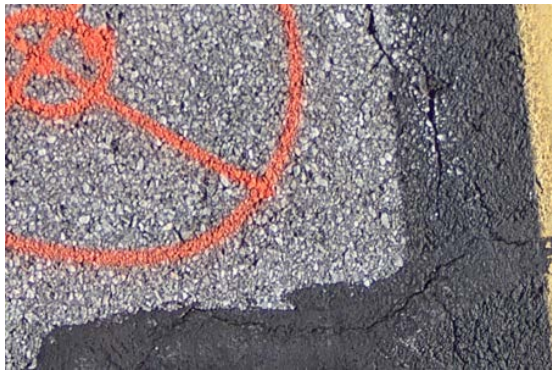
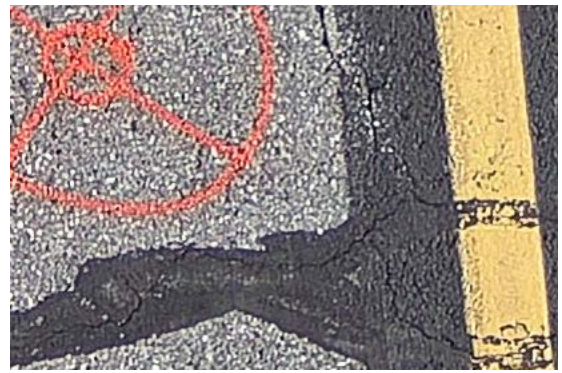
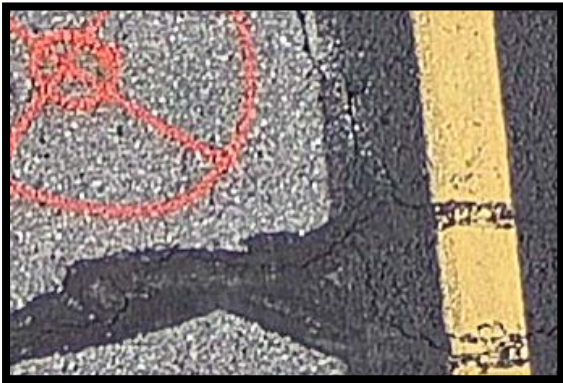
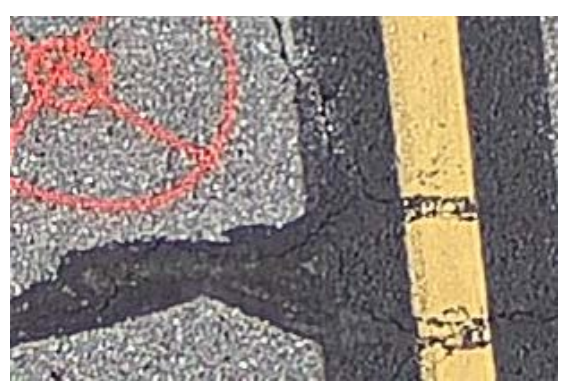
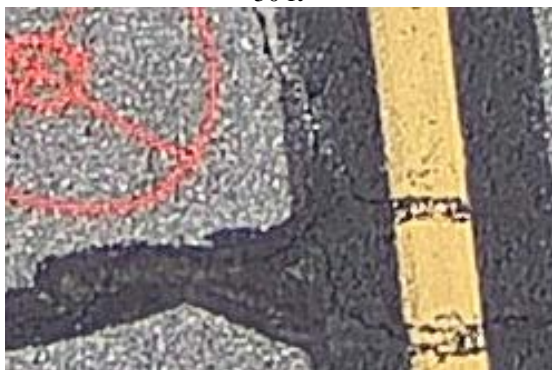
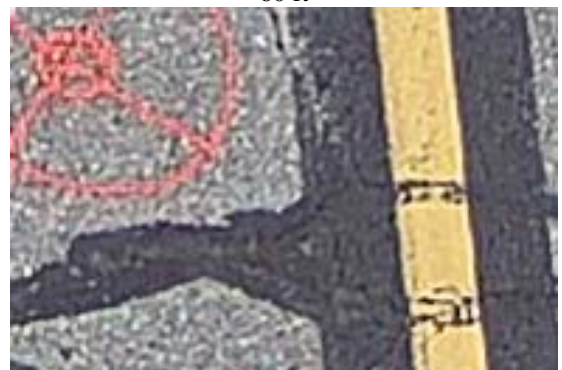
**Figure 4.3: Pavement image taken by the elevator flight**

To investigate how height may affect the image quality, the MassDOT Aeronautics Division helped the team conduct another data collection at FMA. Table 4.1 below shows how the second set of data was collected. The *elevator* flight captured pavement images at a single location but at different altitudes using both visual and thermal cameras. The purpose was to find out how altitude may affect the image quality (e.g., inches on the ground per image pixel). With such information, the team was hoping to identify a threshold altitude, beyond which the collected data may become much less useful. Note that such a threshold may depend on the types of drone and camera being used. Therefore, the conclusion in this study may not be generalized to other cameras and drones. The *coverage* flight was designed to collect additional runway pavement images for crack detection model development and testing.

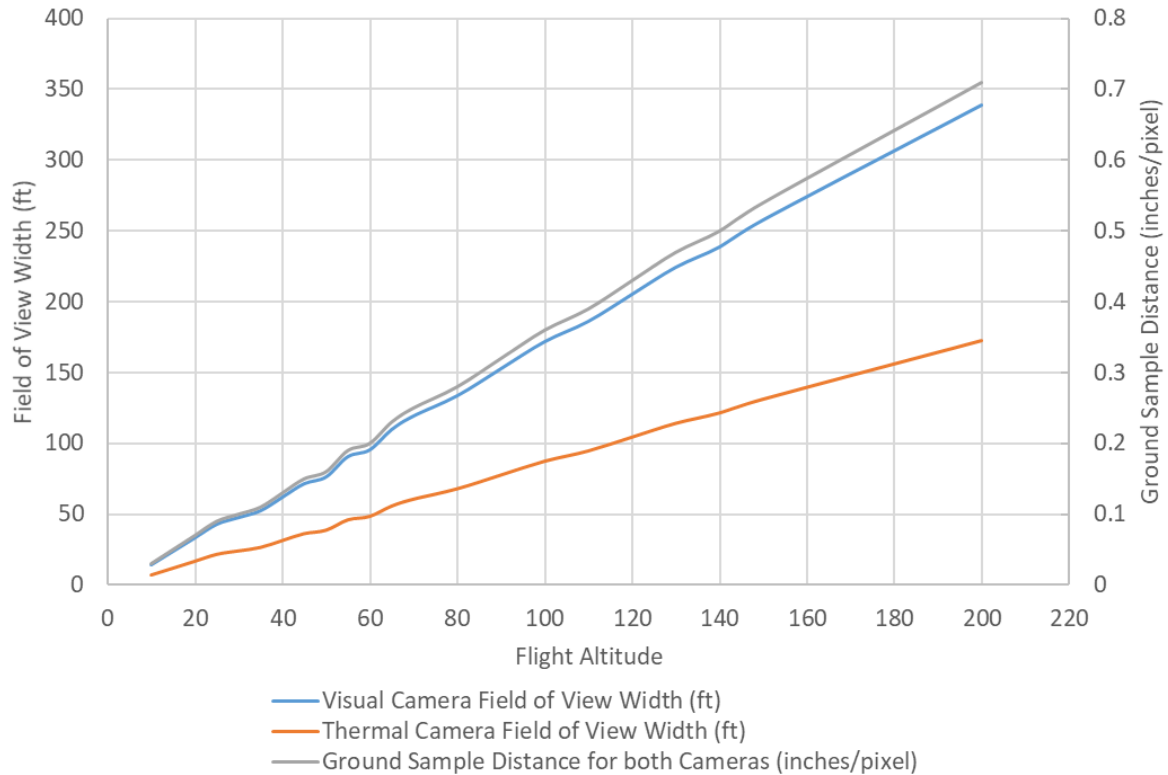
**Figure 4.4: Ground sample distance and field of view width vs. flight altitude**

the relationships between flight altitude and field of view width and ground sample distance measured in inches per pixel (smaller ground sample distances mean better image quality) for the visual and thermal cameras used in this research. Note that both the visual and thermal cameras used in this study have the same ground sample distance performance. Again, depending on the cameras used, this conclusion may be different. However, the overall trend will be the same: higher altitudes will require less flights (i.e., better efficiency) but result in poorer image resolutions. To achieve a balance between image quality and efficiency, the team decided to use the images captured at 50 ft for this research.

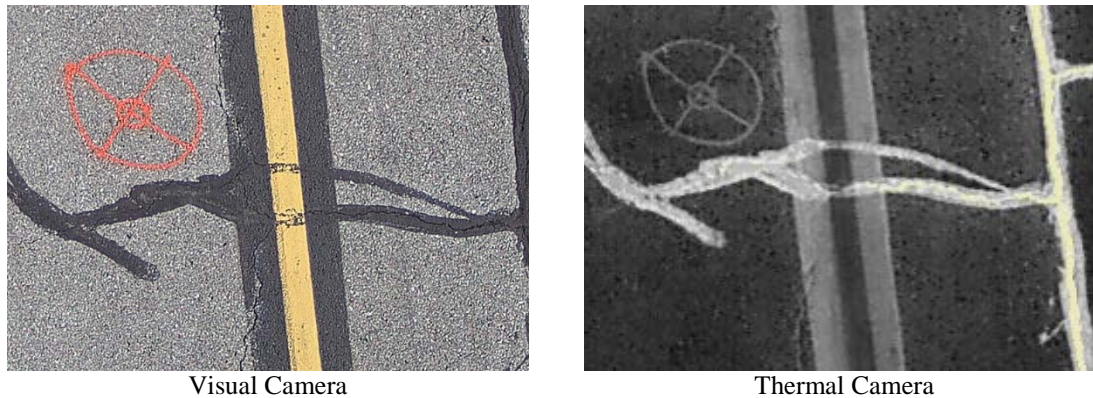
**Figure 4.5: Pavement image taken by the elevator flight**

During the elevator flight, the team collected images using both visual and thermal cameras and the results are compared in Figure 4.5 below. In the thermal image, pixels associated with pavement cracks do not appear to exhibit clearer characteristics compared to those in the visual camera image. For deep learning based crack detection models, cracks in the training images have to be marked at the pixel level. This process typically is done manually. Therefore, being able to identify cracks with naked eyes is essential. Given the quality of the collected thermal images, the team decided to only focus on the visual camera data.

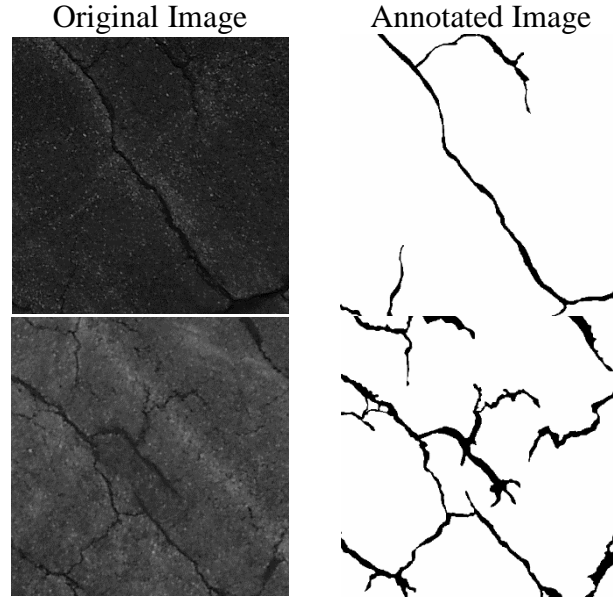
**Figure 4.6: Sample original and annotated pavement images**

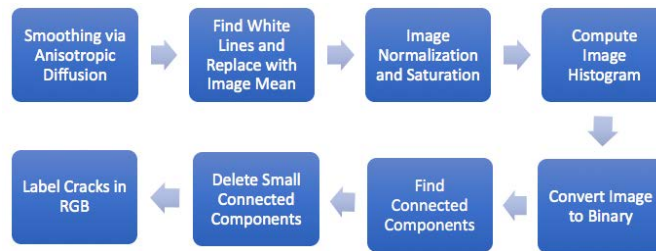
**Figure 4.7: Flow diagram of CrackIT detection method**

The team initially applied the MATLAB-based CrackIT toolbox to the initial FMA dataset. CrackIT provides many functions and routines to aid in the task of automated crack detection. A basic flow diagram describing the CrackIT method is shown in Figure 4.7.

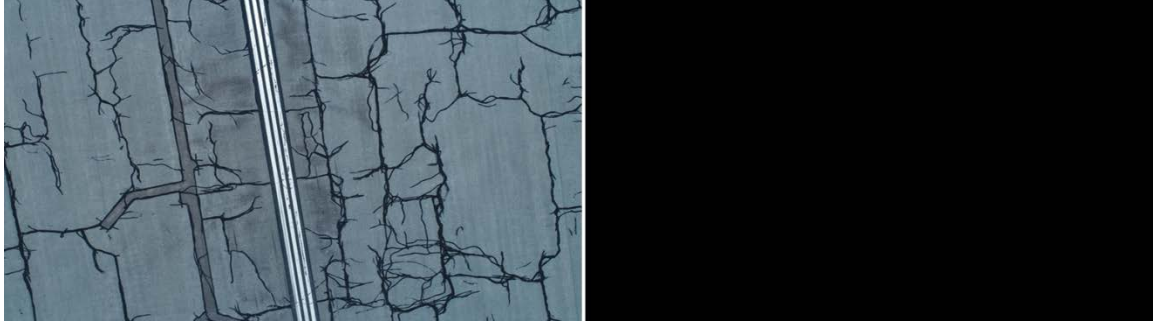
**Figure 4.8: First attempt to apply CrackIT to FMA sample image**

The toolbox only operates on grayscale images, so once an original image from the FMA dataset is read into MATLAB, it is converted to grayscale using the MATLAB function “rgb2gray.” Initially, the toolbox was applied “out of the box” on a sample image from the FMA dataset, and the detected results were poor. On the first attempt (Figure 4.8), CrackIT detected no cracks in the sample image. Only the black background region was returned with no detected cracks.

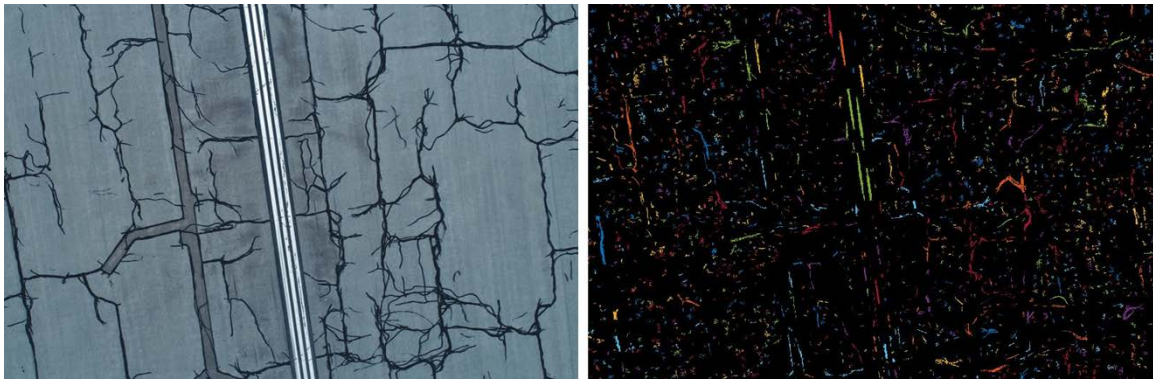
**Figure 4.9: First attempt to fine tune CrackIT parameters**

After adjusting some parameters in the CrackIT functions (primarily those used for white line detection, pre-labeling of crack regions, and converting the image to binary), CrackIT returned a very noisy RGB map which contained little meaningful crack detection data shown in Figure 4.9.

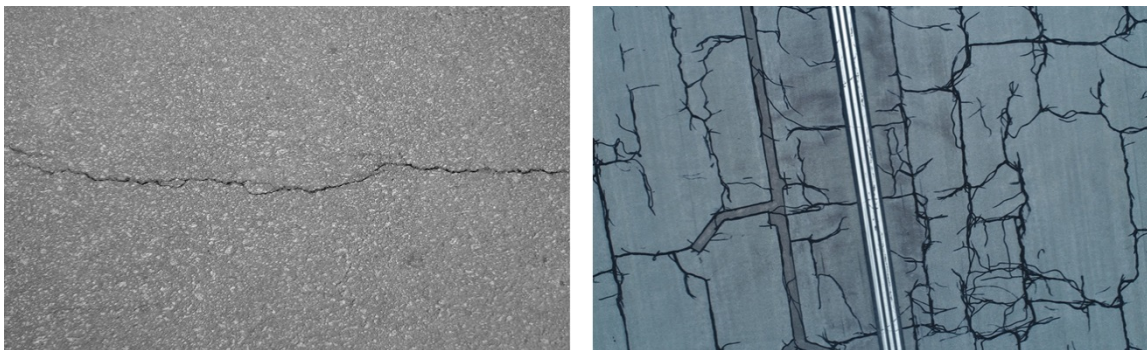
**Figure 4.10: L: Sample image from the CrackIT database; R: Sample image from the FMA dataset**

There are some differences between the images in the CrackIT database and the images in the FMA dataset, such as the overall complexity of the images as well as the presence of many filled cracks in the FMA dataset as shown in Figure 4.10. Additionally, the images in the FMA dataset were captured using a drone, while the images in the CrackIT database were obtained using traditional road survey methods. Thus, it does not seem surprising that CrackIT “out of the box” did not perform well on the FMA data.

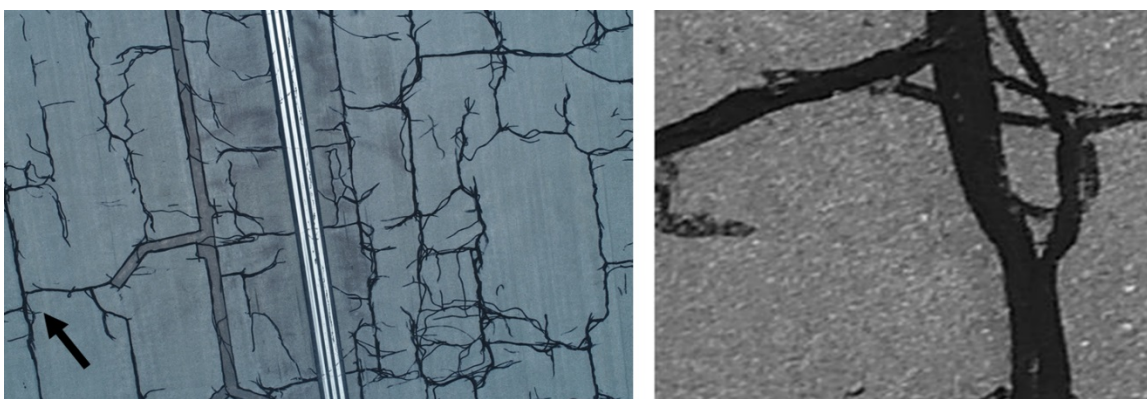
**Figure 4.11: Example chunk from FMA image**

To address this issue, sample images from the FMA dataset were resized and broken down into smaller chunks. The initial size of the images was 3648x4864 pixels. The images were resized to 3600x4800 pixels, and were then broken down into 192 non-overlapping sub-images of size 300x300 pixels as shown in Figure 4.11.

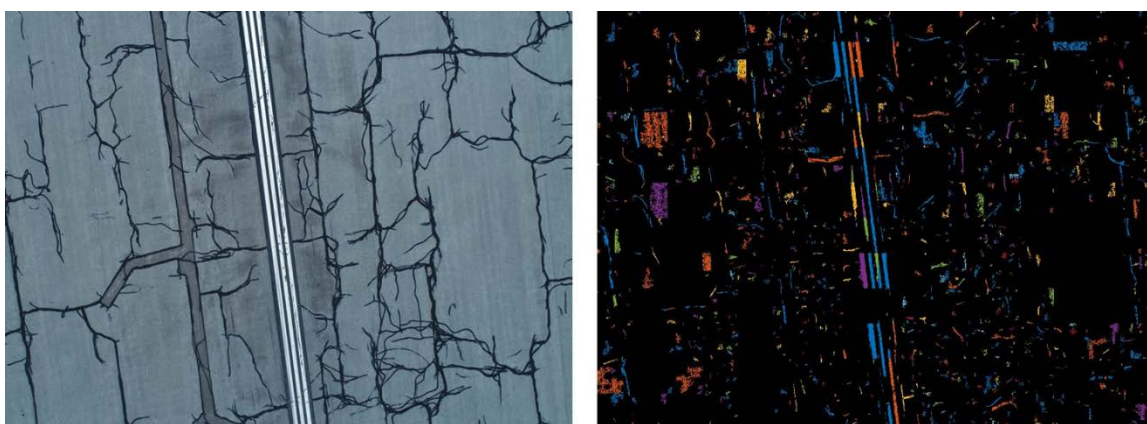
**Figure 4.12: Results of chunking image into 192 nonoverlapping chunks of 300x300 pixels and applying CrackIT on each chunk**

CrackIT was applied on each of these chunks individually, and the chunks were then brought back together to reconstruct a full RGB map of the cracks in the image. This divide-and-conquer approach improved upon the results of applying CrackIT “out of the box” on the full image from the FMA dataset, but the improvement is insignificant. In particular, there were

still many regions of cracks which were not detected, as well as substantial issues with noise/error in the RGB crack map as in Figure 4.12.

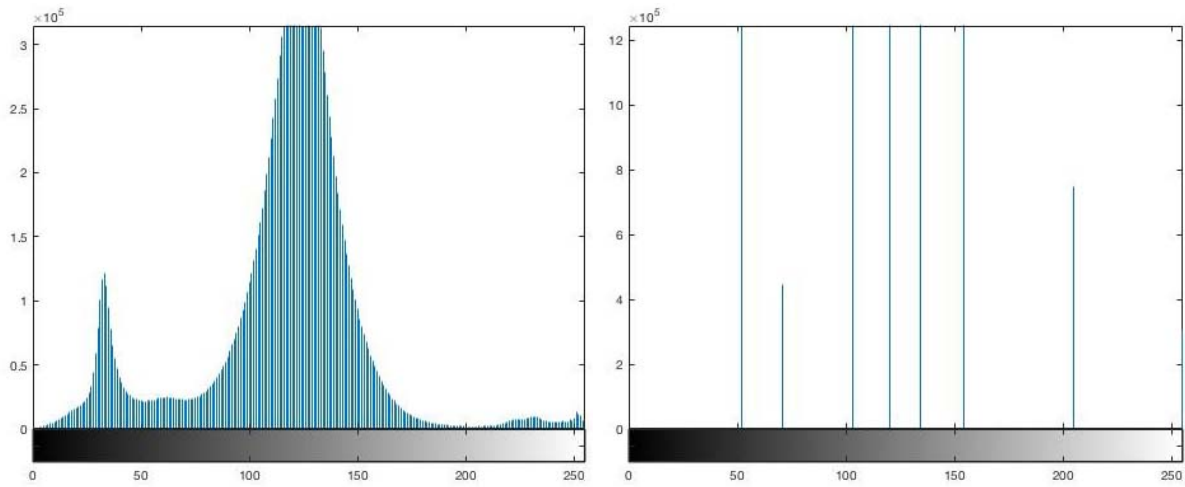
**Figure 4.13: Comparison of image histogram before (L) and after (R) applying multilevel thresholding**

To further simplify the image which was fed into the CrackIT algorithm, an eight-level thresholding was applied to the image before chunking. This eight-level thresholding, which is done utilizing the MATLAB function “multithresh,” maps each pixel in the image to one of eight possible pixel values, greatly simplifying the distribution of pixels in the image and in some sense de-noising the image as shown in Figure 4.13.

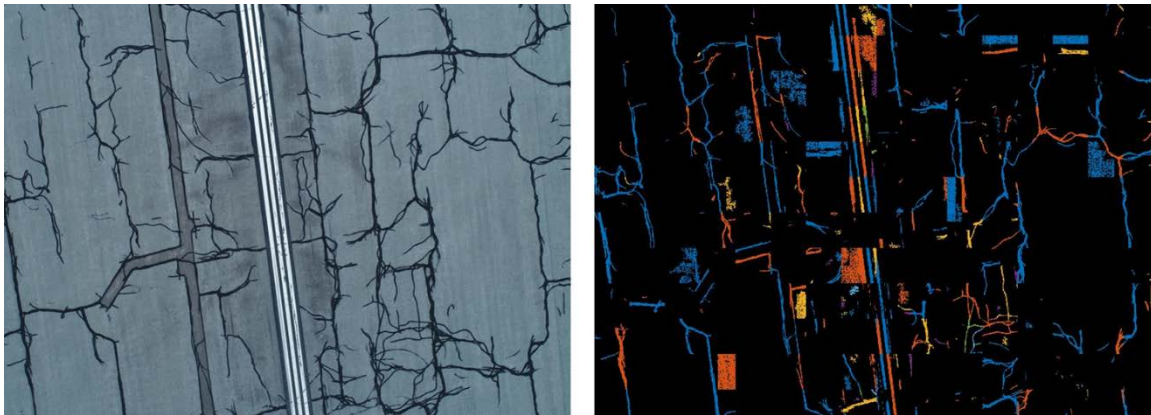
**Figure 4.14: Results of adding multilevel thresholding preprocessing step to CrackIT**

Once this thresholding was complete, the image was again broken into 192 chunks and each chunk was individually processed by the CrackIT algorithm. This eight-level thresholding step improved the results of applying CrackIT on the complex data from the FMA, leading to both increased and improved crack detection as well as a significant reduction in noise in the RGB crack map. A sample of the result is provided in Figure 4.14.

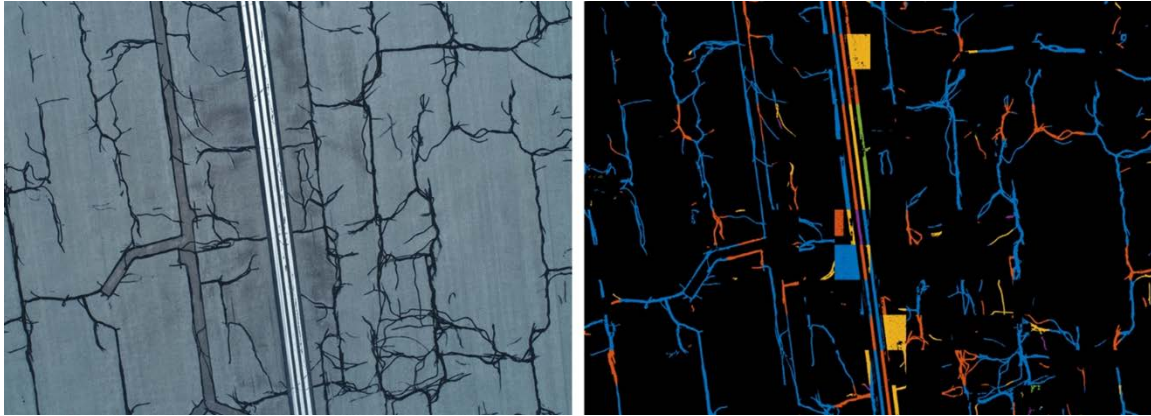
**Figure 4.15: Results of CrackIT with best smoothing parameters**

A significant number of smoothing parameters have been tested to further improve the crack detection results. In each of the above trials, the smoothing parameters passed to the CrackIT anisotropic smoothing routine consisted of 4 iterations of smoothing using a conduction coefficient of 60 and a speed of .125. Further testing revealed that 2 iterations of smoothing with a conduction coefficient of 80, and a speed of .125 seemed to improve the crack detection results. Additionally, further testing at larger numbers of iterations with smaller conduction coefficients revealed that 16 iterations of smoothing with a conduction coefficient of 30 and a speed of .125 seemed to improve the results further, at least for some images, and at this point, these are considered to be the best parameters for smoothing. Figure 4.15 shows the results based on the best smoothing parameters.

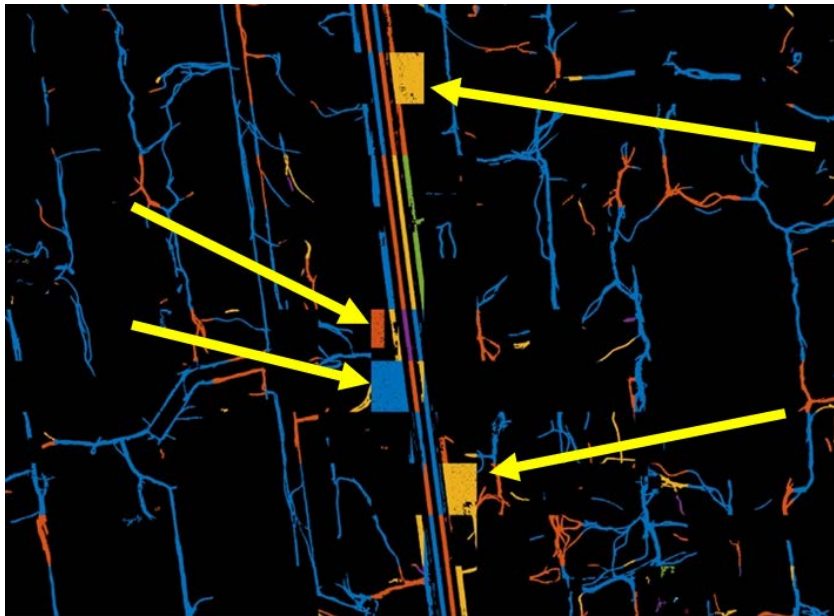
**Figure 4.16: Error/false detection region**

Some issues still remain. The first is the detection of the painted black lines adjacent to the white lines on the runway as crack regions. The second is the detection of false positive/error regions (see those blue, orange, and yellow regions marked in Figure 4.16) in the RGB crack map by the CrackIT algorithm. These false positive regions do not resemble any structures present in the original image, are generally square or rectangular in shape, and fairly densely filled. It is unclear why the algorithm detects these regions as pavement distresses.

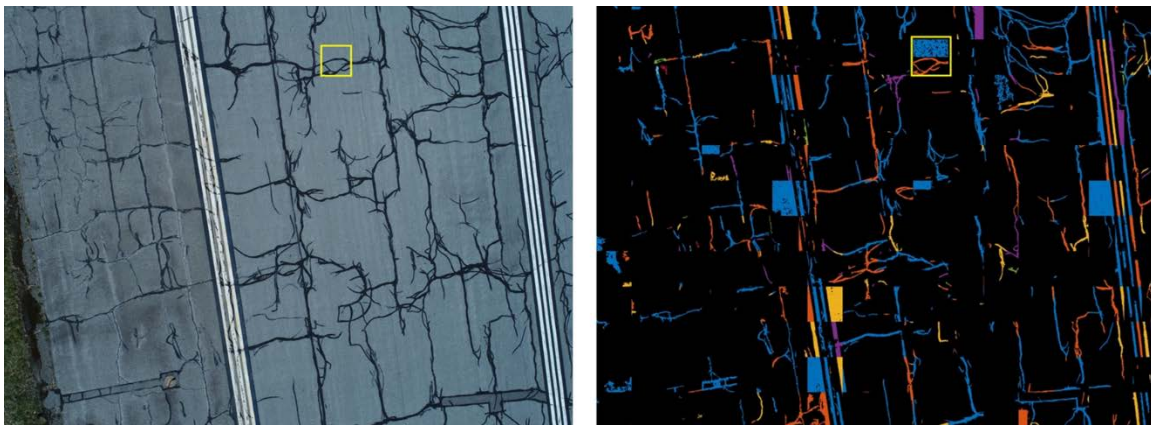
**Figure 4.17: Example of false detection area inspected during field trip**

To further investigate these regions of false positive, a survey of several of these regions (one of them is highlighted in Figure 4.17 below) was conducted during a field trip to the FMA. In general, these regions of false positive do not show any signs of square-like distresses. Some of the regions show some signs of pavement wear, but this is inconsistent from region to region. Additionally, images of these regions were captured with cell phones. These cell phone images were processed using CrackIT, both using the parameters found to work well on the FMA dataset and using CrackIT “out of the box.” The results of a sample image are presented in Figure 4.18. CrackIT “out of the box” returned better results on these cell phone images, which is not surprising given that these images more closely resemble those in the CrackIT database.

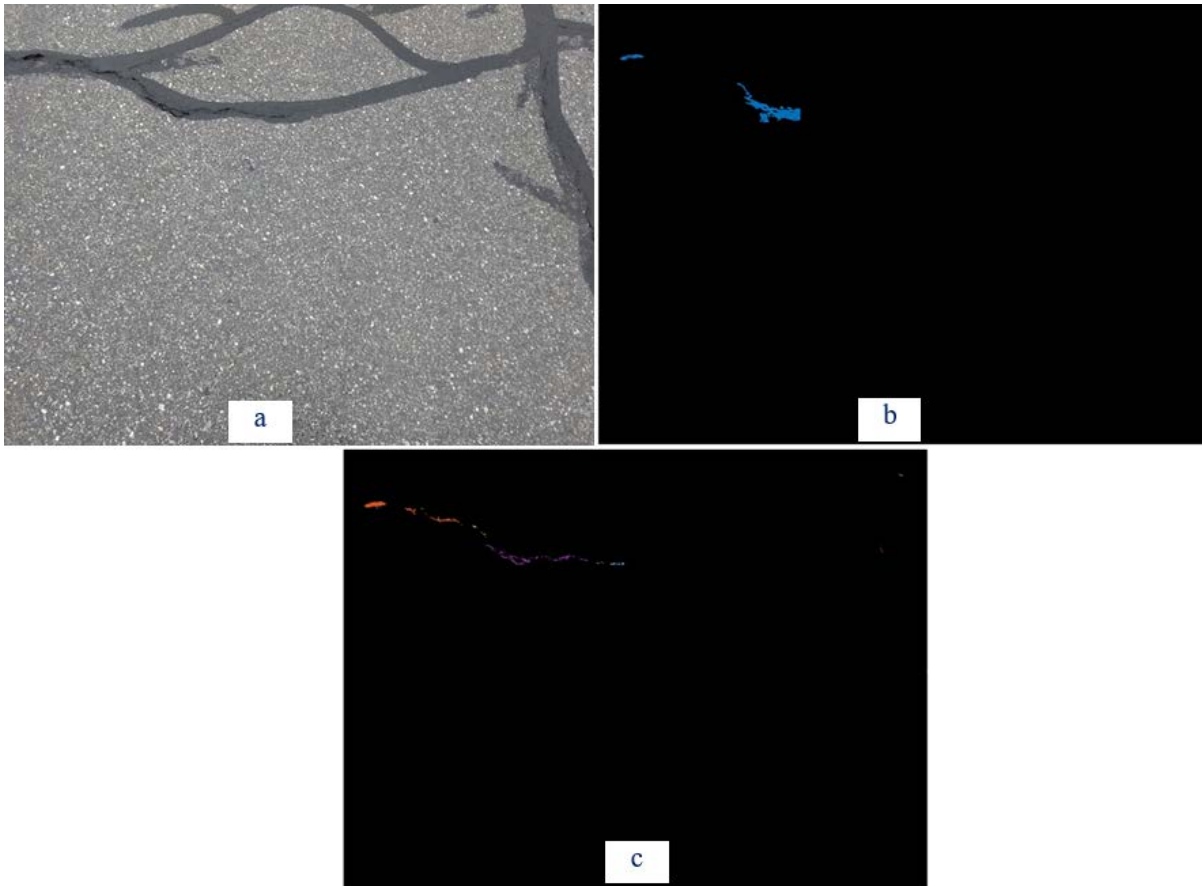
**Figure 4.18: a) Cell phone image of false detection area; b) CrackIT applied on cell phone image using best parameters from processing FMA dataset; c) results of applying CrackIT “out of the box” on cell phone image**

From Figure 4.18, it is clear that there are no square-like regions detected in these cell phone images. Upon inspection of the pavement at FMA and comparison with the drone images, it seems that the drone dataset does not present a completely accurate portrayal of the pavement

condition. For example, small, non-filled crack regions which are visible when walking on the pavement at the airport (and would be visible during a traditional pavement survey) are too small to be visible in the drone images from the initial data collection. A lower flyover height might help to improve the results of applying CrackIT to the drone images. Alternative smoothing methods, such as that of (29), have also been tested but have not yet improved the results. With further testing, alternative smoothing methods might also lead to improved results.

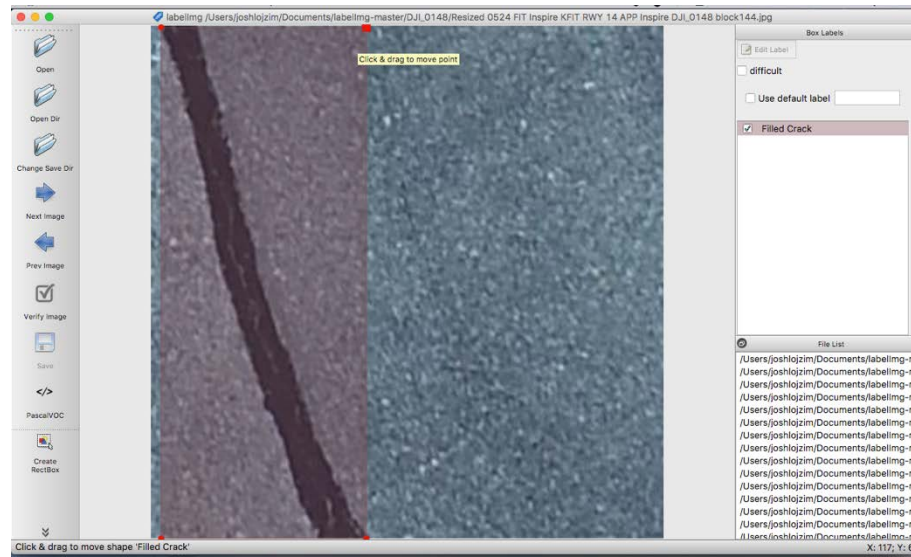
**Figure 4.19: Screenshot of utilizing LabelImg to draw ground truth bounding boxes**

In order to train an object detection network, images were labeled with ground truth bounding boxes which differentiate crack and non-crack regions. Additionally, the SSD Mobilenet network was trained using images of size 300x300 pixels. To prepare a dataset to develop the object detector, three sample images from the initial FMA dataset were resized from 3648x4864 pixels to 3600x4800 pixels, and were then broken into 192 chunks of size 300x300 (just as was done above in the section on CrackIT and shown in Figure 4.11). Each of these 300x300 chunks was then labeled with ground truth bounding boxes using the Python tool LabelImg (34). An example is shown in Figure 4.19. Note that in Figure 4.19, the filled crack area is annotated by a rectangular bounding box. Therefore, utilizing this SSD Mobilenet network model, cracked areas were detected and marked also by a rectangular box instead of at the pixel level as in Figure 4.6.

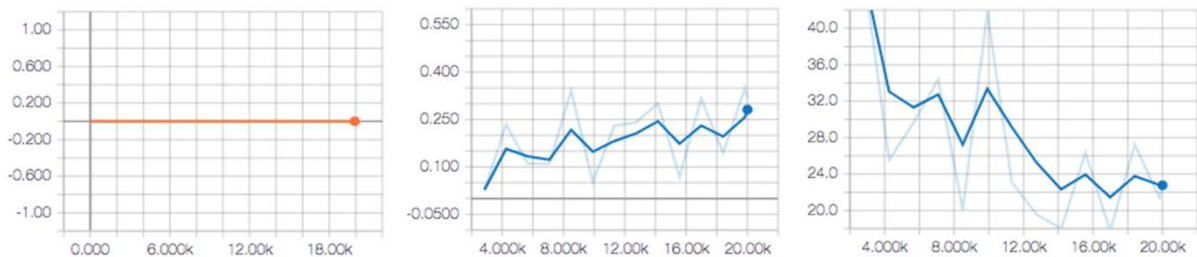
**Figure 4.20: From left to right: Learning rate, mAP, loss for the first attempt**

The first attempt to develop a model on this data was trained for 20,000 steps, utilized a constant learning rate of .0001, did not use data augmentation in the pre-processing, did not utilize dropout, and eventually attained a mAP (mean average precision) of  $\sim .3176$ .<sup>1</sup> There seemed to be issues with the model overfitting the training data, with the testing loss ultimately at a high value of  $\sim 22$ . The results of this model are shown in Figure 4.20, in which the x-axes are for neural network training iteration, and the y-axes are for learning rate, mAP, and loss function value at each iteration, respectively. The learning rate, mAP, and loss function value do not have units.

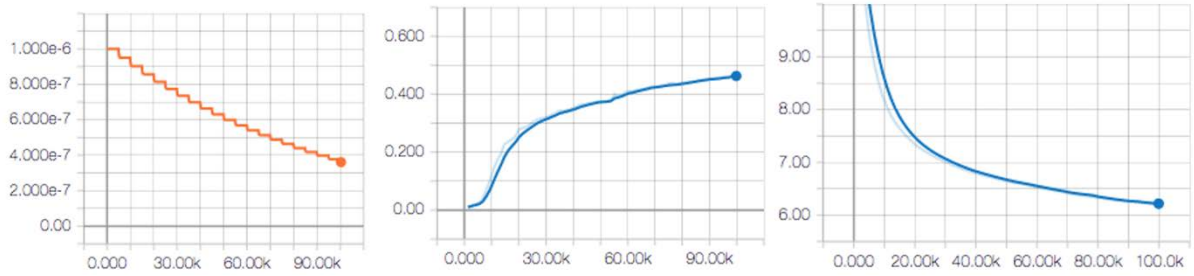
**Figure 4.21: From left to right: Learning rate, mAP, loss for second attempt**

.000001, decaying to an ultimate value of  $3.7735e-7$ , and utilizing dropout at a rate of .2, the network achieved a higher mAP of .4653 as in Figure 4.21.

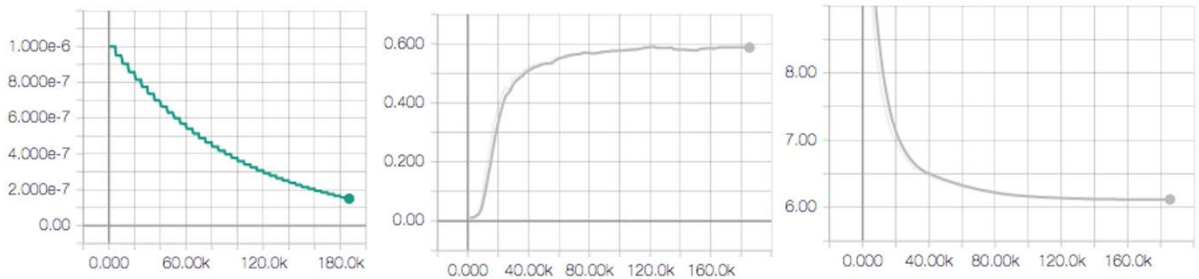
**Figure 4.22: From left to right: Learning rate, mAP, loss for third attempt**

To test the model further, a new random split of the training and testing data was conducted in the third attempt. A model was trained and tested on this new split for ~185,000 steps with a learning rate of .000001, which decayed every 5,000 steps to a final rate of  $1.4989e-7$ . Data augmentation was utilized, as was a dropout rate of .2. Ultimately, a mAP of .5867 was achieved on this split as in Figure 4.22. This was a further improvement over previous results.

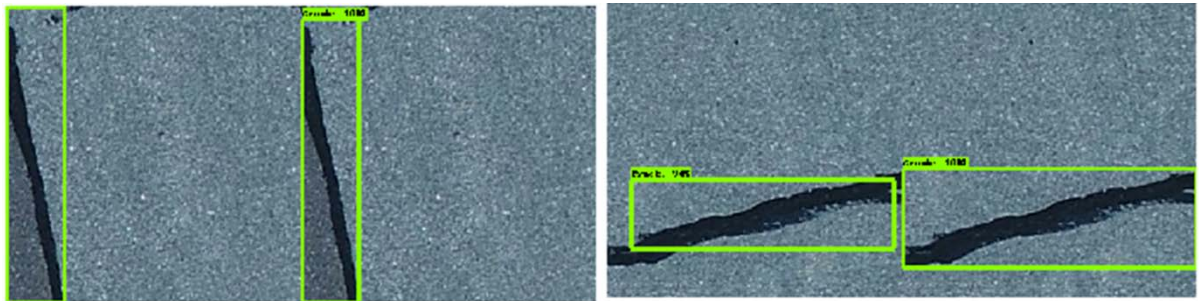
**Figure 4.23: Two example results of transfer learning: Right subimage of each pair is the ground truth, while left is bounding box predicted by neural network.**

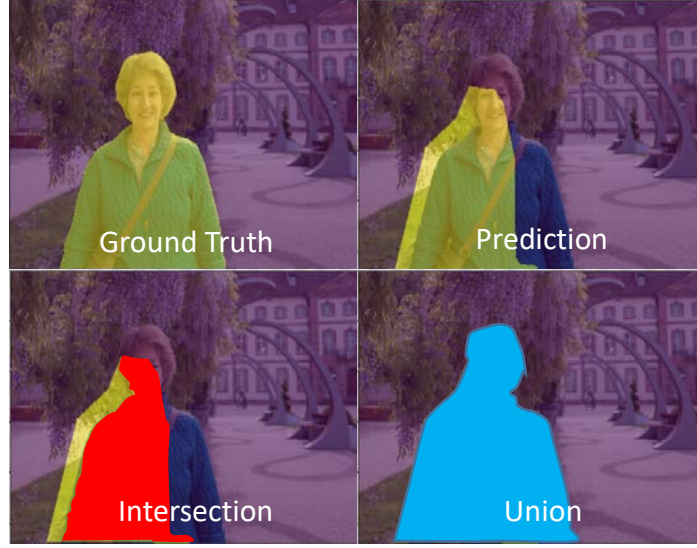
**Figure 4.25: Illustration of how IoU is defined**

In this research, another intuitive and informative metric, *IoU*, is introduced and adopted. As shown in Figure 4.25 (35), *IoU* is defined as the area of intersection divided by the area of union. Intersection represents the area covered by both the ground truth and prediction, while union includes the area in either the ground truth or prediction. If the prediction matches the ground truth perfectly, then the corresponding *IoU* would be 100%.

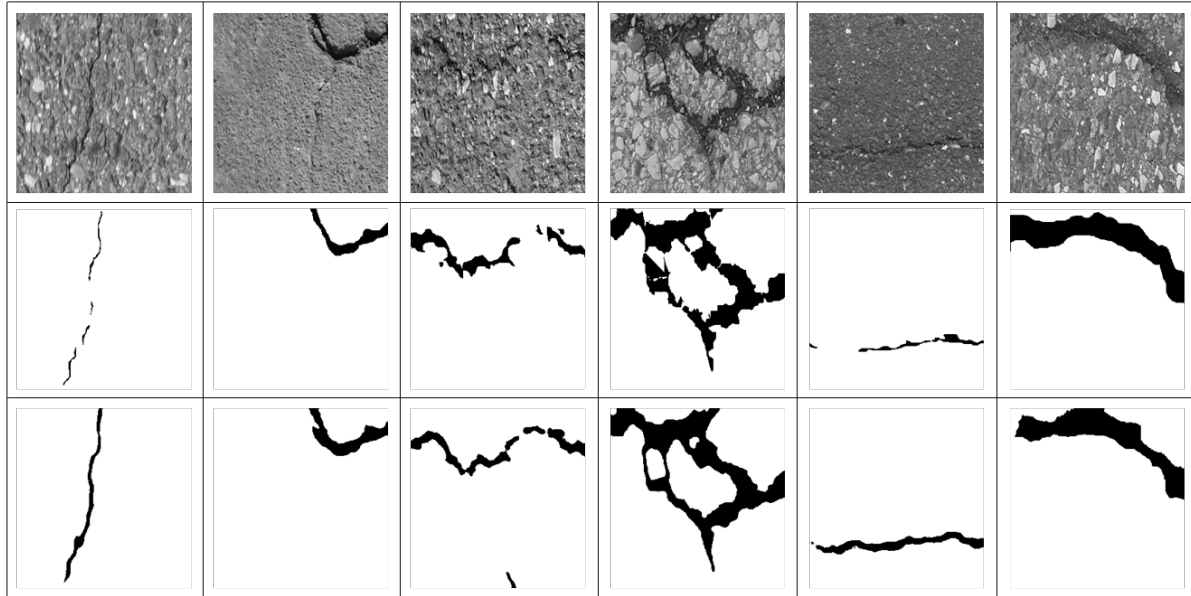
Note: 1st Row: Original Images; 2nd Row: Ground Truth; 3rd Row: Predictions

**Figure 4.26: Prediction results of U-NetCrack500 on Crack500 data**

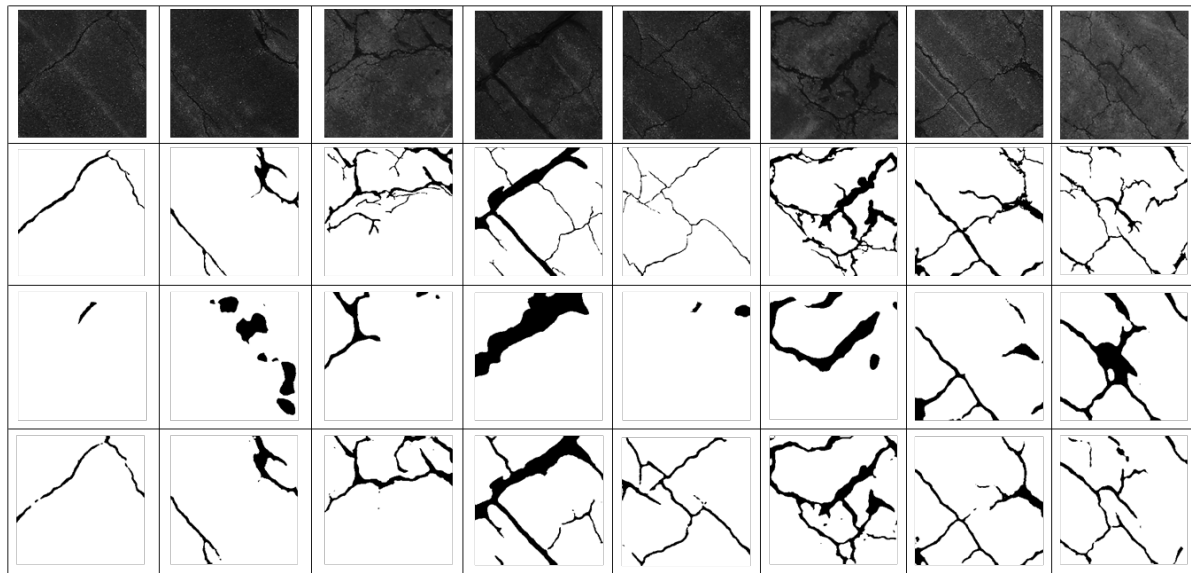
Note: 1<sup>st</sup> Row: Original Images; 2<sup>nd</sup> Row: Ground Truth; 3<sup>rd</sup> Row: U-Net<sub>Crack500</sub> Predictions; 4<sup>th</sup> Row: U-Net<sub>Crack500&FMA</sub> Predictions

**Figure 4.27: Prediction results of U-NetCrack500 and U-NetCrack500&FMA on FMA data**

Similarly, the prediction results of the U-Net<sub>Crack500</sub> and U-Net<sub>Crack500&FMA</sub> models on the FMA testing data are further illustrated in Figure 4.27. A comparison of Figures 4.26 and 4.27 clearly suggests that the Crack500 and FMA datasets are very different. Crack500 data has a higher resolution and differences between cracks and non-cracks can be easily distinguished. On the other hand, FMA data overall is darker and has a lower resolution. Some of the cracks are difficult to identify even manually with human intelligence. In Figure 4.27, the third and fourth rows show the results of the U-Net<sub>Crack500</sub> and U-Net<sub>Crack500&FMA</sub> models, respectively. Compared to the ground truth (i.e., the 2<sup>nd</sup> row), the U-Net<sub>Crack500&FMA</sub> model clearly is able to identify more cracks than the U-Net<sub>Crack500</sub> model. Given the limited time, this research only annotated 160 FMA images. If more annotated FMA images are used in U-Net training, its prediction performance is expected to be further improved.

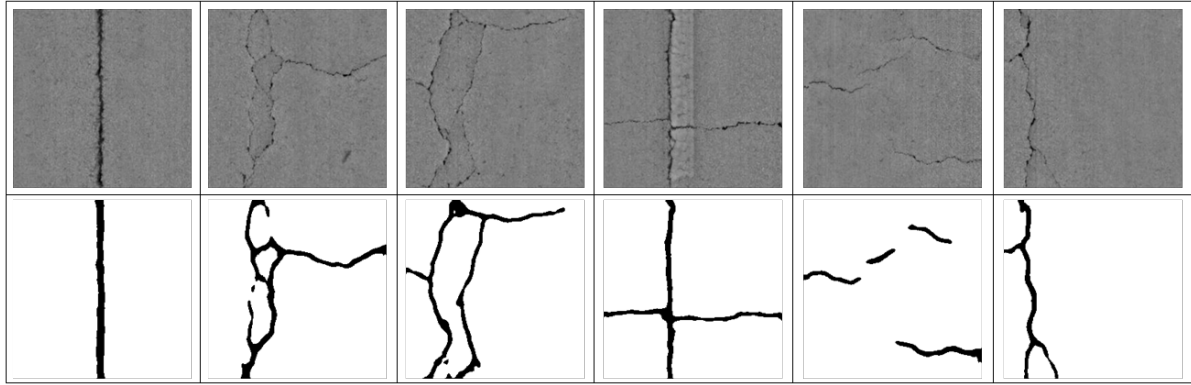
Note: 1<sup>st</sup> Row: Original Images; 2<sup>nd</sup> Row:- Predictions

**Figure 4.28: Prediction results of U-NetCrack500 on highway pavement image data**

are taken about 2 meters/6.6 ft above the ground and are closer to the Crack500 data in terms of resolution than the FMA data. This probably explains why the U-Net<sub>Crack500</sub> model's performance on this dataset is very encouraging, although it is trained on a different set of images. This suggests that the U-Net<sub>Crack500</sub> model has great generalization ability and can potentially be used directly by highway departments on datasets that are similar to the Crack500.

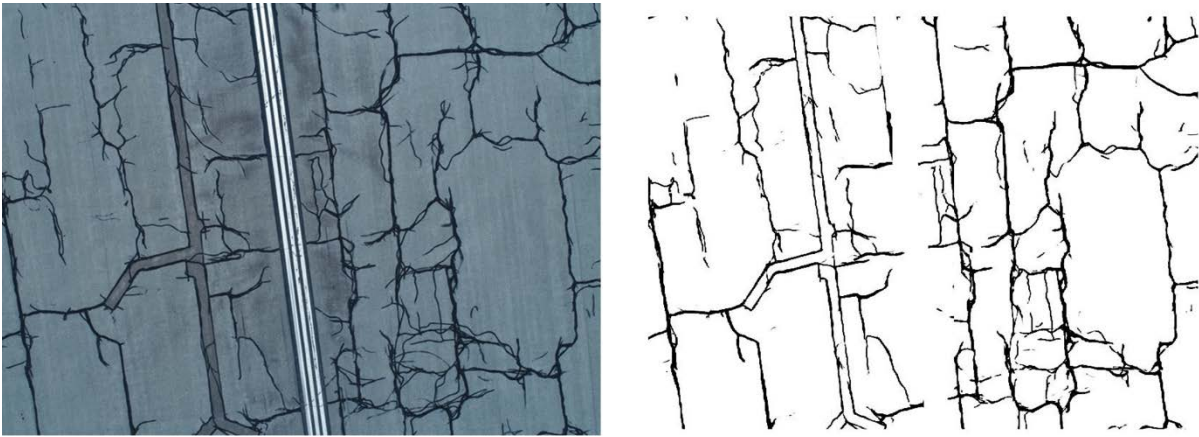
**Figure 4.29: Application of U-Net to initial FMA data**
