Evaluation of the Smart Work Zone Speed Notification System

Minnesota Traffic Observatory

Research Project

Final Report 2019-21

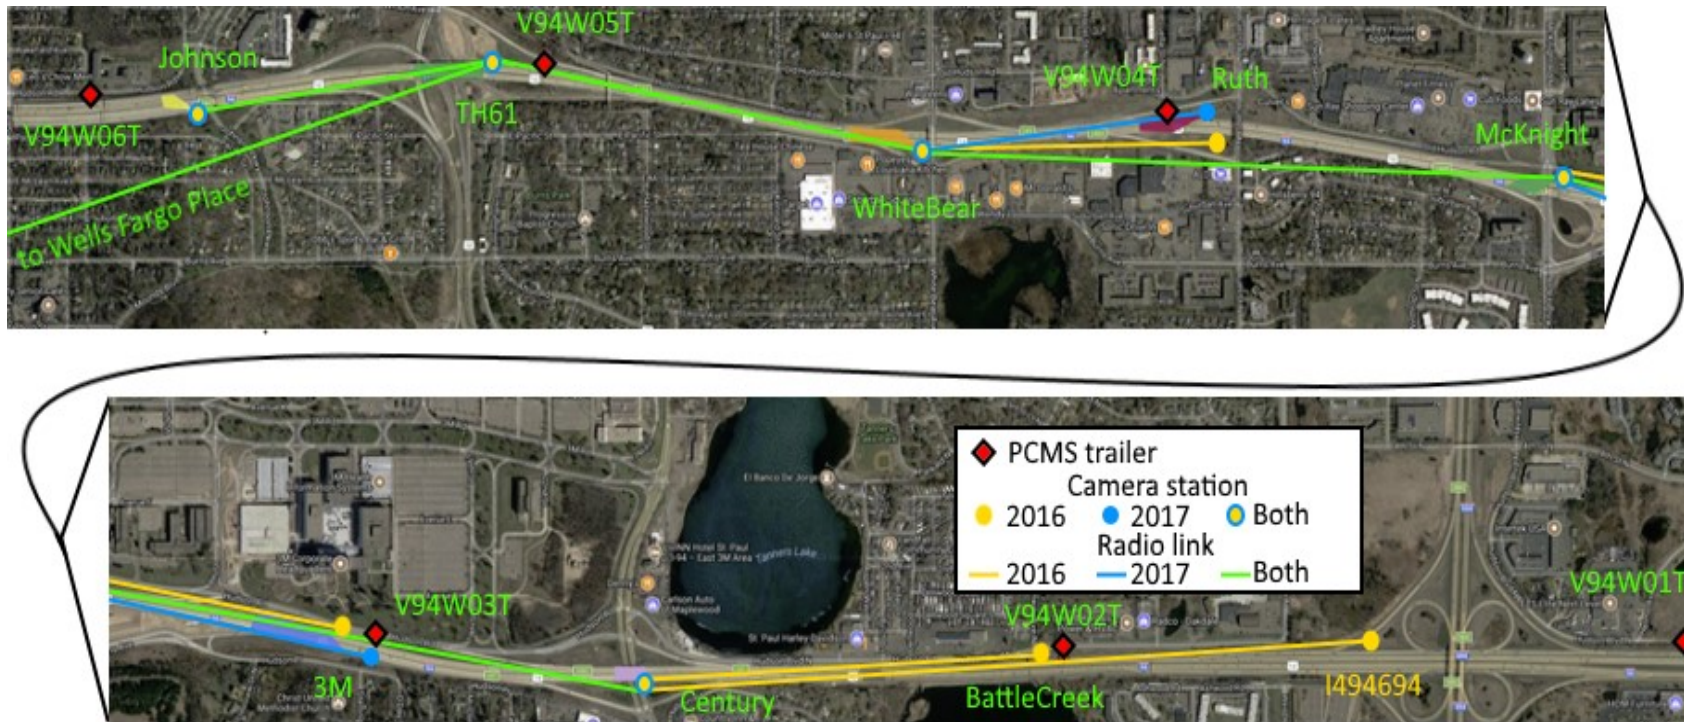
Figure 1.2 Work zone with PCMS trailers, camera stations, and radio links

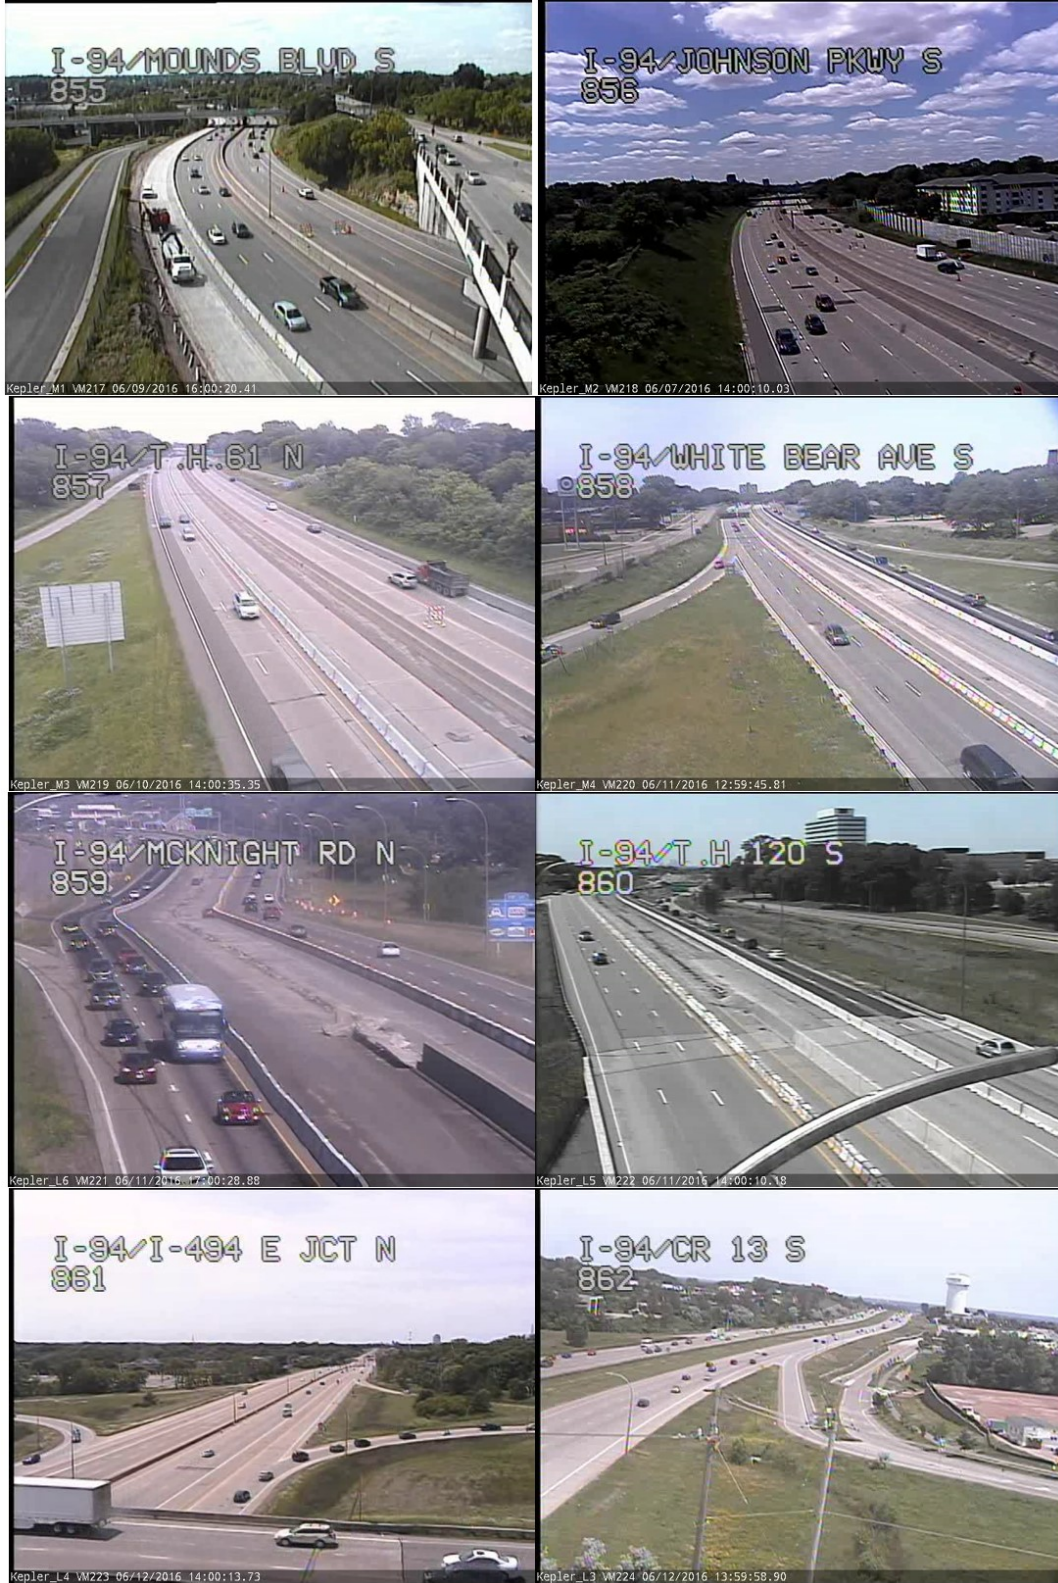
Figure 2.1 MnDOT cameras C855 – C862 along the work zone

To improve the camera angles for the extraction of trajectories from video (see Chapter 4), most of the cameras were repositioned in late September 2016 to test the relative quality of the trajectory extraction. The stations were then deactivated for the winter and the trailer stations were retrieved from the field. During the period between the two seasons, testing of the trajectory extraction was

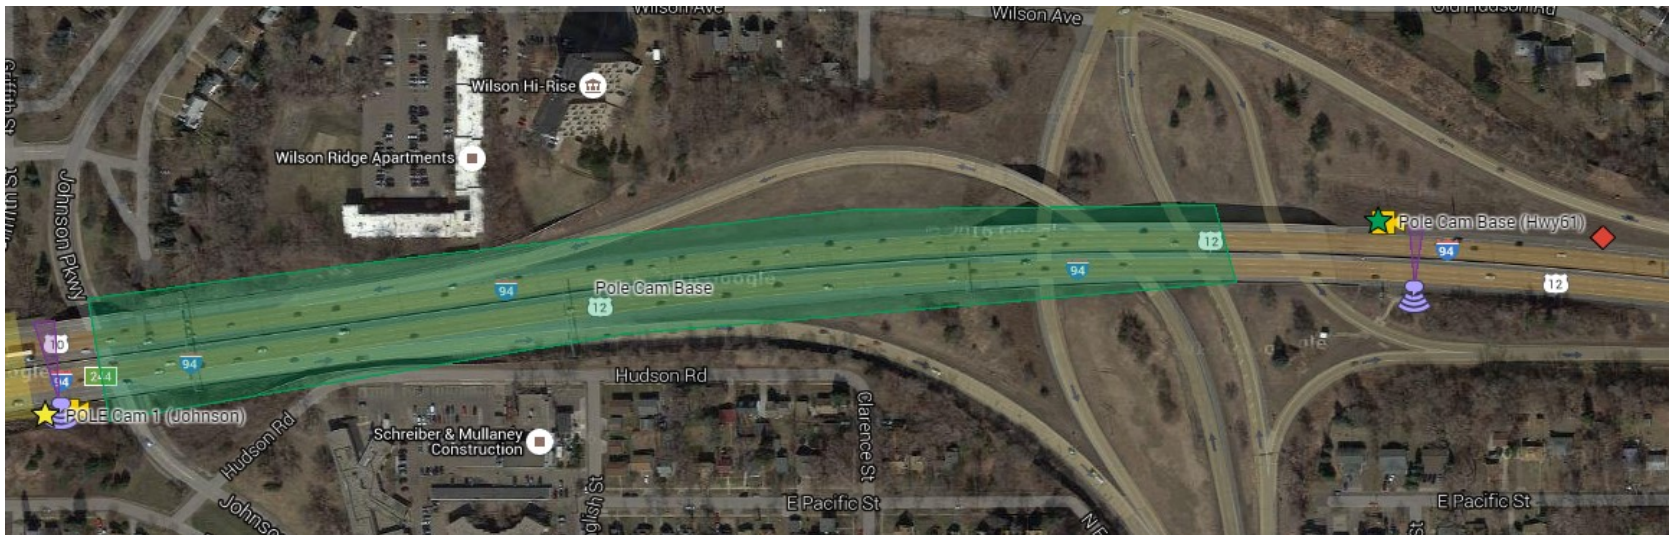
Figure 2.6 Aerial view of the field of view of the camera at TH61 station in 2016

The camera at TH61 station was mounted on MnDOT camera pole C857. In 2016, it was aimed downstream to capture as much of the queue formation process as possible (see Figure 2.6 and Figure 2.8). In 2017, the camera was turned down and mounted higher on the pole to give a closer top-down view of vehicles passing the station to help improve the accuracy of the data produced with the TET (see Figure 2.7 and Figure 2.9).

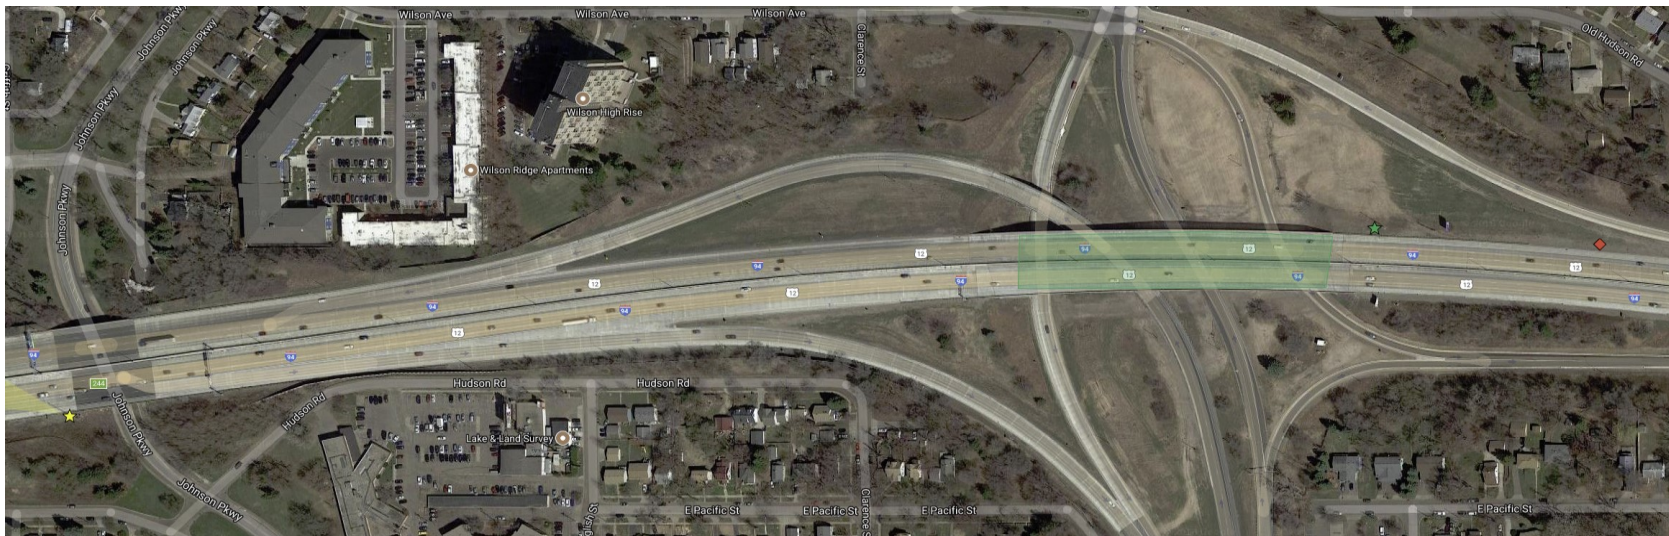
Figure 2.7 Aerial view of the field of view of the camera at TH61 station in 2017

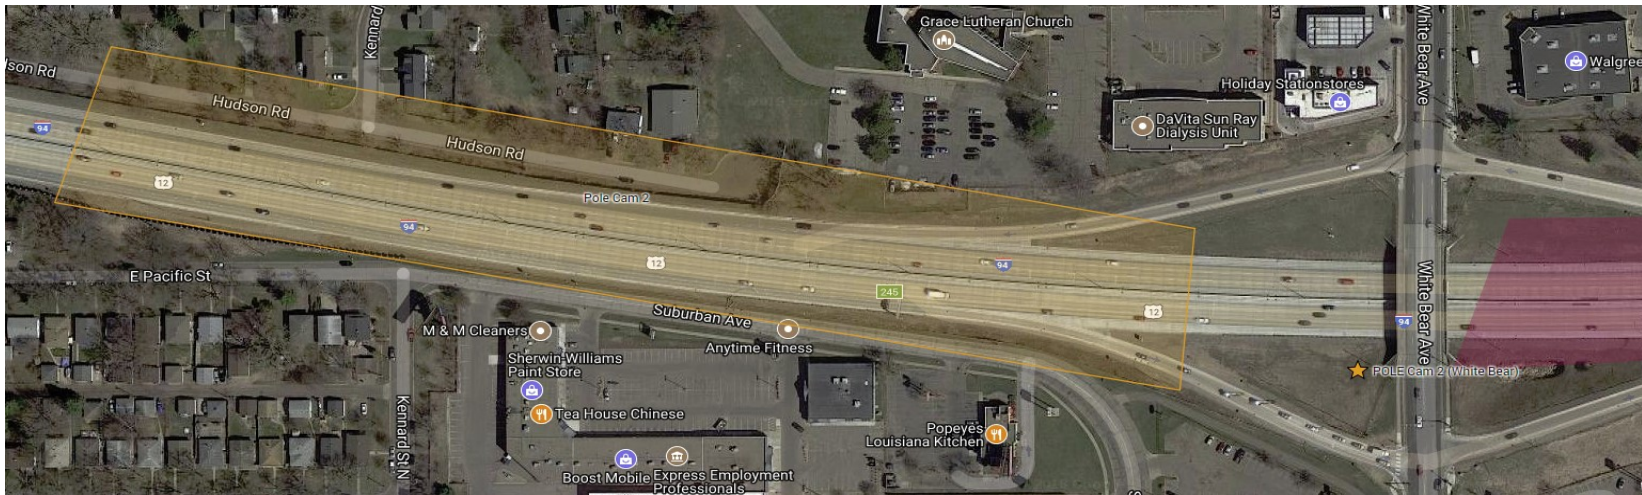
Figure 2.10 Aerial view of the field of view of the camera at White Bear station in 2016

The camera at WhiteBear station was mounted on MnDOT camera pole C858. In 2016, it was aimed downstream to capture as much of the queue formation process as possible (see Figure 2.10 and Figure 2.12). In 2017, the camera was turned down and to the right to give a closer top-down view of vehicles passing the station to help improve the accuracy of the data produced with the TET (see Figure 2.11 and Figure 2.13).

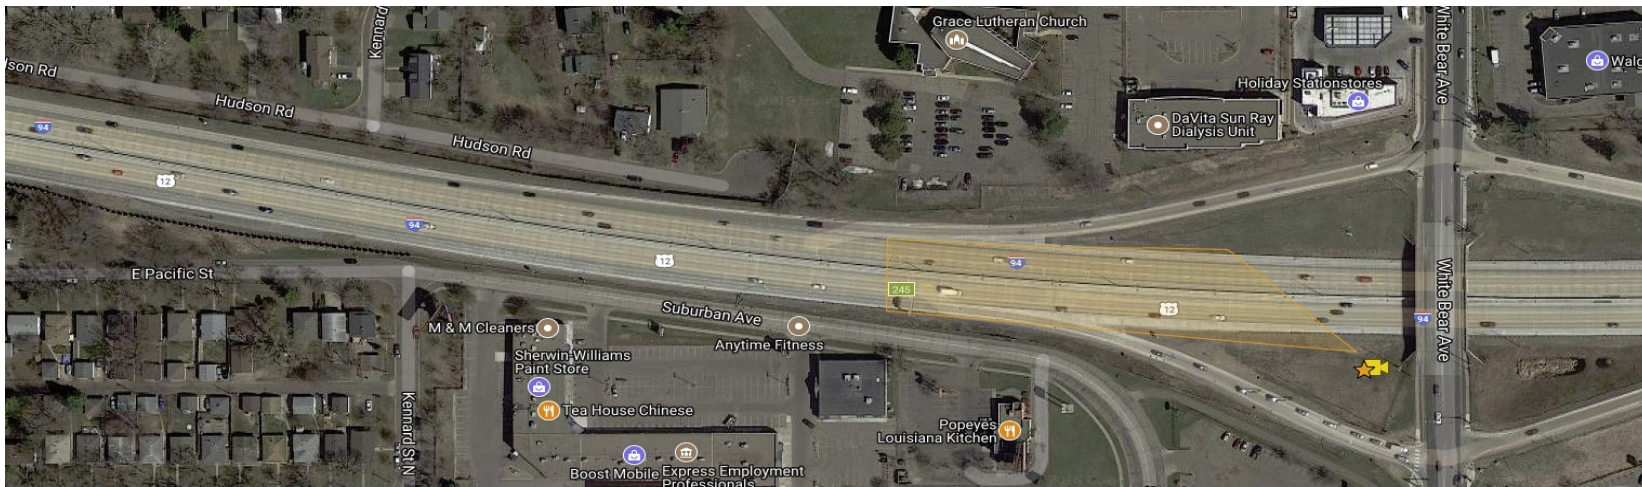
Figure 2.11 Aerial view of the field of view of the camera at White Bear station in 2017

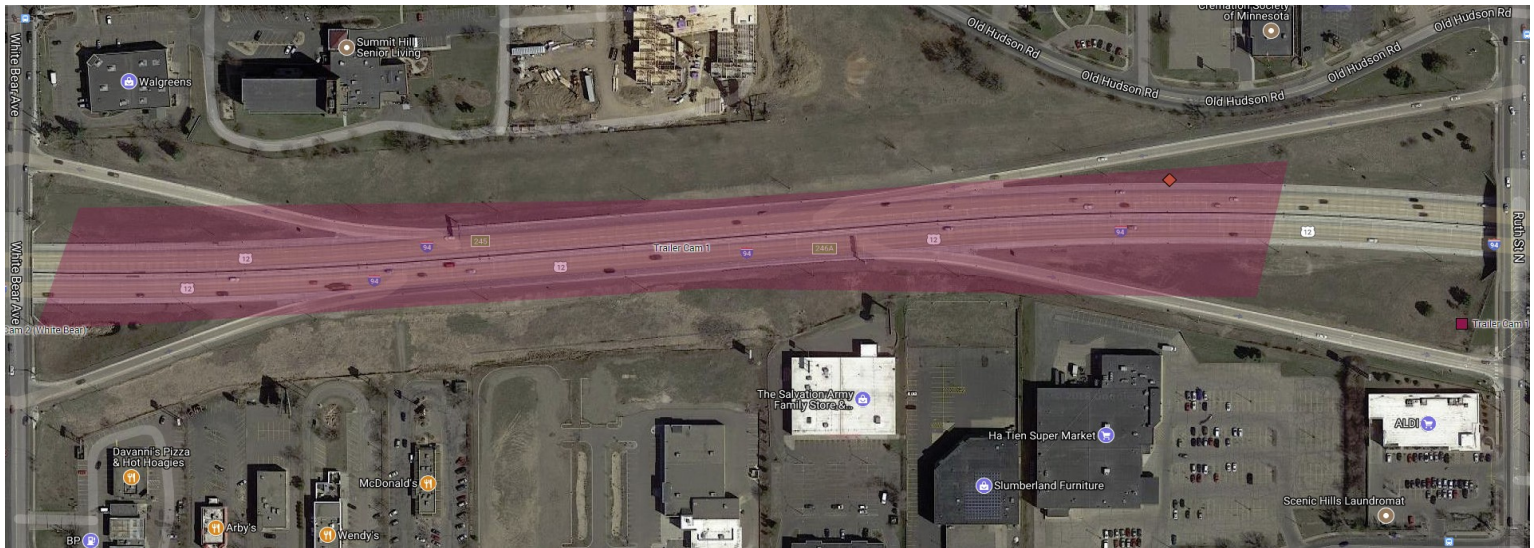
Figure 2.14 Aerial view of the field of view of the camera at Ruth station in 2016

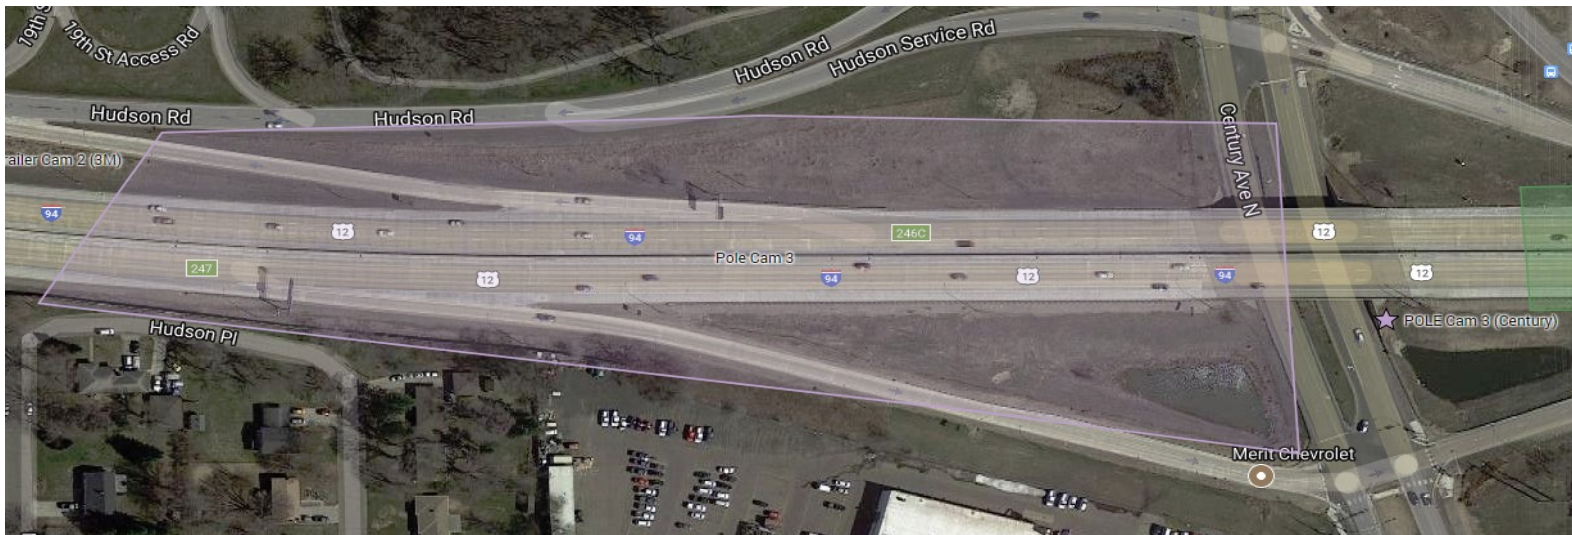
Figure 2.26 Aerial view of the field of view of the camera at Century station in 2016

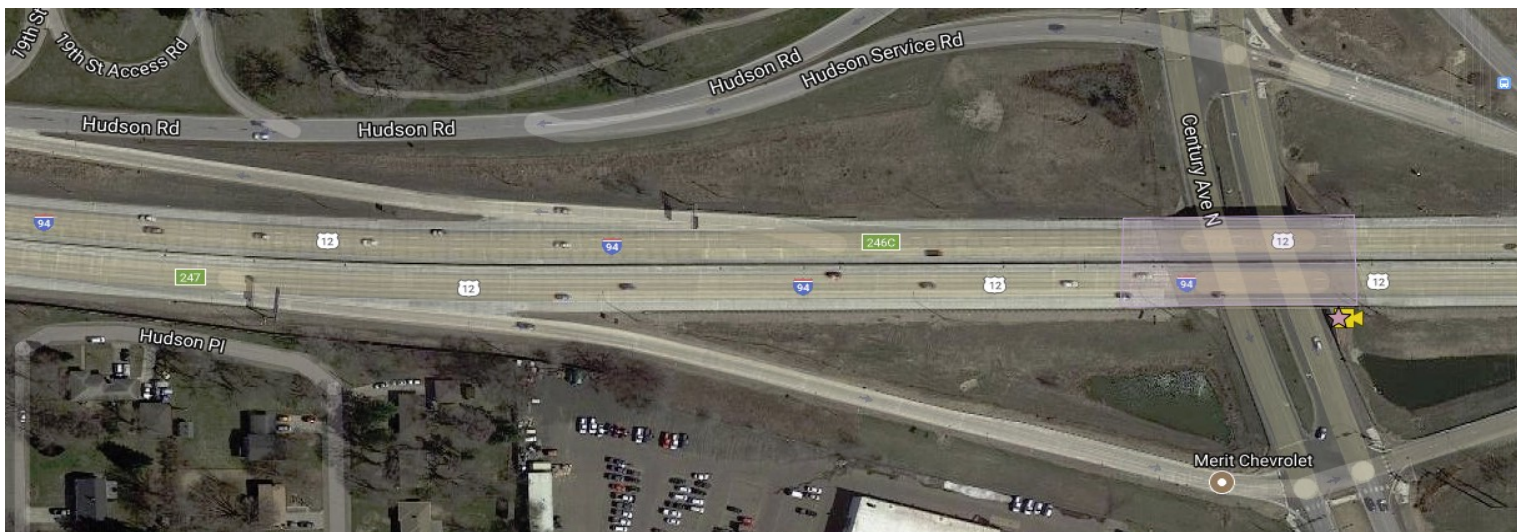
Figure 2.27 Aerial view of the field of view of the camera at Century station in 2017

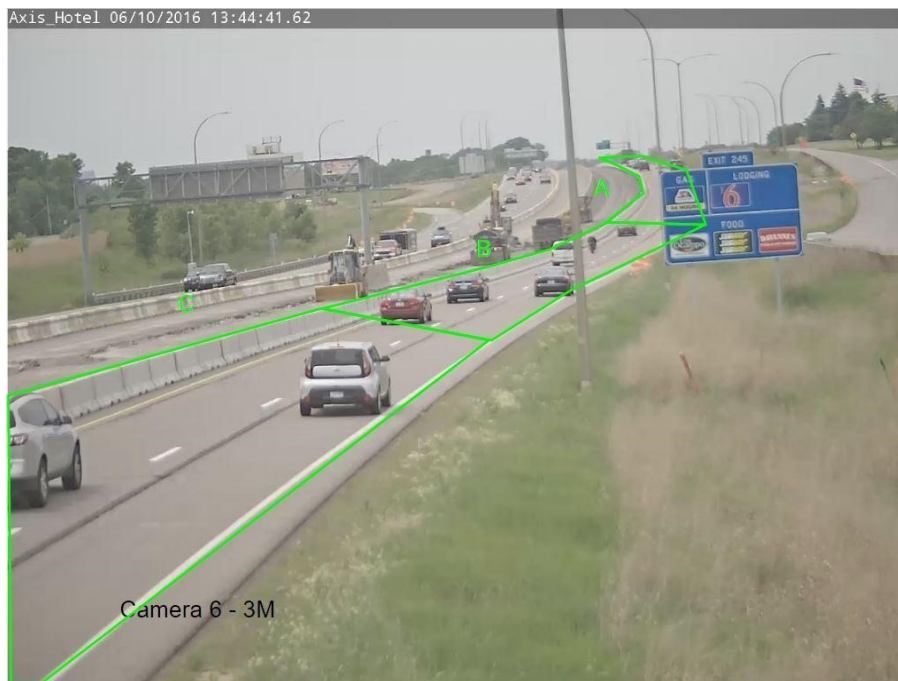
Figure 3.1 Camera 6 Queue End location regions

Each camera view was divided into three or four regions; undergrads noted the time of day that the back of a queue first extended into to a region and the time that the back of the queue receded back upstream of that region. Figure 3.1 shows the four regions in the video from 3M station.

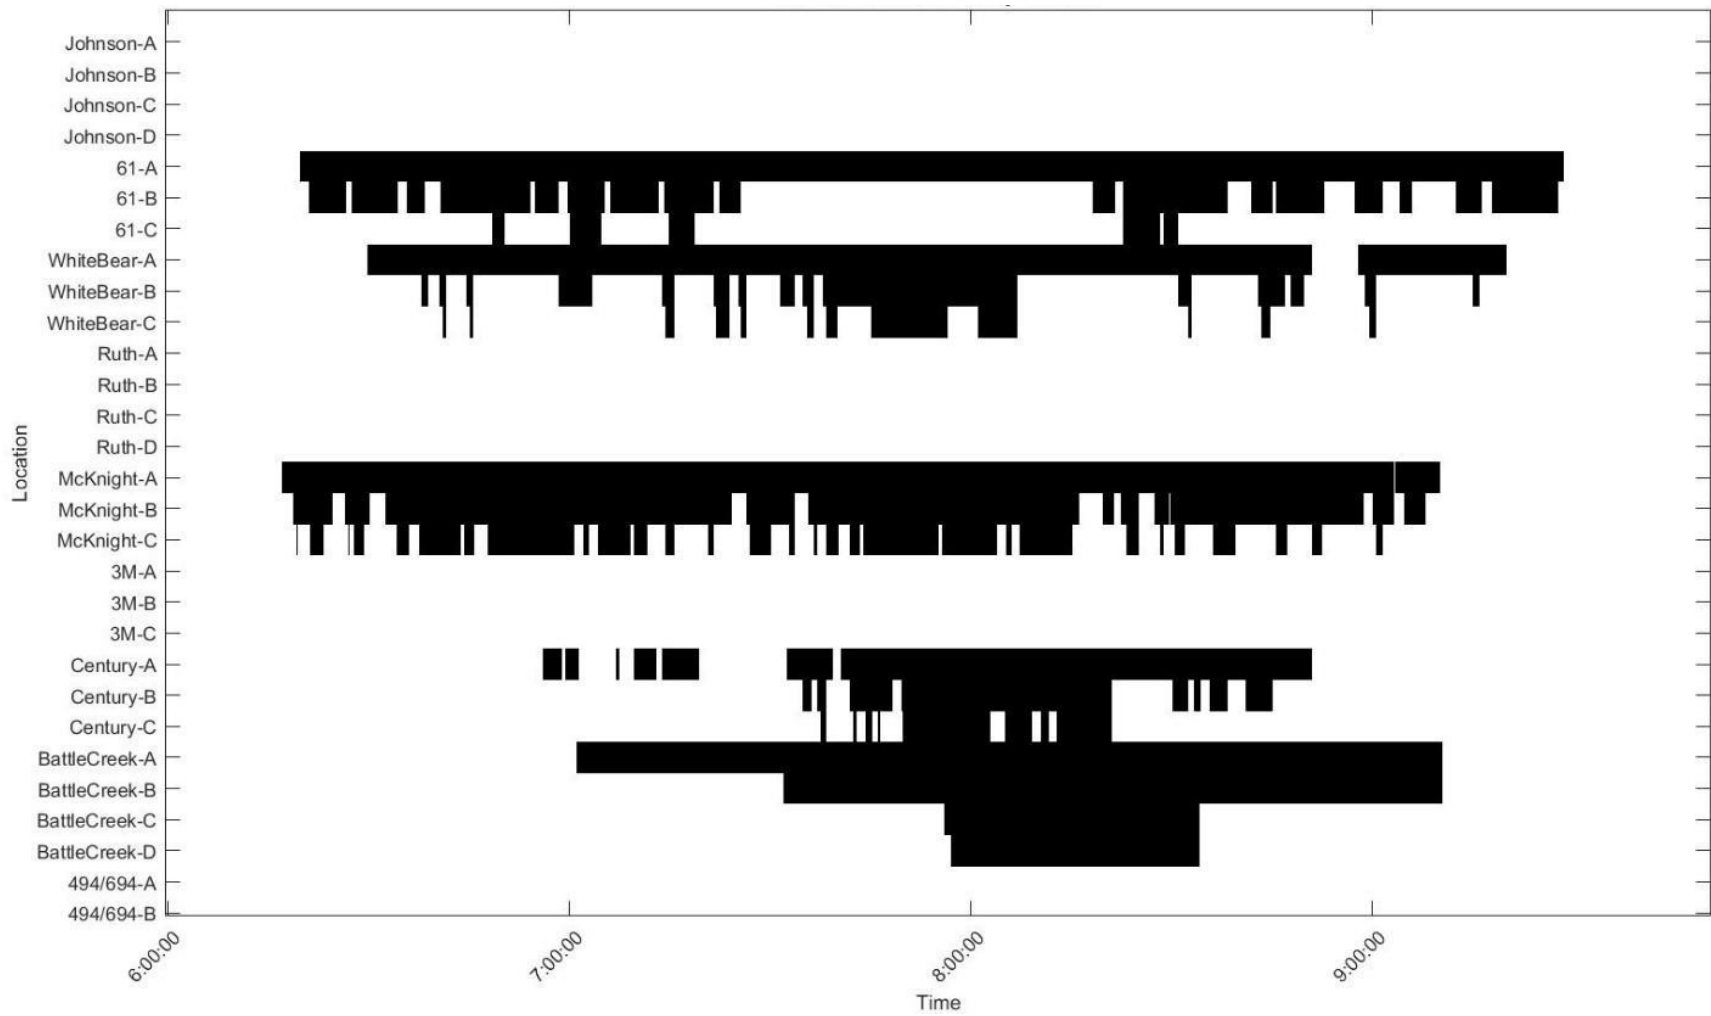
Figure 3.2 Queue location on I-94 WB by region and time of day

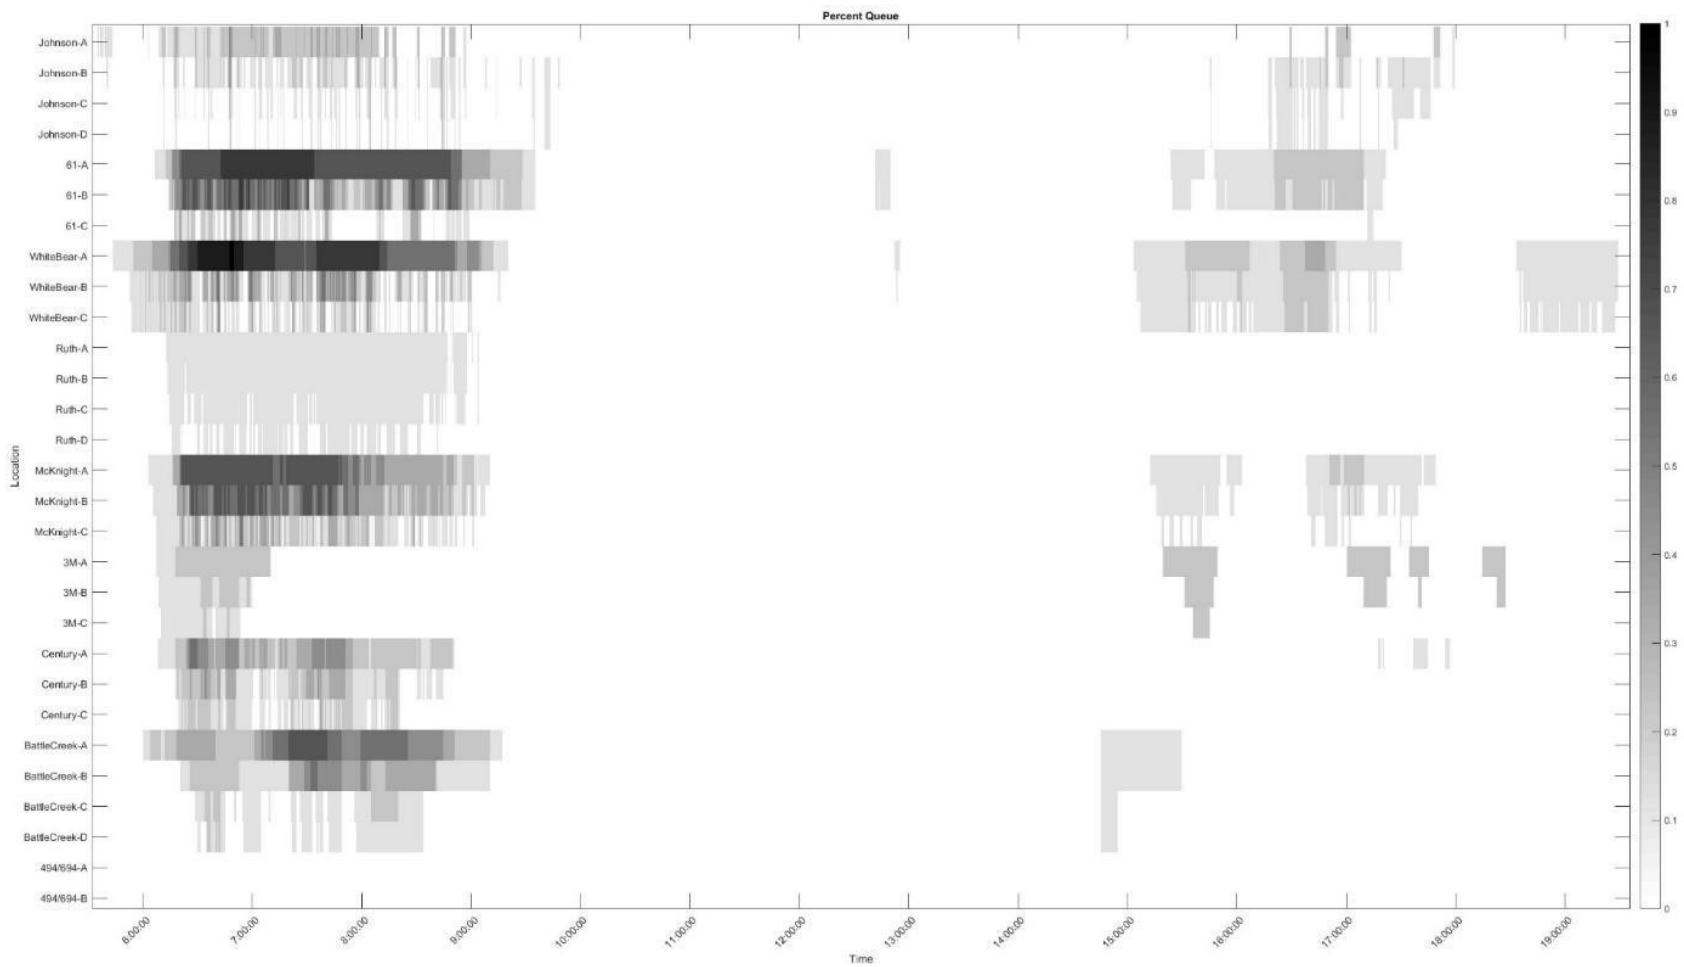
Figure 3.3 Queue frequency on I-94 WB by location and time of day

A more informative view of the queuing behavior was produced by combining the queue location plots for the days analyzed into one queue location summary plot. In Figure 3.3, the percentage of the days sampled where a queue was present at a given location and time is shown. Darker areas indicate locations and times of frequent queueing while lighter grey areas show areas where queues were observed less frequently or less consistent.

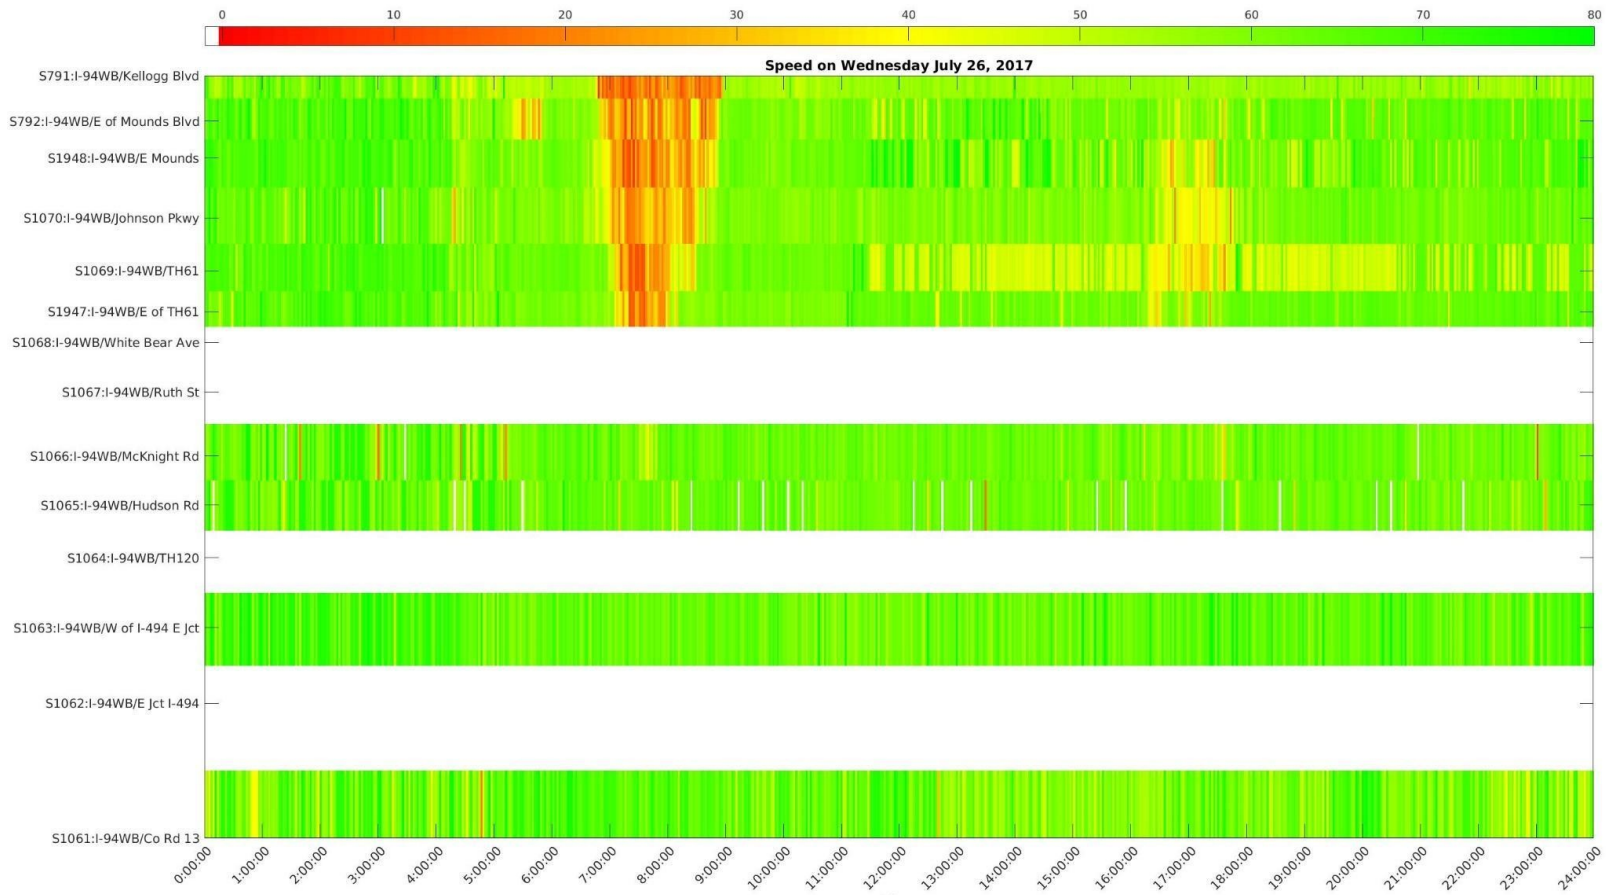
Figure 3.4 Sample heatmap showing average speed on July 26th, 2017 at each station.

To visually show the speeds from the detector data each day, the available speed data is plotted in a contour plot or heatmap. To do this, the available detector data is aggregated by station and then averaged. The resulting averages speed for each 30-second time step is represented by a color ranging from red to green with red corresponding to a speed of 0 mph and green corresponding to 80 mph. For each day of the evaluation period, the data for each station is plotted in ascending chronological order from left to right. The stations' data is then "stacked" on top of each other in the order that they would be encountered by drivers with the furthest upstream detector at the bottom of the plot and the furthest downstream detector at the top of the plot. The resulting plot shows the speeds at every station in 30-second increments for the whole day. An example of a heatmap for July 26th, 2017 is shown in Figure 3.4. The white bars are the result of no detector data being available at some stations due to the detectors being removed during construction. Unlike the SWZSNS which reports the speed of the lane with the lowest speed, the heatmaps show the average of all available lanes.

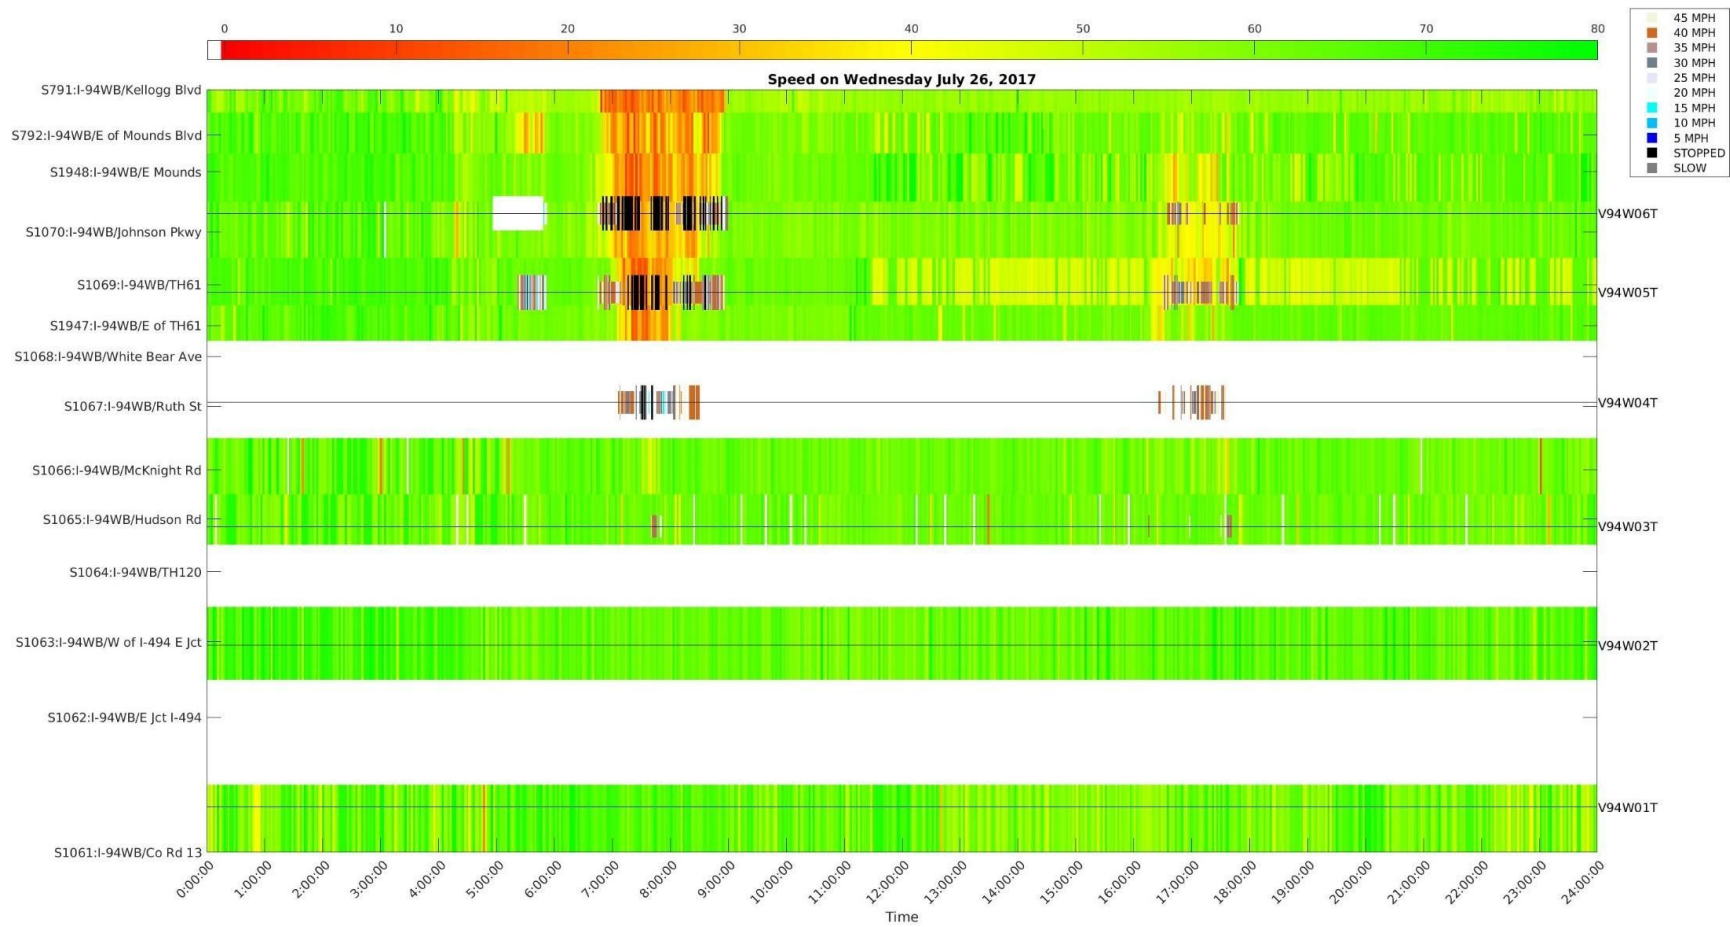
Figure 3.5 Sample heatmap showing average speed on July 26th, 2017 at each station with PCMS messages superimposed.

In the example heatmap, there appears to be an isolated slow-down event between 5:20 a.m. and 5:45 a.m. at the Mounds Blvd station that caused the SWZSNS to display “20 MPH 1 MILE AHEAD” messages at trailer V94W06T for nearly an hour and various “1 MILE AHEAD” messages at trailer V94W05T for the duration of the slow-down. The fact that both trailers, separated by roughly half a mile, are displaying messages with different speeds but the same distance ahead means that one of the trailers – likely V94W06T – is displaying the wrong distance to the slow traffic.

the trailers' messages are represented by the colored bars on those lines. The color of the vertical line corresponds to the color in the legend for the upcoming speed that drivers are being warned about while the height corresponds to the distance drivers are told that the slow traffic will be encountered (short line for ½ mile, tall line for 1 mile). An example of a heatmap for July 26th, 2017 with the sign messages overlaid is shown in Figure 3.5.

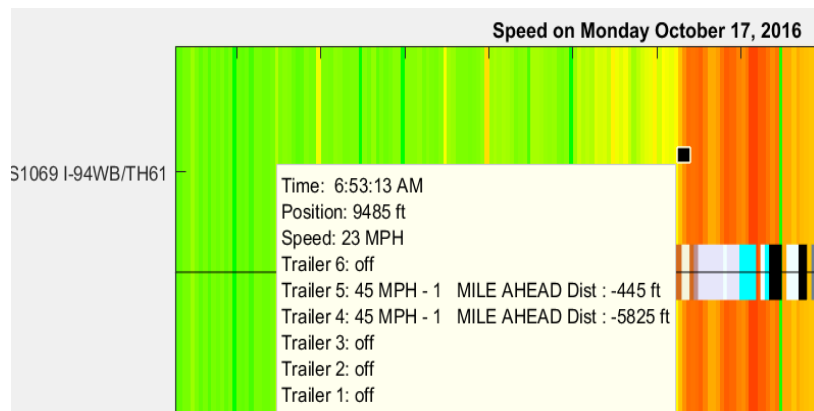
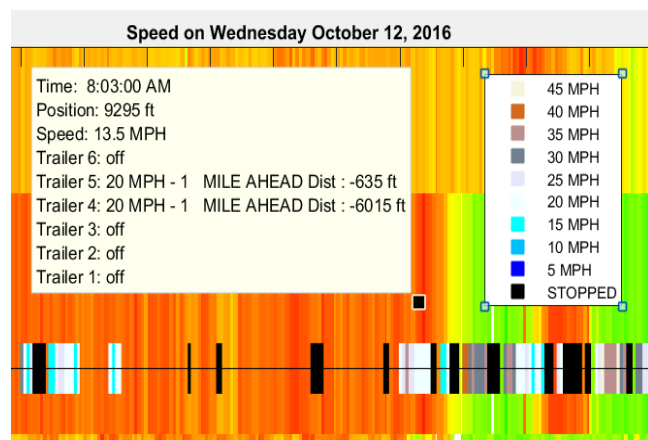
Figure 3.6 Examples where the wrong configuration generated unreasonable messages

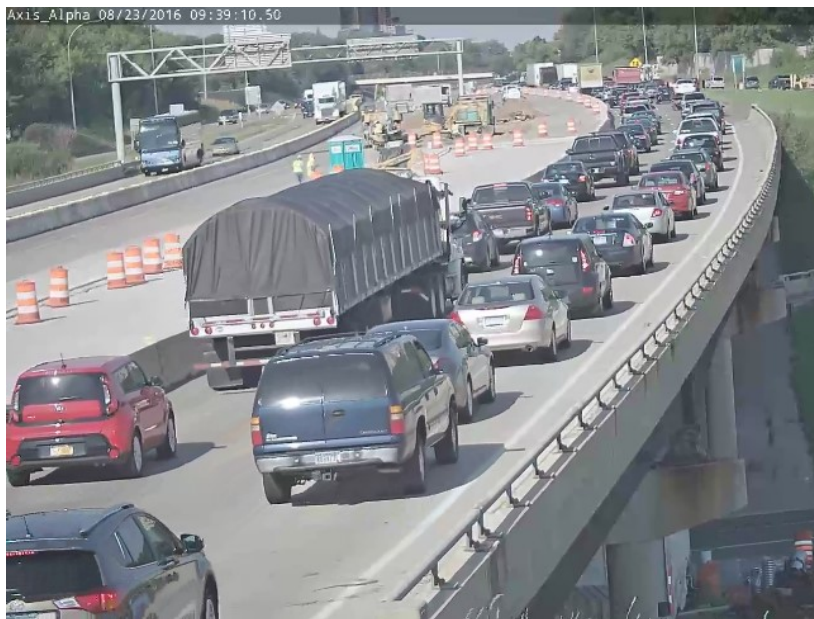
Figure 3.9 Conditions on TH-61 while VMS displayed "Stop Traffic Ahead"

Starting with the simplest example of such counterproductive operation, the method and rules the "Stop Traffic Ahead" message are evaluated in this section. From the algorithm logic description we received from MnDOT, this message was supposed to display the distance to the stopped traffic but the message log from IRIS does not show such messages having the third line in the VMS be the word "Ahead". Using again the examples presented in **Figure 3.7** and **Figure 3.8** we see that the sign remains active even when the traffic is stop-and-go at and upstream of its location. For example, the following picture **Figure 3.9** is a snapshot of the traffic at TH-61 where speeds at this location as well on the upstream detector were consistently below 10mph and the VMS trailer displayed "Stop Traffic Ahead" for at least 10 more minutes.

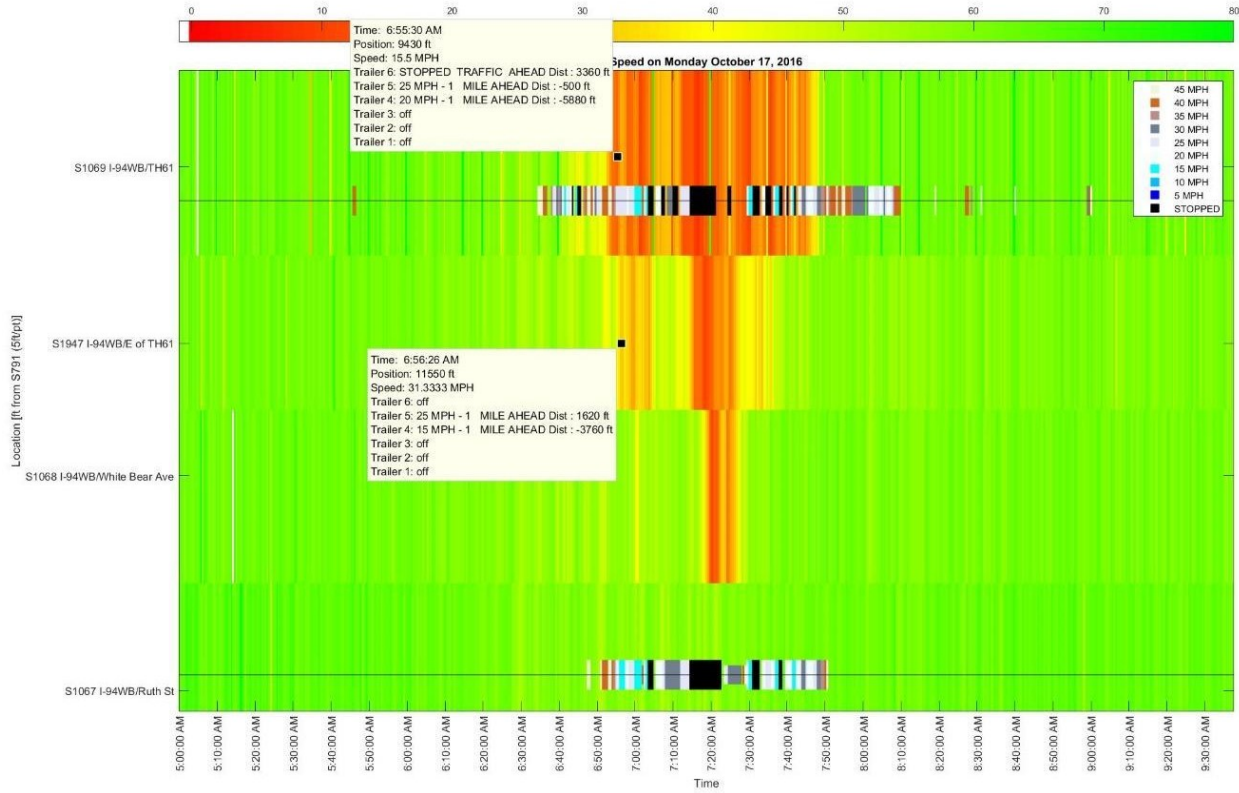
Figure 3.10 Example of message delay and missed warning

Throughout the evaluation period, it was observed that the VMS messages generated have a variable delay in their correlation with the associated speeds at the downstream sensor locations. **Figure 3.10** presents an example of this issue. Trailer #4 (V90W04T) located at the Ruth St Interchange is shown in that figure. This trailer did not present any evidence that is associated with the wrong sensors and seems to be generating messages based on some combination of data retrieved from the sensors west and east of TH-61 and the sensor on White Bear Ave (S1069, S1947, S1068). The time displayed on the top data point is the time of the last sensor record containing a speed of less than 20mph; speeds were below 20mph for 2 minutes before this point. We see that the VMS generates the first “15mph – 1 Mile Ahead” message more than 2 minutes later while the speed at half-mile distance has dropped below 35mph. VMS trailer #4 a few minutes later displays a “25mph – 1 Mile Ahead” while the speed is already at that level at about half-mile distance. The data point distances displayed are the distances between each trailer and the cursor, positive if downstream, negative if the trailer is upstream.

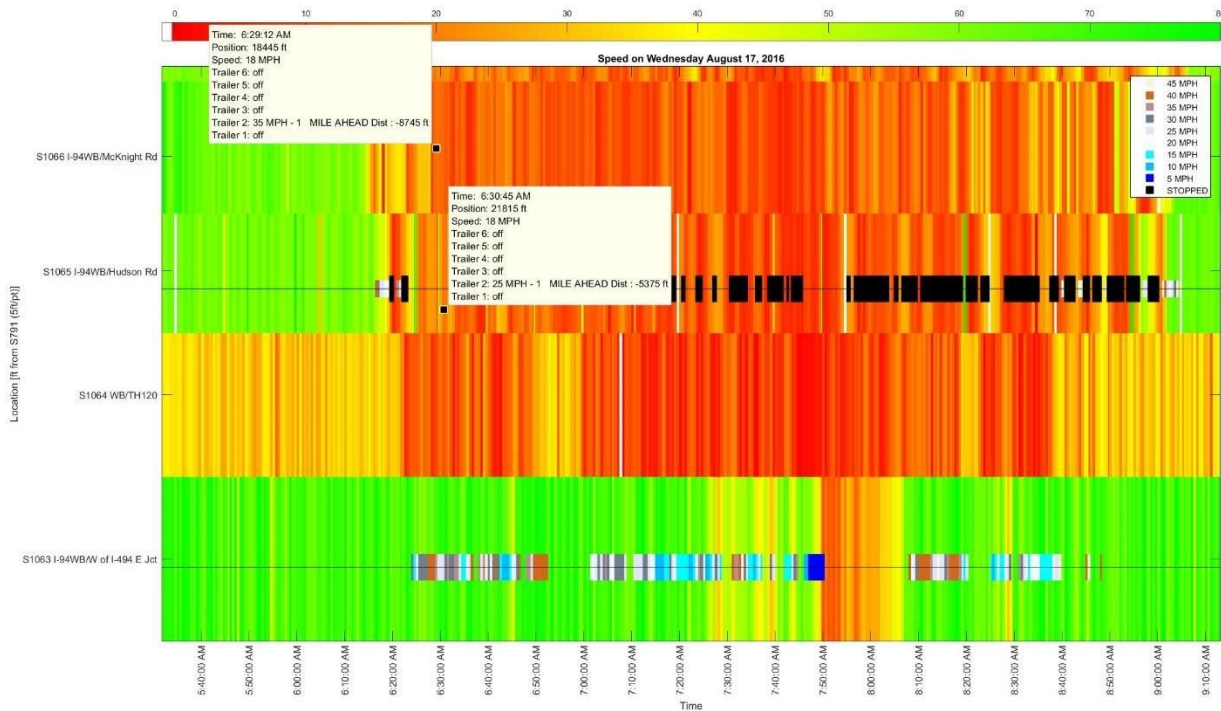
Figure 3.11 Example of Unclear behavior of Trailer 2 (I-494, V94W0T)

In the example shown in **Figure 3.11** an inconsistent behavior of the algorithm is observed in respect to the messages displayed on the VMS trailer west of I-494. As mentioned earlier sensor S1064 located on the TH-120 interchange had calibration issues for the majority of the evaluation period. Regardless, it seems that the sensor was underestimating speed during uncongested conditions but during congestion at least superficially seems to provide legitimate measurements. Naturally, we can only speculate if the algorithm is using this sensor or not but the issues described here seem unrelated to this part. Specifically, the messages displayed on trailer 2 don’t agree with any of the immediately downstream sensors ½ or 1 mile away. As seen in the figure, even if we account for the delay described earlier the displayed messages are very different from the conditions measured by the sensors. In the example, the message is “25mph – 1 Mile Ahead” but speeds are below 20mph consistently ½ away to at least 1.5 miles downstream. Separately, trailer 2 never displays a “Stop Traffic Ahead” message even when conditions clearly justify it but it turns off, as it should when congestion reaches its location in difference to most of the other trailers. Again, we can only point out the discrepancy but cannot hypothesize on the reason behind it.

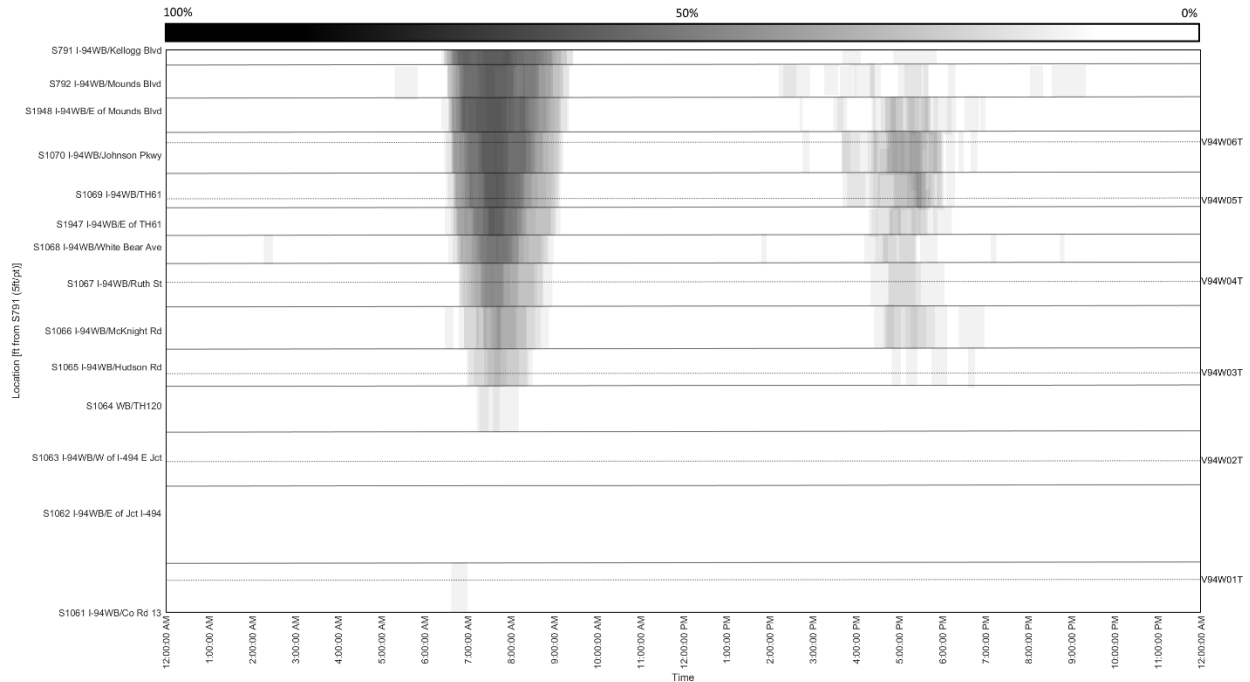
Figure 4.1 Queue frequency by location and time based on 20 normal days

Similar to the conditions observed in 2016, queuing is most frequent in the morning between 6:30 a.m. and 9:30 a.m. (i.e., the morning peak) with some scattered queuing in the afternoon between 3:00 p.m. and 7:00 p.m. (i.e., the afternoon peak). The queue frequency plot shows that queuing generally extends up to McKnight Rd, but sometimes it can travel as far upstream as TH-120/Century Ave.

To show present the results in a similar fashion to the queue location summary for the 2016 data collection, a tool was created to combine several heatmaps and produce a gradient of queue frequency for each time and location. This new queue location summary is broken down by detector station instead of camera view region and includes the locations of the PCMS trailers. To show the “normal” queue locations, the queue location plots of 20 average days were combined to form the queue frequency summary plot. The resulting queue frequency plot is shown in **Figure 4.1**. The days used were selected by comparing each day’s total volume entering and the fluctuations of the entering volume throughout the day. This helped to control for variations in the number of vehicles on the road at any given time from day to day. This process took a research engineer approximately 10 hours over the course of two weeks.
