Evaluation of the Smart Work Zone Speed Notification System

Minnesota Traffic Observatory

Research Project

Final Report 2019-21

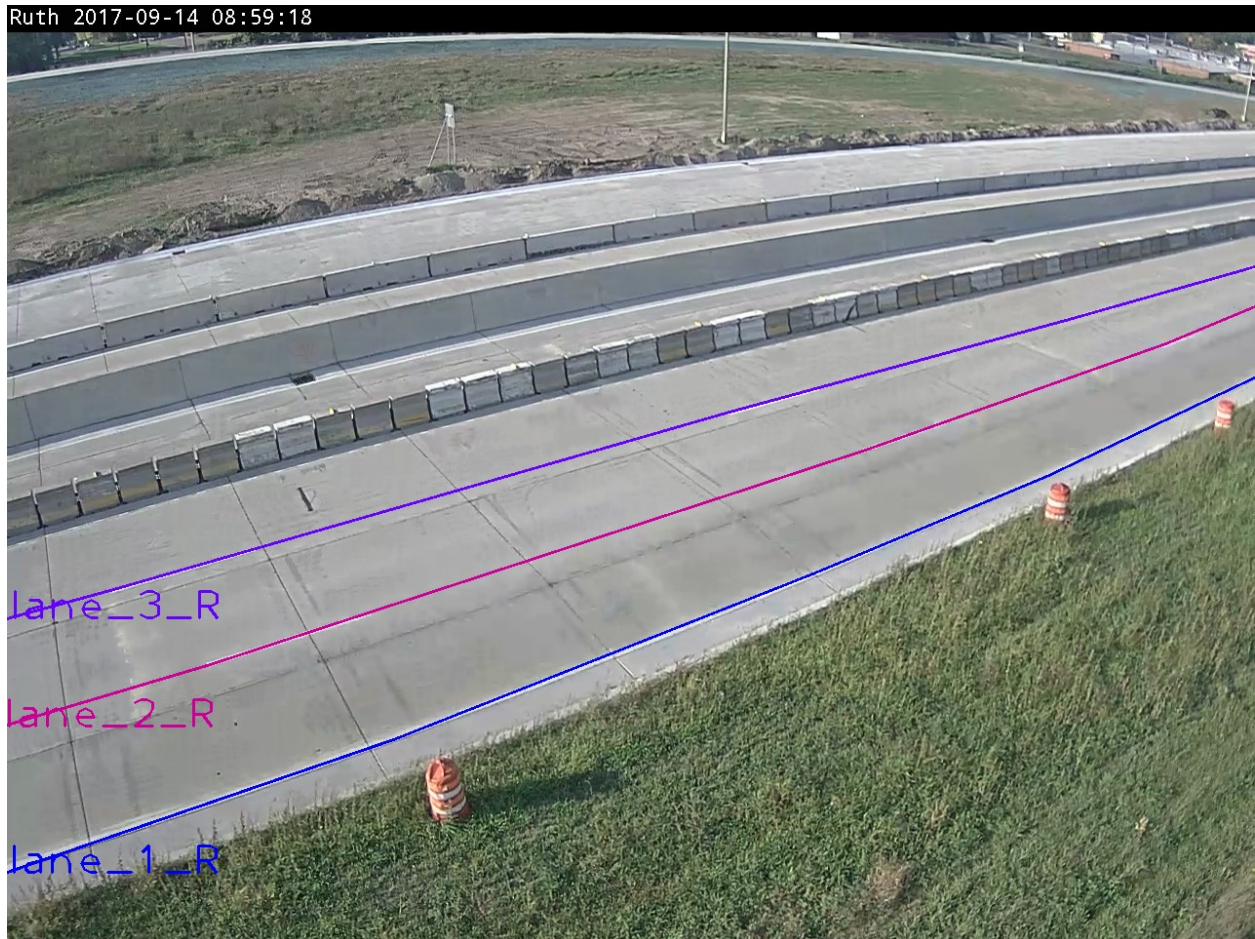
Figure 4.4 Example of lanes defined in a camera viewing vehicles from the right, where the right lane markers are defined.

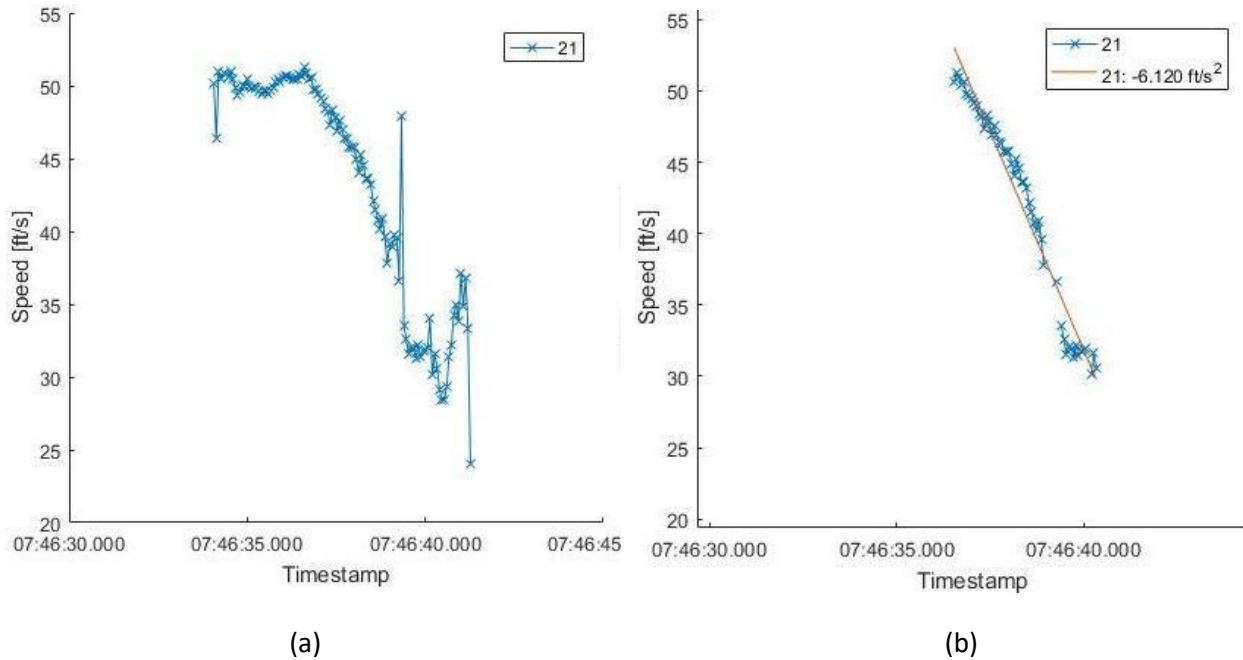
Figure 4.5 Sample of velocity vs time plot before (a) and after (b) removing noise and fitting deceleration rate

If an object's trajectory meets the above criteria, the noisy data points are removed. An example of a trajectory before cleaning is shown in **Figure 4.5 (a)**. A balance must be struck between removing noise and removing so many points that the trajectory is no longer an accurate representation of the path of the object. The same trajectory is shown in **Figure 4.5 (b)** after the removal of noise and a deceleration rate has been fit to the remaining points. This process of cleaning and fitting is repeated for a given analysis group until there are no more trajectories to choose from or enough samples have been selected to carry out a meaningful analysis at which point the process is repeated for the analysis group with the next highest priority.

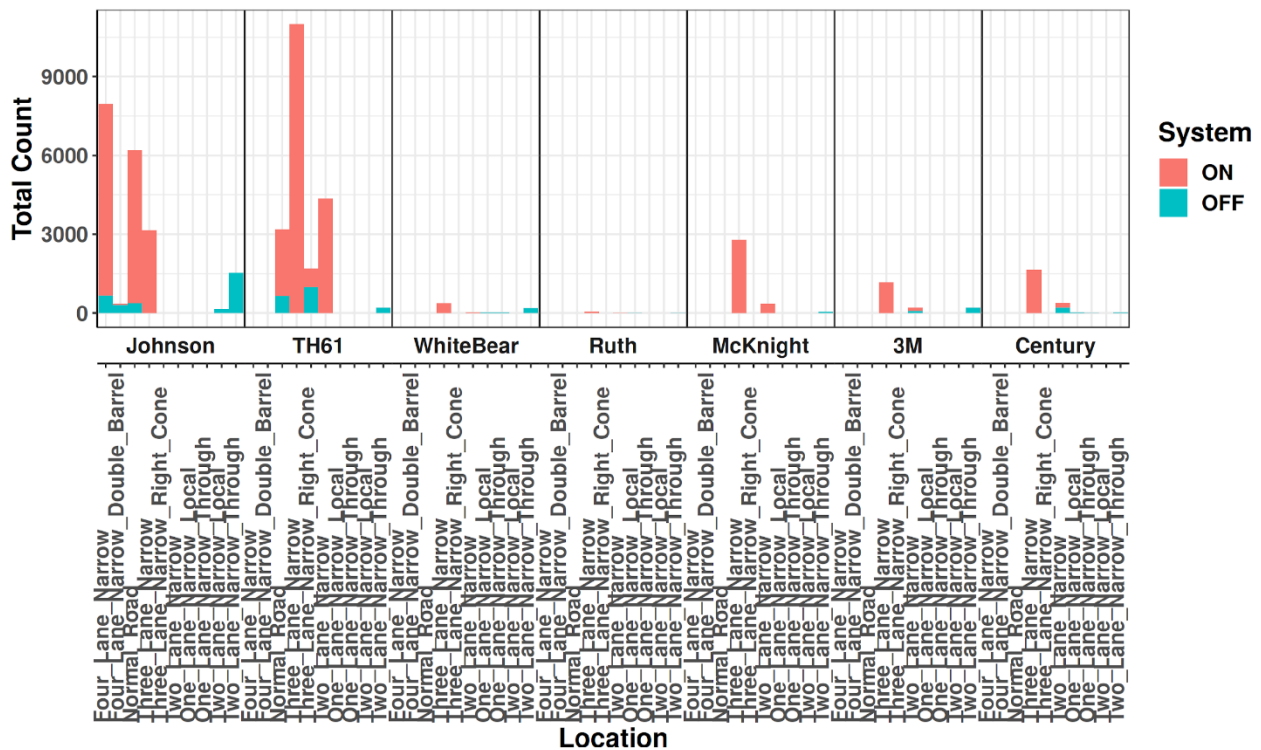
Figure 5.1 List of Available data per construction zone layout

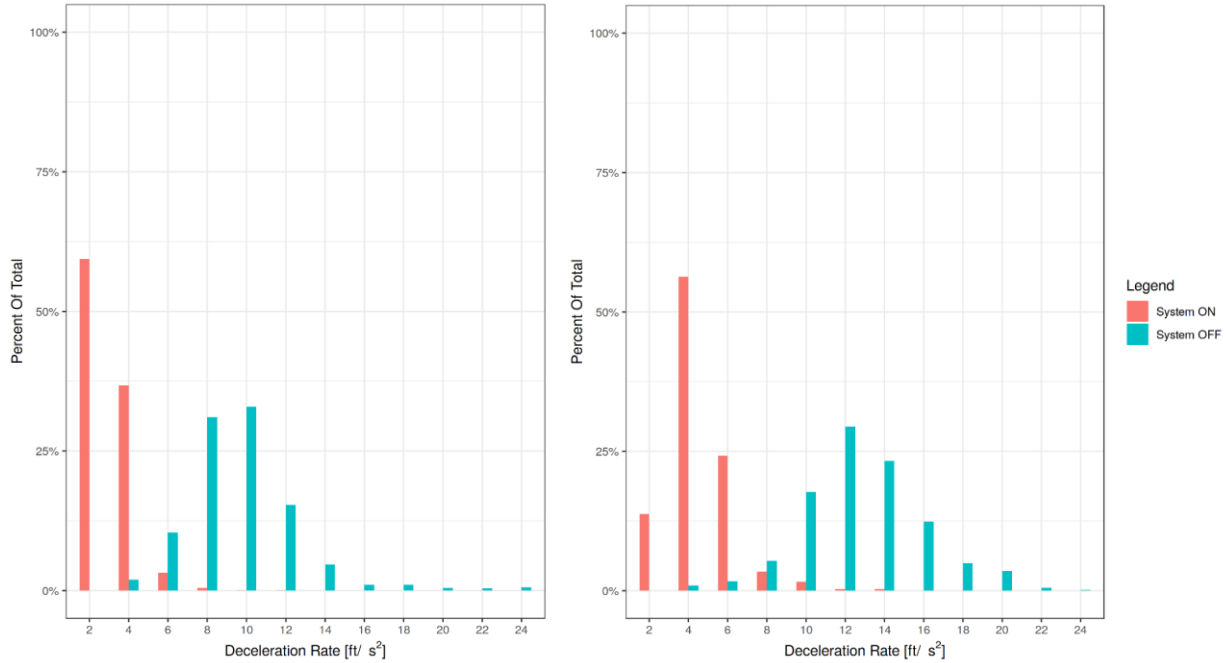
Figure 5.4 Johnson Pkwy Station. Reduced Lane Work Zone Layouts. Decelerations (Calculated, Manual)

The extracted deceleration (calculated and manual) in **Figure 5.4** show a substantial decrease of the level of decelerations with the system in place. These graphs present observations during periods of reduced lane road conditions.

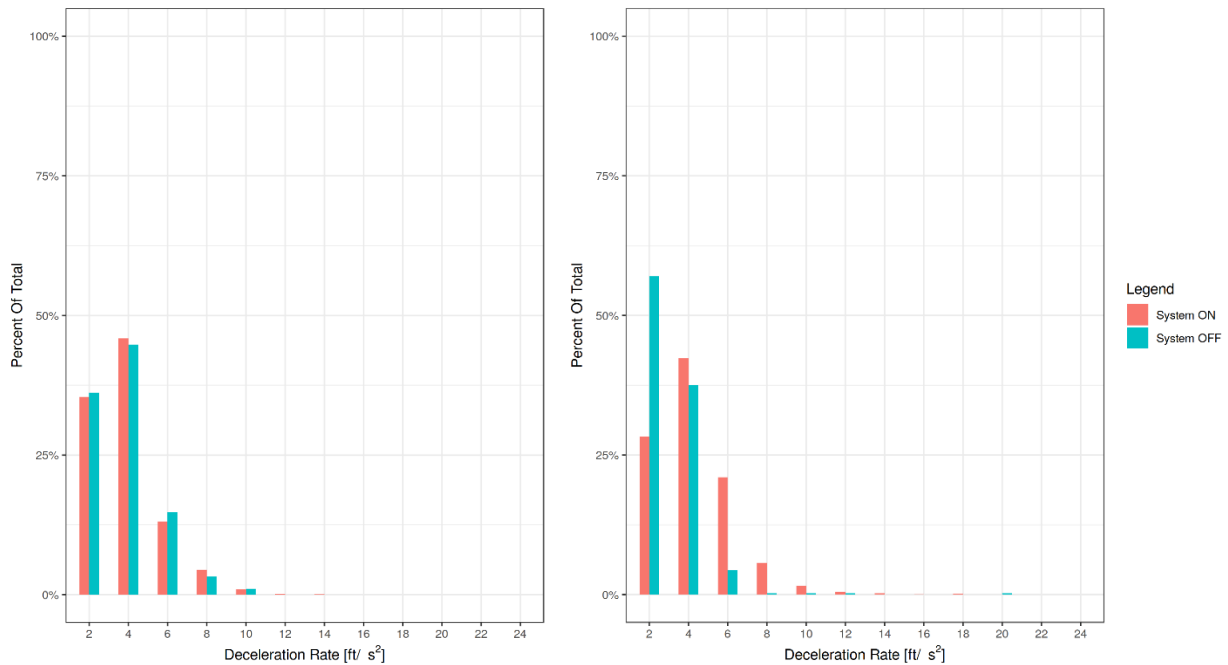
Figure 5.5 Johnson Pkwy Station. Calculated Deceleration. 4-Lanes no shoulder and Normal Road

In difference, as seen in **Figure Figure 5.5** on periods where the road was with all four lanes available either with no shoulder or with no active work zone (Normal Road). When there is no significant capacity reduction due to the work zone the speed notification system doesn't seem to offer any benefit although there was congestion forming.

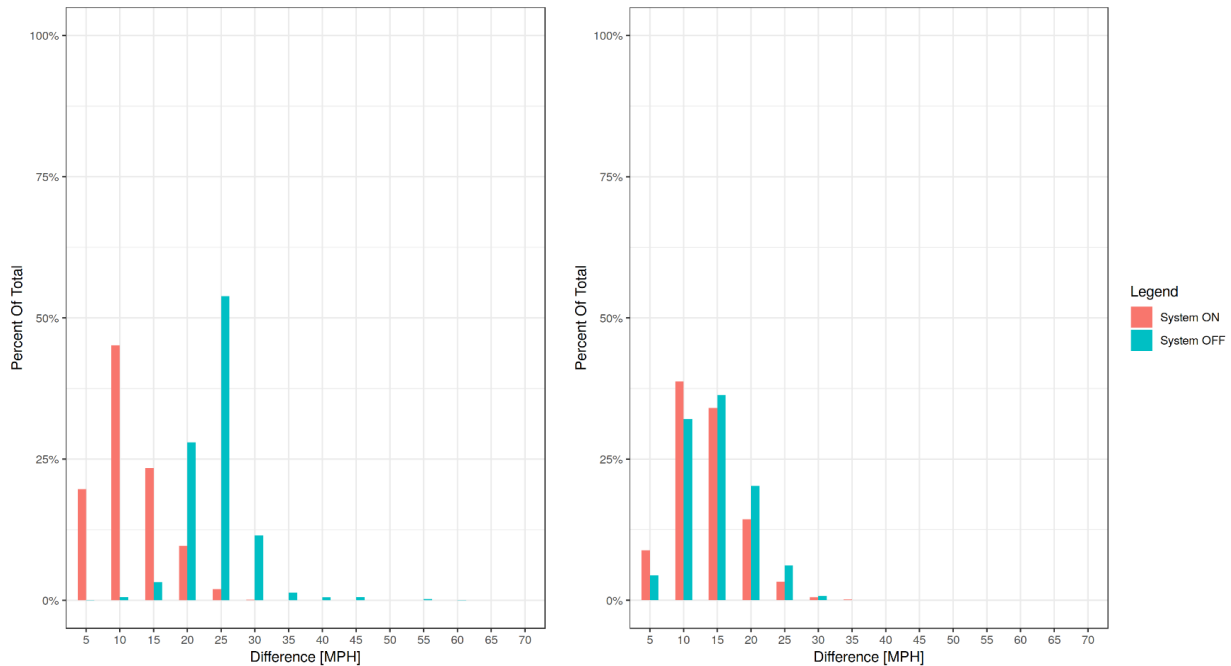
Figure 5.6 Johnson Ave Station. Speed Difference. Reduced Lanes and 4-Lane No-Shoulder

One reason for this behavior could be the fact that the difference between 15th-percentile and 85th-percentile (**Figure 5.6**) speeds was high without the system during the reduced capacity conditions while under all-lanes open conditions that difference is much lower, similar to the reduced capacity days.

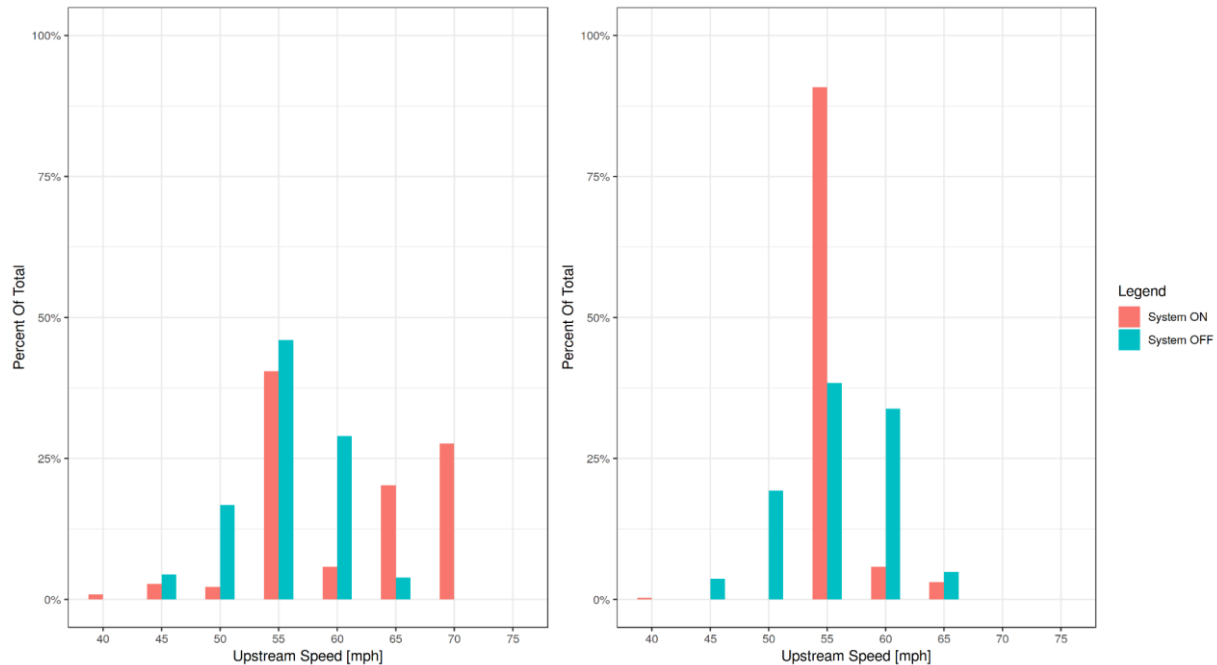
Figure 5.7 Johnson Pkwy Station. Upstream Speed. Reduced Lanes and 4-Lane No-Shoulder

It is interesting to note that the speeds on the upstream detector station didn't change much between the two layouts. Notice, on the days the system was on and there was a capacity reduction some speeds were actually higher. One can hypothesize that under all-lanes open conditions, drivers are approaching the congestion at normal speeds. Given that there is no reduction in lanes, they do not pay attention to the messages on the trailers, but because they are able to use more lanes to decelerate, they generate a smoother slow down similar to the one achieved by the system under reduced capacity conditions.

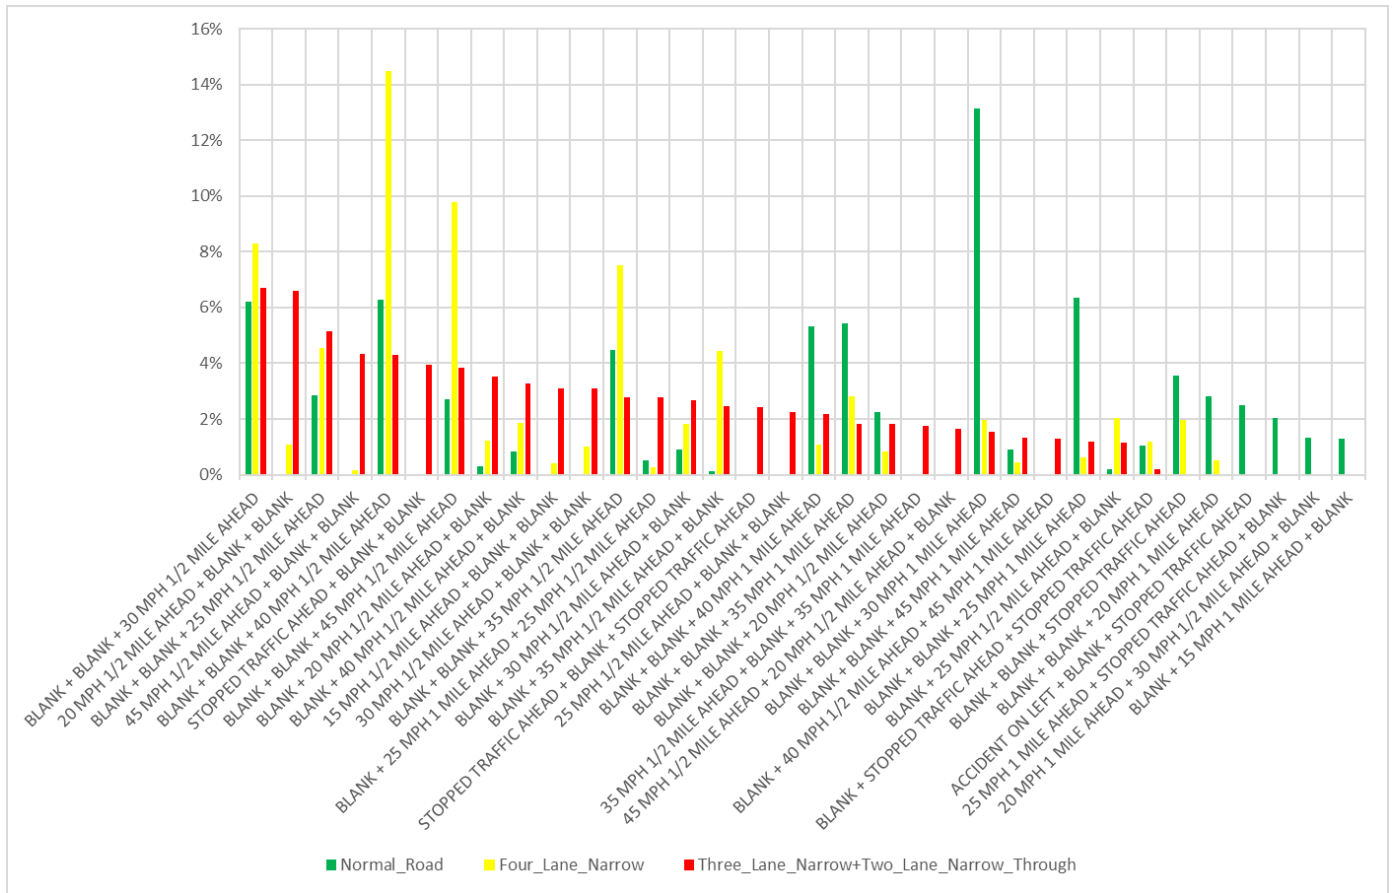
Figure 5.8 Johnson Pkwy Queued Vehicles Message history over last three trailers (three layouts)

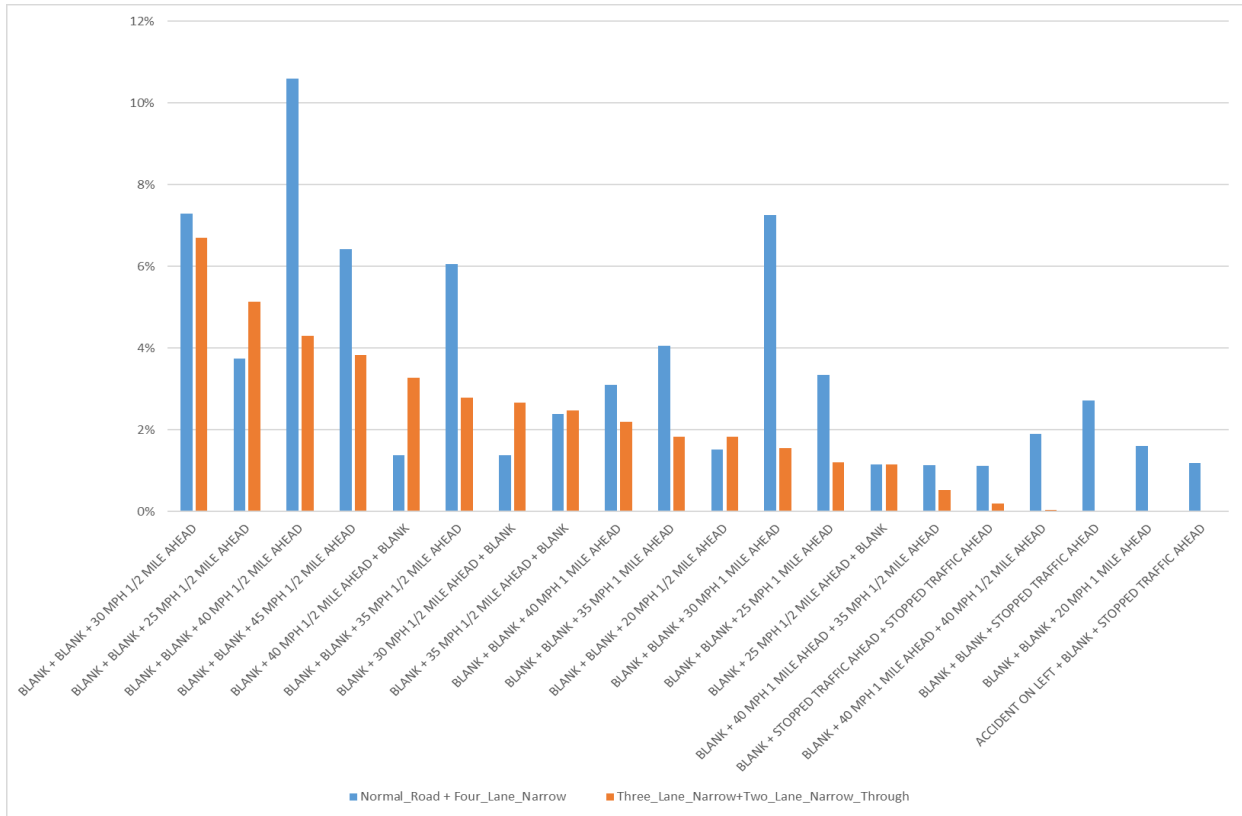
Figure 5.9 Johnson Pkwy Queued Vehicles Message History over last three trailers (combined layouts)

The deceleration results presented in this section were combined to form two groups, reduced capacity and full # of lanes road layouts. **Figure 5.9** presents the messages drivers were exposed to when the Normal_Road and Four_Lanes_Reduced cases are combined. The aforementioned frequent display of inaccurate downstream condition messages is still evident but it is observed that the frequency of such misleading information is less frequent under the restricted capacity periods which agrees with the better performance observed during these periods.

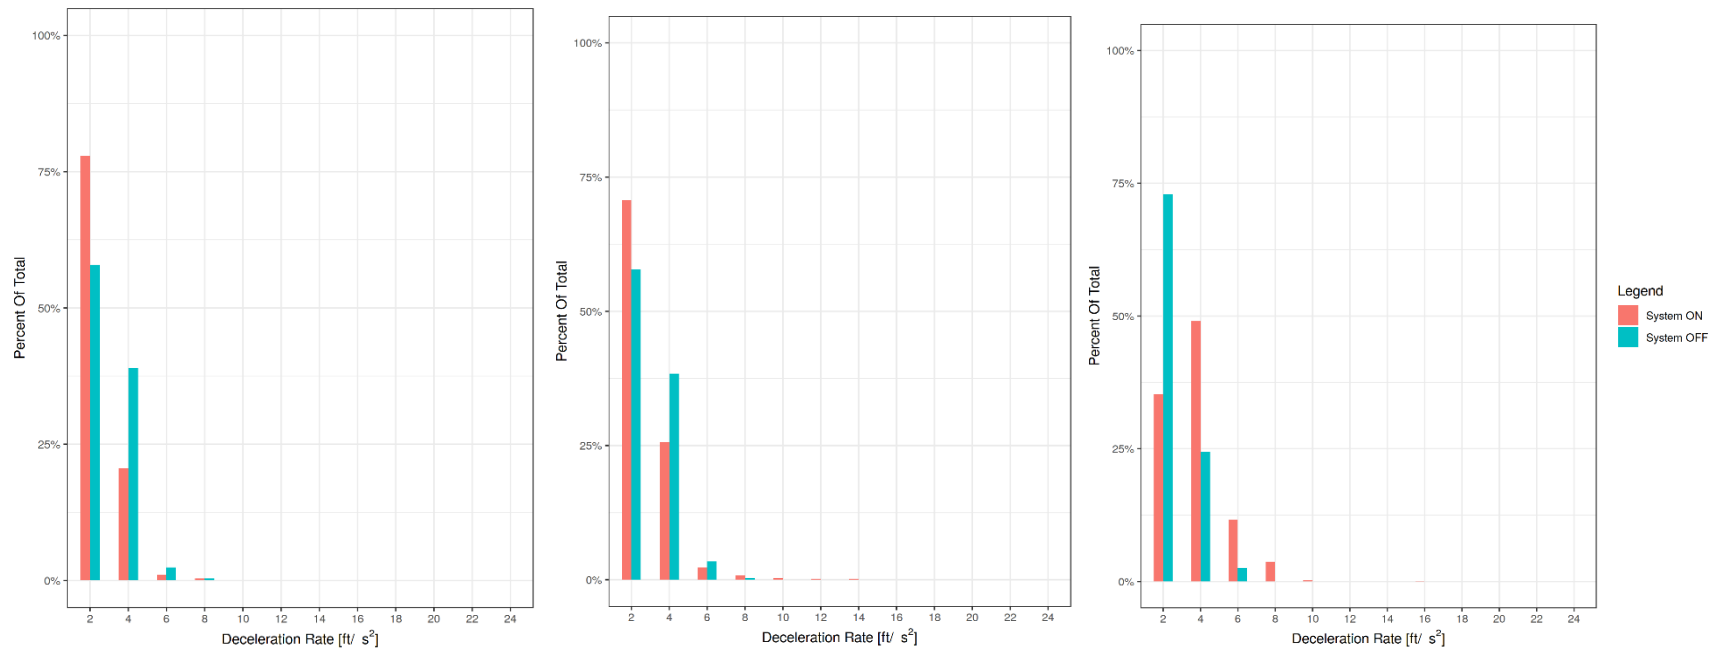
Figure 5.12 TH-61 Station. Calculated Deceleration. 3-Lane No Shoulder, Normal Road, Reduced Lanes Layouts

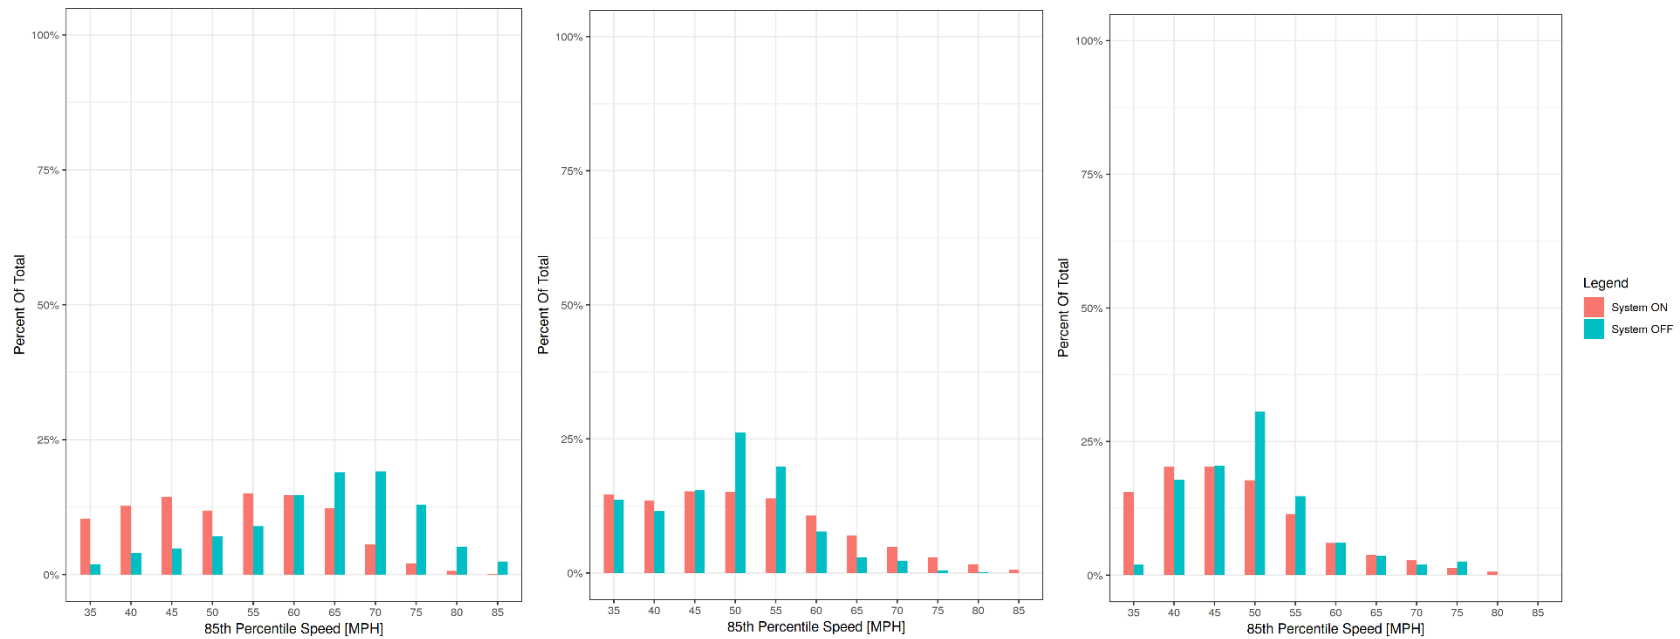
Figure 5.13 TH-61 Station. 85th-Percentile Speed. 3-Lane No Shoulder, Normal Road, Reduced Lanes Layouts

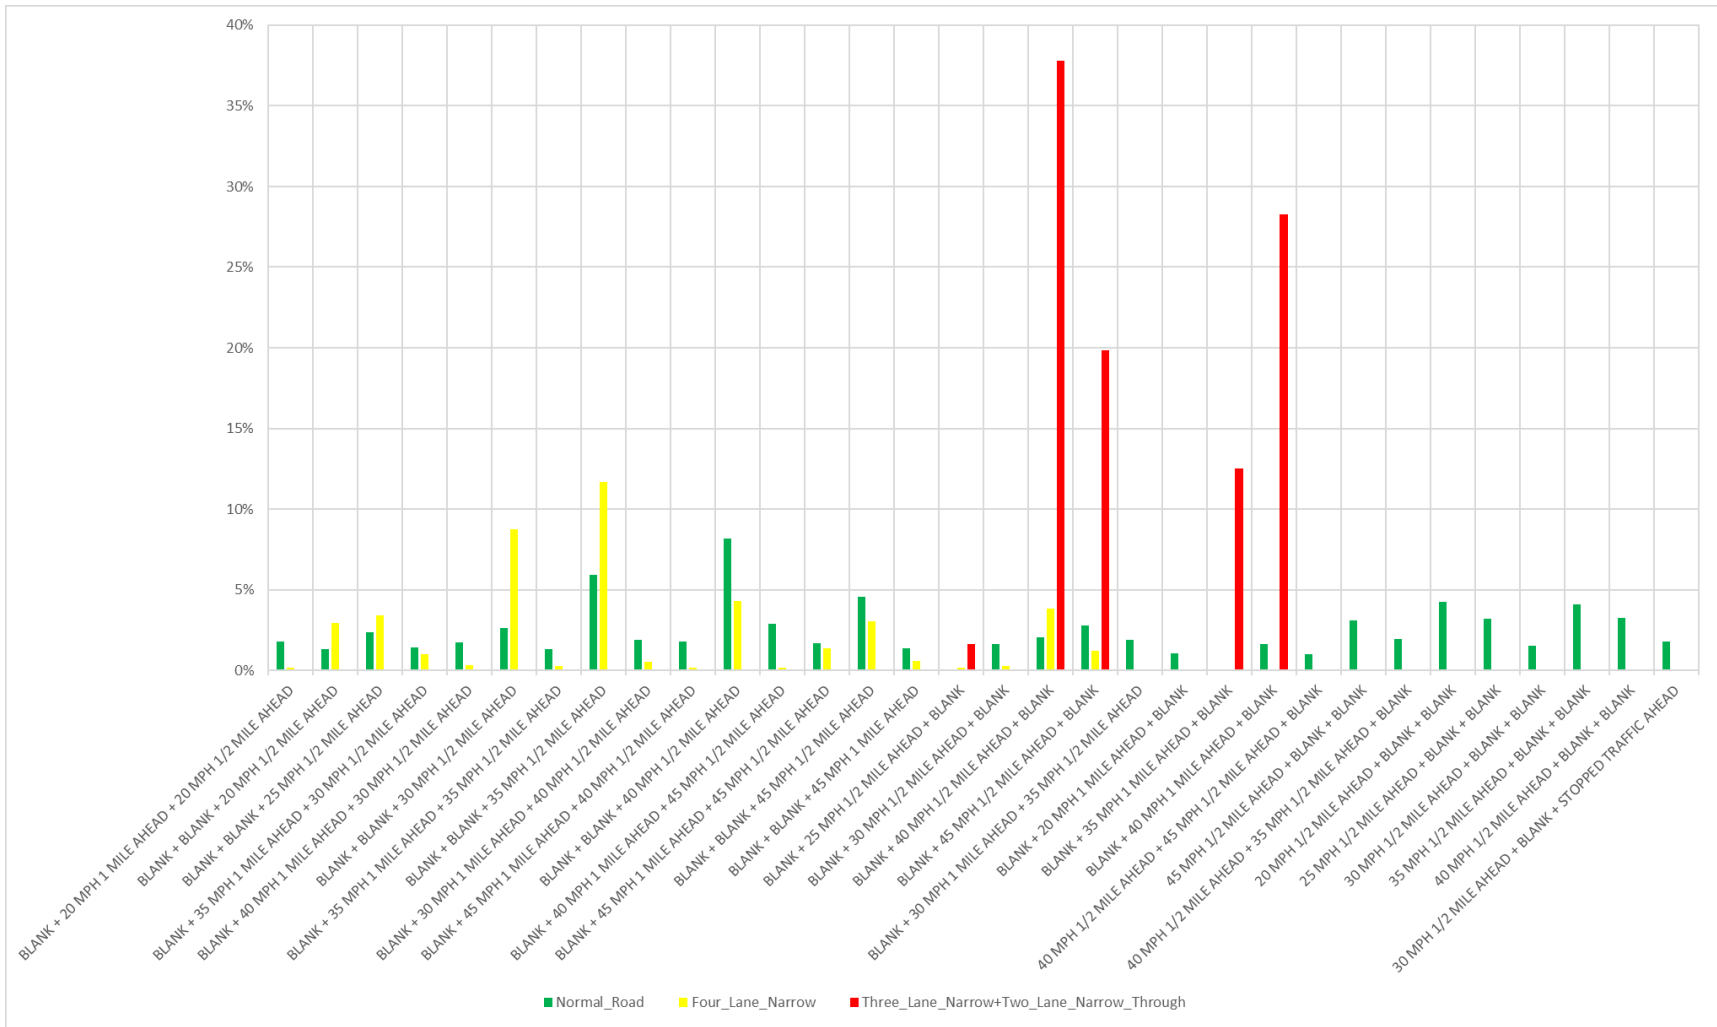
Figure 5.14 TH-61 Queued Vehicles Message history over last three trailers (three layouts)

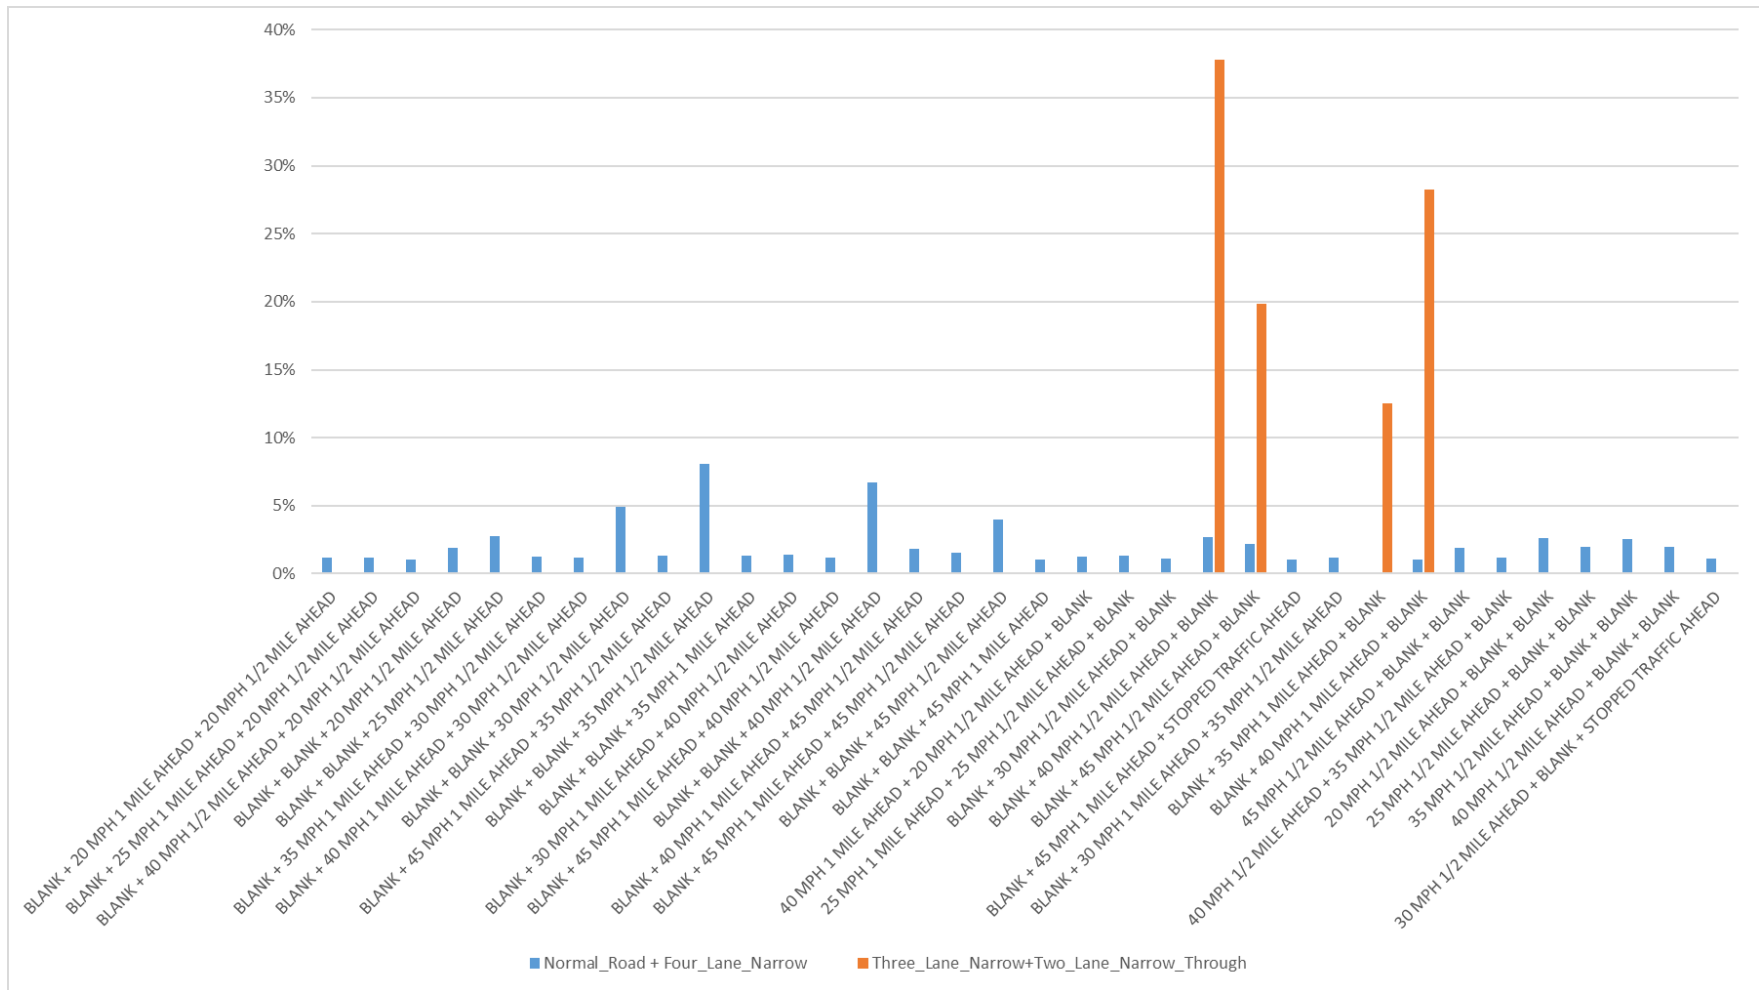
Figure 5.15 TH-61 Queued Vehicles Message history over last three trailers (combined layouts)

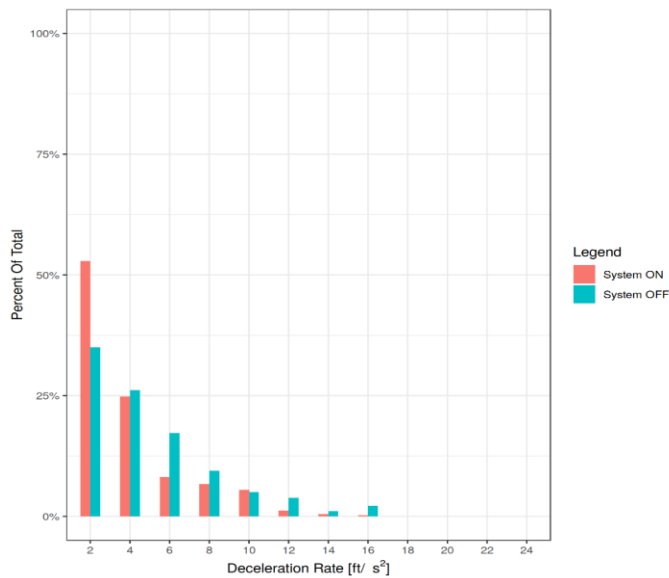
Figure 5.17 White Bear Ave Station. Calculated Deceleration. Reduced Lanes Layouts

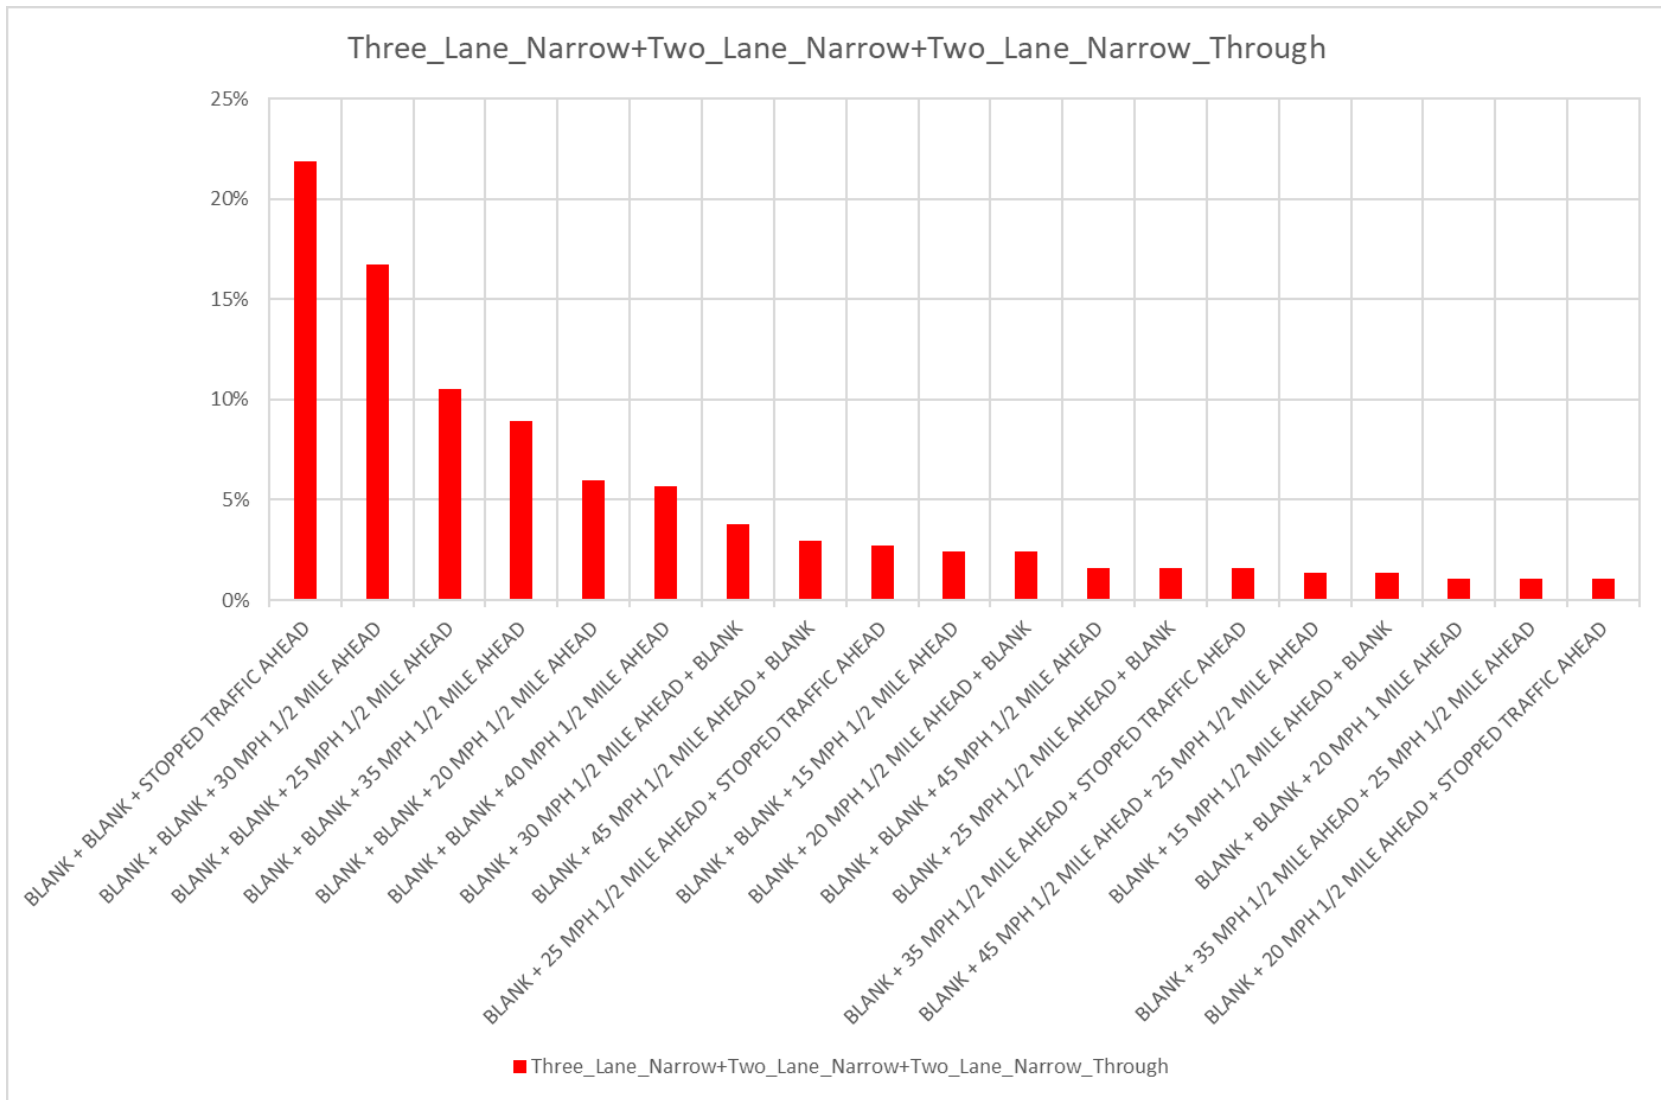
Figure 5.18 White Bear Ave Queued Vehicles Message history over last three trailers

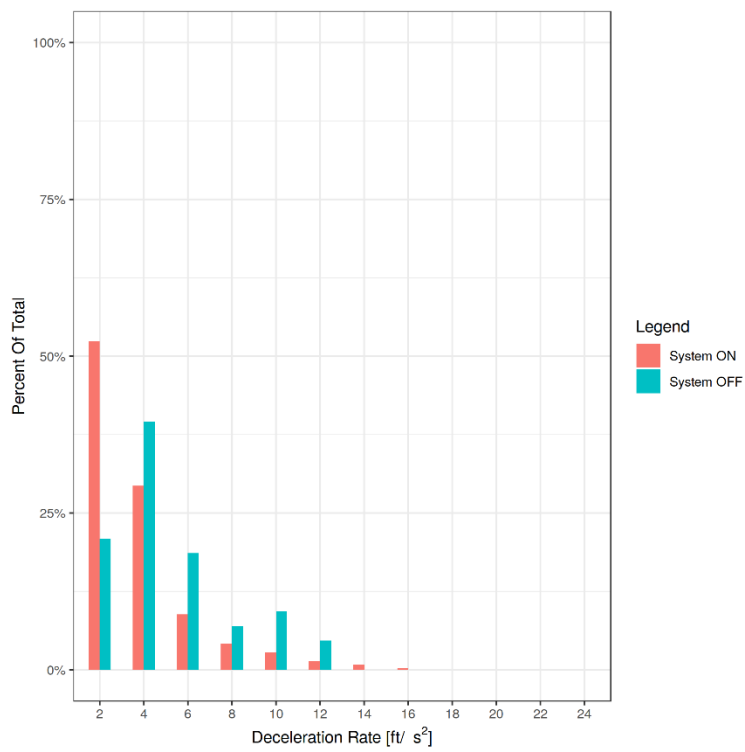
Figure 5.20 McKnight Ave Station. Calculated Deceleration. Reduced Lanes Layouts

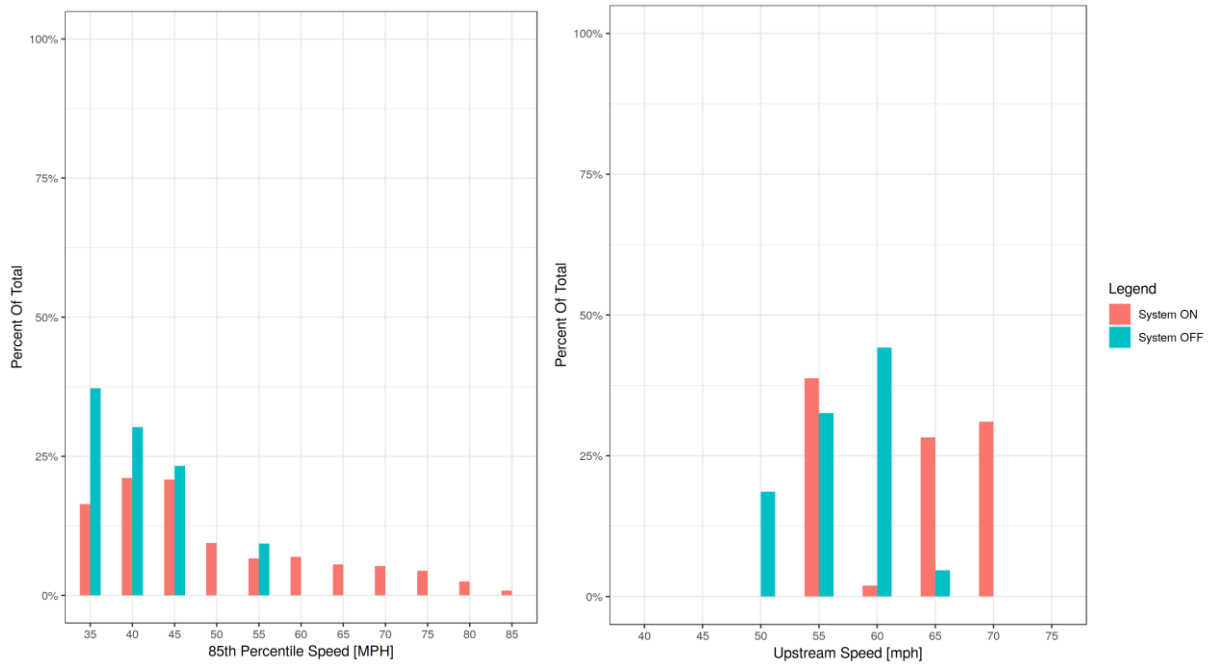
Figure 5.21 McKnight Ave Station. 85th-percentile Speed and Upstream Detector Speed. Reduced Lanes Layouts

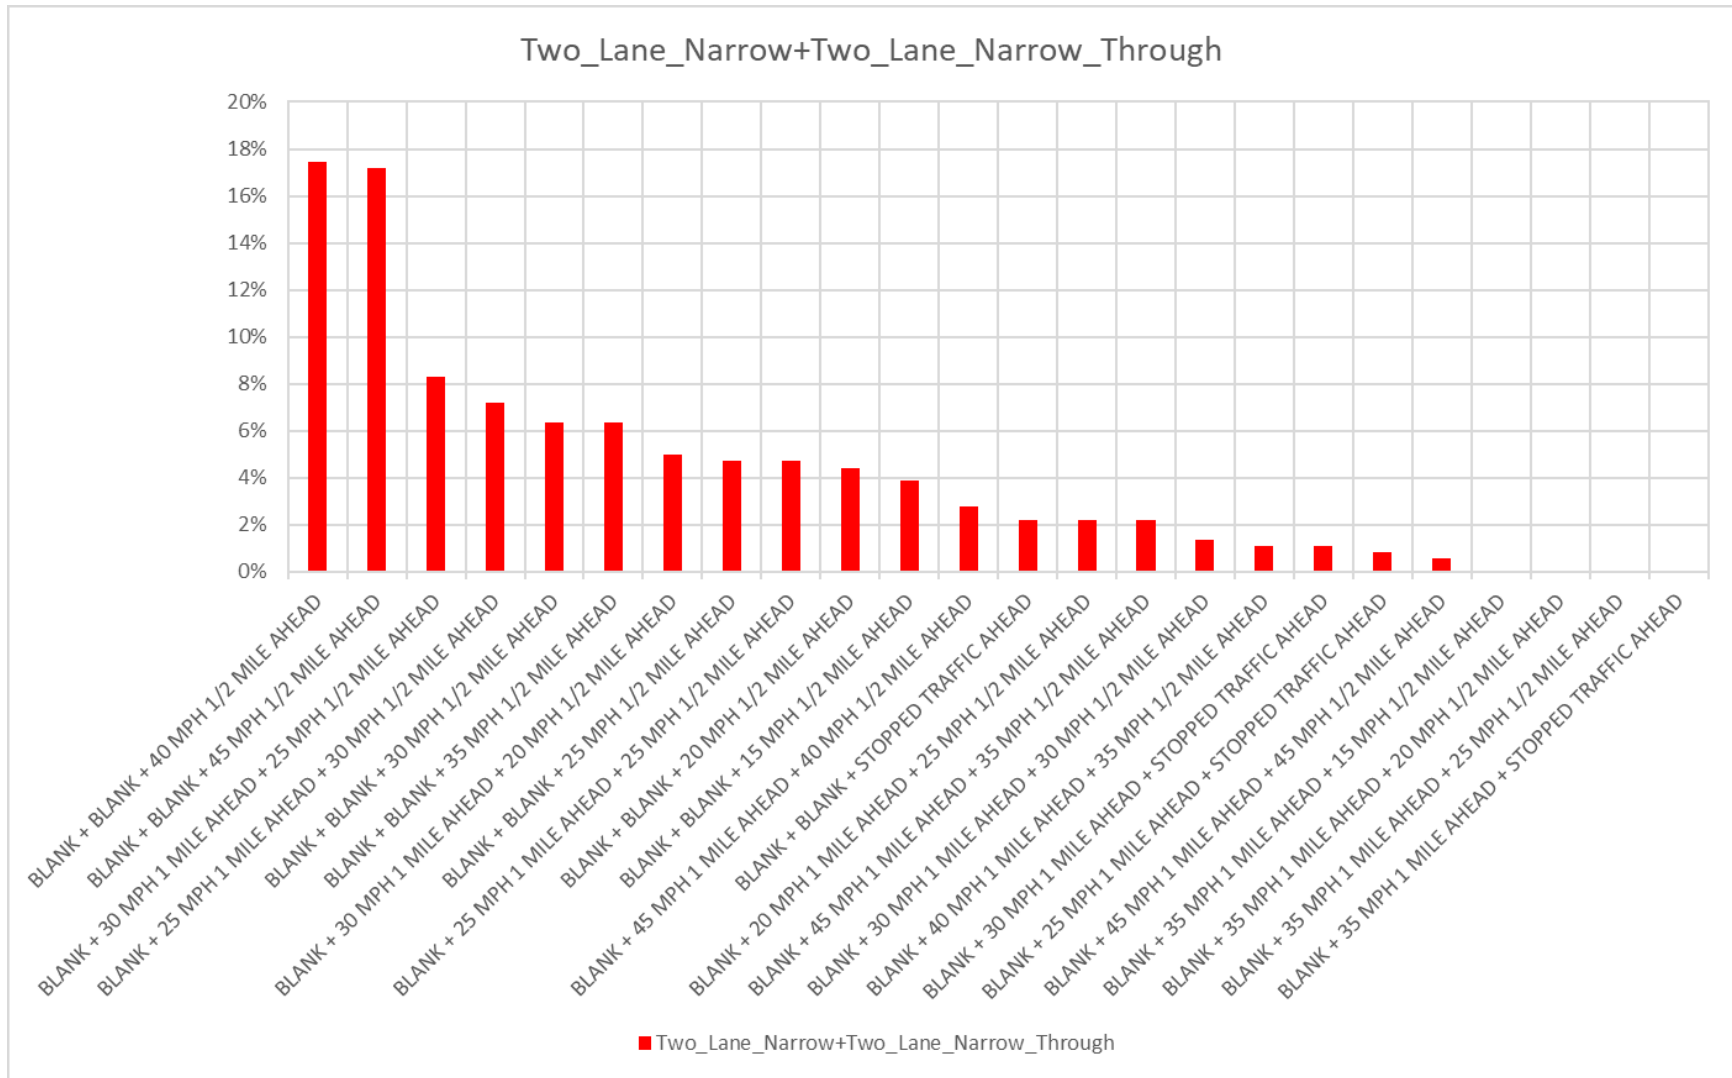
Figure 5.22 McKnight Ave Station Queued Vehicles Message history over last three trailers .

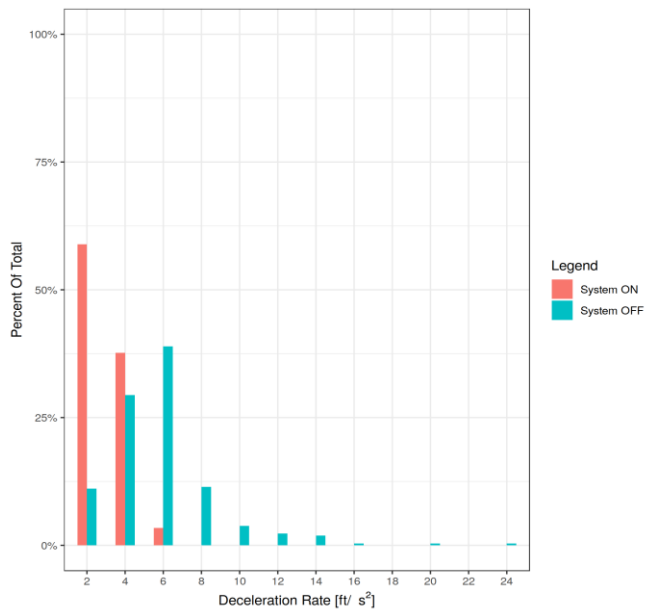
Figure 5.24 3M Station. Calculated Deceleration. Reduced Lanes Layouts

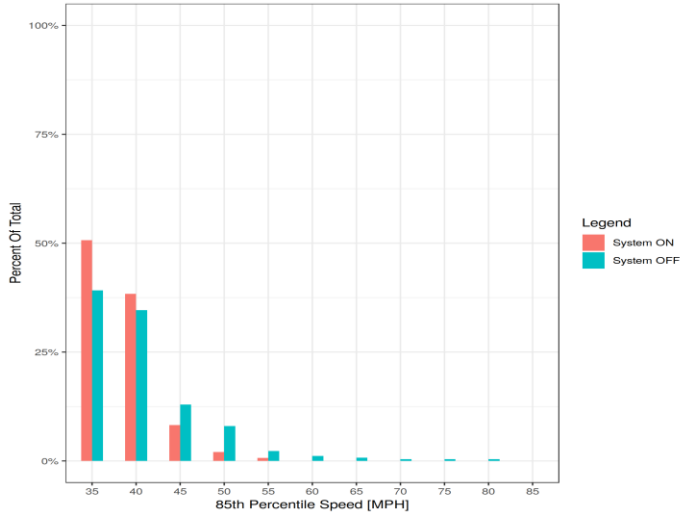
Figure 5.25 3M Station. 85th-percentile Speed. Reduced Lanes Layouts

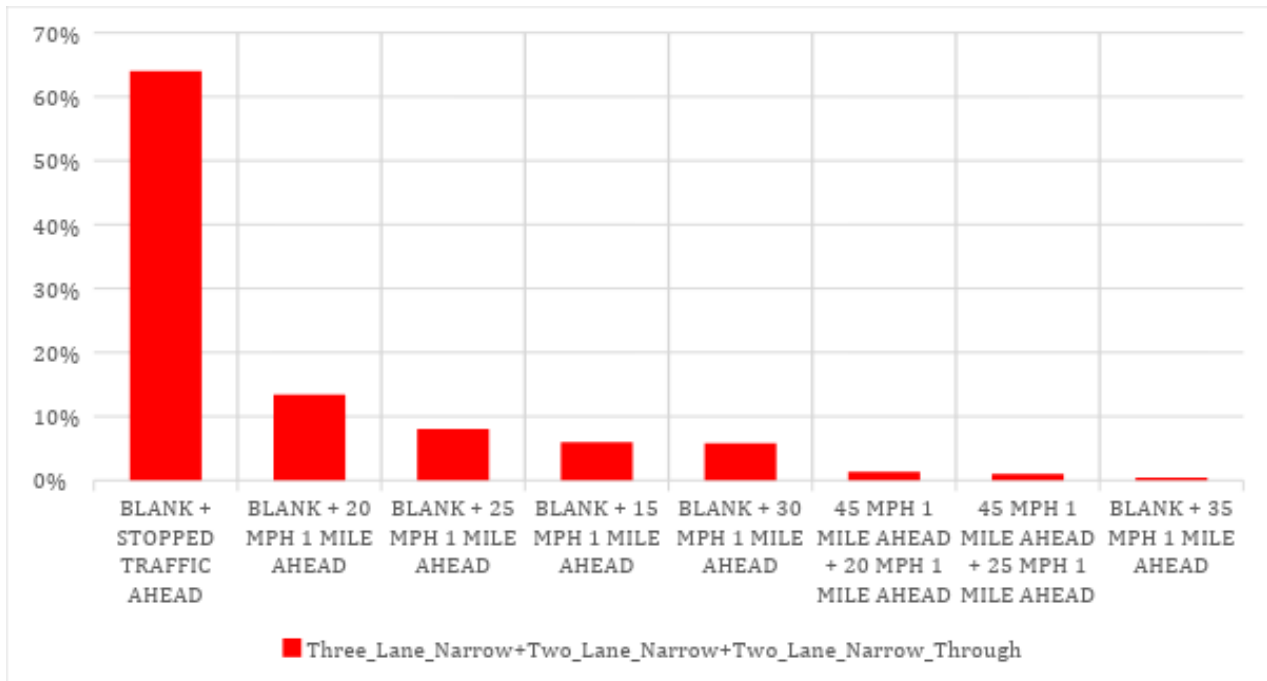
Figure 5.26 3M Station Queued Vehicles Message history over last three trailers

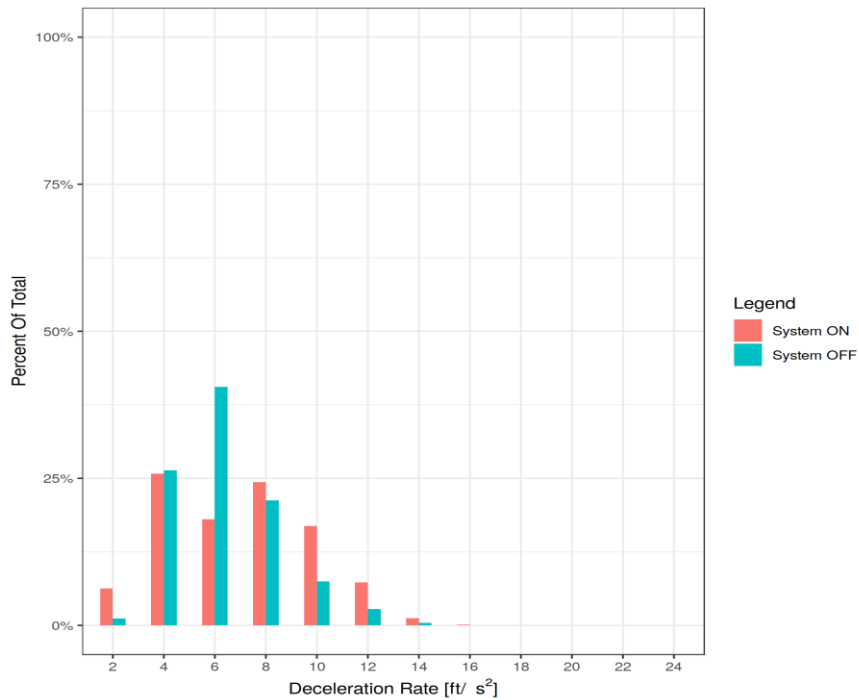
Figure 5.28 Century Avenue Station. Calculated Deceleration. Reduced Lanes Layouts
