Evaluation of the Smart Work Zone Speed Notification System

Minnesota Traffic Observatory

Research Project

Final Report 2019-21

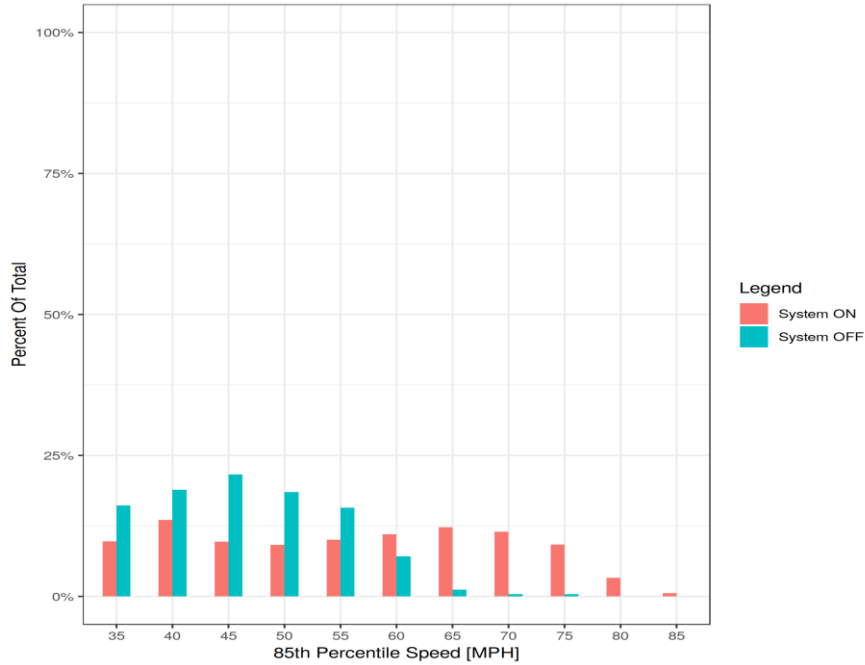
Figure 5.29 Century Ave Station. 85th-percentile Speed. Reduced Lanes Layouts

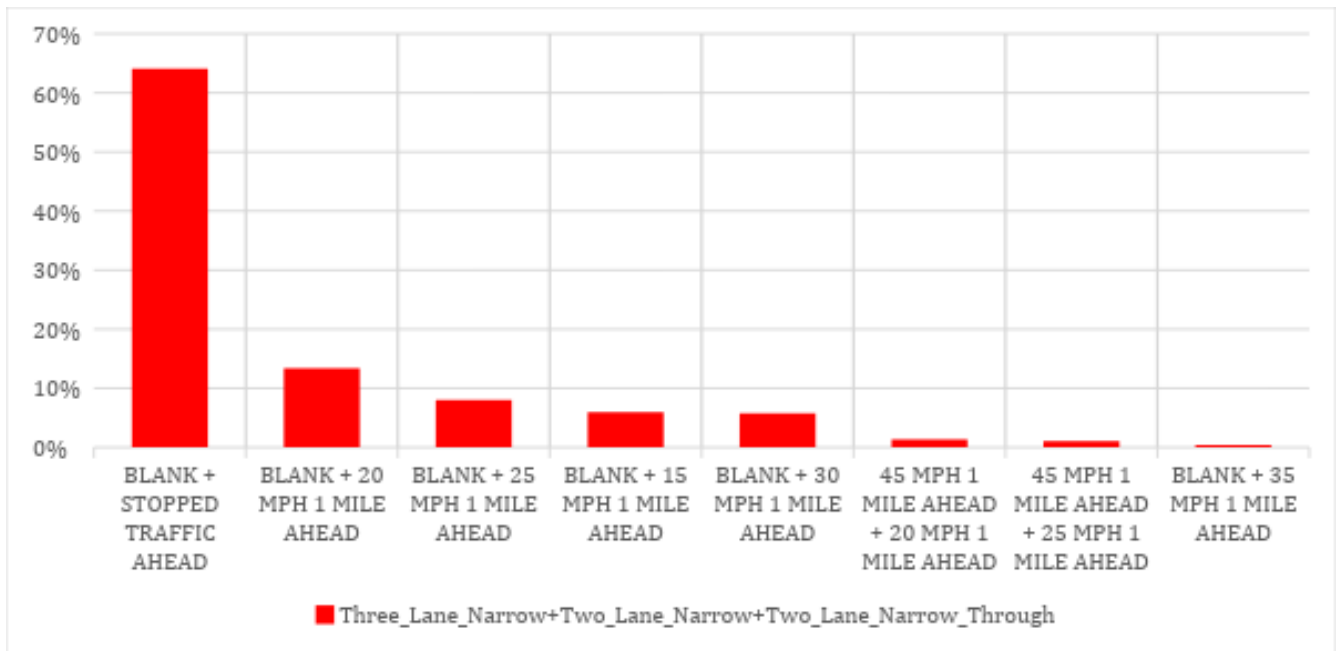
Figure 5.30 Century Ave Station Queued Vehicles Message history over last three trailers
