*Research Project No. TPF-5(193) Supplement #103  
NDOT Sponsoring Agency Code RHE-17M*

## **34-IN. TALL THRIE BEAM TRANSITION TO CONCRETE BUTTRESS**

MwRSF Research Report No. TRP-03-367-19

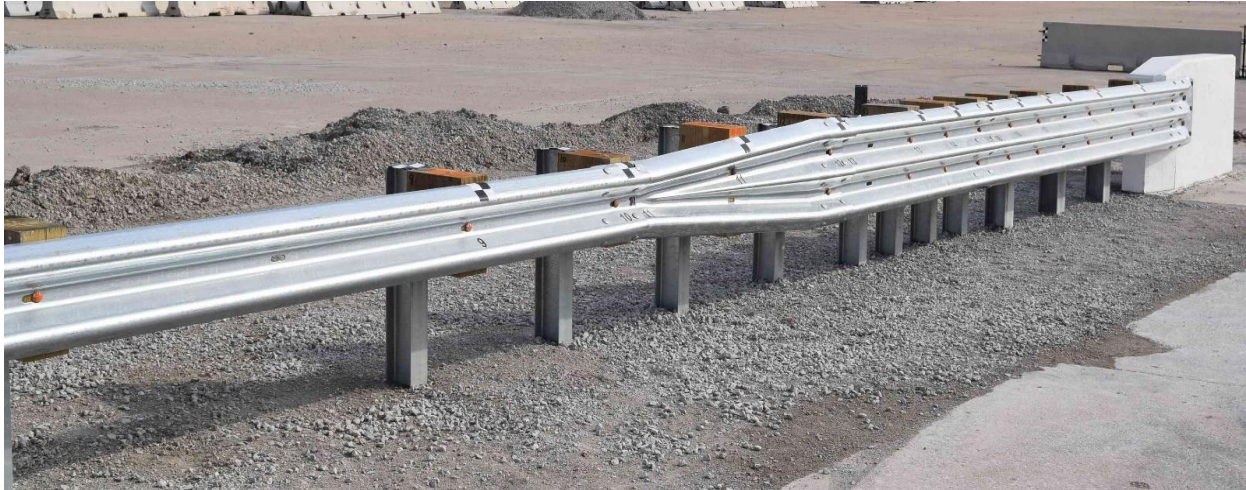
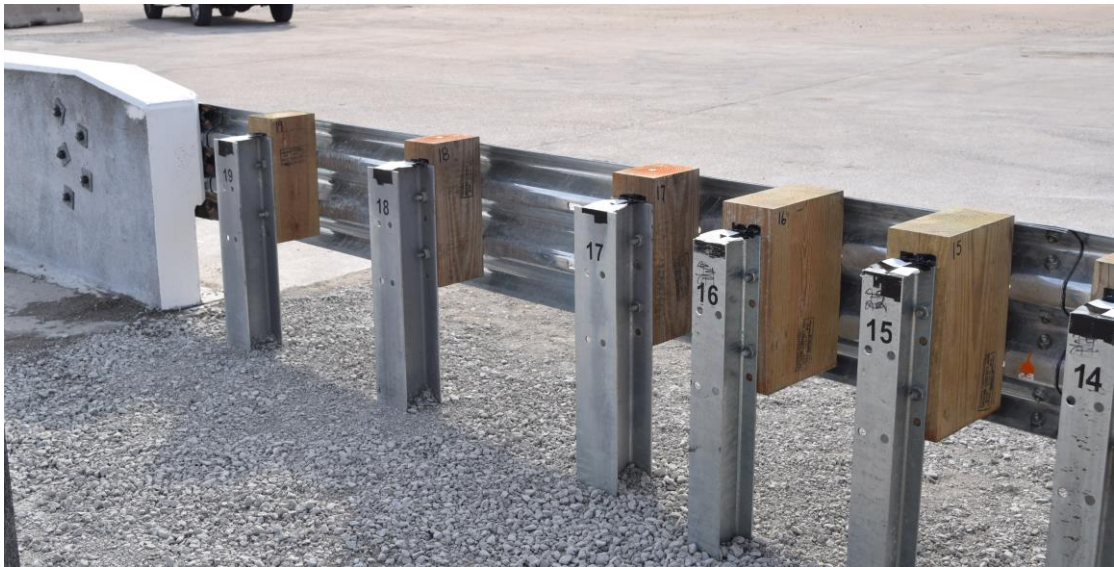
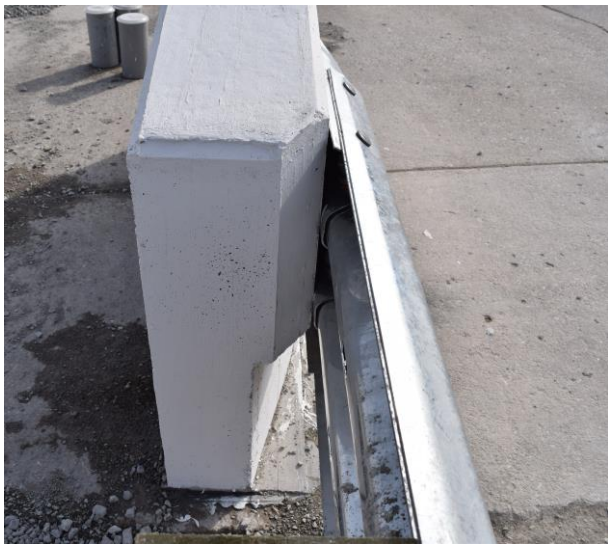
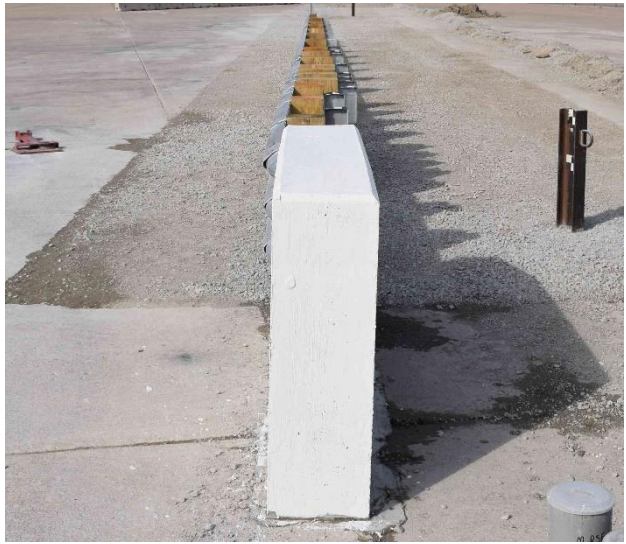
Figure 31. Test Installation Photographs, Test No. 34AGT-1

As requested by NDOT, test nos. 34AGT-1 and 34AGT-2 featured two different configurations of the splice between the nested thrie beam and the thrie beam terminal connector. In test no. 34AGT-1, the terminal connector was placed behind both plies of the nested thrie beam, as shown in Figure 31, while in test no. 34AGT-2 the terminal connector was sandwiched between the two plies of the nested thrie beam, as shown in Figure 32. NDOT typically installs terminal connectors in the sandwiched configuration.

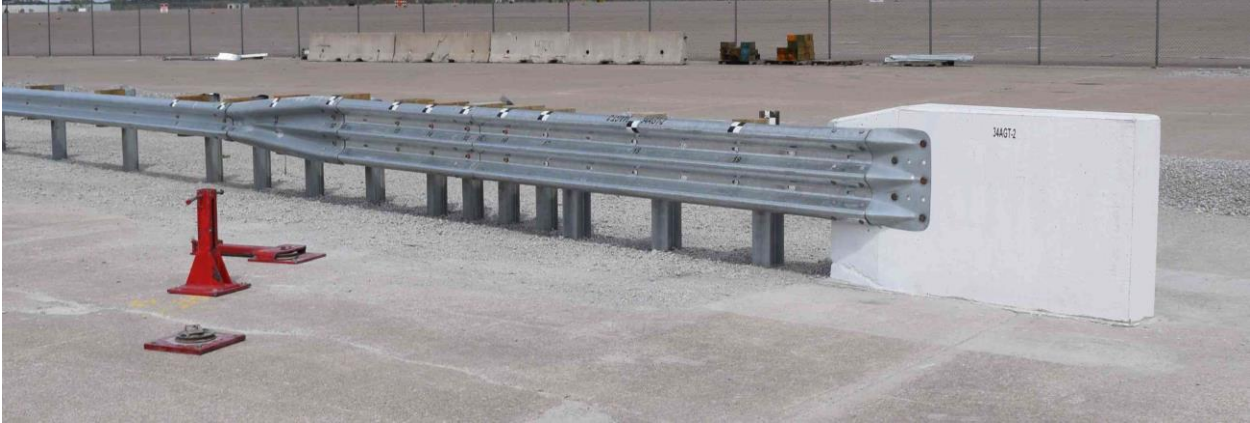
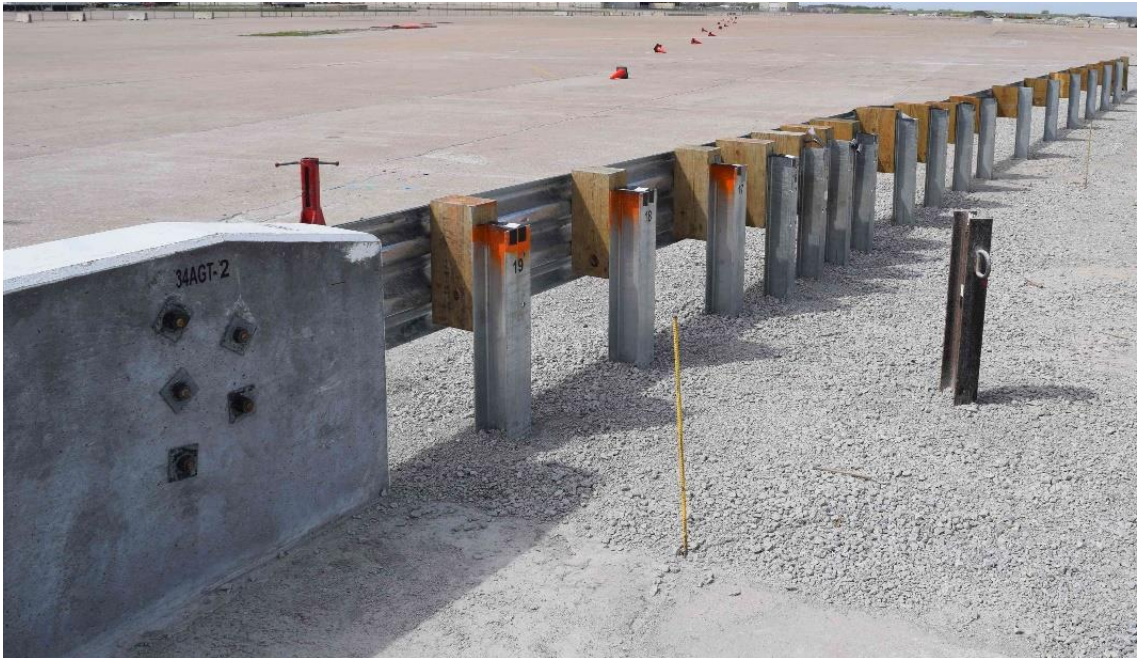
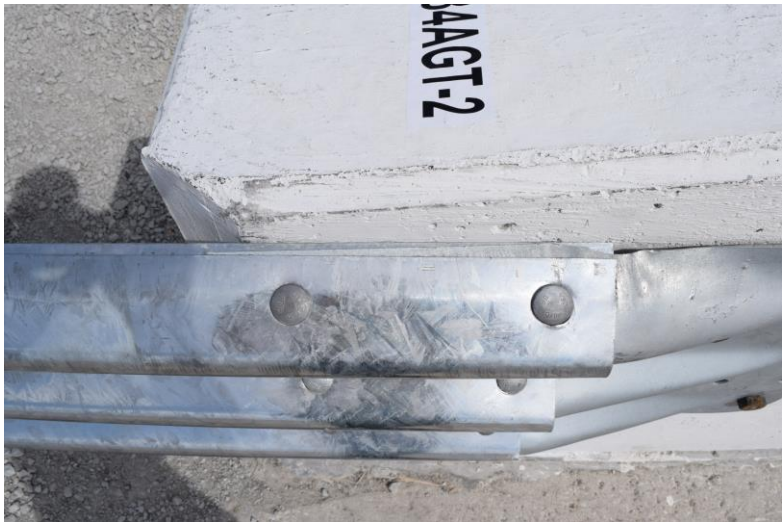
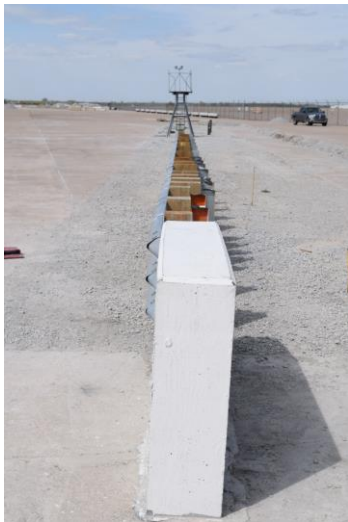
Figure 32. Test Installation Photographs, Test No. 34AGT-2

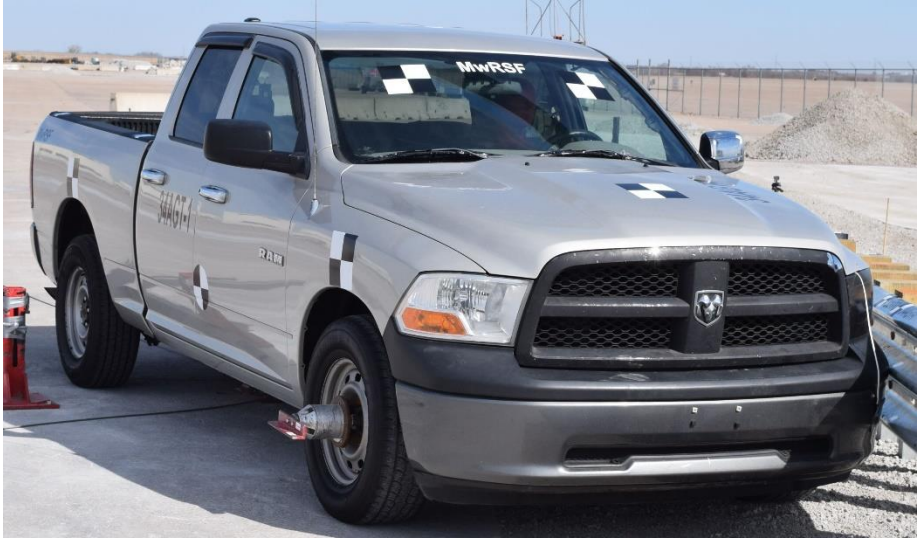
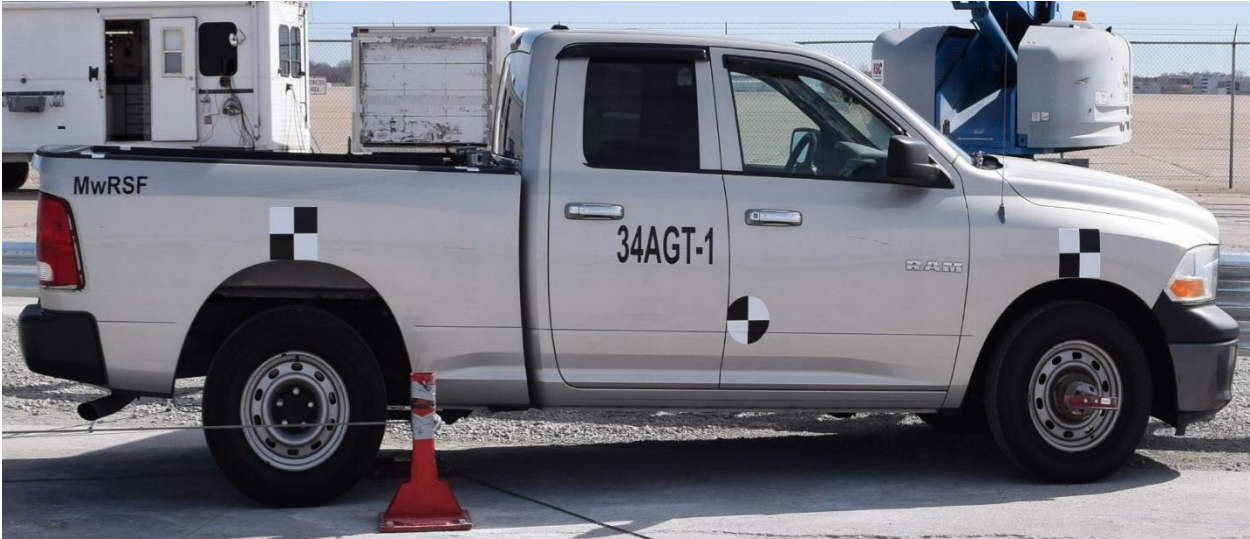
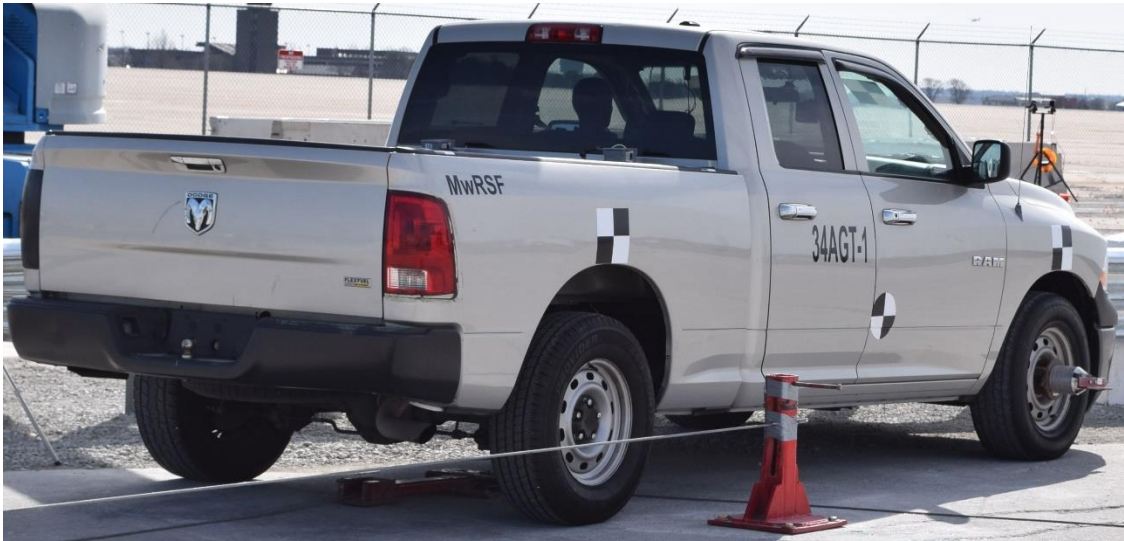
Figure 33. Test Vehicle, Test No. 34AGT-1

For test no. 34AGT-1, a 2010 Dodge Ram 1500 crew cab pickup truck was used as the test vehicle. The curb, test inertial, and gross static vehicle weights were 5,085 lb (2,307 kg), 5,024 lb (2,279 kg), and 5,189 lb (2,354 kg), respectively. The test vehicle is shown in Figure 33, and vehicle dimensions are shown in Figure 34. Note, pre-test photographs of the vehicle's interior floorboards and undercarriage for test no. 34AGT-1 were not available.

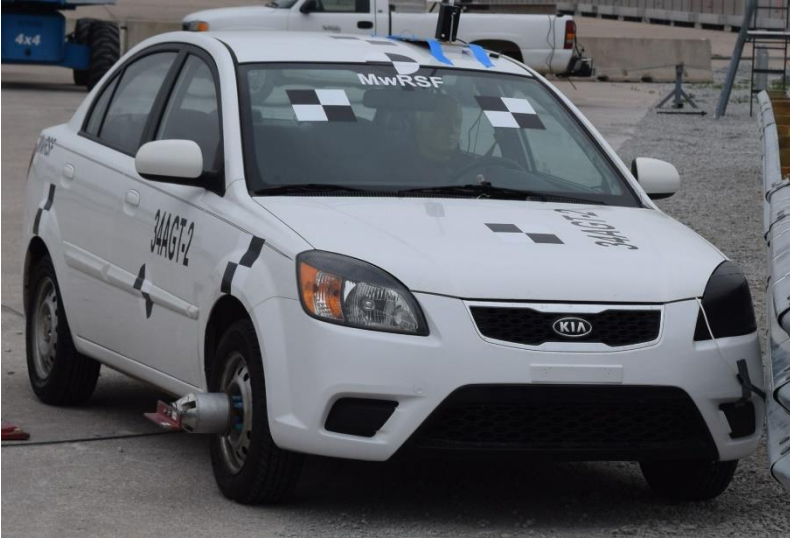
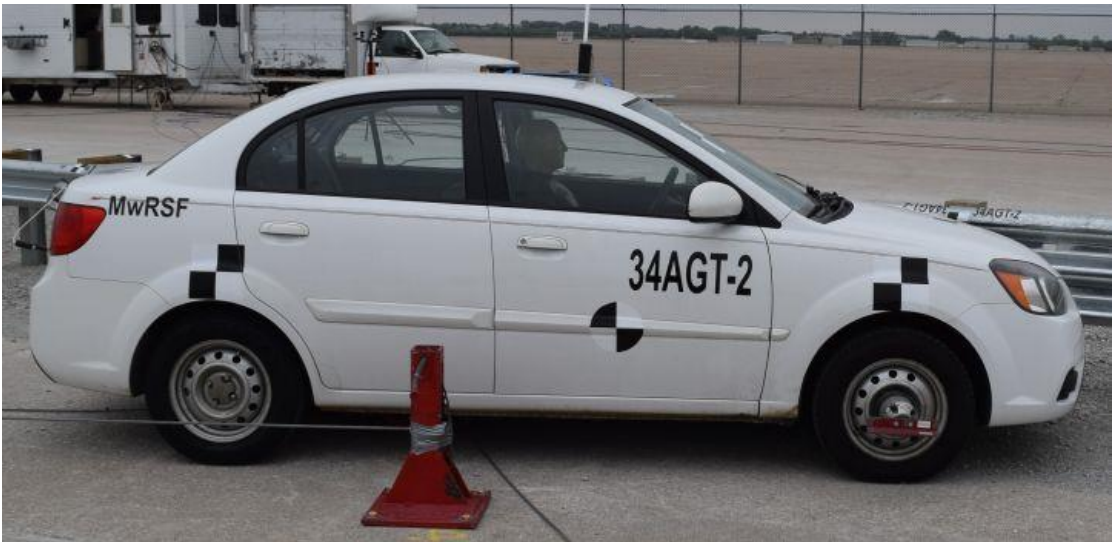
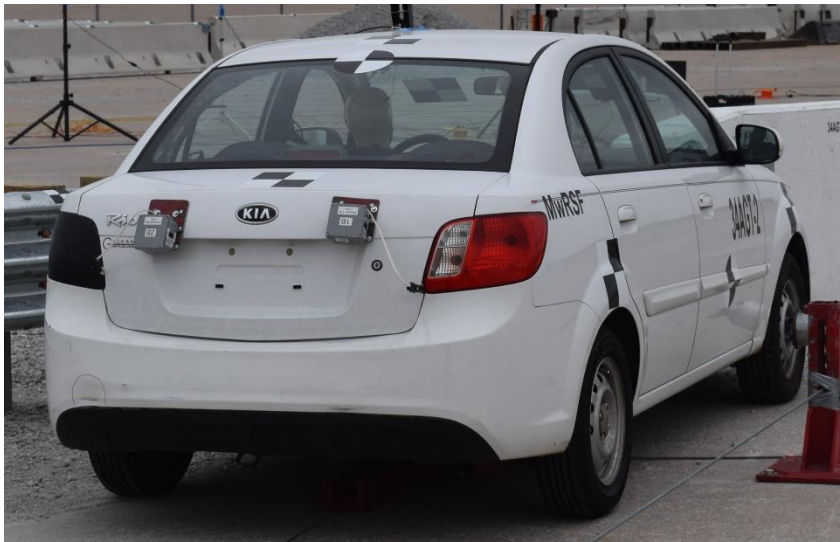
Figure 35. Test Vehicle, Test No. 34AGT-2

For test no. 34AGT-2, a 2011 Kia Rio subcompact sedan was used as the test vehicle. The curb, test inertial, and gross static vehicle weights were 2,331 lb (1,057 kg), 2,420 lb (1,098 kg), and 2,580 lb (1,170 kg), respectively. The test vehicle is shown in Figure 35, and vehicle dimensions are shown in Figure 36. Note, pre-test photographs of the vehicle's interior floorboards and undercarriage for test no. 34AGT-2 were not available.

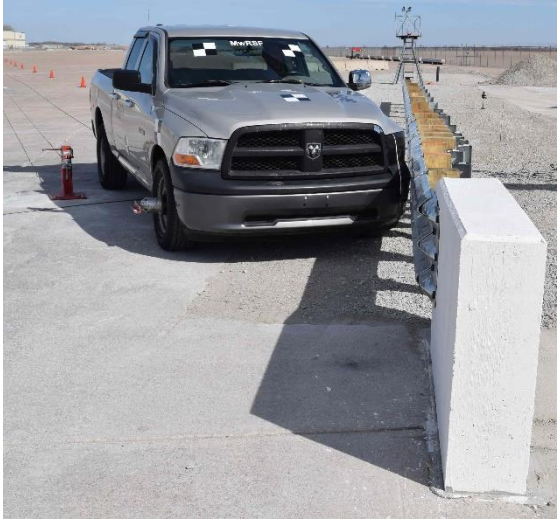
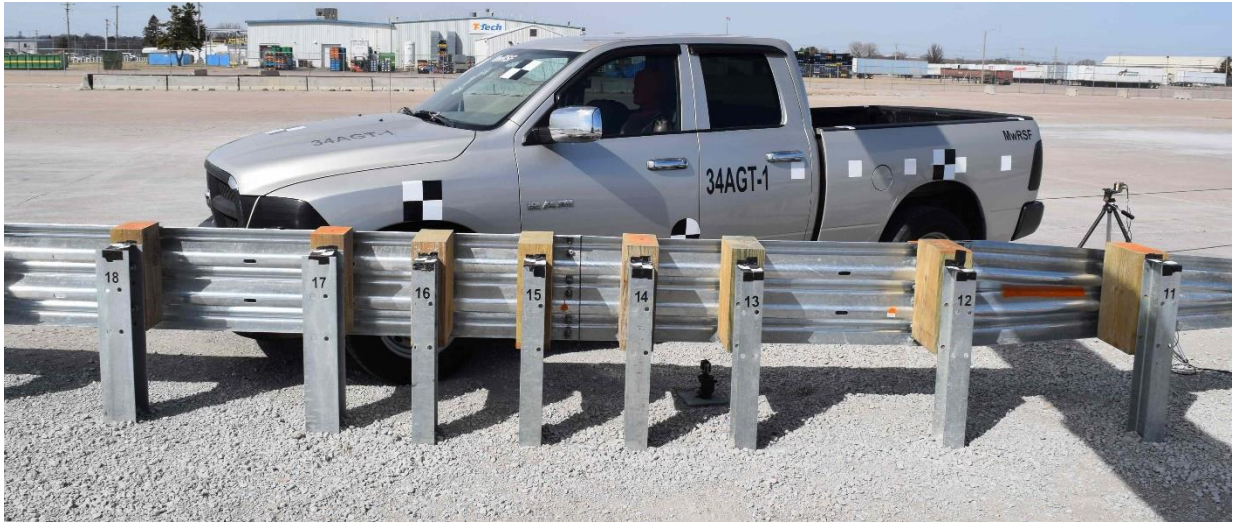
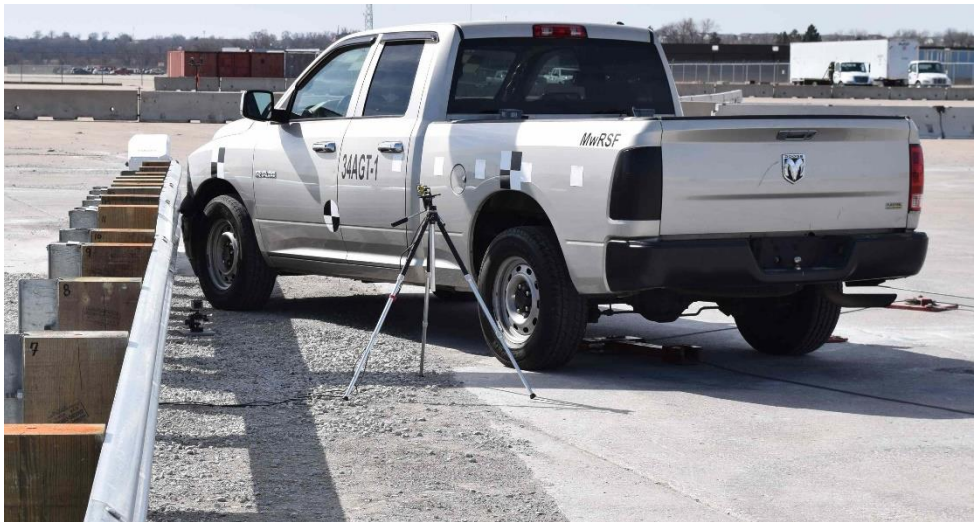
Figure 41. Impact Location, Test No. 34AGT-1

The main concern with vehicles impacting the 34-in. (864-mm) tall AGT was related to vehicle snag on the rigid parapet. Accordingly, the critical impact point for test no. 34AGT-1 was selected using the tables provided in section 2.3.2.1 of MASH 2016 to maximize the potential for snag on the upstream face of the concrete buttress. The critical impact point was determined to be 89 in. (2,261 mm) upstream from the concrete buttress, as shown in Figure 41.

During test no. 34AGT-1, the 5,024-lb (2,279-kg) pickup truck impacted the AGT 90½ in. (2,299 mm) upstream from the concrete buttress at a speed of 62.2 mph (100.1 km/h) and an angle of 24.8 degrees. The vehicle was contained and smoothly redirected with an exit speed and angle of 42.1 mph (67.8 km/h) and -10.8 degrees, respectively. The vehicle remained stable throughout the impact event with maximum roll and pitch angular displacements of only 12 degrees and 4 degrees, respectively. After exiting the system, the vehicle impacted a row of temporary concrete barriers 162 ft (49.4 m) downstream from impact and quickly came to a stop.

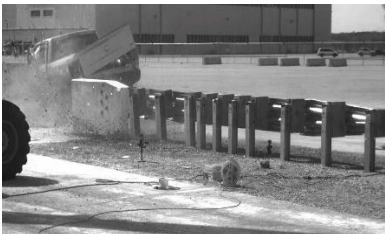
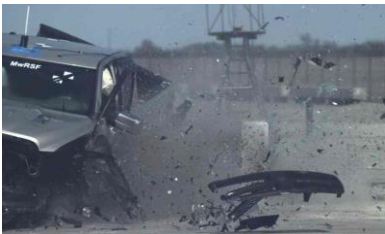
Figure 42. Additional Sequential Photographs, Test No. 34AGT-1

A detailed description of the sequential impact events is contained in Table 4. Sequential photographs are shown in Figures 42 and 43. Documentary photographs of the crash test are shown in Figure 44. Vehicle trajectory and final position photographs are shown in Figure 45.

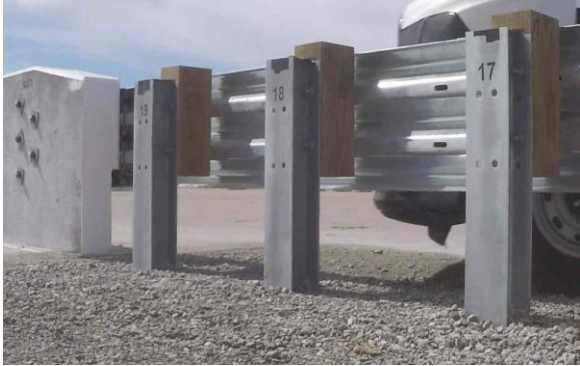
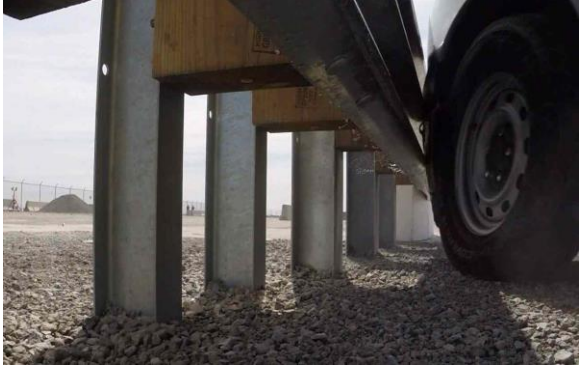
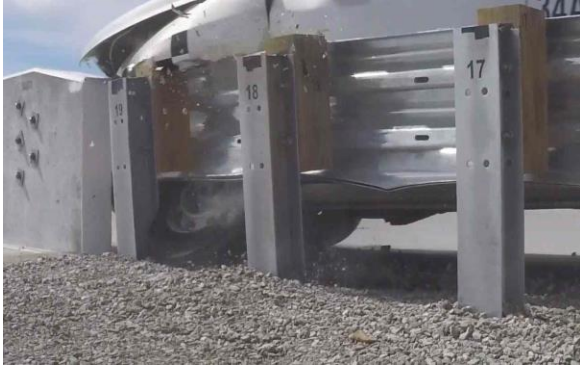
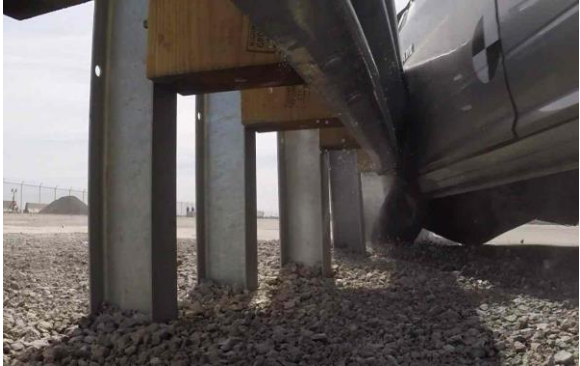
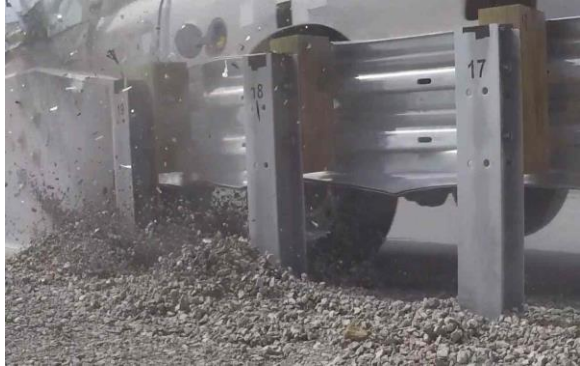
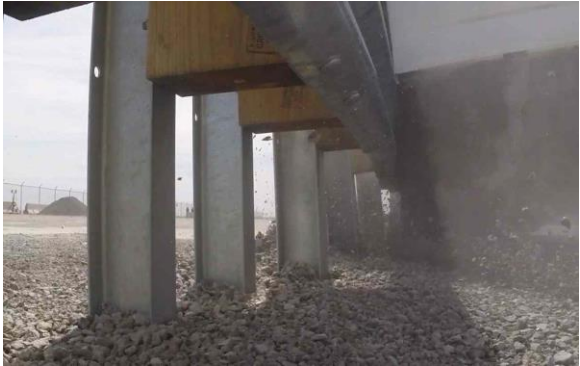
Figure 44. Documentary Photographs, Test No. 34AGT-1

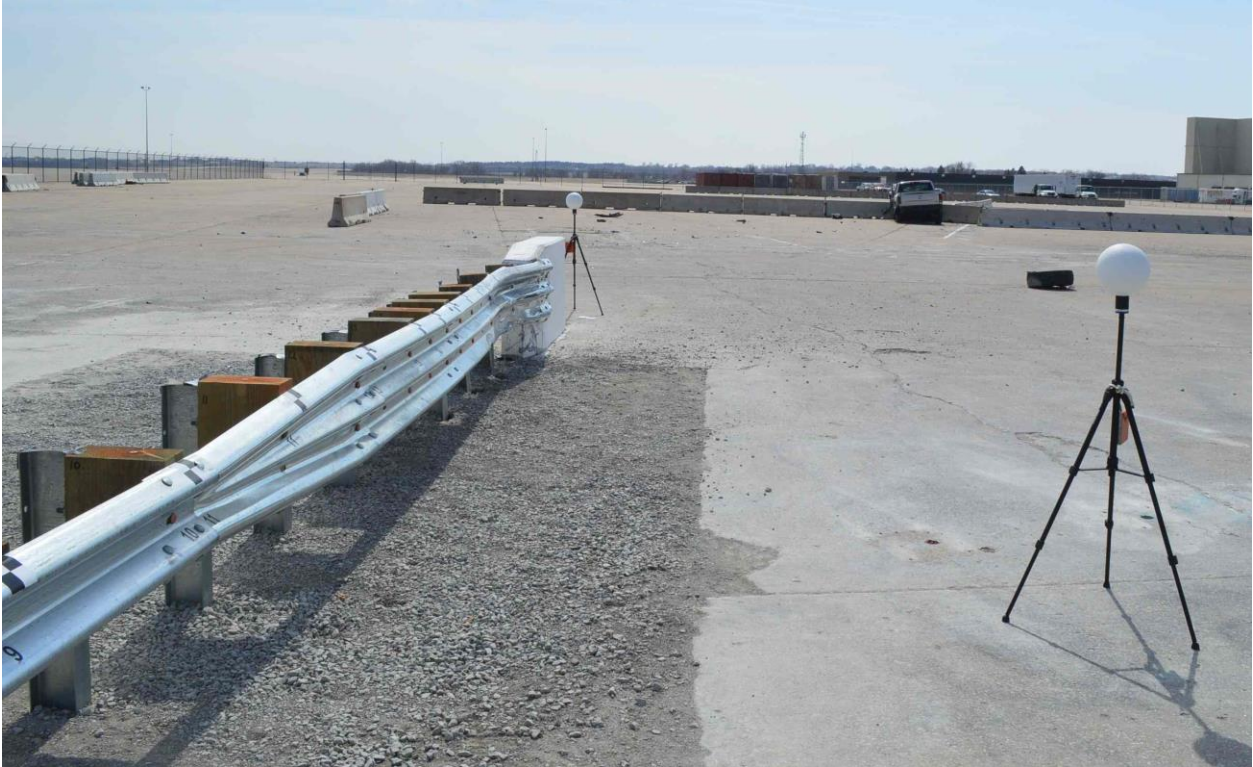
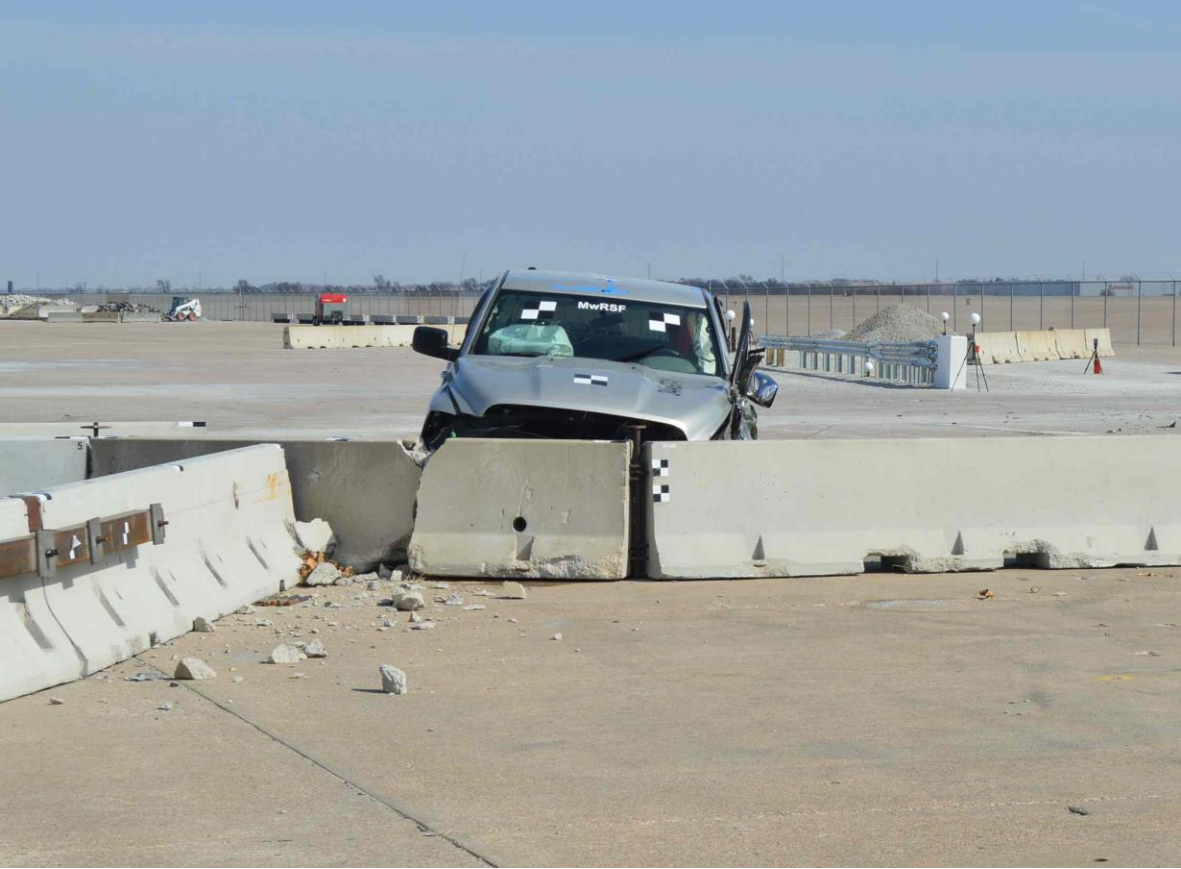
Figure 45. Vehicle Final Position and Trajectory Marks, Test No. 34AGT-1

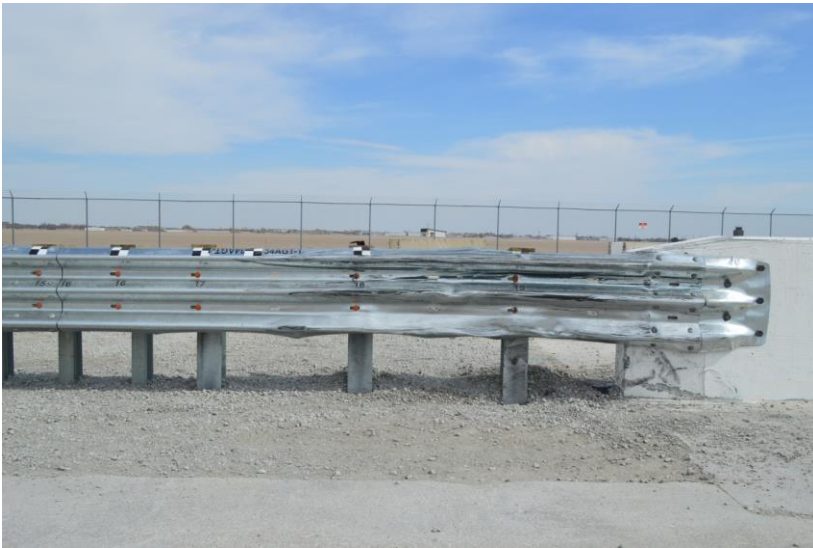
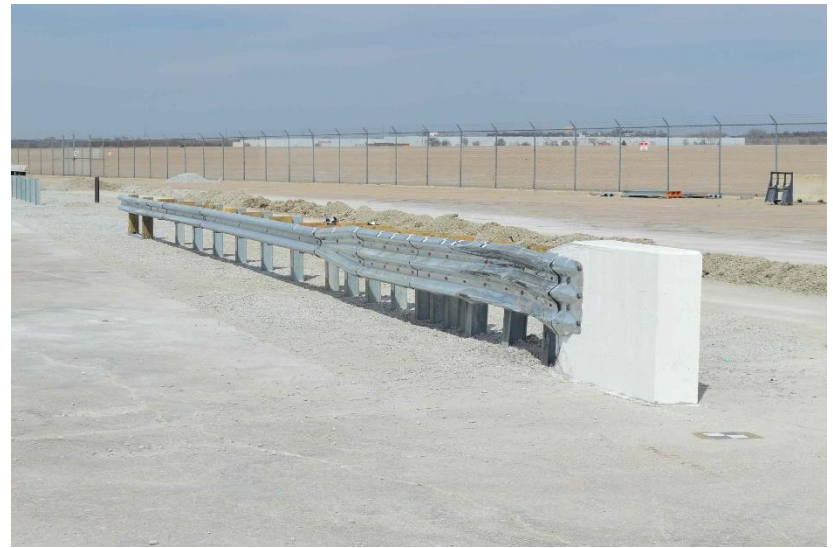
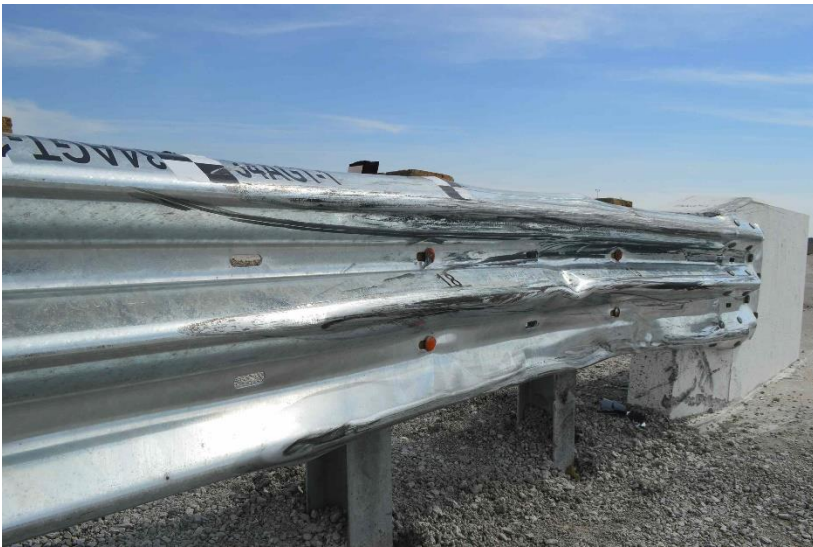
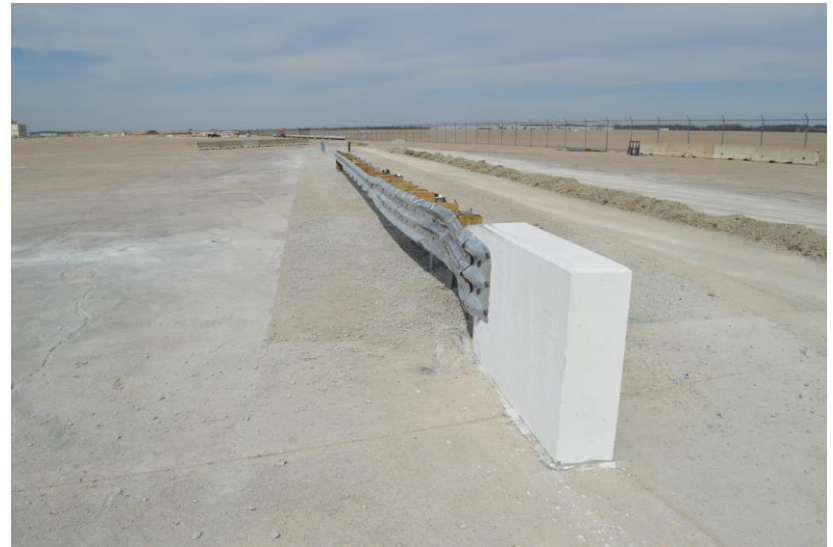
Figure 46. System Damage, Test No. 34AGT-1

Damage to the barrier was moderate, as shown in Figures 46 through 49. Barrier damage consisted of rail and post deformation, contact marks on the top and front face of the concrete buttress, concrete gouging, and concrete cracking. The length of vehicle contact along the barrier was approximately 12 ft – 2½ in. (3.7 m) which spanned from 10 in. (254 mm) downstream from post no. 17 to 28 in. (711 mm) from the downstream end of the concrete buttress.

Tire marks were visible on the front face of the concrete buttress and on the lower chamfer of the buttress. Concrete gouging was observed along the entire length of the lower chamfer of the buttress and extended an additional 3 in. (76 mm) onto the front face of the buttress. The gouging was 3 in. (76 mm) from the bottom, and gradually sloped down to the bottom edge over its duration. Contact marks were found on the top and front face of the buttress beginning at the upstream end and extended to 28 in. (711 mm) from the downstream end. A hairline crack was found on the front face of the concrete buttress, extending upward and downstream at approximately a 45-degree angle from the top bolt hole of the thrie beam terminal connector to the top surface of the buttress.

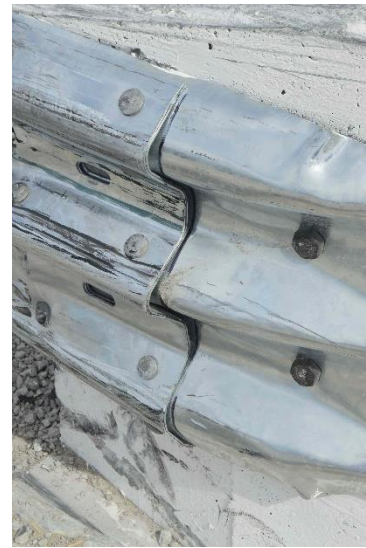
Figure 48. System Damage, Post No. 19 and Rail Connection Terminal, Test No. 34AGT-1

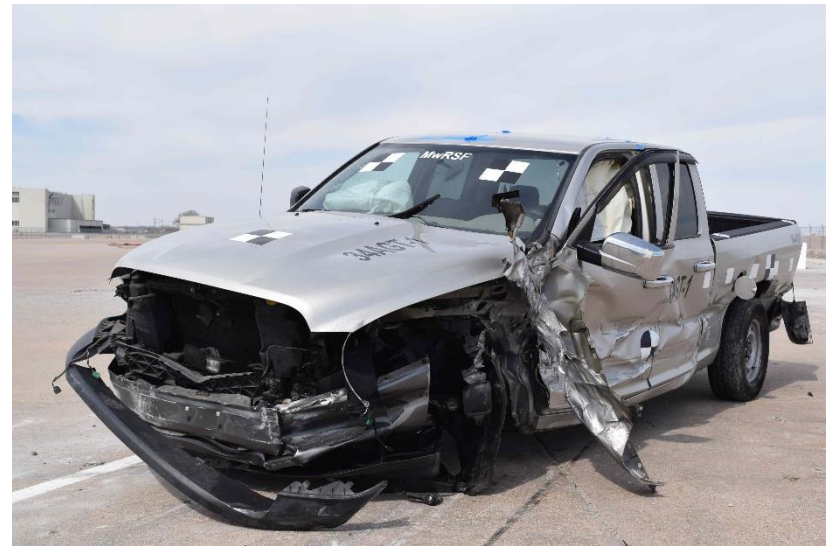
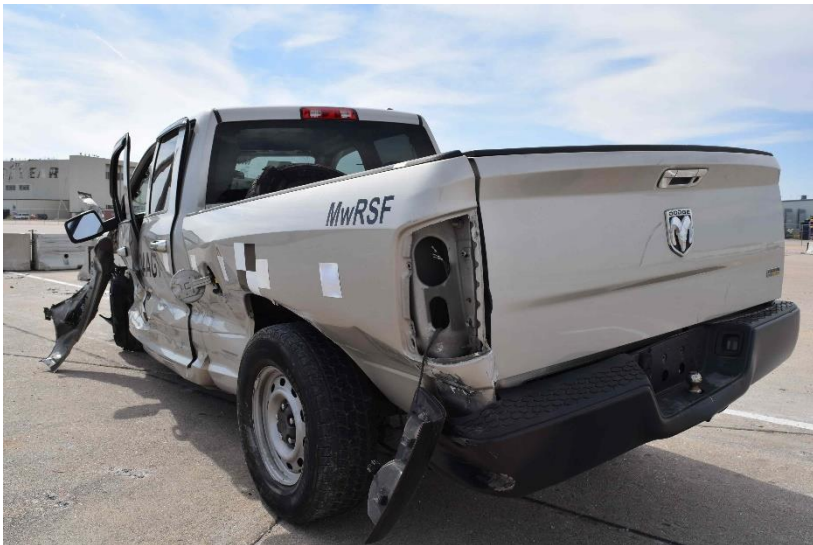
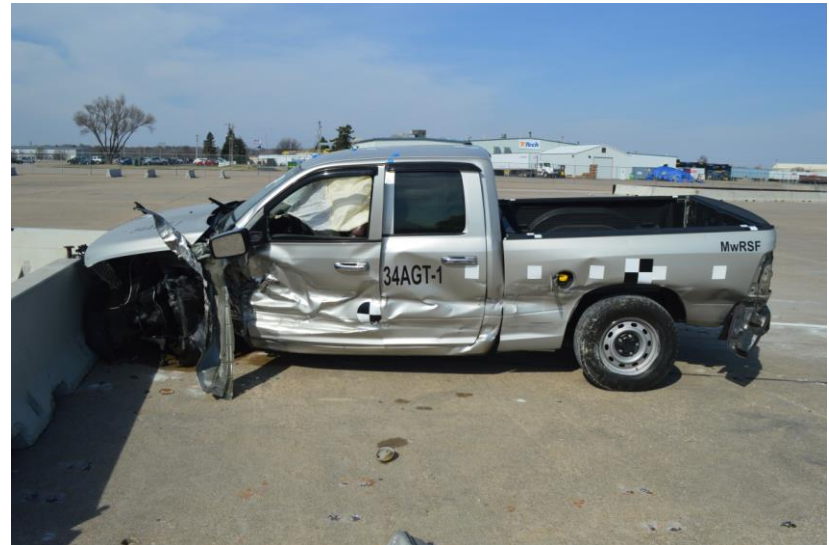
Figure 51. Vehicle Damage, Test No. 34AGT-1

The damage to the vehicle was moderate, as shown in Figures 51 through 53. The majority of damage was concentrated on the left-front corner and left side of the vehicle where the impact occurred. The left side of the front bumper was crushed inward and back. The left-front fender was pushed upward near the door panel and was dented and torn behind the left-front wheel. Both headlights and the grille were disengaged from the vehicle. The left side of the radiator was pushed backward. Denting and scraping was observed on the entire left side of the pickup truck. The bottom of the left-front door was crushed inward, and the top of the door was ajar. The left-rear door was dented. The left taillight was out of socket, but remained attached. The left side of the rear bumper was dented, scuffed, and partially disengaged.

The left-front wheel was disengaged from the vehicle, and the steel rim was deformed with tears and significant crushing. The left-front tire was torn and deflated. The left upper control arm was fractured. The left-front steering knuckle and ball joints were disengaged, and the upper control arm was bent toward the engine. The left-rear wheel assembly was deformed inward, the steel rim was dented, and scuff marks were found on the tire.

The right side of the front bumper was deformed inward and downward. The hood had a 2-in. (51-mm) gap on the right side. The right-front fender was dented in at the top and back, and the right-front tire was deformed inward. The right side of the windshield was deformed and had spiderweb cracking from the airbag deployment. The left-front window was shattered. The roof had a minor dent, and the remaining window glass remained undamaged. Note, a portion of the vehicle damage, especially to the front and right side of the truck, was due to the secondary impact with the portable concrete barriers downstream of the system that was set up to contain the vehicle after exiting the system.

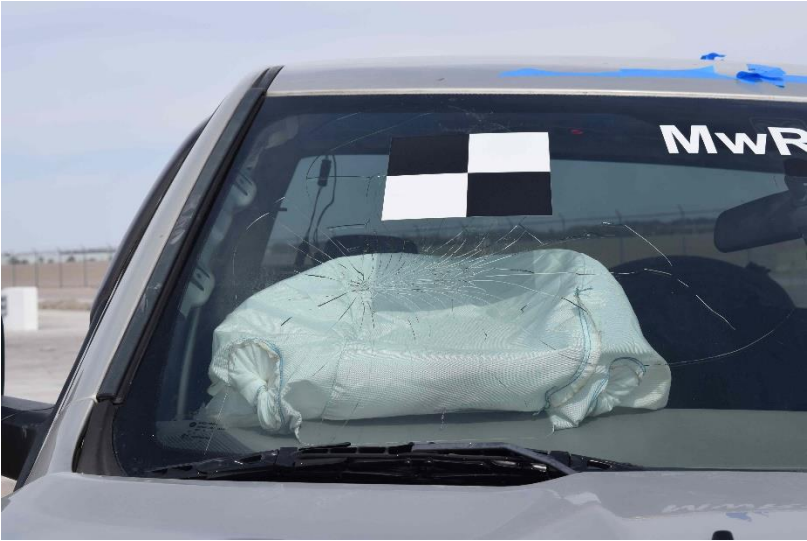
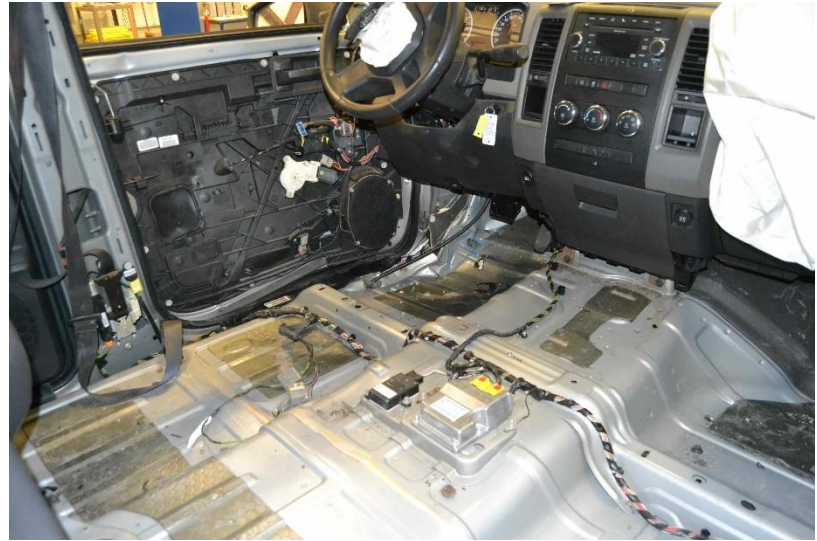
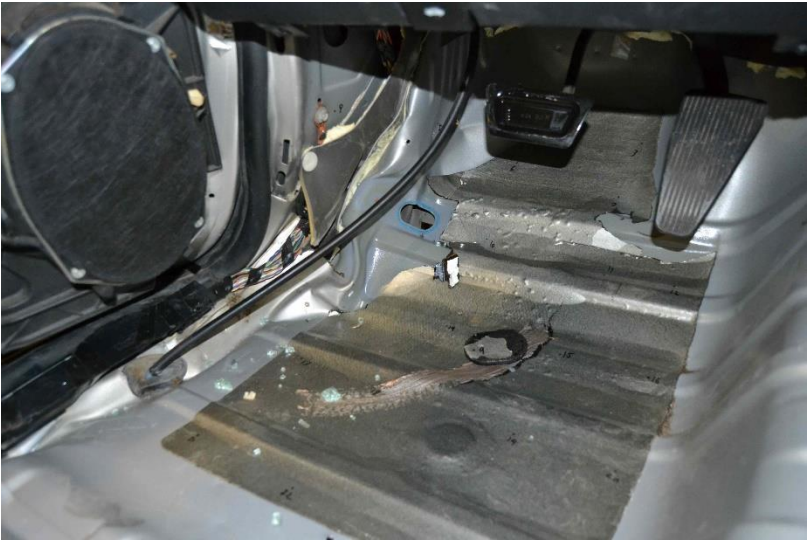
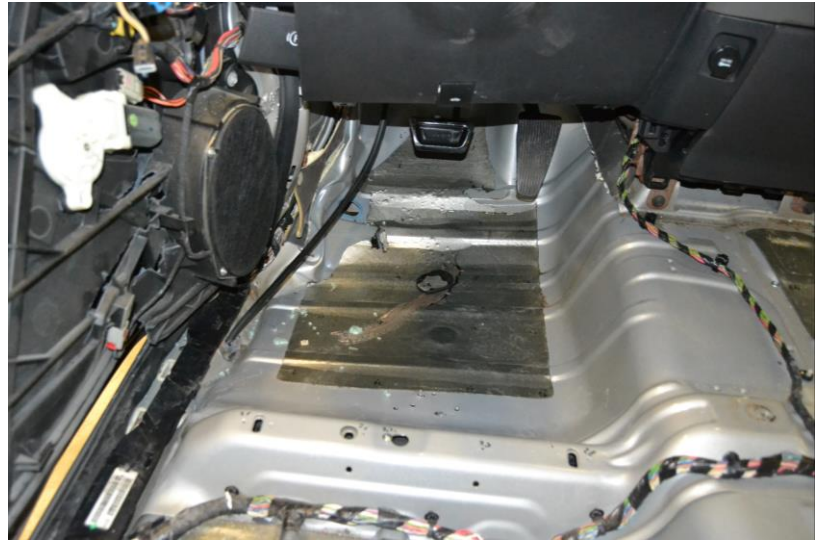
Figure 52. Windshield Damage and Occupant Compartment Deformation, Test No. 34AGT-1

The maximum occupant compartment intrusions are listed in Table 5 along with the intrusion limits established in MASH 2016 for various areas of the occupant compartment. MASH 2016 defines intrusion or deformation as the occupant compartment being deformed and reduced in size. Significant crushing was observed to the left-side front panel and the toe pan where the tire, which had impacted the buttress, was pushed backward and toward the occupant compartment. However, none of the MASH 2016 deformation limits were violated. Complete occupant compartment and vehicle deformations and the corresponding locations are provided in Appendix D.

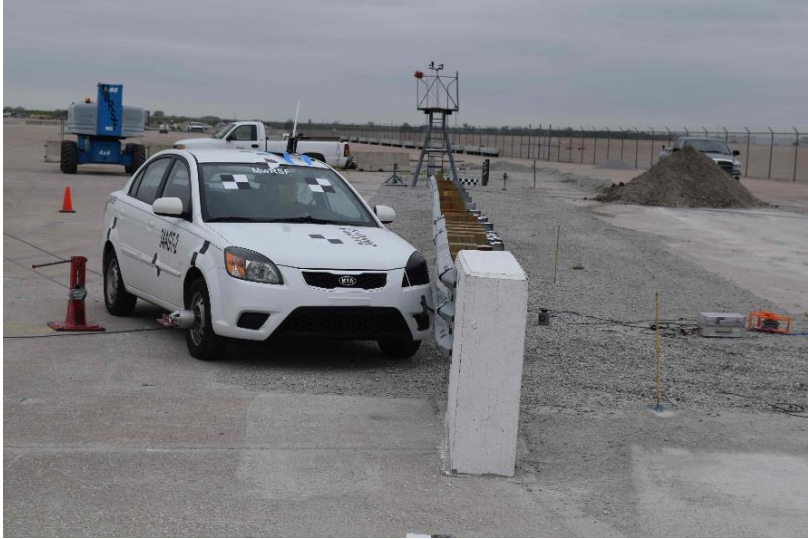
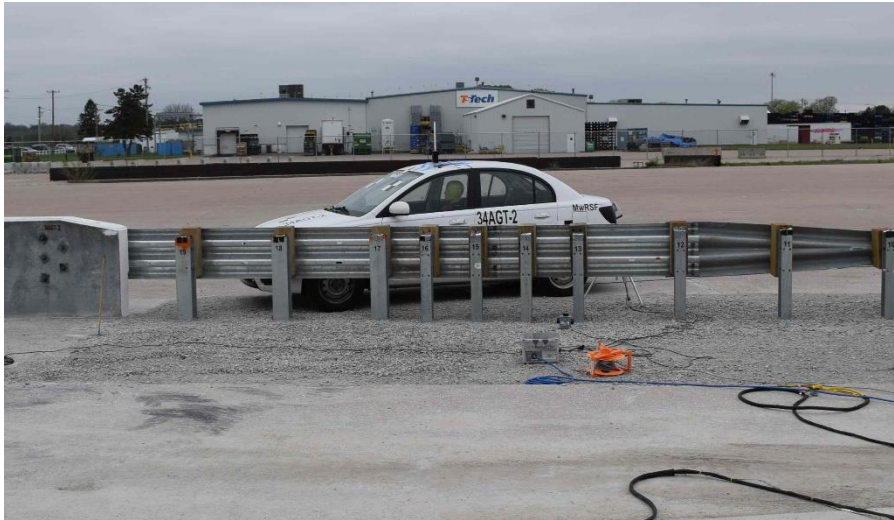
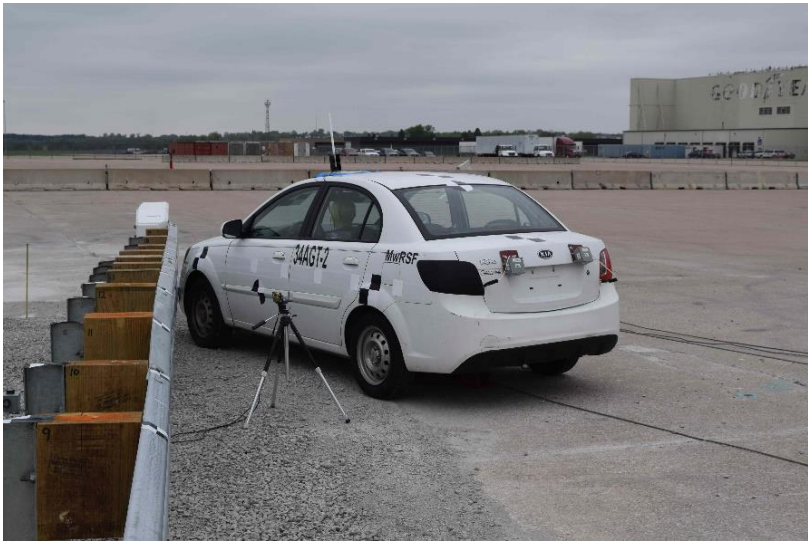
Figure 55. Impact Location, Test No. 34AGT-2

The main concern with vehicles impacting the 34-in. (864-mm) tall AGT was related to vehicle snag on the rigid parapet. Accordingly, the critical impact point for test no. 34AGT-2 was selected using the tables provided in section 2.3.2.1 of MASH to maximize the potential for snag on the upstream face of the concrete buttress. The critical impact point was determined to be 63 in. (1,600 mm) upstream from the concrete buttress, as shown in Figure 55.

During test no. 34AGT-2, the 2,420-lb (1,098-kg) small car impacted the AGT 65 in. (1,651 mm) upstream from the concrete buttress at a speed of 62.1 mph (99.9 km/h) and an angle of 25.5 degrees. The vehicle was contained and smoothly redirected with an exit speed and angle of 40.7 mph (65.5 km/h) and -6.4 degrees, respectively. The vehicle remained stable throughout the impact event with maximum roll and pitch angles of 10 degrees and 6 degrees, respectively. After exiting the system, the left-front door opened as the small car rolled away and impacted a row of temporary concrete barriers 145 ft (44.2 m) downstream from impact and rapidly came to a stop.

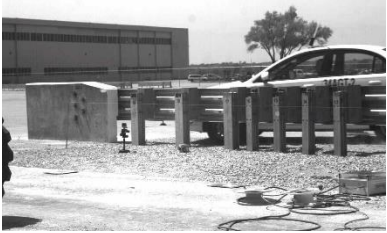
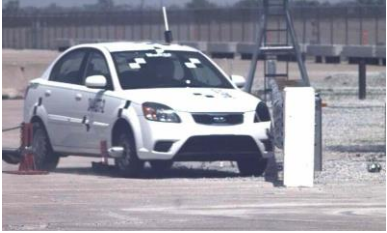
Figure 56. Additional Sequential Photographs, Test No. 34AGT-2

A detailed description of the sequential impact events is contained in Table 8. Sequential photographs are shown in Figures 56 and 57, and documentary photographs of the crash test are shown in Figure 58. The vehicle trajectory and final position are shown in Figure 59.
