*Research Project No. TPF-5(193) Supplement #103  
NDOT Sponsoring Agency Code RHE-17M*

## **34-IN. TALL THRIE BEAM TRANSITION TO CONCRETE BUTTRESS**

MwRSF Research Report No. TRP-03-367-19

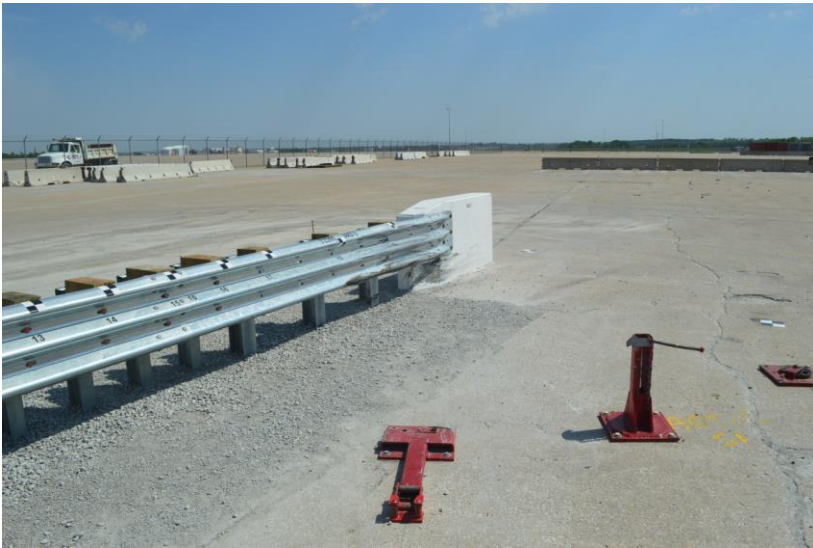
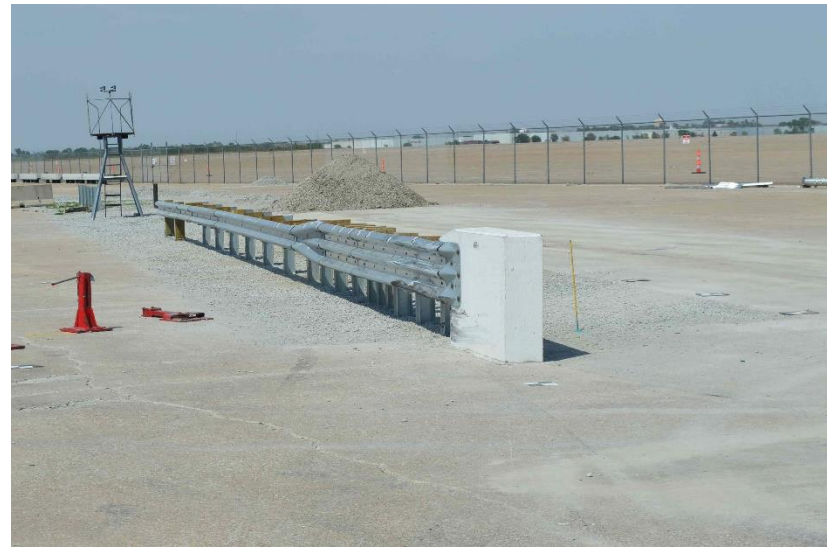
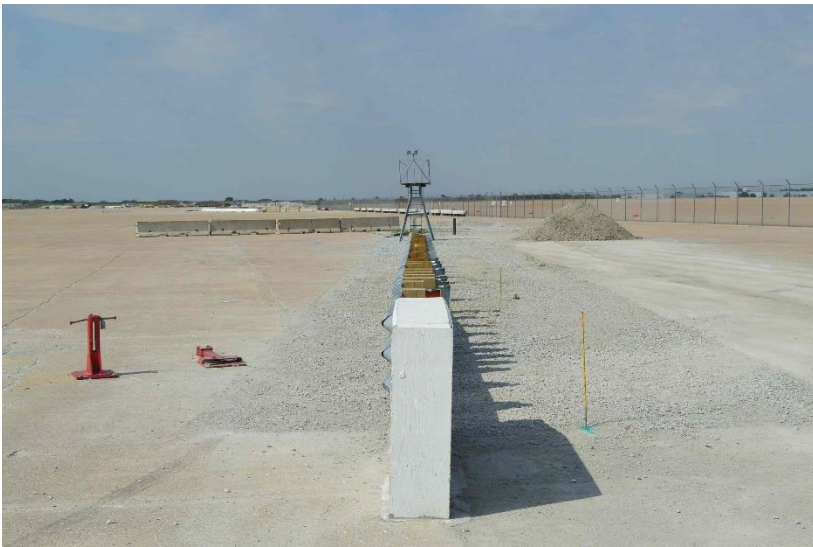
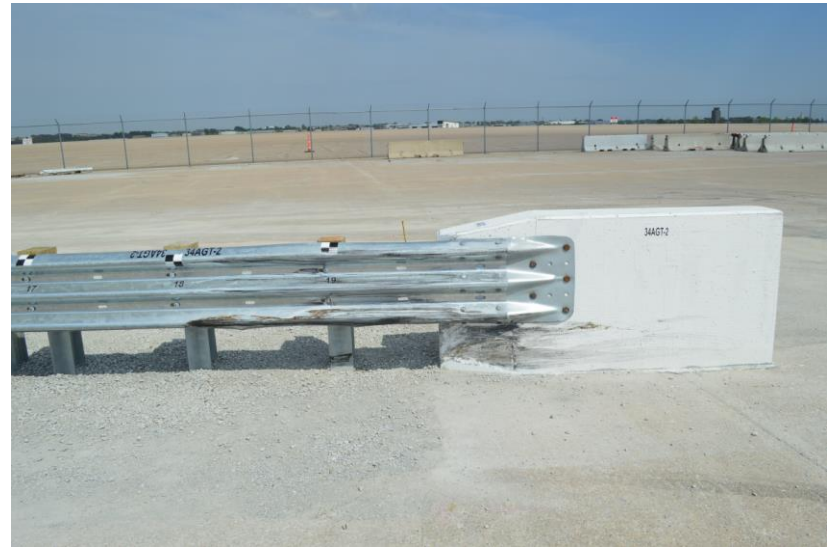
Figure 60. System Damage, Test No. 34AGT-2

Damage to the barrier was minimal, as shown in Figures 60 through 62. Barrier damage consisted of rail and post deformation, contact marks on the upstream and traffic faces of the concrete buttress, and concrete gouging. The length of vehicle contact along the barrier was approximately 12 ft – 1 in. (3.7 m) which spanned from 2 in. (51 mm) upstream from the centerline of post no. 18 to 4 in. (102 mm) from the downstream end of the concrete buttress.

Tire marks were visible on the bottom corrugation of the thrie beam starting at the centerline of post no. 18 and extending 8½ in. (216 mm) onto the terminal connector. General contact marks and minor deformations were found on the upper half of the thrie beam between post no. 18 and the concrete buttress. A kink occurred in the bottom of the thrie beam, 13 in. (330 mm) downstream from the centerline of post no. 18. Approximately 4 ft (1.2 m) of the thrie beam's bottom corrugation was flattened at the downstream end. Tire marks were also found on the front flange of post no. 19 just above the ground line. Post nos. 18 and 19 were each deflected backward less than 1 in. (25 mm).

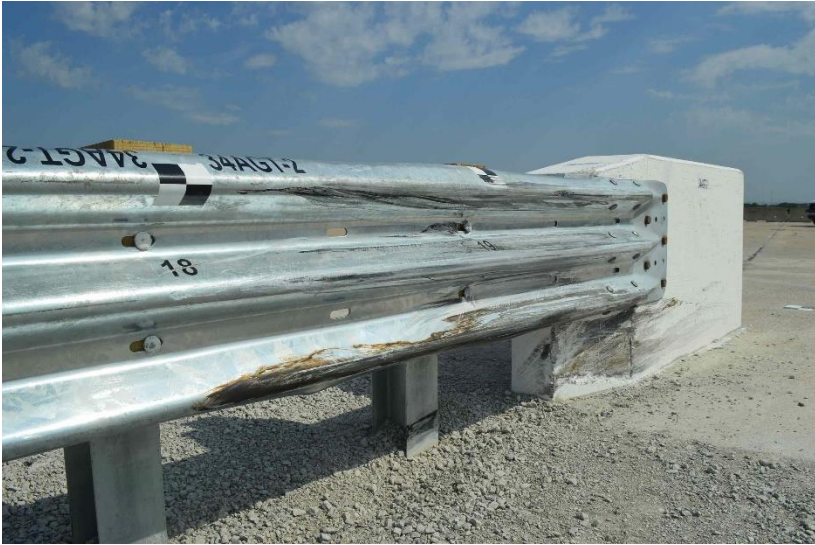
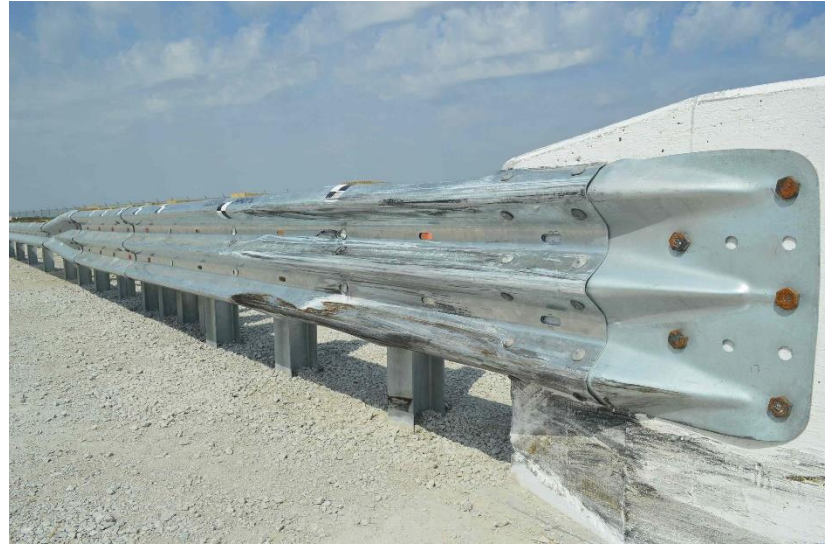
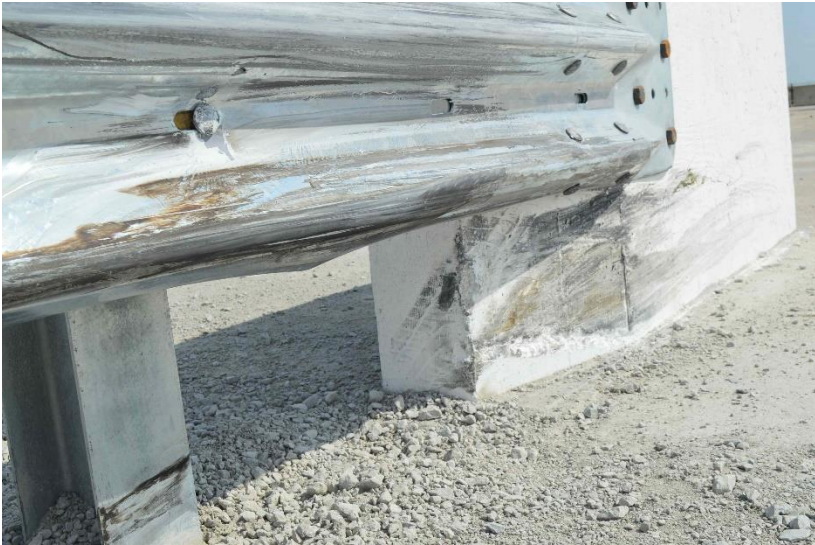
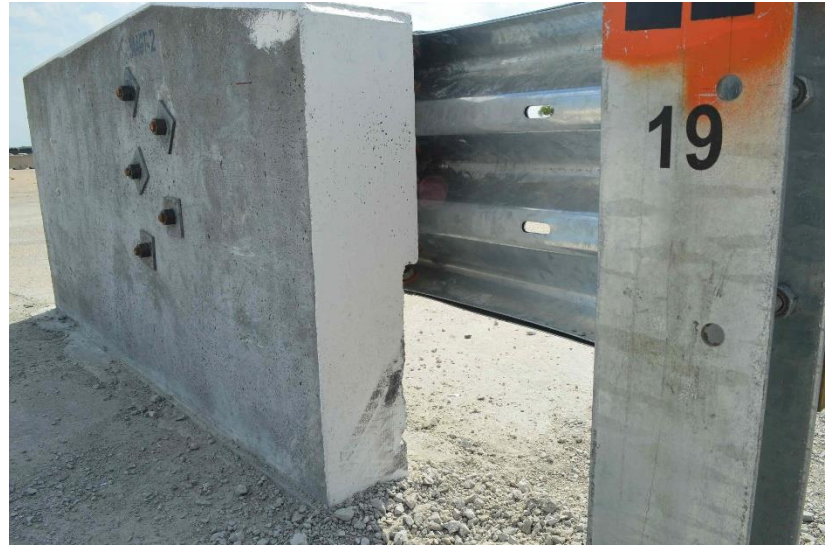
Figure 62. System Damage, Concrete Buttress, Test No. 34AGT-2

The concrete buttress had tire marks visible on its upstream end starting 1 in. (25 mm) from the back surface of the buttress and extended across the upstream face, the lower chamfer, and onto the front face of the buttress. Tire marks continued on the front face of the buttress for a distance of 80 in. (2032 mm) downstream from the upstream face. Concrete gouging was found on the lower chamfer and front face of the buttress below the thrie beam rail. Minor contact marks were also present on the top, sloped face of the buttress.

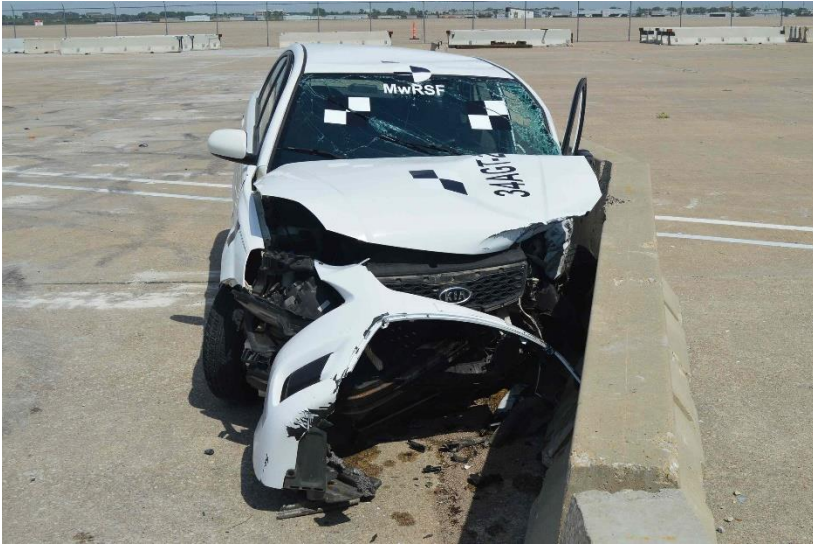
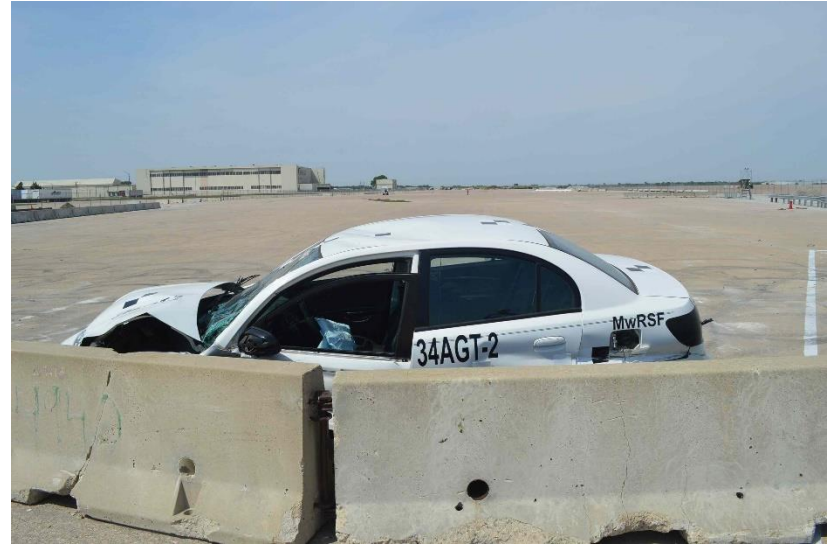
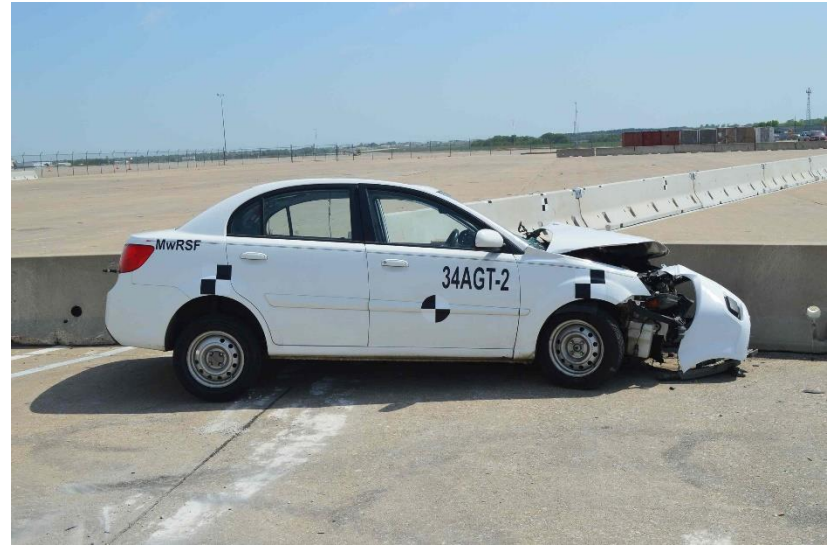
Figure 64. Vehicle Damage, Test No. 34AGT-2

The damage to the vehicle was moderate, as shown in Figures 64 through 68. The majority of damage was concentrated on the left-front corner and left side of the vehicle where the impact occurred. The left side of the bumper and the left-front fender were crushed, and the fender was dented and torn behind the left-front wheel. The left side of the radiator was pushed backward. The left-front steel rim was deformed with tears and significant crushing. The left lower control arm and ball joint were disengaged, and the left-front tire was torn. The left side frame horn and chassis mount were bent back and up. Denting and scraping was observed on the entire left side of the vehicle. The left-front door was ajar, and the left-rear door was dented. The left-rear steel rim was dented, and scuff marks were found on the tire.

The right side of the front bumper was detached. There was a 1-in. (25-mm) gap along the B-pillar and the right-front door. The hood was crushed and buckled, but remained attached. The right-front fender was dented in at the top and back. The windshield experienced significant cracking over its entirety and had a 20 in. (508 mm) long tear from the right-top corner down toward the left-bottom corner. A small hole was found near the left-bottom of the windshield, which occurred due to airbag deployment and contact with the hood. The left-front window was shattered. The roof buckled, leaving a 2¼-in. (57-mm) dent. The remaining window glass remained undamaged. Note, part of the vehicle damage was due to the secondary impact with the temporary concrete barrier system that was set up to contain the vehicle after exiting the AGT.

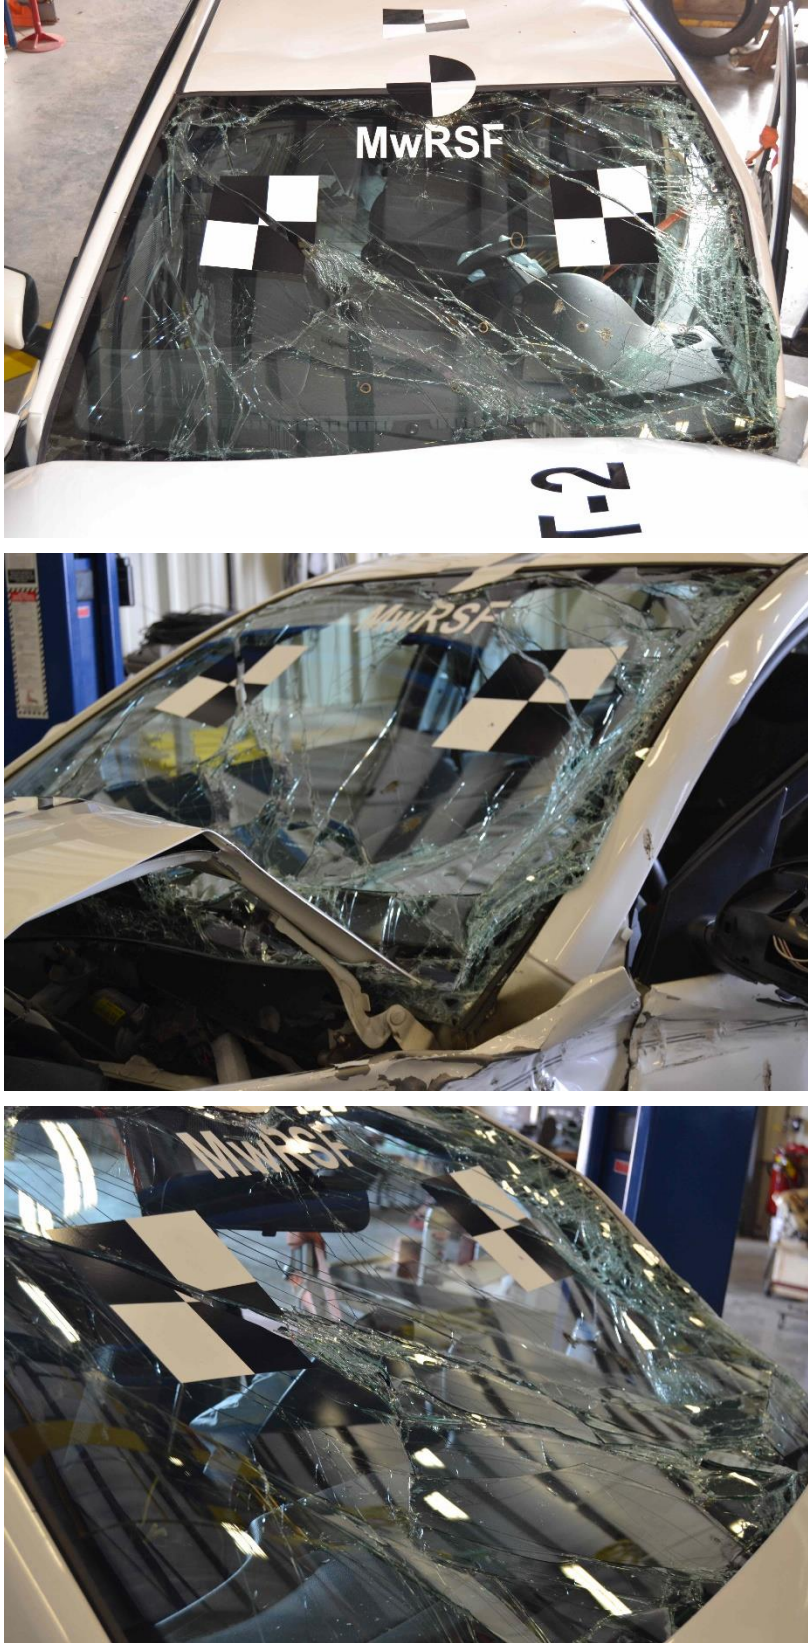
Figure 66. Windshield Damage, Test No. 34AGT-2

The windshield of the small car was cracked and torn during the impact event. However, the windshield damage was initiated by the impact of the airbags deploying during the impact event. Damage to the windshield was intensified by deformations of the vehicle's A-frame and contact from the vehicle's hood. The test article never contacted the windshield directly, and there was no potential for the test article to penetrate into the vehicle. As such, the windshield damage was not considered to be a result of the system performance, and there was no perceived risk to the occupant.

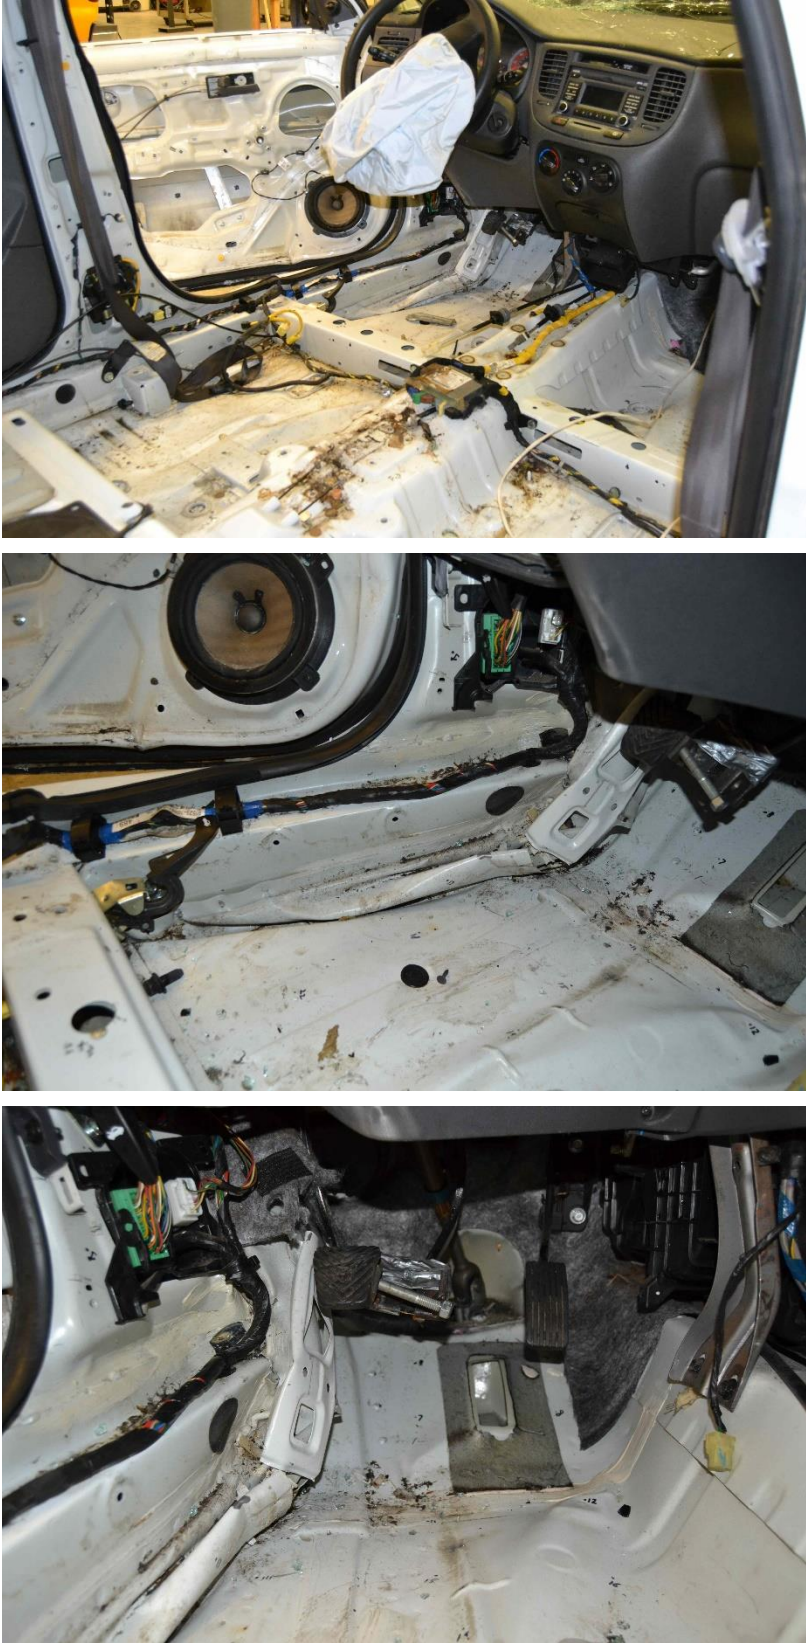
Figure 67. Occupant Compartment Deformation, Test No. 34AGT-2

The maximum occupant compartment intrusions are listed in Table 9 along with the deformation limits established in MASH 2016 for various areas of the occupant compartment. MASH 206 defines intrusion as vehicle deformations that result in a reduction in size of the occupant compartment. Note, damage to the lower front corner of the vehicle door frame prevented the left-front door from being shut after it had opened during the test. Consequently, intrusion deformations could not be measured along the door. The door itself was not severely damaged, so intrusion of the door into the occupant compartment would have been minimal and was not a safety concern. During test no. 34AGT-2, the left-front tire extended below the thrie beam rail, impacted the buttress, and was pushed toward the occupant compartment creating significant displacements to the toe pan and side front panel of the vehicle. Although, none of the established MASH 2016 deformation limits were violated, these deformations shifted the reference points established within the vehicle that would have been utilized to measure deformations. Thus, maximum occupant crush intrusions had to be made by comparisons to an exemplar vehicle of the same make, model, and year.

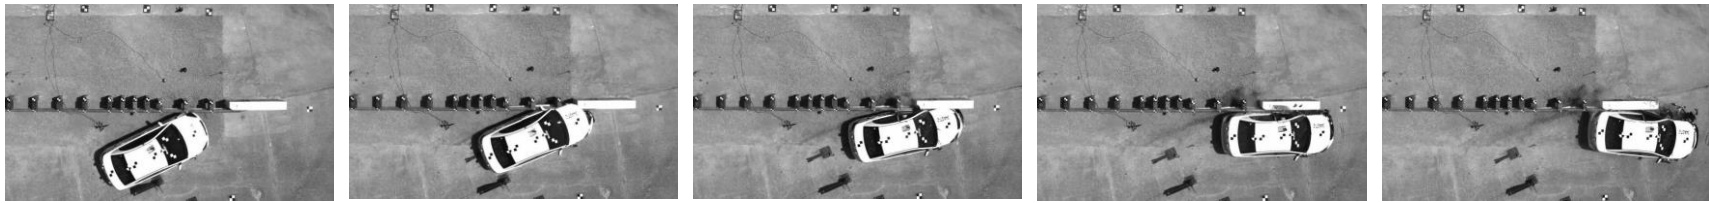
- Test Agency .....MwRSF
- Test Number.....34AGT-2
- Date.....5/9/17
- MASH 2016 Test Designation No.....3-20
- Test Article.....34-in. (864-mm) Tall Thrie Beam AGT

- Total Length ..... 87 ft – 11¼ in. (26.8 m)
- Key Component – Thrie beam Guardrail
  - Thickness.....12 ga. (2.7 mm)
  - Mounting Height ..... 34 in. (864 mm)

- Vehicle Make /Model.....Kia Rio
  - Curb.....2,331 lb (1,057 kg)
  - Test Inertial.....2,420 lb (1,098 kg)
  - Gross Static.....2,580 lb (1,170 kg)
- Impact Conditions
