**Federal Railroad
Administration**

Full-Scale Rollover Test and Corresponding Analytical Modeling – Survivability of Top Fittings for a CPC-1232 Tank Car

13. ABSTRACT (Maximum 200 words) A full-scale rollover test was performed on a CPC-1232 tank car body to determine the survivability of the top fittings and provide a comparison to past tank car-type rollover tests. Dynamic simulations were performed prior to the test to determine appropriate test conditions and parameters. Pivoting the carbody in a fixture about a fixed axis controlled the test conditions. The test was designed so that the manway bonnet, the highest profile top fitting, impacted a concrete target pad at 7.8 mph. As a result of the impact, the manway bonnet sheared off at its fasteners, several fasteners securing the pressure plate cover failed, and the unloading/loading valves sheared off. This resulted in a lading release. Post-test, the analytical simulation was correlated against the test results. Researchers recommend that methods to avoid the “unzipping” failures of bolted connections be considered for future designs. Alternatively, the observed failure mechanism may be incorporated into the design/specif

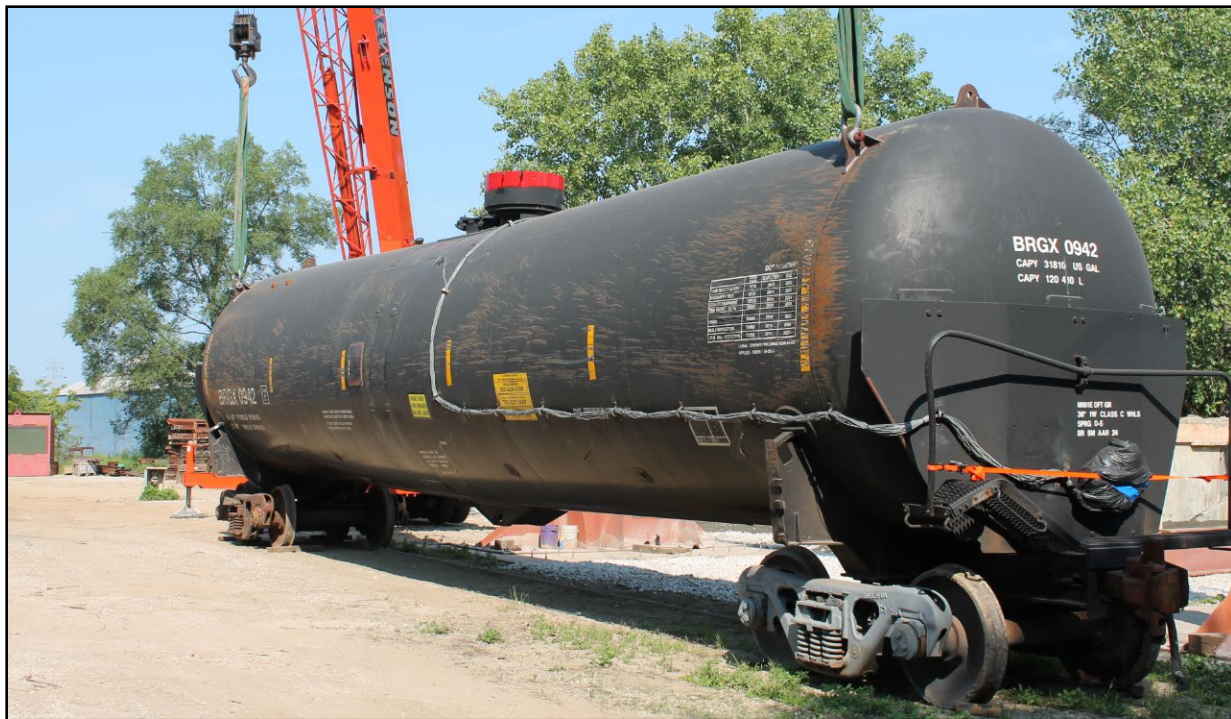
Figure 2-1. FRA Test Article

The tank car available for this test was the Trinity built BRGX 0942 (Figure 2-1). These cars are 31,808-gallon crude oil service cars of AAR class DOT111A100W1. They have a lightweight of 74,800 lbs, a load limit of about 211,200 lbs, and a truck center spacing of 45'-10 $\frac{1}{4}$ ". The car is equipped with a common crude oil car fittings arrangement. This includes a vacuum release valve, a loading valve, a vent valve, and a safety valve. These valves are shown in Figure 2-2. For this test, the total test article weight (carbody minus trucks filled to a 20 percent outage with water) was 266,000 lbs. Since water has a higher specific weight than crude oil (8.34 lbs/gal versus 6.63 lbs/gal), a large outage (using water) was required to keep the theoretical gross rail load of the trucked car to its maximum rating of 286,000 lbs. This was calculated using a 2 percent typical outage for crude oil.

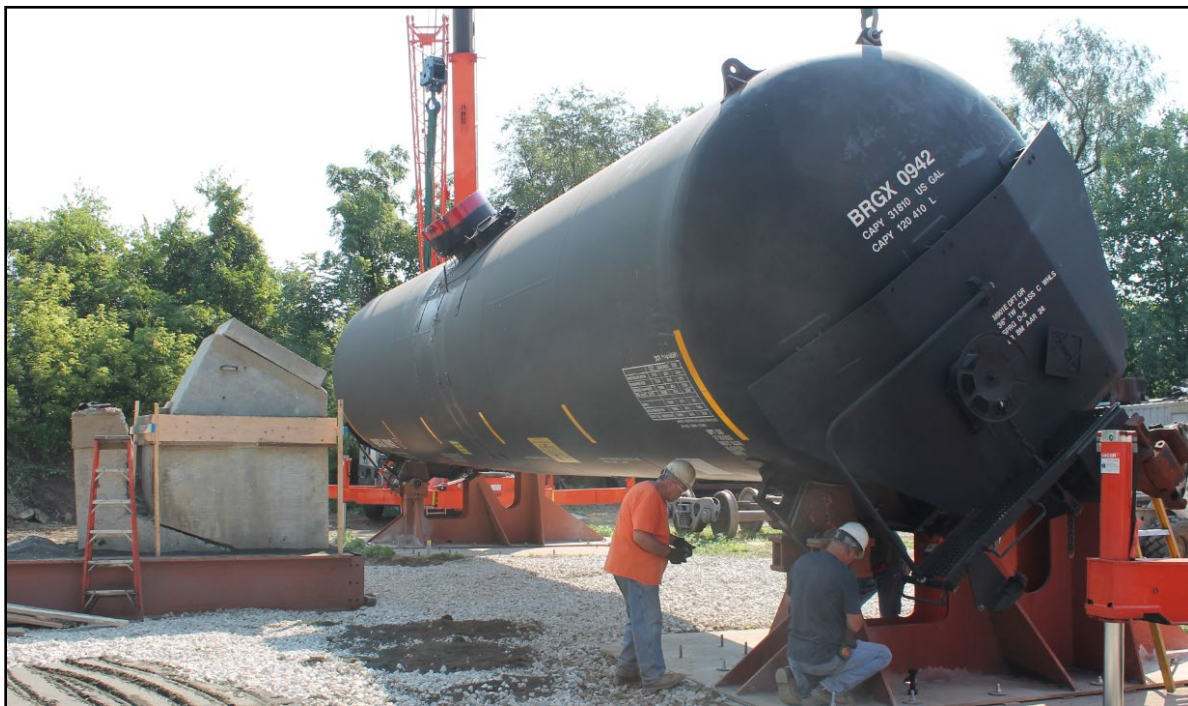
Figure 3-2. FRA Tank Carbody in Test Fixture

The full-scale tank car was placed into a test fixture designed to roll the entire loaded un-trucked carbody about a fixed pivot. The tank was filled with water to a 20 percent outage. The carbody was pushed to the point of imminent rotation and then rotated under the force of gravity until impact. A concrete surface target was used to stop the car rotation and provide for impact of the top fittings manway bonnet. This type of arrangement was chosen to control the impact of the top fittings with the target surface and provide repeatable test conditions. An additional advantage of this arrangement was that the vertical location of the concrete target surface was adjustable – to obtain different impact speeds as agreed upon by FRA, SA and industry partners. The tank shell, unloading nozzle, and manway bonnet were instrumented with strain gauges and accelerometers to obtain stresses and forces on the materials (Figure 2-3).

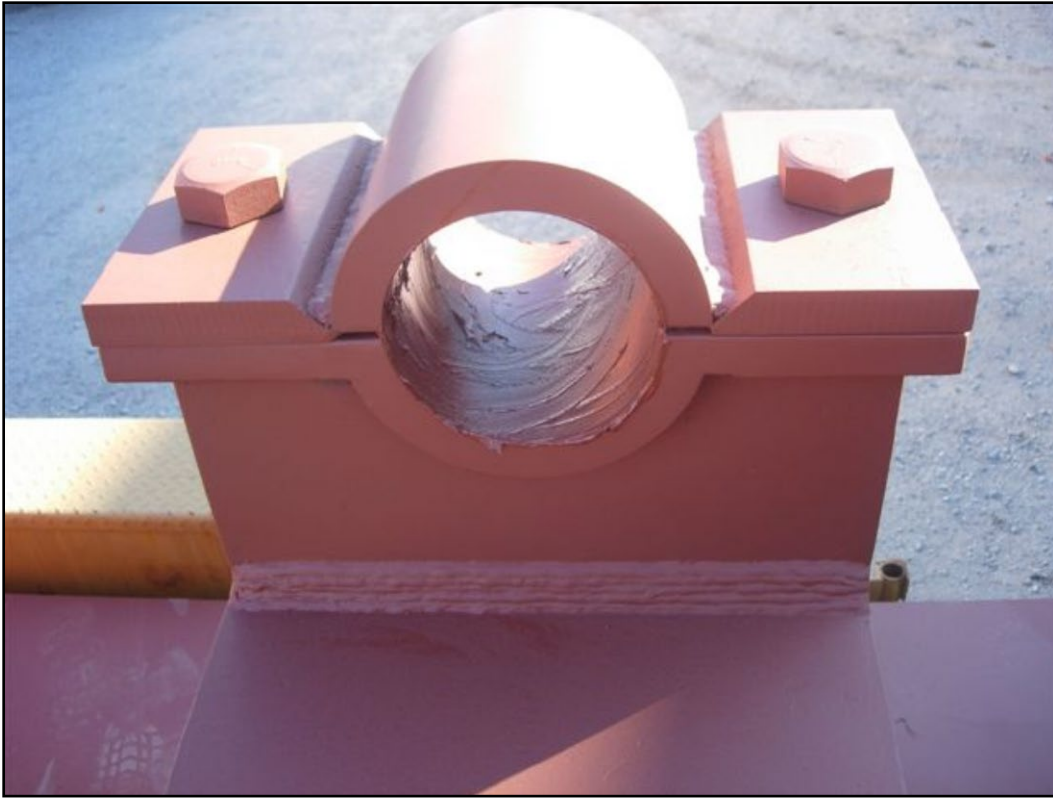
Figure 4-1. Bearing to Accept Pivot Shaft

Two fabricated fixtures were used to support the tank car body, one at each bolster. A concrete base was poured at each fixture location to anchor the fixtures – large enough to accommodate a range of tank car sizes for future testing. Plain pivot bearings were provided integral with the fixtures to accept a shaft that was welded perpendicular to each carbody bolster web. These bearings are made from steel tube stock and have a lower and upper half. After the shaft was placed in the lower half bearing, the upper half bearing was bolted to secure the tank body in position in the fixture ([Figure 4-1](#) and [Figure 4-2](#)).

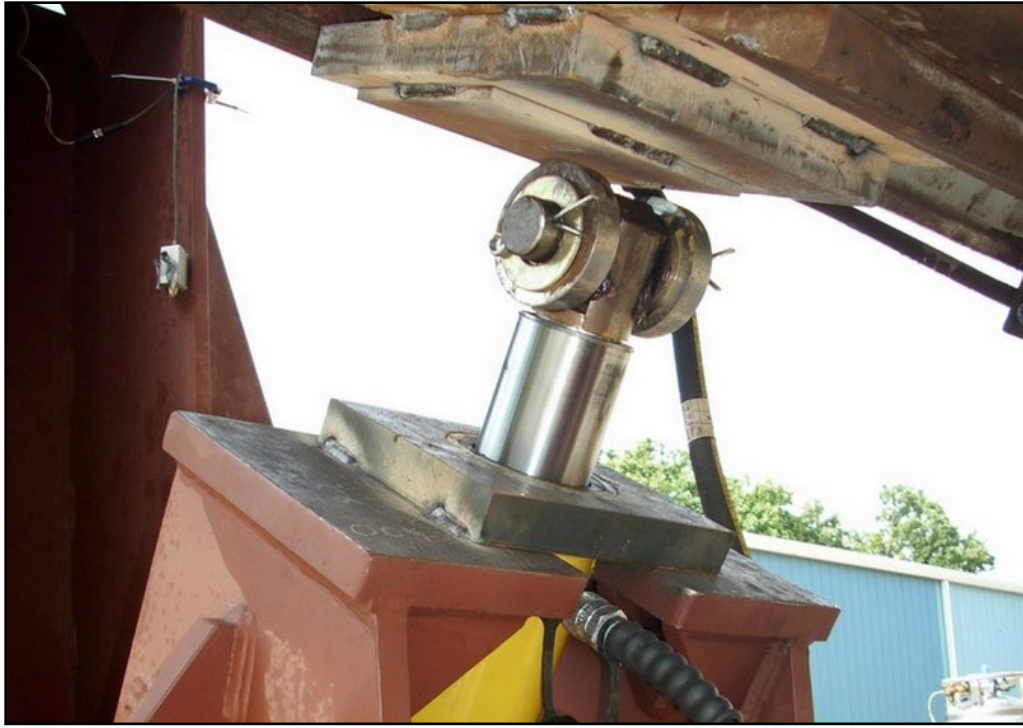
Figure 4-3. Hydraulic Cylinder and Rollers

A 75-ton hydraulic cylinder was mounted in each fixture with a clevis eye and roller attached ([Figure 4-3](#)). The roller exerts force on the bolster flange to roll the tank car body about the pivot bearing.

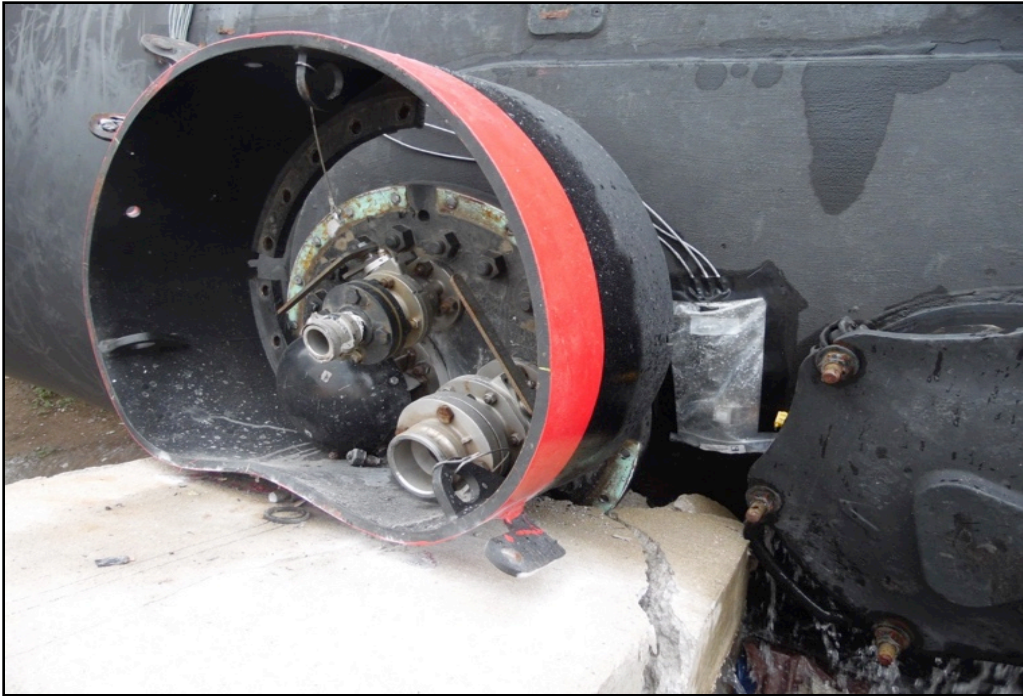
Figure 5-2. Post-Test View 1

As a result of the impact, the manway bonnet sheared off at its fasteners, several fasteners securing the pressure plate cover failed, and the unloading/loading valves sheared off. This resulted in a lading release.

The initial impact occurred between the leading edge of the manway bonnet and the top sacrificial concrete block. The bonnet leading edge impacted the concrete block at 7.8 mph impact speed. The manway bonnet deformed to where its lateral outside diameter (OD) became 28 $\frac{7}{8}$ " and its longitudinal OD became 39 $\frac{5}{8}$ ". The flange of the leading side of the bonnet deformed in and sheared off the vacuum relief valve causing leaking of water through the connection. All the $\frac{3}{4}$ " studs securing the bonnet to the pressure plate cover sheared off. The bonnet separated from the remaining fittings. Four of the 1 $\frac{1}{8}$ " studs fastening the pressure plate cover to the nozzle flange sheared off as the nozzle and cover broke through the top sacrificial concrete block and penetrated a couple inches into the larger block below (Figure 5-1).

A key reason behind the failure seen during the test was the sequential failure of bolts at the pressure plate and bonnet. The bolted connection between the bonnet and the flange is designed so the bolts are loaded uniformly; however, under actual impact conditions the load distribution is not uniform, leading to an “unzipping” effect and separation of the bonnet from the flange.

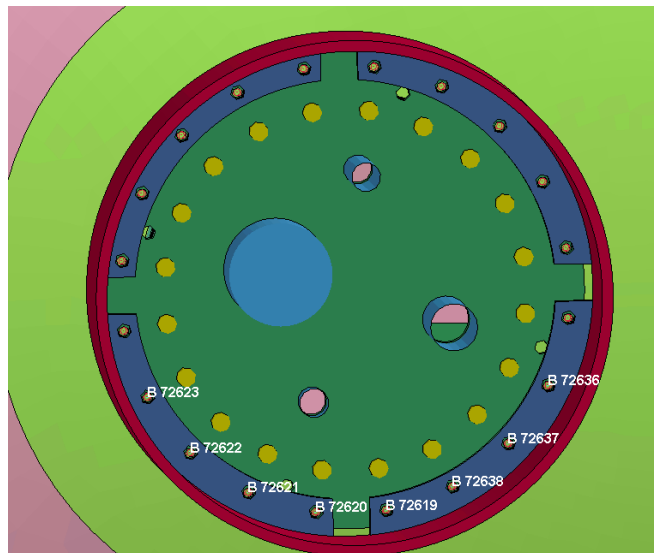
Figure 6-11. Resultant Forces on the First 8 Leading $\frac{3}{4}$ " Dia. Studs

Figure 6-11 shows the resultant forces of the first eight failing studs. The plot shows the beam elements were preloaded to 29,557 lbf for bonnet bolts and 61,213 lbf for the fitting plate studs. The preload was calculated based on the section area of the stud, the proof load (85 percent of the yield stress), and stud coefficient of 0.75 (for connections requiring reuse).

The calculated axial failure force for the $\frac{3}{4}$ " diameter bolts was 37,750 lbf (area*ultimate stress) while for the $1\frac{1}{8}$ " diameter bolts it was 72,680 lbf. The shear failure forces were obtained by multiplying the 0.6 factor to the axial failure force. Researchers noticed that all the bonnet bolts were failing too fast (axial failure) with respect to the test, so a few other trials were made to match the simulation with the test. The final axial failure force for the bonnet studs used in the simulation was 43,800 lbf and for the pressure plate studs was 79,700 lbf, while the shear failure force remained unchanged for both types of studs (bonnet and pressure plate) which was a 0.6 factor of the axial failure force. Researchers anticipated that a higher failure force would be acceptable for this dynamic test since the failure force formula was based on a static test.

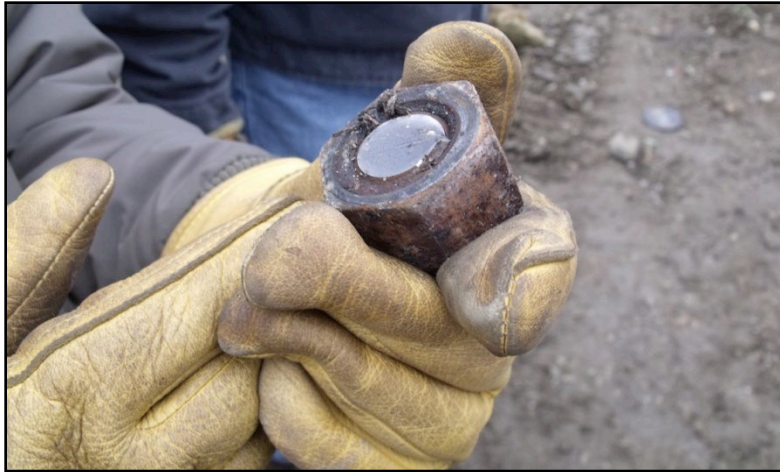
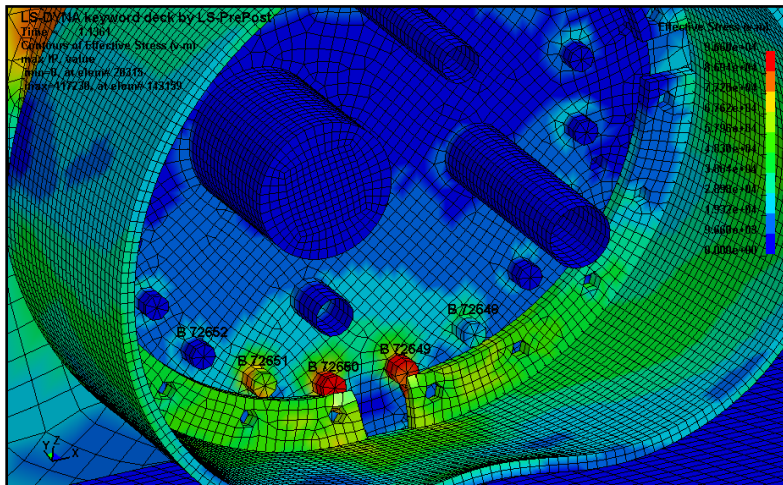
Figure 6-15. Sheared Stud from Fitting Plate

The failure of the fittings plate bolts in the test seems to have been due to high shear forces seen by the studs when in contact with the bonnet.

Figure 6-12 shows a close view of the resultant forces of the failing studs. As expected, the first 2 studs experienced the highest force before failing, followed in sequence by the other 18 studs. Figure 6-13 plots axial and shear forces of the leading bonnet stud #72619. In this plot, shear forces experienced by the studs at the moment of impact were much lower than the axial forces. Figure 6-14 plots axial and shear forces of the leading pressure plate stud #72650. The shear and axial forces of the beam elements that represent the pressure plate studs were all lower than the corresponding failure strengths. This was mainly because of the way the studs were modeled in LS-DYNA, where the beam elements were connecting the two plates, and the nuts were modeled using shell elements. Four nuts (shell elements) in the simulation failed at 0.2 strains, similar with the test results, where four of the pressure plate studs failed because of the shear loads (Figure 6-15).

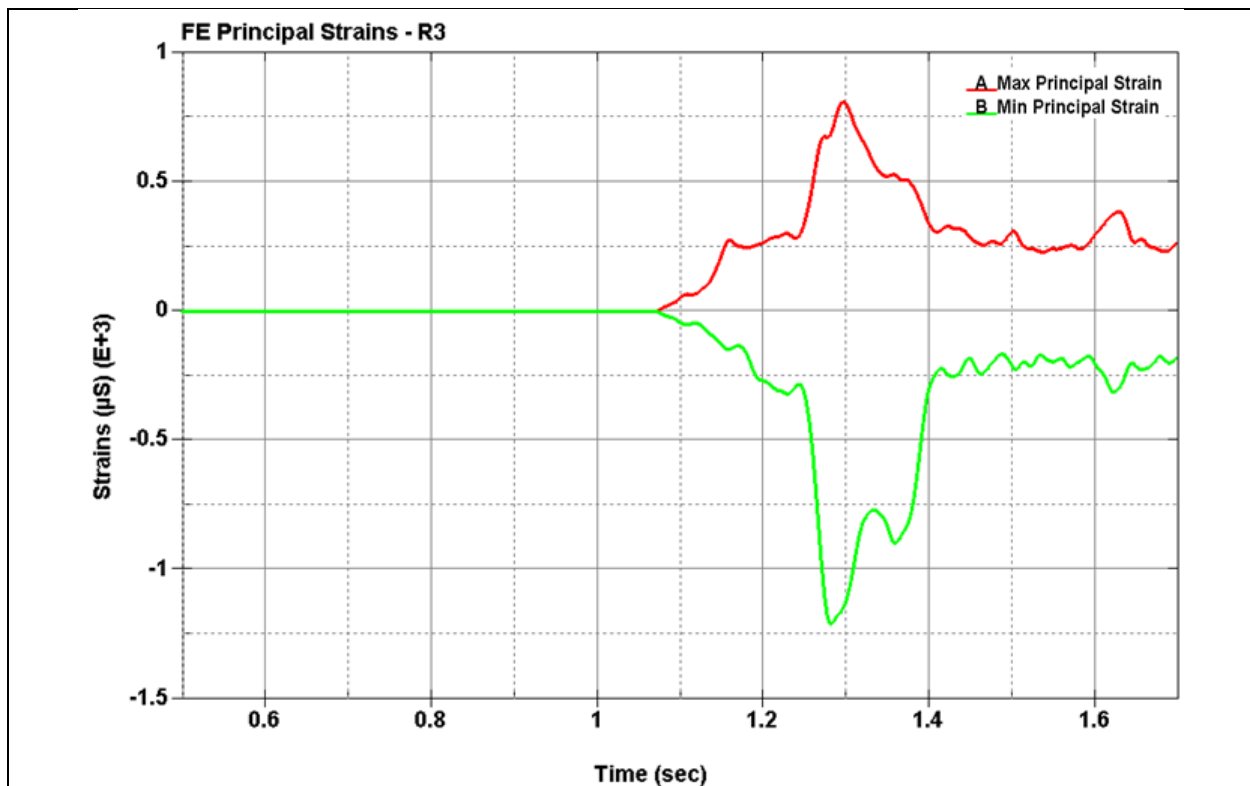
Figure A1

Principle Strains from LS-DYNA Simulation Location R3

Principle Strains from Actual Test Location R3
