U.S. Department of
Transportation

**Federal Railroad
Administration**

Ground Penetrating Radar (GPR) Technology Evaluation and Implementation

1. AGENCY USE ONLY (Leave blank)		2. REPORT DATE May 2020		3. REPORT TYPE AND DATES COVERED Technical Report June 2015 to January 2018
4. TITLE AND SUBTITLE Ground Penetrating Radar (GPR) Technology Evaluation and Implementation			5. FUNDING NUMBERS DTFR53-11-D-00008 Task Order 357

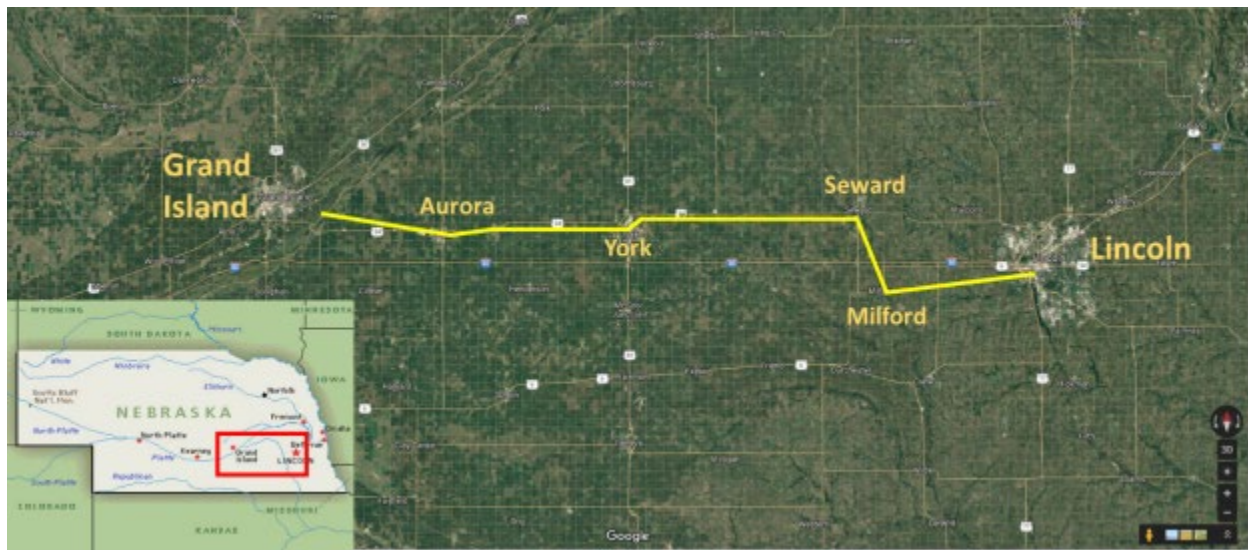
Figure 42. Ravenna Subdivision Sampling and Test Section

The BNSF Ravenna Subdivision from MP 10 to MP 40 was selected for this study and is shown in [Figure 42](#). This line is a double mainline track, with Track 1 primarily concrete ties and Track 2 primarily timber ties. The line supports about 45 million gross tons (MGT) annually of dominantly coal train traffic.
