Accelerating Roundabout Implementation in the United States - Volume I of VII

Evaluation of Rectangular Rapid-Flashing Beacons (RRFB) at Multilane Roundabouts

PUBLICATION NO. FHWA-SA-15-069

SEPTEMBER 2015

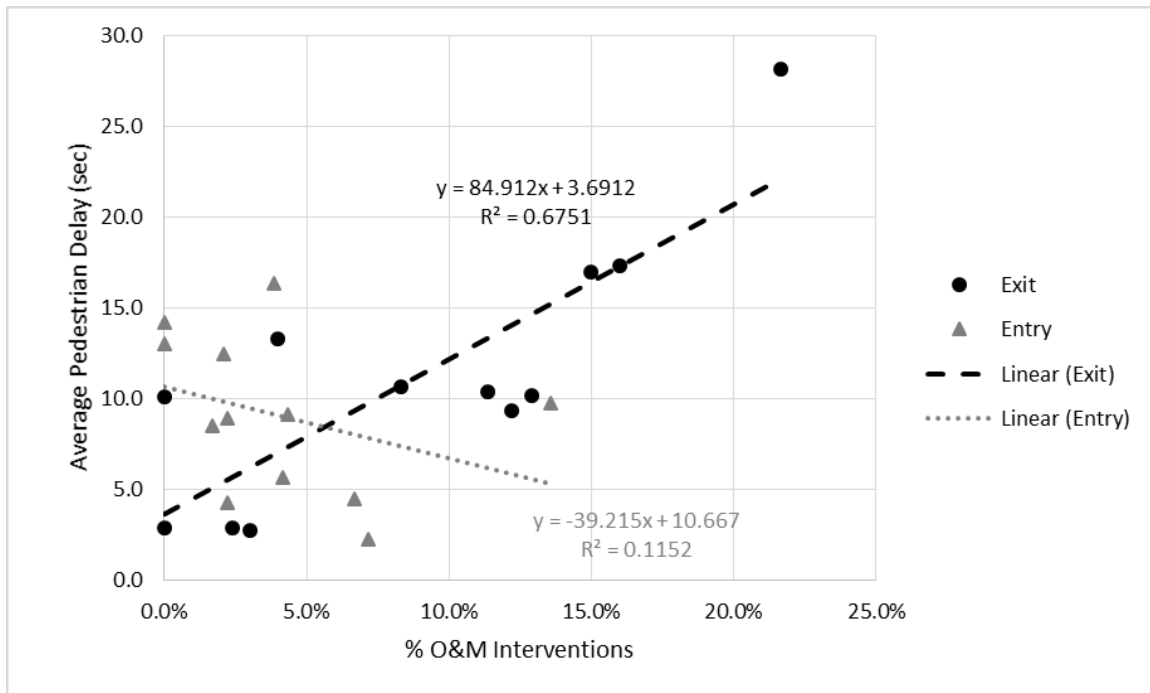
Figure 11 plots the relationship between interventions and delay for the various approaches. The relationship is very strong for exit legs (black dashed line) with an R-squared value of 0.6751. The relationship indicates increasing delay with increasing percent intervention; the exits with the highest rates of interventions were also those exit legs with the shortest delay. For entry legs, the trend is the opposite; exits with high percent interventions tended to also have the shortest delays, but that trend is weak, with an R-squared value of 0.1152. The differing trends show that blind participants experienced more challenges at exit legs compared to entry legs.

Figure 11. Graph. Percent interventions and delay correlation.
