**Report SPR-P1(17) M061**

**Final Report**  
26-1121-4036-001

## **Nebraska Specific Slope Design Manual**

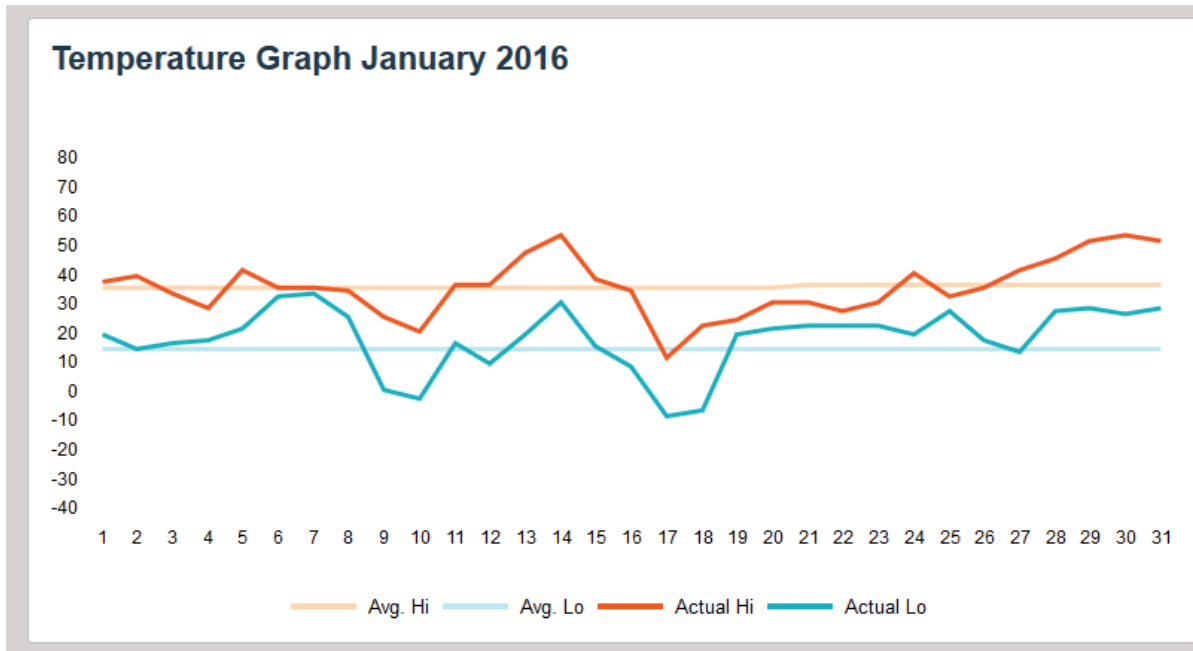
**Figure 1.6** Temperature pattern of Lincoln, NE for Jan. 2016 (Accuweather, 2016)

The temperature of Nebraska is high in the summer and particularly cold in the winter. The temperature pattern during Jan. 2016 is shown in Figure 1.6 A special weather pattern that may affect the rock slope stability is the repeated freeze and thaw pattern. This weather pattern will allow precipitation to infiltrate into rocks through cracks and joints. Then this water can freeze, applying high expansion pressure resulting in new cracks or expanding existing cracks. The repeated cycle of freeze and thaw is one of the potential factors which can cause rock fall or rock slope sliding.
