Report # MATC-MS&T: 136-1

Guide for the Selection of Rapid Repair Systems for Earthquake-Damaged Reinforced Concrete Bridge Columns

2019

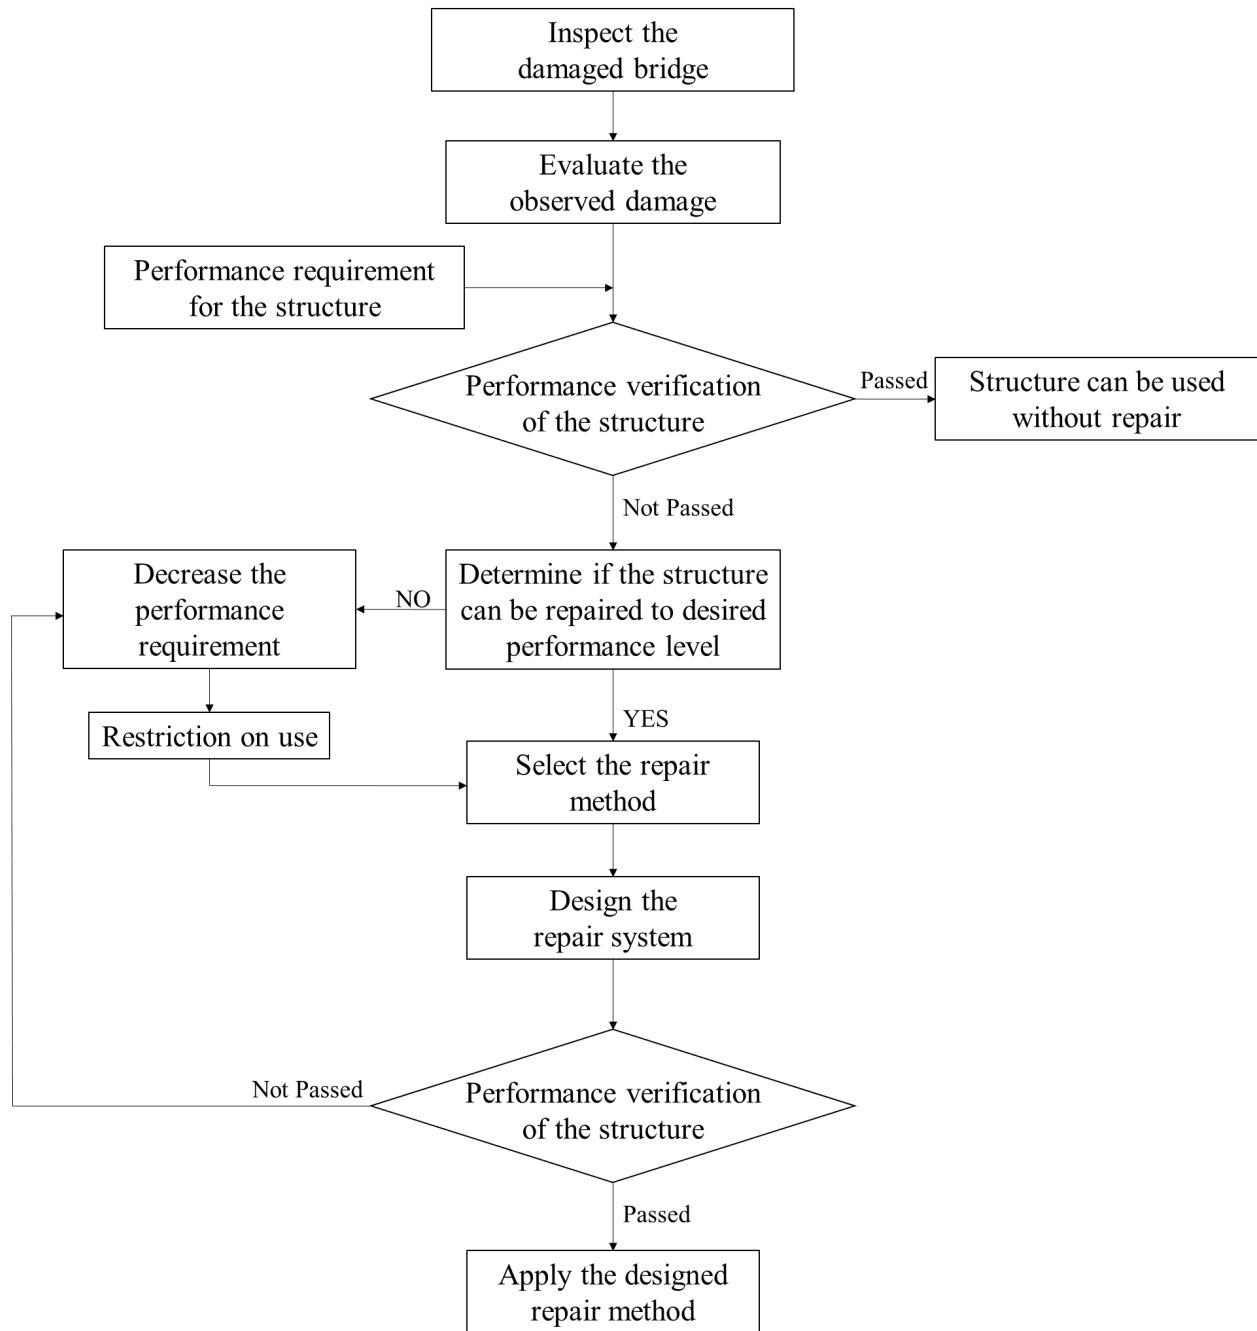
Figure 1.1 Flow chart describing the process for selecting a rapid repair system for earthquake-damaged bridges

Figure 1.1 illustrates the process for selecting a rapid repair system for a bridge damaged by a seismic event. This logical process is valid for essential bridges that must be repaired (i.e., the option to abandon the bridge is not allowed).

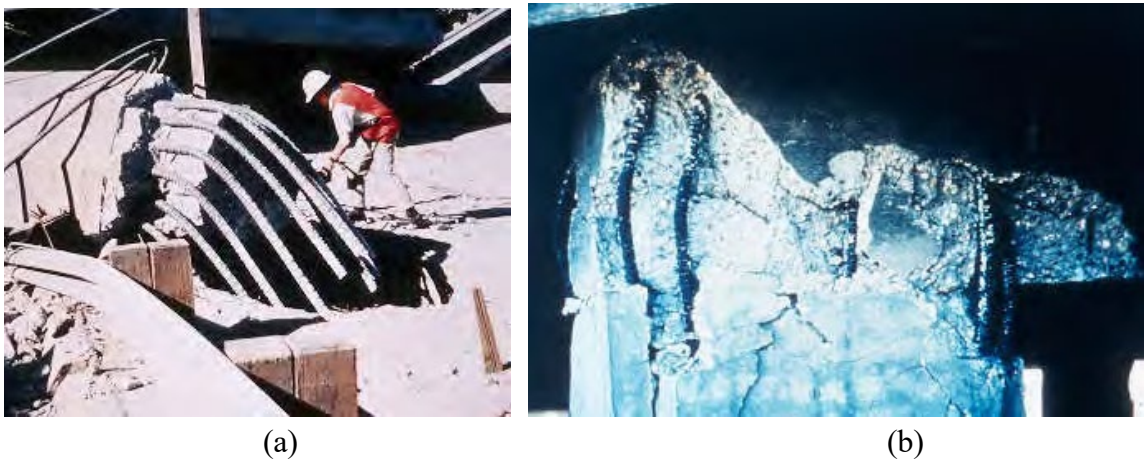
Figure 3.1 Pullout (a) and buckling (b) failure of bridge damaged in the 1971 San Fernando earthquake (Caltrans 2006).

practice was to splice the bars at locations of high flexural demand (e.g., right above the footing) using a length of only 20 bar diameters. It was also common practice to anchor the longitudinal bars in the footing without using 90-degree hooks and with an embedment length of only 20 bar diameters. Columns designed with such short lap splice length or embedment length can exhibit brittle failure due to the slipping or pullout of the bars.

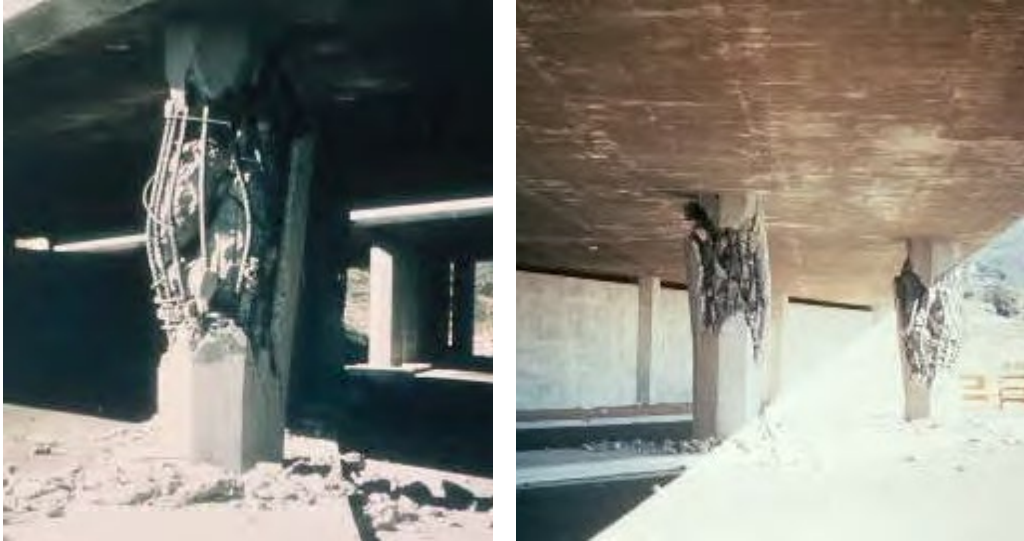
Figure 3.2 Shear failure of a bridge damaged in the 1971 San Fernando Earthquake due to the low thickness and high spacing of the transverse reinforcement (Caltrans 2006).

Before 1974 RC bridge columns were typically designed with transverse reinforcement consisting of #4 bars spaced at 12 in., regardless of the size of the column or of the longitudinal reinforcement. Therefore, fracture of transverse reinforcement as well as local buckling of the longitudinal bars are common. In the case of a low transverse reinforcement ratio, aggregate interlock becomes the main shear resisting mechanism. However, dynamic loading can create wide cracks in the column reducing the aggregate interlock effect. For these reasons shear typically governs the failure mechanism, which occurs in a brittle manner, for columns of bridges built before 1974.

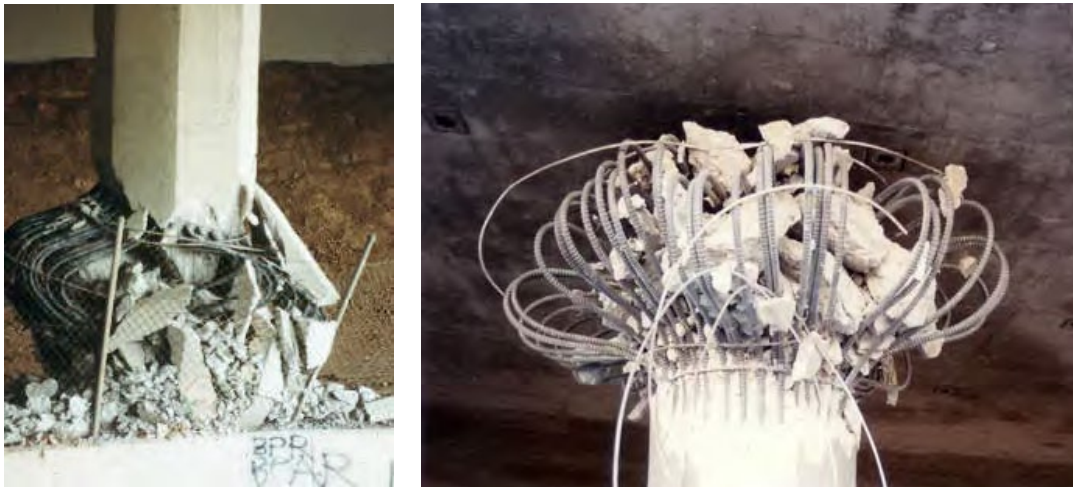
Figure 3.3 Failure due to strength degradation at plastic hinge regions of bridges damaged in the 1994 Northridge Earthquake (Caltrans 2006).

Due to the revised design provisions, columns of bridges built between 1974 and 1994 are typically able to reach the yielding moment of the section. On the other hand, inadequate confinement of the plastic hinge regions amplifies the strength degradation due to cyclic load. Buckling of the longitudinal bars due to the fracture of transverse reinforcement is also common.

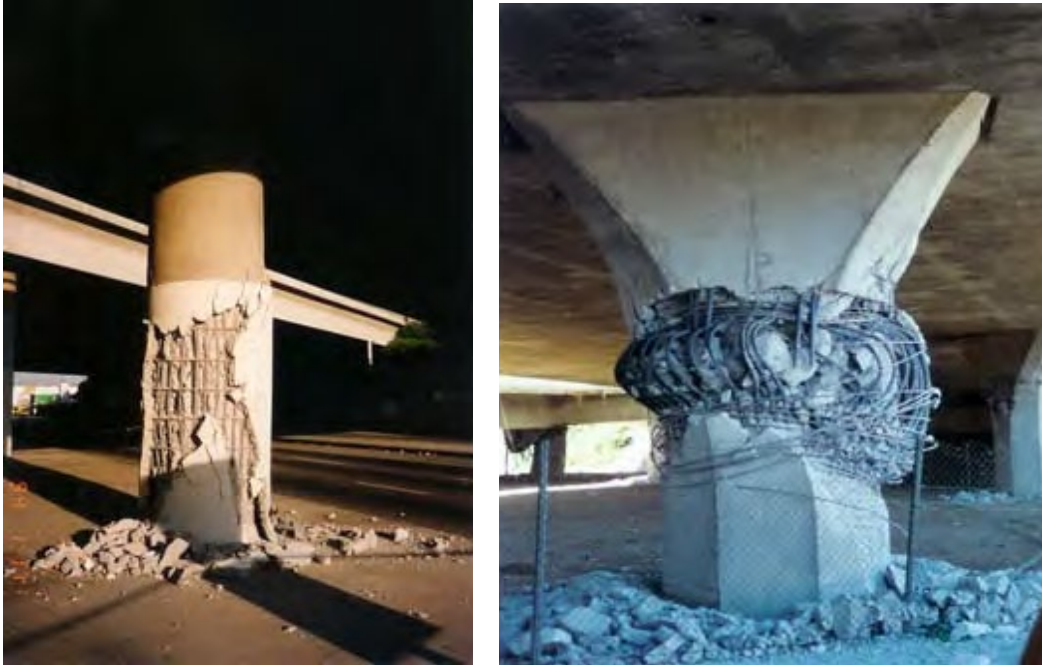
Figure 3.4 Shear failure of bridges damaged in the 1994 Northridge Earthquake. In (b) the use of a flare created a “short column” that is very sensitive to shear actions (Caltrans 2006).

Bridge columns built between 1974 and 1994 were typically designed with sufficient transverse reinforcement to reach the full flexural capacity. However, the effect of the cyclic degradation as well the effect of the buckling of the longitudinal bars were not considered. Shear failure in the plastic hinge region is common.

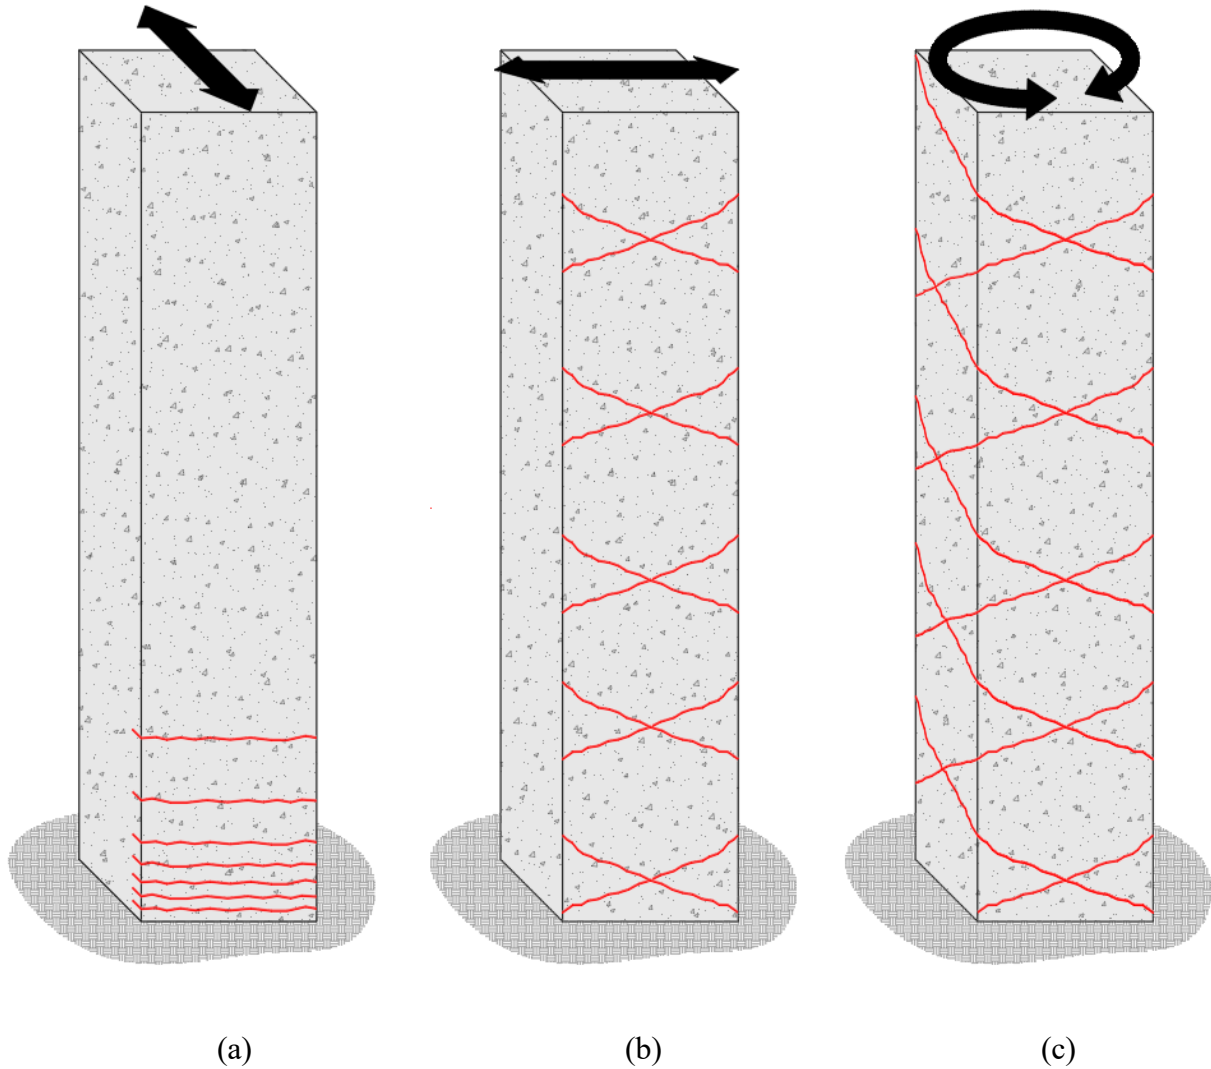
Figure 4.1 (a) Flexural cracking, (b) shear cracking, (c) torsional cracking

Concrete cracking occurs when the tensile stress reaches the tensile strength of the concrete. For RC columns subjected to bending moment, the typical crack pattern is represented by flexural cracks that are generally perpendicular to the longitudinal axis of the column emanating from the tensile face. For columns under a combination of bending moment, shear, and/or torsion, the direction of cracks is inclined to the longitudinal axis of the column (Belarbi et al. 2010). If shear action is predominant, the cracks appear on opposite faces of the column and are generally parallel to one another. If torsional action is predominant, the cracks spiral around the column in a continuous manner, and thus the cracks on opposite faces of the column are generally perpendicular to one another.

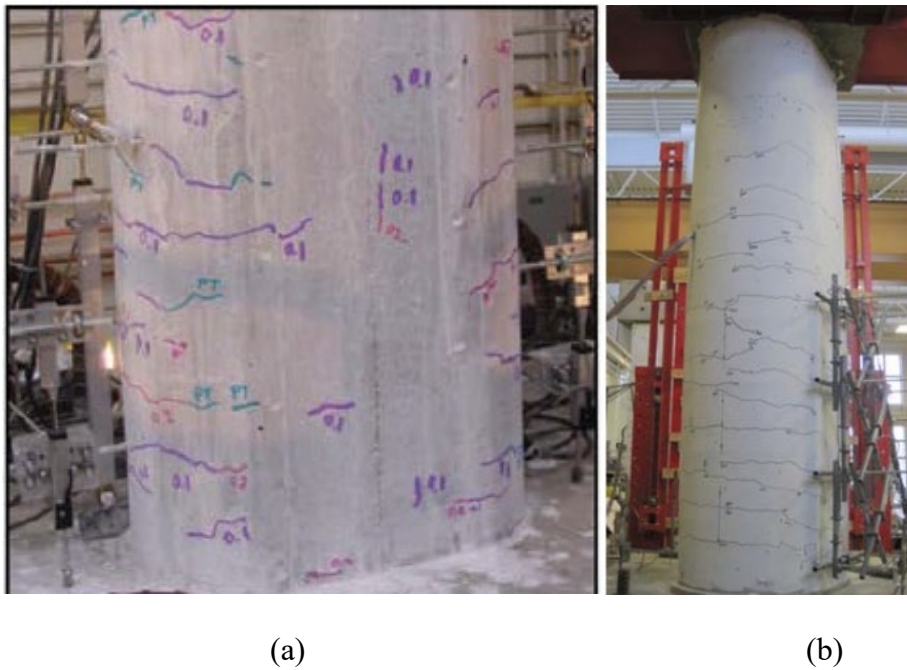
Figure 4.2 Examples of columns with damage state DS-1: flexural cracks: (a) from Vosooghi and Saiidi (2010); (b) from Li (2012)

DS-1. Damage state DS-1 is assigned to RC columns that exhibit flexural cracks after the seismic event. Repairing a column in this state should be evaluated with a cost-benefit analysis because it may not be necessary.

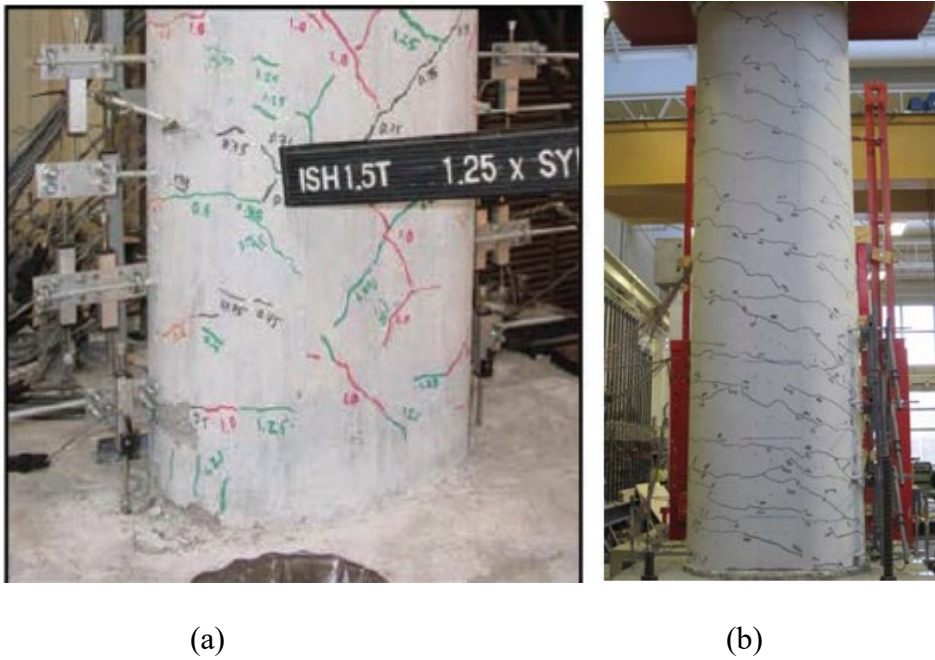
Figure 4.3 Examples of columns with damage state *DS-2*: first spalling and shear cracks (a) from Vosooghi and Saiidi (2010); (b) from Li (2012)

DS-2. Under damage state *DS-2* minor spalling and shear cracks are observed on the column surface. Columns that show a damage condition classified as *DS-2*, if repaired, are subjected to repairs capable of minor improvement.

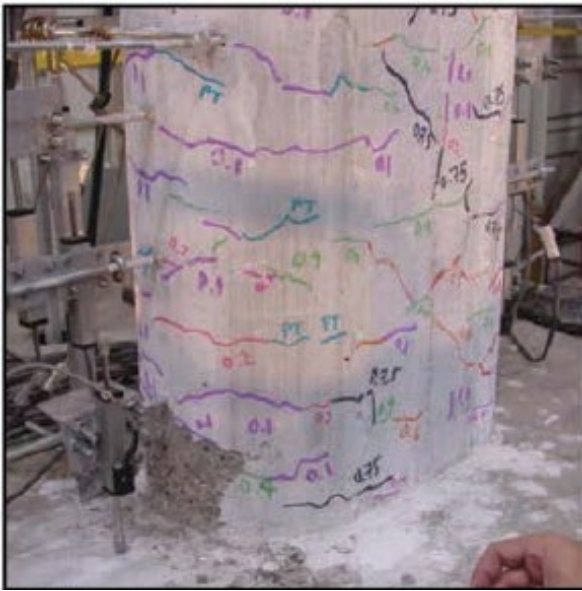
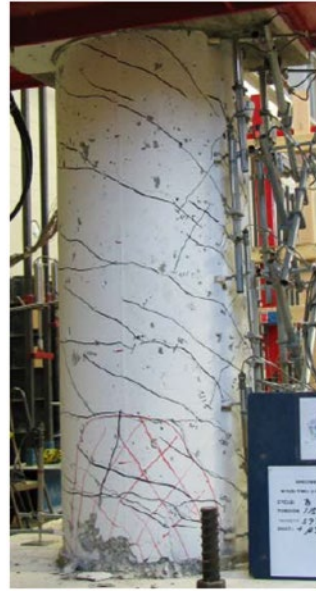
Figure 4.4 Examples of columns with damage state *DS-3*: extensive cracks and spalling (a) from Vosoghi and Saiidi (2010); (b) from Prakash (2009)

DS-3. In damage state *DS-3*, a large number of cracks of significant width are present, and concrete spalling occurs in a relatively large region. Columns that show a damage condition classified as *DS-3* are subjected to repairs capable of minor improvement.

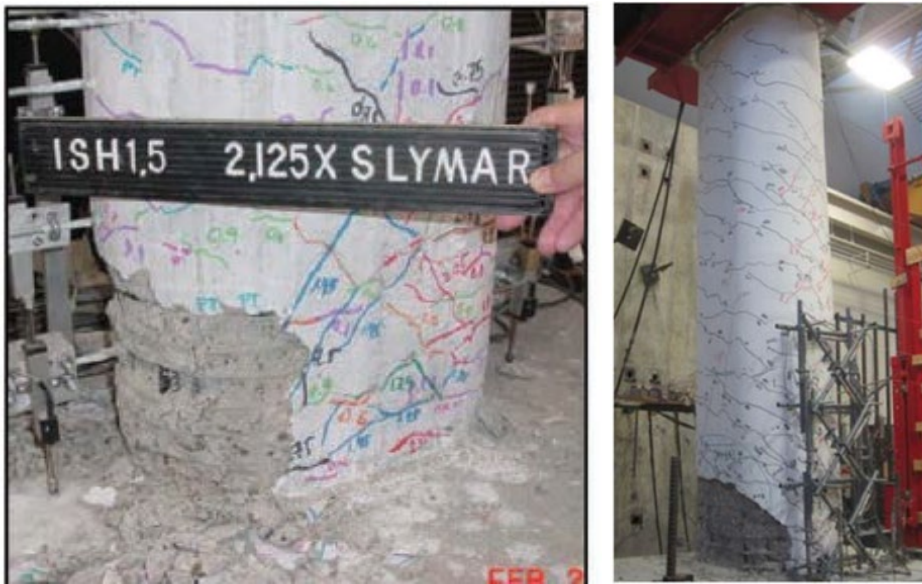
Figure 4.5 Examples of columns with damage state *DS-4*: transverse and longitudinal bars visible (a) from Voosoghi and Saiidi (2010); (b) from Li (2012)

DS-4. Under damage state *DS-4*, the transverse reinforcement and possibly the longitudinal reinforcement are visible. This indicates a loss of unconfined concrete. Columns in this damage state may be subjected to repairs capable of moderate improvement.

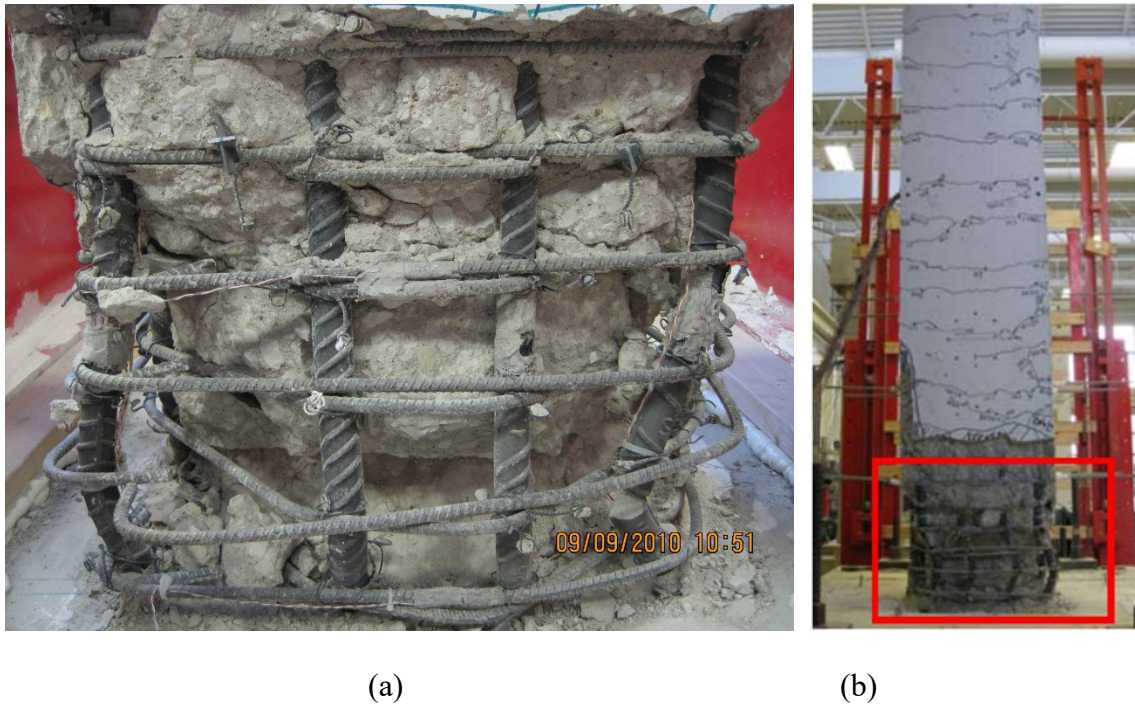
Figure 4.7 Examples of columns with damage state *DS-6*: column failure (a) fractured rebar; (b) local buckling (Li 2012)

DS-6. Under damage state *DS-6*, the confined core is compromised. Longitudinal bar buckling as well as longitudinal and transverse reinforcement fracture may be present. Repairing a column in this condition requires extensive use of different repair systems, and therefore, if possible, need for replacement of the element should be evaluated. In the case of a rapid repair, a lower performance level may be required, even with intensive repair.

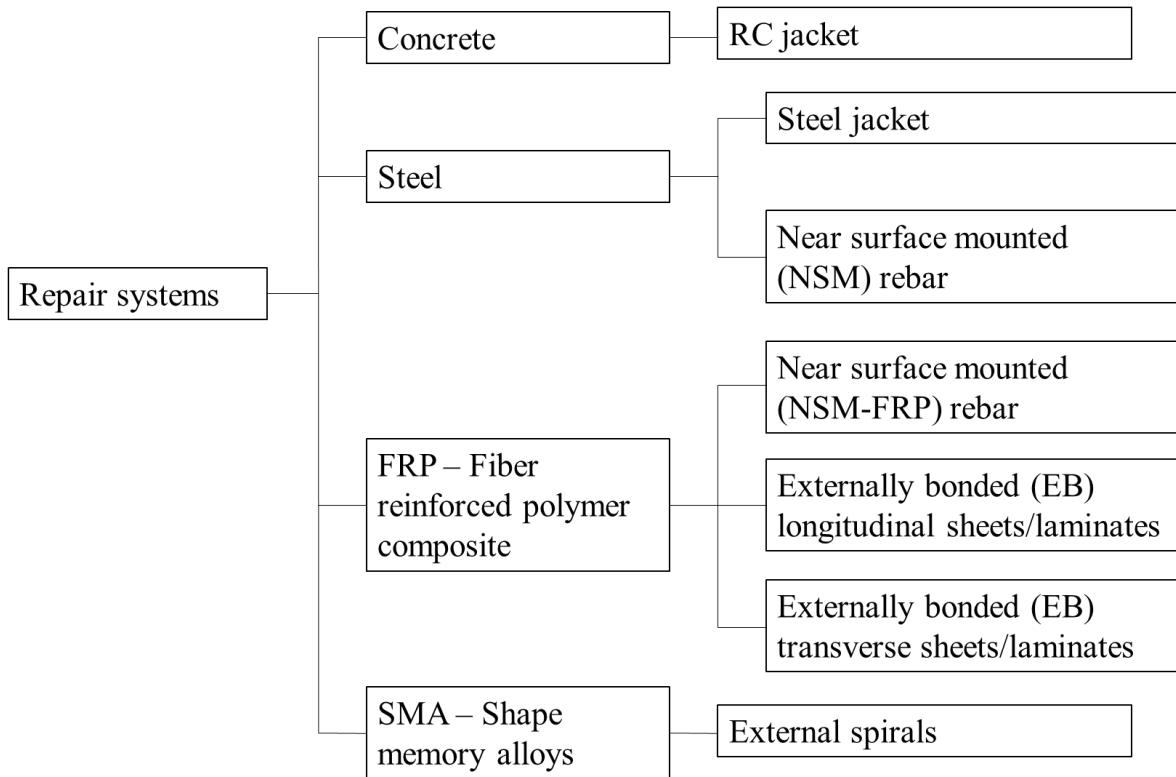
Figure 5.1 Repair systems for repairing damaged RC bridge columns

The repair systems discussed in this guide include those that have been experimentally tested and reported in the literature for repairing RC bridge columns (see Chapter 2 and Appendix A). This section describes the different systems that have been used, organized first by different repair materials (Section 5.2), and then by different repair techniques available (Section 5.3). Pros and cons of the different repair materials and techniques are discussed. Figure 5.1 shows the repair materials and systems discussed in Sections 5.2 and 5.3. Finally, Section 5.4 provides a brief discussion of emerging systems that have been used to reinforce and/or repair RC members but that have not been tested on elements having the same scale as real bridge columns.

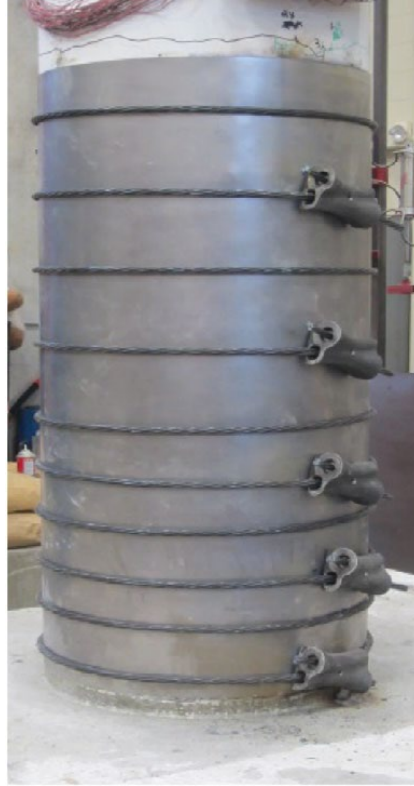
Figure 5.2 Column repaired with hybrid steel jacket (Fakhairifar et al 2015a)

- *Pros:* Can be used to improve the flexural, shear, and compressive strength of the column.
- *Cons:* Confining pressure is not uniform in the case of discontinuous reinforcement (e.g., hoops, spirals, straps); increases the column mass (in the case of continuous steel jackets); steel must be protected to avoid environmental degradation.

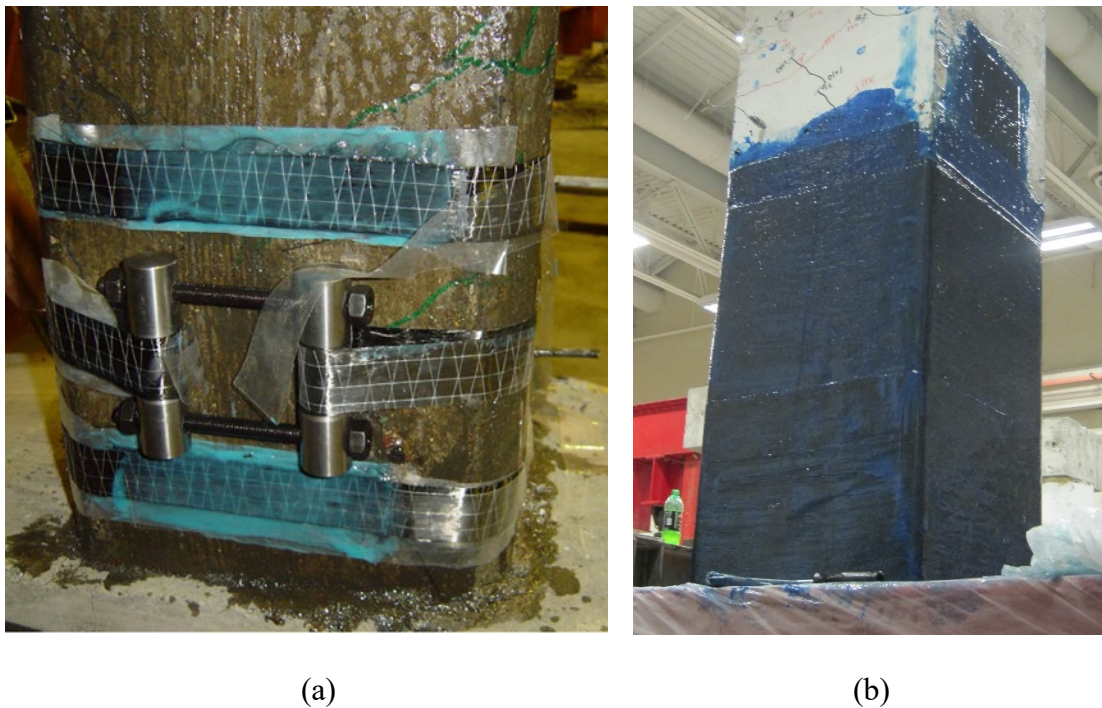
Figure 5.3 (a) Prestressed FRP wraps (Nesheli and Meguro 2006), (b) FRP jacket (b). Note the rounded column corners at the jacket location.

For the case of thin precured FRP laminates, an initial layer of epoxy adhesive is applied to the concrete. Then the laminate is wrapped around the column and bonded to the surface. Continuous precured FRP laminates can also be used as a stay-in-place formwork, if replacement of concrete is needed (Yang et al. 2015b). This method can only be used on columns with circular or elliptical cross-sections.

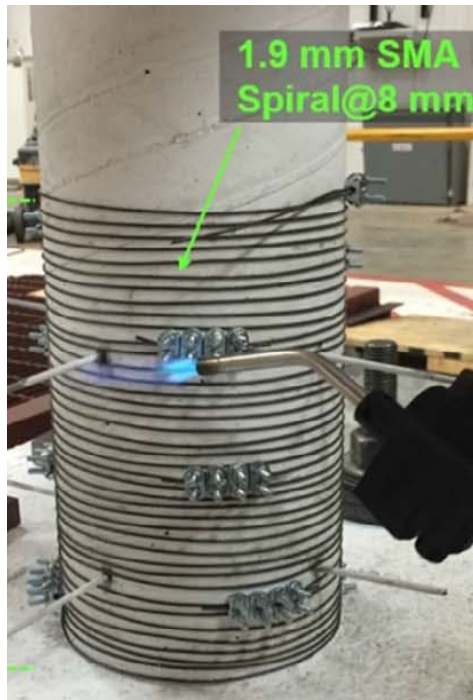
Figure 5.4 SMA active confinement (Jung et al. 2018)

This method can only be used on columns with circular or elliptical cross-section (Choi et al. 2015). In addition, the high cost of SMA material generally limits the application to the plastic hinge region only.

- *Pros:* Generate active confinement, does not increase the column mass or cross-sectional dimensions; fast installation.
- *Cons:* High cost of SMA material; material may not be readily available; can only be used on columns with circular or elliptical cross-section.

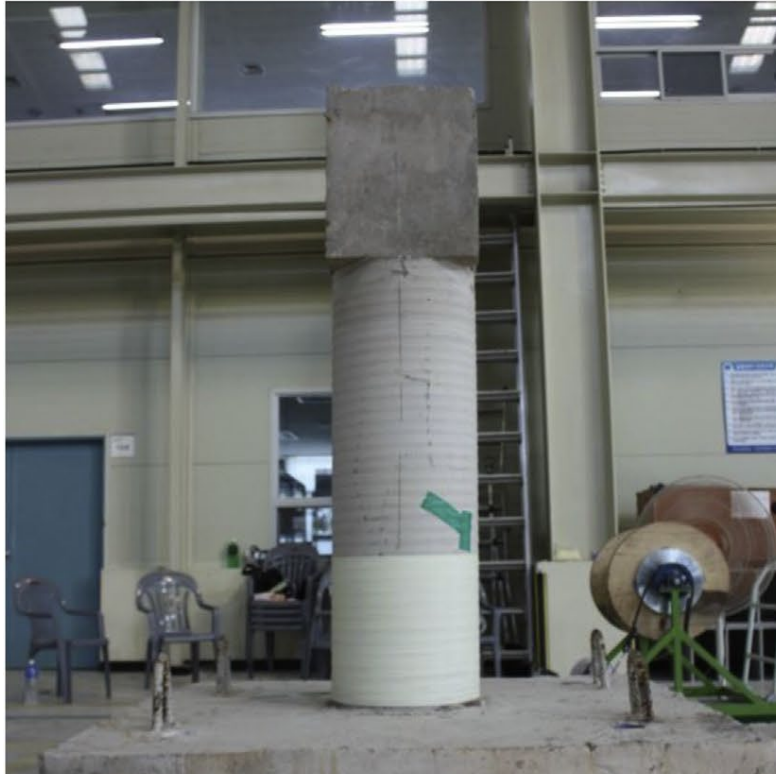
Figure 5.5 RC column reinforced with externally wound FRP wires (Choi et al. 2015)

FRP wires have been used to increase the strength, ductility, and stiffness of RC columns with circular cross sections. Choi et al. (2015) demonstrated the use of small GFRP wires (diameter of 1 mm) wound around severely damaged RC columns. The wires were pre-tensioned with a small force during the winding process, and no adhesive was used to bond the wires to the

surface. Promising results were achieved in terms of strength, ductility, and stiffness. The use of this method is reserved for columns with circular or elliptical cross-sections.
