EXPERIMENTAL RESULTS OF RAWCAD STATIC TEST

From September 7, 2018, to December 16, 2019, the Federal Railroad Administration supported the performance of semi static tests on two cracked axles as part of the Resonant Acoustic Wayside Automated Cracked Axle Detection (RAWCAD) project. The performance of detection algorithms for distinguishing frequency shift in cracked axles was evaluated at the Transportation Technology Center (TTC) in Pueblo, CO. Two cracked axles were tested, one on each of the two railcars. The remaining axles on both cars were unblemished. Originally, locations of the cracked axles were unknown to the analyst, making this initial evaluation a blind test of the detection algorithm. This test procedure called for impacting each axle with a hammer and measuring the response with an accelerometer attached to the axle. This impact/measure sequence was repeated as the railcar was indexed forward an incremental distance. Since the crack breathing phenomenon causes a crack to open and close once per revolution, the measured frequency response for the cracked axle should vary as the railcar is moved through one complete wheel revolution. Alternatively, there should be

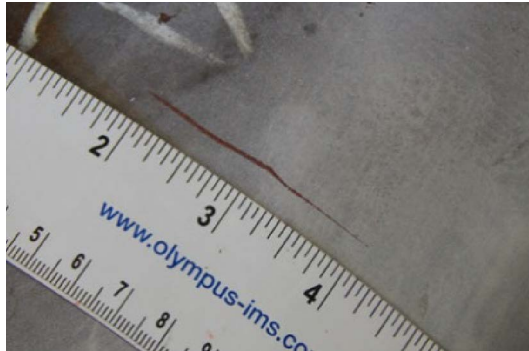
[Figure 2](#) shows the crack for one of the two solid axles from TTCI (Axle 1822). This axle was removed from the heavy axle load train operated at the TTC's Facility for Accelerated Service

Testing (FAST). The crack is similar in size to that shown in Figure 1 for the Lucchini axle. The crack is made visible by the use of a dye applied to the axle at the crack location.

Figure 2. Transportation Technology Center, Inc. (TTCI) cracked axle (Axle 1822)

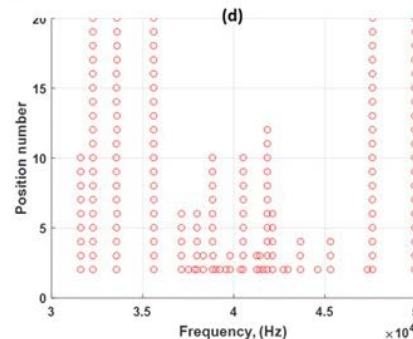
1. For each railcar location, measure response to multiple impacts

2. Take segment for each impact, take Fourier transform and find frequency peaks

3. Find subset of peaks (within some percentage) that occur for each impact and each railcar position

Figure 3. Algorithm for determining axle frequency shift vs axle position

Algorithms for detecting crack breathing were developed by Vibroacoustic Concepts (VaC). Figure 3a–d shows the steps in these algorithms and typical results obtained. Figure 3c shows that the peak picking algorithm yields many frequency peaks corresponding to each response spectrum. Furthermore, the same frequency peaks are not present for each impact response.

To reduce the amount of data and increase the data quality, only the spectral peaks which are present for each of the multiple impacts are selected. The algorithm then determines a

frequency band and selects only the frequency peaks that occur for each position. Figure 3d shows a typical result for this step. Finally, by plotting the actual frequencies for each axle rotation, it is then possible to determine the amount of frequency shift.

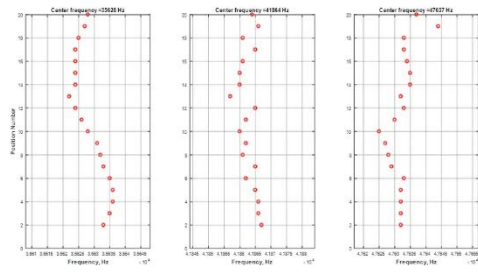
Figure 4. UP 33394 Axle 1

The results obtained using the crack shift algorithm are shown in Figure 4 through Figure 11. Each of these graphs represents the frequency response variation for three selected frequencies over a complete wheel revolution. Theoretically, the results for the cracked axle would show a sinusoidal frequency shift. In fact, all the axles on UP 33394 show some amount of frequency shift, but none of them show a consistent once per revolution frequency shift as expected. Instead, all the graphs show a frequency variation on the order of 10 to 20 Hz.

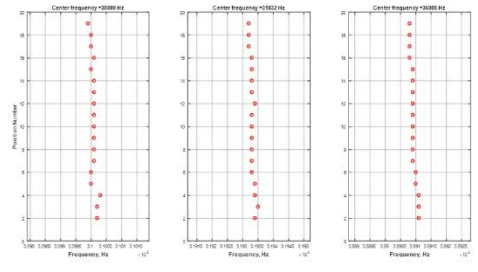
Figure 11. NW120004 Axle 4

Similarly, the results for car NW 120004 do not clearly indicate a cracked axle (Figure 8 to Figure 11). Good axles 2, 3, and 4 show little variation, but the cracked axle (Axle 1) does not vary as expected over all of the frequencies.
