DOT HS 812 942

June 2020

Vehicle Bumper Performance in Part 581 Versus Pedestrian Leg Protection

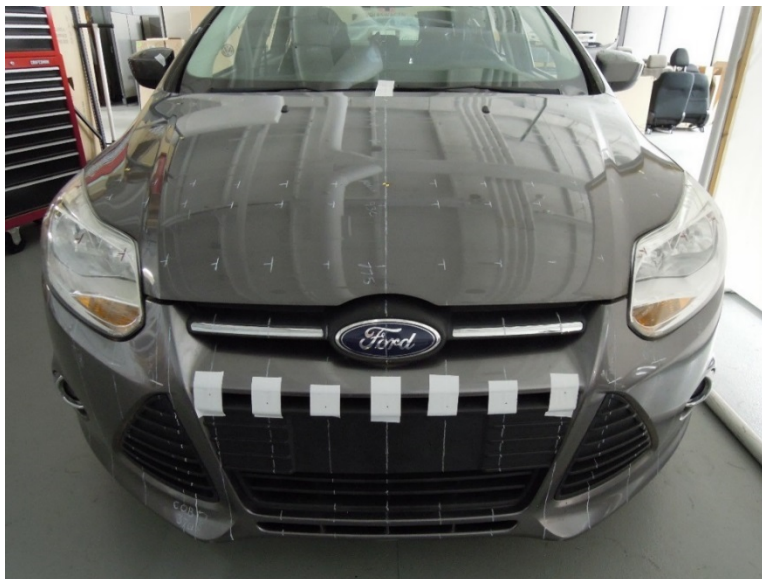
Externally, the U.S. and E.U. versions of the 2012 Ford Focus are identical (same front bumper fascia for both versions) and both are represented by Figure 1.

Figure 1. 2012 U.S. and E.U. Ford Focus

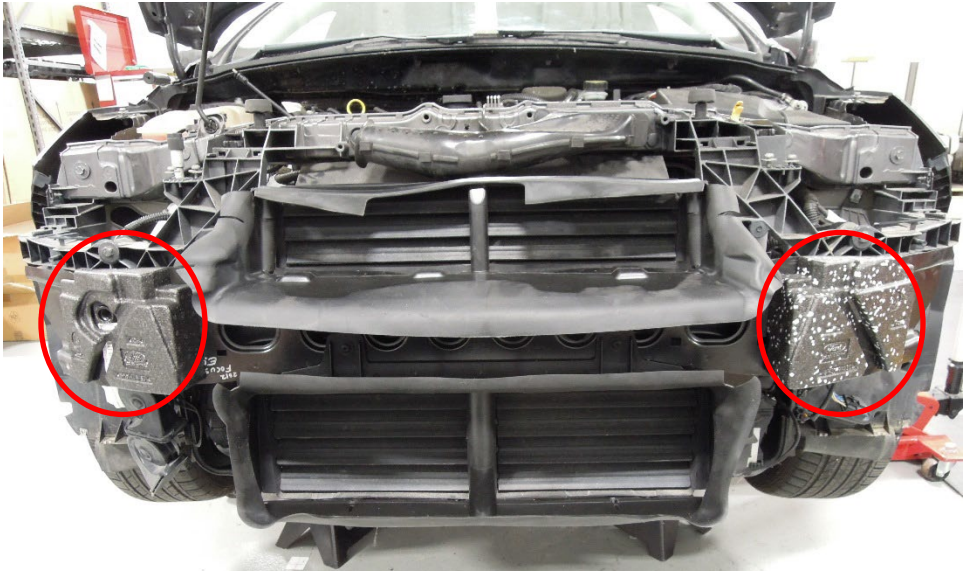
Figure 5. 2012 E.U. Ford Focus front bumper absorber configuration. The bumper absorbers (red) only cover the bumper beam support areas with empty space along the middle of the bumper.

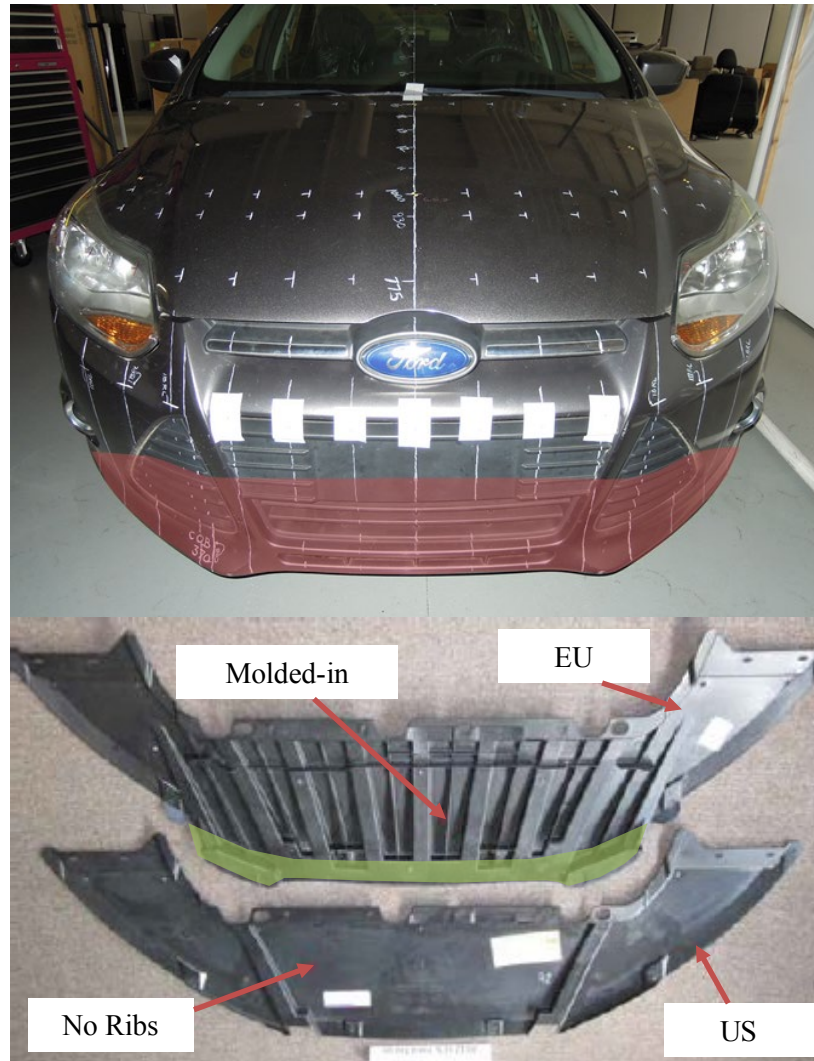
Another difference between the two models is in the underbody deflector that is located along the bottom edge of the front bumper and is shown in Figure 6. The U.S. deflector is a thin, flexible sheet of plastic that only acts as an underbody “cover” as it attaches to the underside flap of the front fascia. On the other

hand, the E.U. deflector is much thicker, stiffer, and heavier and contains molded-in ribs. Additionally, the E.U. deflector has additional material in the front, which is highlighted in Figure 6, that extends into and presses against the front fascia, acting as both a support to the lower portion of the front fascia as well as an underbody cover.

Figure 6. Top image shows the location (highlighted in red) of the underbody deflector panels. Bottom image shows the differences between the 2012 U.S. and E.U. Ford Focus underbody deflector panels. The additional material in the E.U. deflector is highlighted in green

The underbody deflector, shown in Figure 6, will also significantly affect lower legform impact results. As mentioned earlier, the U.S. deflector is a thin, flexible sheet of plastic while the E.U. deflector is much thicker and stiffer and contains molded-in ribs. The thin deflector on the U.S. Focus does not add any structural support to the lower part of the bumper fascia and during a lower legform impact, the Flex-PLI will bend around the bumper beam. On the other hand, in the E.U. Focus, the stiffer underbody deflector adds support and stiffens the lower part of the bumper fascia preventing bending of the legform below the

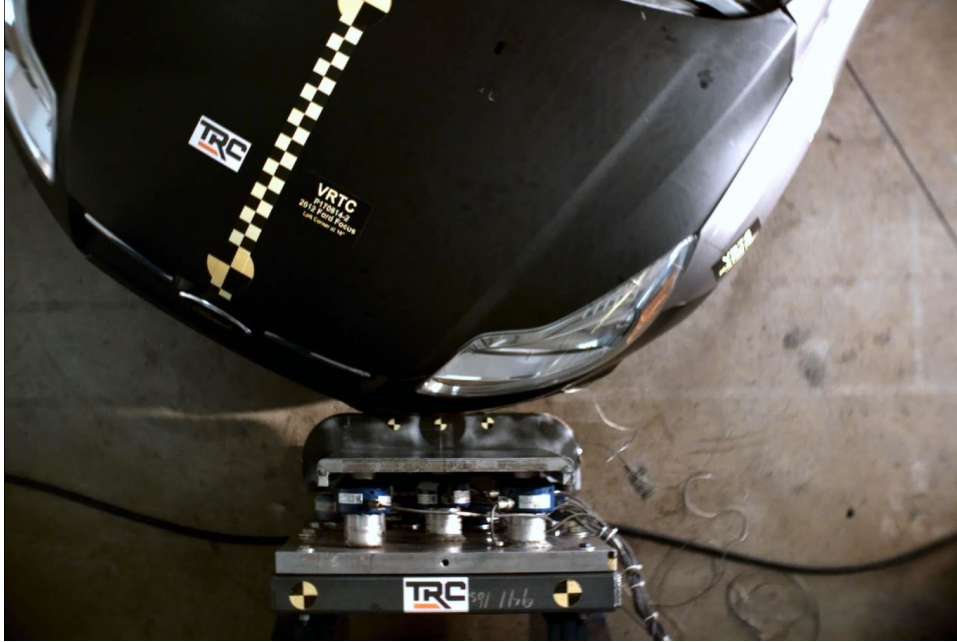
Figure 9. Front bumper corner impact. Pendulum contact with the absorbers is present in both the U.S. and E.U. Focus.

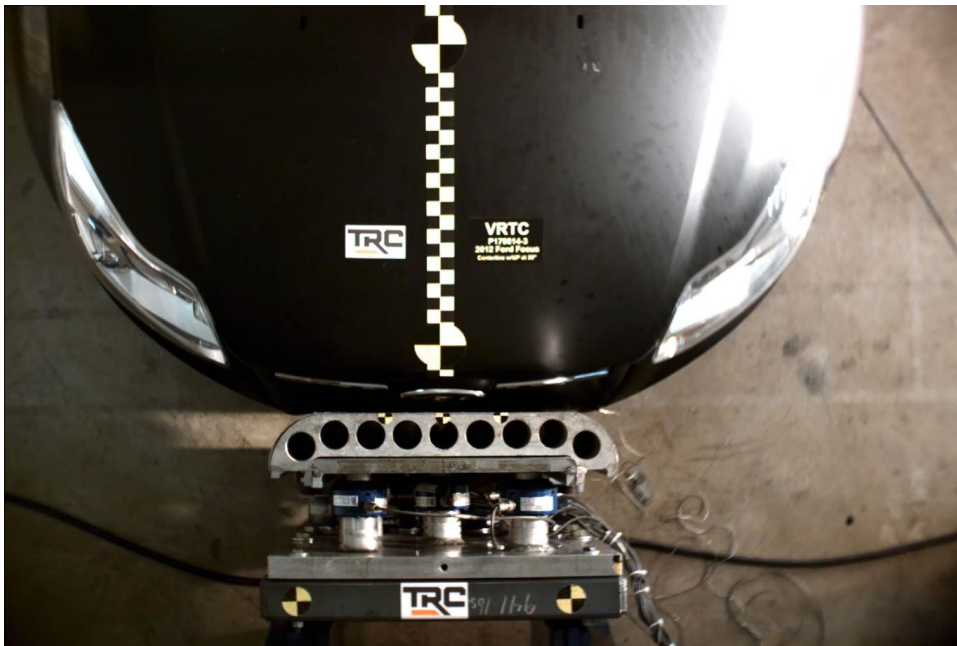
Figure 10. Front bumper impact at centerline. For the E.U. Focus, pendulum contact lies between the absorbers. Pendulum contact is present in the U.S. Focus.

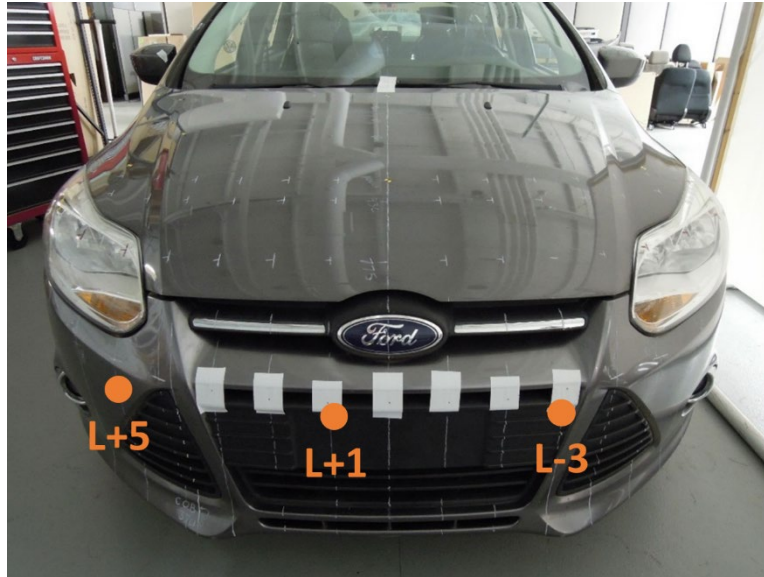
The lower legform impact points for the 2012 U.S. and E.U. Ford Focus are shown in Figure 11.

Figure 11. Lower legform impact points for the 2012 U.S. and E.U. Ford Focus

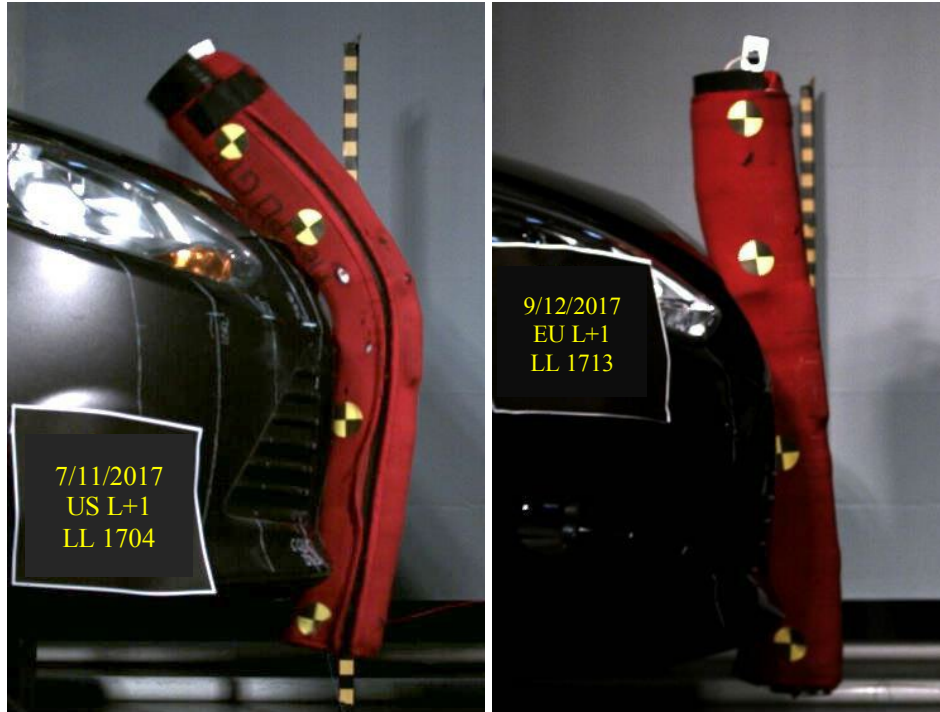
High speed video screen captures of the Flex-PLI at maximum bending are shown for the U.S. and E.U. Ford Focus impacts at the three impact locations in Figure 15 to Figure 17 below. At impact location L+1 (Figure 15), the U.S. Focus produced greater leg bending while the E.U. Focus maintained a straighter leg. At impact location L-3 (Figure 16), the U.S. Focus again produced greater leg bending while the E.U. Focus maintained a straighter leg. At impact location L+5 (Figure 17), the U.S. and E.U Focus produced a similarly bent leg.

Figure 15. High speed video screen capture of the Flex-PLI at maximum bending at impact location L+1 for the 2012 U.S. (left) and E.U. (right) Ford Focus. The U.S. Focus produces greater bending than the E.U. Focus.

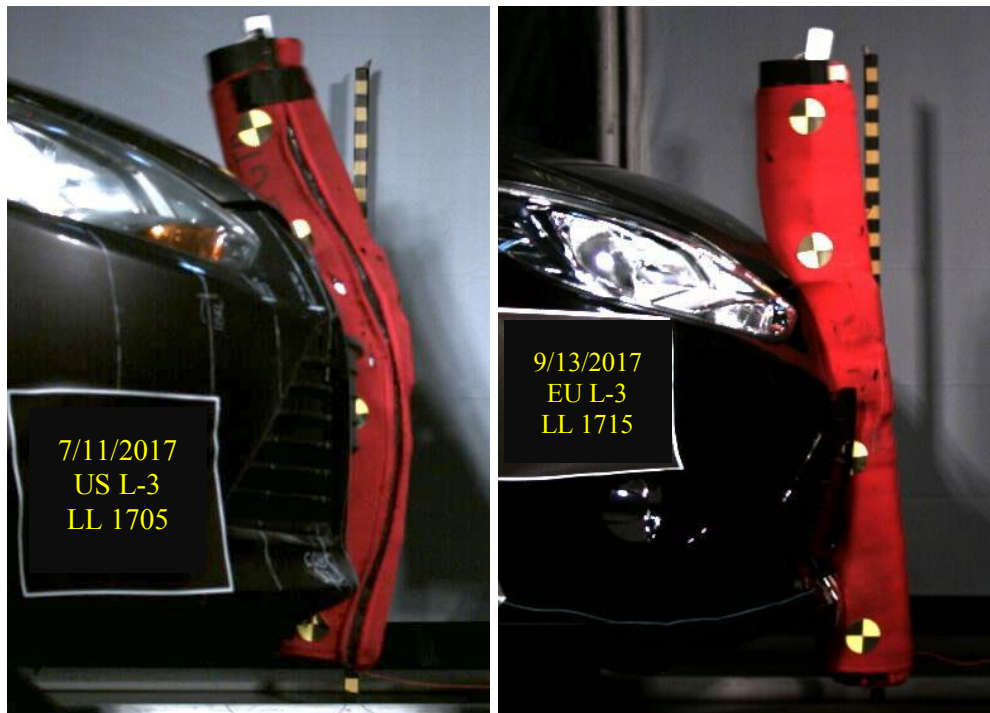
Figure 16. High speed video screen capture of the Flex-PLI at maximum bending at impact location L-3 for the 2012 U.S. (left) and E.U. (right) Ford Focus. The U.S. Focus produces greater bending than the E.U. Focus.

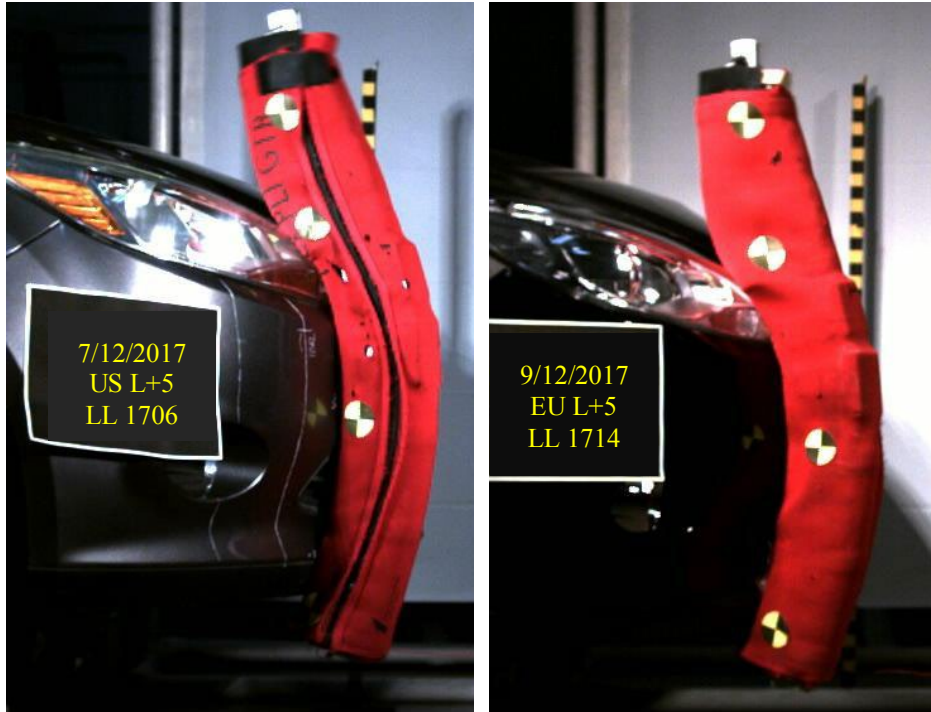
Figure 17. High speed video screen capture of the Flex-PLI at maximum bending at impact location L+5 for the 2012 U.S. (left) and E.U. (right) Ford Focus. Both U.S. and E.U. versions of the Focus produce similar bending.

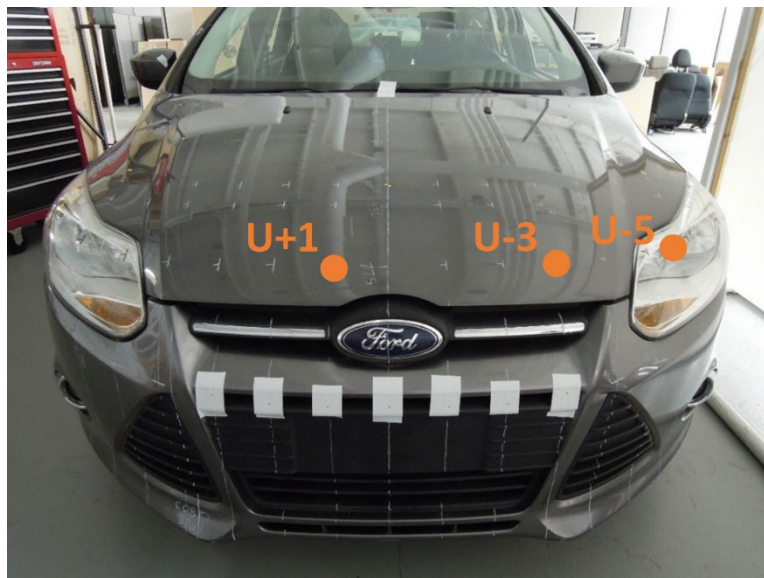
The upper legform impact points for the 2012 U.S. and E.U. Ford Focus are shown in Figure 18.

Figure 18. Lower legform impact points for the 2012 U.S. and E.U. Ford Focus

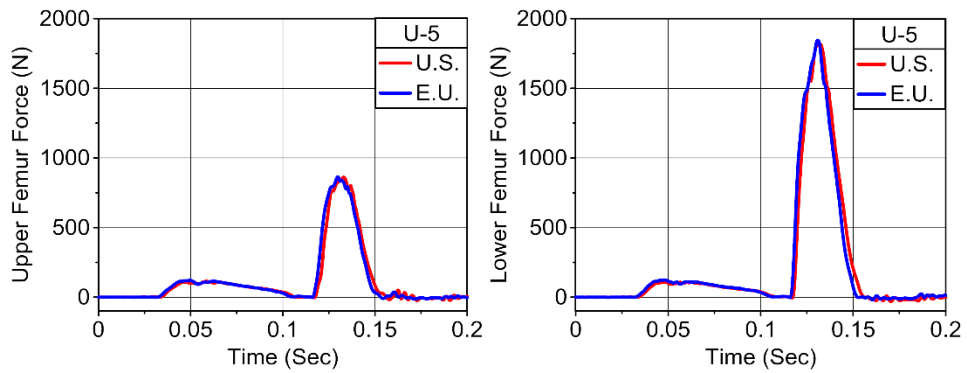
Figure 24. Upper legform femur force time histories for the 2012 U.S. and E.U Ford Focus at impact location U-5.

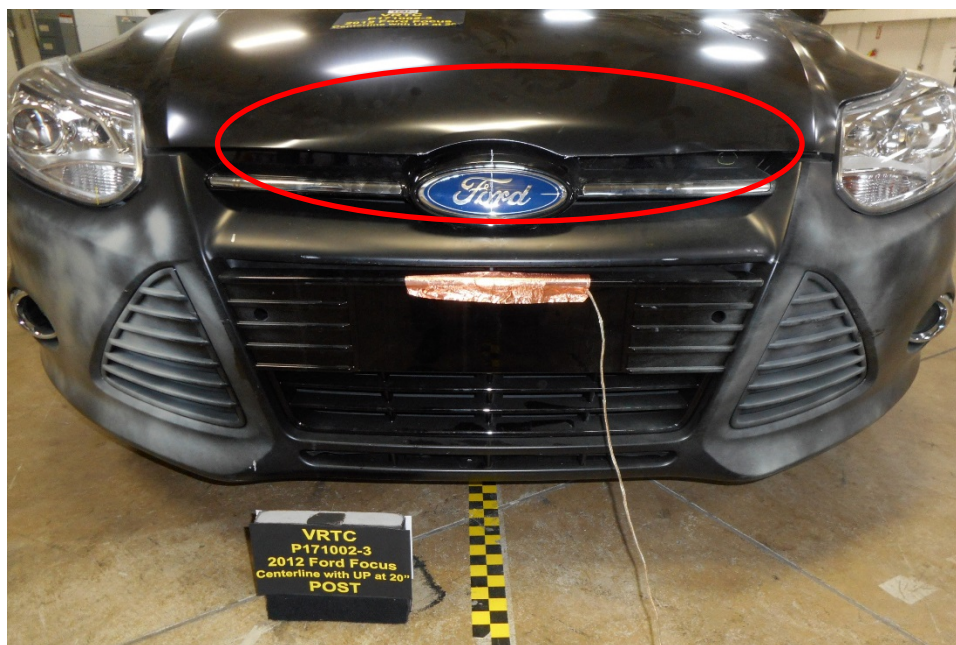
Additionally, the E.U. Ford Focus displayed more damage than the U.S. version as described in Table 5. The U.S. version only observed minor damage in the form of minor scuffs/scratches where the pendulum contacted the fascia. Like the U.S. version, the E.U. version also observed scuffs/scratches. However, the E.U. version also observed contact and damage to its hood, which is pictured in Figure 29 on the next page.

Figure 29. Hood damage (crumpled/bent hood leading edge) to the E.U. Ford Focus (circled in red) that was not observed in the U.S. Focus.

These internal differences also explain the increased pendulum forces and greater damage in the 2012 E.U. Ford Focus in the Part 581 bumper damageability tests. The lack of structures in the center of the E.U. Focus allowed for intrusion of the pendulum into the bumper, allowing the Upper Plane B to make contact with the hood of the E.U. version of the Focus that was not observed in the U.S version as shown in Figure 32. The hood intrusion in the E.U. version resulted in higher forces due to contact with the Upper Plane B and additional damage to areas other than just the bumper. The Part 581 test procedure also allows for varying test heights from 16 to 20 inches. Since the middle bumper of the pendulum impactor makes contact with the absorber area of the Ford Focus throughout this range, it is hypothesized that similar plane forces and damage would be observed at the varying heights.

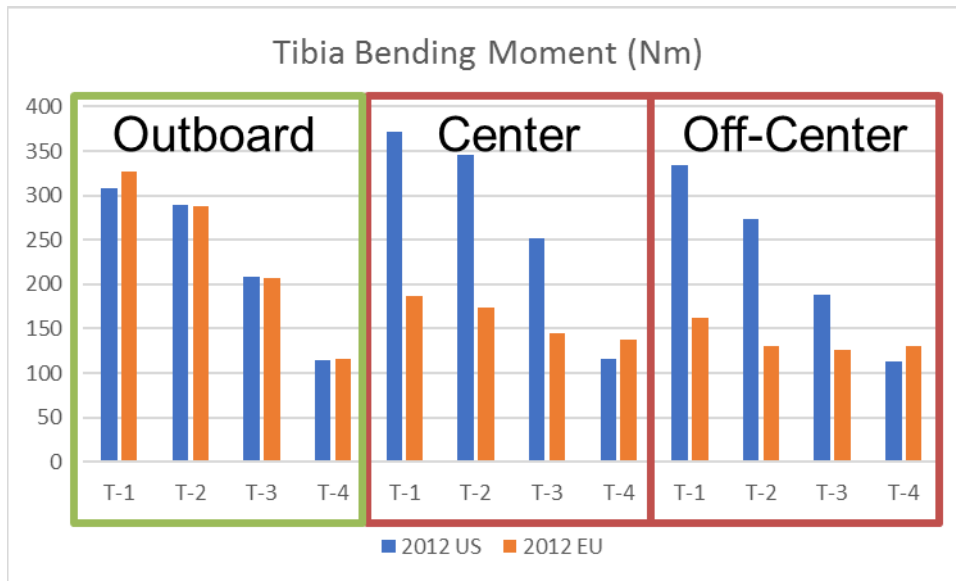
The energy absorber, on the other hand, is expected to significantly influence legform impact results since it is directly beneath the bumper fascia. The differences between the U.S and E.U. Ford Focus designs explain the similarities and differences in the pedestrian lower legform results. Figures 3 through 5 show how the U.S. absorber spans the entire length of the bumper beam while the E.U. absorber consists of two pieces of foam that only cover the outboard beam support areas, leaving the center of the beam uncovered. Figure 30 and Figure 31 below show the lower legform tibia bending moment and ligament elongation results, respectively. The outboard impact results (highlighted in green) are very similar between the 2012 U.S. and E.U. Ford Focus due to the presence of an absorber at the outboard areas of the bumper. The center impact results (highlighted in red) are much different between the U.S. and E.U. Focus due to the presence of an energy absorber along the center of the U.S. Focus and the lack of an absorber and presence of empty space in the E.U. Focus. The empty space along the center of the E.U. Focus would allow for the lower legform to intrude into the front bumper more, producing less bending in the legform and lower overall measurements than the U.S Focus. Screen captures of lower legform center tests in Figure 15 and Figure 16 also show how the Flex-PLI intrudes into the center of the softer E.U. Focus bumper while bending around the stiffer U.S. Focus bumper.

Figure 30. 2012 U.S. and E.U. Ford Focus tibia bending moment results showing similarities at the outboard location and differences at the center locations.

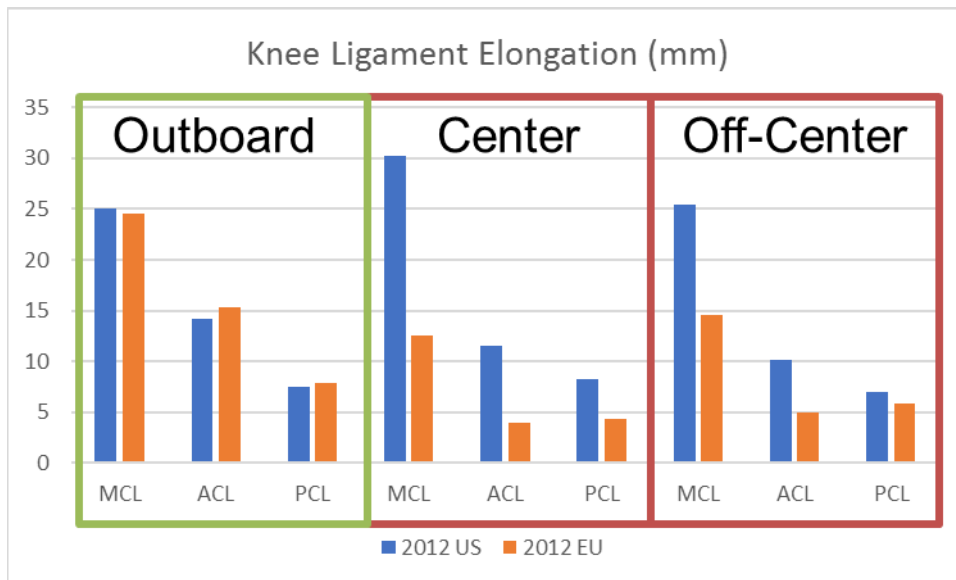
Figure 31. 2012 U.S. and E.U. Ford Focus knee ligament elongation results showing similarities at the outboard location and differences at the center locations.
