DOT HS 812 869

June 2020

# **THOR-50M Durability Report**

<b>16. Abstract</b> This report documents the methods and results of qualification-type testing performed to evaluate the durability of the THOR 50th Percentile Male Dummy (THOR-50M). This evaluation concluded that the THOR-50M exhibited acceptable durability when exposed to elevated energy qualification-type tests. The durability assessment began with a baseline qualification test, and then the input energy levels were increased by 10 percent, 20 percent, and 30 percent prior to performing a final baseline test. The responses produced during the pre-durability baseline tests and post-durability baseline tests were evaluated against the qualification corridors, and the THOR-50M's durability was deemed acceptable where the dummy passed the qualification requirements and didn't show visible signs of deterioration.					
<b>17. Key Words</b> THOR-50M crash test dummy				<b>18. Distribution Statement</b> Document is available to the public from the National Technical Information Service, <a href="http://www.ntis.gov">www.ntis.gov</a> .

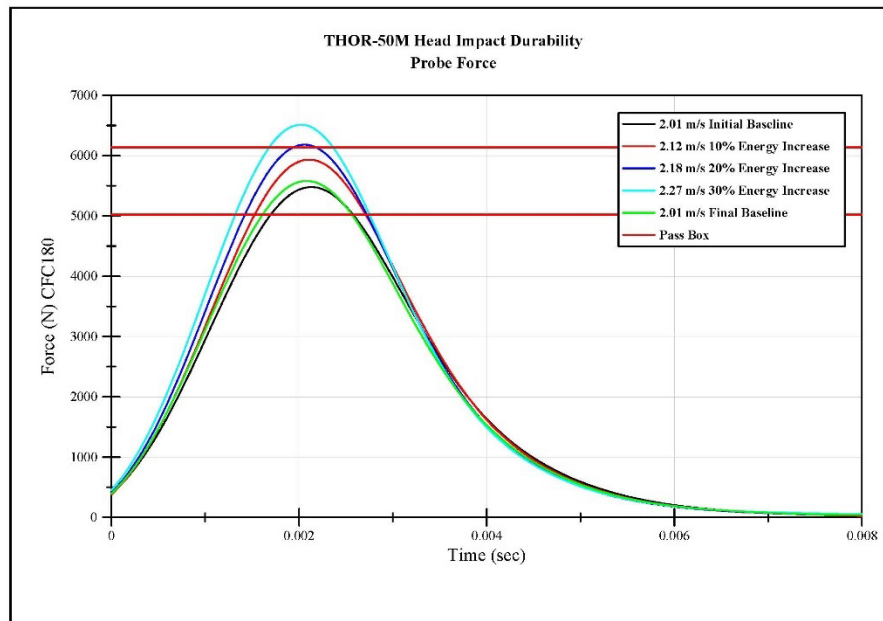
**Figure 3-2. Probe force for head durability tests**

For the baseline THOR-50M head qualification tests, the peak force and the peak head center of gravity (CG) resultant acceleration must be within the ranges provided in Table 3-2. Table 3-3, along with Figure 3-2 and Figure 3-3, illustrates the results of the durability tests.

The final baseline test results showed that the head returned to specification values for both peak probe force and head resultant CG after the increased energy tests. No visible damage to the head was observed post-testing. Results indicate that the head displays acceptable durability.

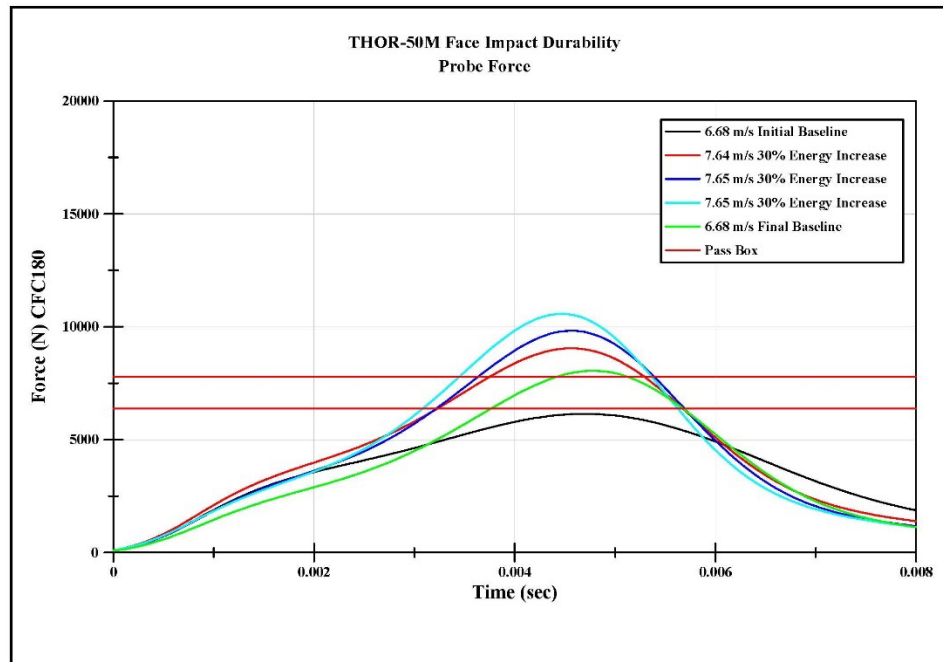
**Figure 3-5. Probe force for face impact durability tests**

Despite the fact that the initial baseline tests were slightly below the specification corridors, the final baseline test results showed that the face exceeded the specification values for peak probe force and peak head CG resultant acceleration after the increased energy tests. No visible damage to the face was observed post-testing. Results indicate that the face has a limited number of impacts where it remains within the corridor; this result was also observed in the repeatability and reproducibility tests.<sup>6</sup>

Even for recovery periods of 24 hours or longer, it was found that the face foam never completely recovered to its pretested condition; this was also observed in the *THOR-50M Repeatability and Reproducibility of Qualification Tests*.<sup>8</sup> However, the R&R results show that the face foams remain within the qualification corridors for approximately ten subsequent impacts; this suggests that the face foams have a limited lifespan before requiring replacement, but do provide clearly failing qualification results when the life of the foam is exhausted.

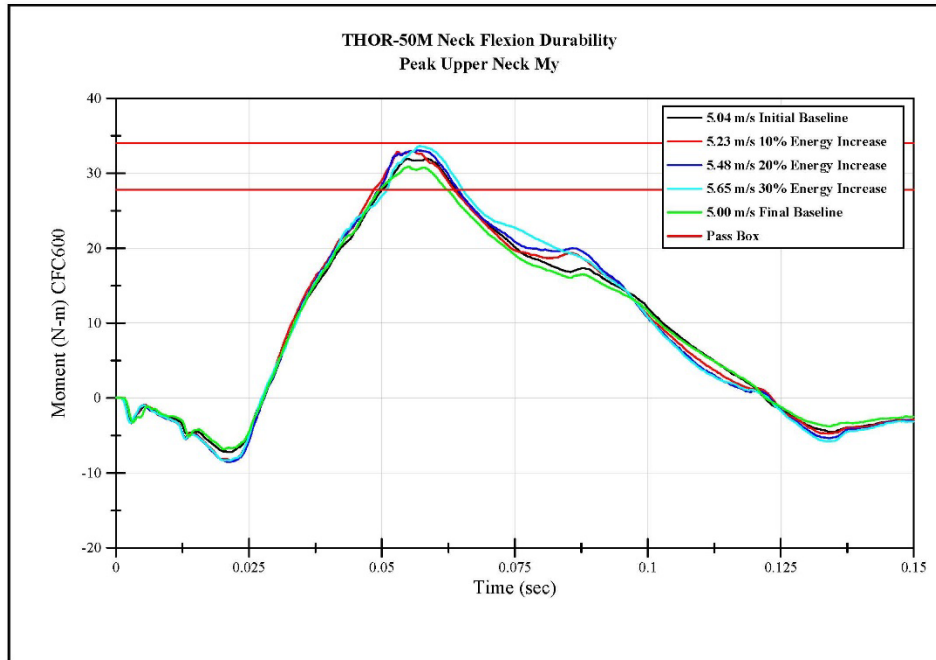
Figure 3-8. Peak upper neck moment about Y axis for neck frontal flexion durability tests

The final baseline test results showed that the neck returned to specification values for upper neck moment and force ( $M_y$  and  $F_z$ ), head angular rate, and head rotation after the increased energy tests. No visible damage to the neck was observed post-testing. Overall, the results indicate that the neck displays acceptable durability with respect to flexion.

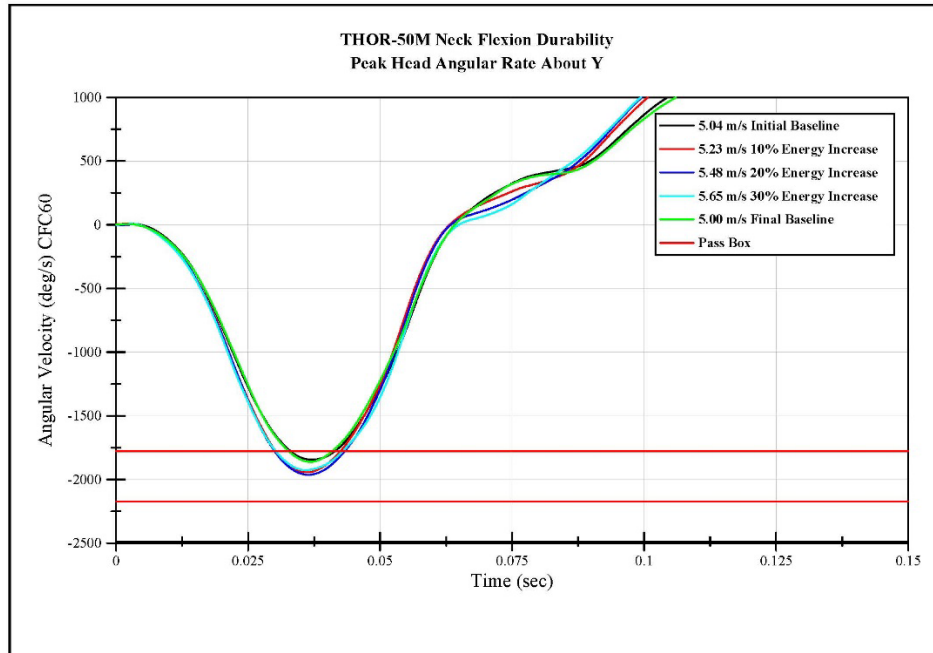
**Figure 3-10. Peak head angular rate for neck frontal flexion durability tests**

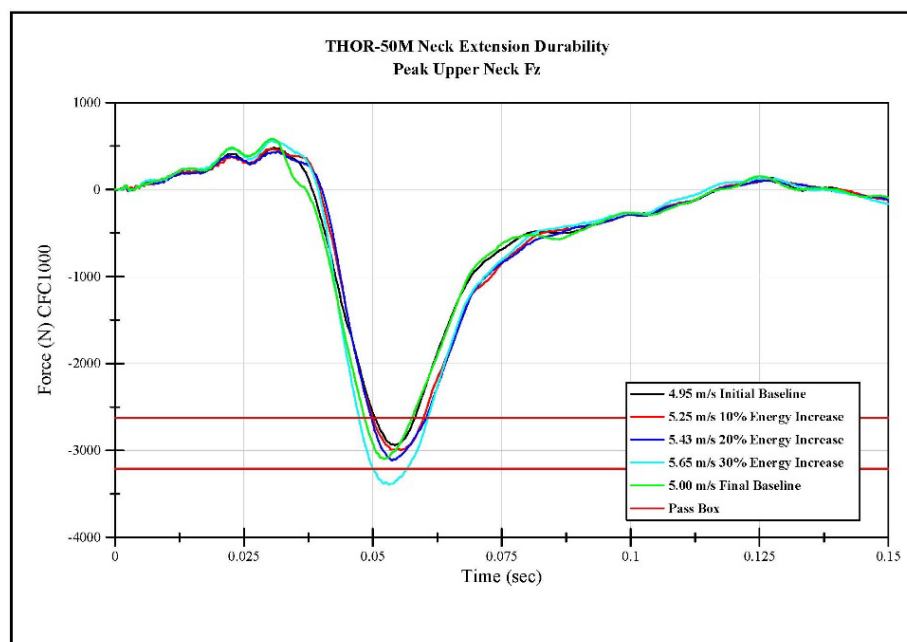
Figure 3-14. Peak upper neck Z axis force for neck extension durability tests

The final baseline test results showed that the neck returned to specification values for the upper neck moment (My), upper neck force (Fz), head angular rate, and head rotation after the increased energy tests. No visible damage to the neck was observed post-testing. Overall results indicate that the neck displays acceptable durability with respect to extension.

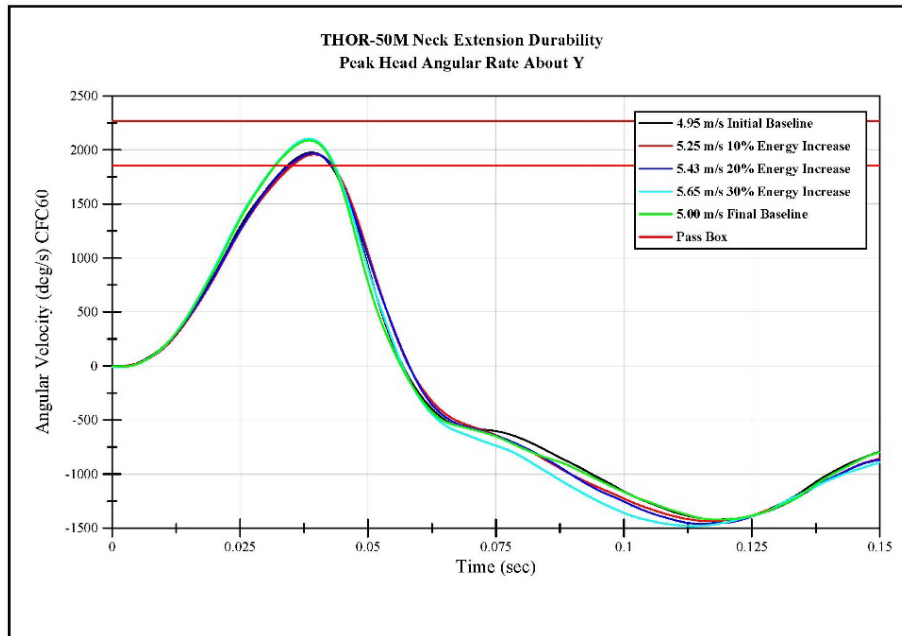
Figure 3-15. Peak head angular rate for neck extension durability tests

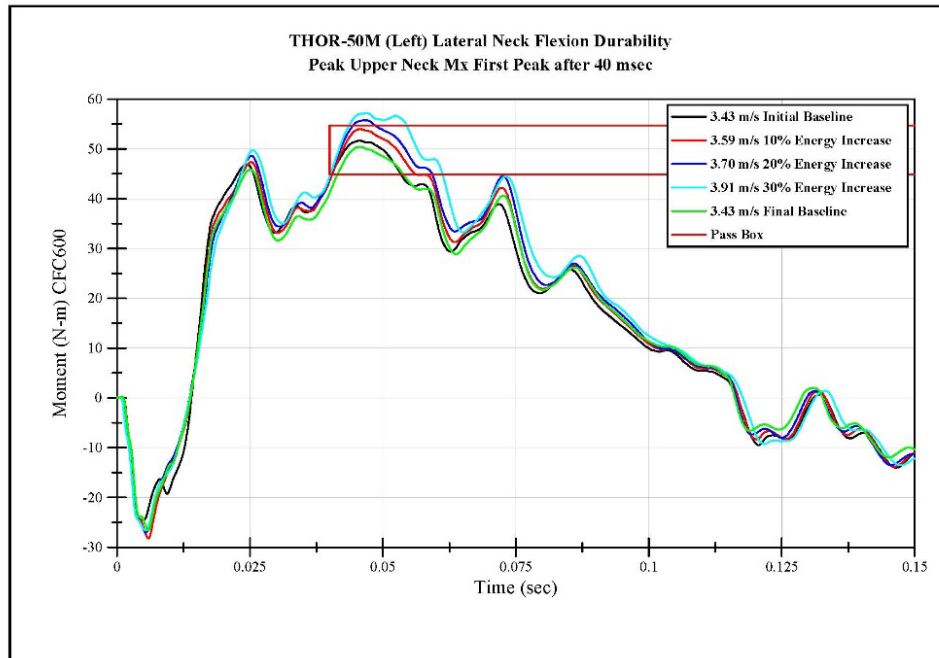
**Figure 3-18. Peak upper neck moment about X axis for neck lateral flexion durability tests**

The final baseline test results showed that the neck returned to specification values for the upper neck moment (M<sub>x</sub>), head angular rate, and head rotation after the increased energy tests. No visible damage to the neck was observed post-testing. Overall results indicate that the neck displays acceptable durability with respect to durability in lateral flexion.

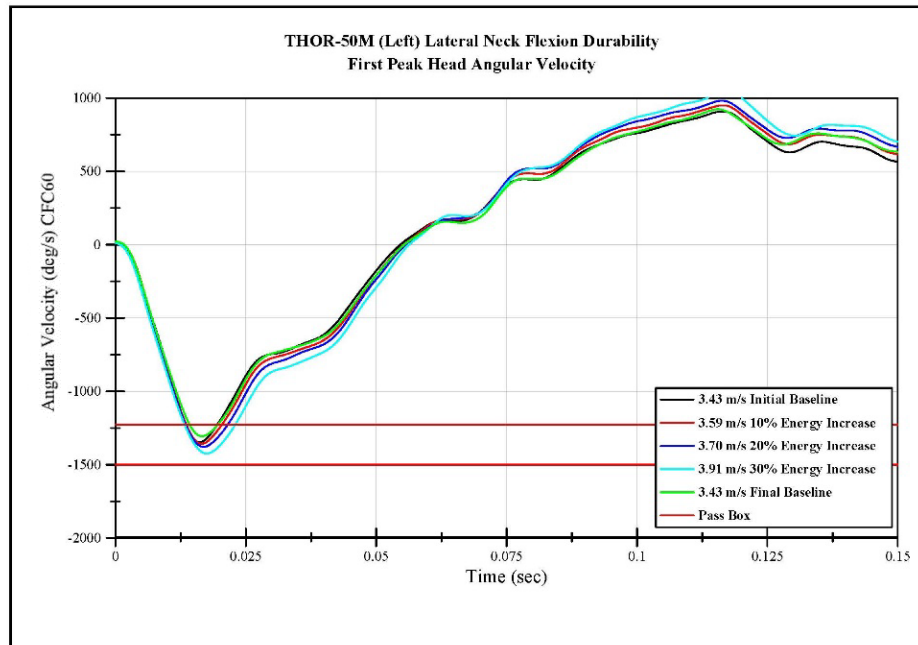
Figure 3-19. Peak head angular rate about X axis for neck lateral flexion durability tests

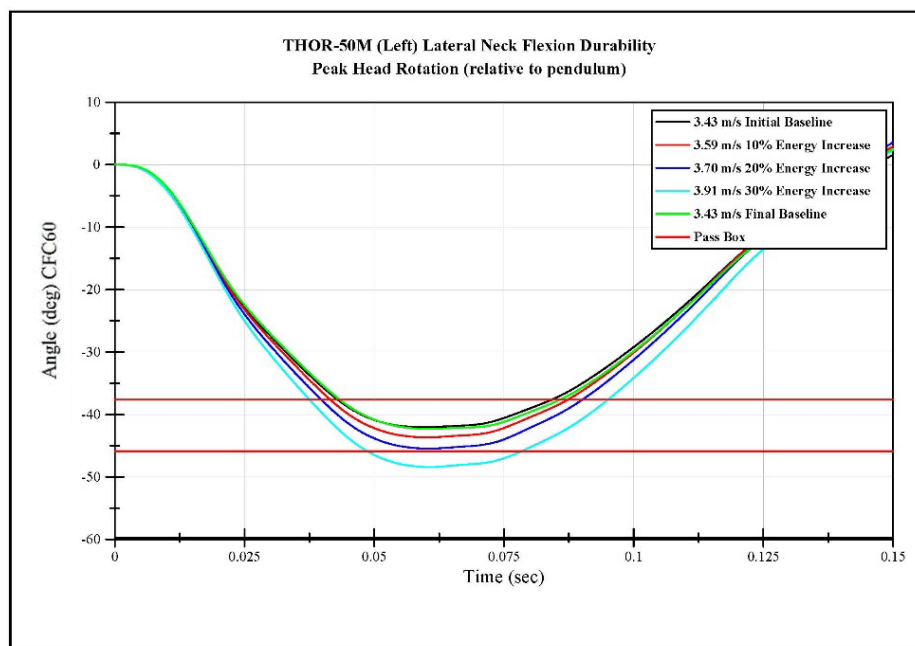
Figure 3-20. Peak head rotation for neck lateral flexion durability tests

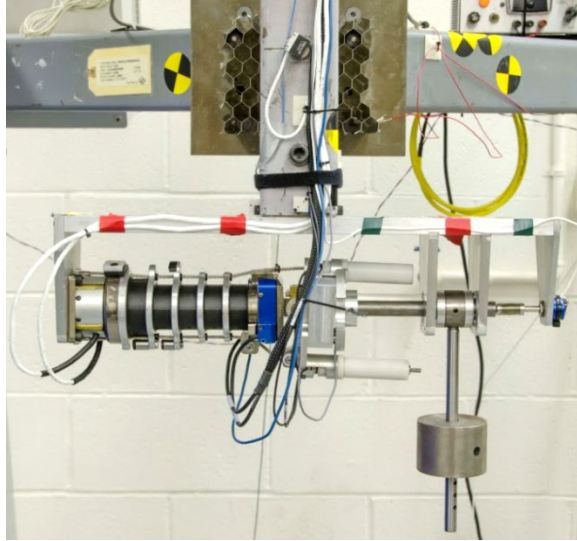
Figure 3-21. Neck torsion test setup

Durability tests were performed using the neck torsion qualification procedures described in the *THOR-50M Qualification Procedures Manual*. The neck torsion tests assess the response of the neck about the Z axis. The pendulum is also used for neck torsion tests, but instead of the lower neck load cell being attached to the pendulum, a neck torsion fixture (drawing DL472-1000) is used (Figure 3-21). The neck qualification in the torsion mode uses 152.4 mm (6") Hexcel aluminum honeycomb (or equivalent) for pendulum deceleration from an impact velocity of  $5.00 \pm 0.05$  m/s. For durability tests on the neck in the torsion mode, the test energy was elevated from the qualification baseline in increments of approximately 10 percent, to a maximum of approximately 30 percent, by increasing the test velocity (Table 3-16). After the 30 percent energy increase, another baseline test was conducted to make certain that no changes in response were observed due to elevating the test energy level.

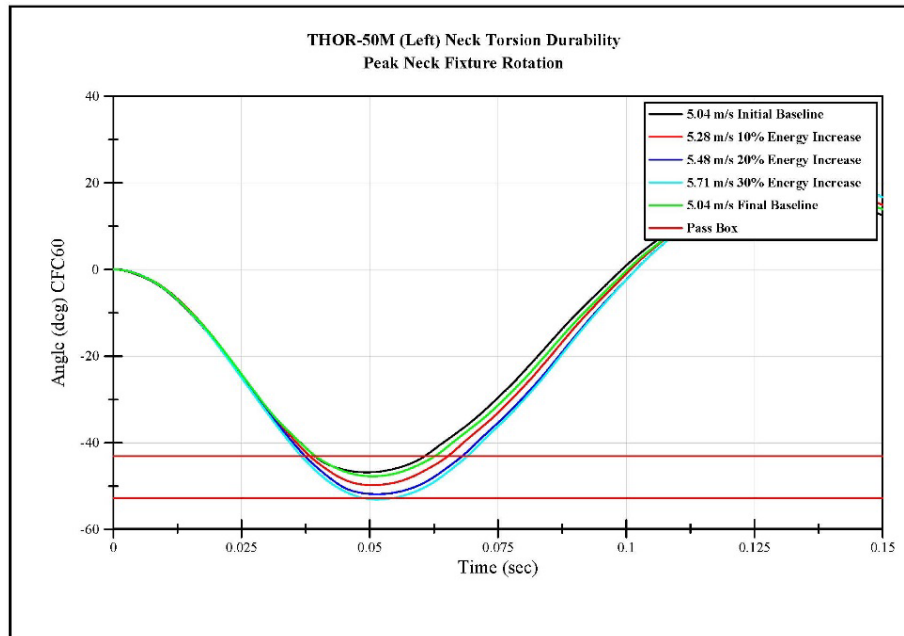
Figure 3-23. Peak neck fixture rotation for neck torsion durability tests

The final baseline test results showed that the neck returned to specification values for the upper neck moment (Mz), neck angular rate, and neck fixture rotation after the increased energy tests. No visible damage to the neck was observed post-testing. Overall results indicate that the neck displays acceptable durability with respect to durability in torsion.

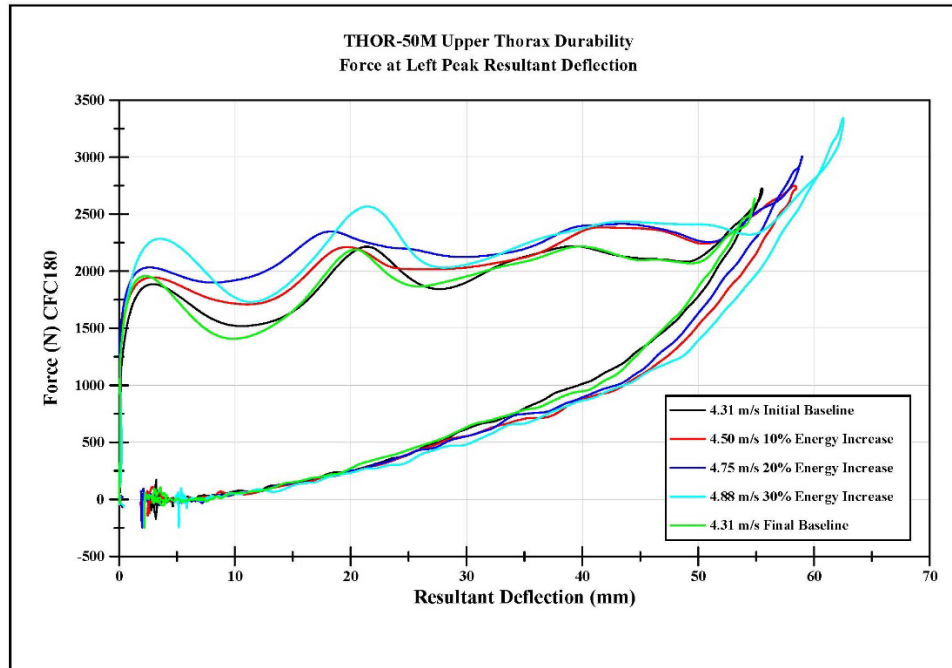
Figure 3-29. Force at left peak resultant deflection for upper thorax durability tests

The final baseline test results showed that the upper thorax returned to specification values for probe force, resultant upper deflections, and force at peak deflection after the increased energy tests. No visible damage to the thorax or ribs was observed post-testing. Results indicate that the upper thorax displays acceptable durability.

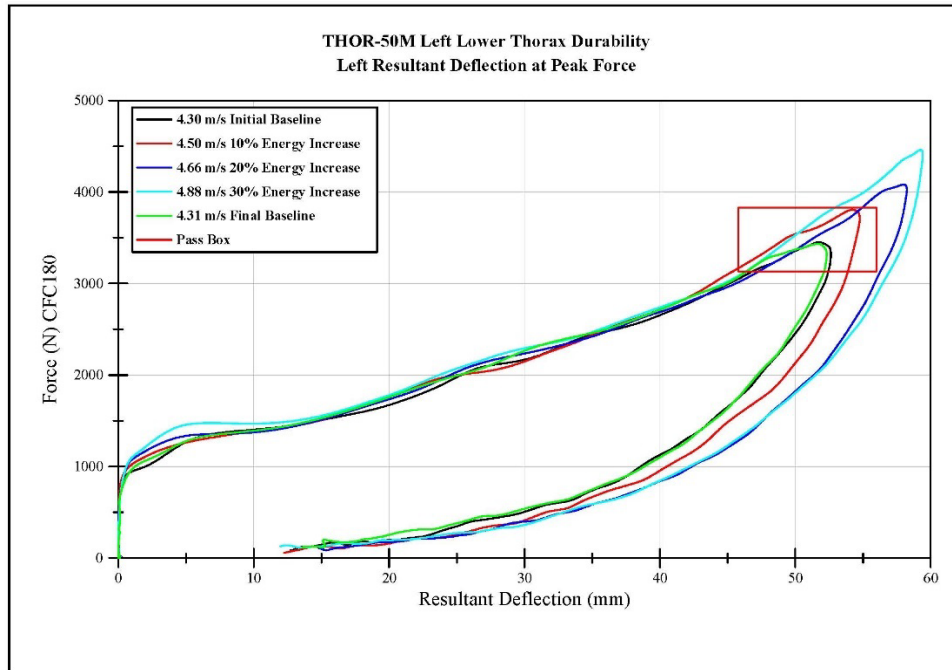
**Figure 3-32. Force-deflection for left lower thorax durability tests**

For the lower thorax durability test series, both the initial baseline test and the final baseline test demonstrated resultant deflection and probe force within the specification. No visible damage to the thorax or ribs was noted post-testing. Results from this testing indicate that the lower thorax displays acceptable durability in deflection and probe force at the time of peak deflection.

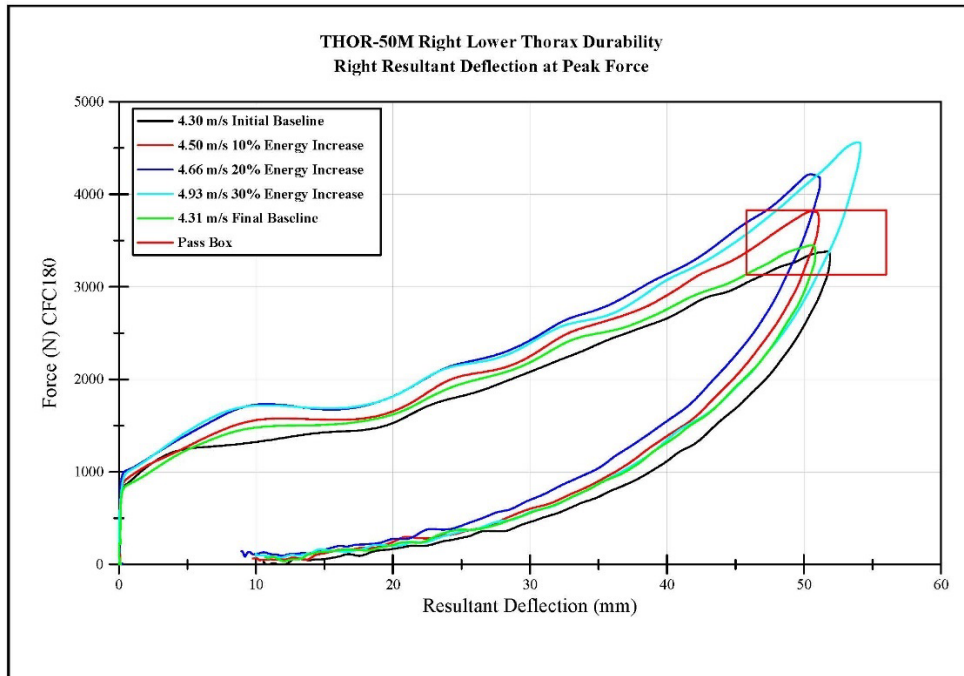
**Figure 3-33. Force-deflection for right lower thorax durability tests**

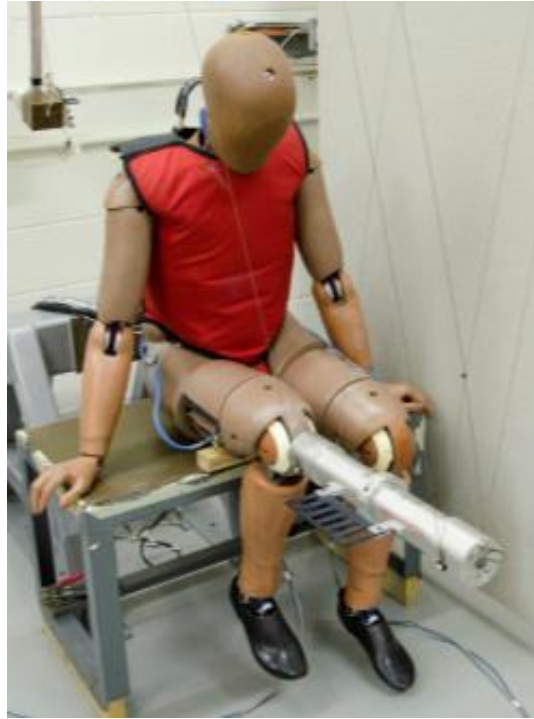
**Figure 3-36. Upper leg impact test for knee skin and compliant bushing**

of the way during those tests; however, the baseline tests were performed *without* a block behind the pelvis. For these tests, femurs from THOR-50M DO9798 were used.
