# Performance Evaluation of One-Coat Systems for New Steel Bridges

PUBLICATION NO. FHWA-HRT-11-046

JUNE 2011

U.S. Department of Transportation  
**Federal Highway Administration**

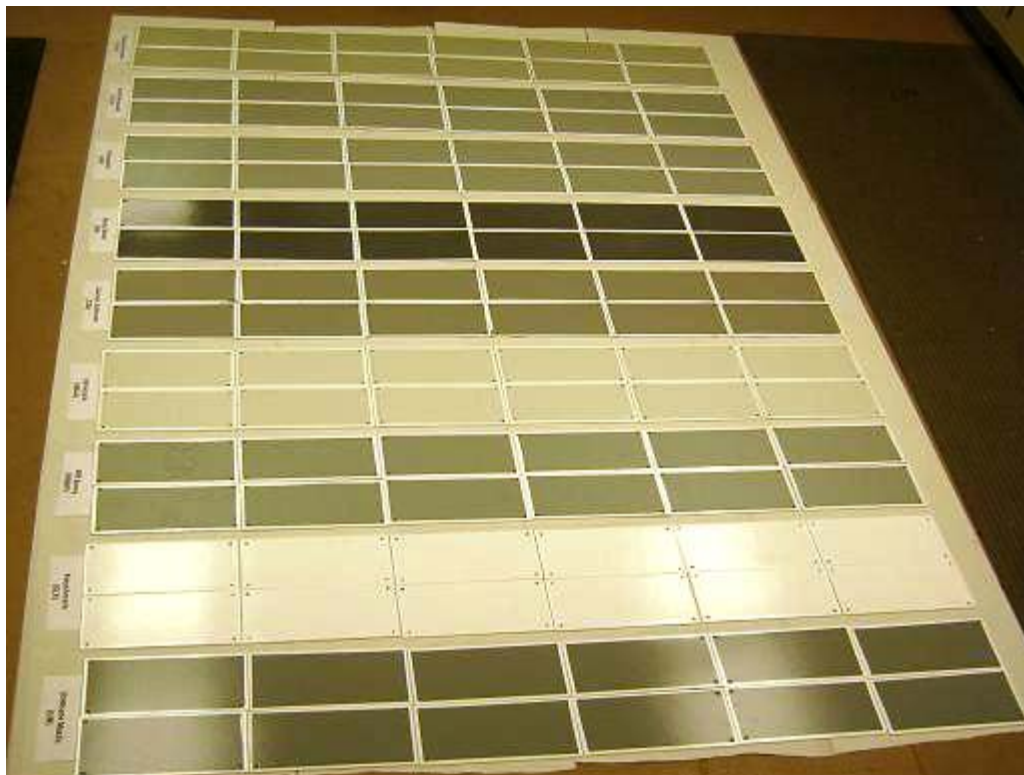
**Figure 2. Photo. Composite of large panels.**

Two sizes of steel test panels were used in this study. The small panels were 4 x 6 x 0.2 inches (10 x 15 x 0.48 cm), while the large panels were 6 x 12 x 0.2 inches (15 x 30 x 0.48 cm) (see figure 1 and figure 2). All test panels were blast cleaned to Society for Protective Coatings (SSPC) specification (SP)-10 with measured anchor profiles in the range of 2.2–2.9 mil (55–72  $\mu\text{m}$ ).<sup>(15)</sup> Coatings were then applied on the cleaned test panels using an airless spray method by a professional coating laboratory.

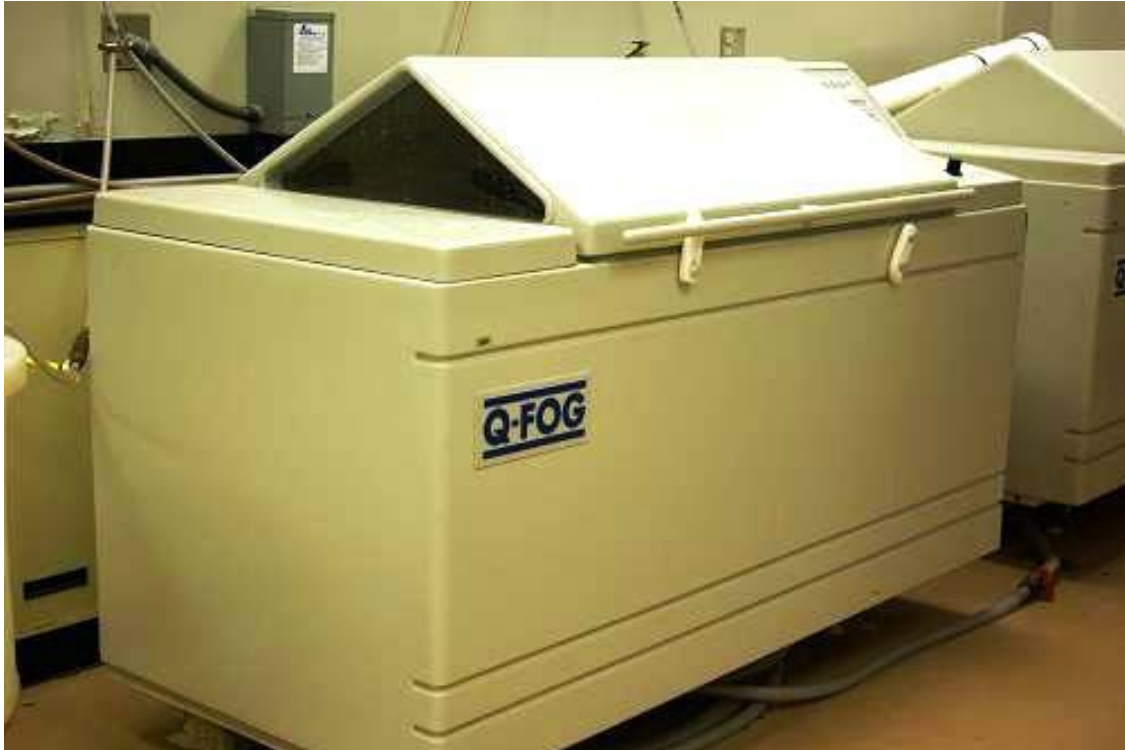
**Figure 4. Photo. Salt-fog chamber.**

Figure 4 and figure 5 show a salt fog chamber and a weathering tester, respectively. A 16-h salt-fog accumulation test was conducted before each cyclic salt-fog test to check the atomizing and fog quantity as well as the pH of the collected solution. The test panels were evaluated after every test cycle of 360 h and at the termination of each laboratory test.

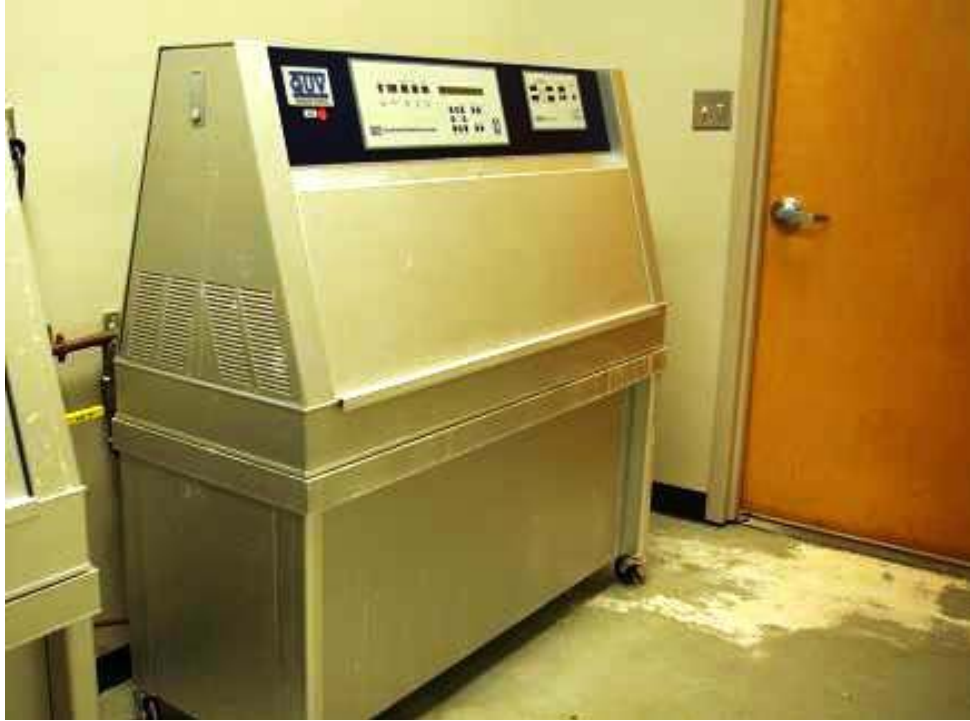
**Figure 5. Photo. UV weathering tester.**

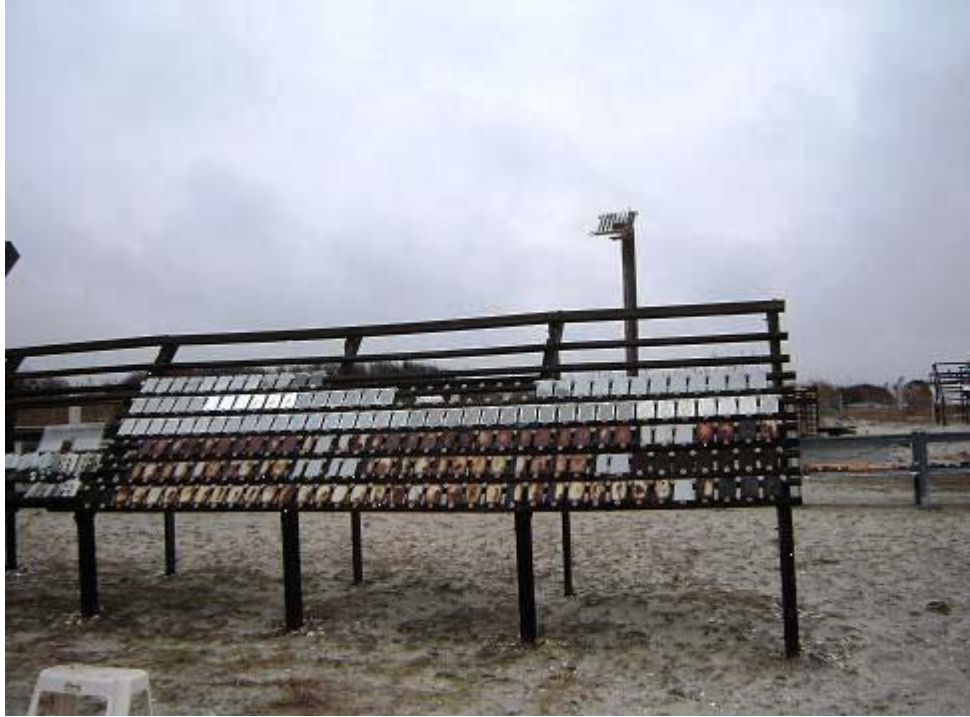
**Figure 6. Photo. ME exposure rack in Sea Isle City, NJ.**

A group of 54 test panels was exposed in Sea Isle City, NJ, at a ME site. All of the test panels were placed on a 45-degree-angle wooden rack facing south as shown in figure 6. The test site is located in a harsh environment with high chloride and high time-of-wetness.<sup>(18)</sup> Table 3 lists the summary of the environmental factors during the 2-year panel exposure period. The test panels were sent back to TFHRC CCL for performance evaluation every 6 months. The total exposure time was 24 months.

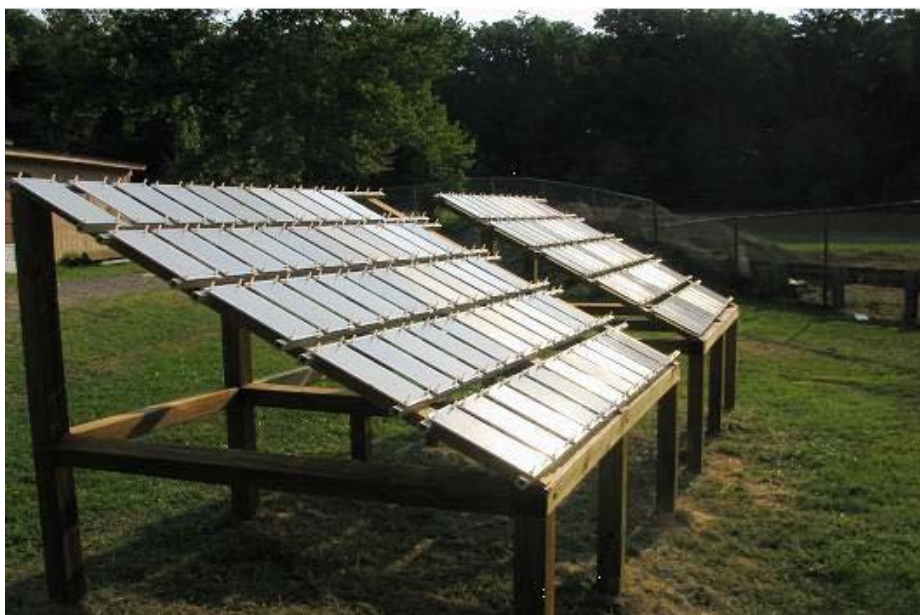
**Figure 7. Photo. Mild NW exposure rack at TFHRC.**

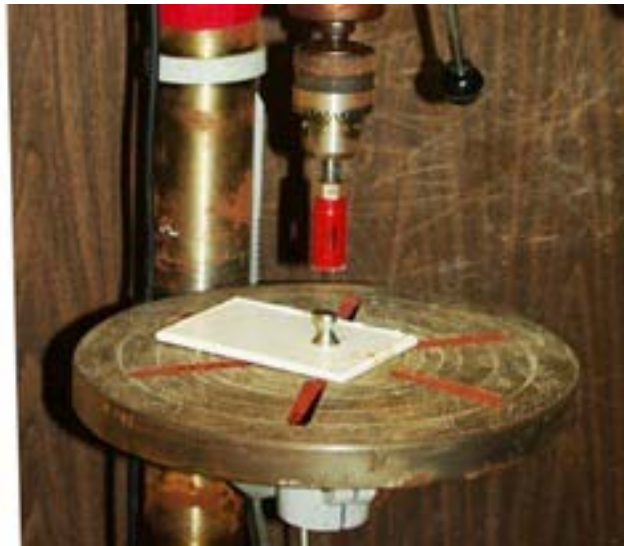
**Figure 9. Photo. Drill press to score a test area around a dolly.**

The surface of coated test panels and the base of the dollies were cleaned with detergent water and were lightly roughened with an abrasive pad. The dollies were glued to the test panel surface using a high-strength epoxy adhesive. The cut through the coating around the edge of the dolly was performed using a drill press after the complete cure of the adhesive shown in figure 9. The initial adhesion strength was measured by two pull-off methods: the hydraulic method and the pneumatic method. The final adhesion strengths of coating systems were measured using the hydraulic method. Figure 10 shows the hydraulic adhesion tester used to pull off the dollies for adhesion strength testing. Three pull-off adhesion tests were performed after exposure on each test panel except for some UM and ASP test panels due to their severe surface failures after ALT. No adhesion tests were performed on scribed UM and ASP test panels, while two adhesion tests were performed on unscribed UM panels.

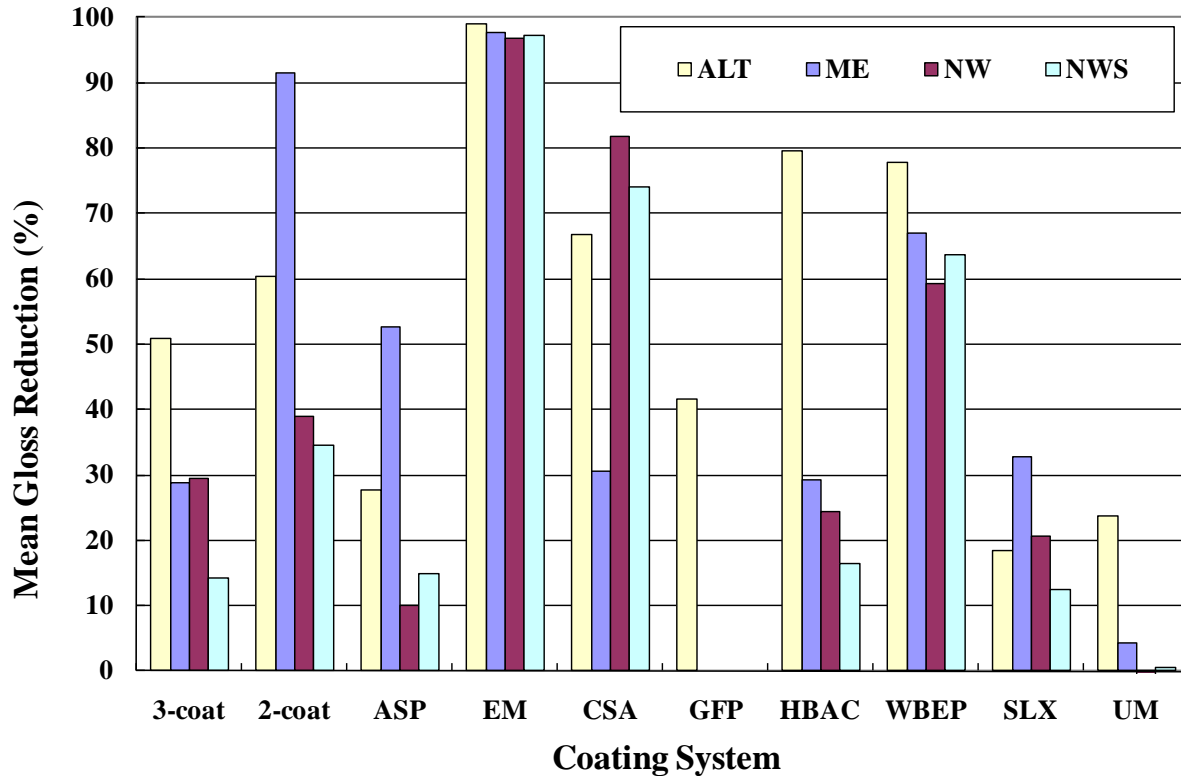
**Figure 13. Graph. Mean gloss reduction data.**

The initial measurements before exposure exhibited a broad range of gloss values. GFP was a flat coating with a low gloss of 4.6; EM, SLX, and UM were highly glossy (78–93), and the rest of the coatings were semi-glossy (12–60).

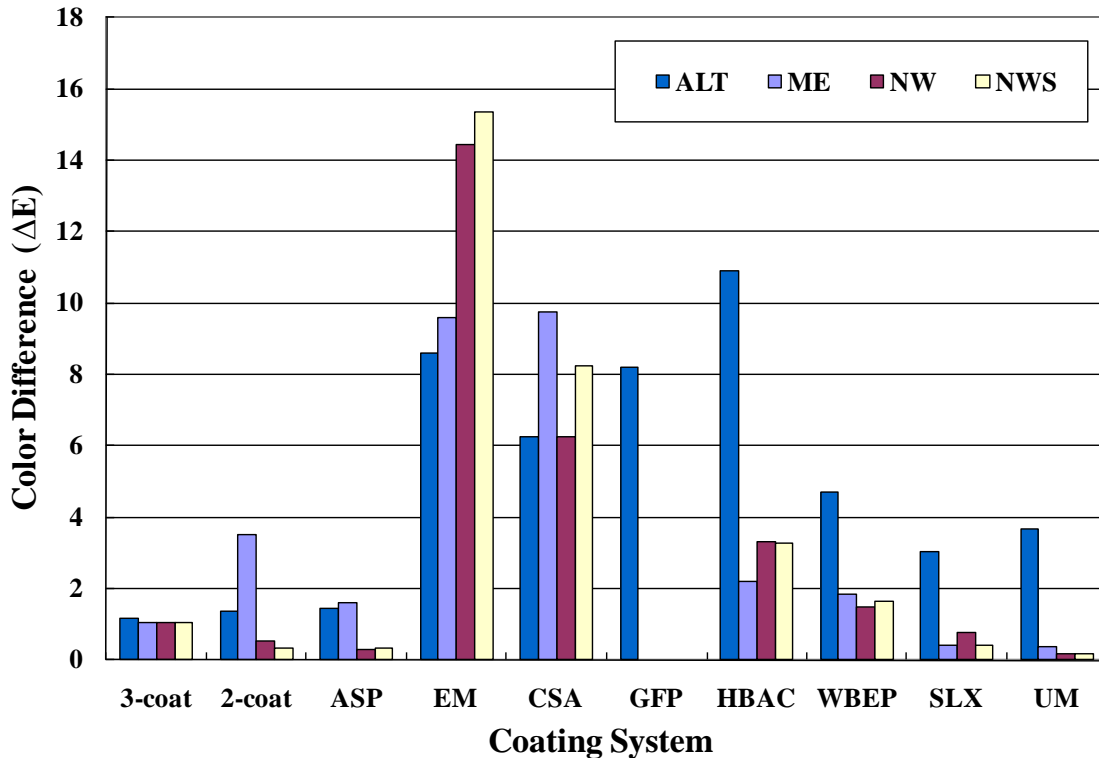
Figure 14. Graph.  $\Delta E$  after exposure tests.

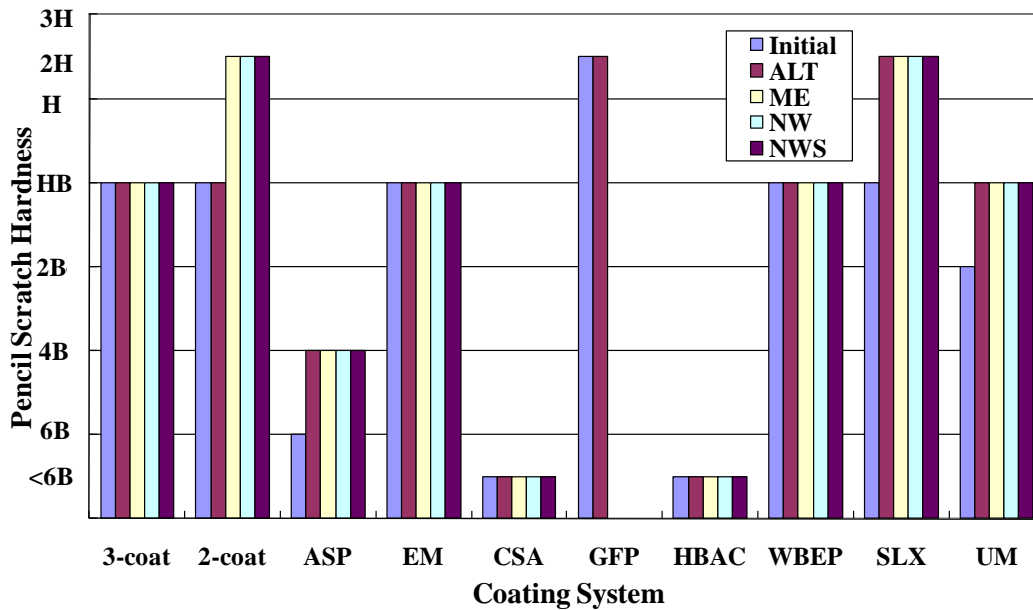
**Figure 15. Graph. Pencil scratch hardness before and after exposure tests.**

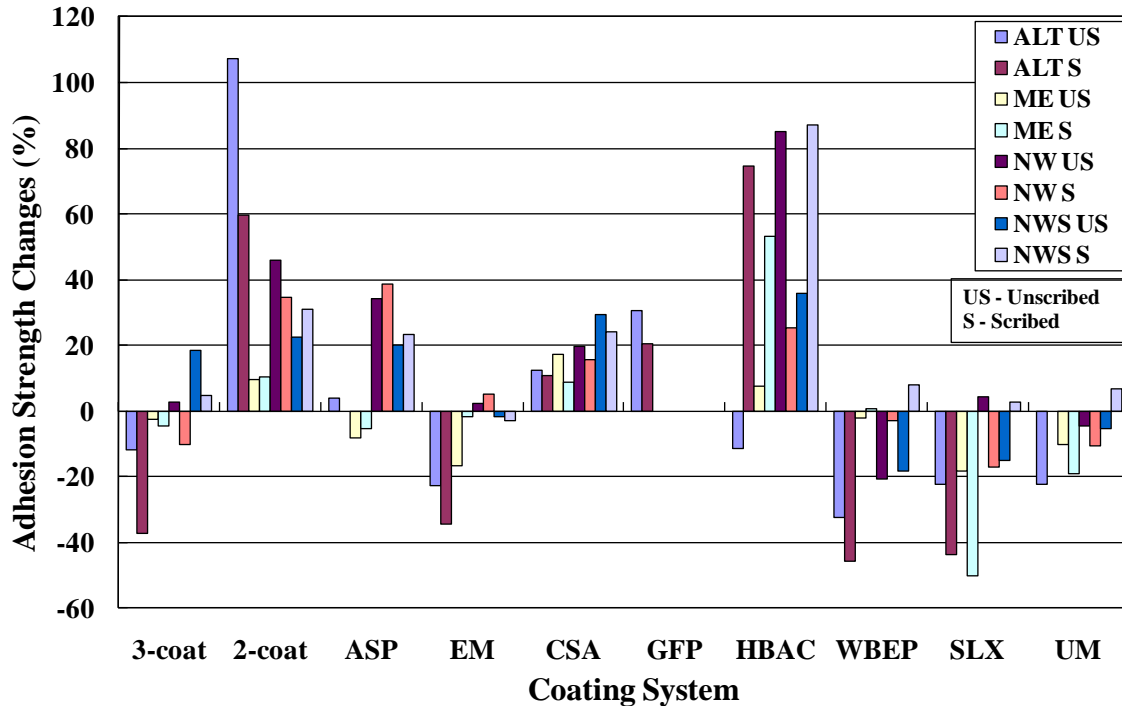
Figure 17. Graph. Changes in mean adhesion strength after ALT and outdoor tests.

Adhesion strengths varied with either an increase or decrease after ALT. ASP had the lowest adhesion strength increase (4 percent), while the two-coat system had the highest adhesion strength increase (>100 percent) among unscribed panels. The three-coat system (12 percent) and WBEP (32 percent) had the lowest and highest decrease in adhesion strength variation among unscribed panels. HRCSA (11 percent) and HBAC (75 percent) had the lowest and highest increase in adhesion strength, while EM (34 percent) and WBEP (46 percent) had the lowest and highest decrease in adhesion strength among scribed panels. CV of the adhesion test data ranged from 3 to 36 percent with a median value of 16 percent.

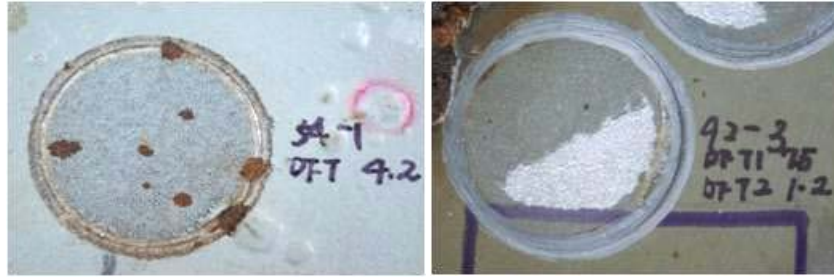
**Figure 18. Photo. Cohesive failure modes of ASP and EM.**

The three-coat system, EM, and WBEP had a shallow cohesive failure mode where residual DFT were close to their initial DFT, and the failure mode was observed close to the panel surface. Figure 18 shows the cohesive failure mode of the ASP and EM test panels. ASP had an initial DFT of 20 mil (508µm), leaving 4 mil (101.6µm) of DFT on the adhesion spot after testing. EM coating system had an initial DFT of 9 mil (228.6µm) and had 8 mil (203.2µm) of DFT remaining on the pull-off spot after the test.

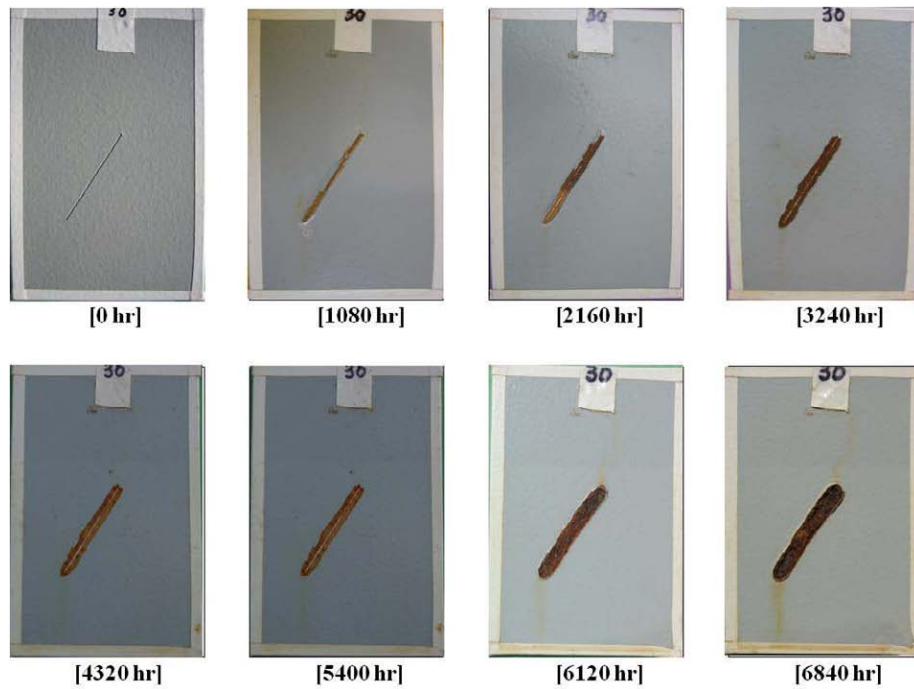
**Figure 23. Photo. Progressive changes of panel 30 (two-coat: ALT).**

The two-coat (see figure 23) and EM (see figure 31) coating systems reacted differently compared to ASP and UM. Both systems did not develop any surface blisters or rust pits during the entire test period. However, when panels from the two-coat system were scanned by the holiday detector after 6,120 h, all of the test panels suggested the development of numerous defects by emitting a countless beeping sound. Most of the EM panels also indicated many defects after 6,480 h. Microscopic examination revealed numerous hairline cracks that had developed on the surface of the two-coat test panels. Figure 60 shows the photomicrograph of surface cracking of the two-coat panels. EM, however, did not show any surface cracking/deterioration when examined under the optical microscope.

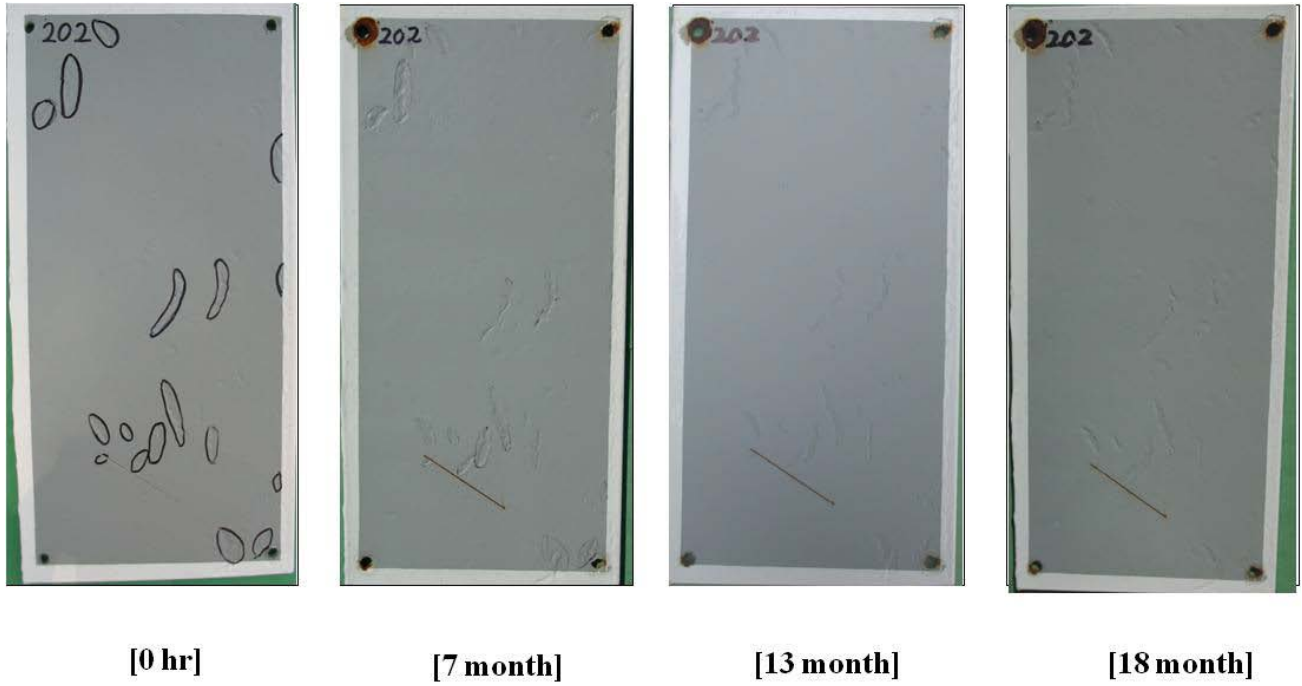
**Figure 46. Photo. Progressive changes of panel 202 (WBEP: NW).**

All coating systems performed well in NW and NWS except for WBEP (see figure 46 and figure 47). As discussed earlier, WBEP test panels had some initial film defects. DFT was less than 1 mil ( $25.4\mu\text{m}$ ) at several areas. There were also some small dent areas on the surface. Typical defective surface condition and the resultant surface appearance after outdoor exposure can be seen in figure 62. The small dents grew into size 6 blisters after NW. In NWS, the small dents grew into size 6 rusted blisters, and all of the thin DFT areas became rusted (the rusting grade was G6). Many defects were detected by the holiday detector on the test panel surfaces.

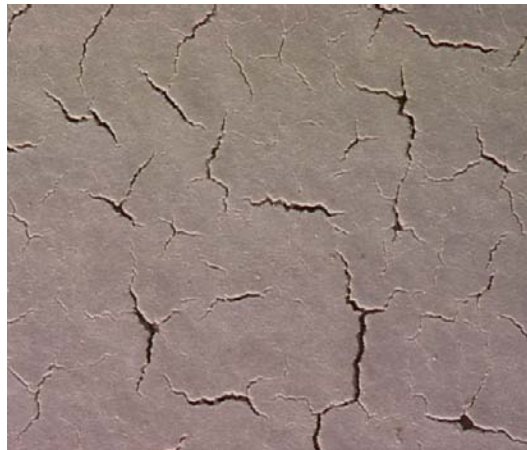
**Figure 60. Photo. Surface coating failure by cracking (two-coat system).**

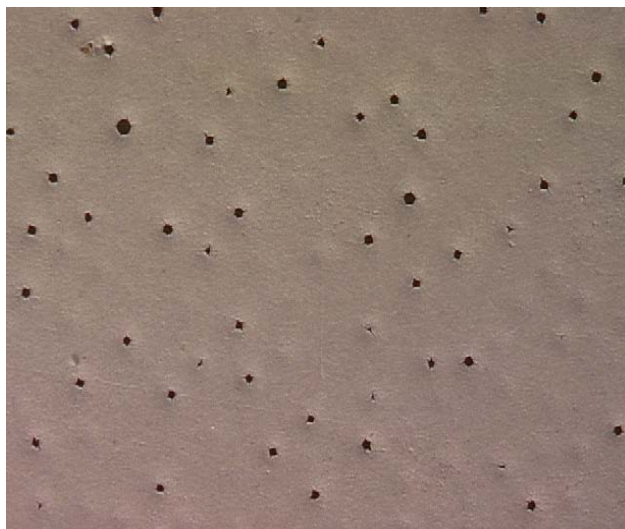
**Figure 61. Photo. Surface condition of the three-coat system.**

The microscopic examination of the three-coat system taken after 6,120 h also revealed some small holes on the panel surfaces. Figure 61 shows the photomicrographs of the surface of the three-coat system. However, the micro-sized holes were not holidays and thus did not affect the coating performance during ALT.

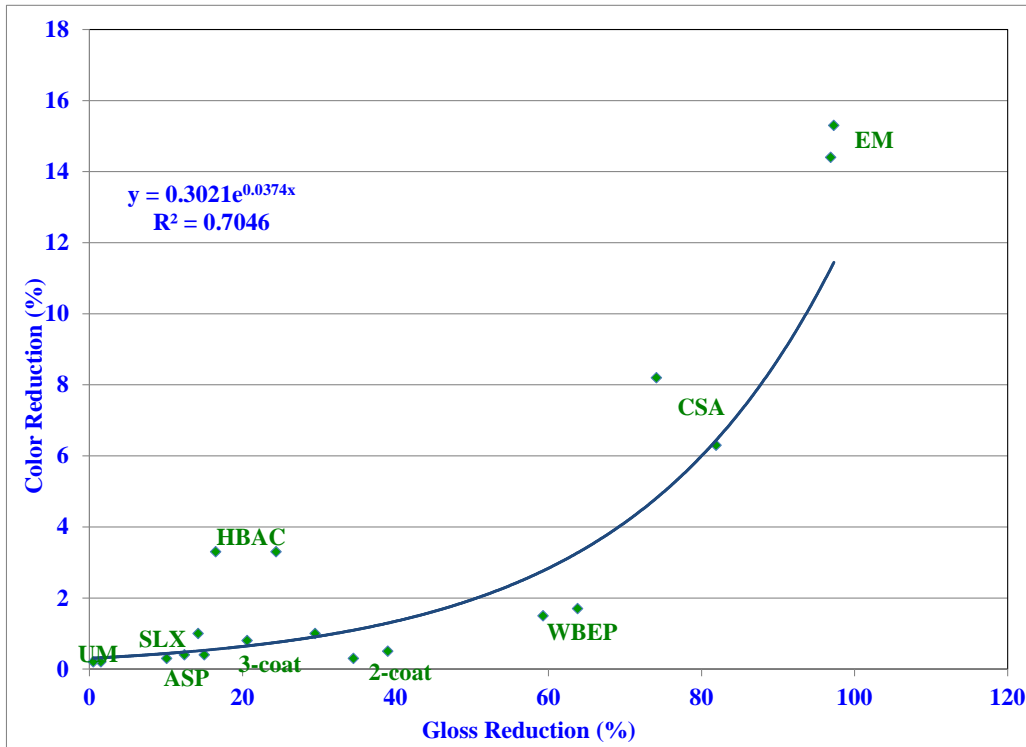
**Figure 70. Graph. Regression analysis of color versus gloss for one-coat and control coating systems in NW and NWS.**

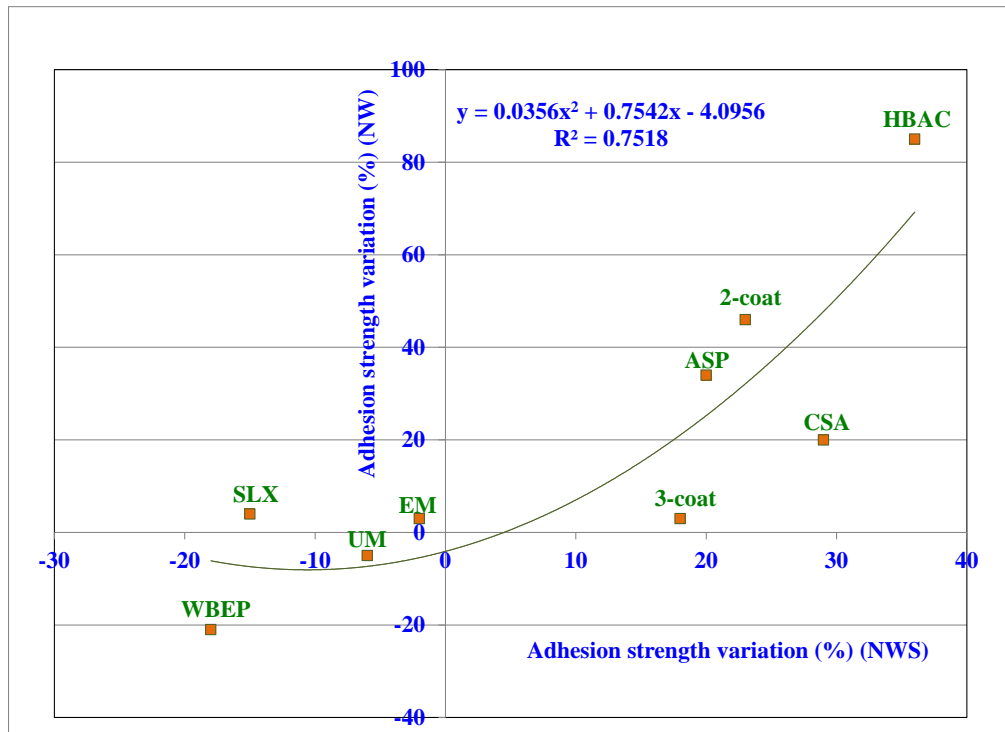
Figure 76. Graph. Relationship between adhesion strength variations of scribed panels in NW and NWS.

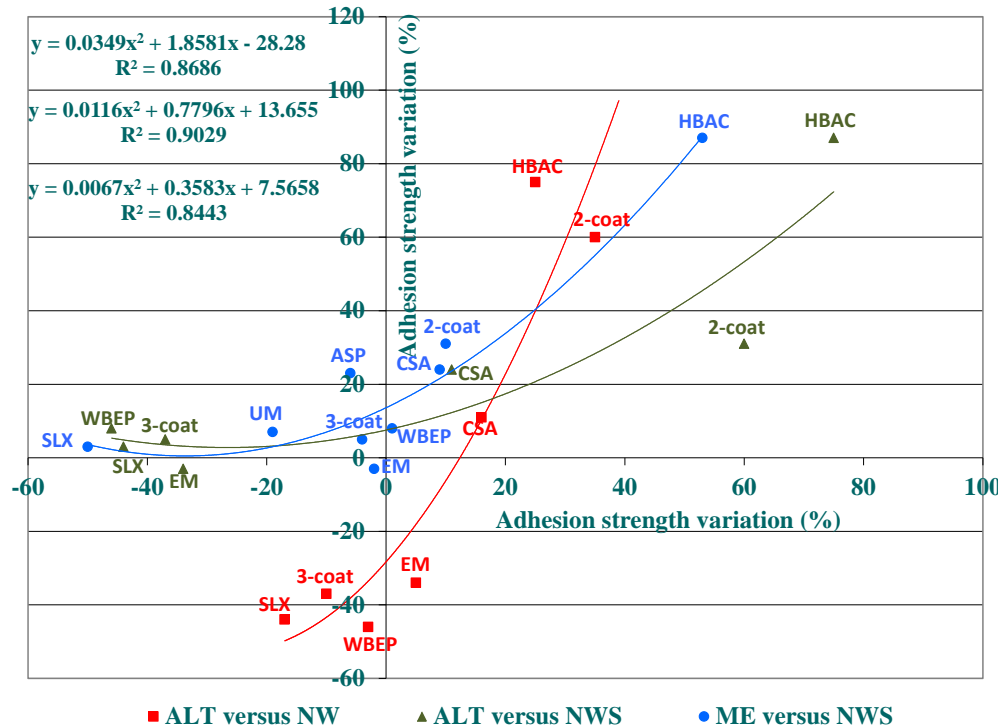
**Figure 77. Graph. Relationship between adhesion strength variations of unscribed panels.**
