**CASE HISTORIES**  
**OF**  
**WETLAND RESTORATION**

U.S. Department  
of Transportation

Federal Highway  
Administration

Publication No. FHWA-EP-00-025  
HEPN/9-2000/(300)

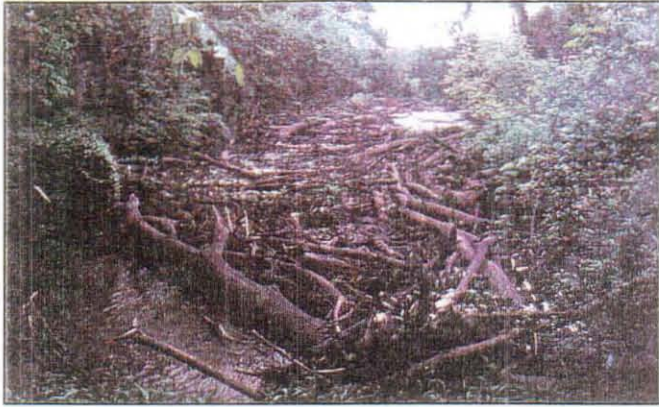
Log jam impounding water and creating habitat

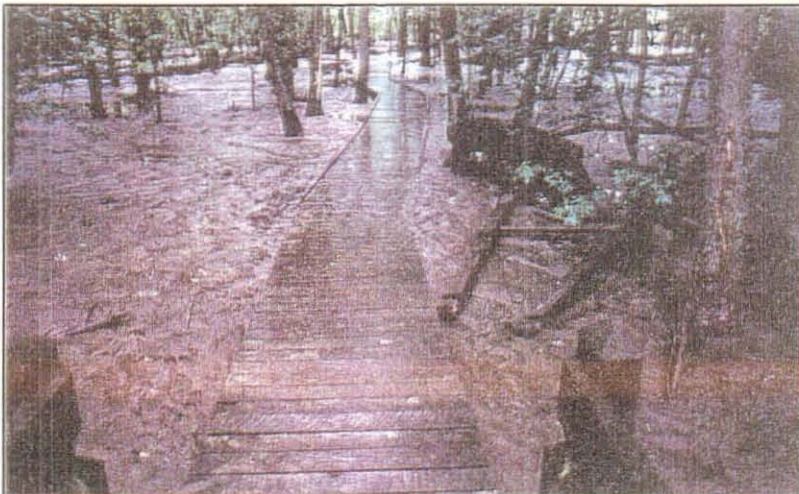
Sediment released by removal of log jam smothering herbaceous layer in forested wetland

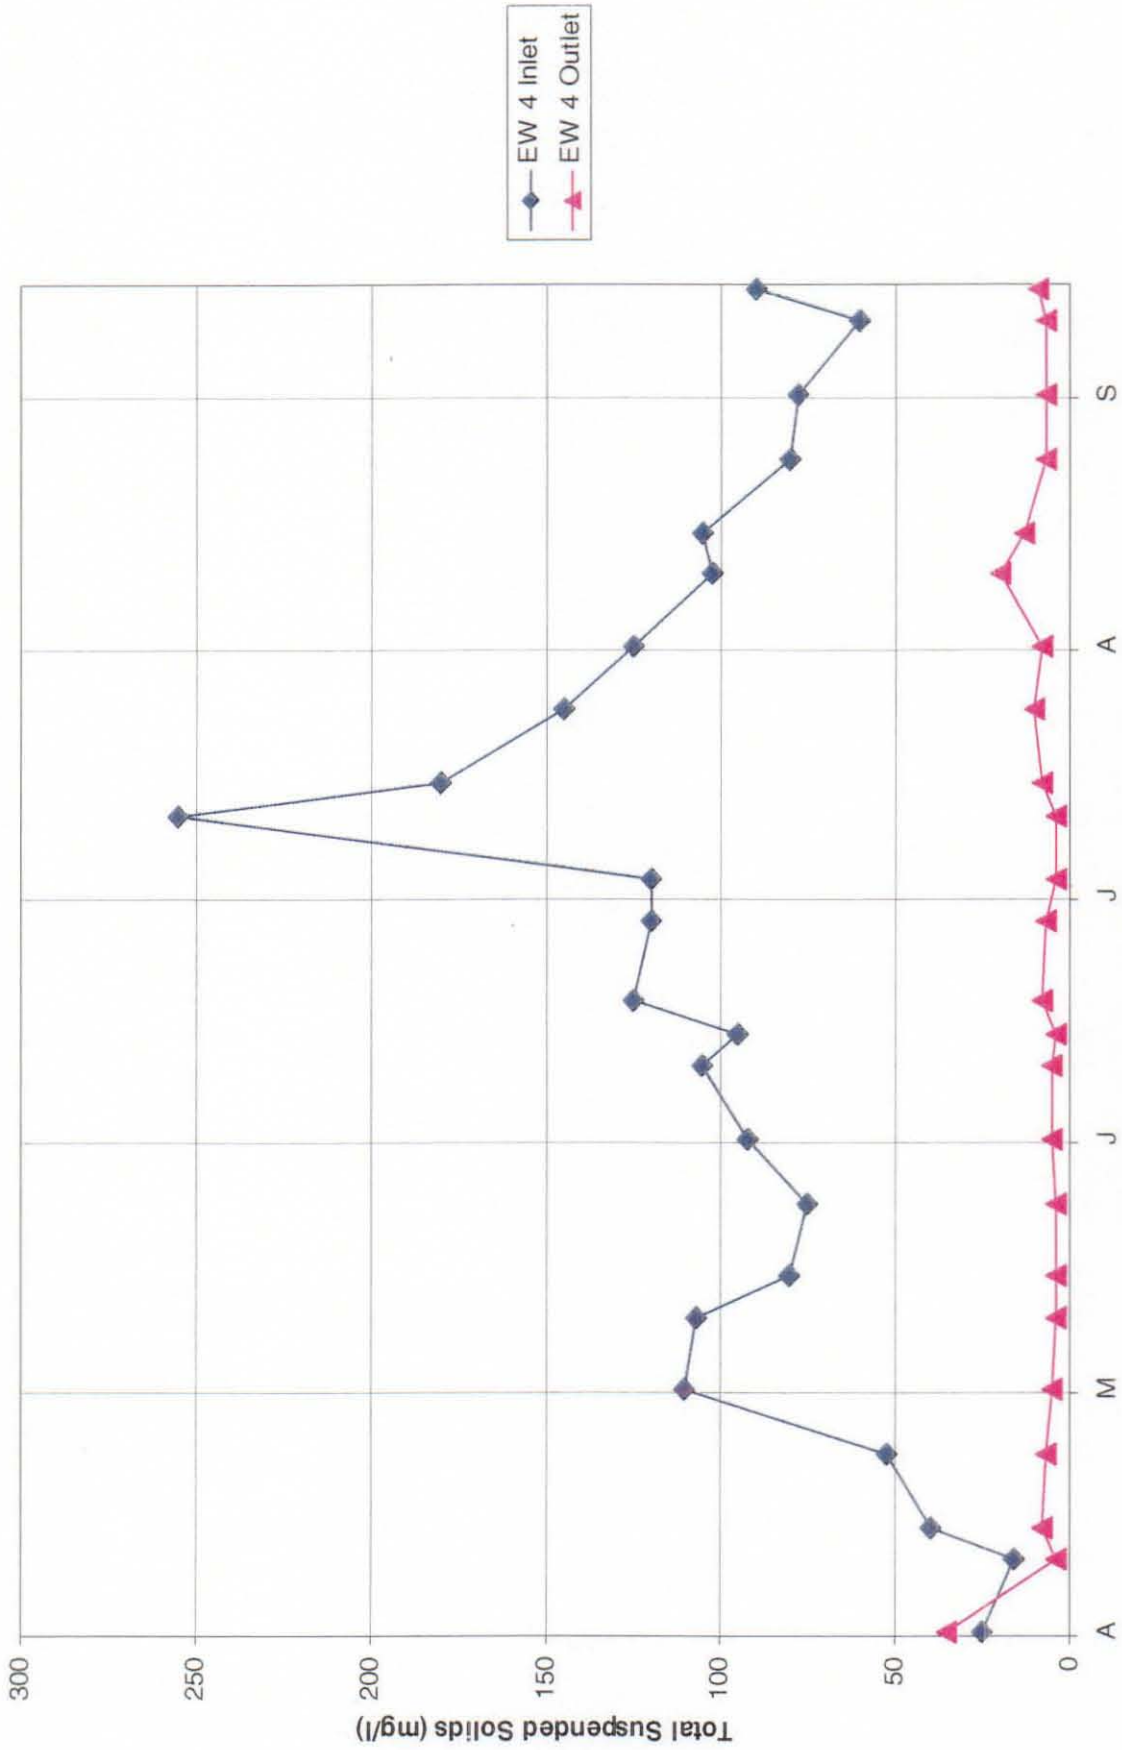
Weekly Samples, April-September 1991

EXHIBIT 2-6: SUSPENDED SOLIDS REDUCTION BY EXPERIMENTAL WETLAND 4 AT THE DES PLAINES RIVER WETLANDS DEMONSTRATION PROJECT (by permission of Wetlands Research, Inc., Chicago, Illinois)

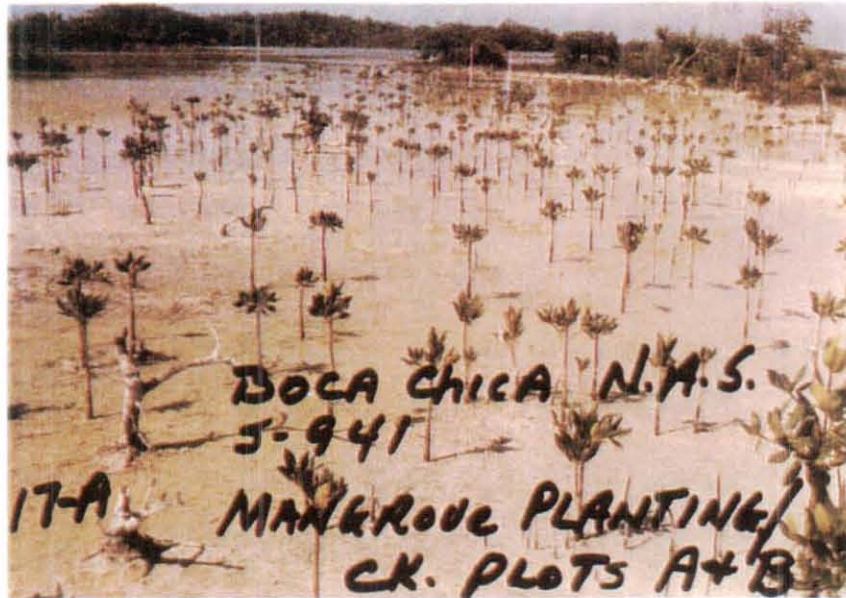
Typical planted red mangroves at culvert C-4, Boca Chica Lagoon, 1985.

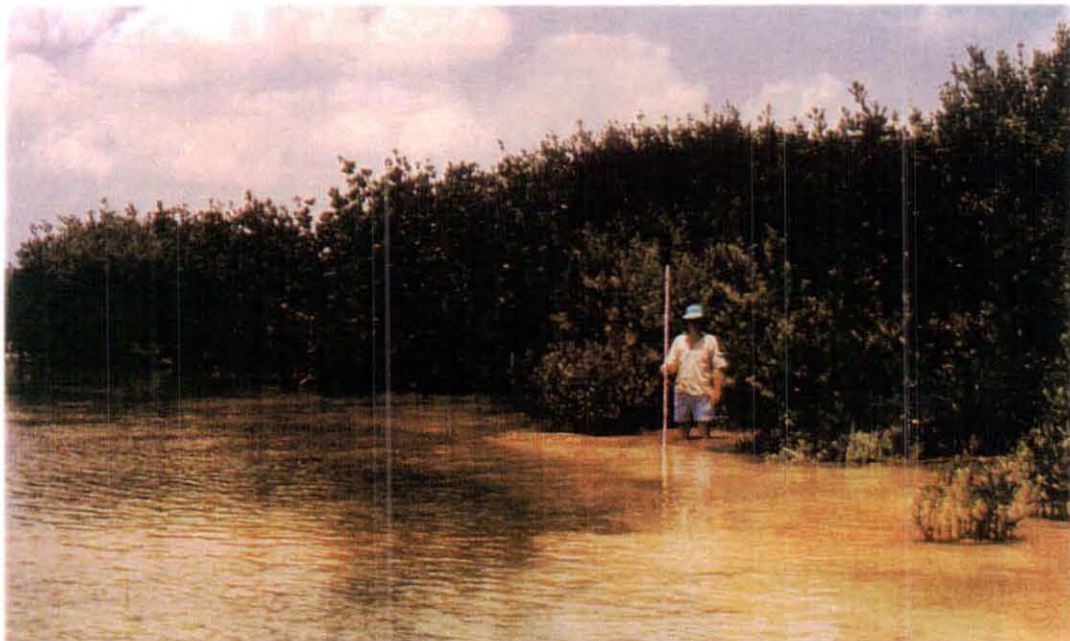
Typical volunteer and planted red mangroves at culvert C-4, Boca Chica Lagoon, 1993. Staff is 2 m tall.

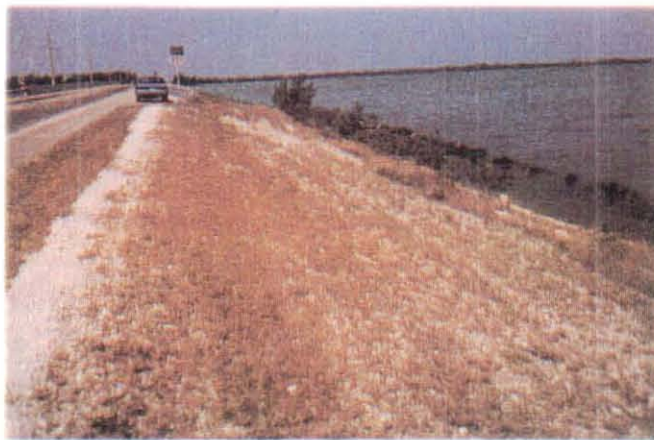
Lower Sugarloaf Channel, erosion limiting revegetation, Miami Gulf side, view west, 5/93.
