Structural Behavior of a 2nd Generation Ultra-High Performance Concrete Pi-Girder

November 2009

FHWA Publication No. FHWA-HRT-10-026

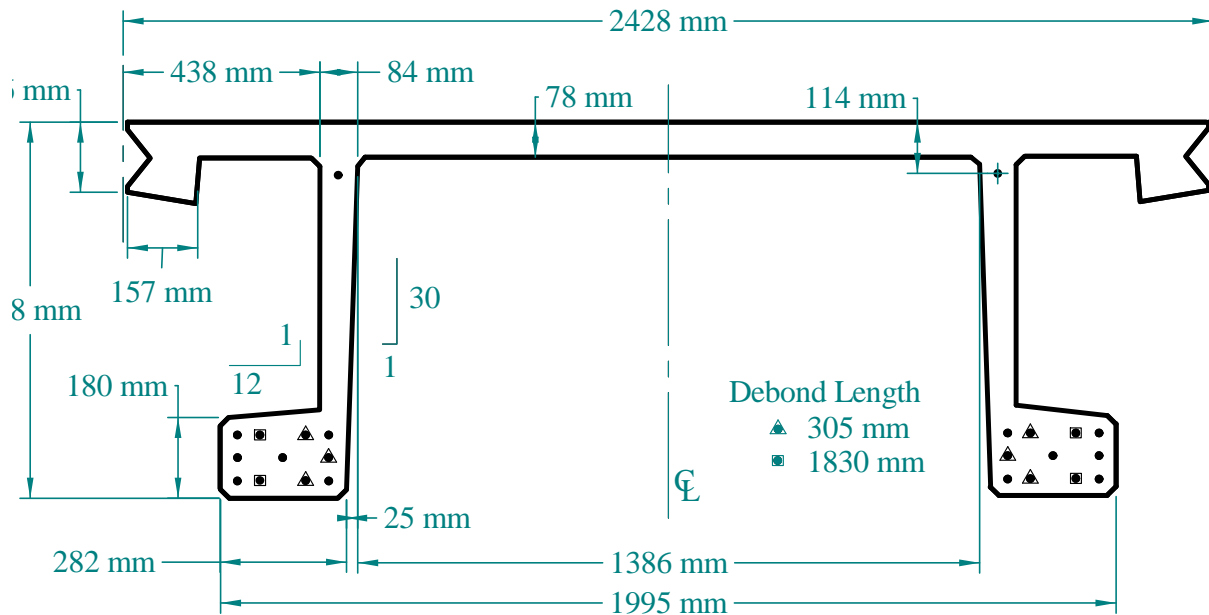
Figure 1 presents the prototype pi-girder cross section. The cross section was designed to span between 21.3 and 30.5 m (70 to 100 feet). The girder is 0.84 m (33 inches) deep, 2.44 m (8 feet) wide, and can contain up to 15 prestressing strands in each bulb. The integral deck of the girder is 76 mm (3 inches) thick, and the webs range from 64 to 84 mm (2.5 to 3.3 inches) thick. A 156 mm (6.1 inch) deep shear key runs the length of each flange tip to allow for connection of adjacent modular components. Basic properties of the girder include an area of 0.392 m² (609 in²), strong axis moment of inertia of 37.07x10⁹ mm⁴ (89,060 in⁴), and a self-weight of 978 kg/m (657 lb/ft).

Figure 1. Illustration. Prototype pi-girder cross section and strand pattern.

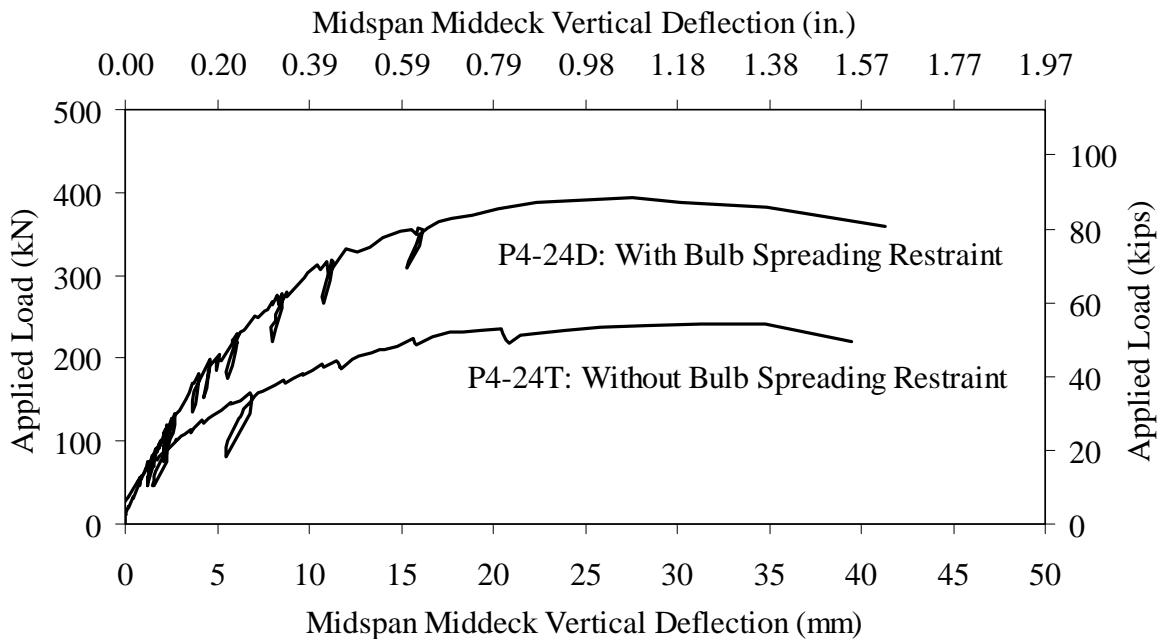
The midspan middeck vertical deflection response of the two test girders is shown in Figure 3. The figure shows that the responses were similar until first cracking, after which P4-24T shows significantly increased vertical deflection per load increment applied. The peak load carried by P4-24D is 60 percent greater than the peak load carried by P4-24T with both girders undergoing similar magnitude deflections prior to failure.

Figure 3. Graph. Midspan middeck vertical deflection results from two transverse flexural response tests.

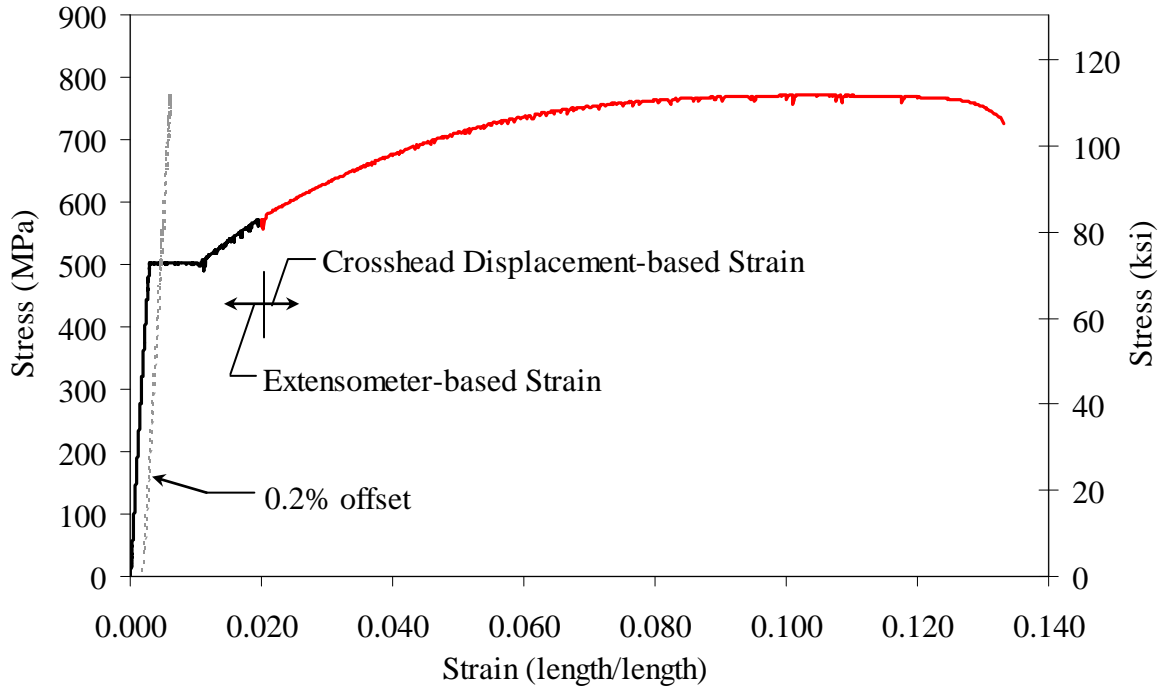
Standard #8 reinforcing bars, 0.66 m (26 inch) in length, were installed in pockets spanning across the grouted joints. Two samples of these bars were tested in uniaxial tension according to ASTM A370⁽¹⁴⁾. The yield strengths of the steel were determined to be 503 and 505 MPa (72.9 and 73.3 ksi) for the two bars based on the 0.2% offset method. The ultimate strengths were 769 and 771 MPa (111.6 and 111.8 ksi). At failure, the elongations over an initial gage length of 200 mm (7.88 inch) were 14.9% and 15.3%. Figure 4 shows the stress-strain response from one of the two tests. Note that the stress is based on the nominal cross section of the bar and thus represents engineering stress. Additionally, note that the strain was calculated through readings captured by an extensometer placed on the bar until the initiation of strain hardening, after which the extensometer was removed and the machine cross-head displacement readings were used.

Figure 4. Graph. Uniaxial stress-strain response of a #8 rebar.

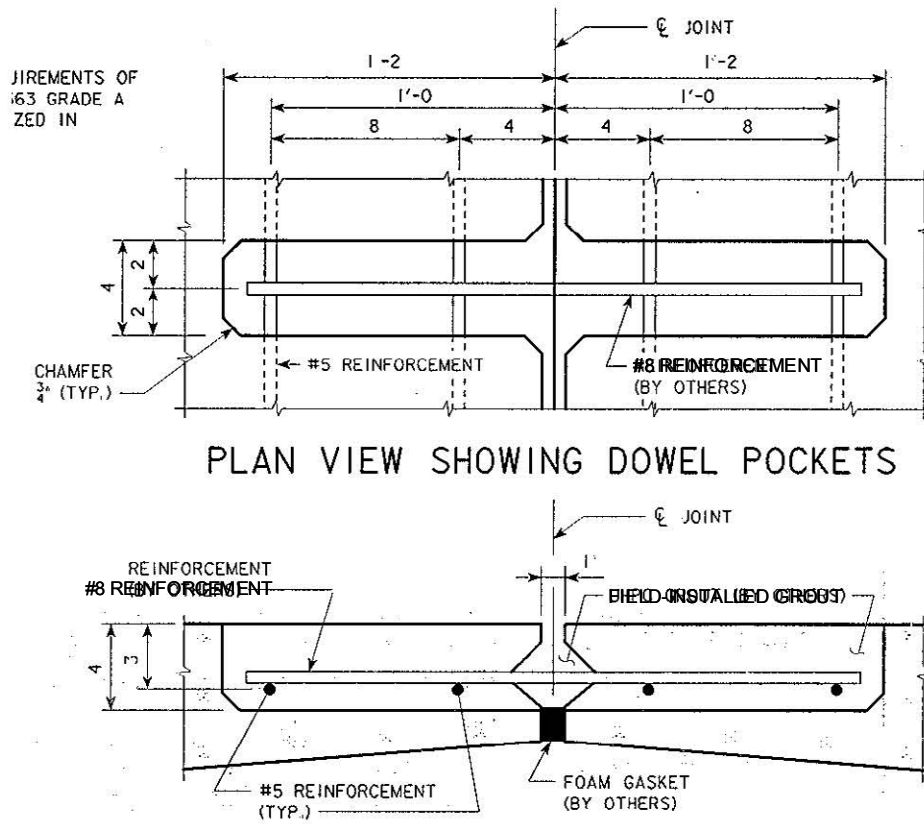
girder and are 102 mm (4 inch) wide and deep. Each pocket is intersected by two #5 reinforcing bars. A 660- mm (26-inch) long #8 reinforcing bar is to be installed in each pocket with the pockets being spaced at 457 mm (18 inch) along the length of the girder.

Figure 8. Illustration. Longitudinal grouted joint detail.

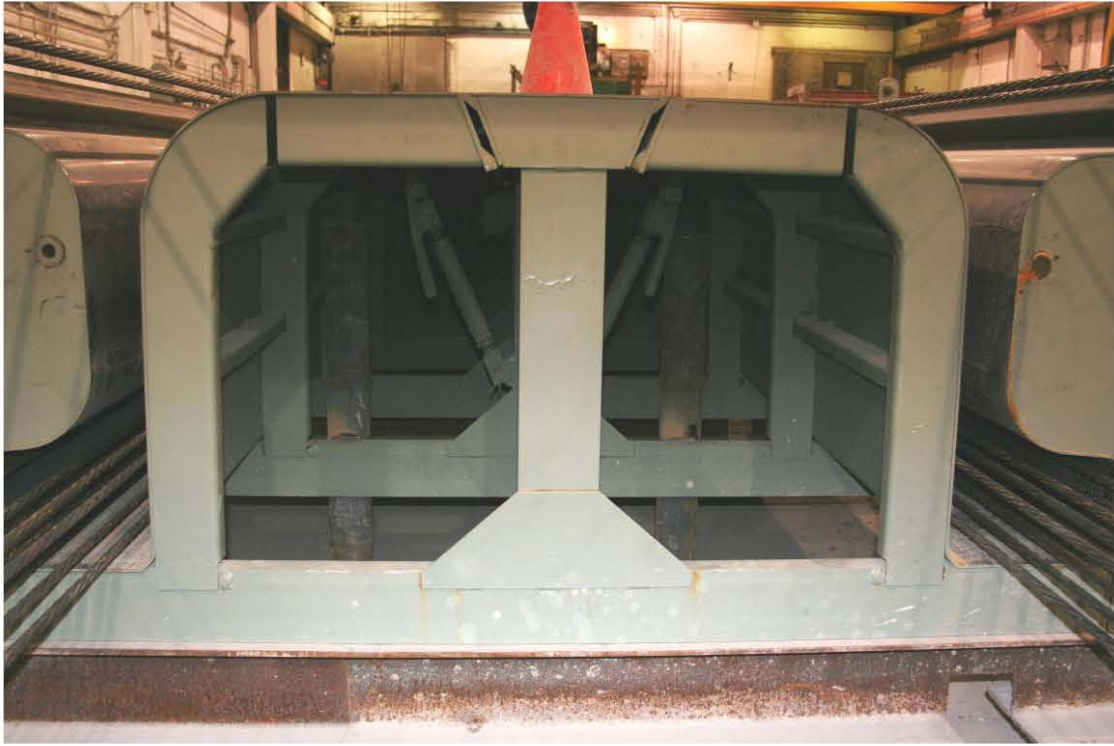
Figure 9. Photo. Girder formwork.

Two UHPC pi-girders were fabricated at the Lafarge Precast facility in Winnipeg, Manitoba. The two girders were fabricated together on the same casting bed in September 2008. The formwork used for the fabrication of the girders was fabricated by Helser Industries, Inc. of Tualatin, Oregon. A pair of approximately 11-m (36-ft) long forms were fabricated and installed end-to-end on the girder casting bed. This casting bed was wide enough to allow for the entire girder width to be supported as well as to allow for the exterior side forms to be slid back from the girder during assembly and disassembly. Figure 9 shows the formwork during assembly on the bed. As can be observed in the figure, the left and right form pieces which support the underside of the concrete deck adjacent to the form's center post can articulate down and toward the middle so as to allow for unrestrained transverse dimensional changes in the girder during setting and hydration. The mechanism for transverse restraint release is shown specifically in Figure 10. An overhead photograph of the forms for girders T1 and T2 is shown in Figure 11.

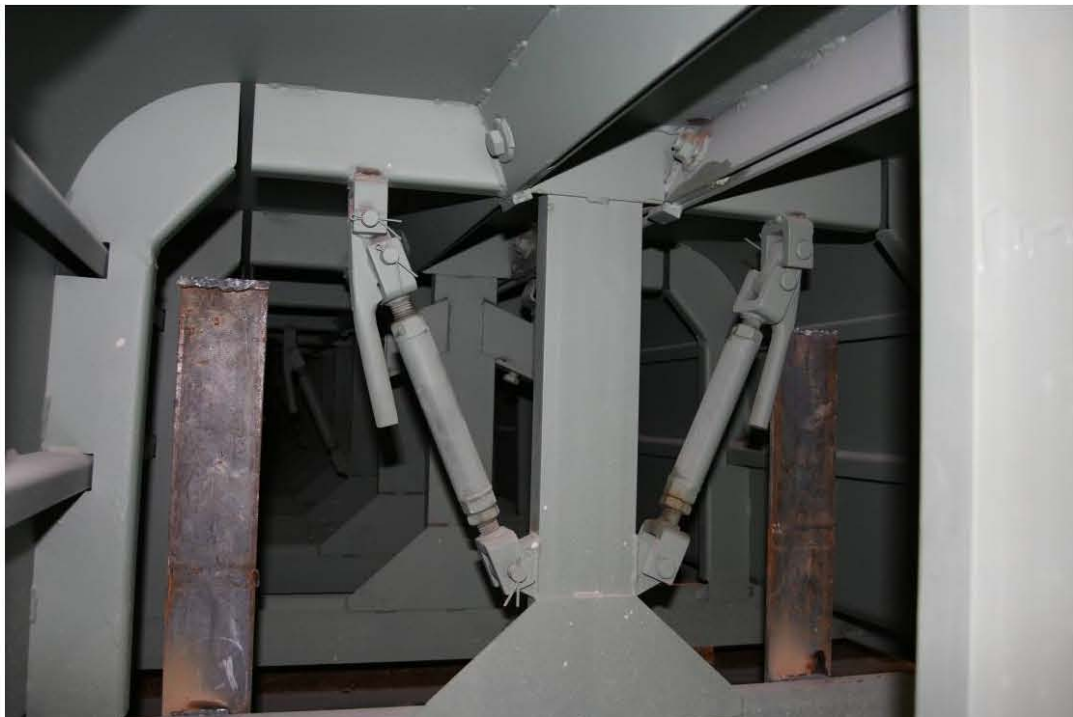
Figure 10. Photo. Girder formwork mechanism for releasing transverse restraint.

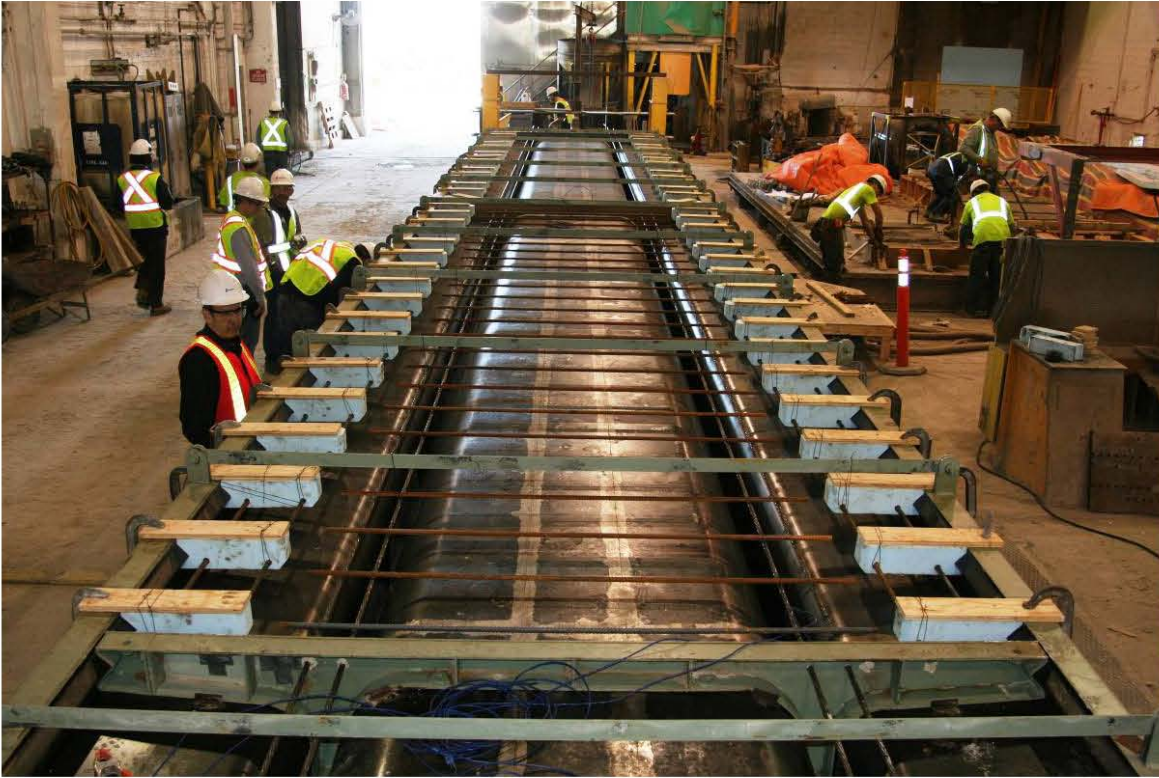
Figure 11. Photo. Girder formwork for T2 (near) and T1 (far).

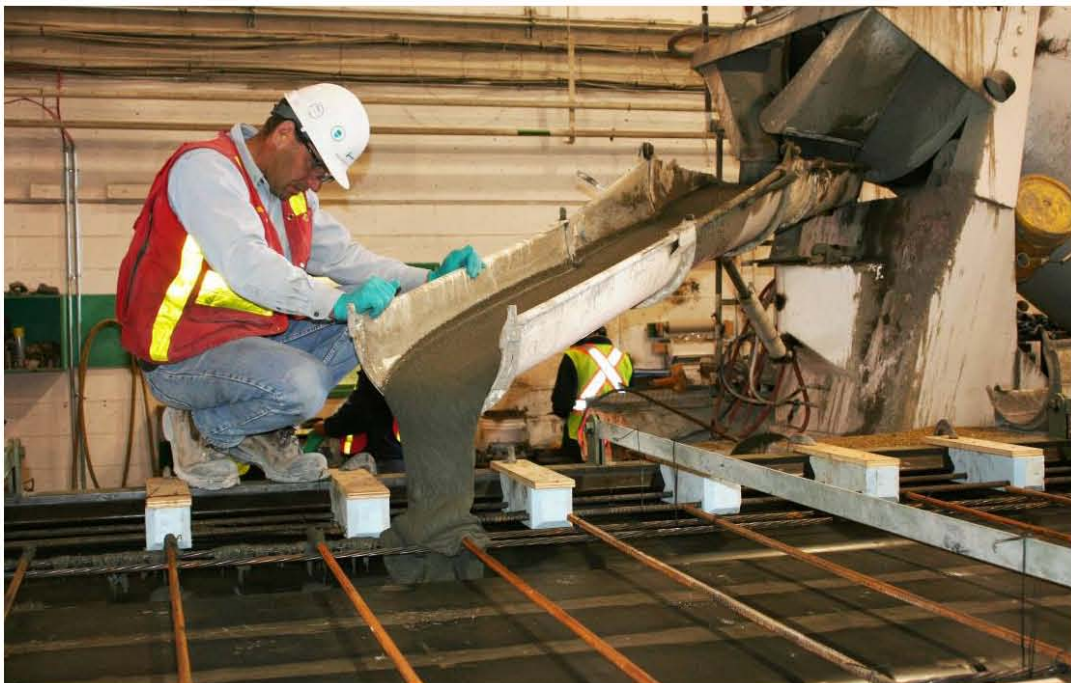
Figure 13. Photo. Concrete placement for girder legs.

After the mixing was complete, the trucks transported the concrete to the form. The first girder was completely cast using concrete from both trucks prior to the start of the filling of the second girder's form. In each case, the bulbs and webs were filled first with one truck on each side of the formwork discharging concrete into the top of the web opening. As the concrete is self-consolidating, the concrete was discharged beginning at one end of the girder and allowed to flow toward the other end. The discharge point moved along the girder length as the form began to fill up, but always remained behind the leading edge of the flowing concrete. Figure 13 shows the concrete being placed in one of the girder legs. Once both webs of the form were full to approximately two-thirds of their height, a trough was inserted in the placement stream to allow for uniform dispersion of the concrete across the deck width. Again, the concrete was always allowed to flow along the length of the girder with deposition of new concrete occurring behind the leading edge. Figure 14 presents a photograph of the placing of the concrete for the deck through the trough which is shown sitting above the form. Short duration bursts of external form vibration were used infrequently during the placing process. This vibration was intended to facilitate the expulsion of air trapped in the concrete during the placing process. As soon as the girder form was full, a thin layer of curing compound was sprayed onto the surface of the deck and then plastic sheeting was placed over the concrete. The plastic was placed directly in contact with the concrete, as is shown in Figure 15.

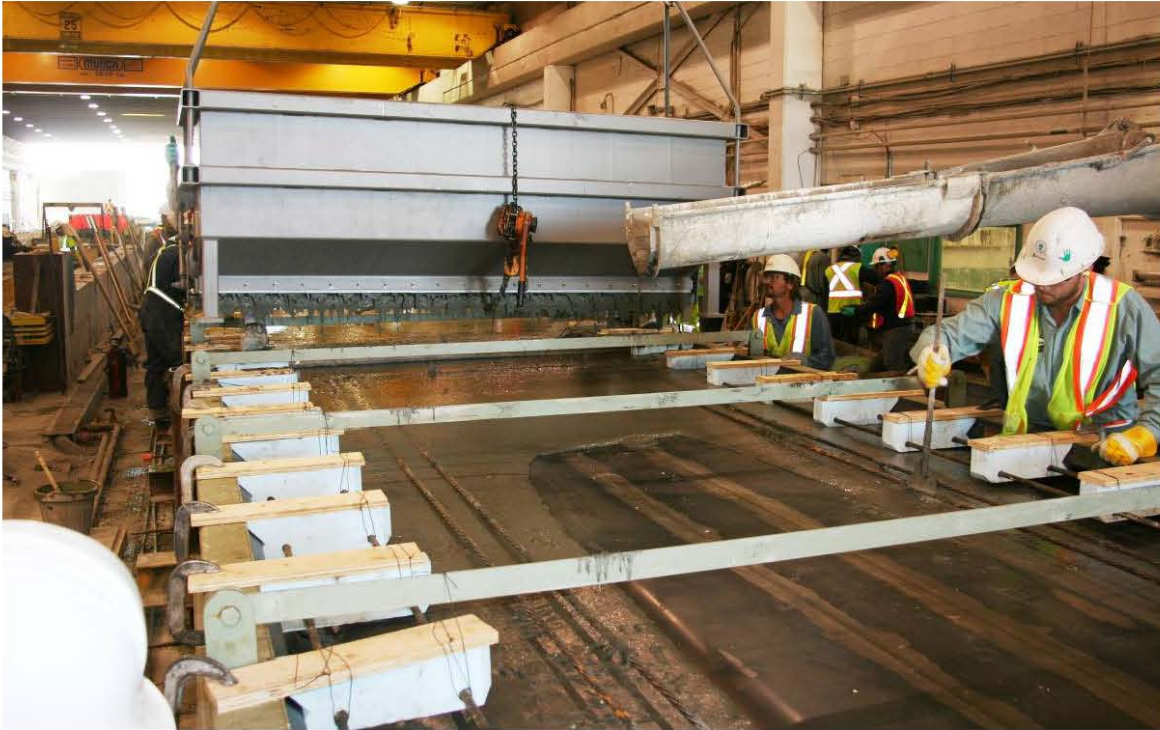
Figure 14. Photo. Concrete placement for girder deck.

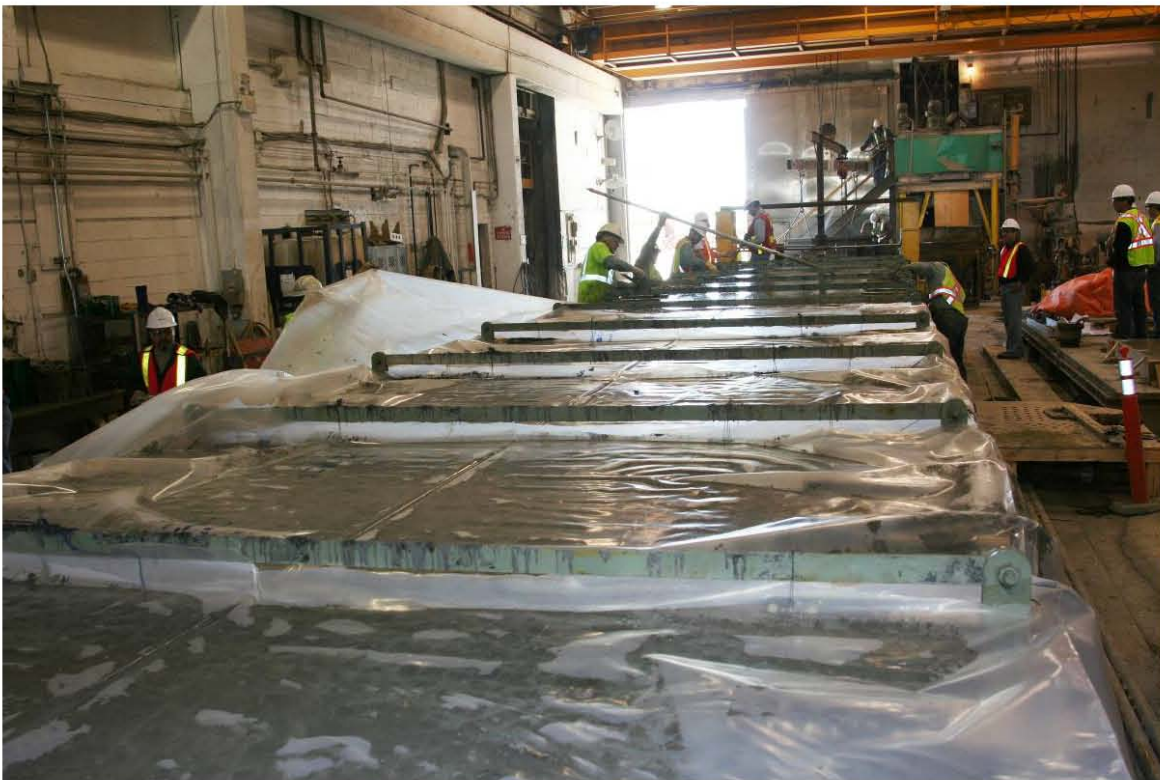
Figure 15. Photo. Plastic tarp installed immediately after concrete placement.

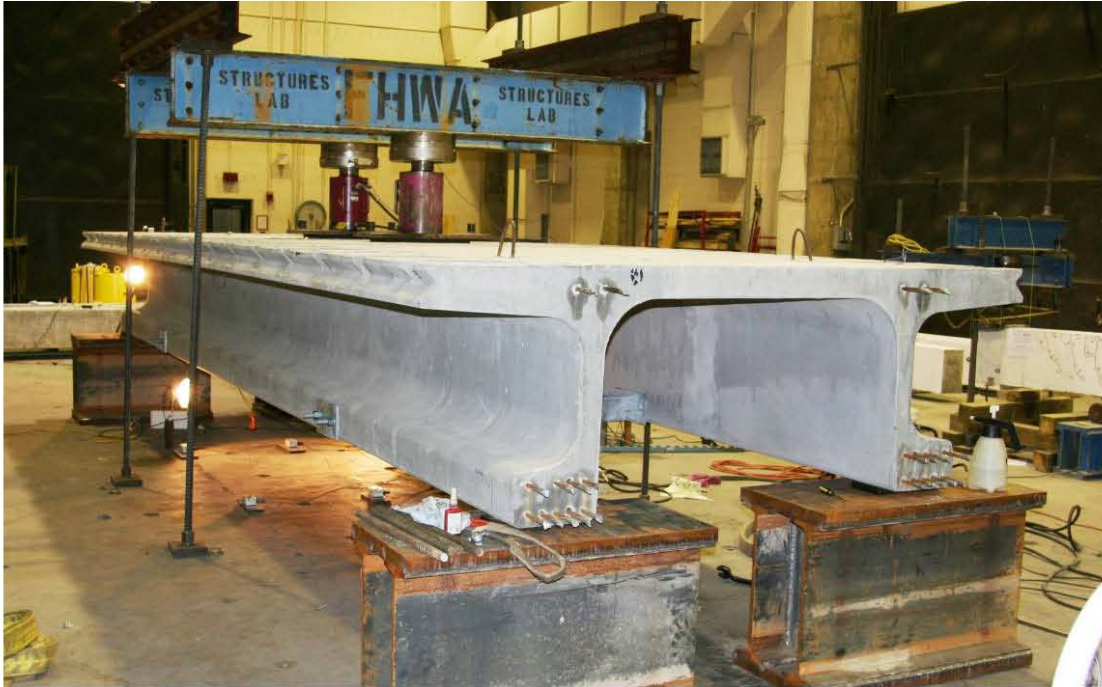
Figure 17. Photo. Setup for Test T2D.

Tests T1D and T2D were nearly identical tests applied to Girders T1 and T2, respectively. These tests focused on the transverse flexural behavior of the 2nd generation pi-girder cross section when subjected to loads applied between an individual girder’s legs. The loading setup for these tests is illustrated in Figure 16. Figure 17 and Figure 18 provide photographs of the setup as applied for Test T2D. Loads were applied vertically downward by hydraulic jacks situated near midspan. Loads were transmitted to the deck through 0.25 m by 0.51 m (10 inch by 20 inch) elastomeric pads located along the centerline of the girder and situated 0.61 m (2 ft) on either side of midspan. These 25 mm (1 inch) thick elastomeric pads were backed by 25 mm (1 inch) thick steel plates. Loads were reacted through 0.15 m by 0.30 m (6 inch by 12 inch) elastomeric pads placed under the girder bulbs at the abutment locations. These elastomeric pads were also 25 mm (1 inch) thick.

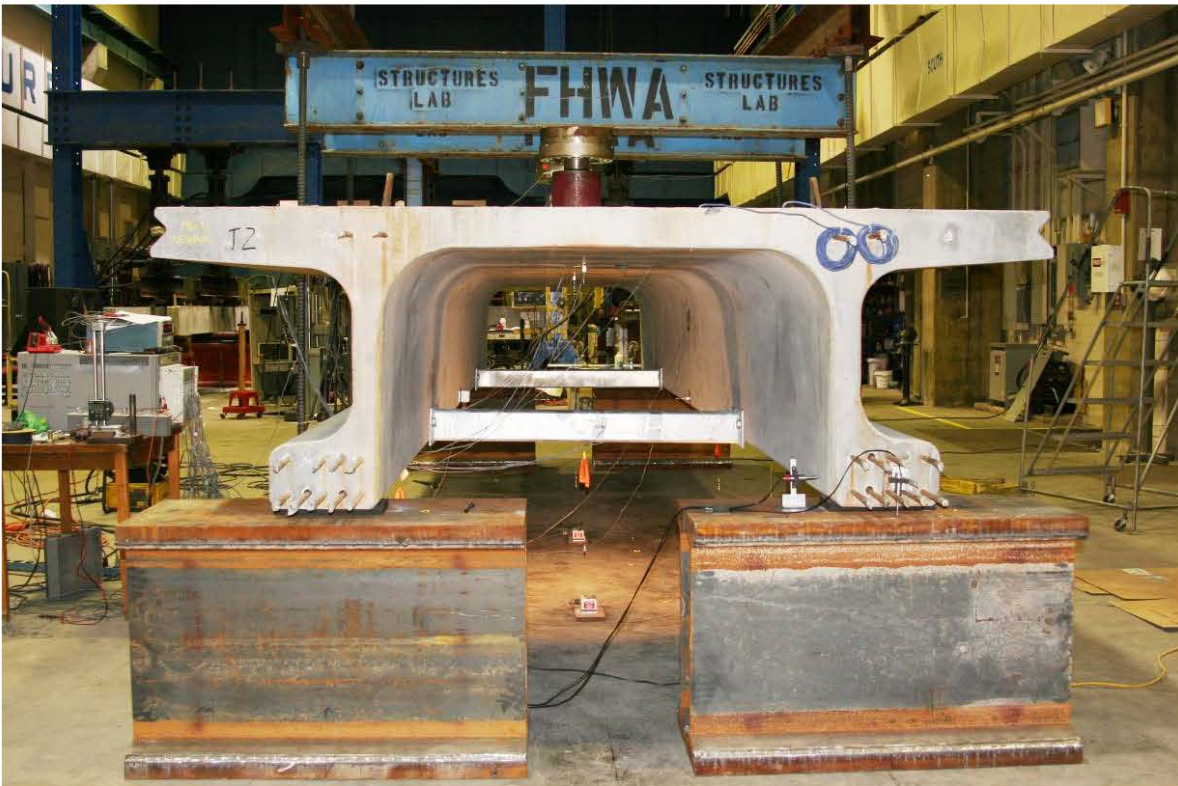
Figure 18. Photo. West end of Test T2D.

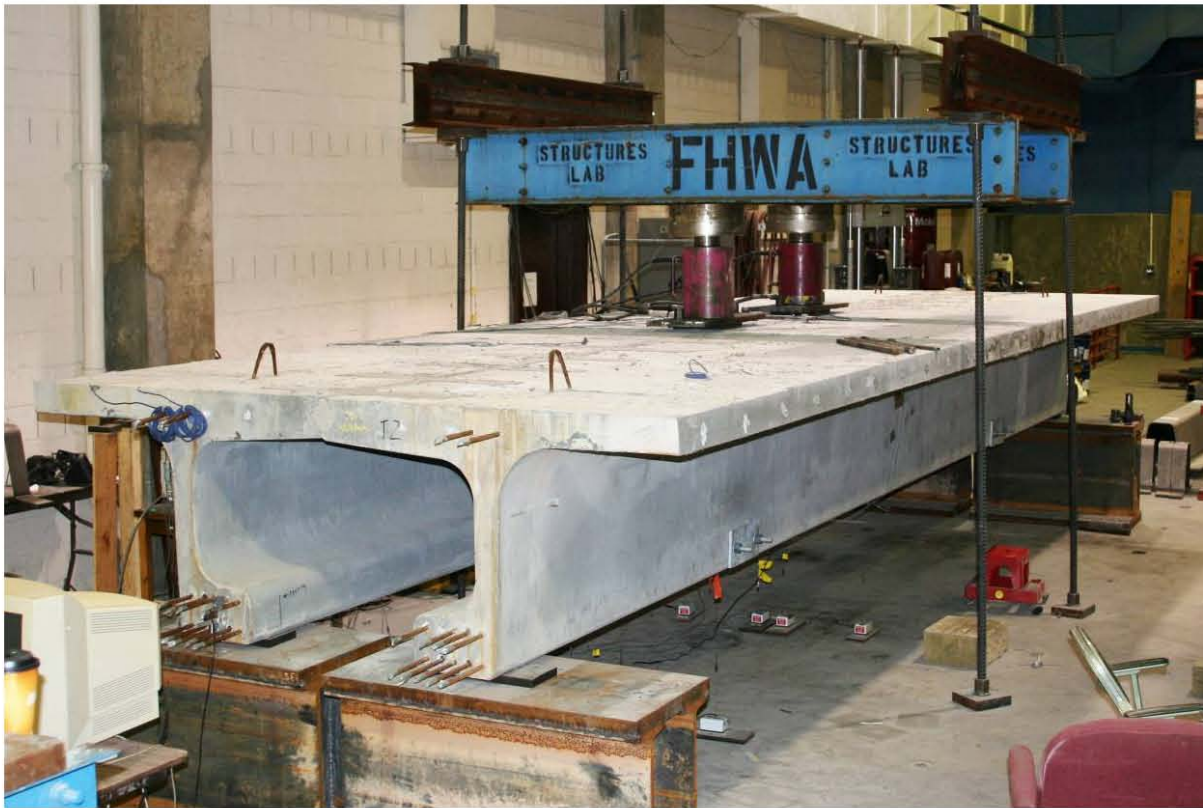
Figure 24. Photo. Setup for Test T2J.

Tests T1J and T2J were nearly identical tests applied to Girders T1 and T2, respectively. These tests focused on the transverse flexural and shear behaviors of the 2nd generation pi-girder cross section when subjected to loads applied between an individual girder’s legs. The elevation view of the loading setup for these tests is identical to that implemented for Tests T1D and T2D and is illustrated in Figure 16. Figure 24 and Figure 25 provide photographs of the setup. Loads were

applied vertically downward by hydraulic jacks situated near midspan. Loads were transmitted to the deck through 0.25 m by 0.25 m (10 inch by 10 inch) elastomeric pads situated 0.61 m (2 ft) on either side of midspan. The pads were aligned such that their south edges coincided with the centerline of the grouted joint. A photograph of the location of the loading pads is provided in Figure 26. These 25 mm (1 inch) thick elastomeric pads were backed by 25 mm (1 inch) thick steel plates. Loads were reacted through 0.15 m by 0.30 m (6 inch by 12 inch) elastomeric pads placed under the girder bulbs at the abutment locations. These elastomeric pads were also 25 mm (1 inch) thick.

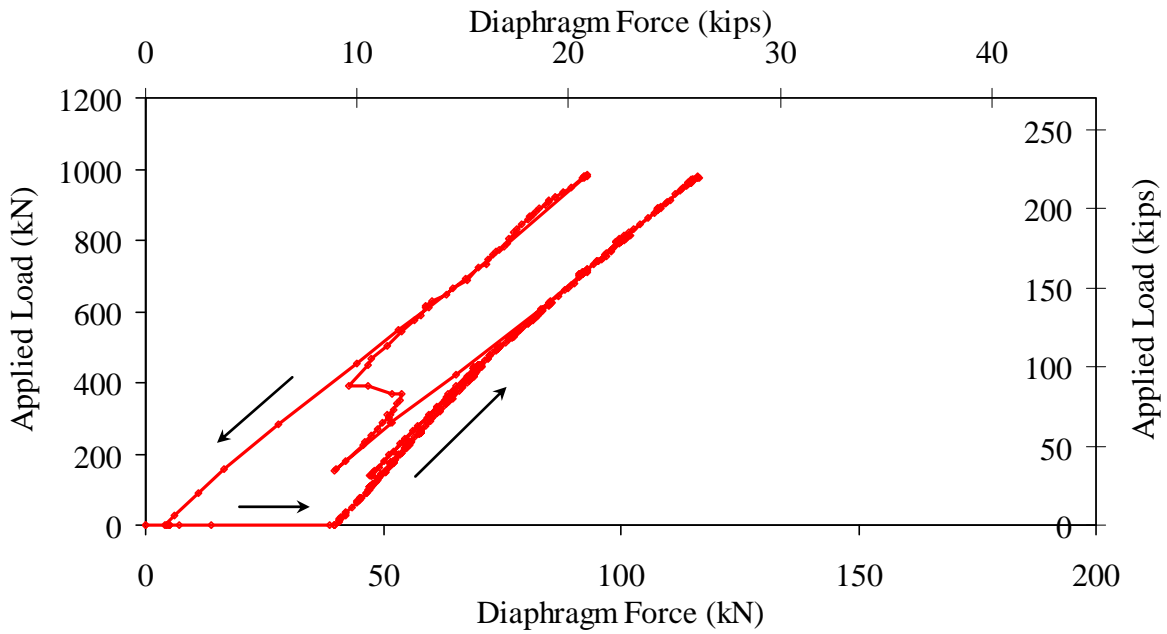
Figure 37 presents the axial load observed in the west diaphragm as calculated from the axial strains measured on the structural tube at midlength. The plot shows that an initial tensile force of 40 kN (9.0 kips) was imparted into the diaphragm during installation, then an additional 76 kN (17.1 kips) was induced during loading to the peak load. During the unload/reload at peak load, the force in the diaphragm abruptly decreased, likely due to slip within the diaphragm to bulb connection. Otherwise, the applied load versus diaphragm force relationship was substantially linear.

Figure 37. Graph. West diaphragm force in Test T1D.

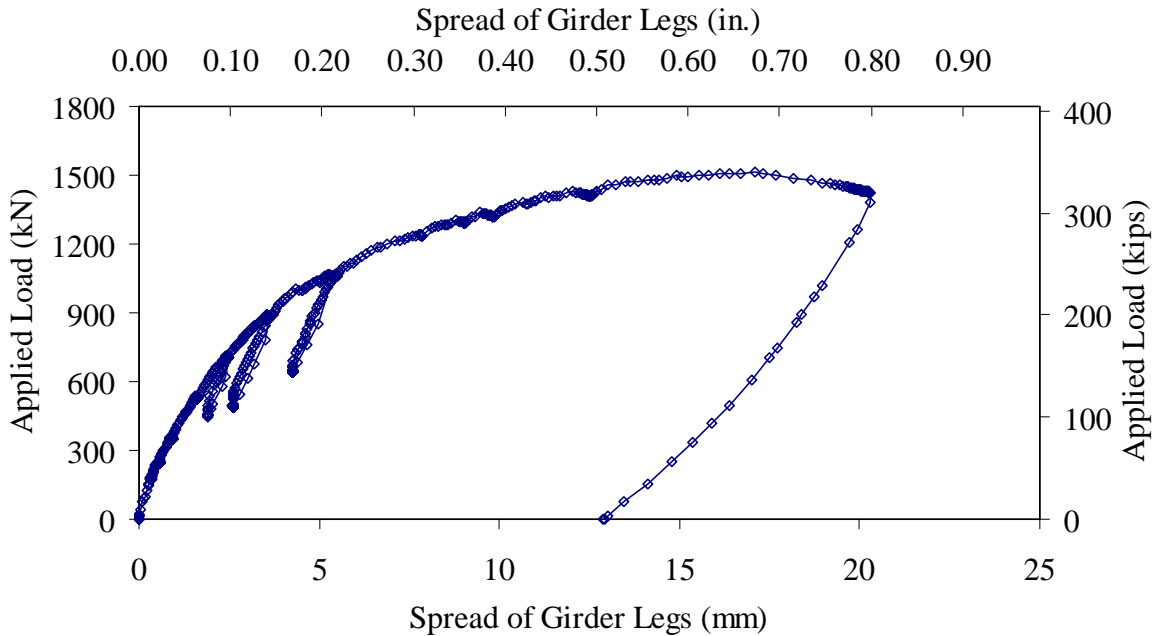
Additional observations related to the global deformation of the girder are presented in Figure 44 which shows the spreading of the girder bulbs at midspan. In total, the bulbs at midspan had spread approximately 17 mm (0.67 inch) by the time the peak load was applied along the girder centerline.

Figure 44. Graph. Spreading between bulbs at midspan of Test T2D.

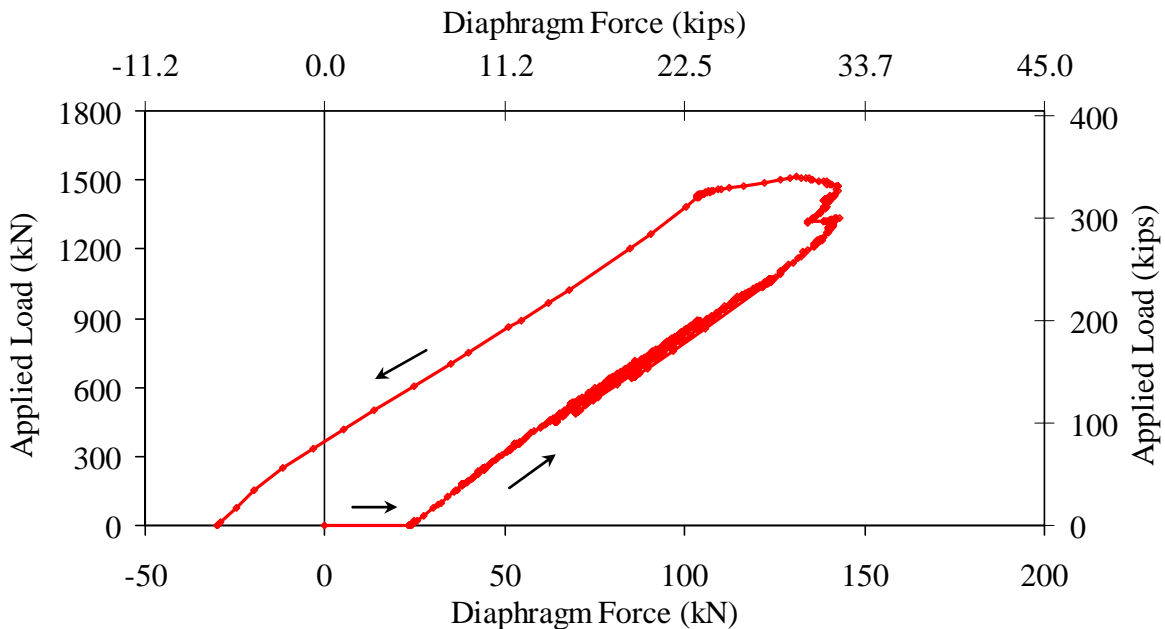
Figure 45 presents the axial load observed in the west diaphragm as calculated from the axial strains measured on the structural tube at midlength. The plot shows that an initial tensile force of 24 kN (5.3 kips) was imparted into the diaphragm during installation, and a total maximum load of 142 kN (31.9 kips) was generated in the west diaphragm. The plot shows that the peak diaphragm force occurred at first at an applied load of 1330 kN (300 kips), then recurred at an applied load of 1470 kN (330 kips). Thereafter, the diaphragm force decreased as the applied load increased to the peak load of 1512 kN (340 kips). The relationship between the applied load and the diaphragm force was substantially linear until the maximum diaphragm force was reached.

Figure 45. Graph. West Diaphragm force in Test T2D.

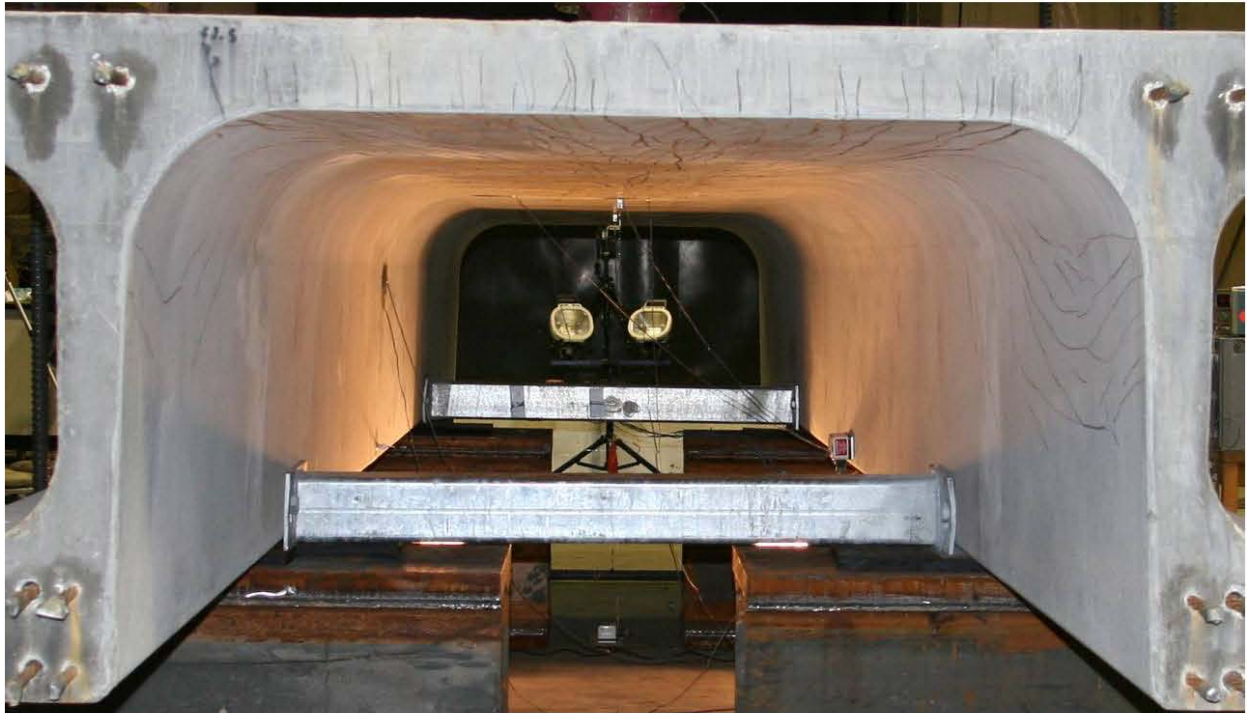
Figure 48. Photo. View from east end after conclusion of Test T2D.

As can be inferred from the results presented above, the global response of the girder in Test T2D was significantly influenced by the behavior of the steel diaphragms. Figure 48 provides a photograph of the east end of the girder after the conclusion of the test. Figure 49 provides a photograph of the north end of the east diaphragm at the time when the peak load was applied to the girder. As the peak diaphragm force was reached, the end plates began to pry and the welds

connecting the end plates to the tubes began to crack. These behaviors resulted in a loss of transverse deformational restraint in the girder bulbs thus allowing increased bulb spreading.

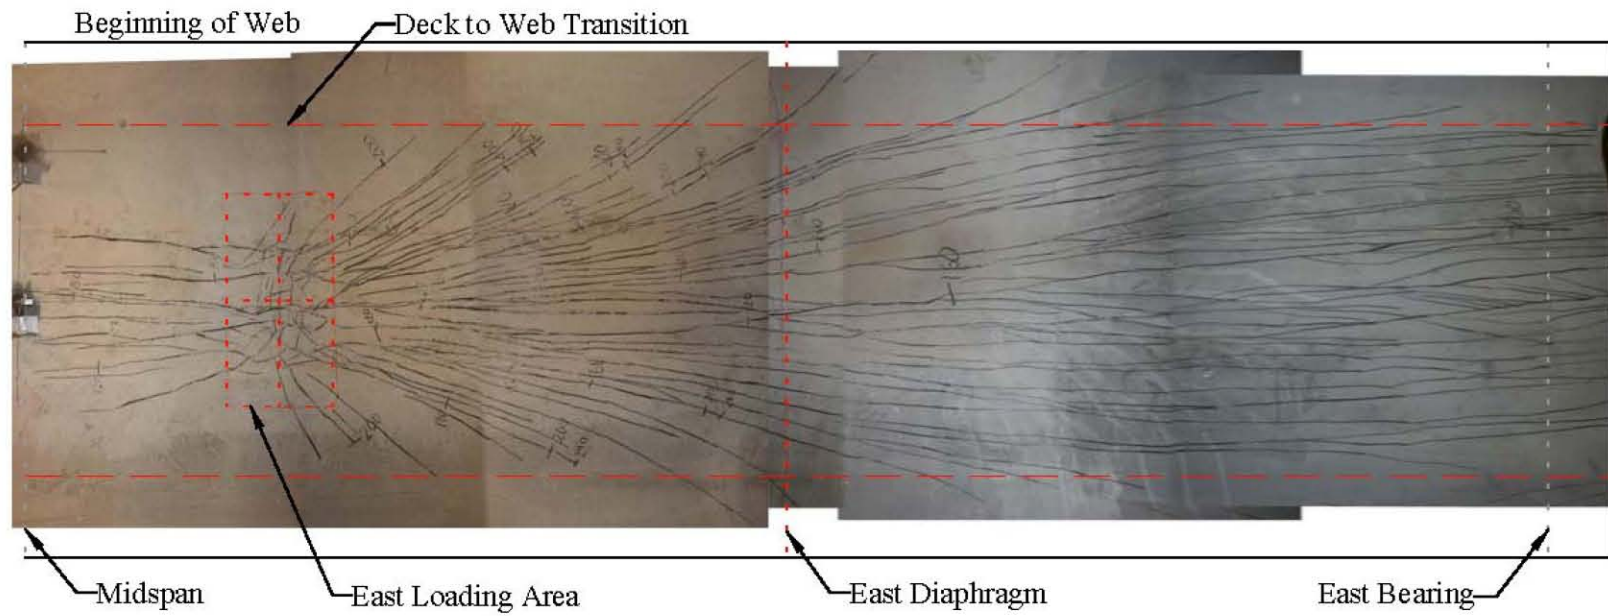
Figure 50. Photo. Underside deck cracking map of T2D after conclusion of test.

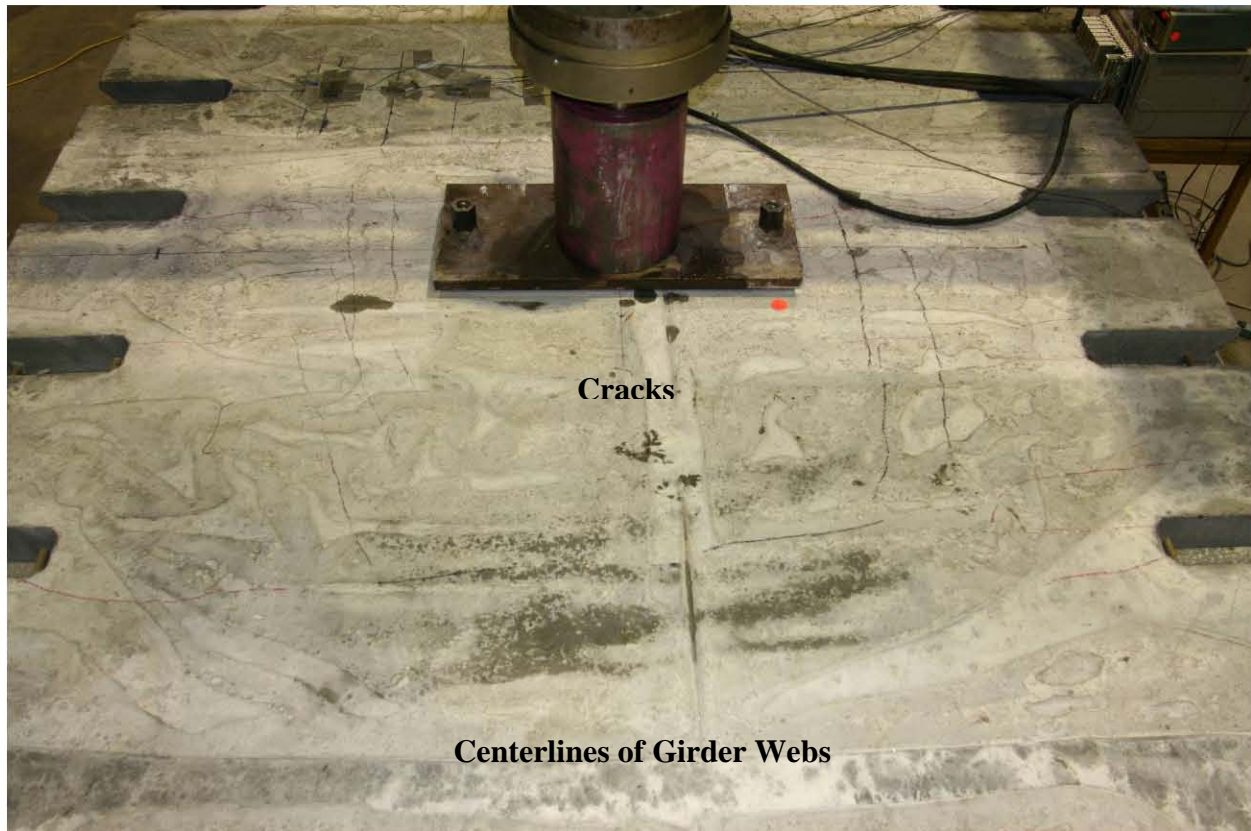
The cracking on the top of the deck was also observed periodically. Figure 58 presents a photograph of the vicinity of the east load point at 1068 kN (240 kips) of applied load. The cracks occur between the centerlines of the two girder webs and tend to encircle the load points with greater longitudinal cracking than transverse cracking.

Figure 58. Photo. Topside deck cracking of T2D at 1067 kN (240 kips) of applied load.

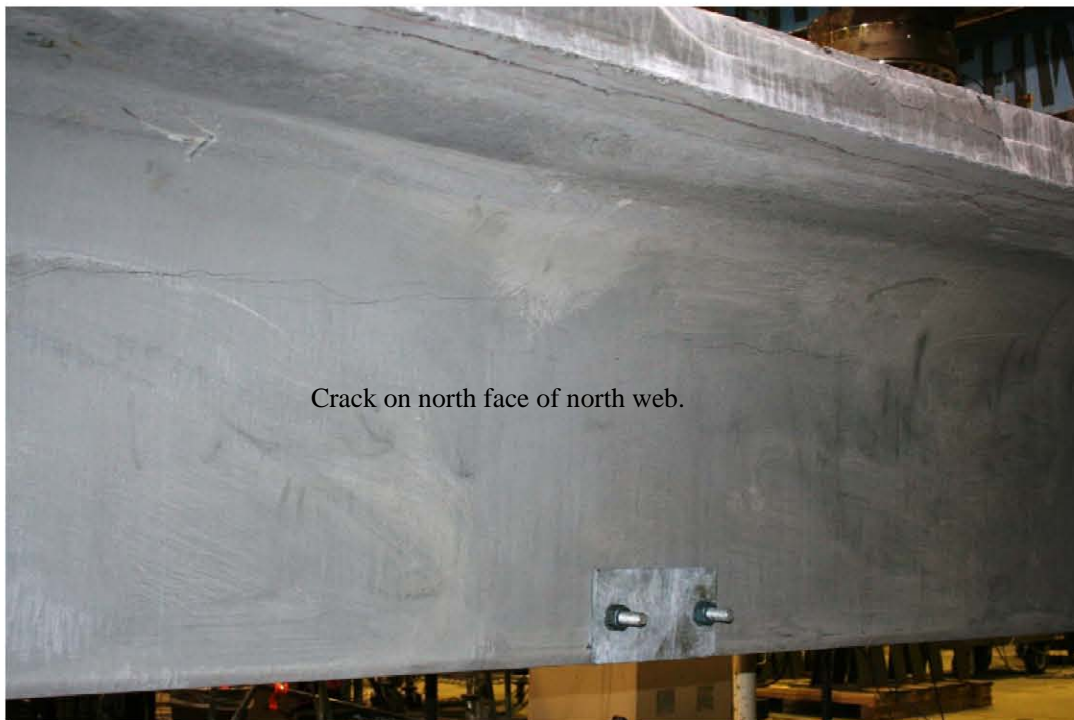
Figure 68. Photo. North face of north web at 1780 kN (400 kips) applied load in Test T1J.

The cracking response of the specimen was monitored qualitatively from north and south of the specimen during the test, and more thoroughly after the completion of the test. During the test, the only distress visually observed was horizontal cracking occurring on the outside of the north and south webs. These cracks emanated symmetrically from midspan toward the ends of the specimen. The cracking was more prevalent on the north side than on the south side. Figure 68 shows the north face of the north web near midspan at an applied load of 1800 kN (400 kips). The large crack visible in the photo is indicative of the initiation of fiber pullout in this face of this leg. Figure 69 shows the entire east end of the north face of the north leg after the conclusion of the test. In this photo, all of the cracks in the web have been located either with the naked eye or through the use of an alcohol spray and indicated on the surface of the girder with red wax crayon. Similar but less extensive cracking was observed in the south face of the south web. Four generally horizontal cracks were noted here at 900 kN (200 kips) of applied load, and nine were noted at 1330 kN (300 kips). The photo in Figure 70 shows the crack map of the south face of the south web after the conclusion of the test.

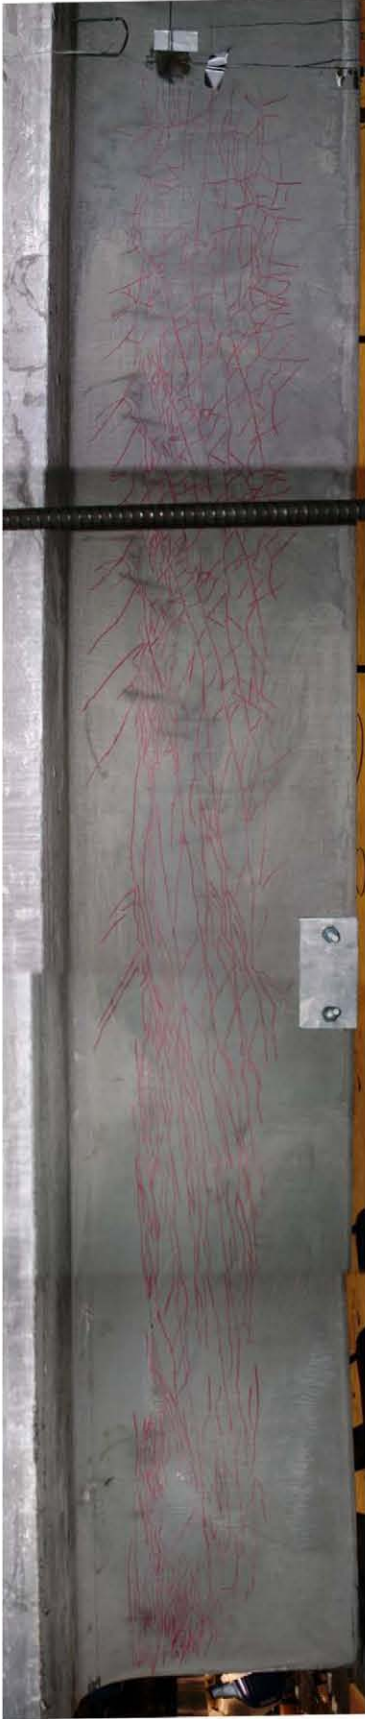
Figure 69. Photo. North face of north web after conclusion of Test T1J.

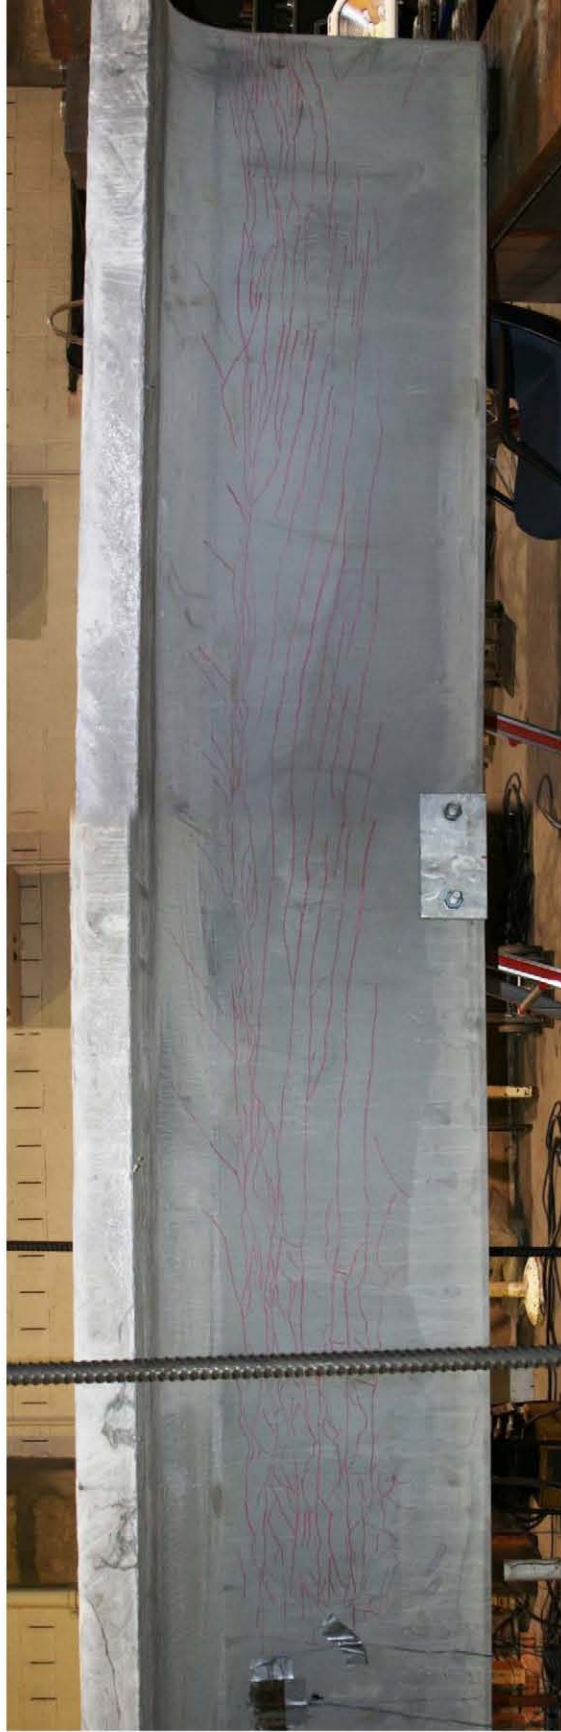
Figure 70. Photo. South face of south web after conclusion of Test T1J.

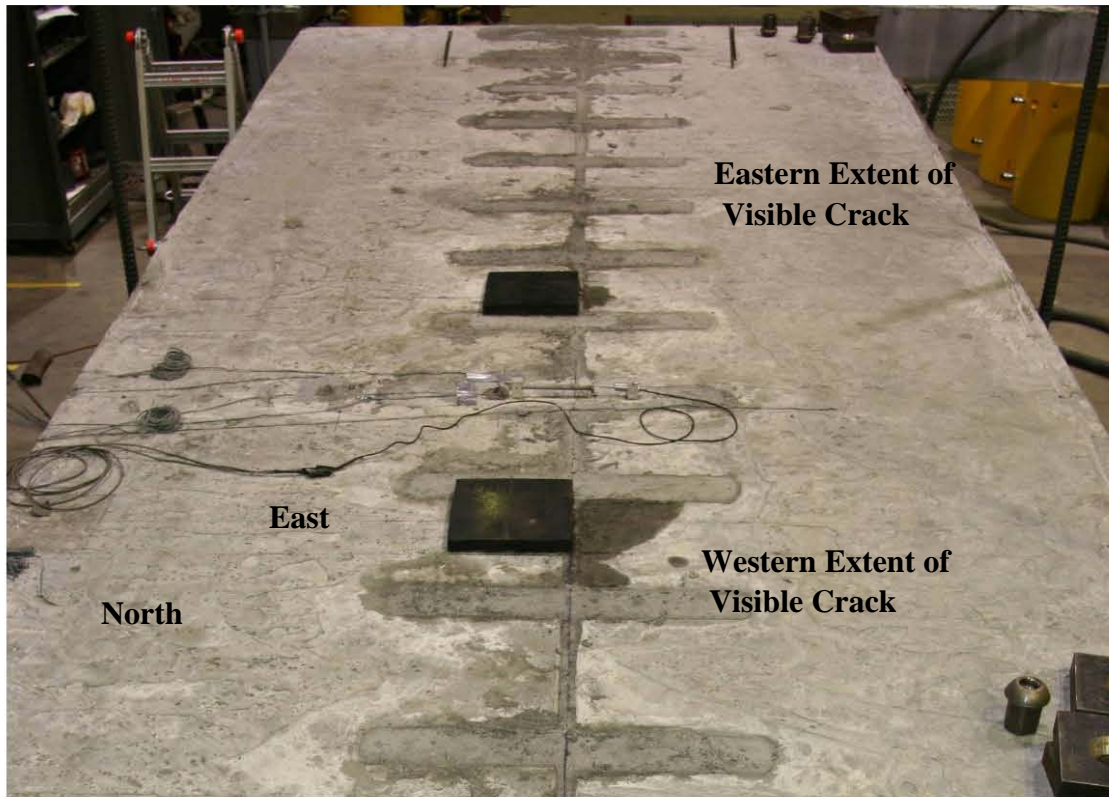
cracks tended to parallel the length of the girder between the load points then turn at a shallow angle toward the joint as they progressed beyond the load points. There were approximately three to five of these cracks on both the north and south sides of the joint. A photo of the top of the deck after the conclusion of the test is shown in Figure 72.

Figure 72. Photo. Top of deck after the conclusion of Test T1J.
