Structural Behavior of a 2nd Generation Ultra-High Performance Concrete Pi-Girder

November 2009

FHWA Publication No. FHWA-HRT-10-026

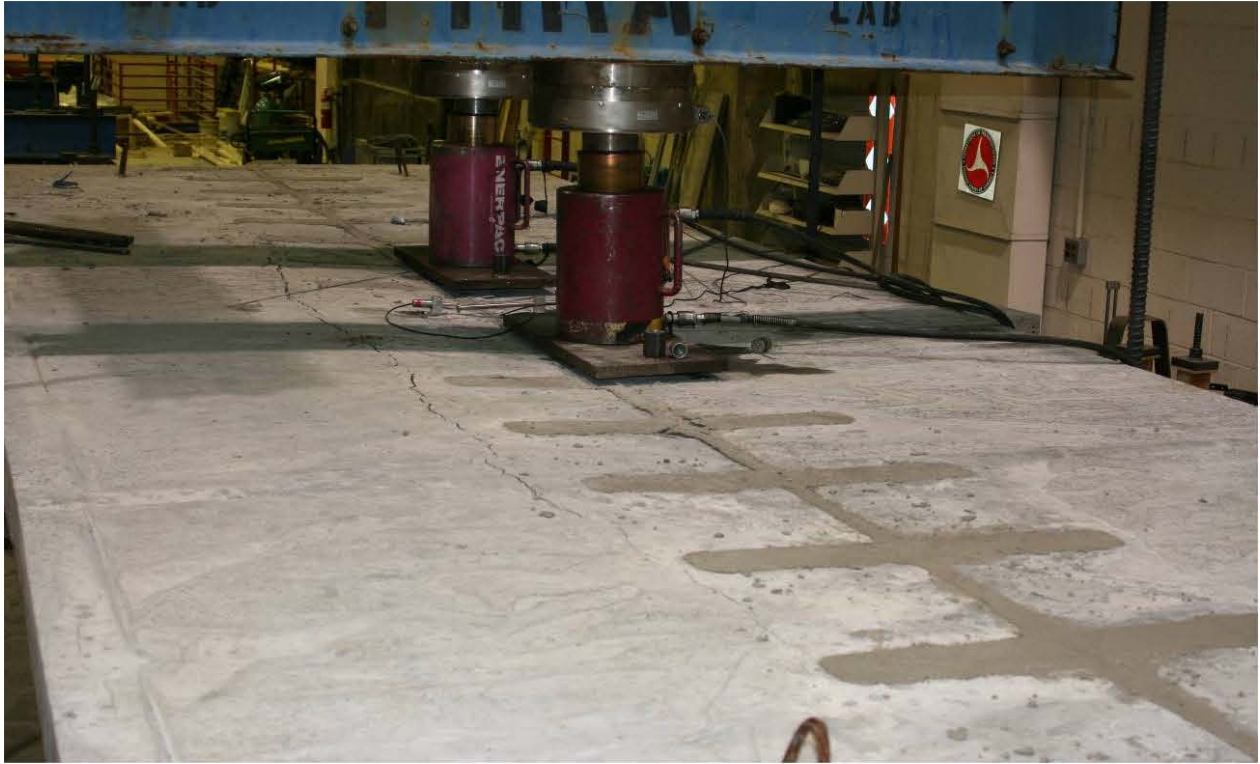
Figure 83. Photo. Top of deck at peak applied load during Test T2J.

The cracking response of the specimen was monitored qualitatively from north, south, and above the specimen during the test, and more thoroughly from all sides after the completion of the test. The cracking observed on the top of the deck was similar to, but more extensive than, the cracking observed in Test T1J. A visual crack assessment was completed of the top of the deck at both 1330 kN (300 kips) and 1780 kN (400 kips) of applied load. Each time, the only crack visible with the naked eye was a single crack in the joint fill material traversing the midspan grout pocket just north of the joint midline. This crack is shown in Figure 82. As the loads increased beyond 1780 kN (400 kips), the cracking apparent on the top of the deck became much more prevalent. Figure 83 shows a photo of the top of the deck just after the peak applied load was reached. Note the grout crushing visible along the joint and the tensile crack visible to the south (left) of the hydraulic jacks. The photograph captured in Figure 84 shows the distress evident on the top of the deck after the conclusion of the test. For clarity, the hydraulic jacks have been removed and the elastomeric loading pad remains in place.

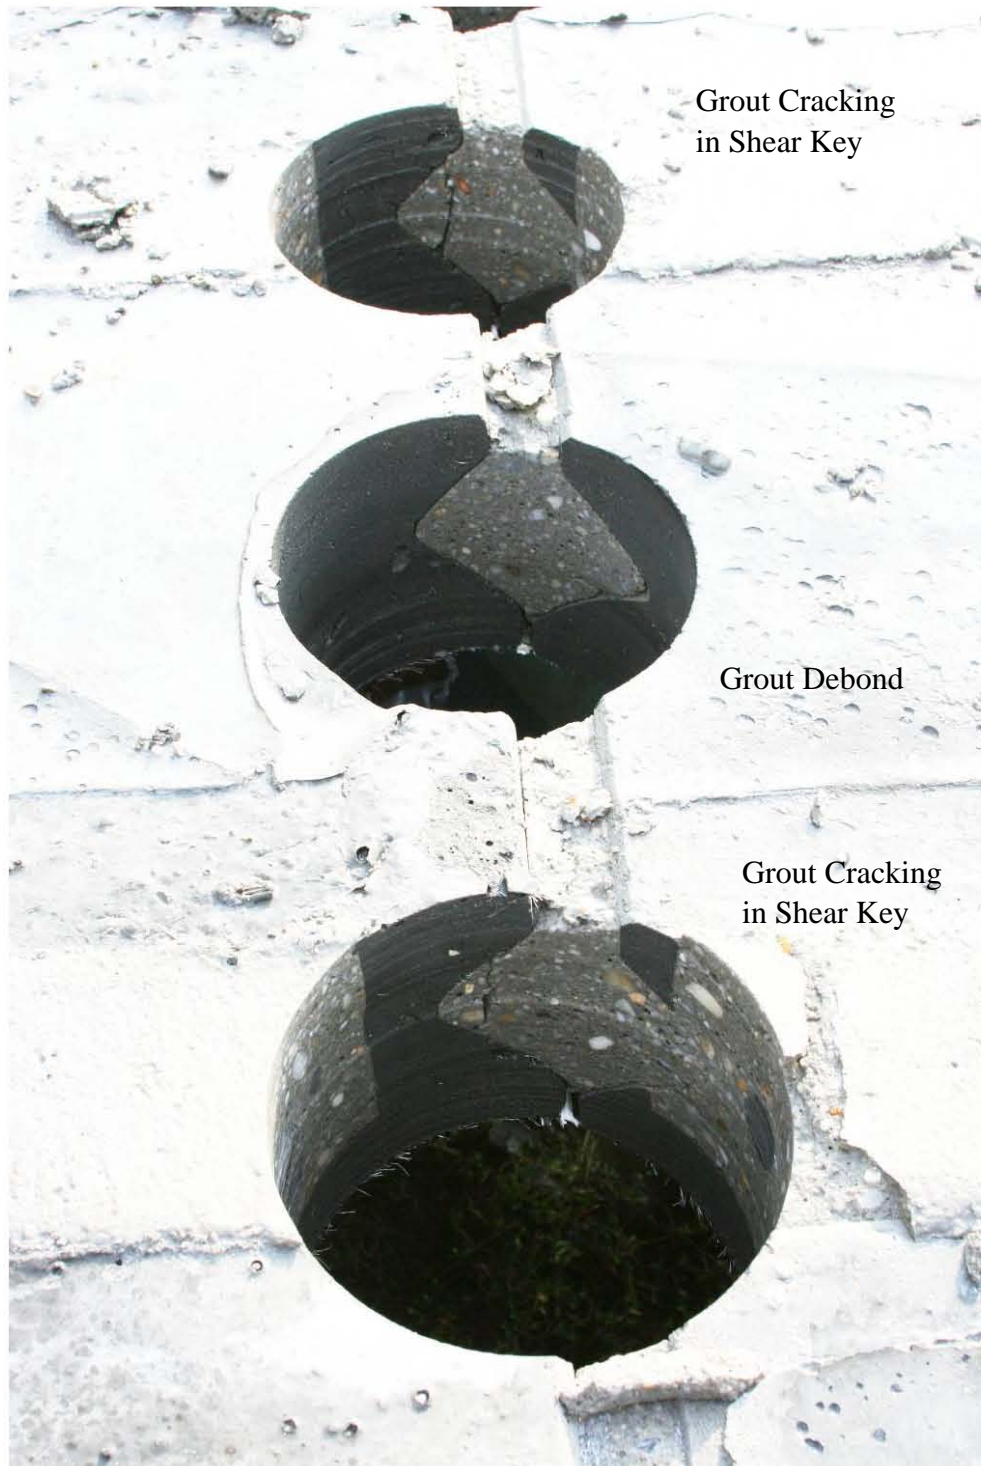
Grout Cracking
in Shear Key

Grout Debond

Figure 85. Photo. Distress visible inside core holes after Test T2J.

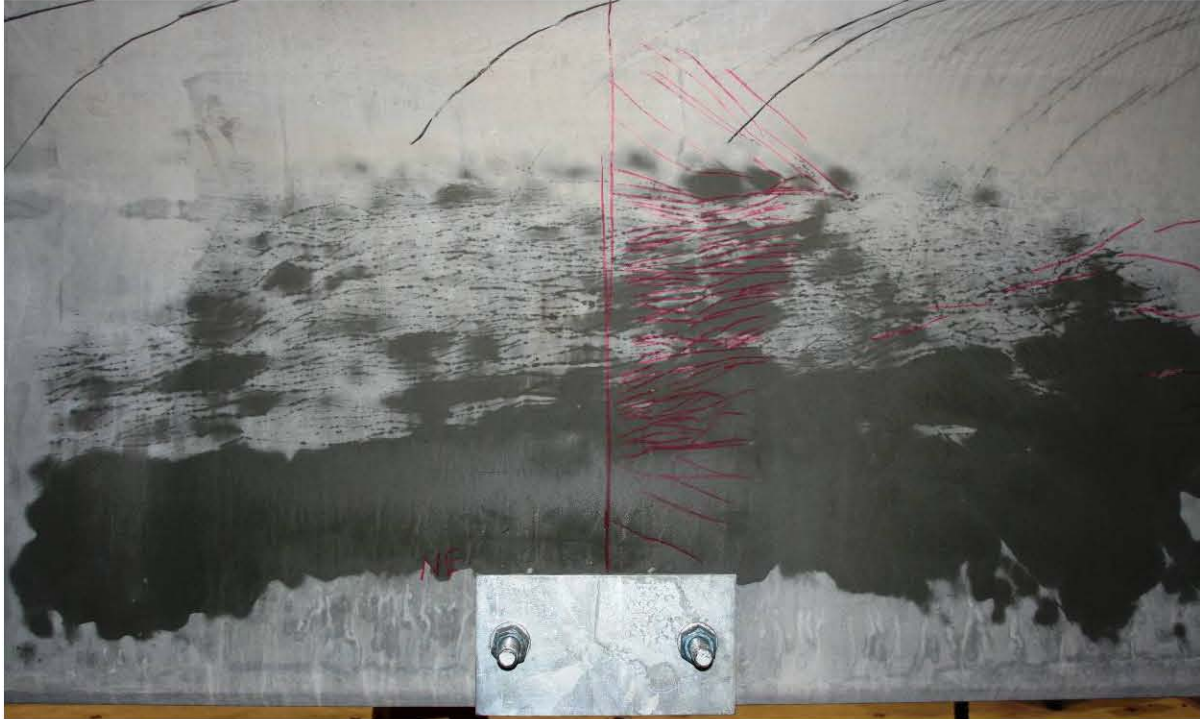
Figure 87. Photo. Cracking on north face of north leg at east diaphragm after conclusion of Test T2J.

The cracking observed on the south face of the south web and on the north face of the north web was similar to the cracking observed during Test T1J. These cracks emanated symmetrically from midspan toward the ends of the specimen. The cracking was more prevalent on the north side than on the south side. On the south face of the south girder six generally horizontal cracks were noted at 890 kN (200 kips) of applied load, and twelve were noted at 1330 kN (300 kips), all running symmetrically about midspan. The cracking at specific locations on the north face of the north web was mapped after the conclusion of the test. Figure 87 shows both cracks visible with the aid of an alcohol spray as well as cracks marked in red wax crayon. The cracks at this location in the web just above the diaphragm were longitudinal and closely spaced. Toward midspan, the longitudinal cracking on the north face of the north web became more dispersed and was interspersed with vertical cracks caused by primary flexure. This is shown in the crack map in Figure 88, which it must be noted was not fully completed to include all cracks being marked over their entire lengths.

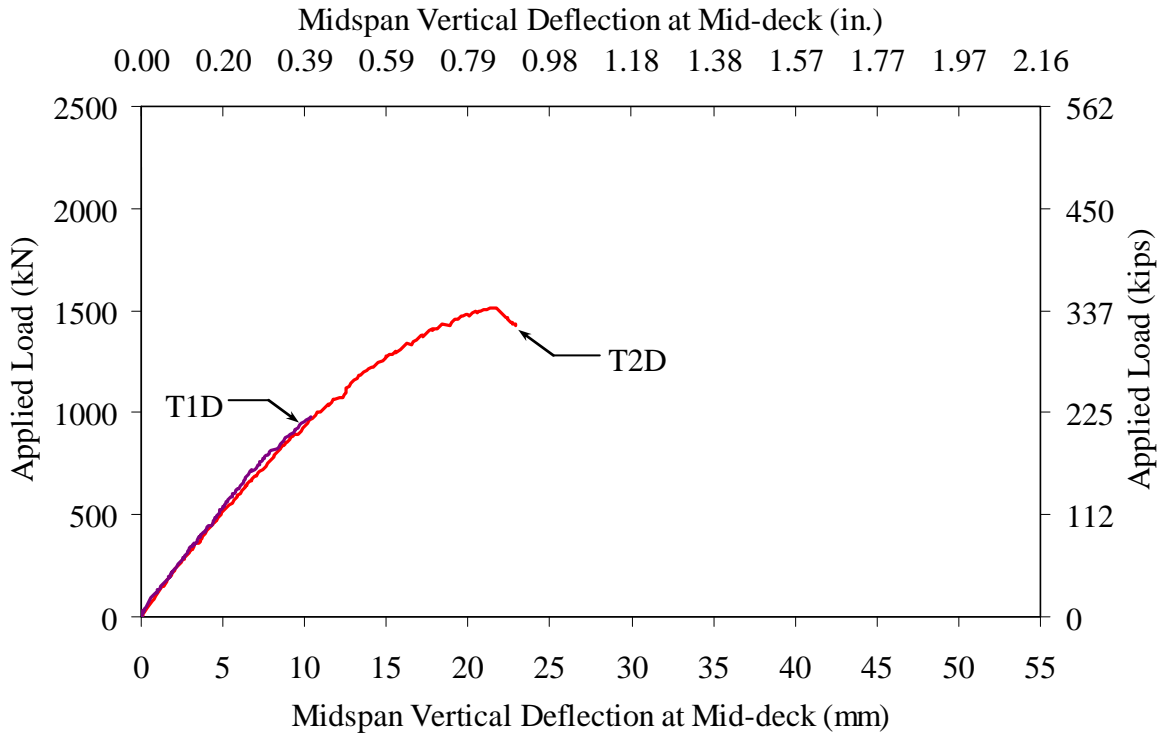
Through the peak load applied in Test T1D, the results from these two tests are nearly identical. The similarity of results can be observed in Figure 89 which shows the vertical deflections captured from the middle of the deck at midspan, in Figure 90 which shows the vertical deflections captured from the north bulb, and in Figure 91 which shows the increase in relative distance between the inside faces of the girder bulbs. Similar behaviors were also observed in the all strain gage readings. Representative results are displayed in Figure 92 and Figure 93. Figure 92 shows the transverse strain readings captured on top of the middle of the deck at midspan. Figure 93 shows the transverse strain readings captured 356 mm (14 inch) south of the underside middle of the deck at the west diaphragm. As no significant differences in structural response were observed between T1D and T2D, it is anticipated that the mild steel reinforcement included in the deck of T1D provided minimal structural benefit up through the application of 983 kN (221 kips).

Figure 89. Graph. Midspan mid-deck vertical deflection results from Tests T1D and T2D.

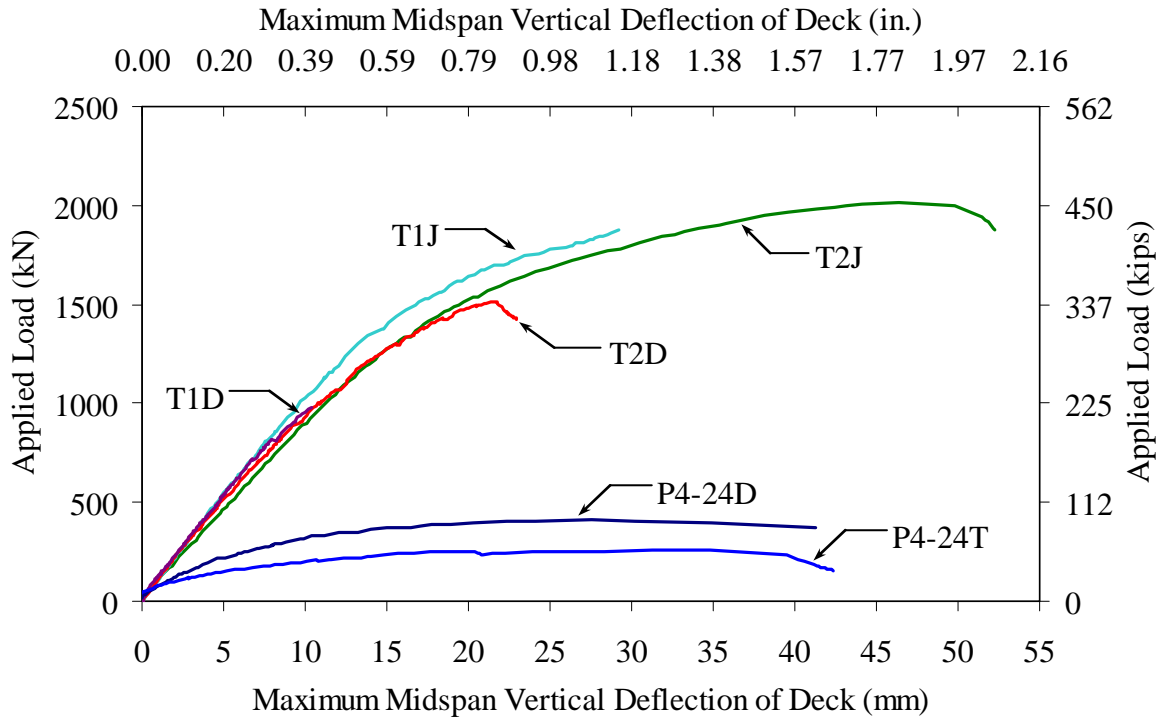
The combination of the results presented in Figure 103 and Figure 104 demonstrates that the modifications implemented in the development of the 2nd generation UHPC pi-girder significantly enhanced the structural response. The discrete diaphragms included at intermediate points along the span, as well as cross-sectional modifications to the shape of the pi-girder both contributed to a stiffer elastic response and a higher capacity. When combined with the results of test T2J which indicated that the longitudinal joint detail had greater transverse flexural capacity than the deck of the as-fabricated girder, these results in total indicate that the 2nd generation UHPC pi-girder exhibits acceptable transverse flexural behavior.

Figure 103. Graph. Deck midspan vertical deflection results from the six pi-girder transverse flexural response tests.

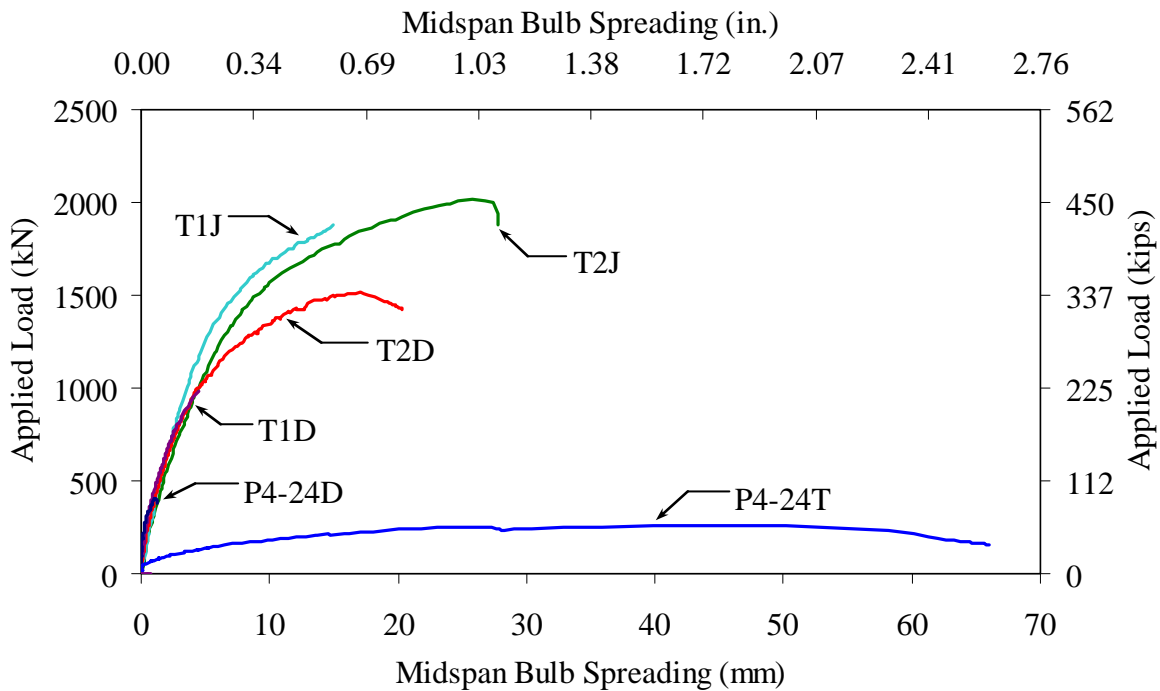
Figure 104. Graph. Deck midspan bulb spreading results from the six pi-girder transverse flexural response tests.

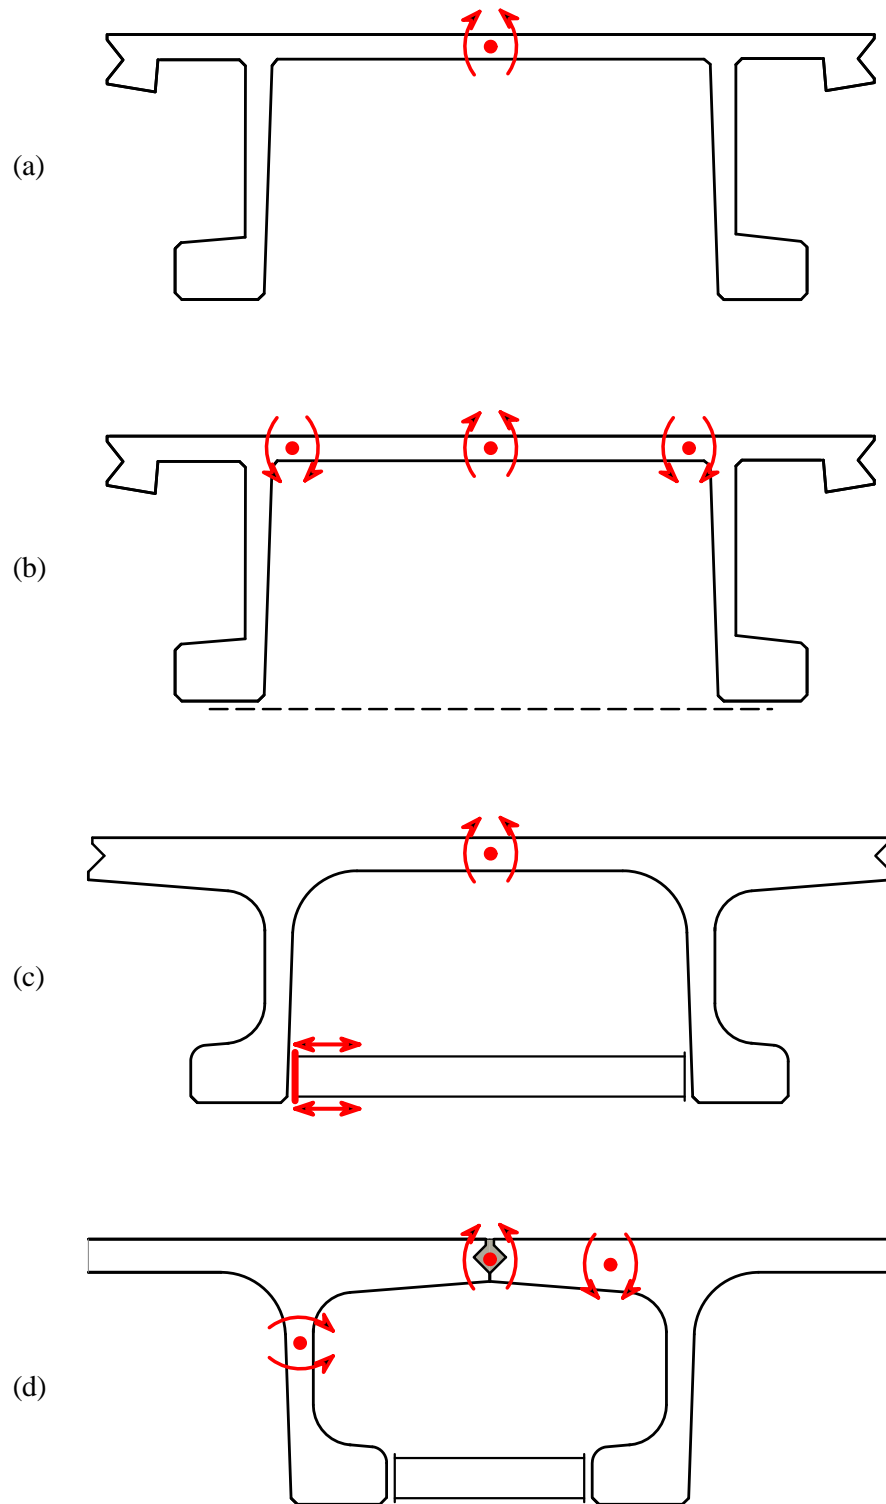
Figure 105 presents a conceptual illustration of the basic transverse flexural mechanisms which were observed in each of the four tests run through failure. Although there was multiple distributed parallel cracking in every test completed, as the peak load was reached local rotation of the cross section at critical crack locations always began to occur. In tests P4-24T and P4-24D, flexural hinging within the deck was sufficient to result in failure of the specimen. In test T2D, the hinging in the deck was combined with the tensile failure of the diaphragm to create a failure mechanism. Finally, in test T2J hinges formed in the UHPC deck, in the UHPC web, and in the mild-steel reinforced grouted joint to results in a mechanism and failure of the specimen. The local flexural hinging of the UHPC cross section consisted of rotation accumulating within specific cracks such that at fiber pullout occurred on the tensile face and the flexural depth of the member at the critical location decreased. The hinging in the grouted joint was akin to an underreinforced concrete section failing in flexure with the mild steel yielding and the concrete eventually crushing.

Figure 105. Illustration. Conceptual failure mechanisms observed in (a) Test P4-24T, (b) Test P4-24D, (c) Test T2D, and (d) Test T2J.

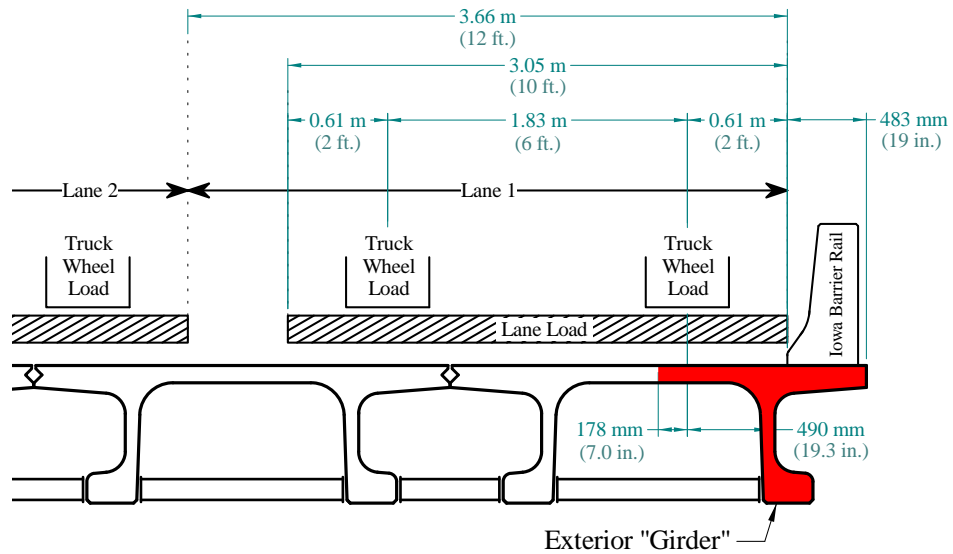
Figure 106. Illustration. Loading configuration for exterior “girder”.
