Ultra-High Performance Concrete Composite Connections for Precast Concrete Bridge Decks

FHWA Publication No. FHWA-HRT-12-041

U.S. Department of Transportation
Federal Highway Administration

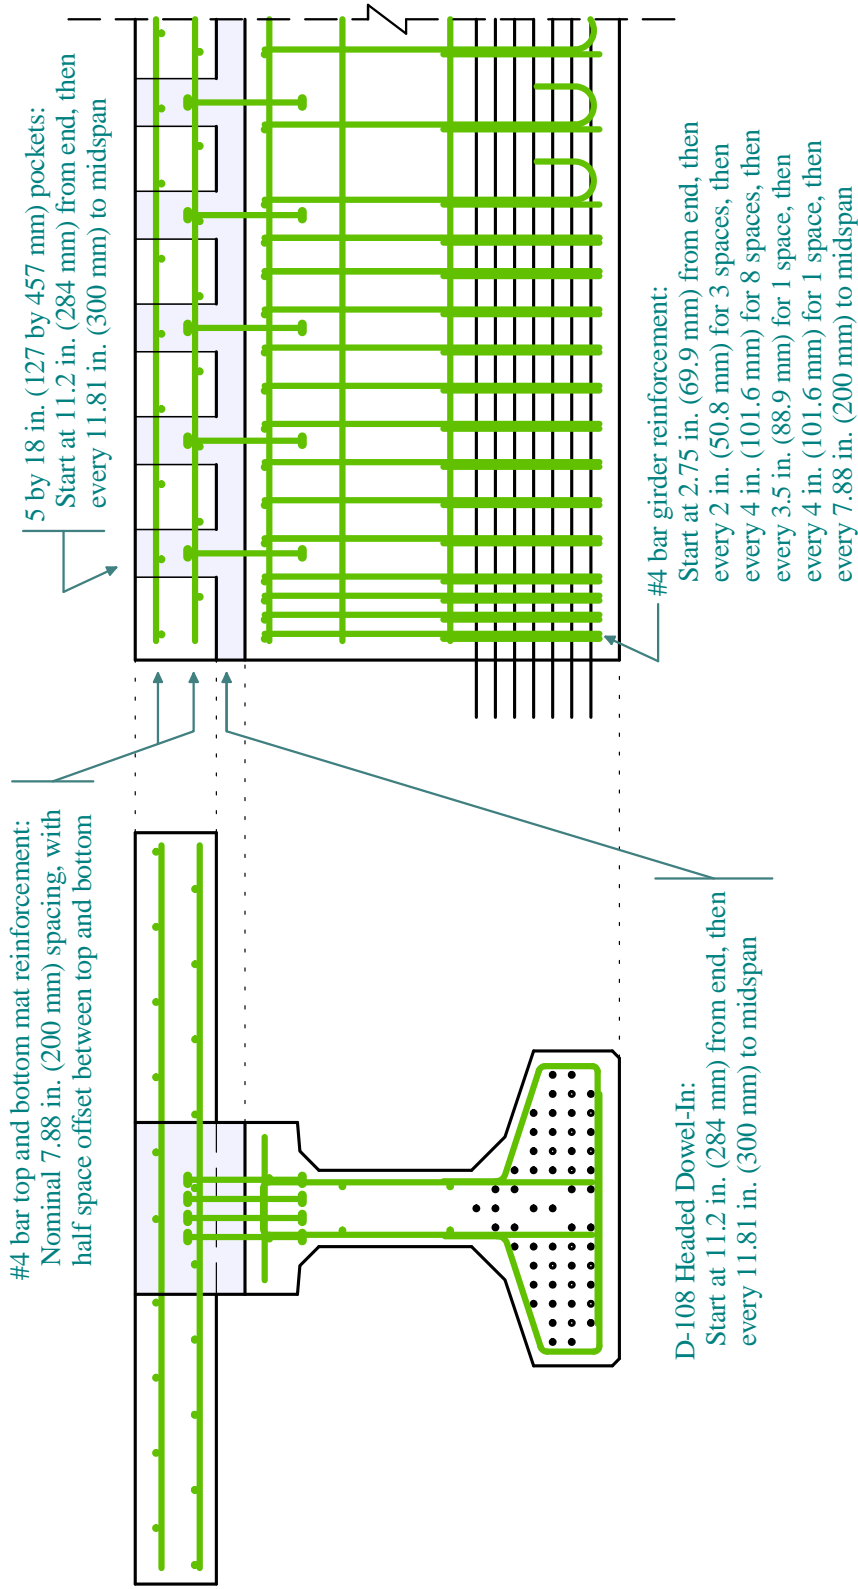
Figure 4. Illustration. Conventional composite connection: Longitudinal cross section of concrete girder connection.

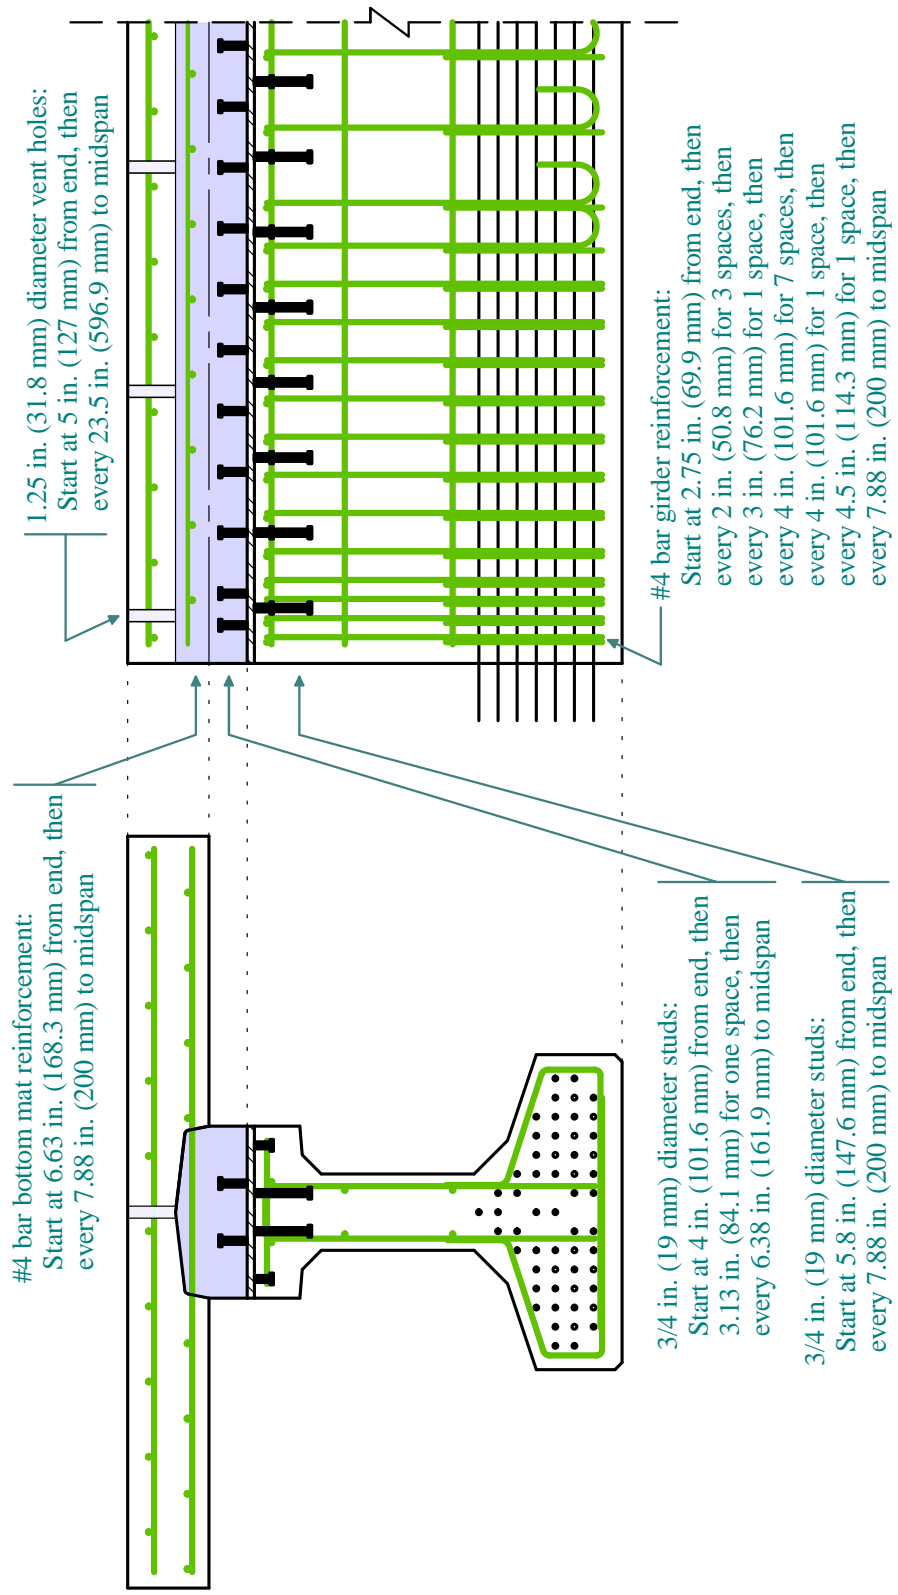
Figure 6. Illustration. UHPC composite connection: Longitudinal cross section of emulative steel girder connection.

horizontal shear of 1.263 kN/mm (7.215 kip/inch) according to LRFD section 6.10.10.4 assuming a stud ultimate strength of 345 MPa (50 ksi). The details pertaining to the emulative steel girder connection end of this test specimen can be found in Figure 5 and Figure 6.

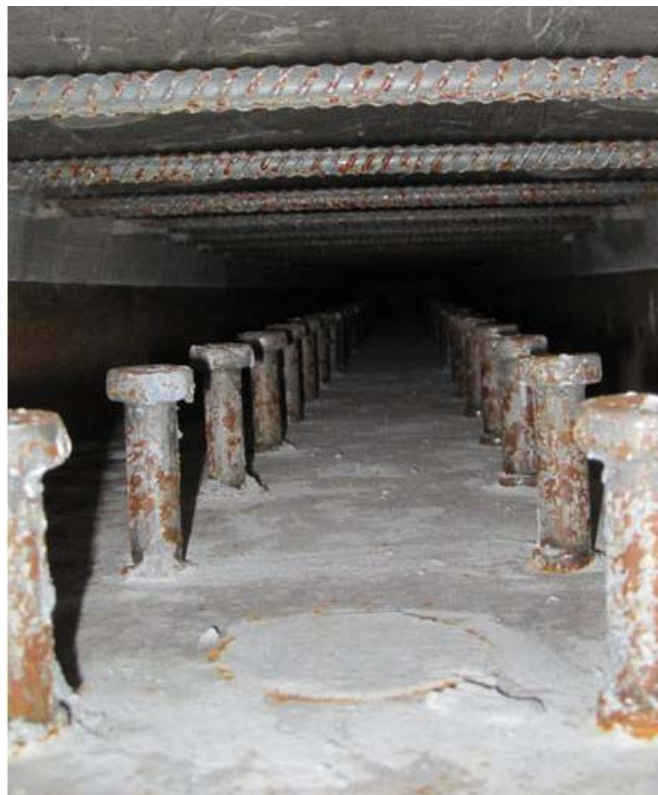
Figure 9. Photograph. Composite connection between emulated steel girder and precast concrete deck immediately prior to field-casting of UHPC.

Lancaster Development, Inc. assembled the precast pieces and cast the grouts in an indoor facility in Binghamton, New York, in February 2011. The novel composite connection detail specimen was assembled first. The two precast deck panels were staged on top of the precast girder, and then the haunch forms were installed. Immediately before UHPC casting, photographs were captured showing the composite connection space between the girder and the deck. Figure 9 pertains to the connection between the emulated steel girder and the precast concrete deck. Figure 10 pertains to the connection between the concrete girder and the precast concrete deck.

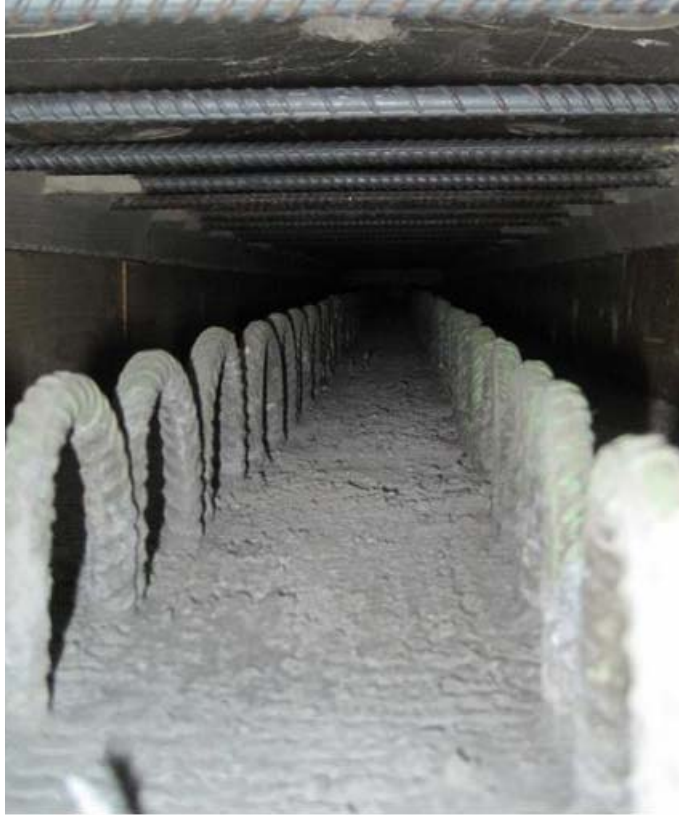
Figure 10. Photograph. Composite connection between concrete girder and precast concrete deck immediately prior to field-casting of UHPC.

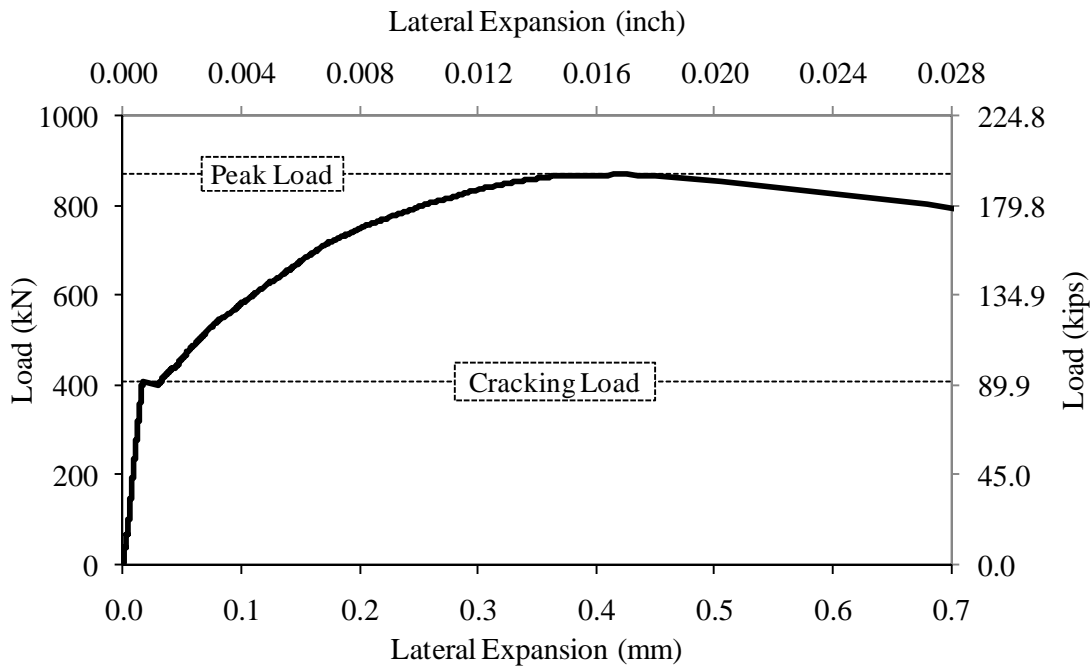
Figure 11 provides an illustration of the type of result captured during the completion of this test method. Although first cracking of the specimen may or may not be apparent through visual or audible indications, the electronically captured data clearly indicates a discontinuity in the lateral expansion consistent with the cessation of elastic behaviors.

Figure 11. Illustration. Sample load versus lateral expansion result from a split cylinder test completed on a UHPC cylinder.

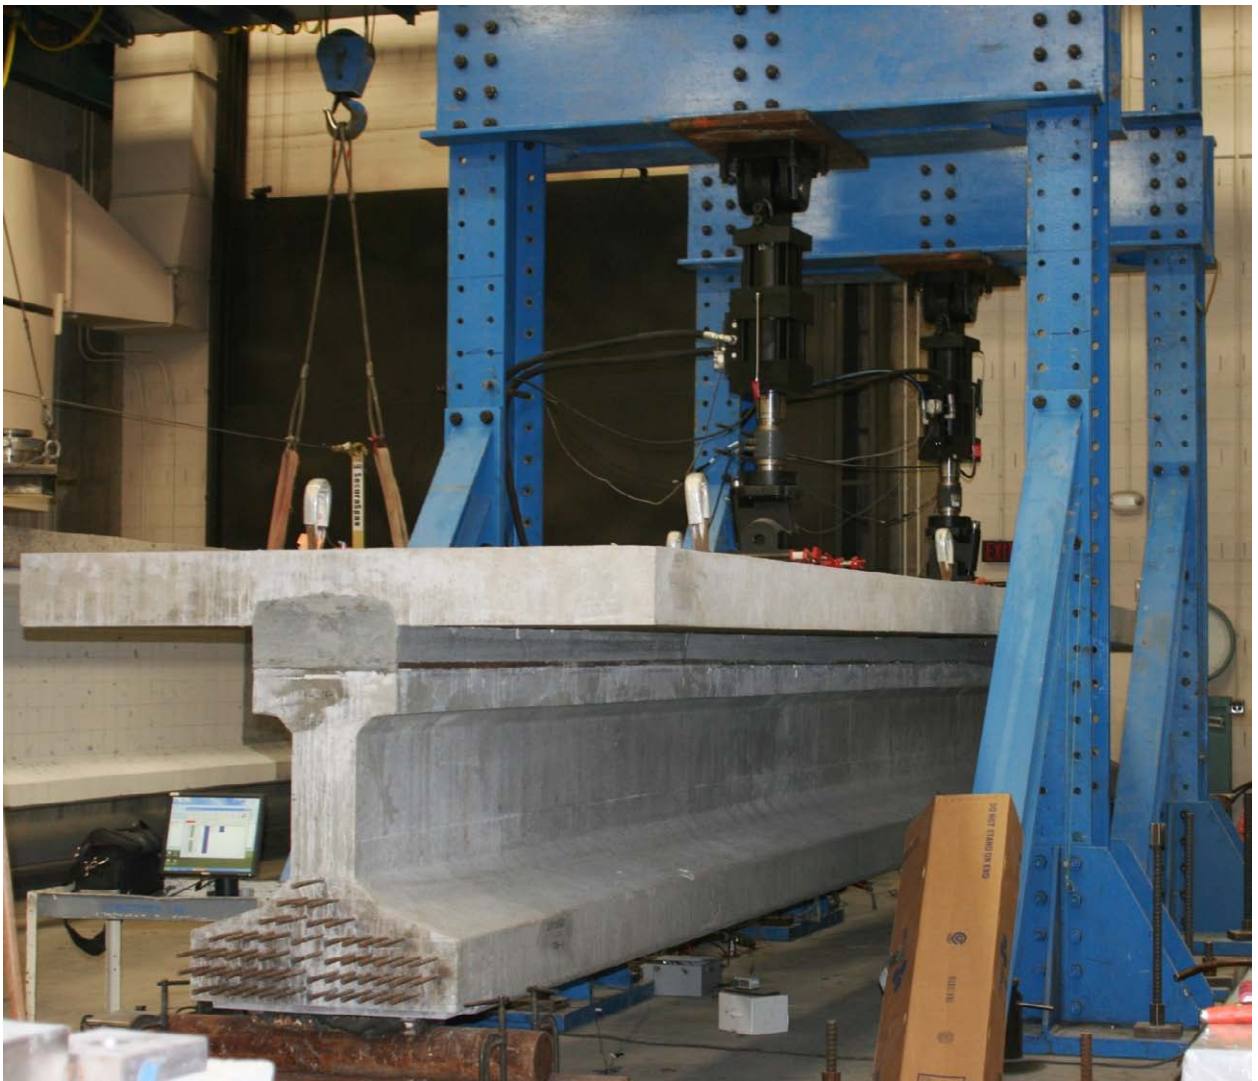
Figure 13. Photograph. Overall test setup for cyclic test program.

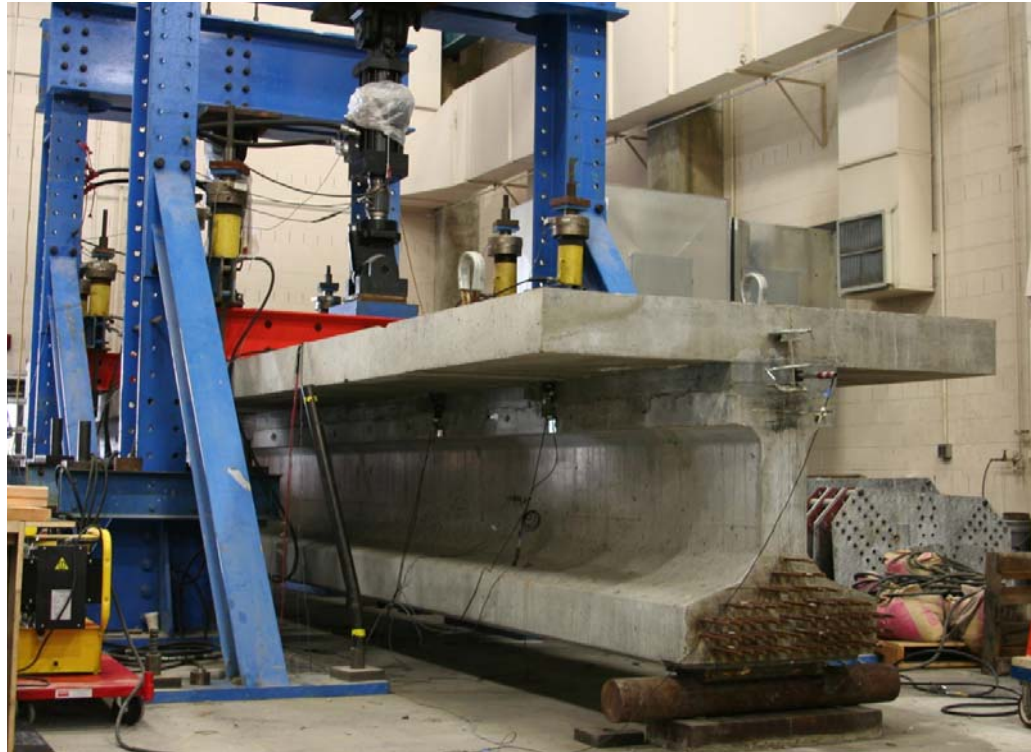
Figure 16. Photograph. Overall test setup for static test program.

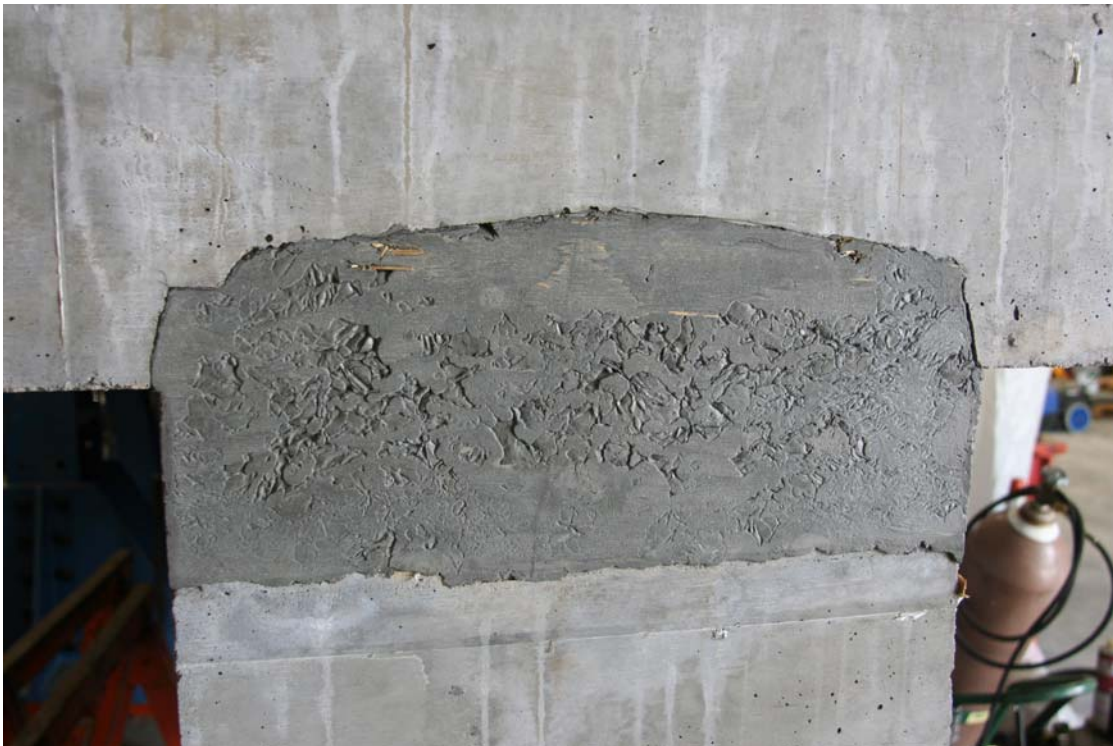
Figure 23. Photo. Haunch connection at portion of test specimen which emulated the composite connection to concrete girder (i.e., west end) at conclusion of cyclic testing.

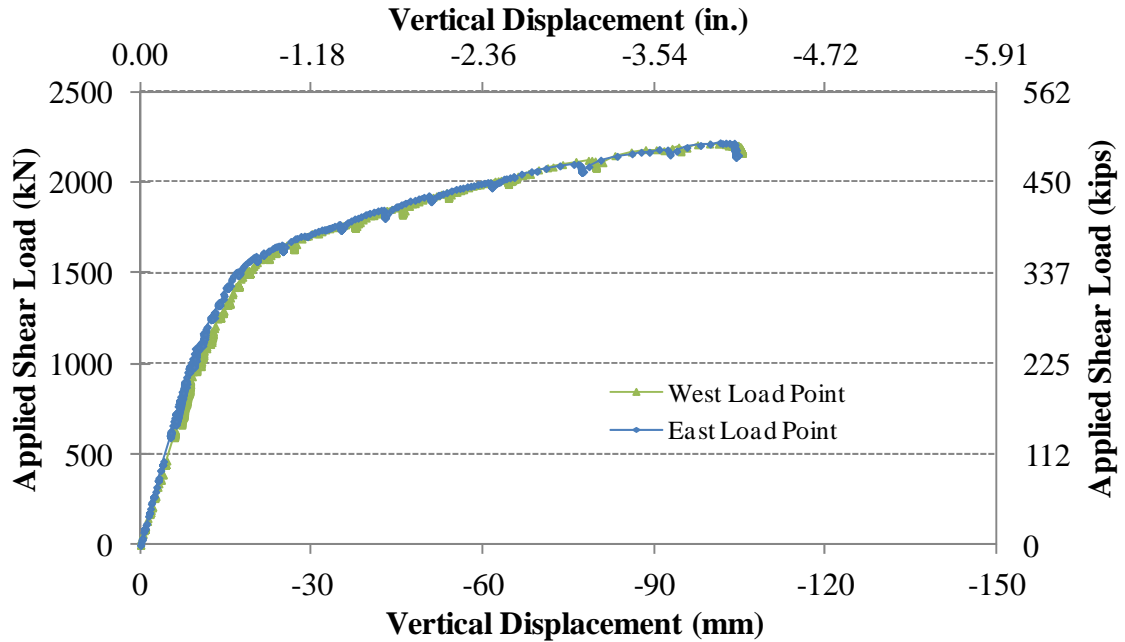
Figure 24. Graph. Load-deflection response of UHPC connection specimen under static load to failure.

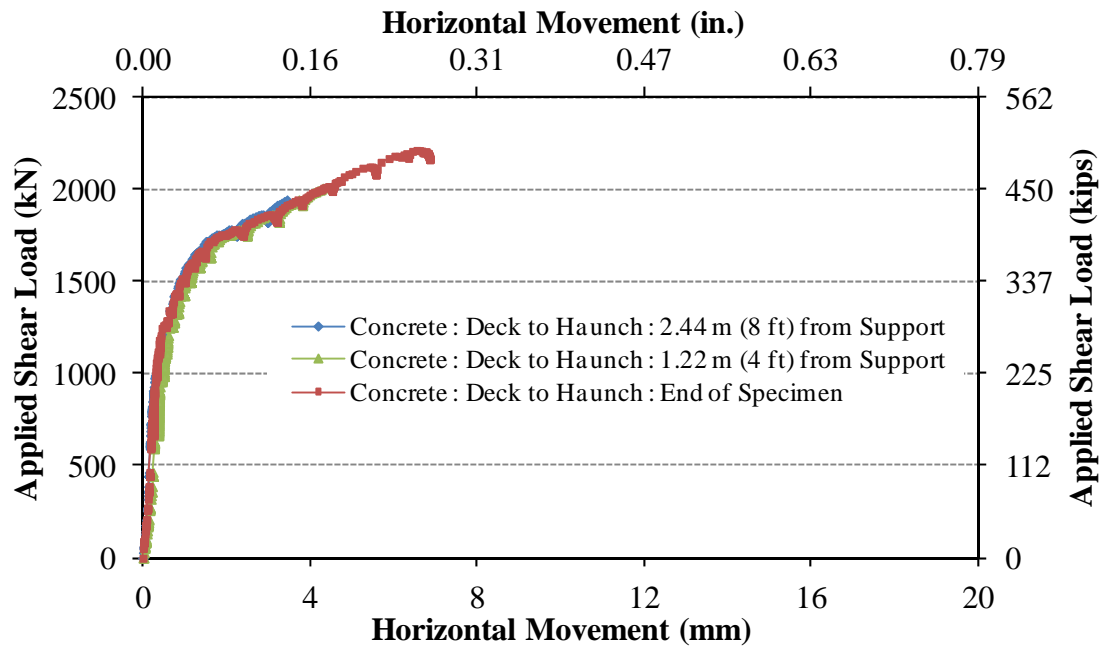
Figure 25. Graph. Horizontal movement between deck and haunch in portion of UHPC connection specimen which emulated the composite connection to a concrete girder when under static load to failure.

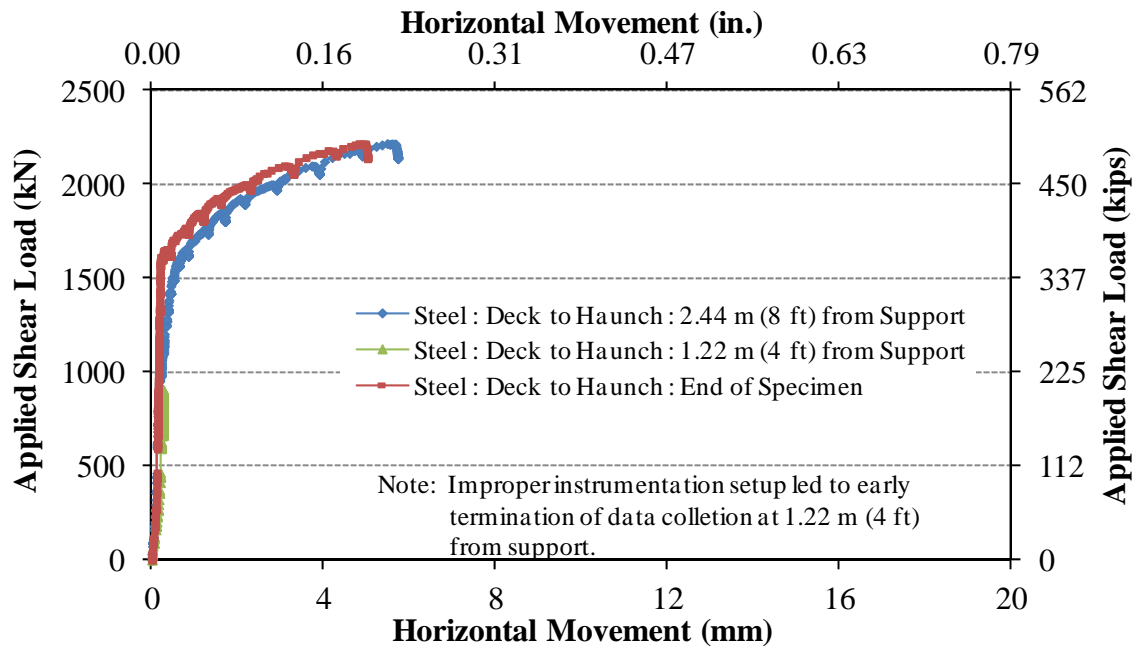
Figure 27. Graph. Horizontal movement between deck and haunch in portion of UHPC connection specimen which emulated the composite connection to a steel girder when under static load to failure.

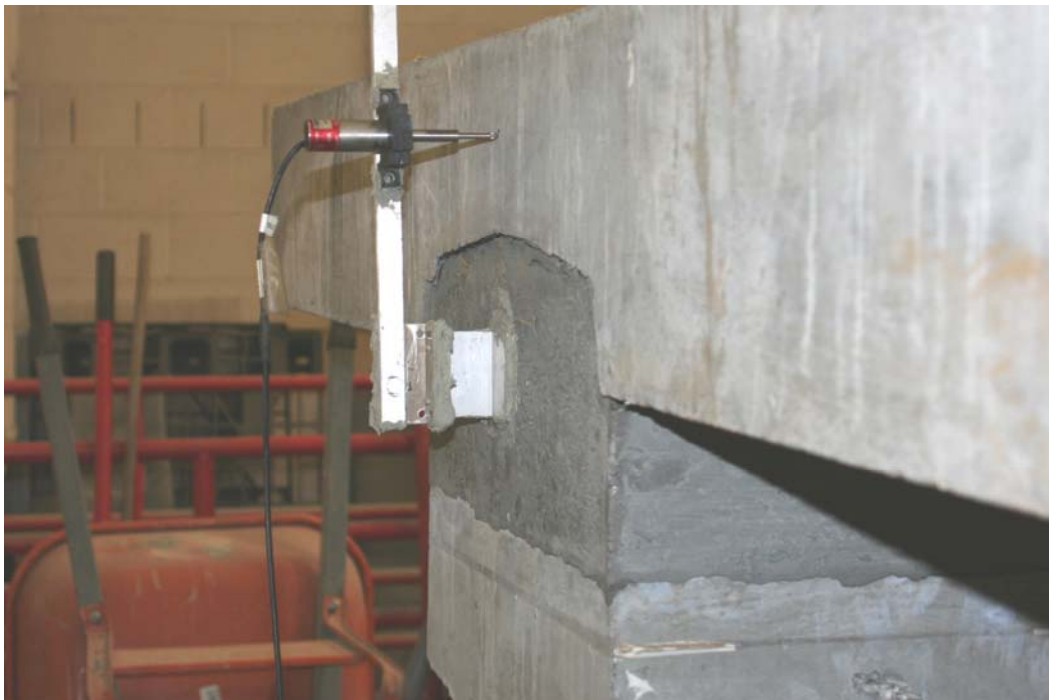
Figure 29. Photo. Haunch connection which emulated the composite connection to a concrete girder (i.e., west end) immediately before the attainment of peak applied load.

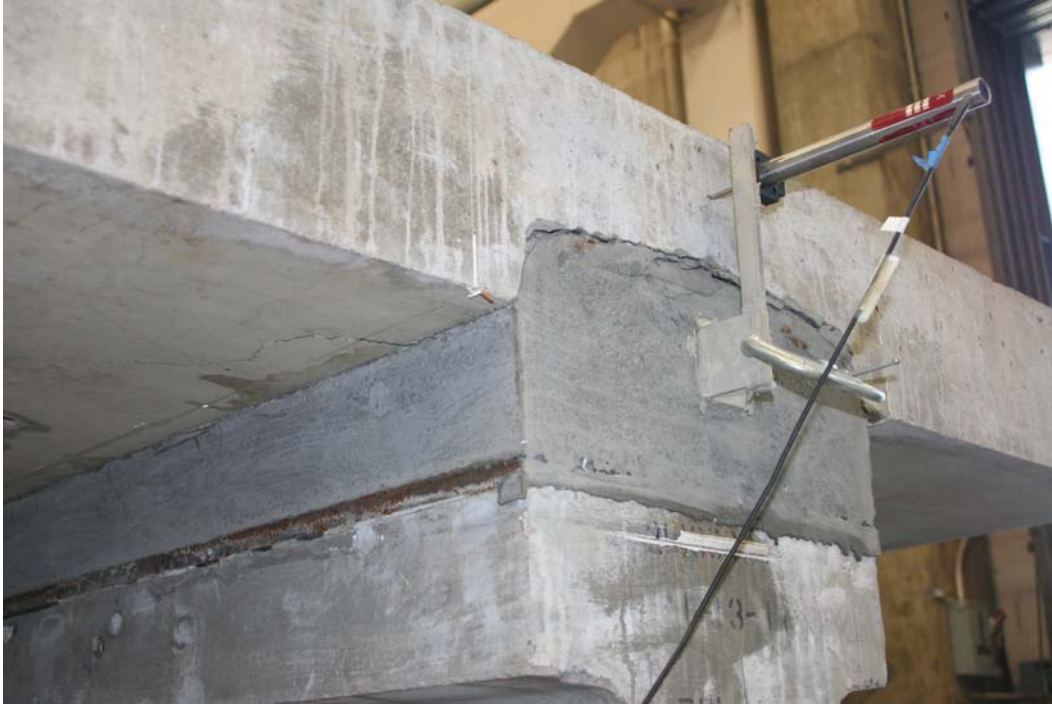
Figure 30. Photo. Haunch connection which emulated the composite connection to a steel girder (i.e., east end) after completion of static testing.

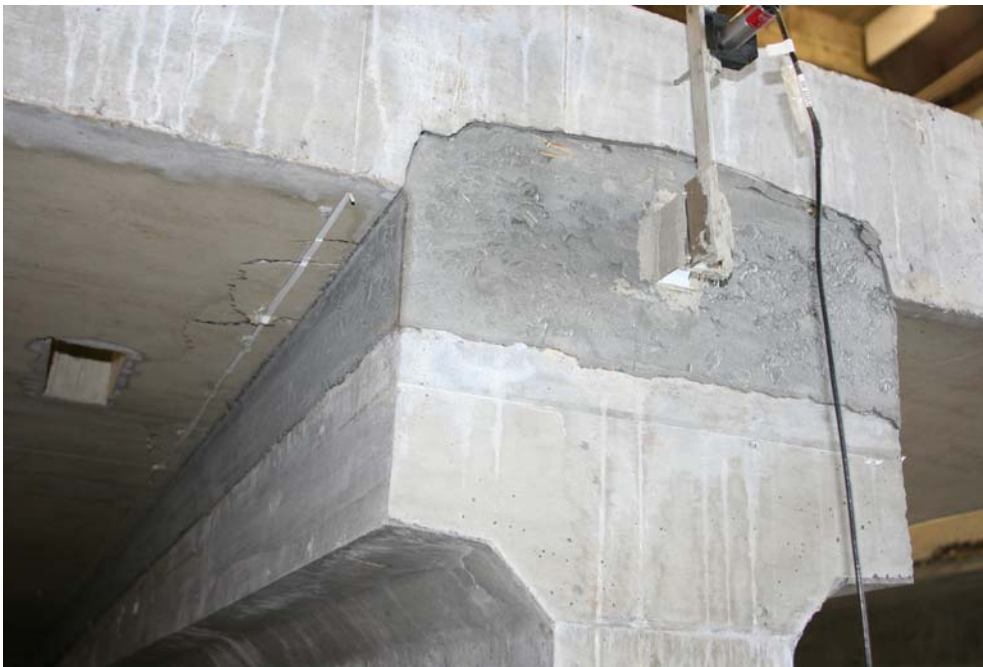
Figure 31. Photo. Haunch connection which emulated the composite connection to a concrete girder (i.e., west end) after completion of static testing.

The failure of the test specimen can be attributed to a horizontal shear failure of the conventional concrete both in the prestressed girder and in the precast deck elements. Figure 30 and Figure 31 show the haunch connections at each end of the test specimen immediately after completion of the test. The deck can be observed to be extended relative to the haunch and the underside of the deck shows structural cracking and spalls beginning at the location of the first bottom mat reinforcing bars. Figure 32 and Figure 33 provide illustrations indicating the locations of the observed structural cracking in each end of the test specimen at the conclusion of testing. The cracks have been drawn onto the photographs in order to facilitate easy viewing. Figure 33, showing the end of the girder which emulated the steel girder connection, shows a small amount of structural cracking in the underside of the deck and a significant amount of shear cracking in the prestressed girder. This shear cracking in the girder web extends into the top flange of the prestressed girder and runs horizontally parallel to the steel plate embedded into the top of the girder. Figure 32, focusing on the end of the girder which emulated the concrete girder connection, shows a somewhat different response. A greater amount of structural cracking is observed in the underside of the deck, while the shear cracking in the prestressed girder is confined to the web and web transitions.

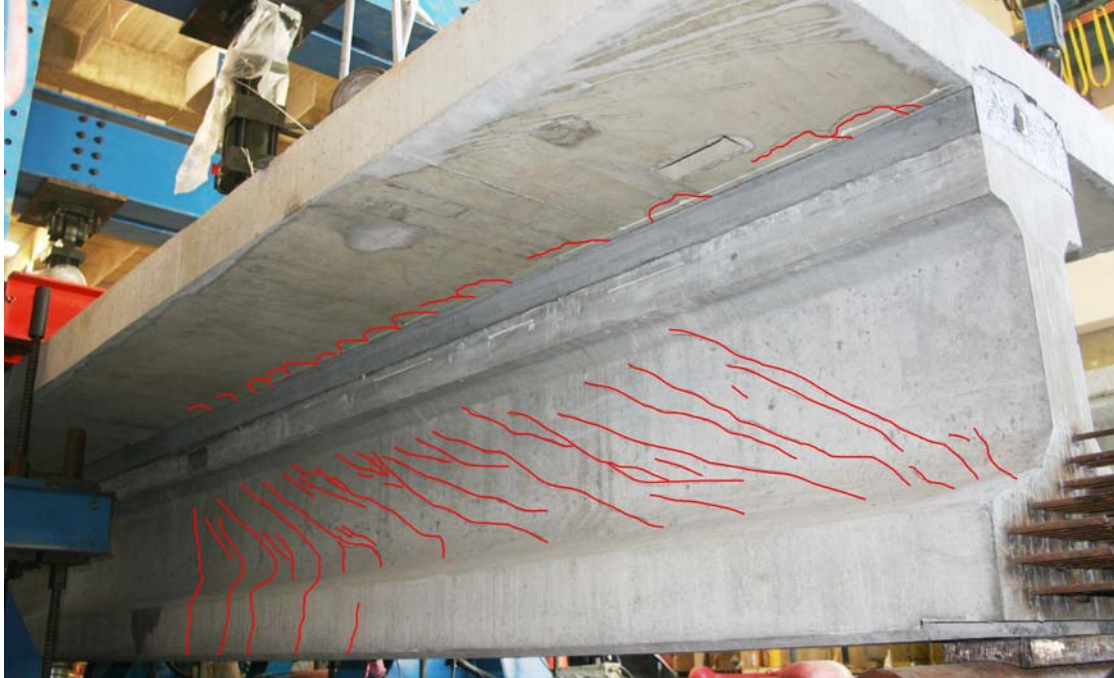
Figure 32. Illustration. Cracking apparent on north face of west end of test specimen after completion of static testing.

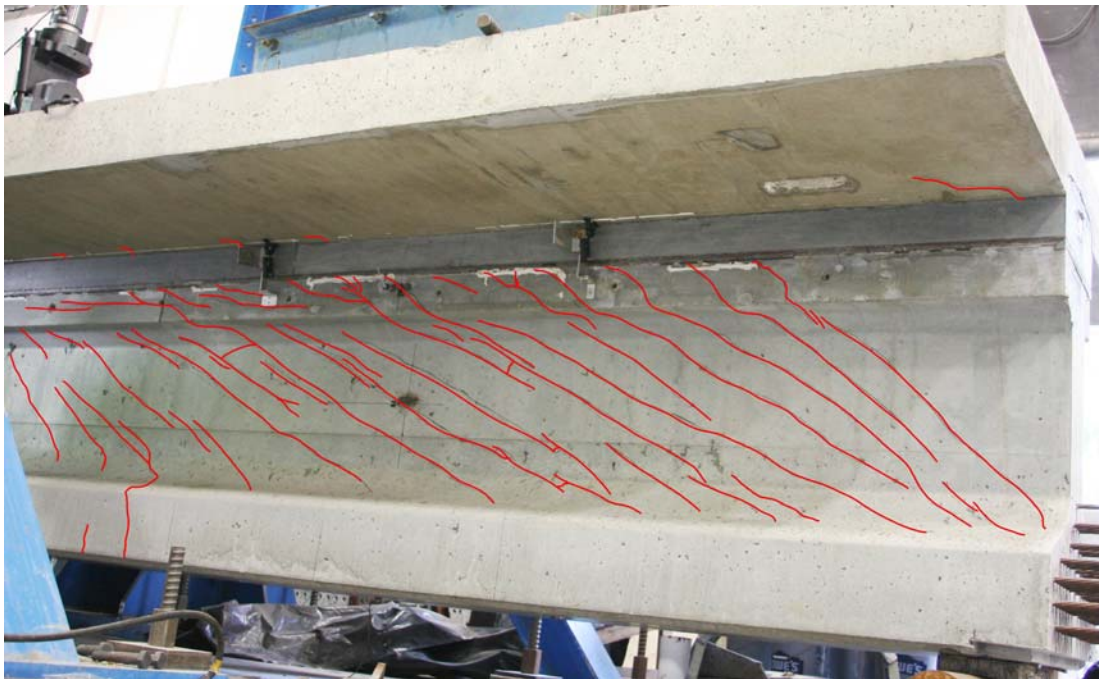
Figure 33. Illustration. Cracking apparent on south face of east end of test specimen after completion of static testing.

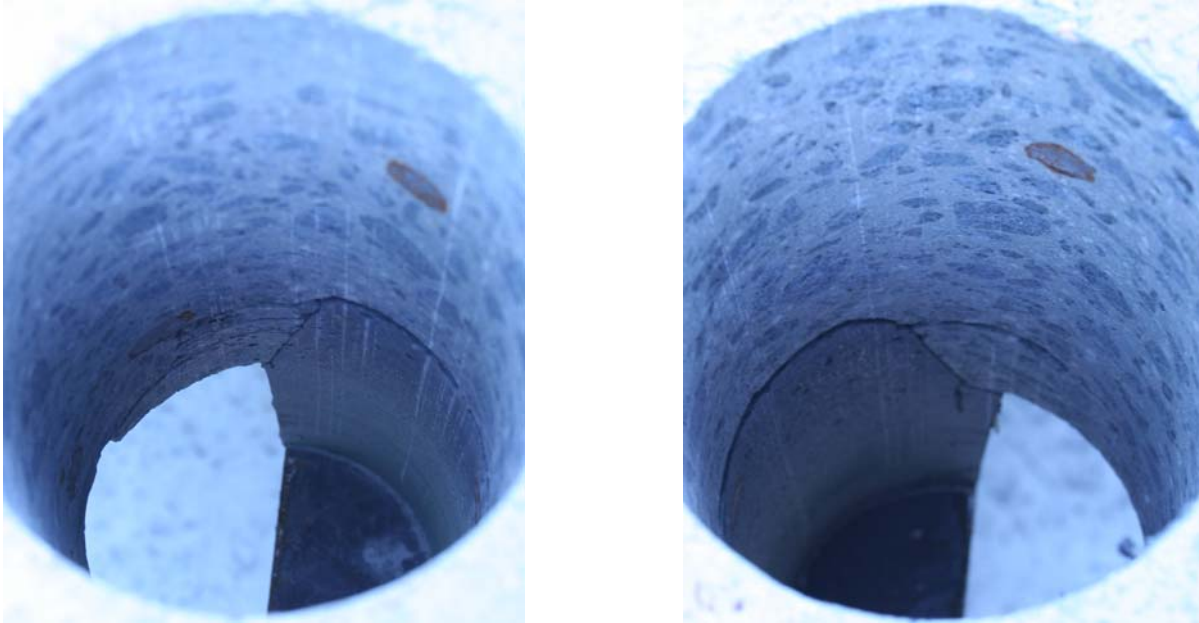
Figure 34. Photo. Distress in deck concrete at haunch connection near east end of test specimen which emulated the composite connection to a steel girder. Left photo pertains to south face. Right photo pertains to north face.

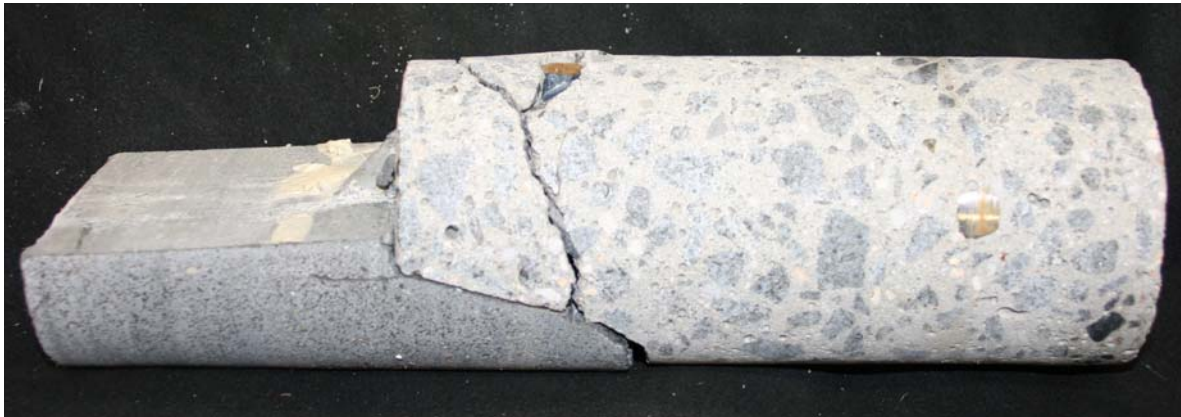
Figure 35. Photo. Distress in core extracted from haunch connection near east end of test specimen.

The distress apparent at the conclusion of the static test is also shown in Figure 34 and Figure 35. Two cores were extracted from the east end of the test specimen, each one drilled downward through the top of the deck to the top of the steel plate. The cores were aligned so that half of each hole would penetrate the haunch. One of the cores intersected the easternmost transverse bar in the bottom mat of reinforcement immediately above the south face of the girder. The other core intersected the second bottom mat transverse bar from the east end immediately above the north face of the girder. Views down into the core holes are provided in Figure 34. The distress in the conventional concrete in the vicinity of the UHPC haunch can be observed in each core hole. Figure 35 shows one of the cores after extraction. The transverse bar was firmly embedded in the UHPC with no indication of UHPC or rebar degradation. The conventional concrete which was immediately adjacent to this transverse bar has failed, allowing the bar and haunch to move relative to the concrete. Identical behaviors were observed in both cores.

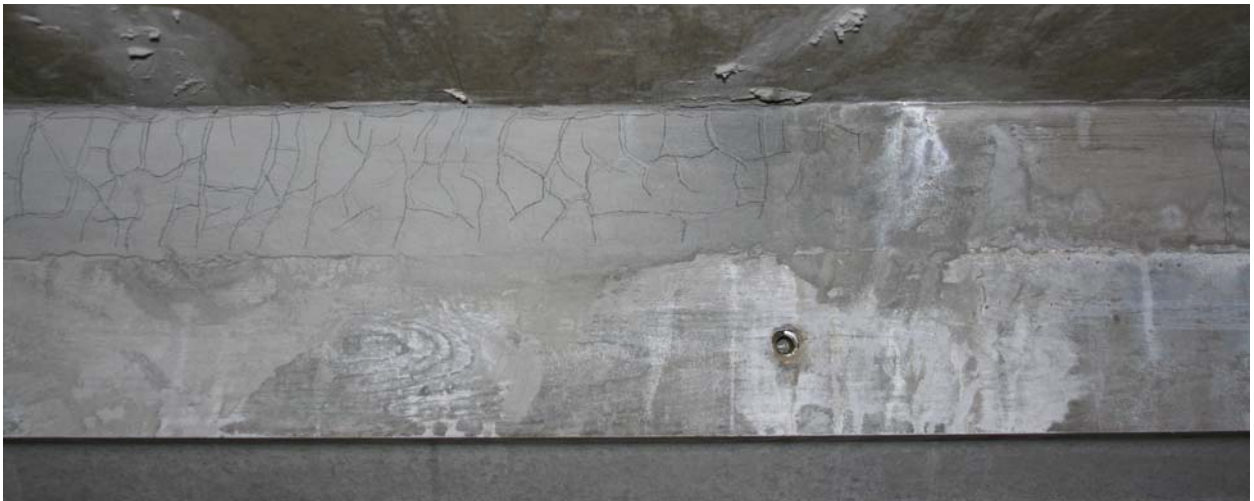
Figure 36. Photo. Cracking apparent on north face of haunch near east end of test specimen.

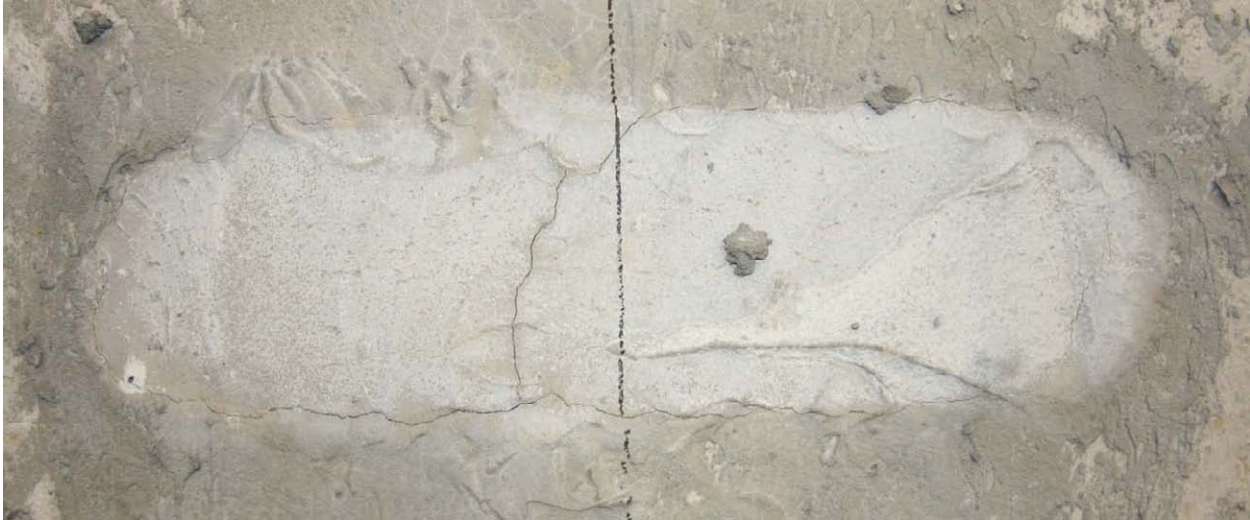
Figure 37. Photo. Cracking apparent on top of deck at grout pocket near east end of test specimen prior to start of structural loading.

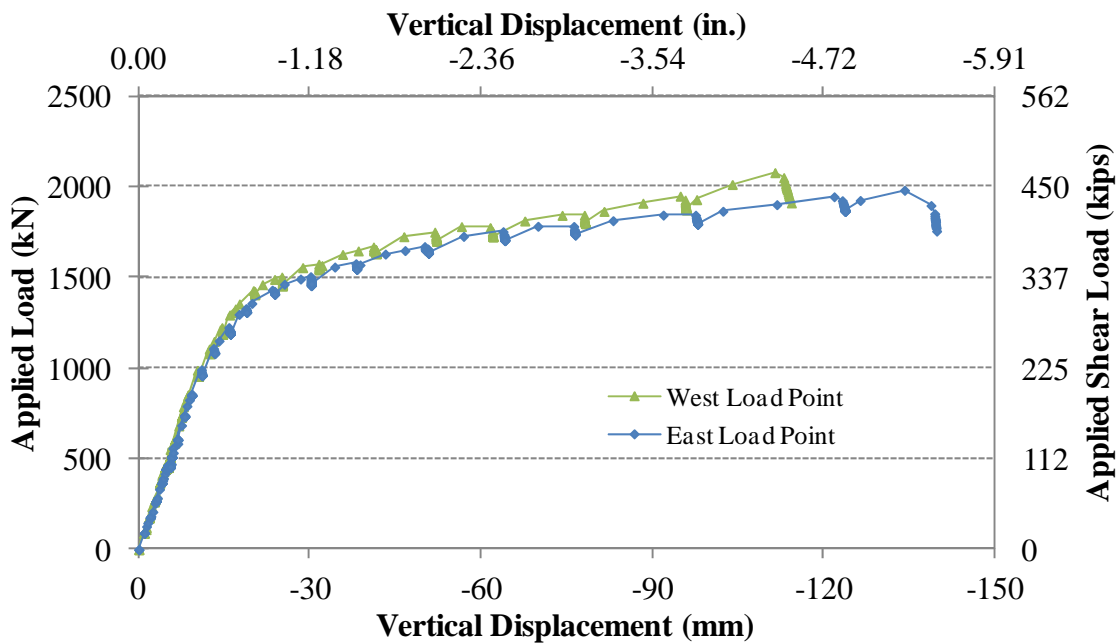
Figure 42. Graph. Load-deflection response of conventional connection specimen under static load to failure.

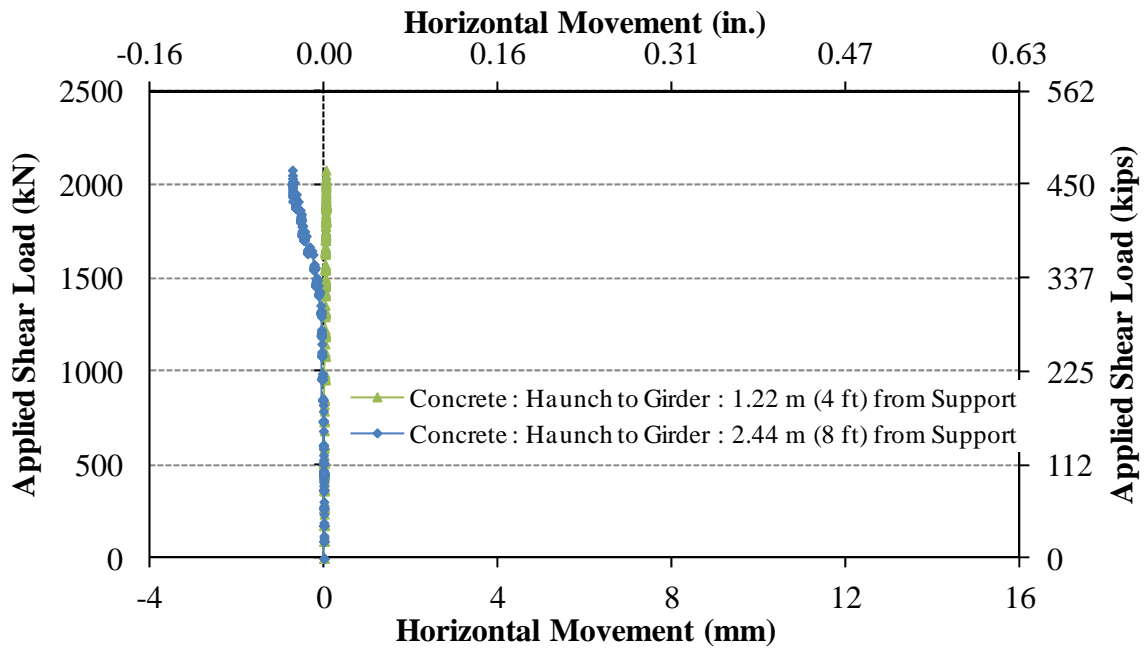
Figure 44. Graph. Horizontal movement between haunch and girder in portion of conventional connection specimen which emulated the composite connection to a concrete girder when under static load to failure.

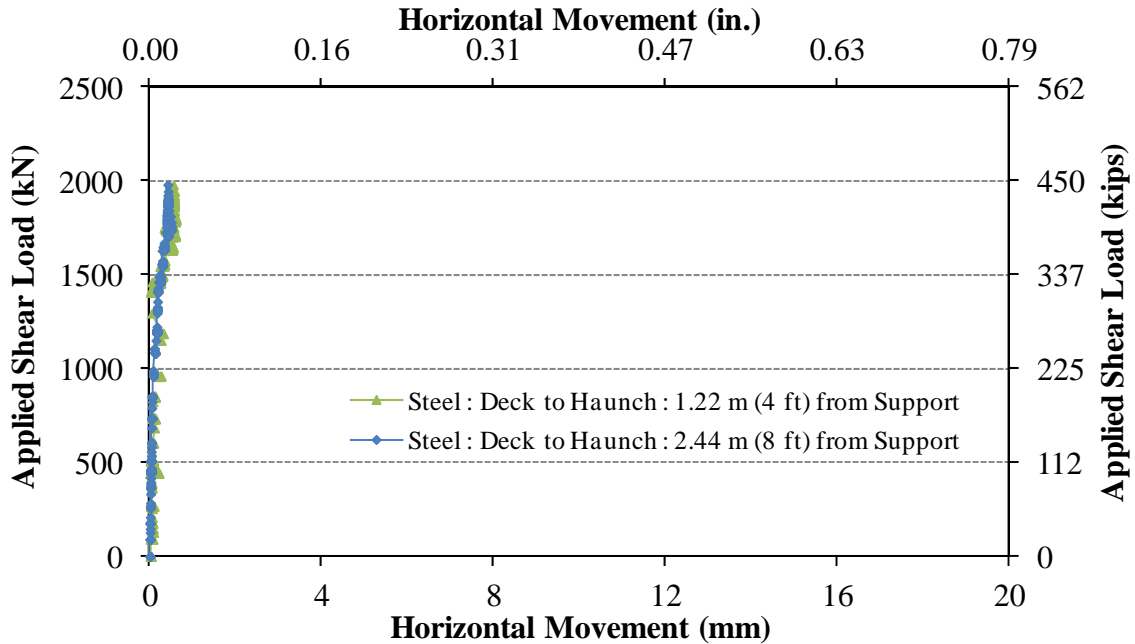
Figure 45. Graph. Horizontal movement between deck and haunch in portion of conventional connection specimen which emulated the composite connection to a steel girder when under static load to failure.

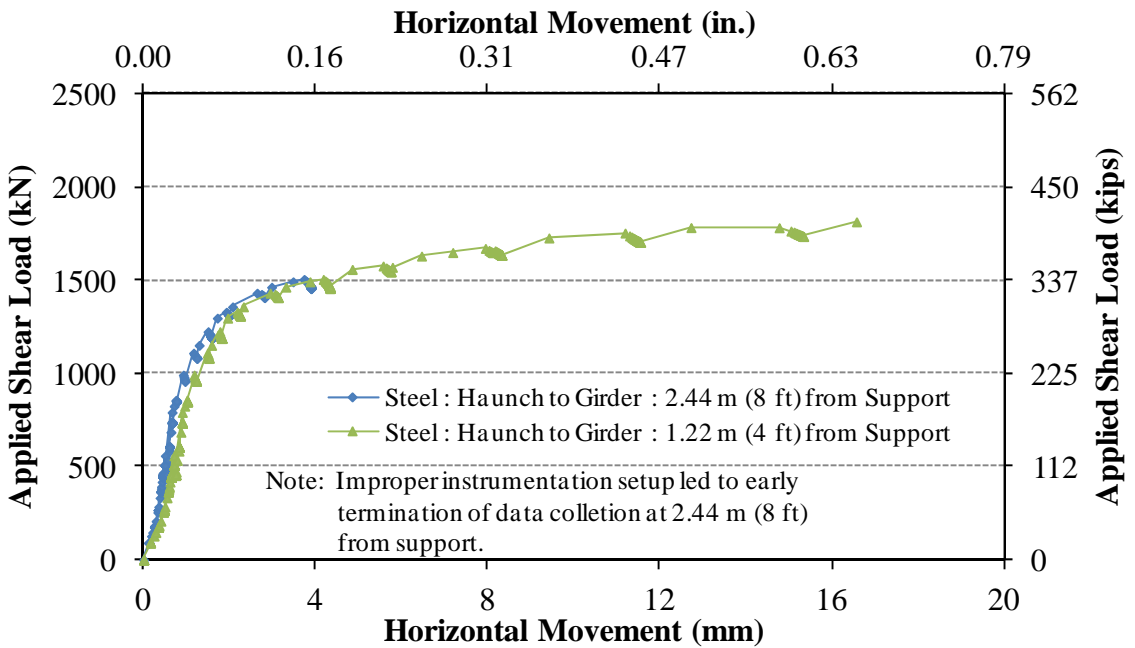
Figure 46. Graph. Horizontal movement between haunch and girder in portion of conventional connection specimen which emulated the composite connection to a steel girder when under static load to failure.

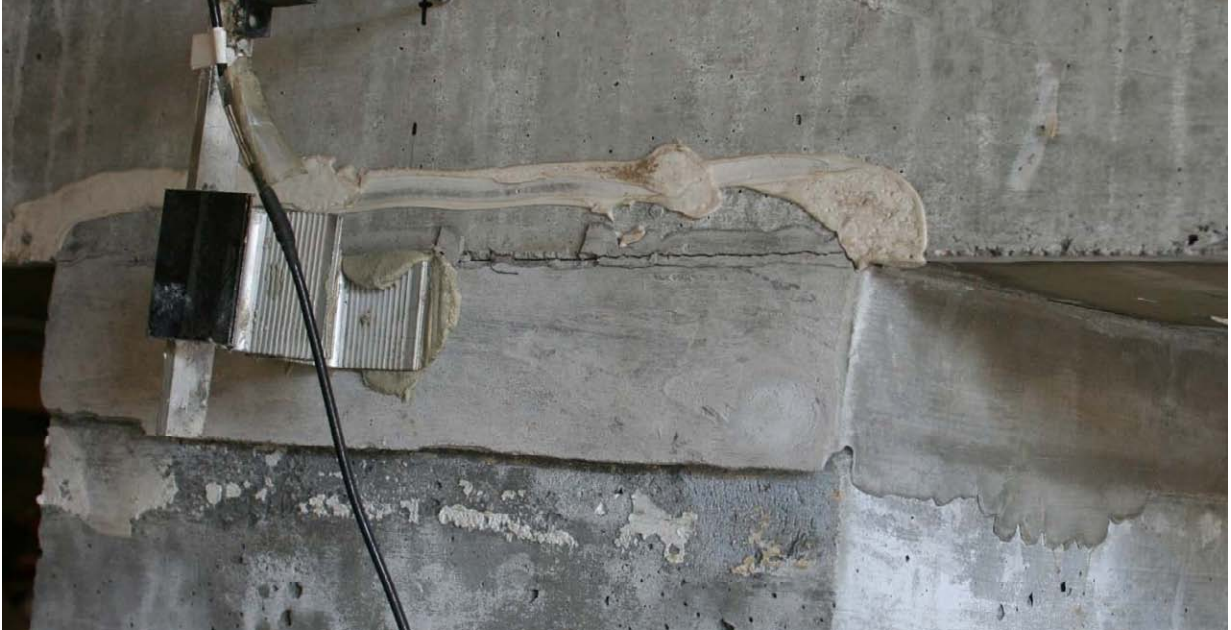
Figure 47. Photo. West end and south face of test specimen immediately after completion of test.

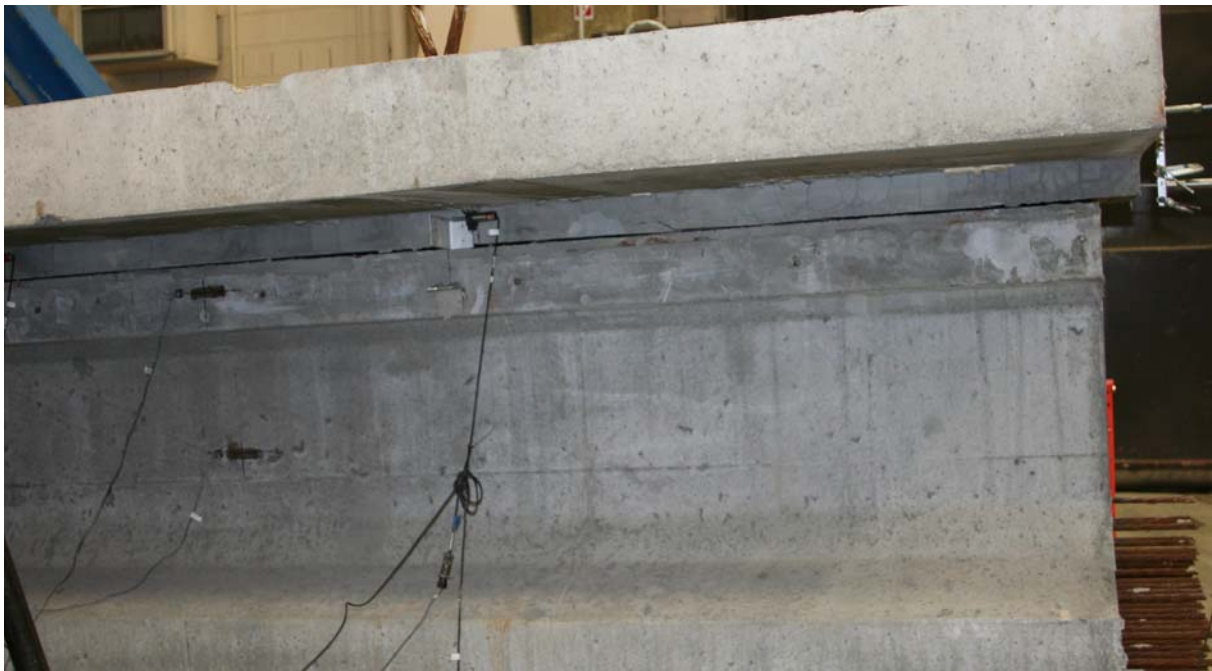
Figure 50. Photo. Haunch connection on south face at east end of test specimen immediately after completion of test.
