Ultra-High Performance Concrete Composite Connections for Precast Concrete Bridge Decks

FHWA Publication No. FHWA-HRT-12-041

U.S. Department of Transportation
Federal Highway Administration

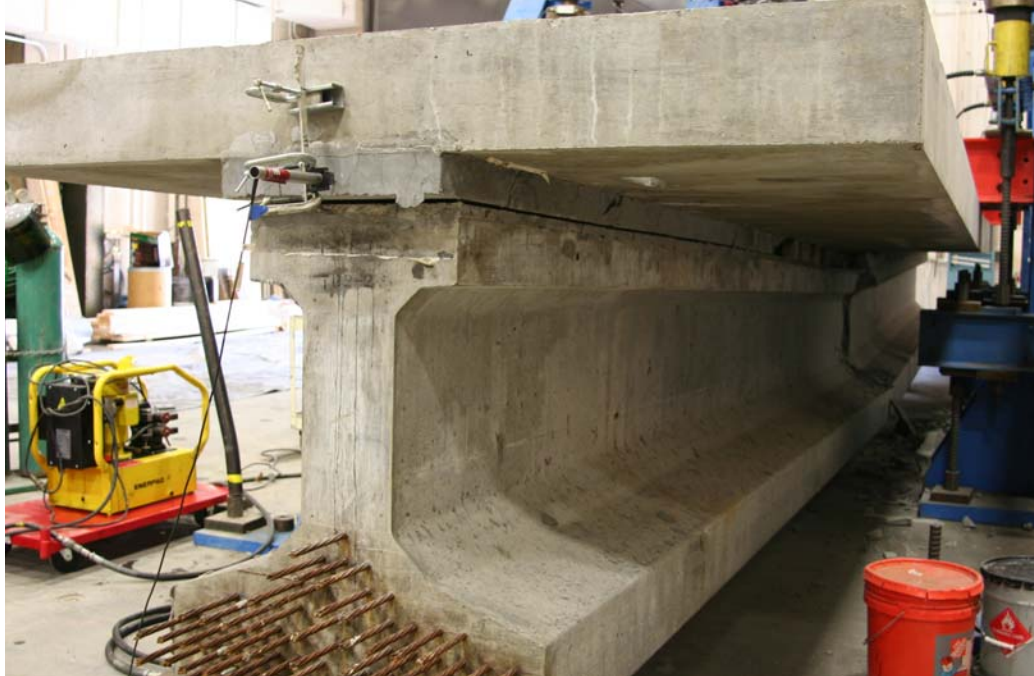
Figure 51. Photo. East end and north face of test specimen immediately after completion of test.

The failure of the test specimen occurred when the composite connection between the steel plate on the top of the precast girder and the haunch connected thereto became completely disconnected from midspan to the east end of the test specimen. As this connection disconnected, the eastern half of the specimen ceased to be a composite beam and began functioning as a significantly shallower member. The compressive flexural capacity of this remaining cross-section was superseded by the applied load, resulting in compressive failure of the top flange of the prestressed girder at midspan. Figure 51 shows the east end and part of the north face of the girder immediately after failure. Figure 52 shows the failure location as viewed from the north side. The termination point of the steel plate just under the haunch area coincides with midspan of the test specimen.

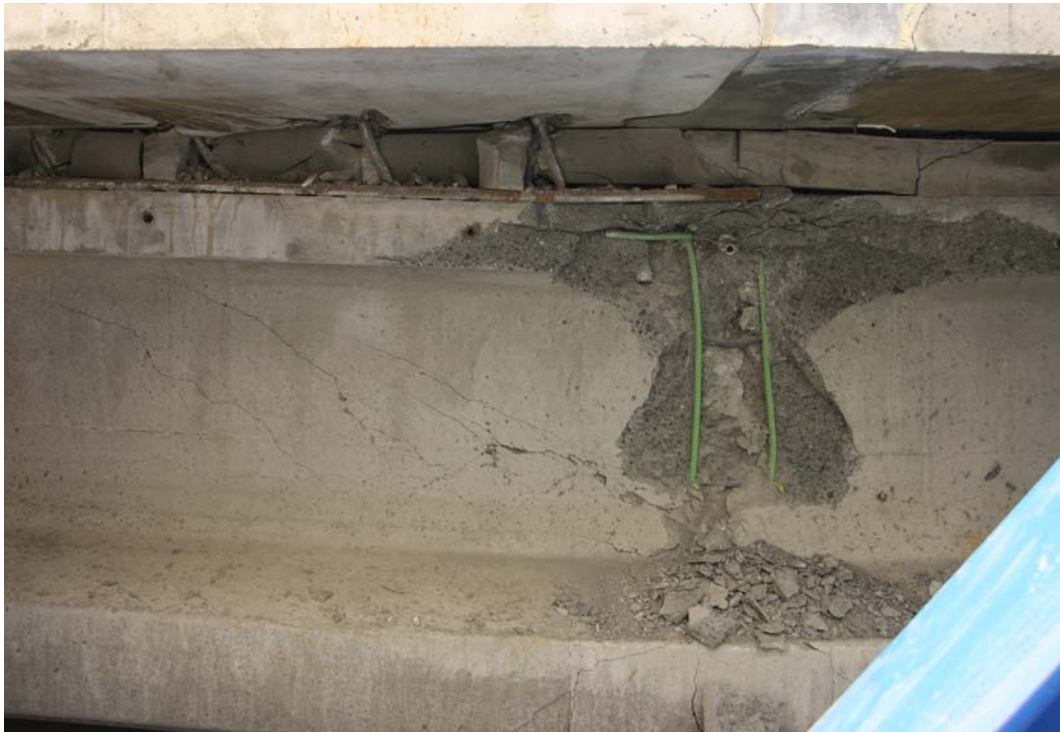
Figure 52. Photo. Midspan north face of test specimen immediately after completion of test.

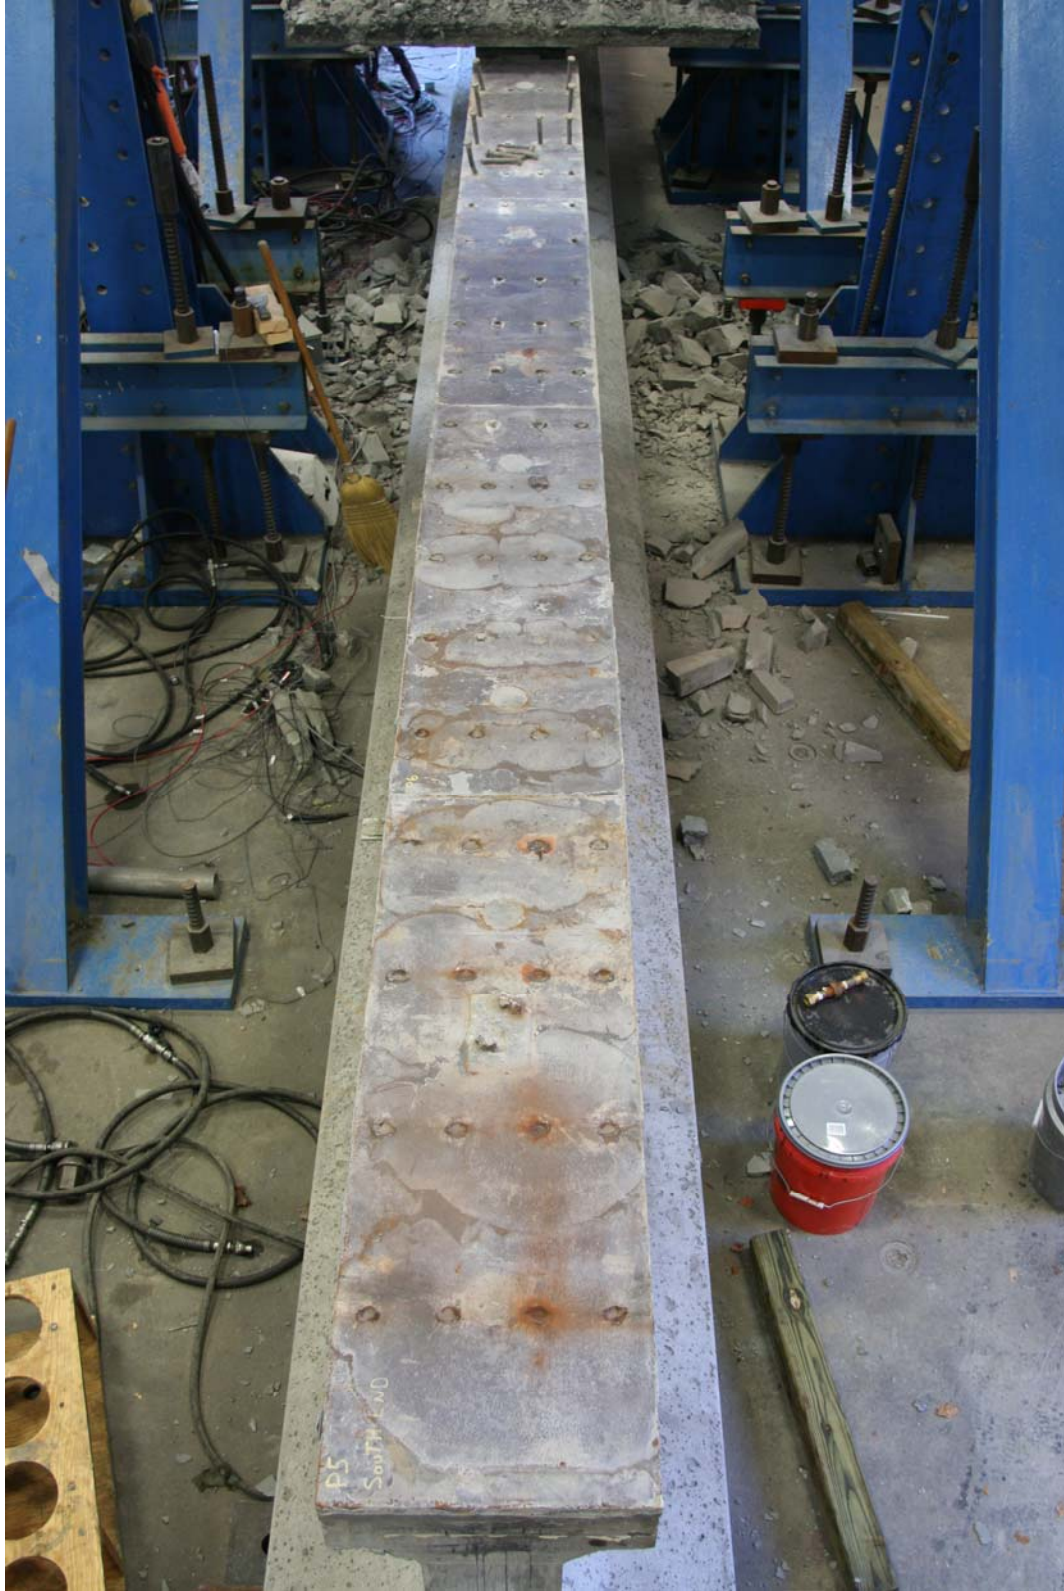
Figure 53. Photo. Emulated steel girder composite connection after completion of test and removal of haunch/deck.

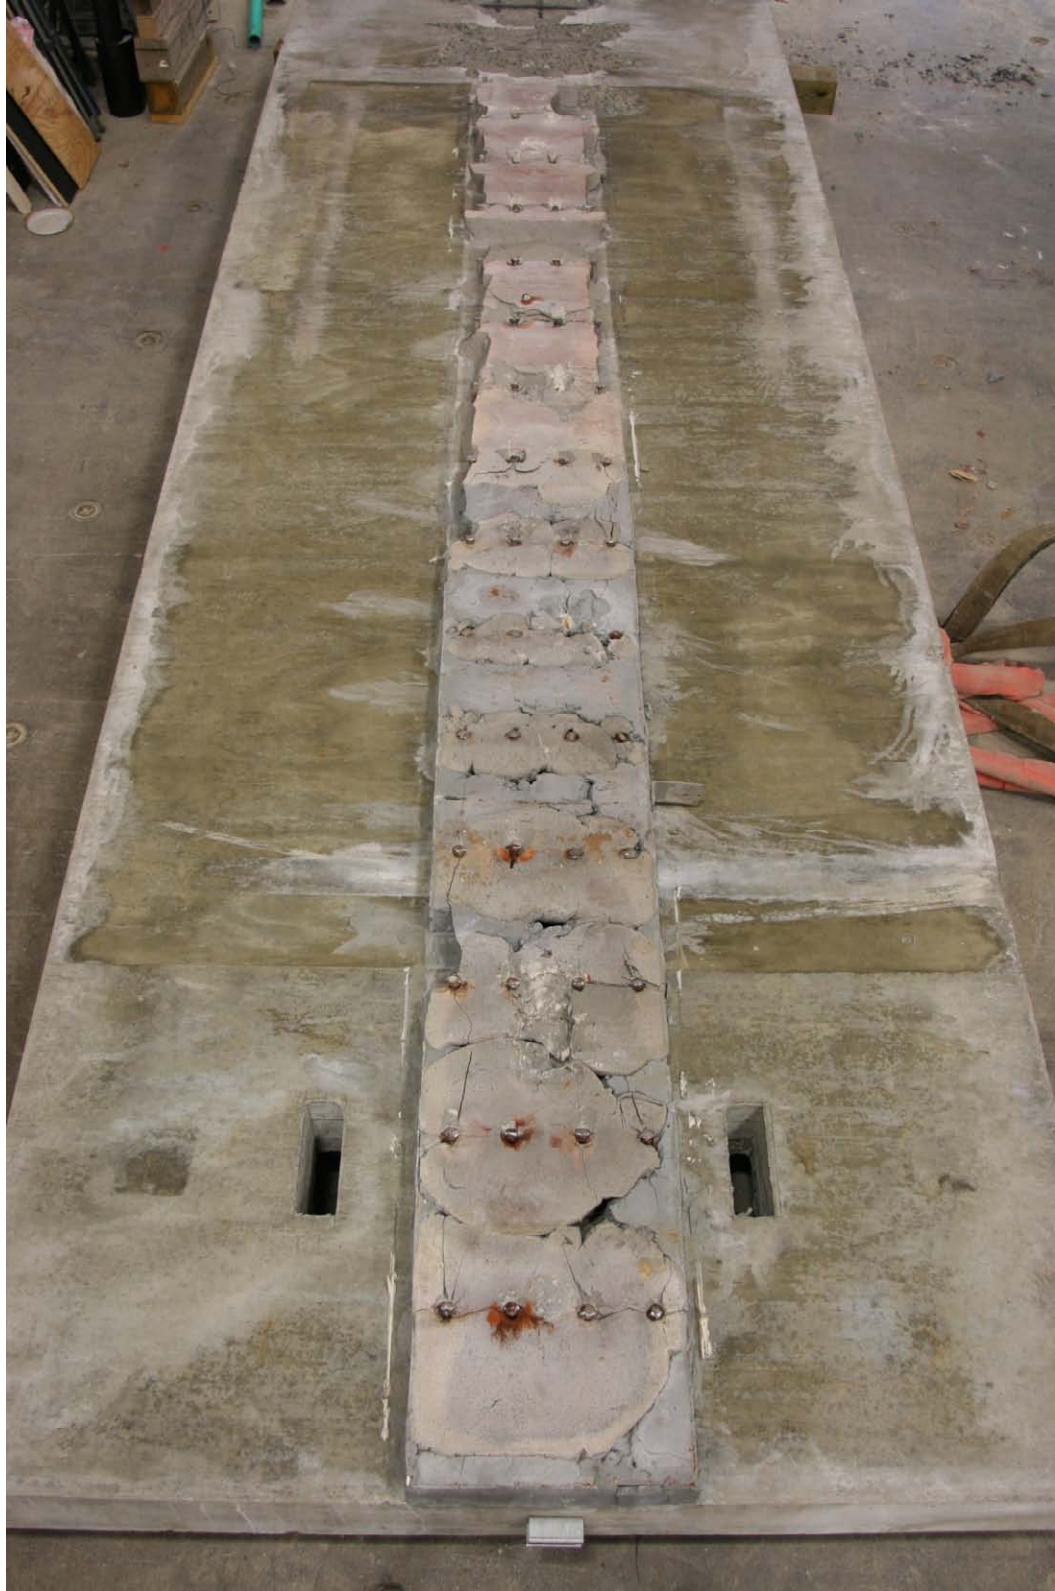
Figure 54. Photo. Emulated steel girder composite connection after completion of test and removal of haunch/deck.

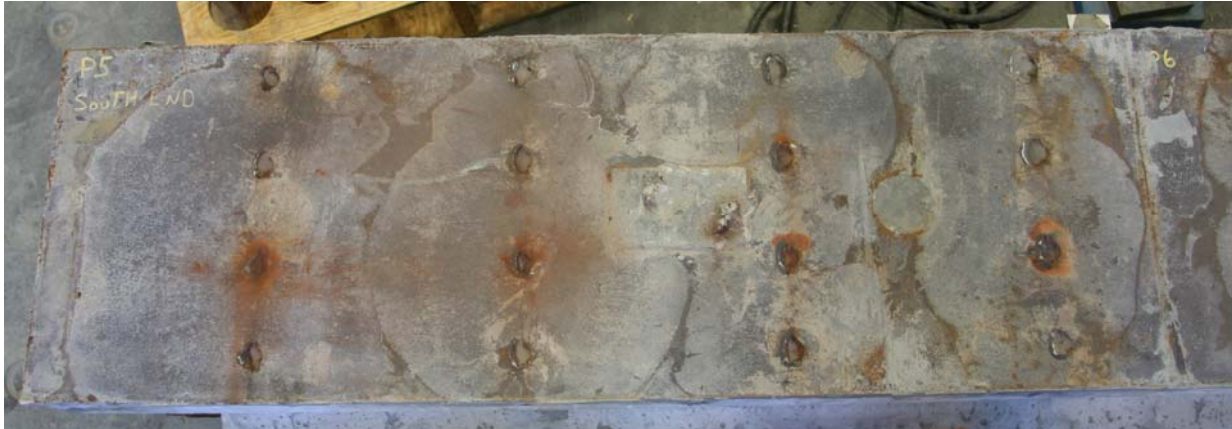
Figure 55. Photo. Easternmost steel plate on top of girder within emulated steel girder composite connection.

The precast deck element and the still connected haunch details on the eastern end of the test specimen were removed in order to inspect the failure plane. Since all 72 shear stud connectors on the top of the steel plate had either failed by pullout or failed at their bases, the removal of the deck element only required cutting the deck-to-deck connection at midspan. Figure 53 provides a view of the steel plate side of the composite connection on the eastern half of the test specimen. A corresponding view of the haunch/deck side of the connection is provided in Figure 54. Close-up photographs of the easternmost four stud row locations on the steel plate and the easternmost two stud row locations on the haunch are provided in Figure 55 and Figure 56, respectively.

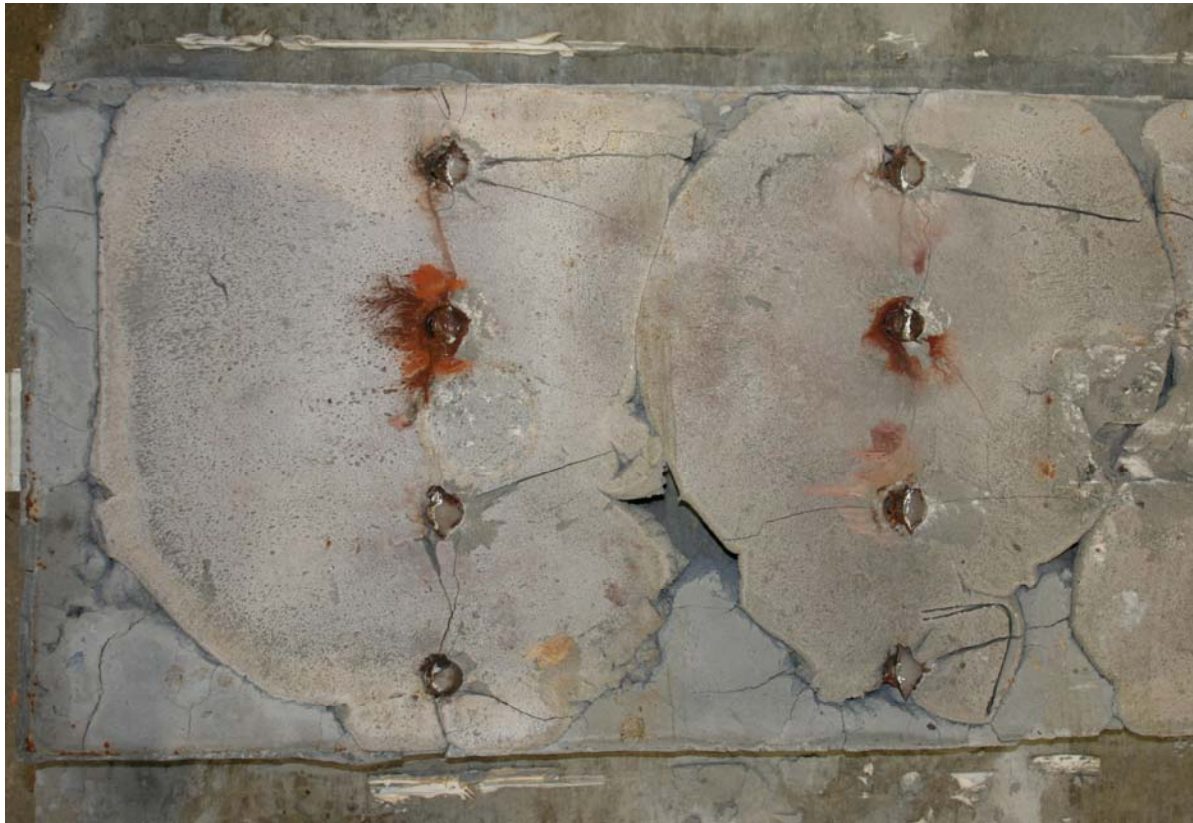
Figure 56. Photo. Easternmost two rows of shear studs emanating from conventional grout and precast deck.

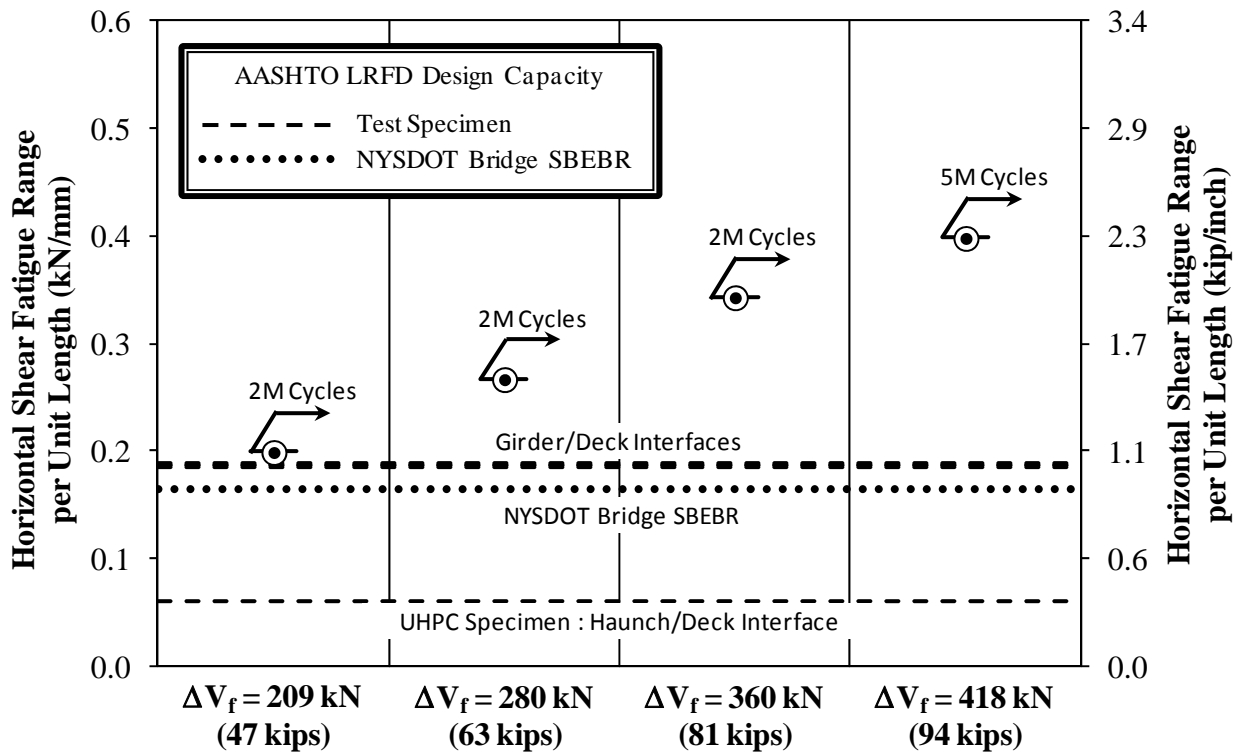
Figure 58. Graph. Design values of horizontal shear fatigue range in relation to applied shear ranges.

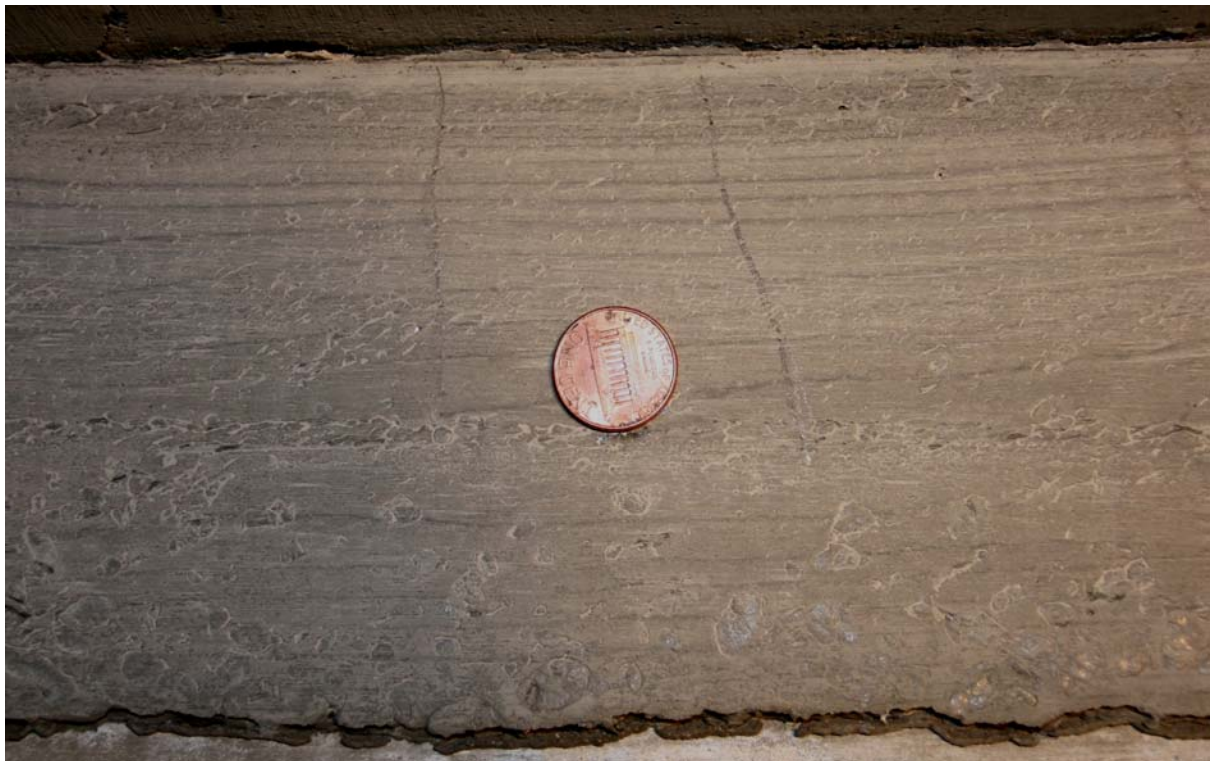
Figure 70. Photo. Shrinkage cracks in haunch on north face near west end of UHPC test specimen.

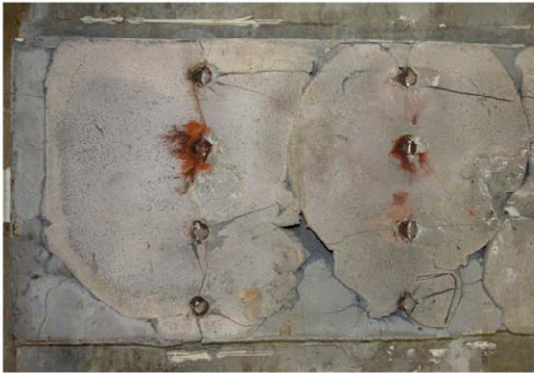
Fig A3. Close-up of the detached stud welds, so called ‘divots’.
[Reproduced from Figure 56 of main body of report.]

Note the extensive amount of oxidation shown in Fig. A3. This figure shows Rows 1 and 2 from Fig. A2.

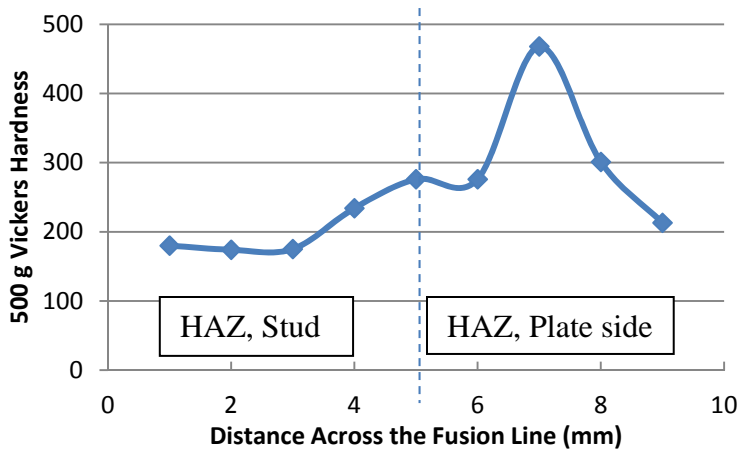
Fig A5. Hardness profile, LETU Sample # 3

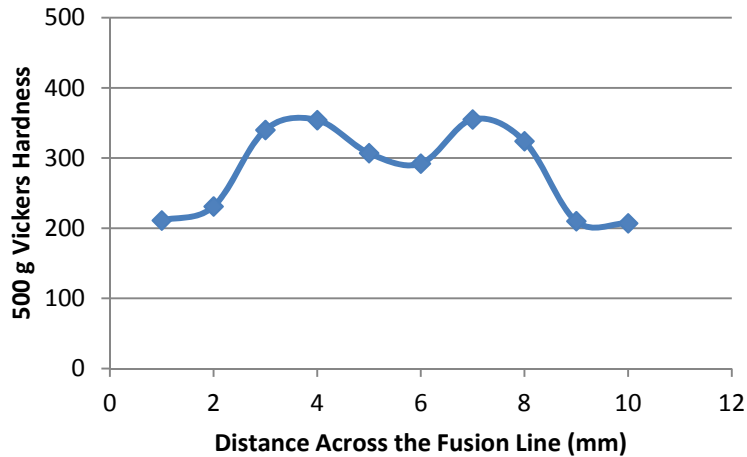
Fig. A6. Hardness profile across weld #4. Notice similar HAZ hardnesses on both the stud- and plates side of the stud weld.

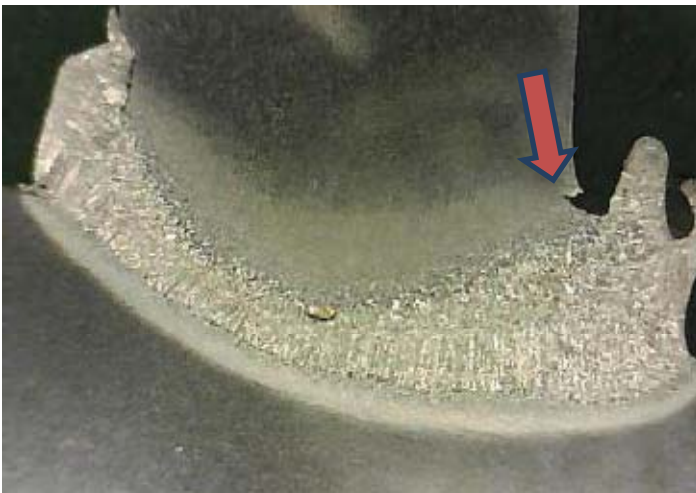
Fig. A11. Sample S-1. Asymmetrical, but adequate weld. Note ductile failure initiation near the stud HAZ, arrow, representing the preferred mode of failure for cases wherein the stud welds has good quality.
