# Strength and Serviceability of Damaged Prestressed Girders

WisDOT ID no. 0092-17-02  
May 2019

WISCONSIN HIGHWAY RESEARCH PROGRAM

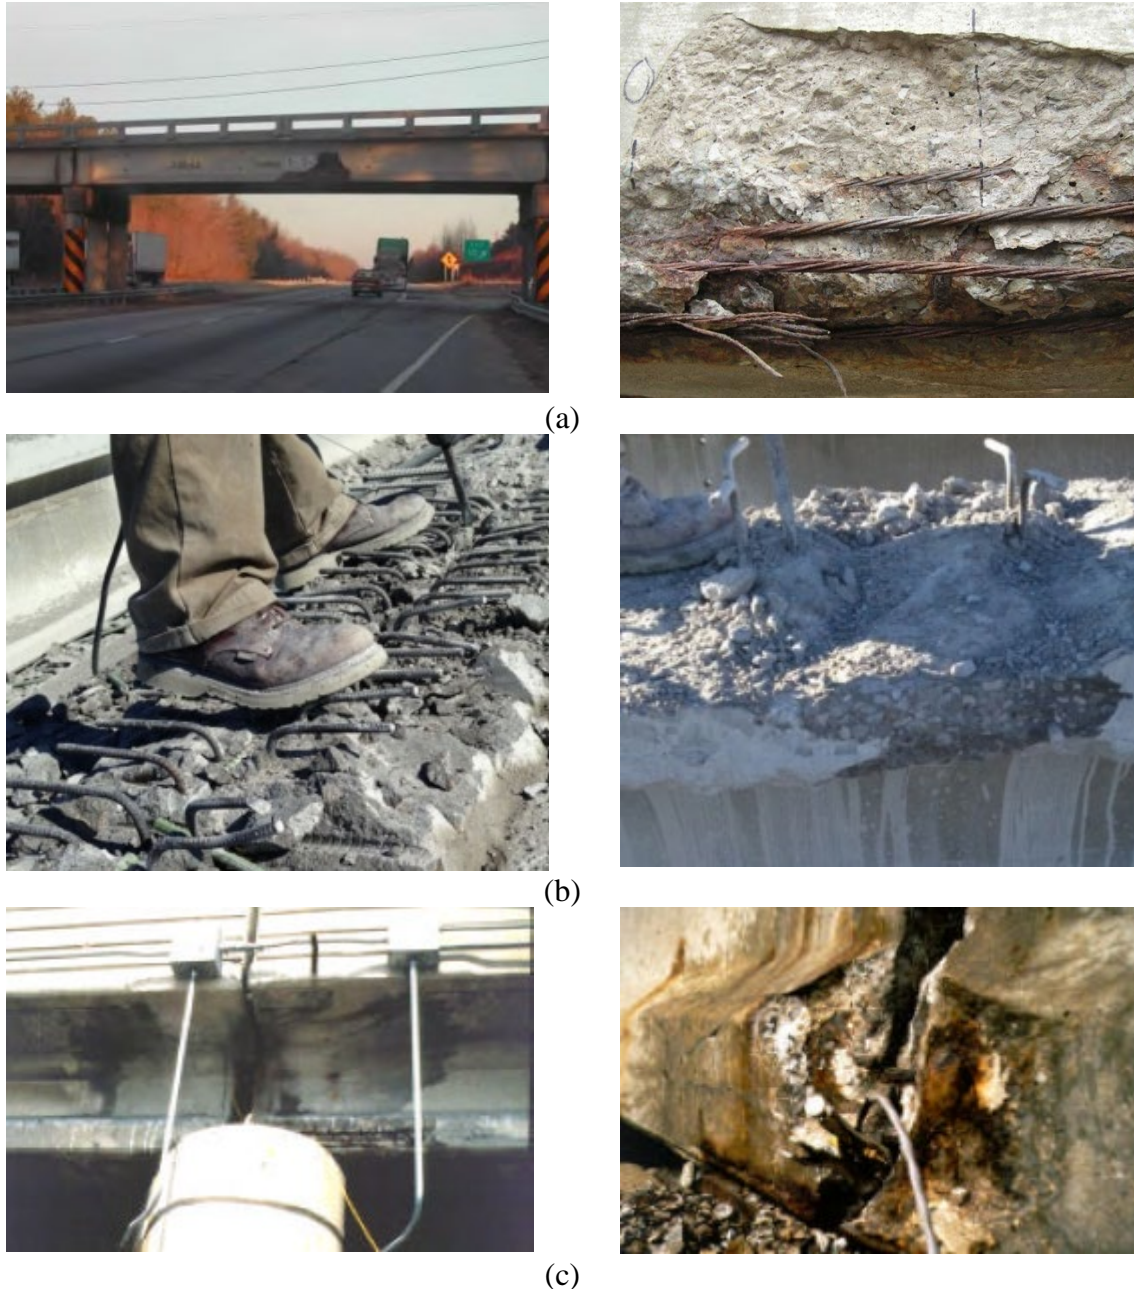
Figure 1.1. Modes of damage to prestressed girders: a) Accidental over-height vehicle impact (Harries 2006); b) Unintended damage during deck slab removal (Assad, 2014); and c) Corrosion damage to prestressed beam ends (Tabatabai et al., 2005)

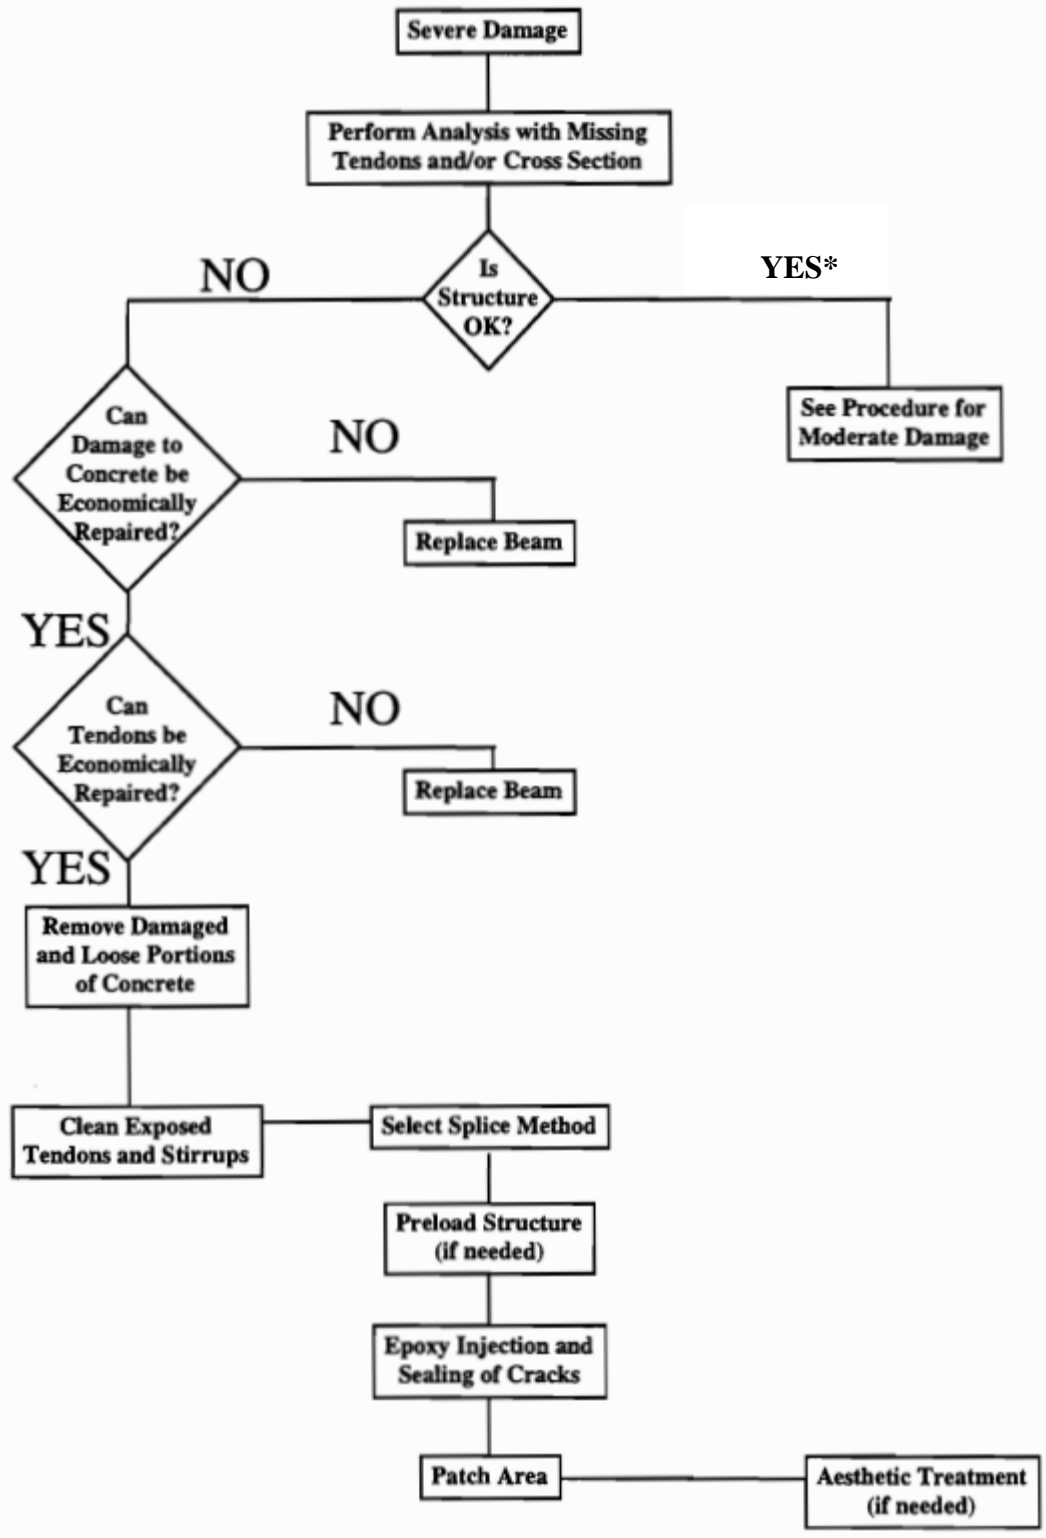
Figure 2.3. Flowchart for repair of severely damaged girders (from Feldman et al., 1996) (\*apparent typographical error has been corrected).

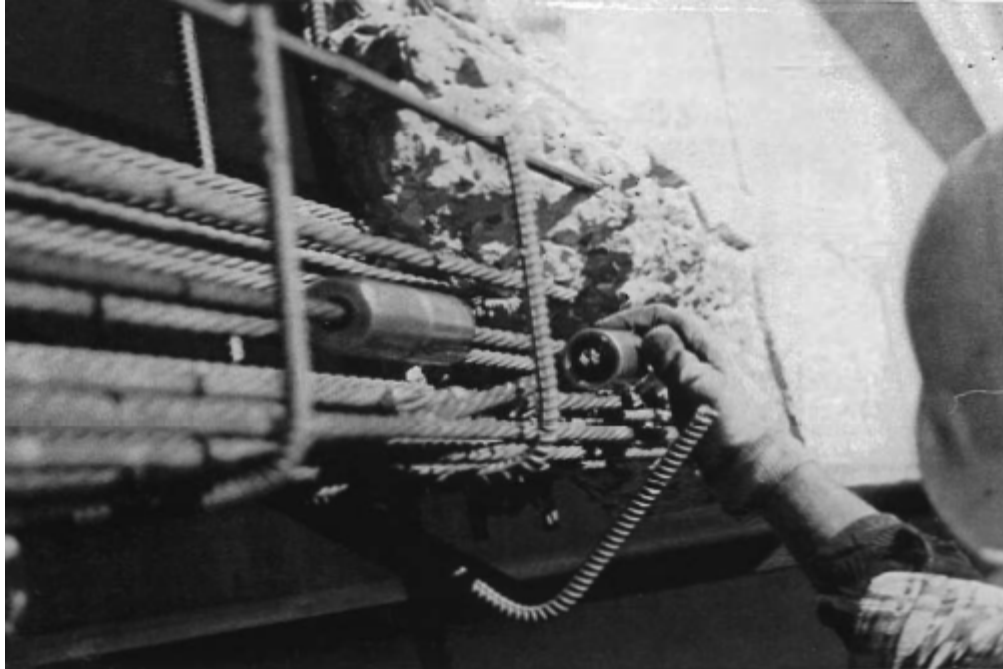
Figure 2.4. Installation of internal splice device (from Feldman et al., 1996)

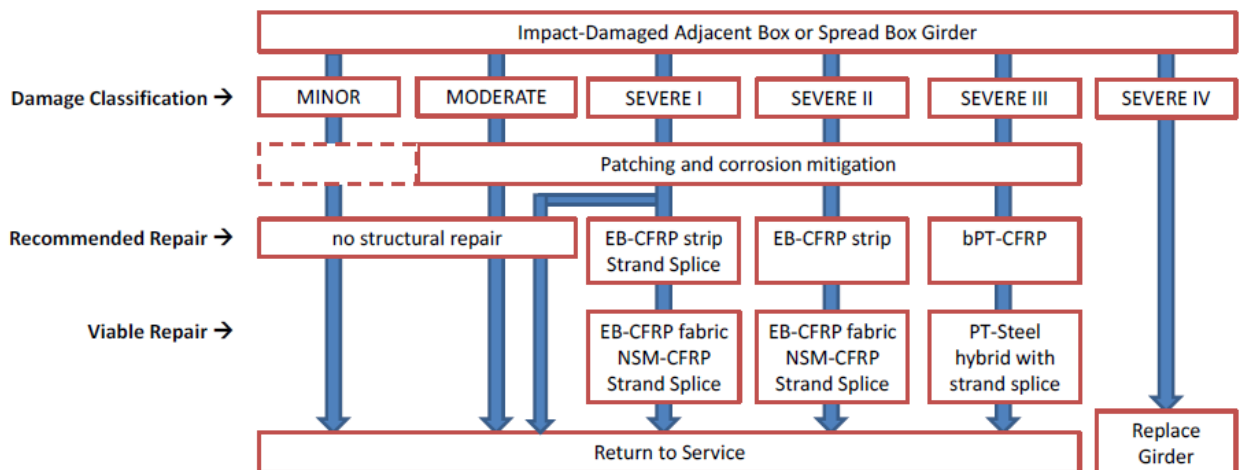
Figure 2.9. Selection of repairs for damaged prestressed box girders (Harries et al. 2012)

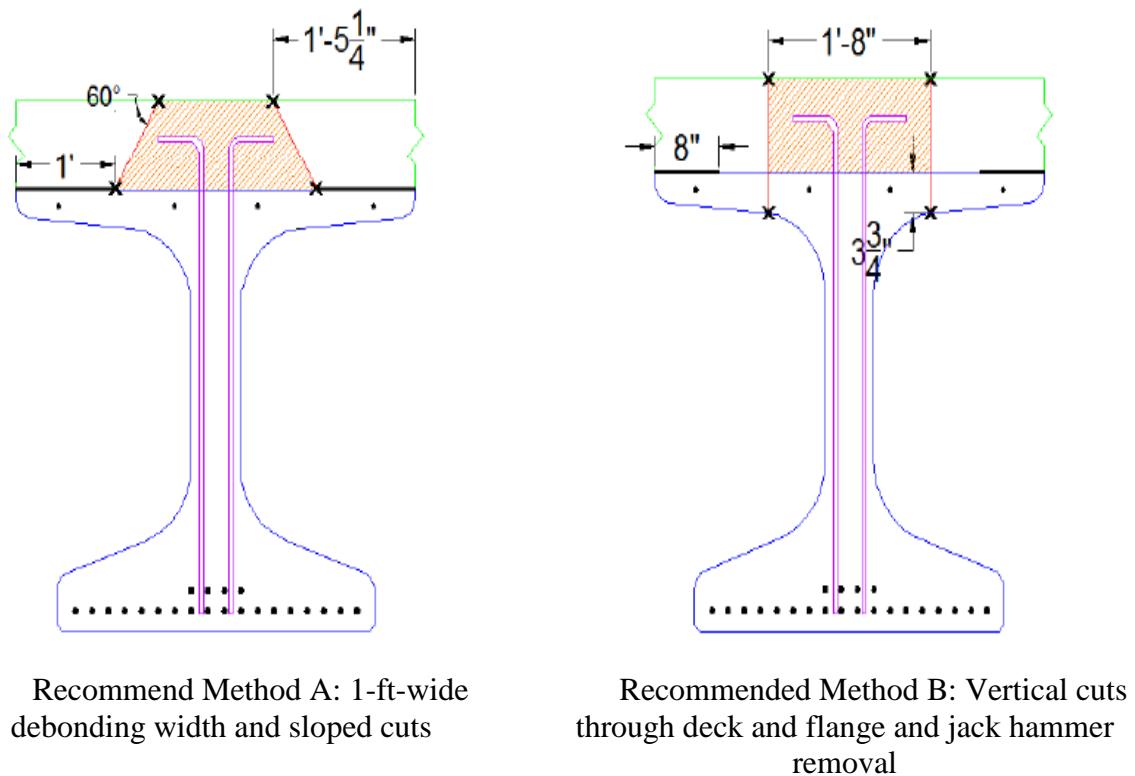
Figure 2.12. Recommended deck removal methods (Assad 2016)

Finally, the author recommended a method for new construction involving increased debonding length and 60-degree sloped cuts (Method A in Figure 2.12), and a method for existing bridges with low span-to-depth ratios involving vertical cuts through the deck and flange, and removal of the remaining concrete using 60-lb jack hammers above the shear connectors, and 30-lb hammers below the shear connectors (Method B in Figure 2.12).

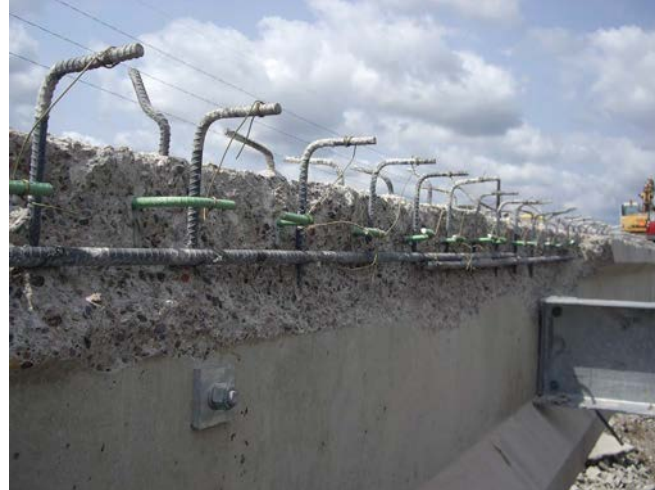
Figure 3.1. Damage to the top flange of prestressed concrete girder on B-64-122 resulting from deck removal.

Structures B-64-122 and B-64-123 are a pair of parallel bridges in Walworth County that sustained a significant amount of damage to the top flanges of several girders during a bridge deck replacement project. Figure 3.1 shows the damage incurred during deck removal to a section of the top flange of a girder on structure B-64-122 that was repaired using patching material. There are two girders that have approximately 15-20-foot-long repair patches to the top flange (Figure 3.1) and another girder that incurred damage to the top flange on both faces of the flange. Figures 3.2 and 3.3 show the repair done to the damaged girders of bridge B-64-122 and B-64-123, respectively. The available repair information for bridge B-64-123 is shown in Figure 3.4.

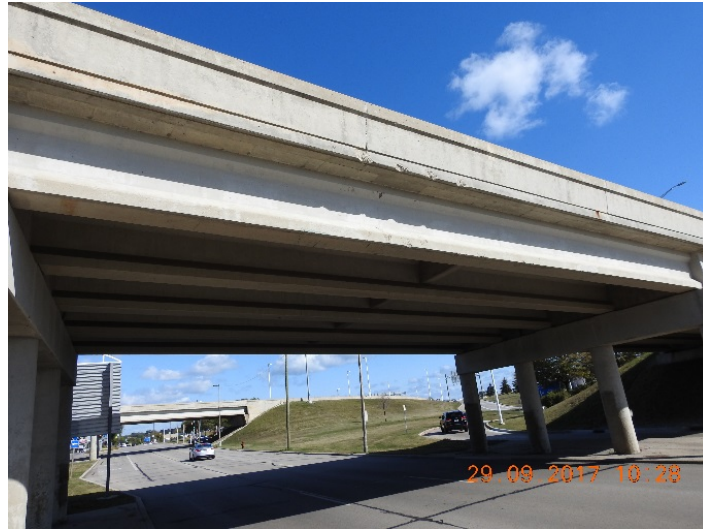
Figure 3.5. Bridge B-40-485 with minor damage on the prestressed girder

This structure had numerous instances of minor damage to the bottom flanges of girders (Figure 3.5) as well as spalling on the bridge deck soffit. Deck spalling appears to be unrelated to the accidental flange damage. While the girders on this bridge do not appear to have any major damage, there are numerous nicks and gouges to the exterior girders. Figure 3.6(a) shows small nicks and gouges to an exterior girder and bottom of the barrier facing oncoming traffic. These are considered minor as they are small and do not expose any steel. Figure 3.6(b) shows a repair patch approximately 18-24 inches long that has subsequently experienced more minor damage.

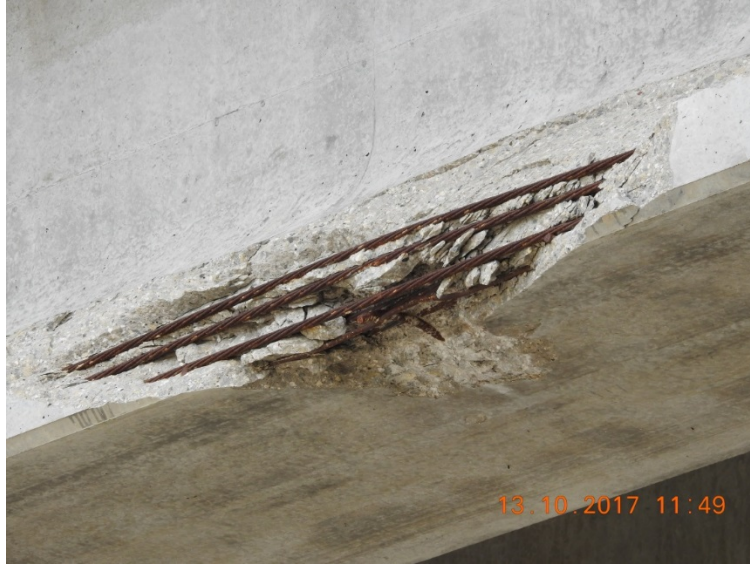
Figure 3.7. Impact damage to bottom flange of Girder 4 in B-20-157 (initial strike)

The damage shown in Figure 3.7 and Figure 3.8 show the impact damage. Concrete damage was relatively narrow (approximately 1 to 1.5ft) at the bottom of the flange where impact occurred. The damage and spalling were wider (a length of 3-4 feet) at the top of the bottom flange. Both instances of damage exhibit a similar pattern.

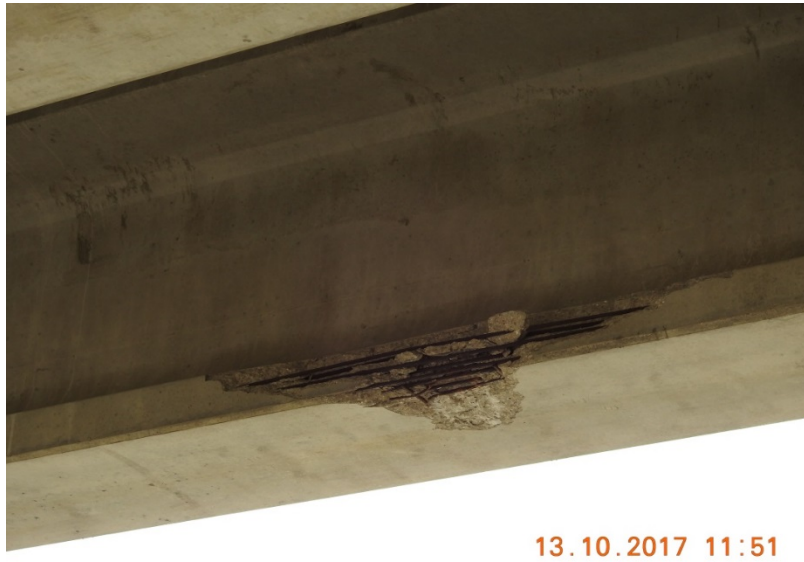
Figure 3.8. Damage to the bottom flange of Girder 1 in B-20-157 (rebound impact)

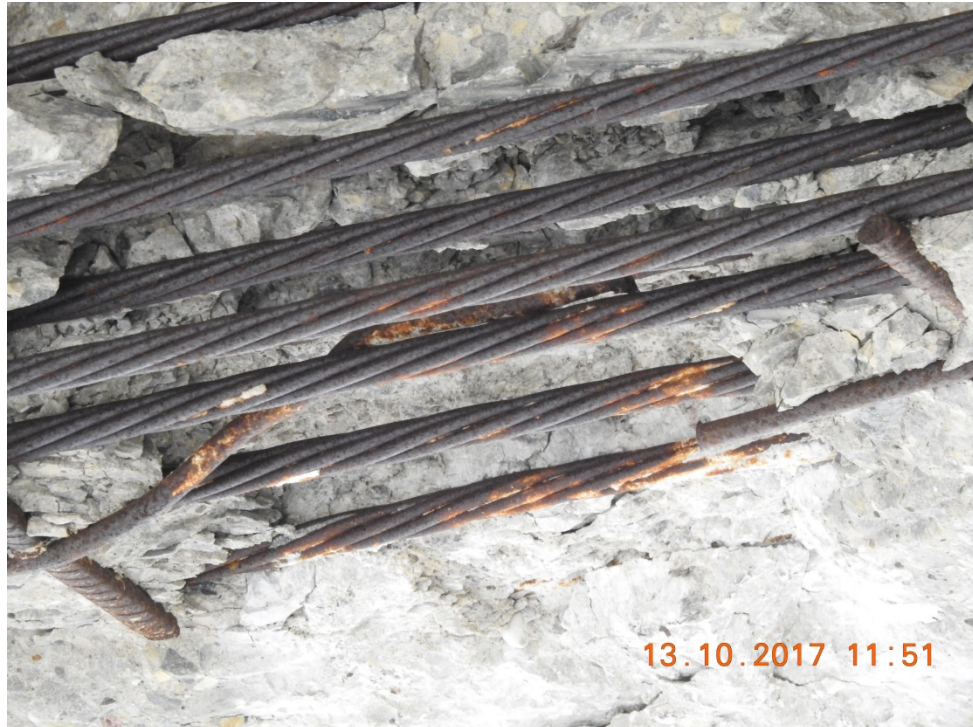
Figure 3.9. Corrosion of prestressing strands and reinforcing steel in Girder 4 on B-20-147

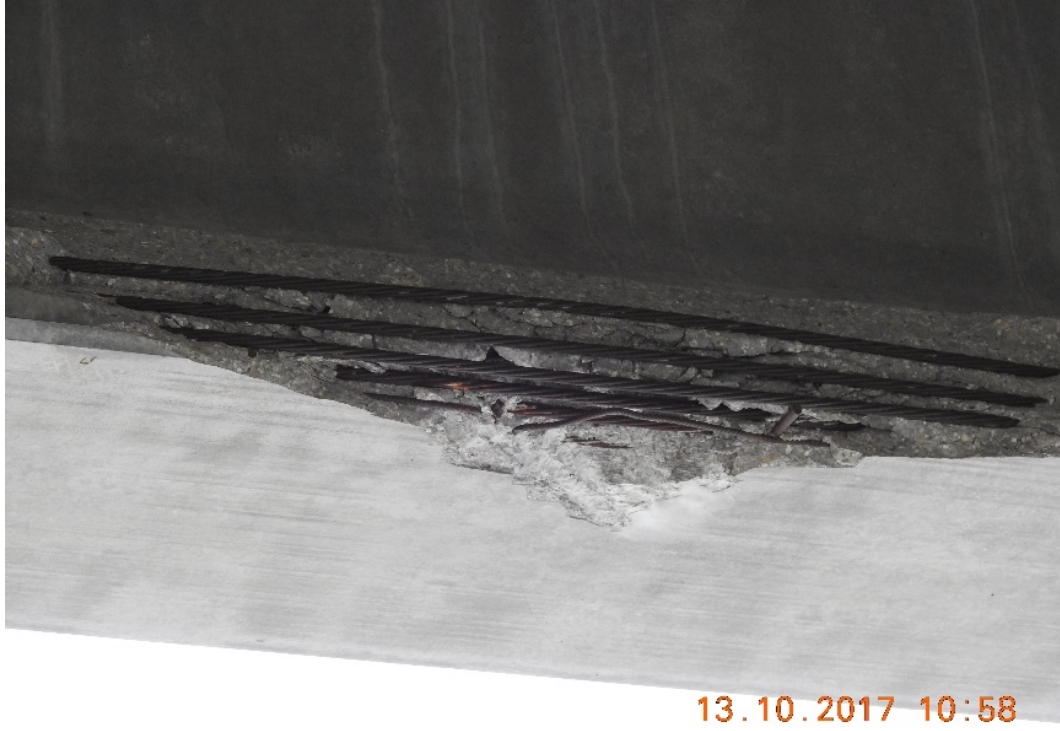
Figure 3.10. Damage with exposed strands to Girder 1 in B-20-147

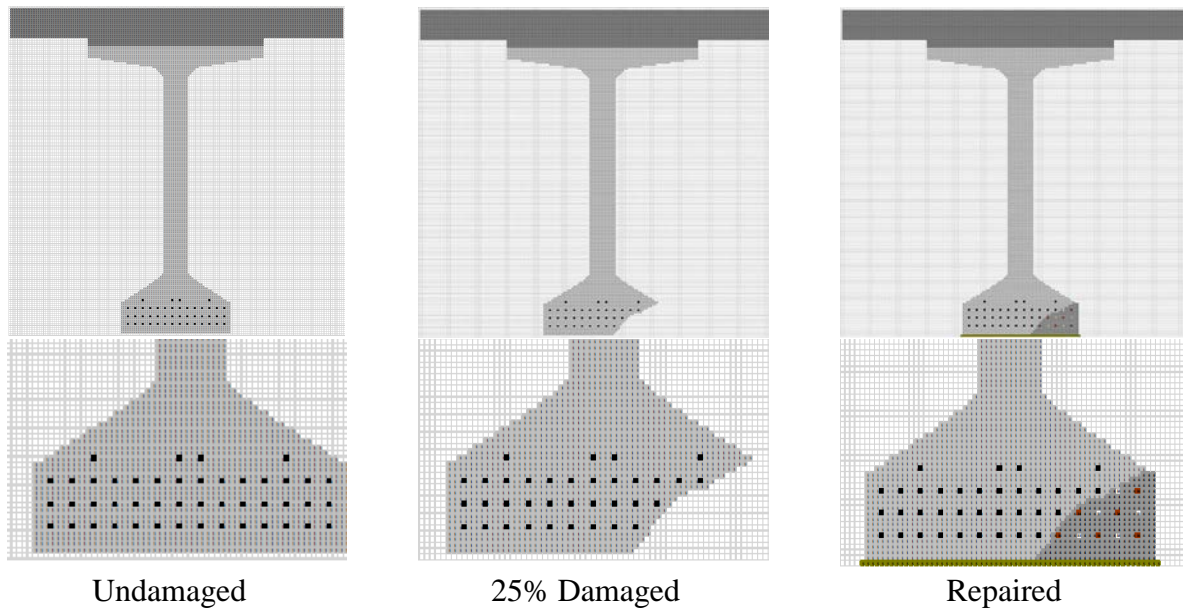
Figure 7.3. Structure 1 under the 25% bottom damage case

Figures 7.1 through 7.6 shows examples of damage and repair conditions in various damage cases for both structures.

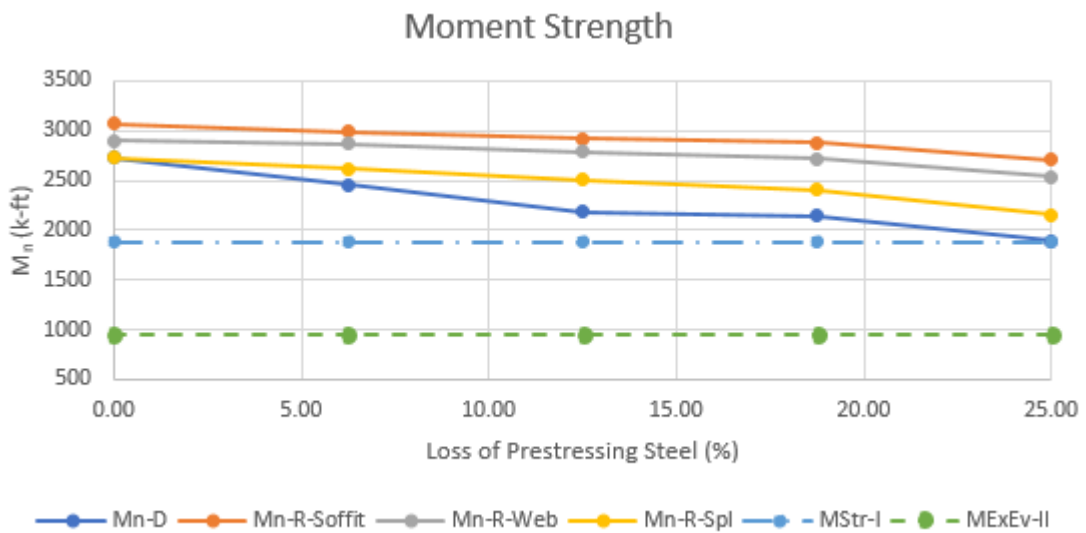
Figure 7.10. Structure 2 – variation of moment strength with loss in prestressing steel

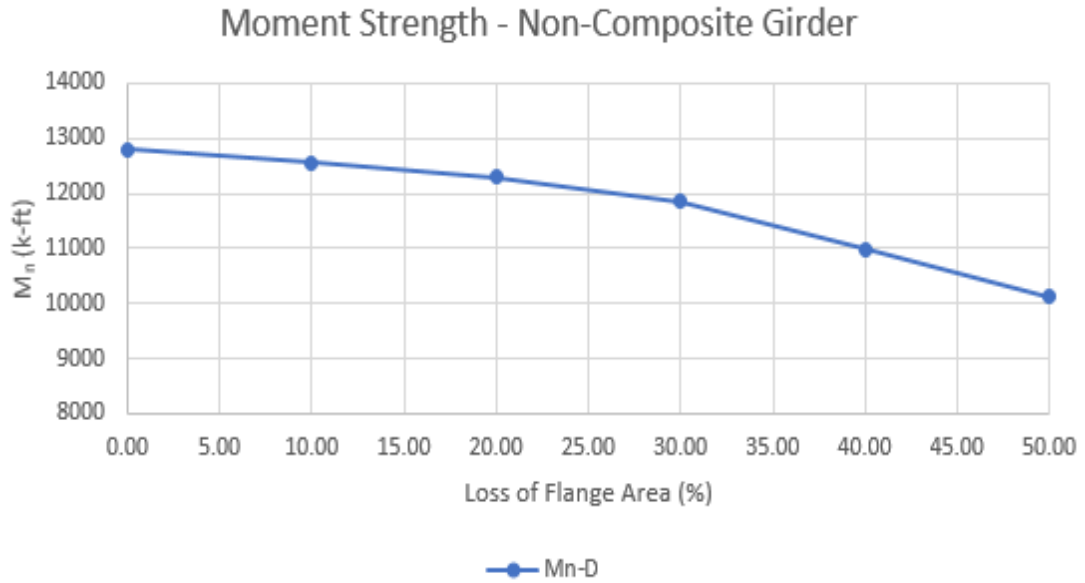
Figure 7.13. Structure 1 – variation of moment strength of non-composite girder as a function of extent of damage to top flange

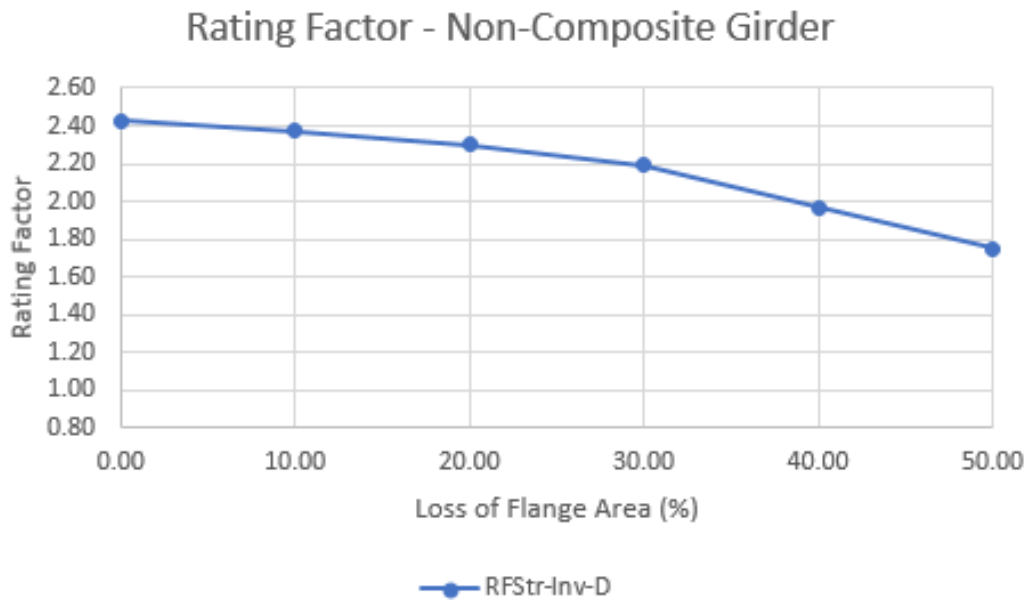
Figure 7.14. Structure 1 – variation of inventory rating factor for the non-composite girder as a function of extent of damage to top flange

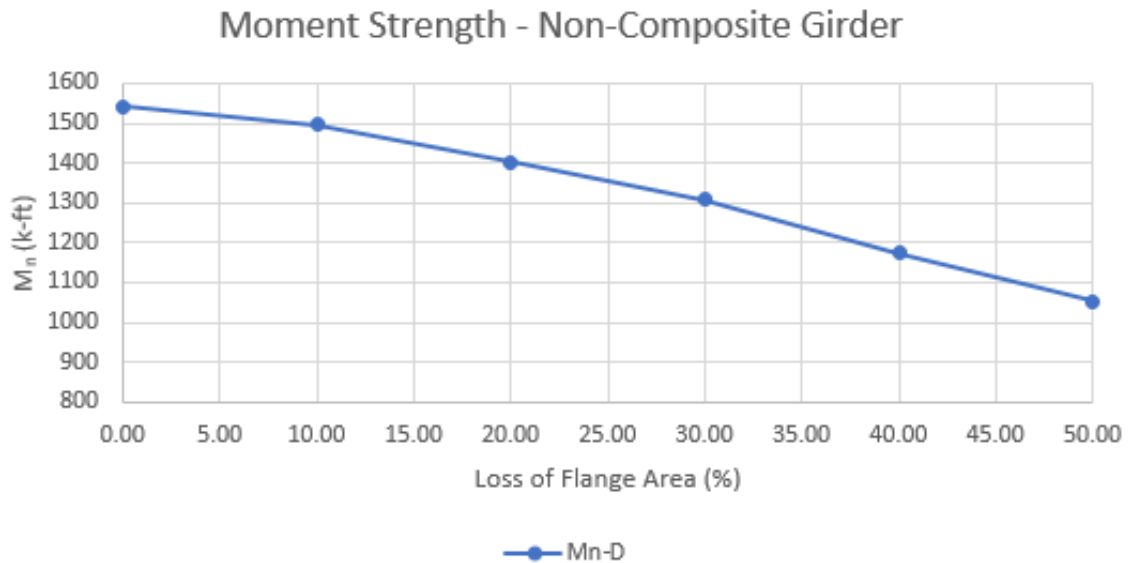
Figure 7.16. Structure 2 – variation of moment strength of non-composite girder as a function of extent of damage to top flange
