U.S. Department  
of Transportation  
**Federal Railroad  
Administration**

**RR 20-14 | August 2020**

## **AN AUTOMATED, DRONE-BASED GRADE CROSSING INSPECTION SYSTEM**

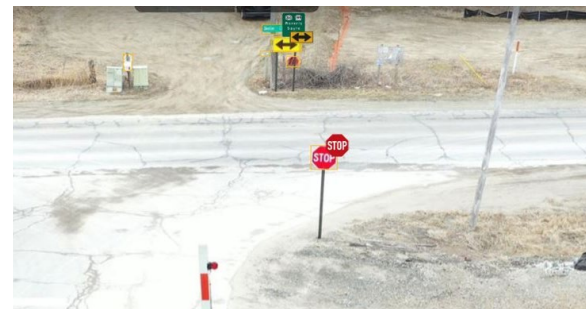
Oblique imagery collected by the DJI Mavic 2 Pro was processed through Mapillary to identify signs at a rail grade crossing. Figure 6 is an example of an oblique image collected for sign identification. Signs identified by the software are outlined by an orange box with the sign interpretation beside it.

**Figure 6: Results from Mapillary detecting signs from a drone collected image**

Researchers collected additional imagery of the rail grade crossing using the DJI Mavic 2 Pro from an oblique angle for the assessment of automated sign detection capability. Mapillary was used to demonstrate the ability of artificial intelligence/machine learning to detect signs in drone-collected imagery.
