**Federal Railroad  
Administration**

## Trespasser Detection Systems on Railroad Rights-of-Way

| REPORT DOCUMENTATION PAGE | | | | | Form Approved<br>OMB No. 0704-0188 | |
|---|---|---|---|---|---|--|
| 1. REPORT DATE (DD-MM-YYYY)<br>27-01-2020 | | 2. REPORT TYPE<br>Technical Report | | 3. DATES COVERED (From - To)<br>September 2016 – January 2020 | | |

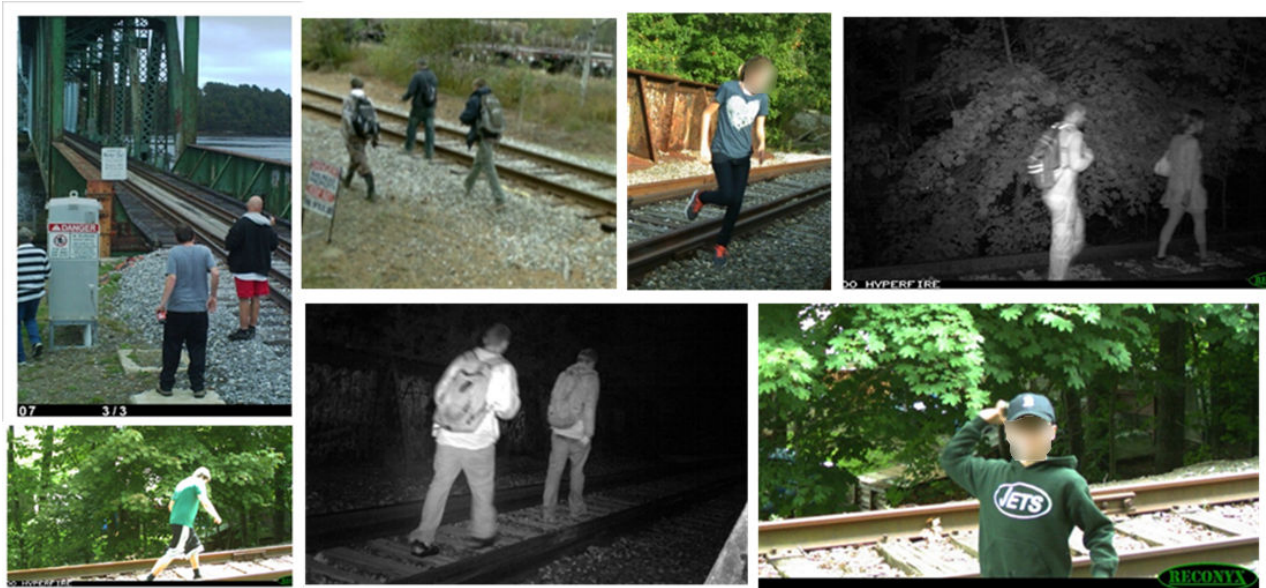
**Figure 2 – Examples of Trespassing Captured by Temporary Cameras**

Some locations proved to have little or no trespassing activity, while others had frequent activity. [Figure 2](#) shows examples of some of the activity captured by the temporary cameras.

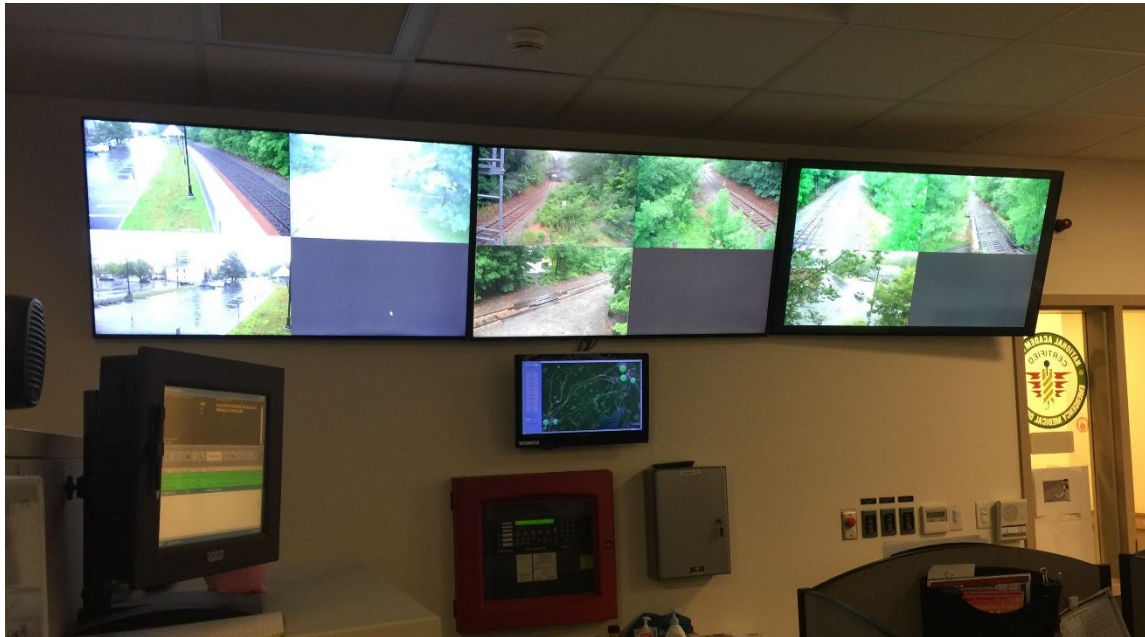
**Figure 3 – Trespass Detection Monitors in the BPD Dispatch Center**

The system as delivered by the contractor provided BPD with multiple video feeds from each camera site. It was based on an AXIS Camera Station enterprise video surveillance platform. Large screen monitors were set up in the BPD dispatch center, as shown in [Figure 3](#), as was a workstation from which dispatchers could control or move cameras and respond to alarms. The video was recorded on an AXIS rack mount hard drive array, with the server hosted on a Dell rack mount server, both of which were located in the BPD radio room.

Live streaming video was transmitted from the Jordan Avenue and Rock Junction sites via wireless broadband service provided by Verizon Wireless. Video from Freeport was transmitted via a Comcast broadband connection provided by the Town of Freeport. The contractor provided video motion detection as a sensor, with the ability to add external sensors later if needed. Automated vehicle location (AVL) software for patrol vehicles, shown in the screen at the bottom center of Figure 3, was also purchased under this program.

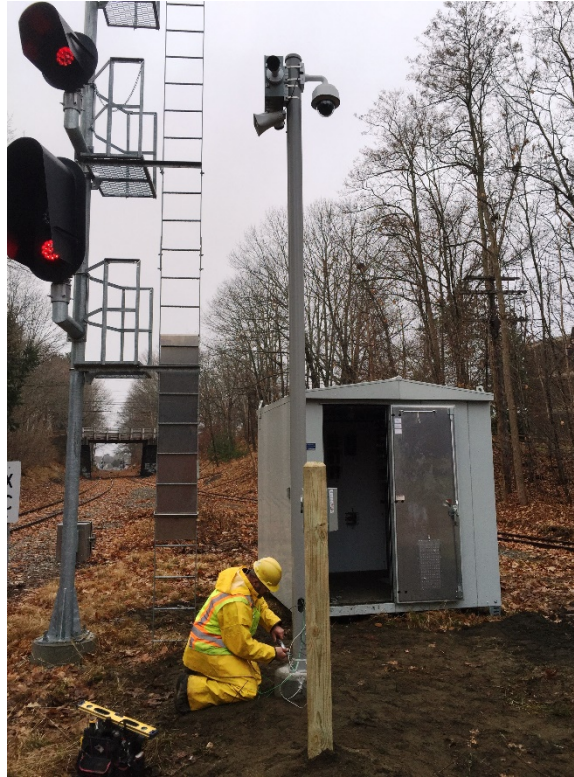
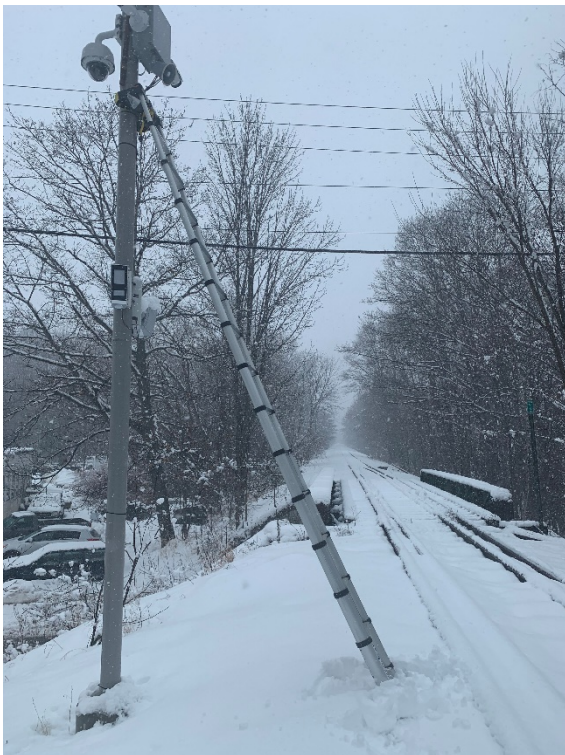
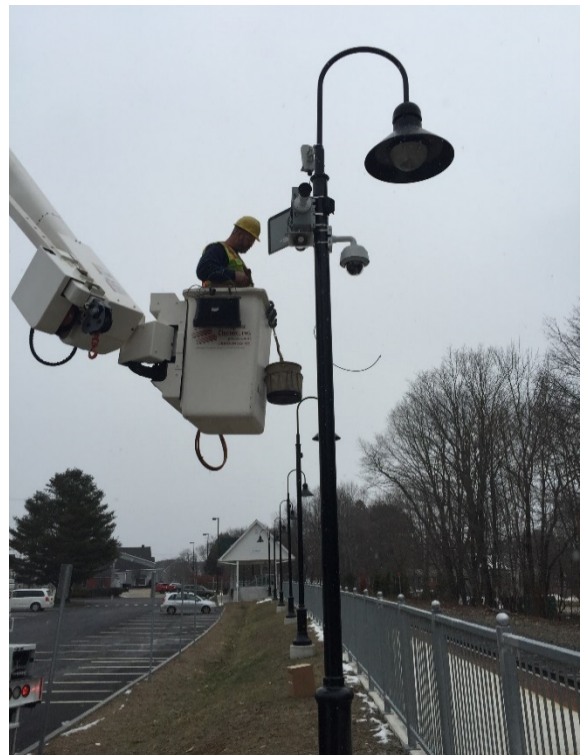
Each camera site had two fixed cameras (AXIS Q1765) and one pan-tilt-zoom camera (AXIS Q6045) on a 12-foot pole. Also, each pole had an AXIS P8221 audio control unit, along with a speaker and microphone that allowed dispatchers to speak and listen to trespassers. At Rock Junction, power was provided from the Pan Am bungalow. At Jordan Avenue, the town had power inside an adjacent flashing school zone sign that was turned off when the school was permanently closed. At Freeport, power was run from the station to the pole through existing conduit. Power and communications equipment was contained in a small enclosure near the top of each pole. The Freeport equipment was located on a light pole on the station platform. Since the internet connection was located at the nearby Chamber of Commerce building and could not be physically connected, an FM-PONTE-50 wireless bridge provided a connection to the cameras and audio devices. Each of the camera sites are shown in [Figure 4](#), [Figure 5](#), and [Figure 6](#) below.

**Figure 4 – Rock Junction Camera Pole**

**Figure 5 – Jordan Avenue Camera Pole**

**Figure 6 – Freeport Camera Pole**

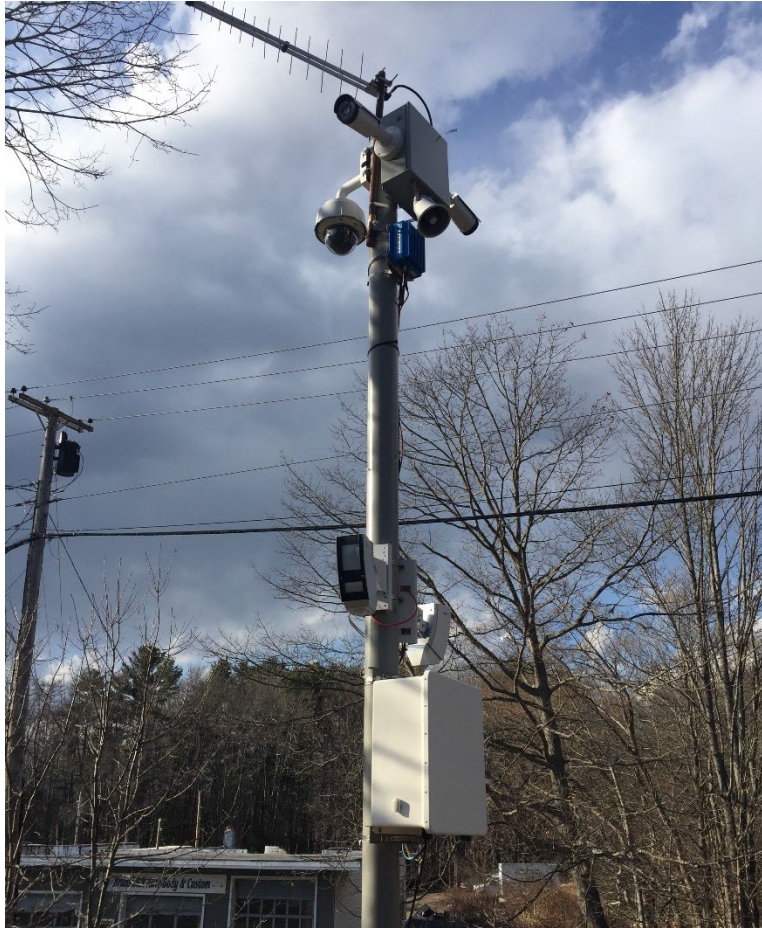
**Figure 10 – Jordan Avenue Pole with Optex Sensors**

At Jordan Avenue, Volpe deployed two sensors from Optex: the SIP-100 and the SIP-5030. These outdoor passive infrared sensors were essentially the same, combining a close-range sensor with a mid-range sensor. The SIP-100 also included a third, long-range sensor that could

detect objects up to 100 feet away. The long range sensor's field of view was also only 10 feet wide. Figure 10 shows the Jordan Avenue equipment pole with the Optex sensors installed.

In spite of repeated tuning and adjusting, these sensors also produced false alarms at a rate similar to the VMD sensors (at least several times per hour). Volpe then considered using a sensor similar to that used in the Pittsford project, which was shown to produce fewer false alarms. In the end, BPD expressed a disdain for any false alarms in their dispatch center, and expected they would continue to mute the alert for all sensors, so Volpe did not continue further sensor testing.
