**Airport Pavement Paint Study
Implementation & Evaluation
Final Report**

Prepared by Jacobs Engineering Group, Inc., for the
New Hampshire Department of Transportation, in cooperation with the
U.S. Department of Transportation, Federal Highway Administration

1. Report No. FHWA-NH-RD-26962T		2. Gov. Accession No.	3. Recipient's Catalog No.
4. Title and Subtitle Airport Pavement Paint Study - Implementation & Evaluation		5. Report Date July 2020

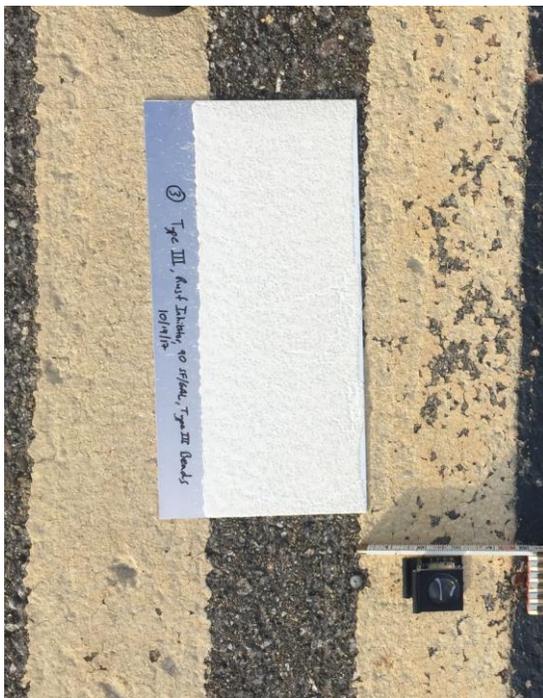
Figure 1: Control Sample Comparison

The first study objective compared control samples placed adjacent to the field painted surfaces. Control samples consisted of aluminum sheets, one for each area that were painted over during the 2017 installation of the study's pavement markings. The control samples were not exposed to sunlight or weather over the study period. This objective also evaluated bottom up rust spot stains that were observable on the surface of the paint and were counted in each of the sample areas.

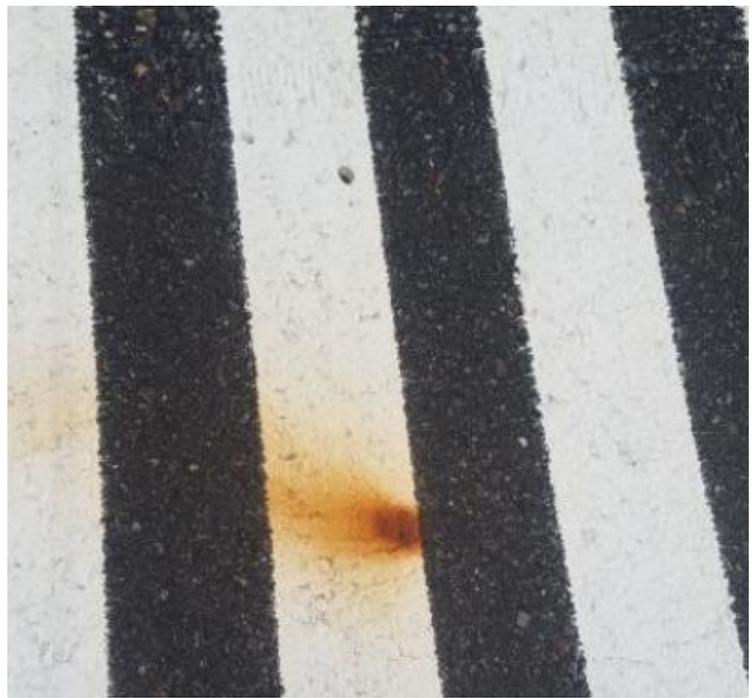
Figure 2: Bottom-up Rust Spot Stain Counting

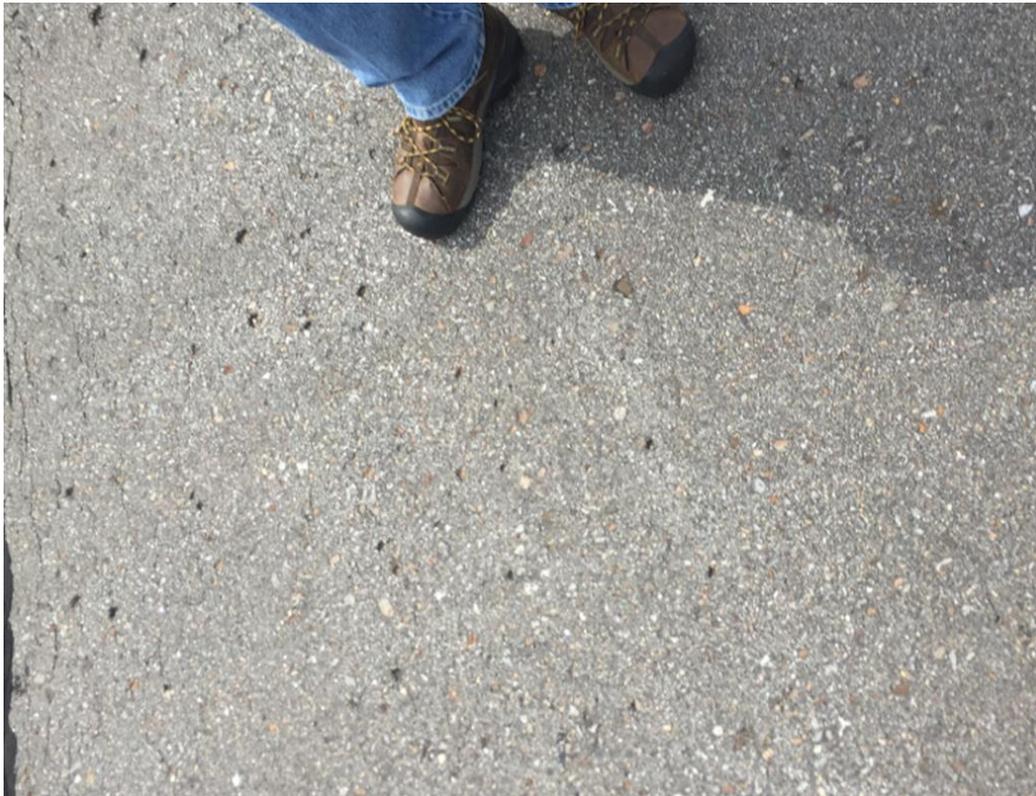
Figure 5: Loss of Aggregate in Runway Surface

The runway pavement condition index (PCI) values were obtained in 2012. The PCI study indicated low to moderate raveling of the pavement aggregates. The raveling is shown in Figure 5. In the figure, the dark spots in the pavement are the small holes (i.e., raveling) where the pavement aggregate has eroded. The raveling is attributed to deleterious pre-weathered aggregates in the bituminous concrete surface⁴. These aggregates decomposed when exposed to the elements. The result of the aggregate weathering are small pockets or holes in the pavement surface. In the Runway 26 seal coat area of the study (area G), the 2012 PCI was estimated at a 46 rendering the pavement in fair condition prior to application of the seal coat. In study areas 1 through 4, the PCI ranged from 74 to 95. These values describe a very good pavement condition.

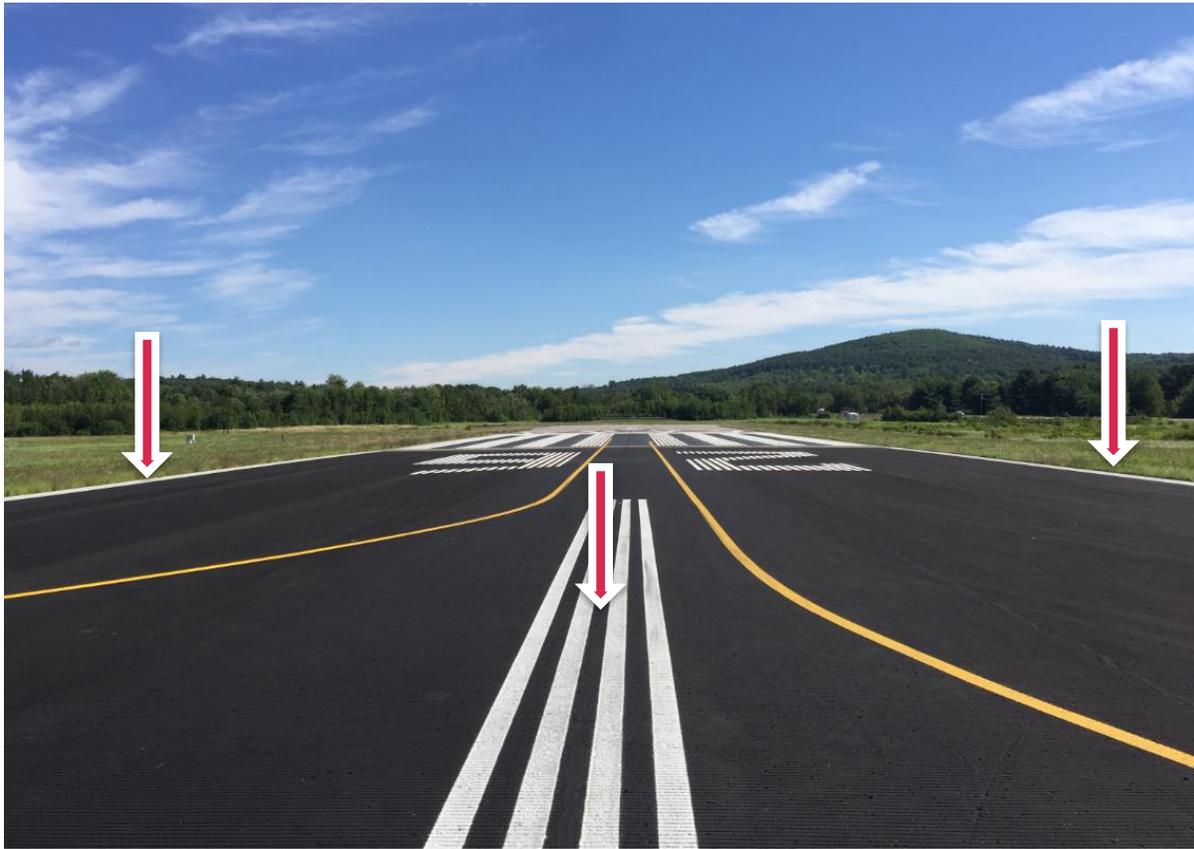
Figure 8: Relationship of Runway Centerline to Edge Stripes

Of all the runway markings, the edge stripes have the largest volume of stormwater flowing over them. The runway is normally crowned with the high point along the runway centerline. The edge stripes start 47 feet away from the runway centerline and the pavement at the edge stripes is 6 inches lower than the runway centerline. This makes it a worst-case location as it has the highest rust loading from the stormwater flowing over one half the width of the runway pavement as well as the opportunity for bottom up rust spot staining. Additionally, if the study paint resulted in significant color changes, the edge stripes were considered as lower priority markings on the runway and therefore a lower safety issue.

Area G ('G' for the Gilsonite in P-608) or the fifth area was selected for its application on the seal-coated surface. The black seal coat is evident in Figure 8. Area G is approximately 900 feet east of the areas 1 through 4 and was paved under the same project as areas 1 through 4.

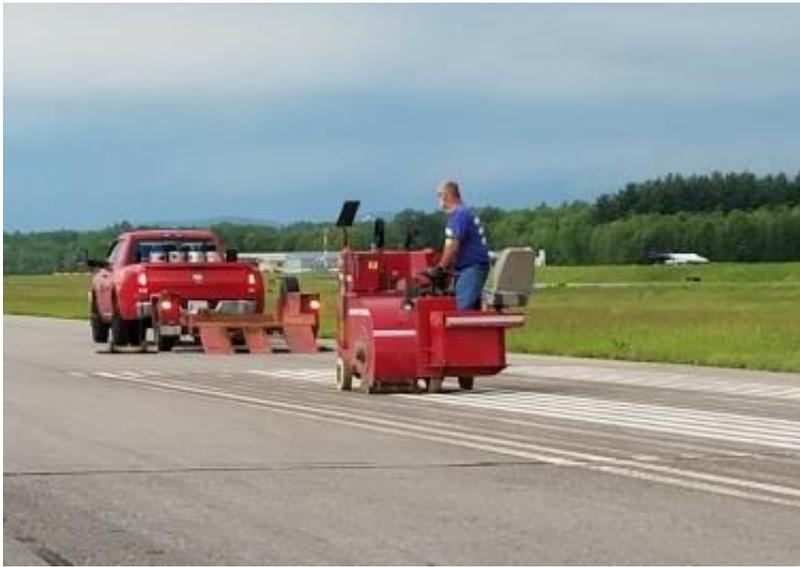
Figure 10: Runway Paint Removal

In study areas 1 through 4, the bituminous surfaces were prepared by grinding the existing paint. The surfaces where the paint was removed were further prepared by sweeping and blowing prior to painting. In area G, the existing paint was removed by grinding and then seal coated with the FAA Specification P-608 seal coat by APS under the airport-contracted project. The seal coat cured 115 days before the study’s paint was applied, well beyond the FAA P-620 30-day typical cure time.

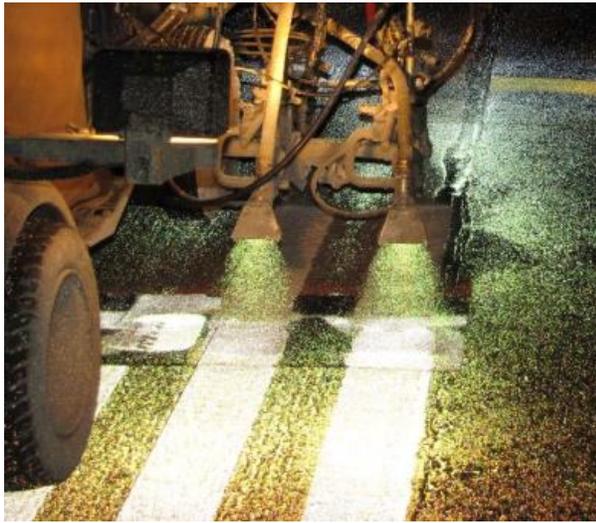
Figure 11: Paint and Bead Installation

Prior to the installation each paint applicator was calibrated to the specified paint and bead application rates on the airport's abandoned runway pavement. Paint was installed with self-propelled, ride-on Graco paint machines that were equipped with automatic, pressurized glass bead dispensers.

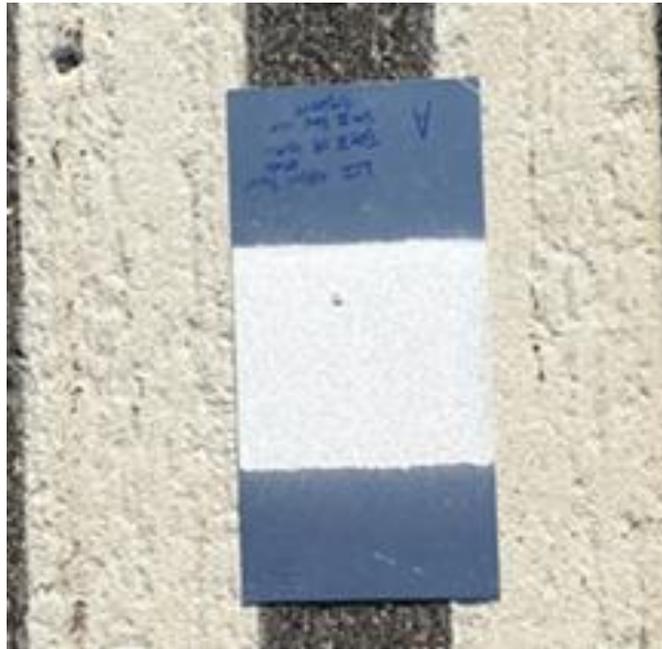
Figure 16: Control Sample Placed Next to Field Paint

At each visit the paint color was photographed using an iPhone 6. The control panel collected during the paint installation was brought in its protective envelope from Jacobs’ office to the field. The sample was placed on the pavement next to the sample paint location and photographed. Each area had its own control sample for that area’s paint and bead type. The same sample was placed at all four sample locations in each area. The time of year and time of day provided different light intensities for the photographs. Some photographs with less than optimum lighting appear darker. The less than optimum lighting did not impact the study comparisons when the photographs are compared over the 24-month study period.

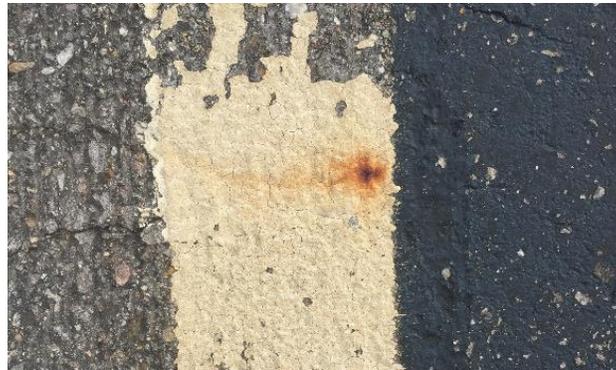
Figure 17: Bottom-up Rust Spot Stain

Bottom-up rust spot stains were counted along the first in-board stripe of each area. The count was made by walking the line and if a rust spot stain could be observed at eyelevel, it was counted. The size ranged from the diameter of a pencil eraser to a U.S. nickel. A typical bottom-up rust spot stain can be seen in Figure 17.

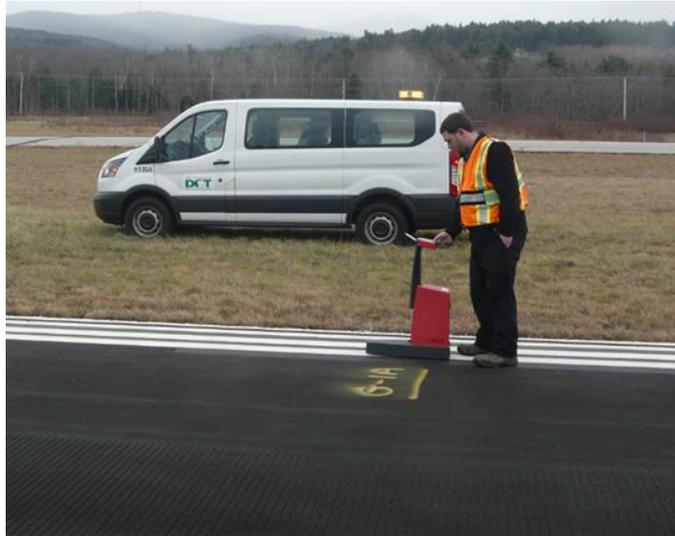
Figure 18: Retroreflectometer Reading

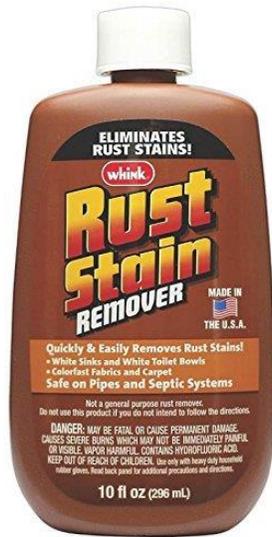
Figure 20: Rust Remover

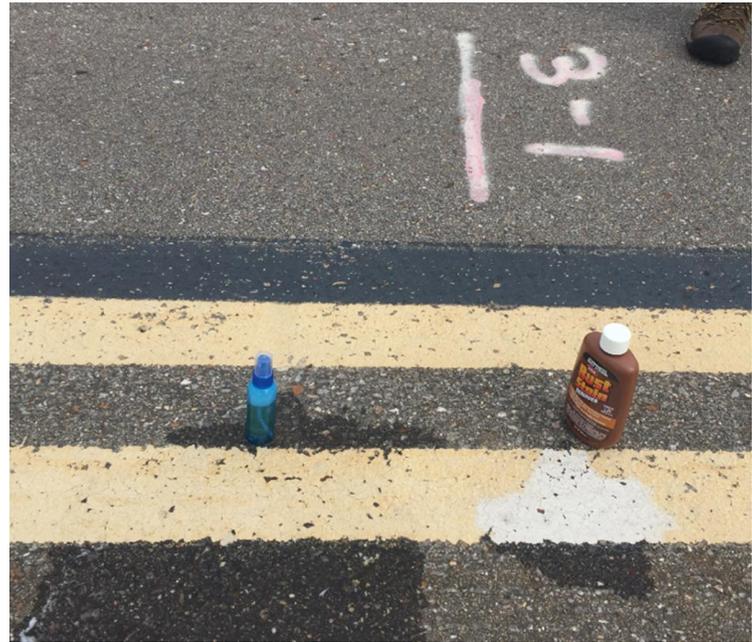
Figure 21: Soap and Water vs. Rust Remover

After the first year of field observations, the study's inspectors noticed the discoloration of the paint was becoming darker with time. Various sources of contamination from dirt, algae and rust were considered. To prove the source of contamination, select sites in each area were scrubbed with soap and water or a rust remover was applied. As soap and water made no change to the paint discoloration, the soil and algae contamination possibilities were eliminated. The application of a commercially available rust remover (Figure 20) resulted in a rapid removal of the contamination on the paint, confirming that the paint contamination was rust. Figure 21 shows the white paint next to where the rust remover was applied. It is noted that the rust staining is only on the surface of the paint. The rust is not within and did not damage the paint. Additionally, the bottom-up rust spot stains were removed with the rust remover.

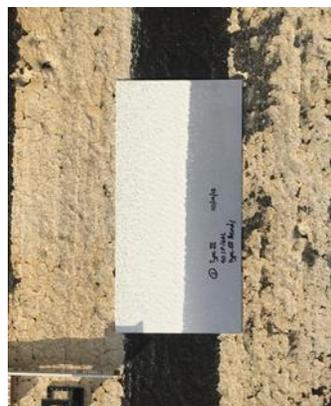
Figure 26: Area G III/III

It was observed that over the 24-month period all paint test areas' color deteriorated, changing from white to brown undertones. The paint stripes observed on September 26, 2019, the last observation at the end of the 24-month study period, for each area can be seen below in Figures 22 through 26 along with their associated control panels:

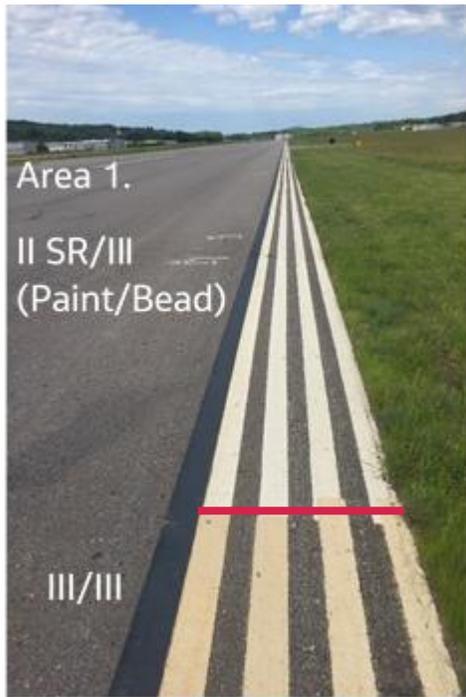
Figure 27: Comparison Area 1 – 7/2/2019

The change in color was also noticed, or not, at the interface between the test area and the control areas adjacent to but outside the test areas. This perspective confirmed the performance of the paint that aged under similar conditions. The paint outside the test areas was the FAA P-620 specification Type III paint with Type III beads. Area G has black seal coat under the white marking. The contrast between the paint and the dark pavement in area G is evident. Representative comparisons of each study area are shown below in Figures 27 through 31 (all control sections are labelled III/III for the standard FAA Type III paint with Type III beads).

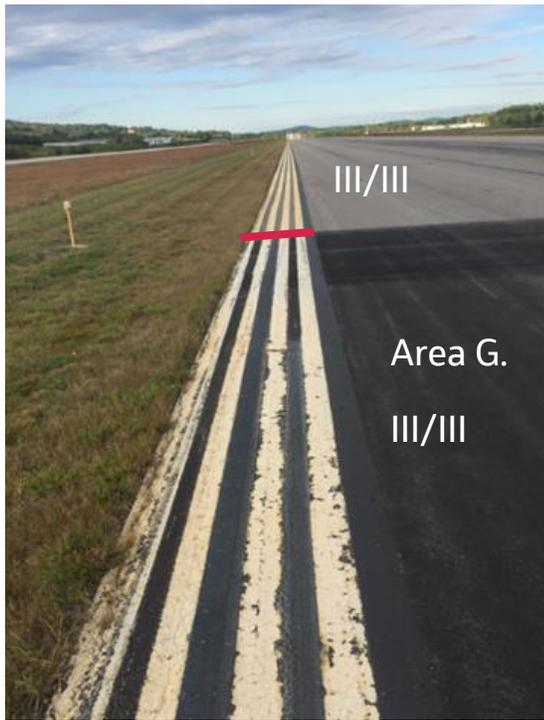
Figure 31: Comparison Area G – 9/26/2019

Legend: Paint type/Bead type
SR – Stain Resistant Additive
RI – Rust Inhibitor Additive

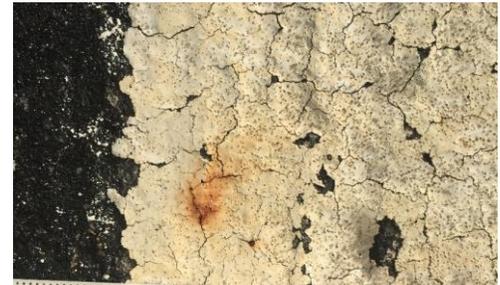
Figure 32: Rust Spot Stain in Area G

The number of bottom-up rust spot stains were plotted as stains per 100 feet, as each area had a different length. The average number of rust spot stains counted during the 24-month period is shown in Figure 33. These stains are not related to the rust laden stormwater sheet-flowing over the paint. These rust spot stains originate from below the paint.

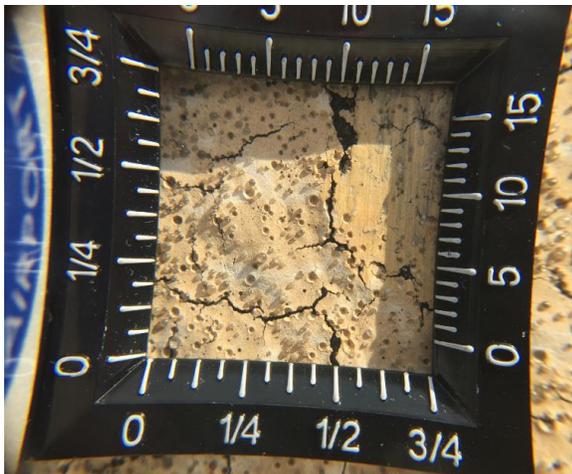
Figure 38: Area G - Sample 2 – 9/26/19

To further illustrate the poor bead embedment in area G, a comparison of areas G and 1 are shown in the Figures 38 and 39 below. Area G has numerous missing bead craters as compared to area 1 with the beads mostly intact.

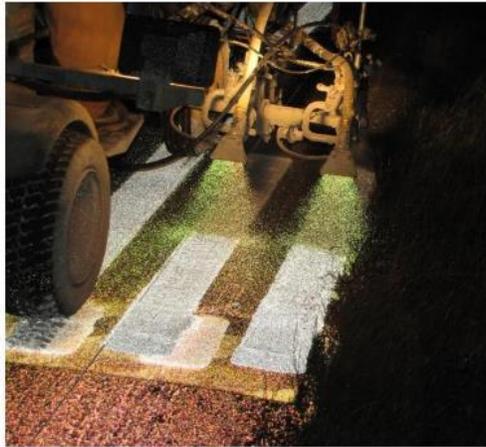
Picture 1 – glass beads spreading too wide.

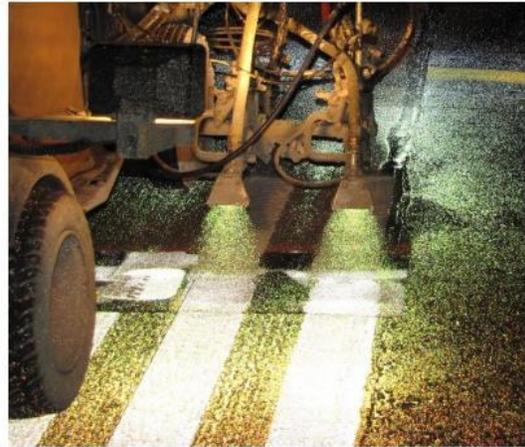
Picture 2 – glass bead guns adjusted.

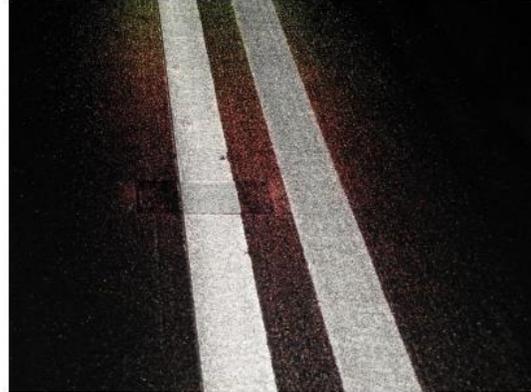
Picture 4 – glass beads applied over line.

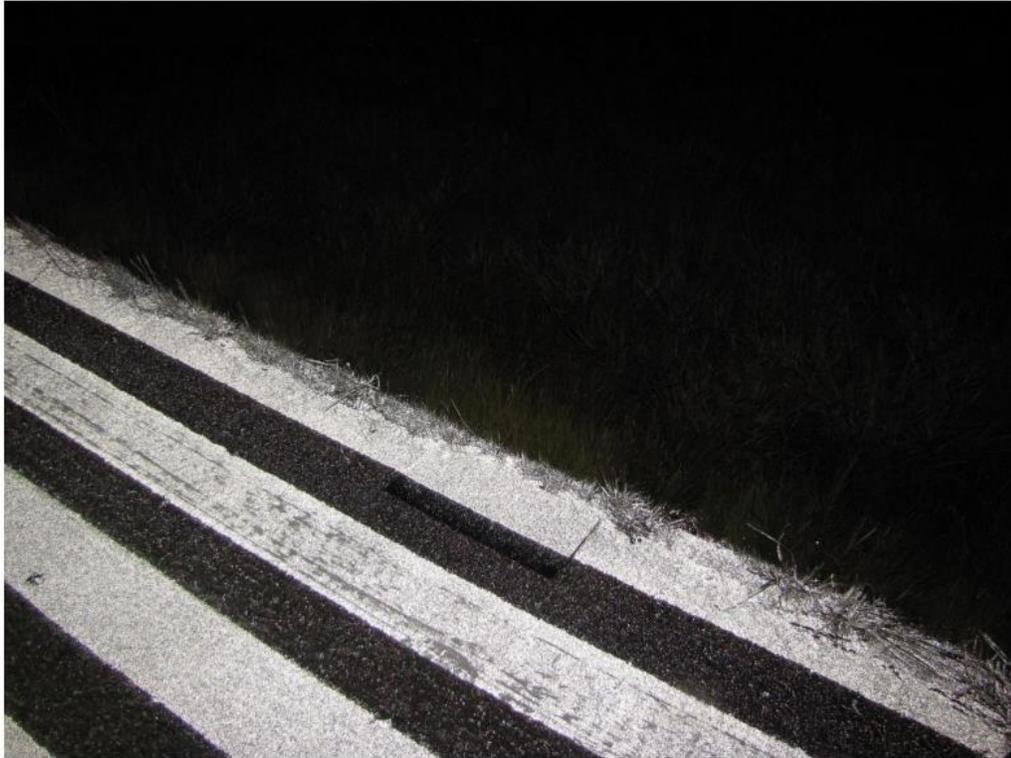
Picture 5 – Test panel placed longitudinally along outer line closest to the grass.

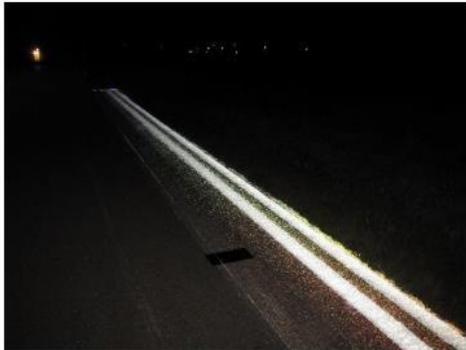
Picture 7 – Test line east of Taxiway F

The second set of 5-inch lines was then painted. The second panel seen in Picture 7 was impacted by the string line when it bounced across the newly painted panel; however, enough of the panel was intact to serve the purpose of the study.

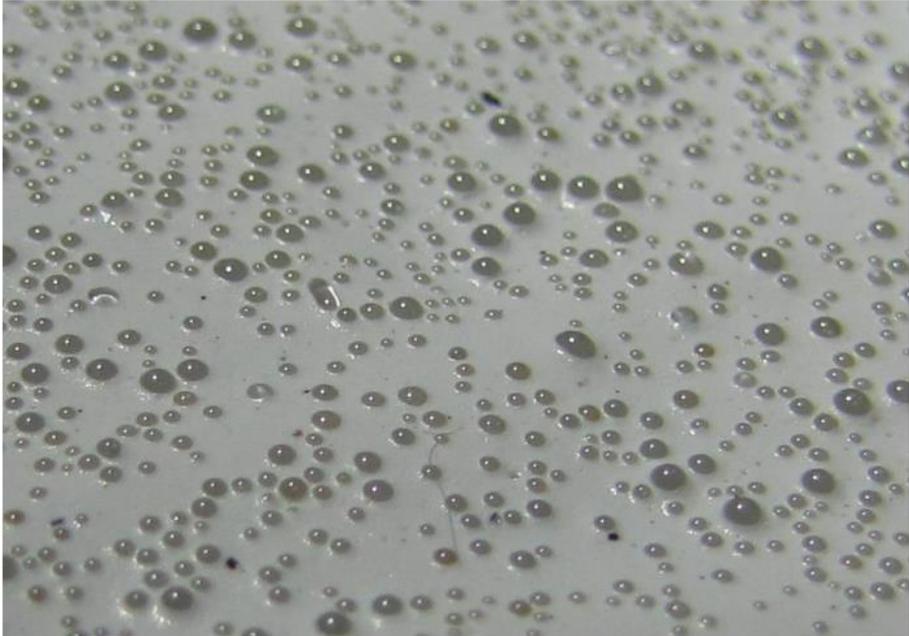
Picture 8 – close up of 25 mil Type III, stain resistant paint with Type III beads at 10# per gallon.

A close up of the 25 mil marking showed excellent glass bead embedment, distribution, and population seen in Picture 8.
