**LOAD AND RESISTANCE FACTOR DESIGN (LRFD) RESISTANCE
FACTORS FOR TIP GROUTED DRILLED SHAFTS**

BDV25-977-37

FINAL REPORT

September 2019

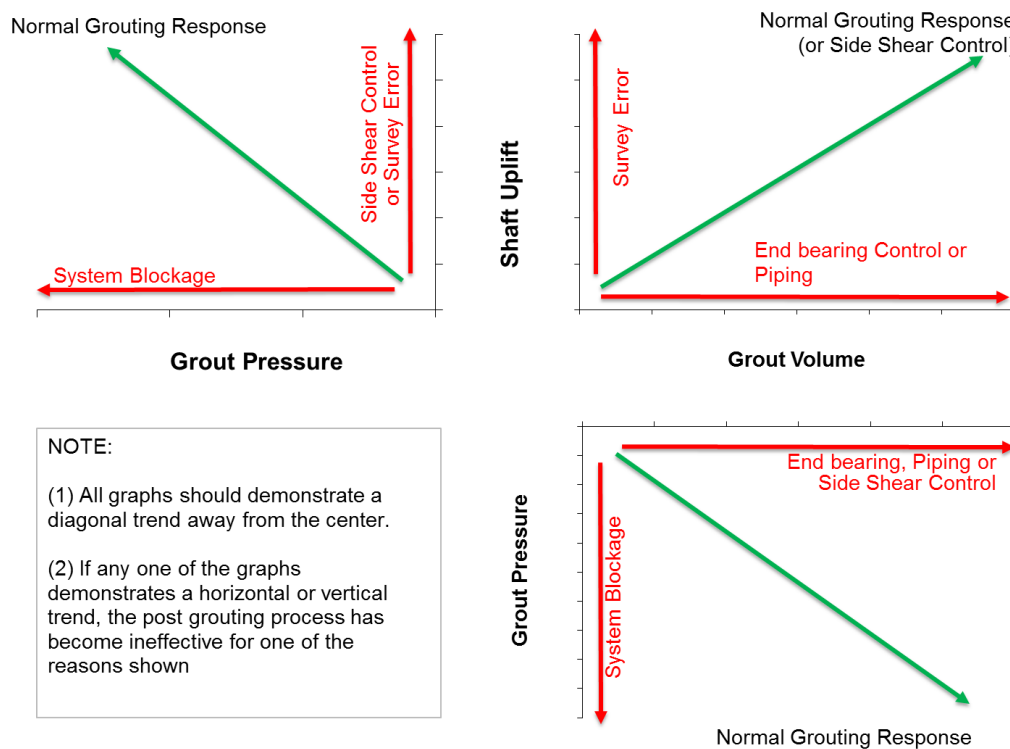
Figure 2.4 Quality assurance plots for postgrouting drilled shafts (Winters, 2014).

Contradictory results of the individual performance measures can lead to inadvertent acceptance of ineffectively grouted shafts. As a result, a performance review is recommended wherein the three field measurements are plotted in tri-axis graphs to show the actual grouted outcome and to confirm proper grouting has been achieved (Figure 2.4).

In short, all graphs should demonstrate a diagonal trend away from the center. If any one of the graphs demonstrates a horizontal or vertical trend and it is confirmed by a second graph, the postgrouting process has become ineffective for one of the reasons shown. Figures 2.5-2.7 show examples of effective grouting, end bearing failure, and grout system blockage, which all would have been missed without using proper quality control/assurance methods as each individual criterion was satisfied. The dashed red lines denote the individual grouting criterion required for each project. Only Figure 2.5 shows all criteria were met “effectively.”

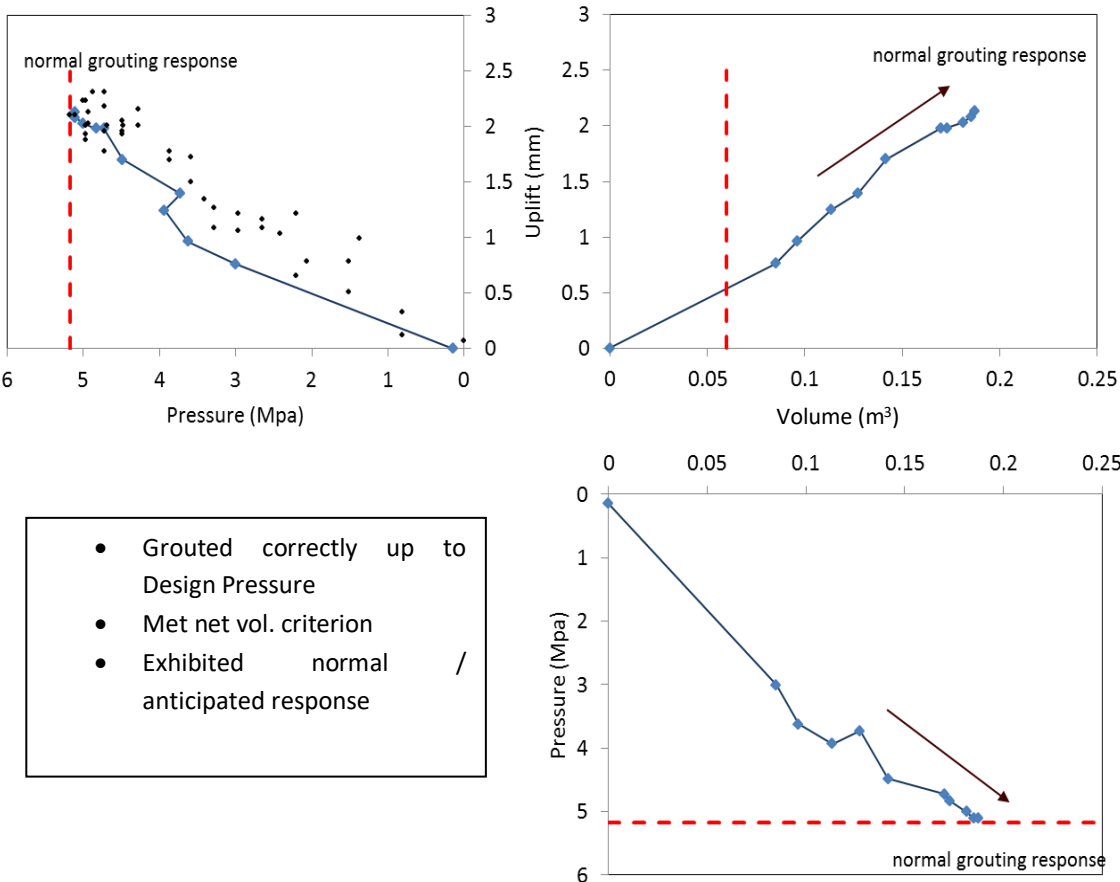
Figure 2.5 Proper grout performance shown from effectiveness plots.

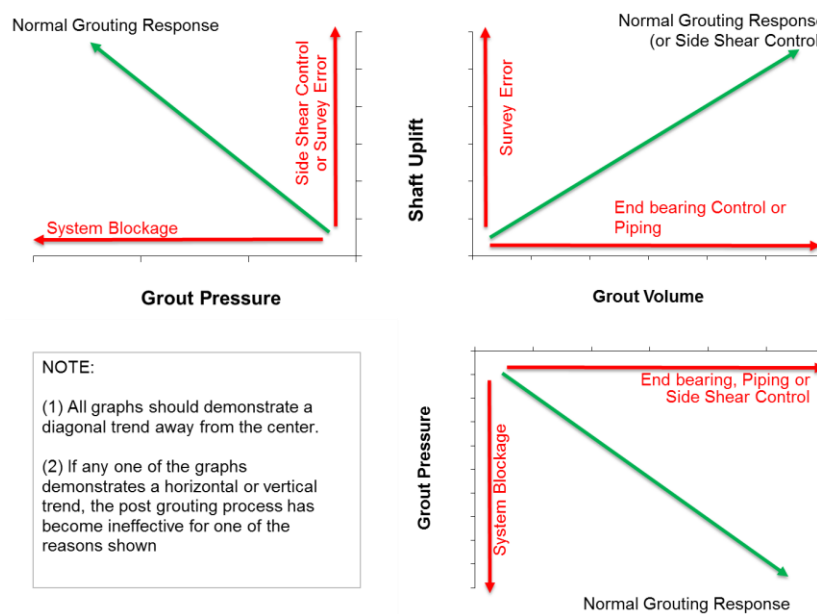
Figure 4.1 Concept tri-axis grouting effectiveness plots.

Tri-axis plots represent the three quality control or quality assurance (QA/QC) thresholds used for grouted shafts. In order to validate the grouting process, all field grouting data was analyzed and graphs correlating pressure vs displacement, pressure vs volume and volume vs displacements were plotted. These were used to determine the true effective grout pressure and the peak field recorded pressure which is often caused by blockage and different from the effective pressure. Data from each site was scrutinized for possible errors or conditions by which grouting became ineffective as indicated by the red arrows in Figure 4.1 (replotted for convenience from Chapter 2).

As noted in Figure 4.1, horizontal data lines in volume vs. pressure graph indicate an end bearing failure or grout loss to a surrounding void or cavern. This should be supported with a similar horizontal line in the volume vs. displacement graph. In this case, the horizontal lines occur at near zero pressure making the volume data suspicious although after the grouting event. Similarly unusual, is the increase in displacement as pressure decreases noted in the pressure vs. displacement graph. No explanations for the anomalous end of grouting conditions are presented, but this would be usually attributed to survey or reference beam disturbance. The max effective pressure was taken at 400 psi; peak measured pressure was 700 psi. Design pressure was 787 psi.

As outlined in Figure 4.1, vertical data lines in displacement indicate a survey error if supported by similar features in both the volume vs. displacement and pressure vs. displacement graphs. This data set supports that type of error. At approximately 11.3 cu. ft. the displacement data original jumped 0.16-in without a commensurate increase in volume. These graphs have been replotted with an assumed displacement offset to account for this error. The maximum effective pressure was taken at 300 psi as at that point an increase in volume accompanied the increase in pressure. The peak recorded pressure was taken at 700 psi which occurred at the point where a vertical line in the data is observed in the pressure vs. volume graph. Again, as noted in Figure 4.1, this indicates an error in grouting which is common for a blocked grouting line.

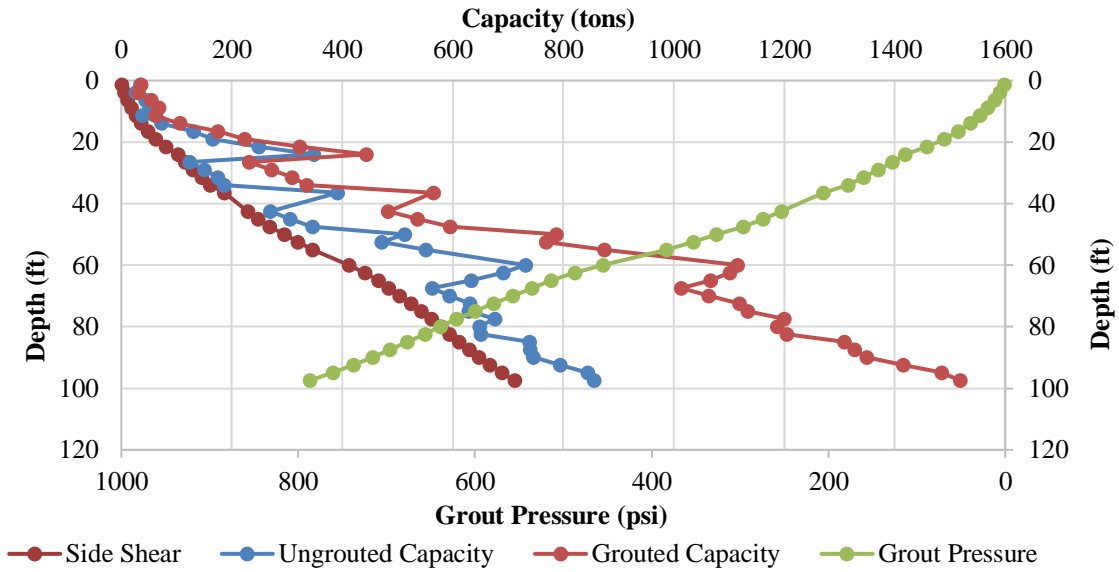
Figure 4.2 Data set 1 design curves.

No design pressure was noted in the grouting and load testing report but figure 4.2 gives the design curves which provides a maximum design grout pressure for the test shaft length.

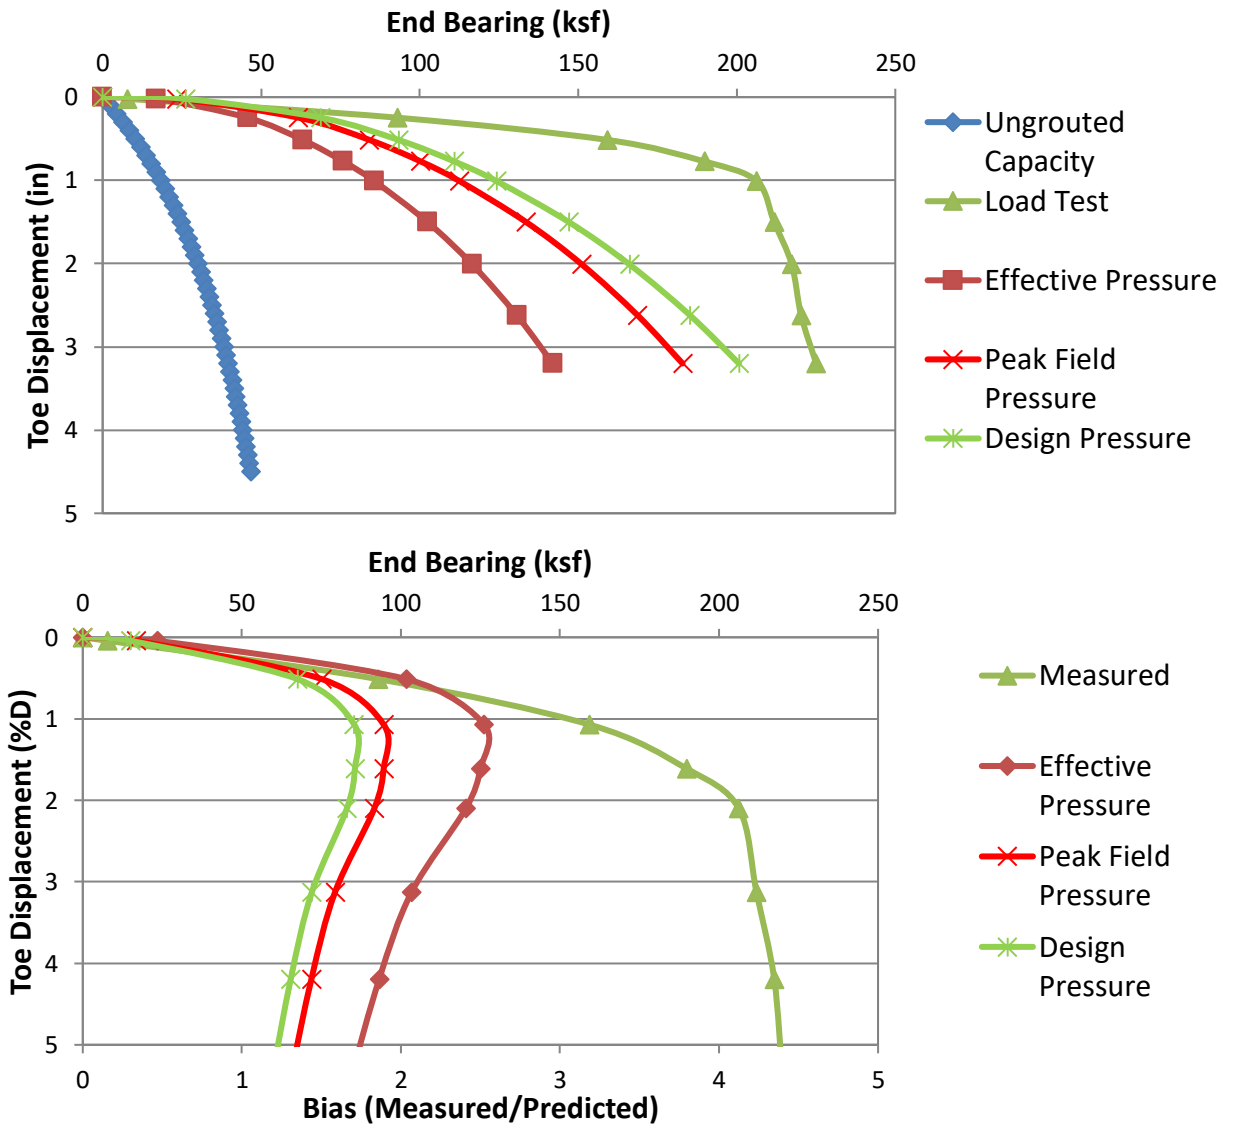
Figure 4.4 Data set 1 predicted/design and load test response (top); bias vs disp. (bottom).

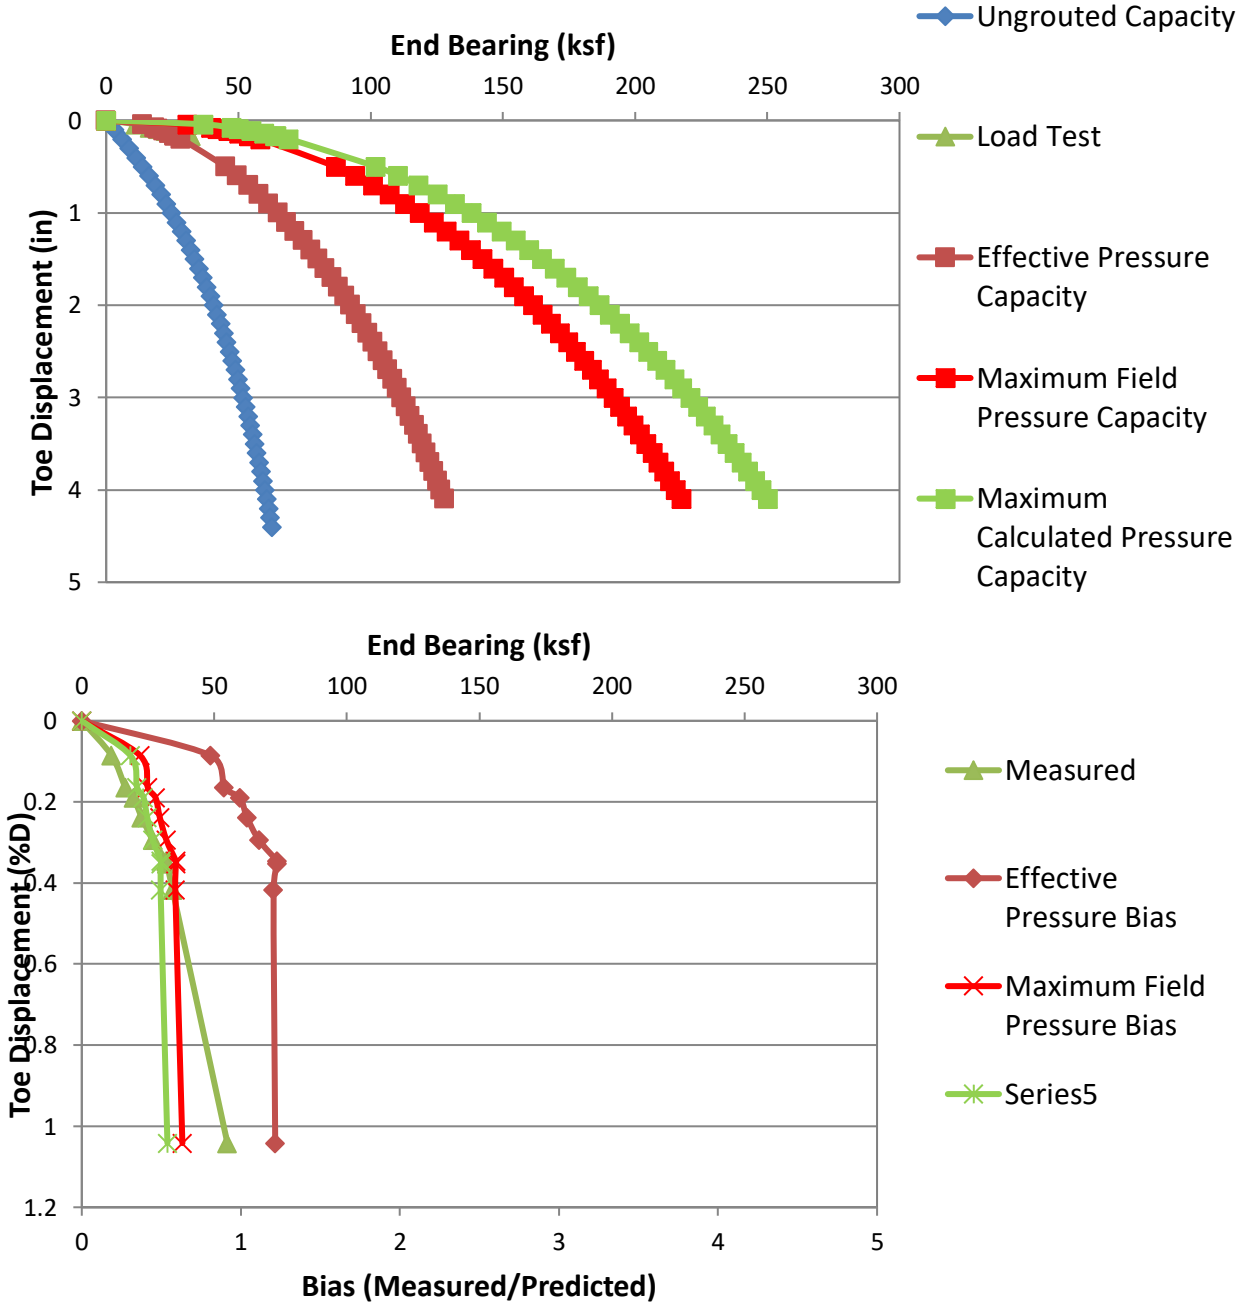
Figure 4.7 Data set 2 predicted/design and load test response (top); bias vs disp. (bottom).

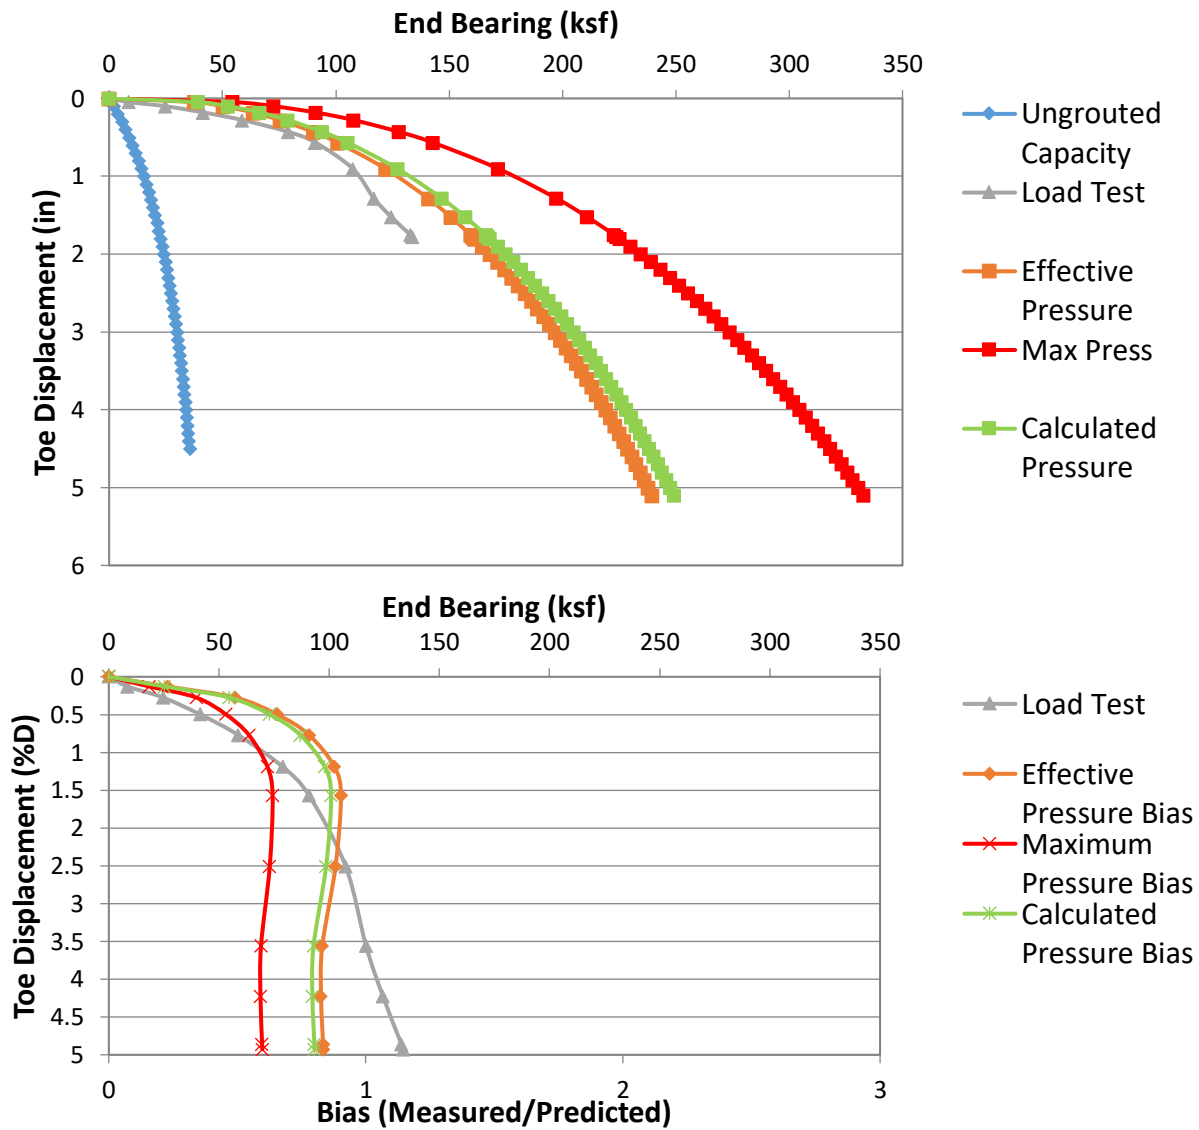
Figure 4.10 Data set 3 predicted/design and load test response (top); bias vs disp. (bottom).

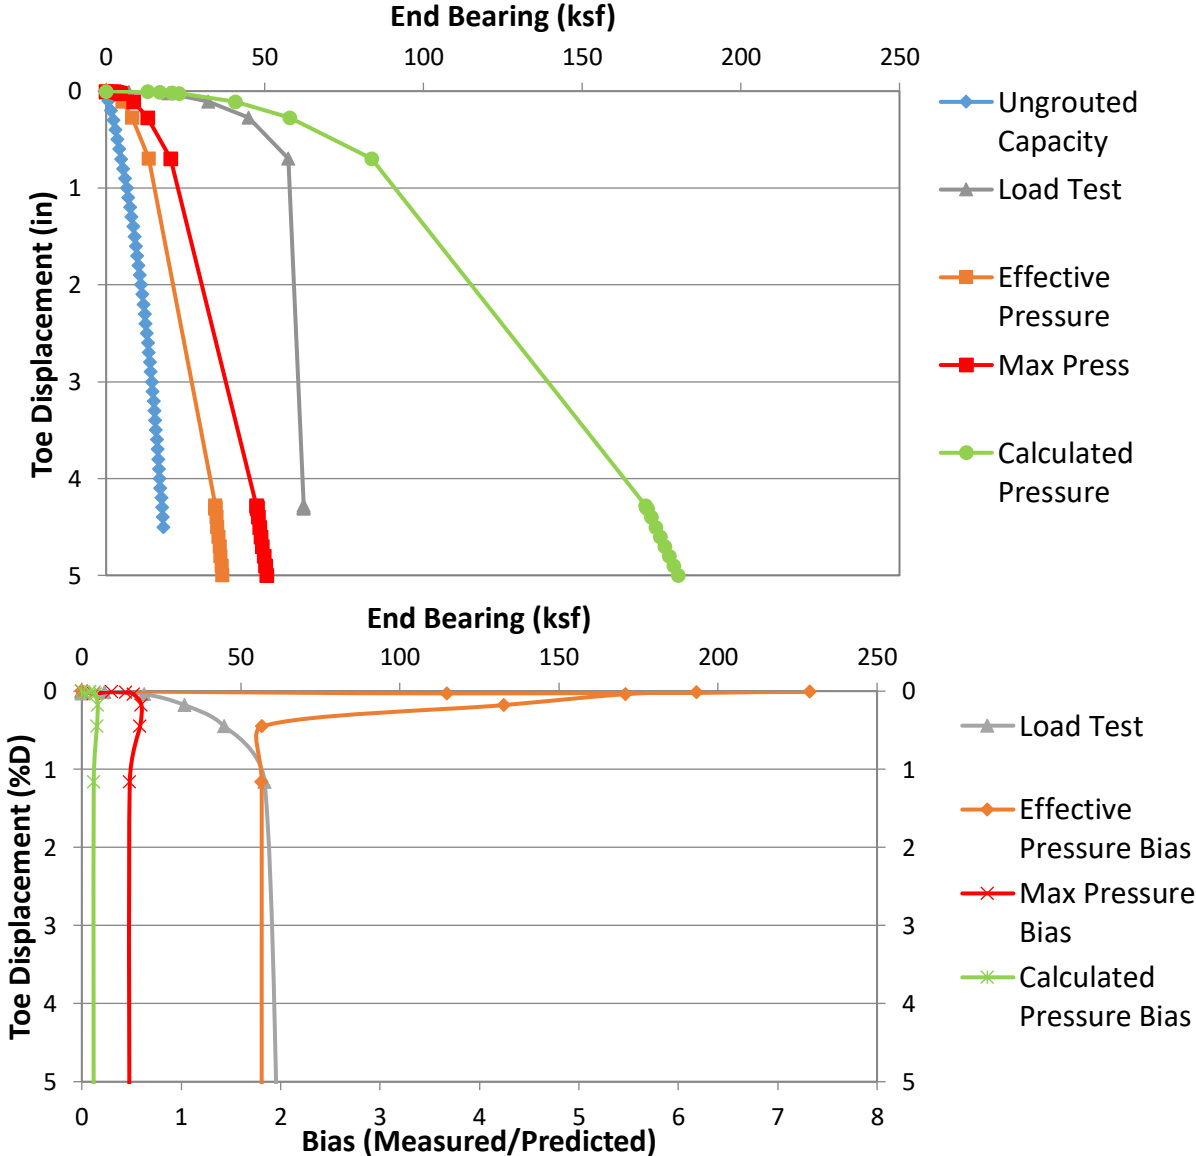
Figure 4.13 Data set 4 predicted/design and load test response (top); bias vs disp. (bottom).

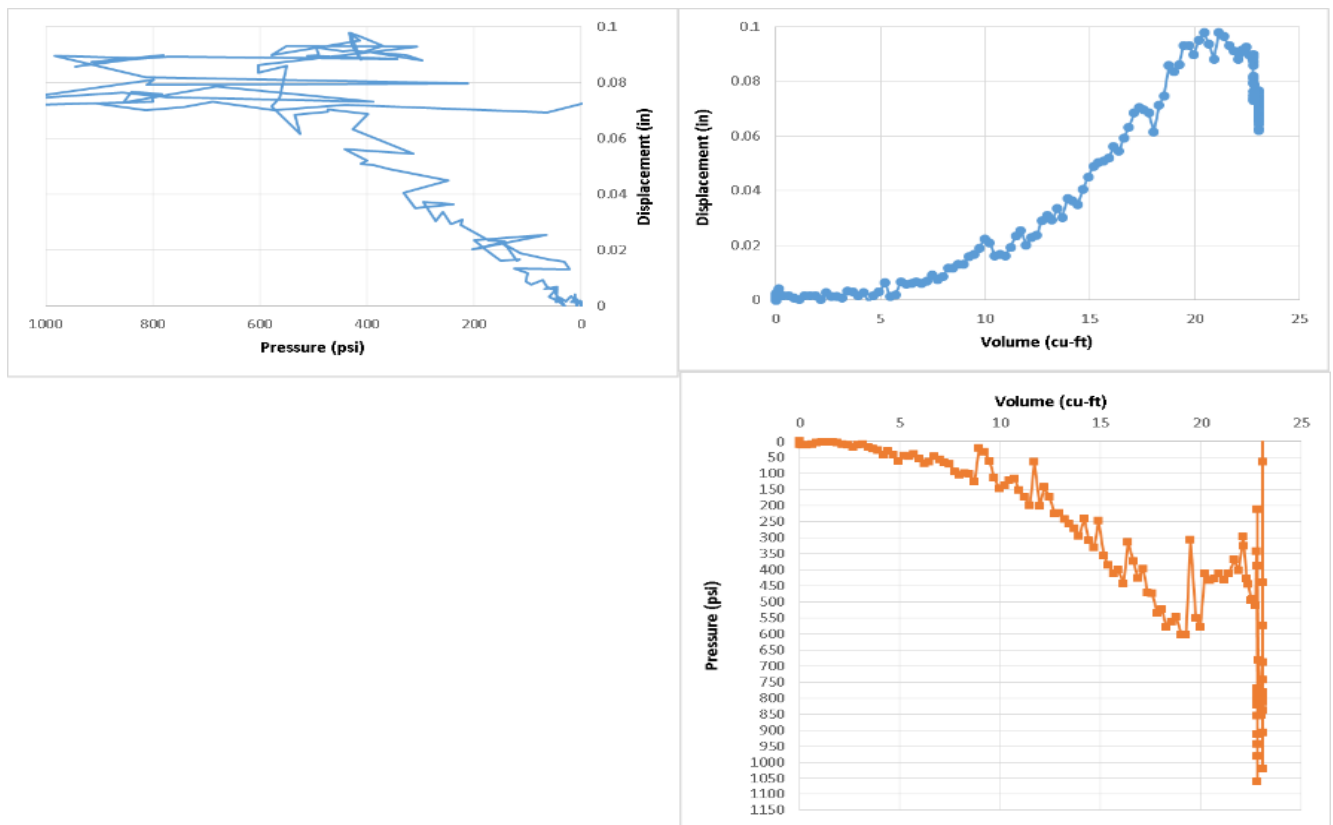
Figure 4.15 Data set 5 tri-axis plots.

Figure 4.15 shows the tri-axis plots for data set 5 and indicates two issues only visible when using the effectiveness plots. Both the pressure vs. volume and volume vs. displacement show horizontal trends supporting end bearing failure or piping at around 600 psi. Both the pressure vs. volume and pressure vs. uplift show spikes in pressure without an associated uplift or volume increase which indicates a grout line blockage at the end of grouting. Effective pressure could be argued to be either 600 or 450 psi. The 600 psi value was legitimately achieved during effective grouting, but that pressure could not be maintained with additional volume which suggests a change in soil structure beneath the shaft tip. The ensuing 400 psi value was sustainable up to the point where the grout line became blocked and spiked a maximum field recorded pressure of 1,060 psi. Effective pressure was taken at 400 psi. Based on shaft length, tip area, and soil strength, the maximum calculated grout pressure was 1,000 psi.

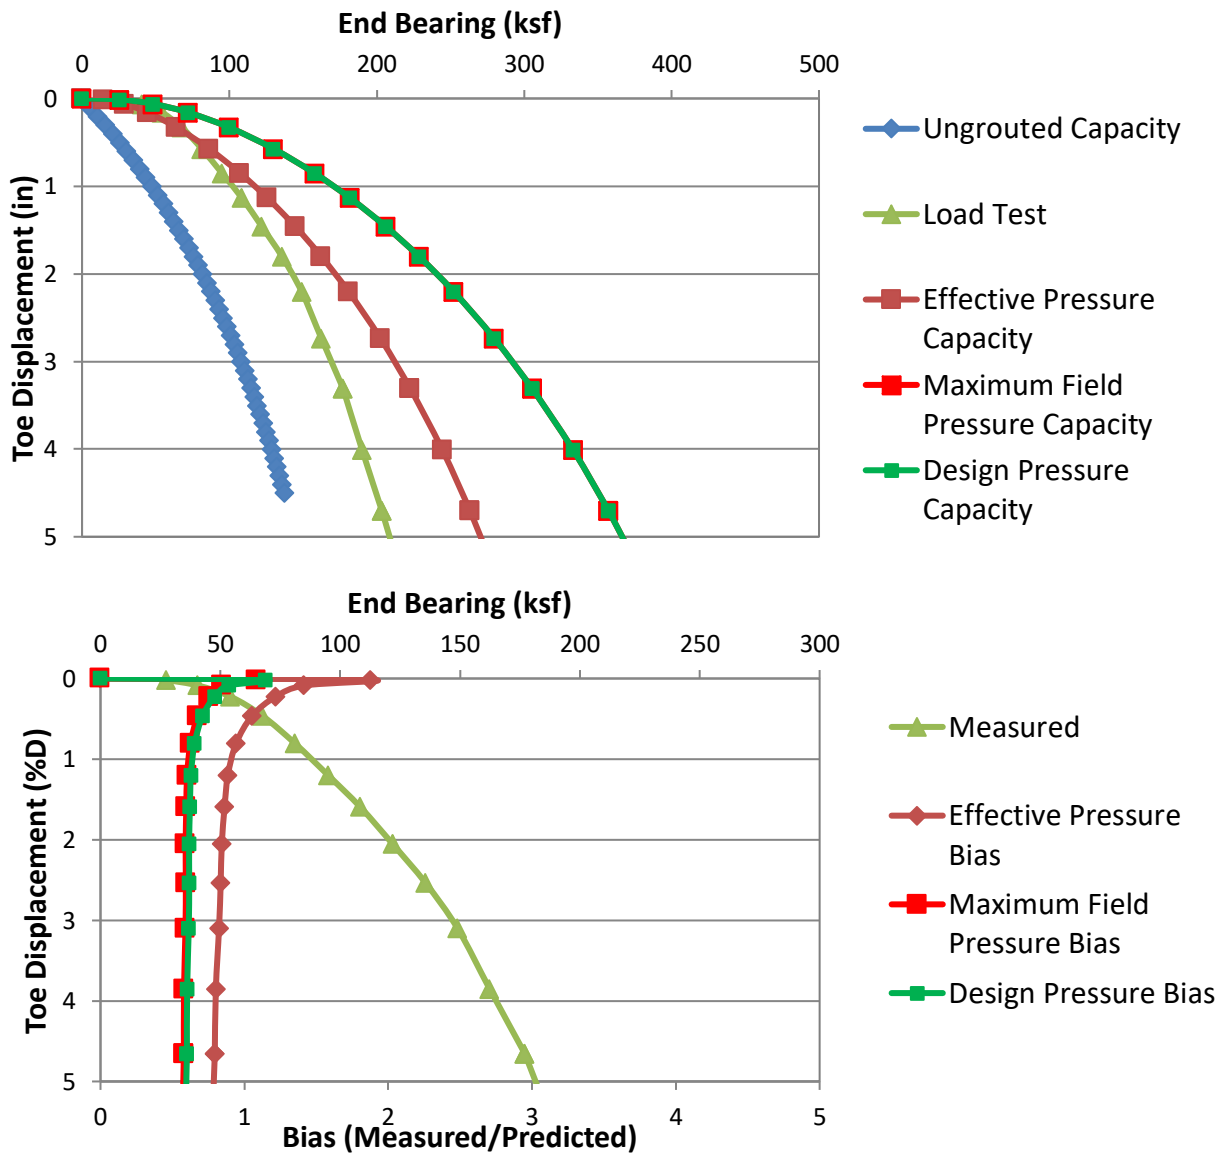
Figure 4.16 Data set 5 predicted/design and load test response (top); bias vs disp. (bottom).

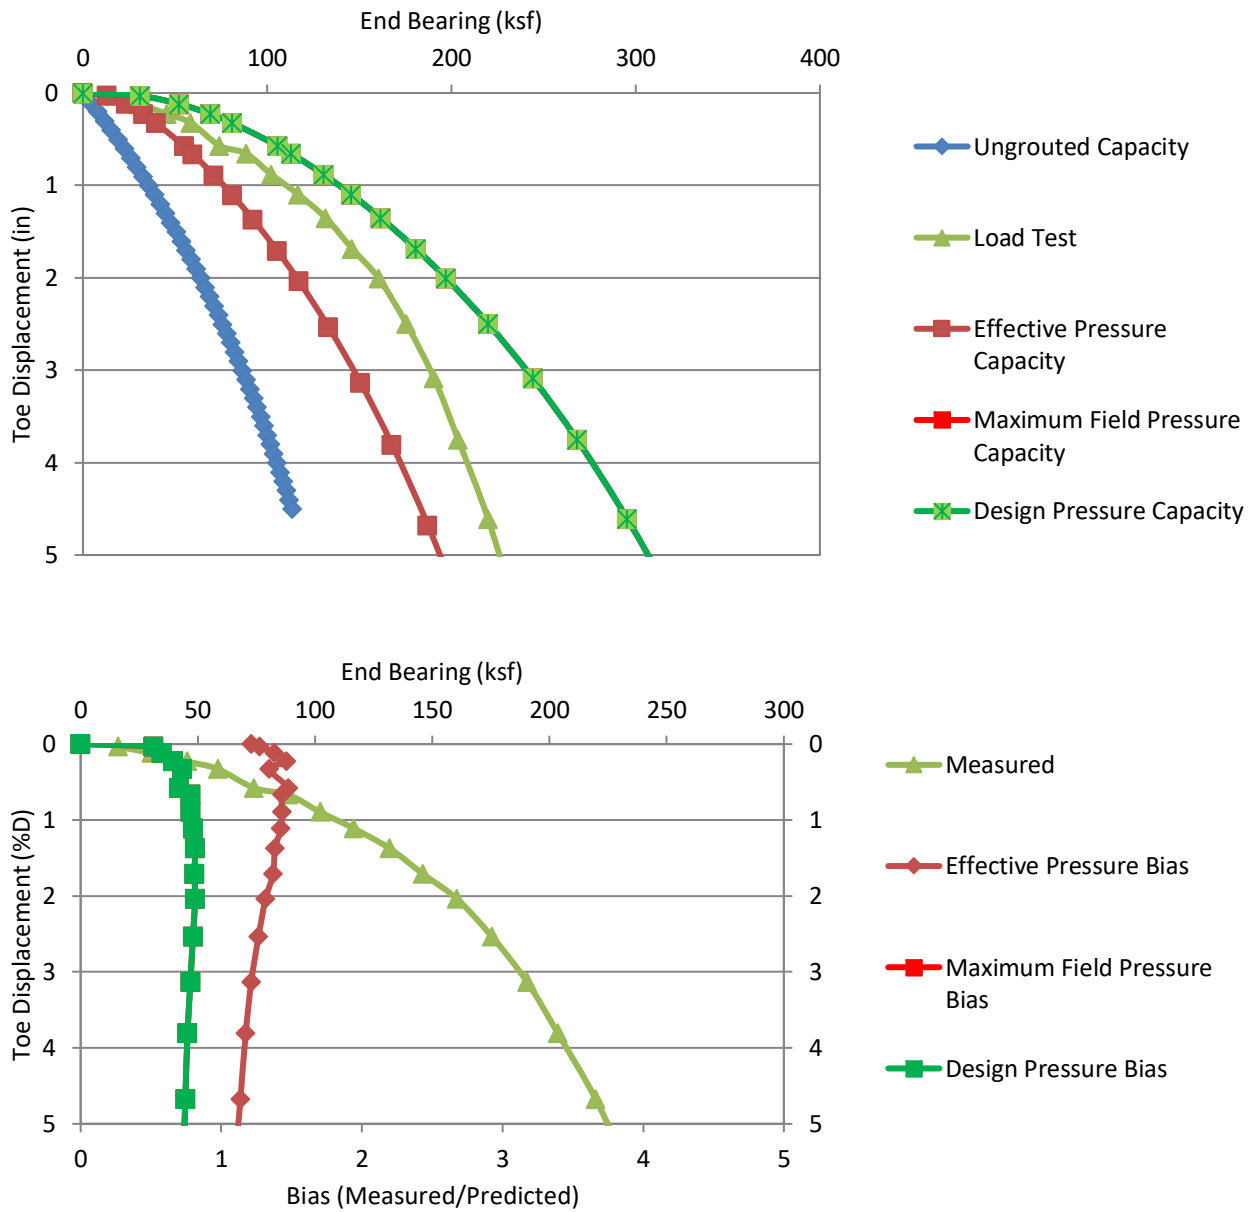
Figure 4.19 Data set 6 predicted/design and load test response (top); bias vs disp. (bottom).

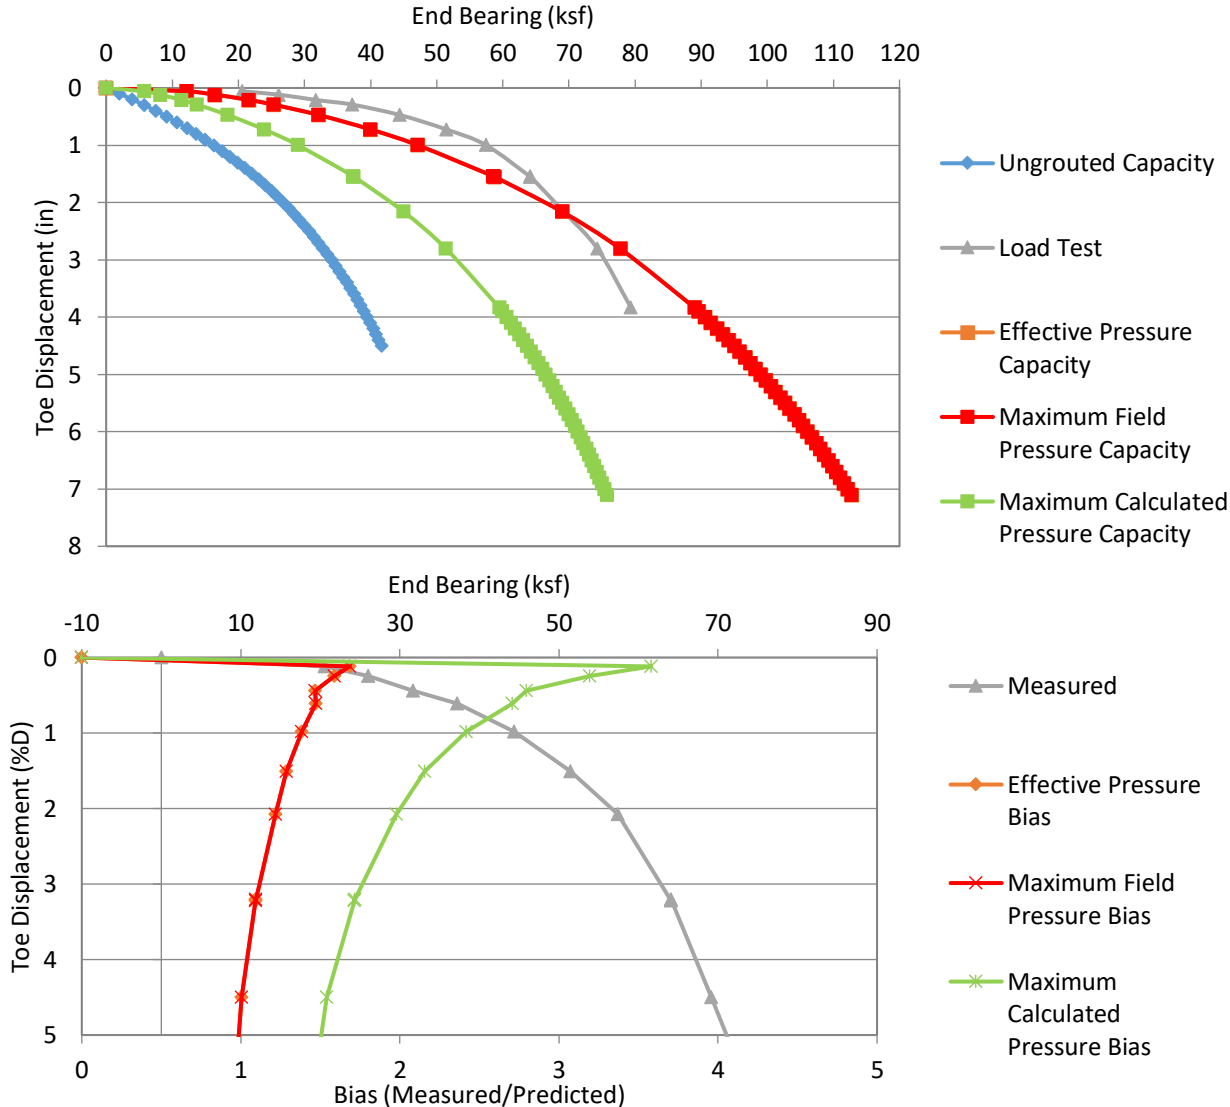
Figure 4.25 Data set 8 predicted/design and load test response (top); bias vs disp. (bottom).

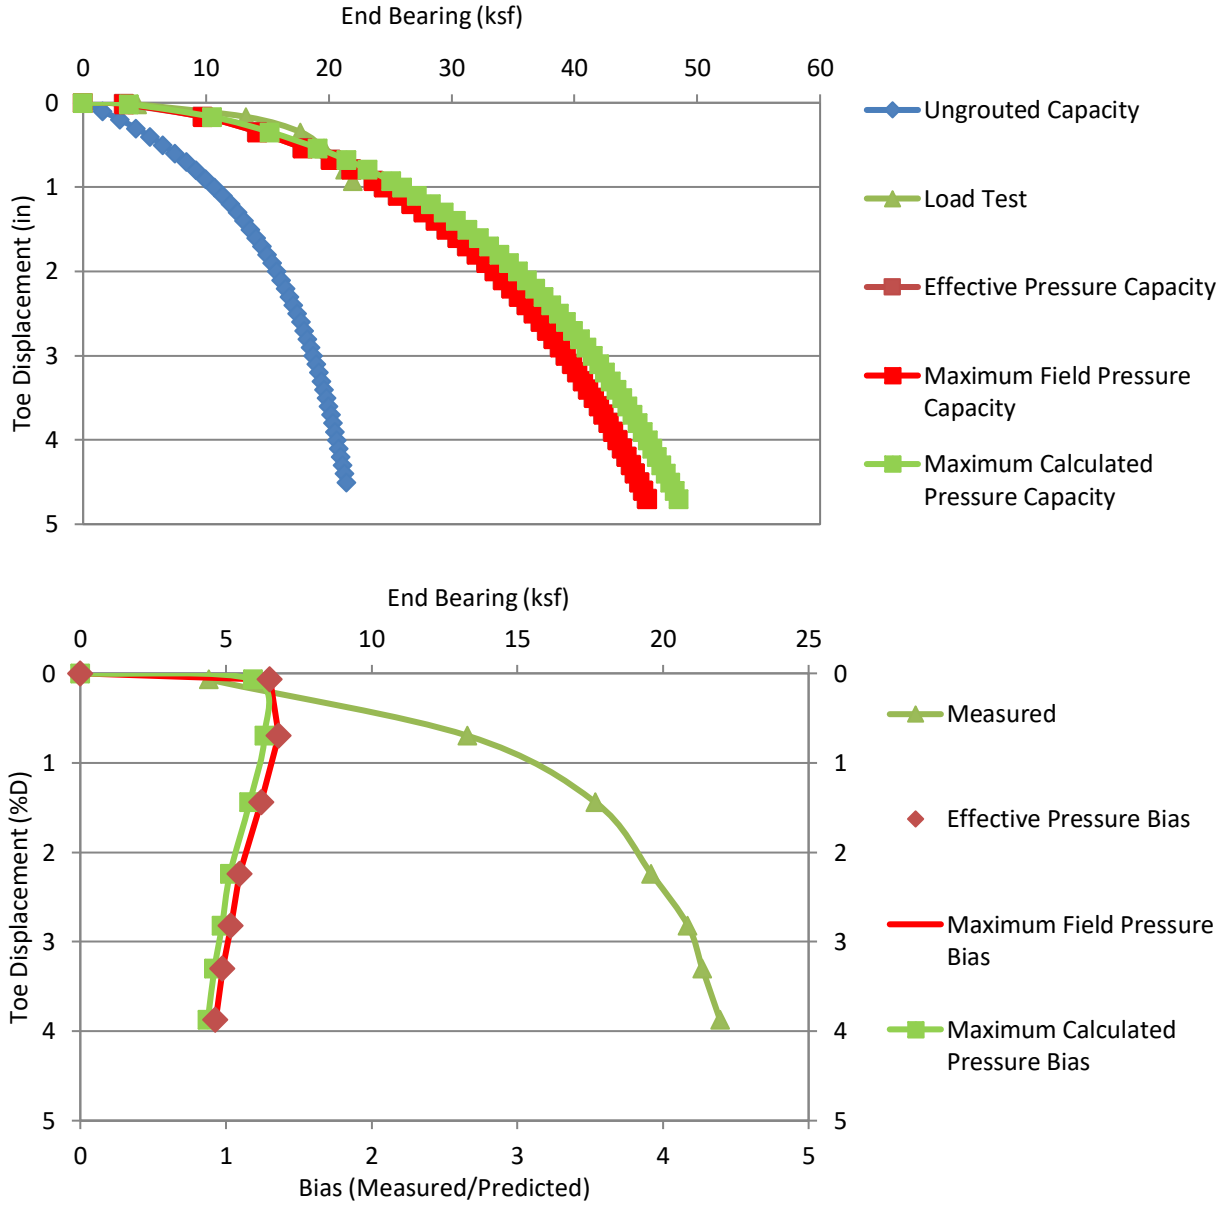
Figure 4.31 Data set 10 predicted/design and load test response (top); bias vs disp. (bottom).

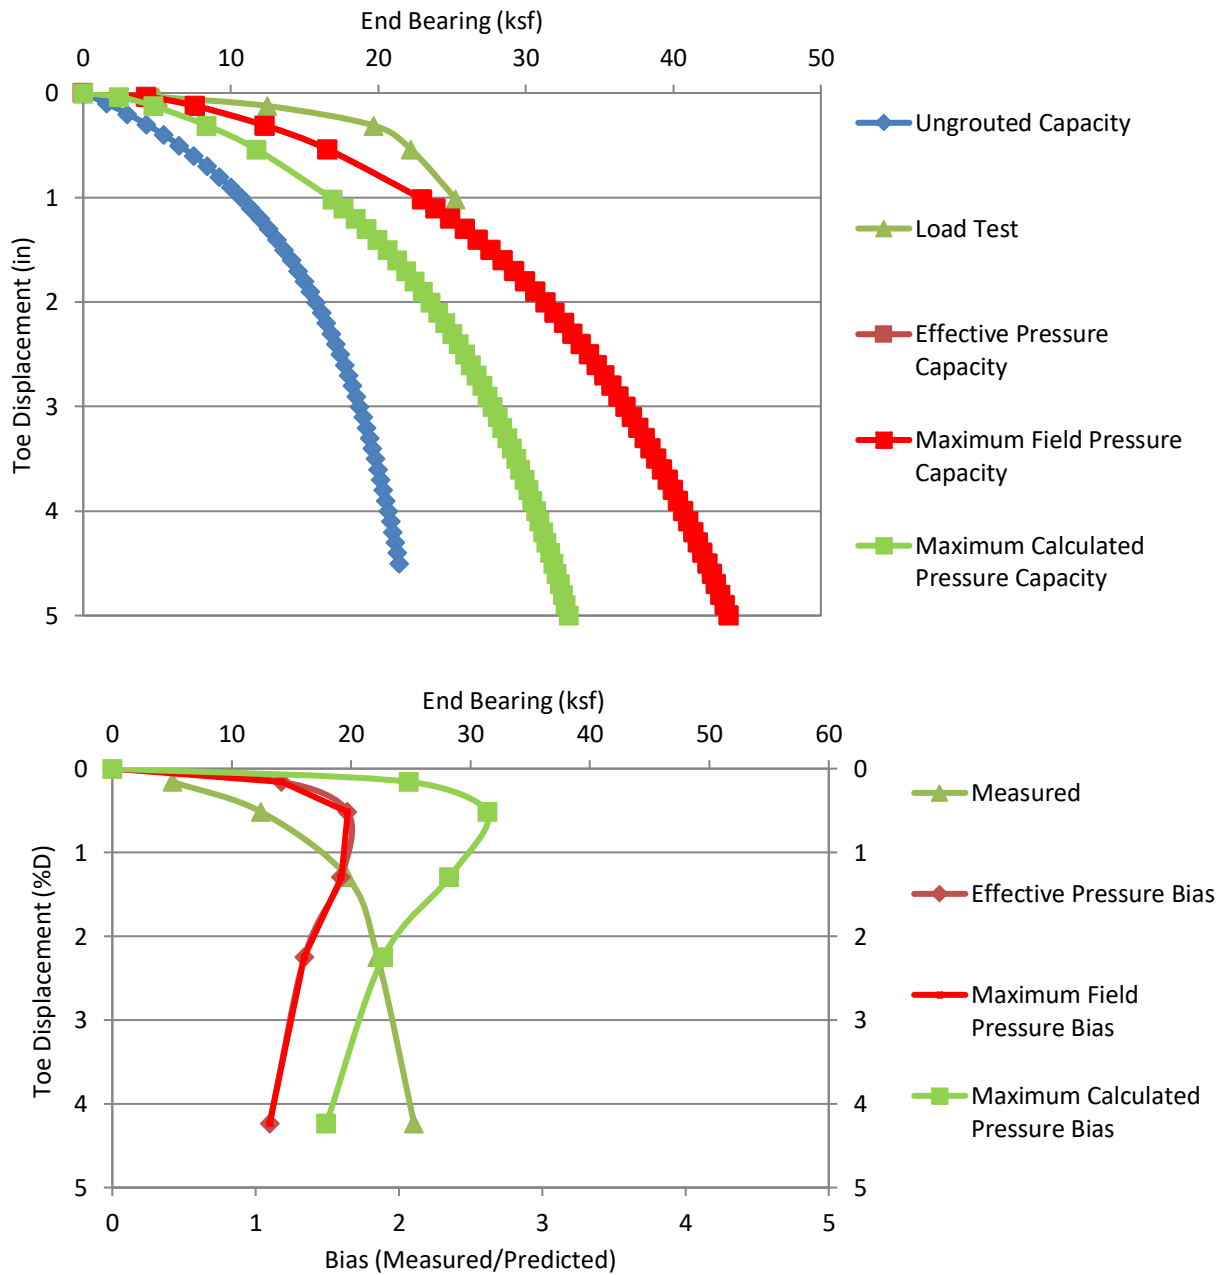
Figure 4.34 Data set 11 predicted/design and load test response (top); bias vs disp. (bottom).

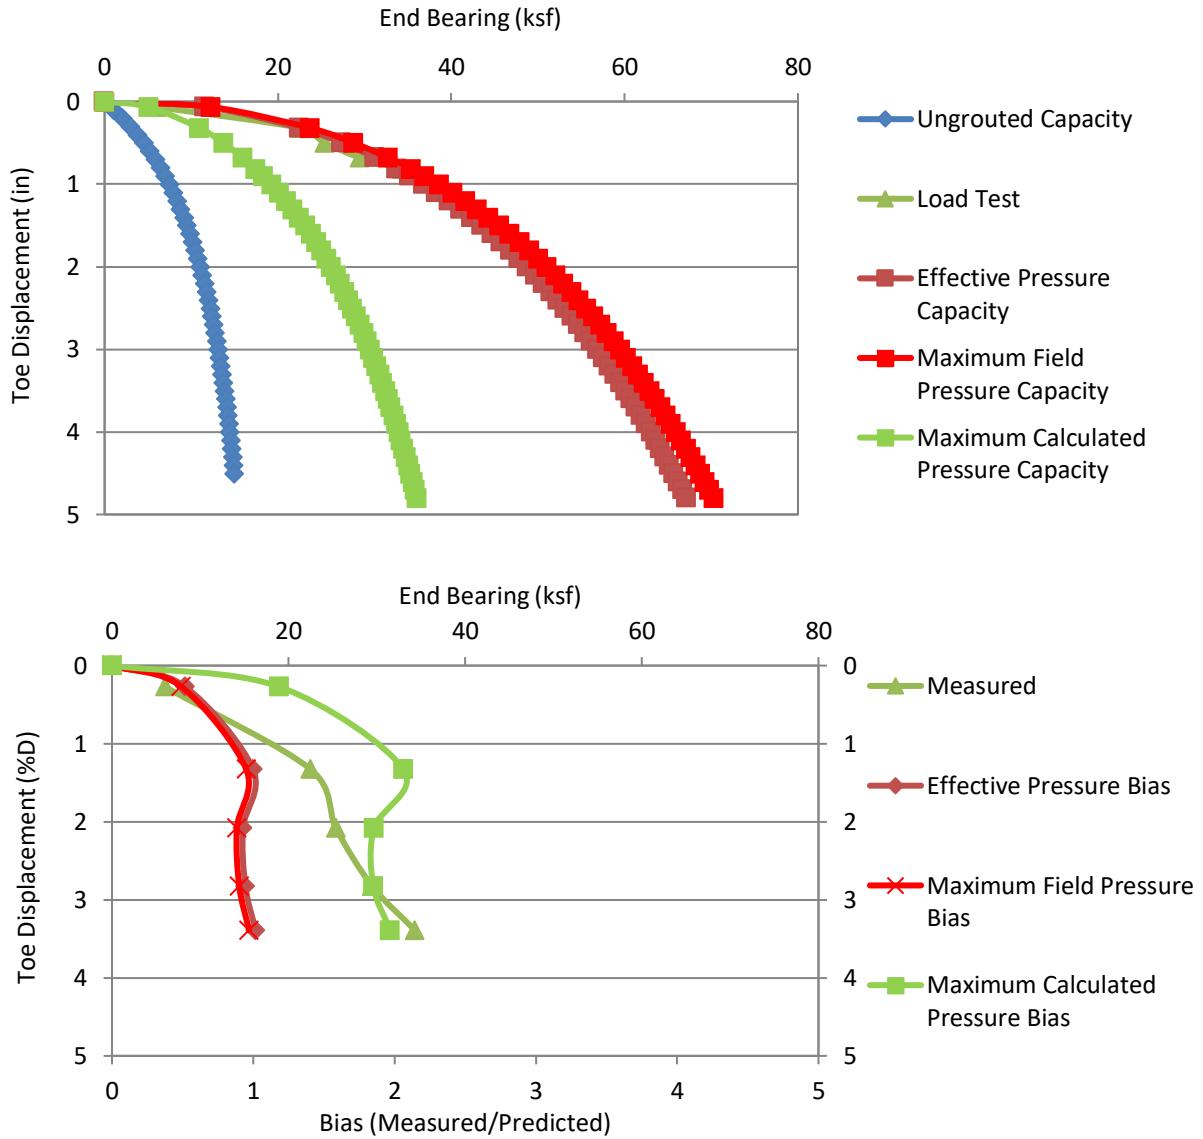
Figure 4.40 Data set 13 predicted/design and load test response (top); bias vs disp. (bottom).

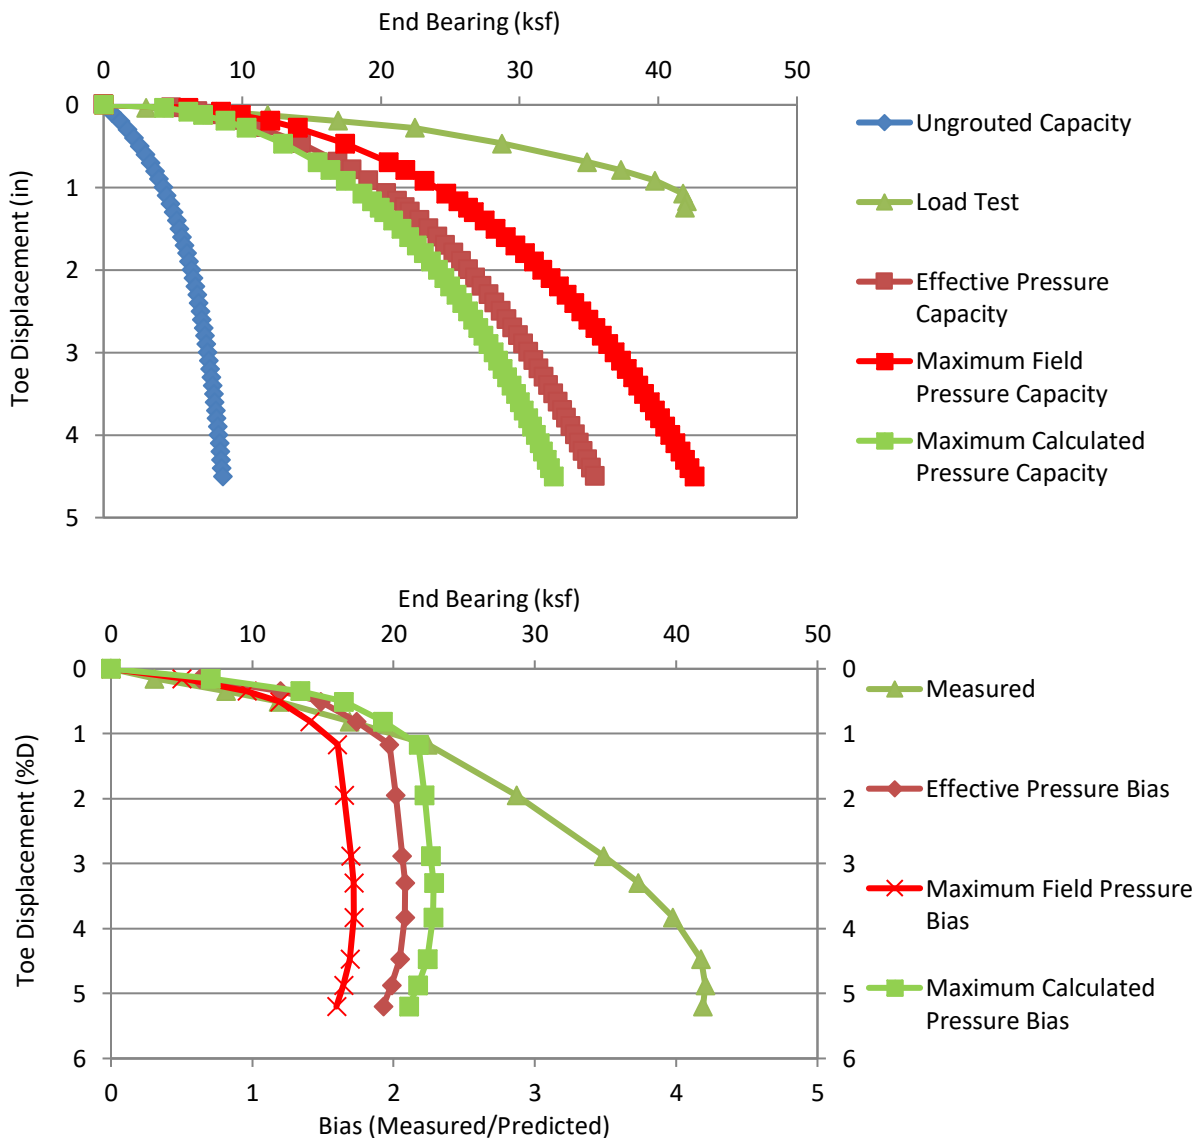
Figure 4.46 Data set 15 predicted/design and load test response (top); bias vs disp. (bottom).

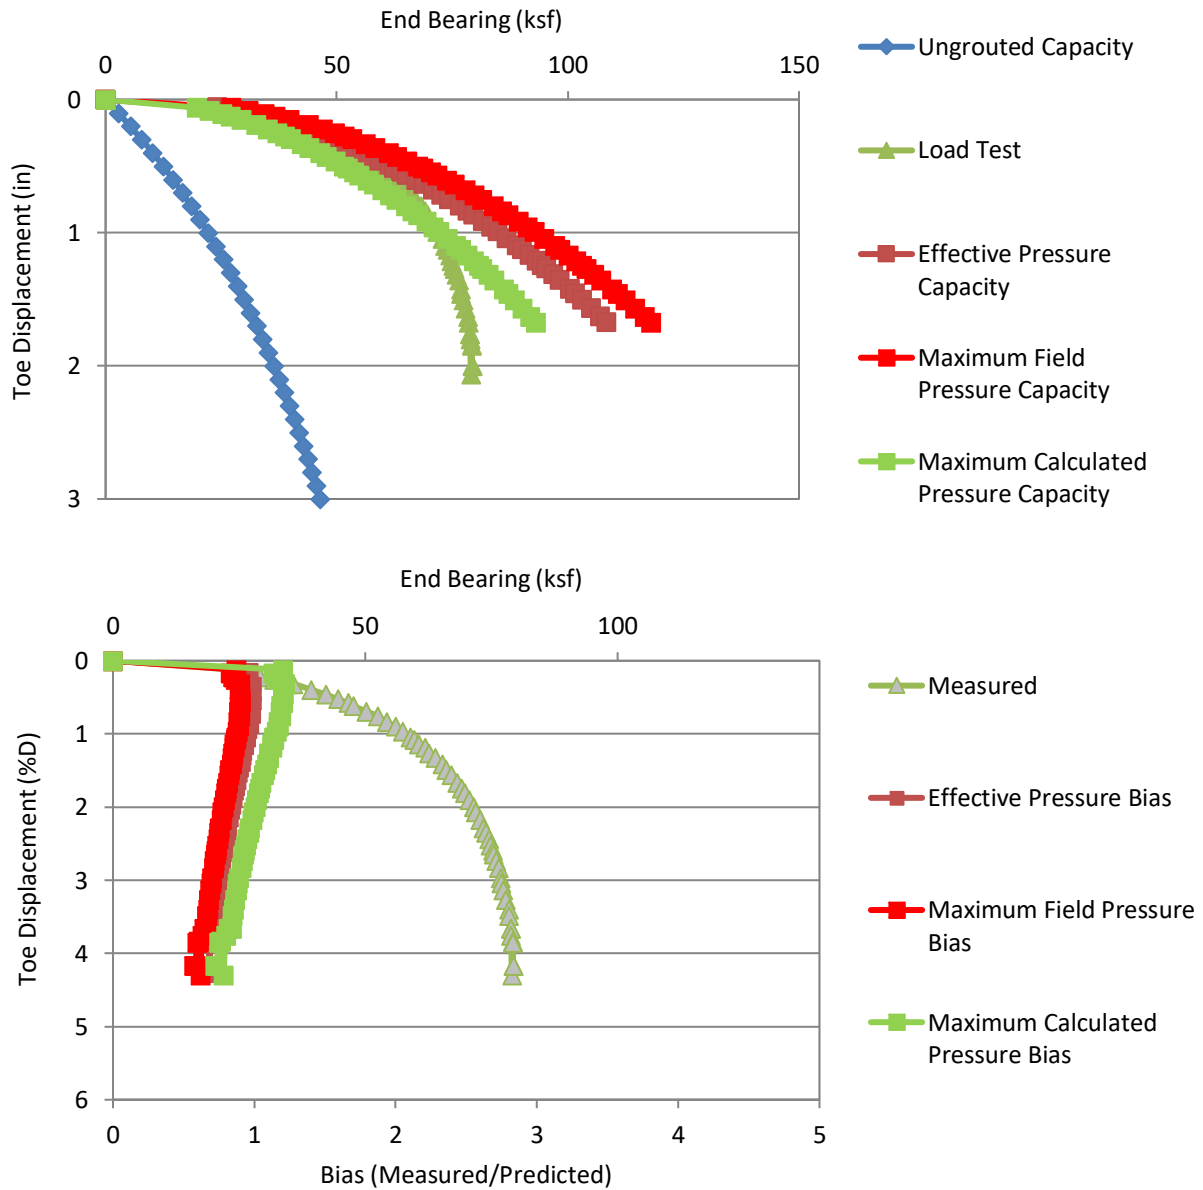
Figure 4.52 Data set 17 predicted/design and load test response (top); bias vs disp. (bottom).
