**LOAD AND RESISTANCE FACTOR DESIGN (LRFD) RESISTANCE
FACTORS FOR TIP GROUTED DRILLED SHAFTS**

BDV25-977-37

FINAL REPORT

September 2019

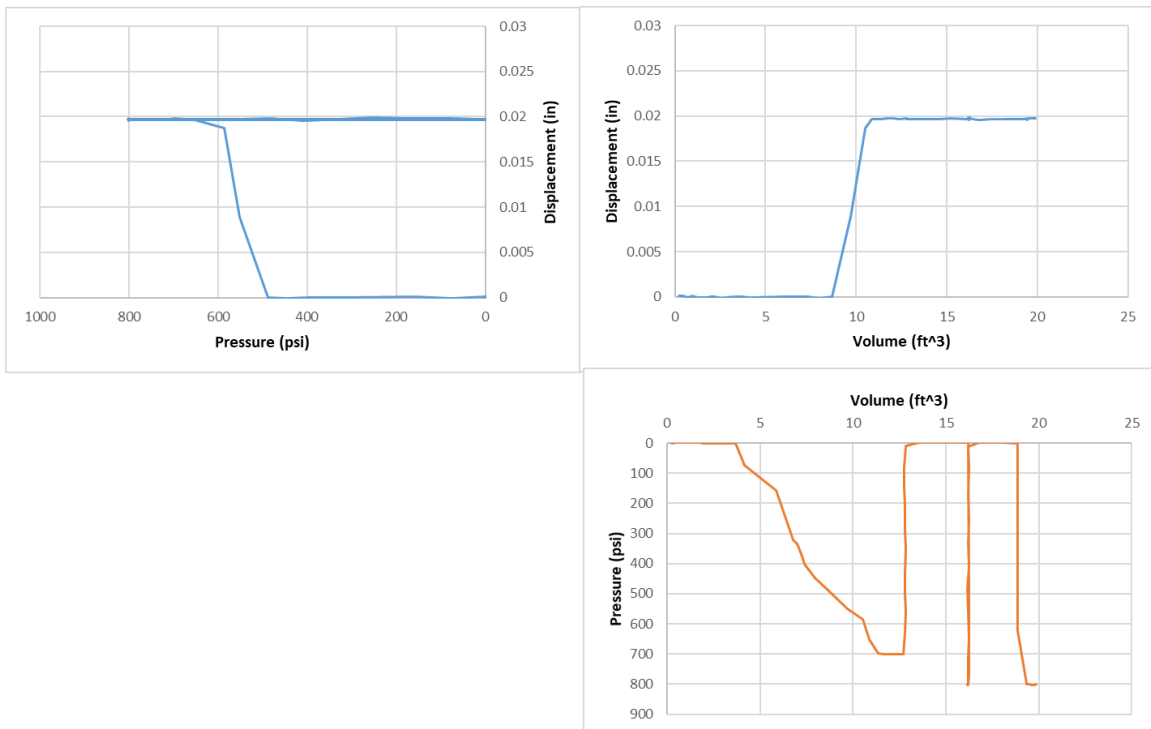
Figure 4.54 Data set 18 tri-axis plots.

Figure 4.54 shows the tri-axis plots for data set 18 and indicates two issues only visible when using the effectiveness plots. Both the pressure vs. volume and volume vs. displacement show horizontal trends supporting end bearing failure or piping. Also, both the pressure vs. volume and pressure vs. uplift show spikes in pressure without an associated uplift or increase in volume which indicates a grout line blockage. Effective pressure was determined to be 700 psi which was sustainable up to the point where the grout line became blocked and spiked a maximum field recorded pressure of 800 psi.

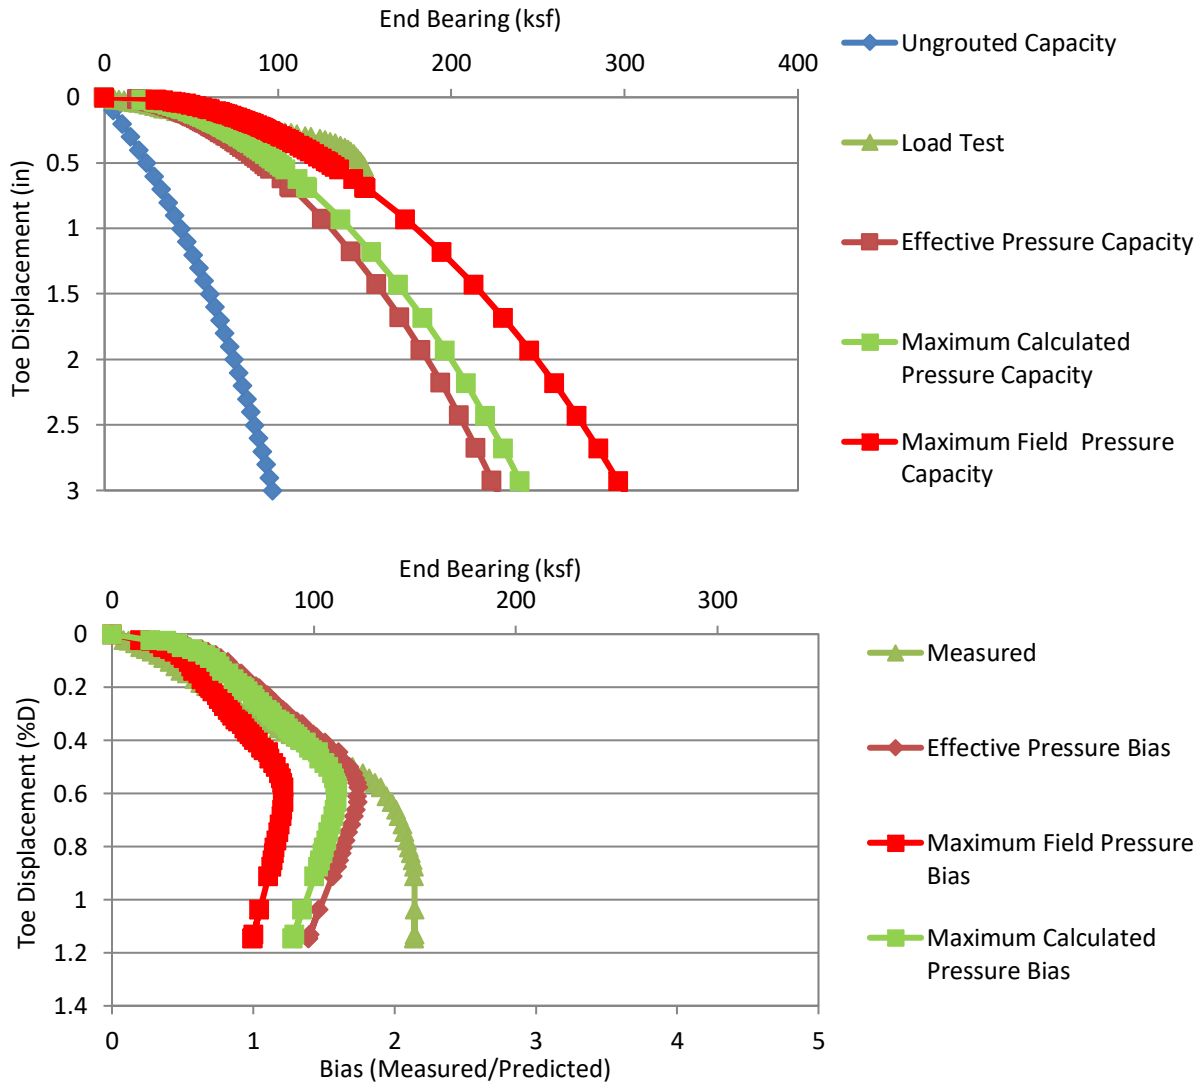
Figure 4.55 Data set 18 predicted/design and load test response (top); bias vs disp. (bottom).

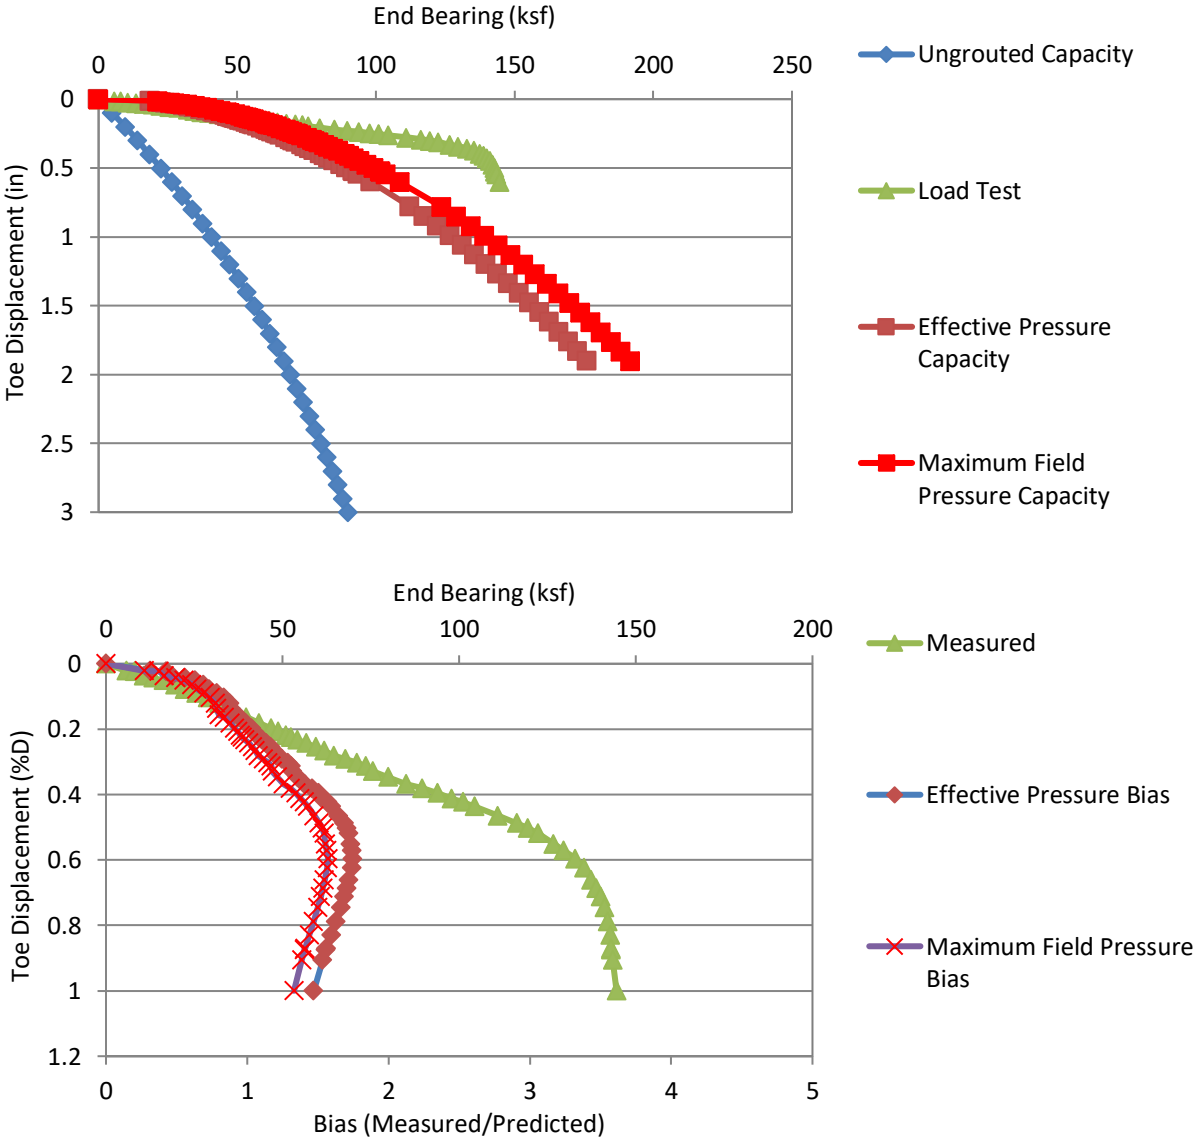
Figure 4.58 Data set 19 predicted/design and load test response (top); bias vs disp. (bottom).

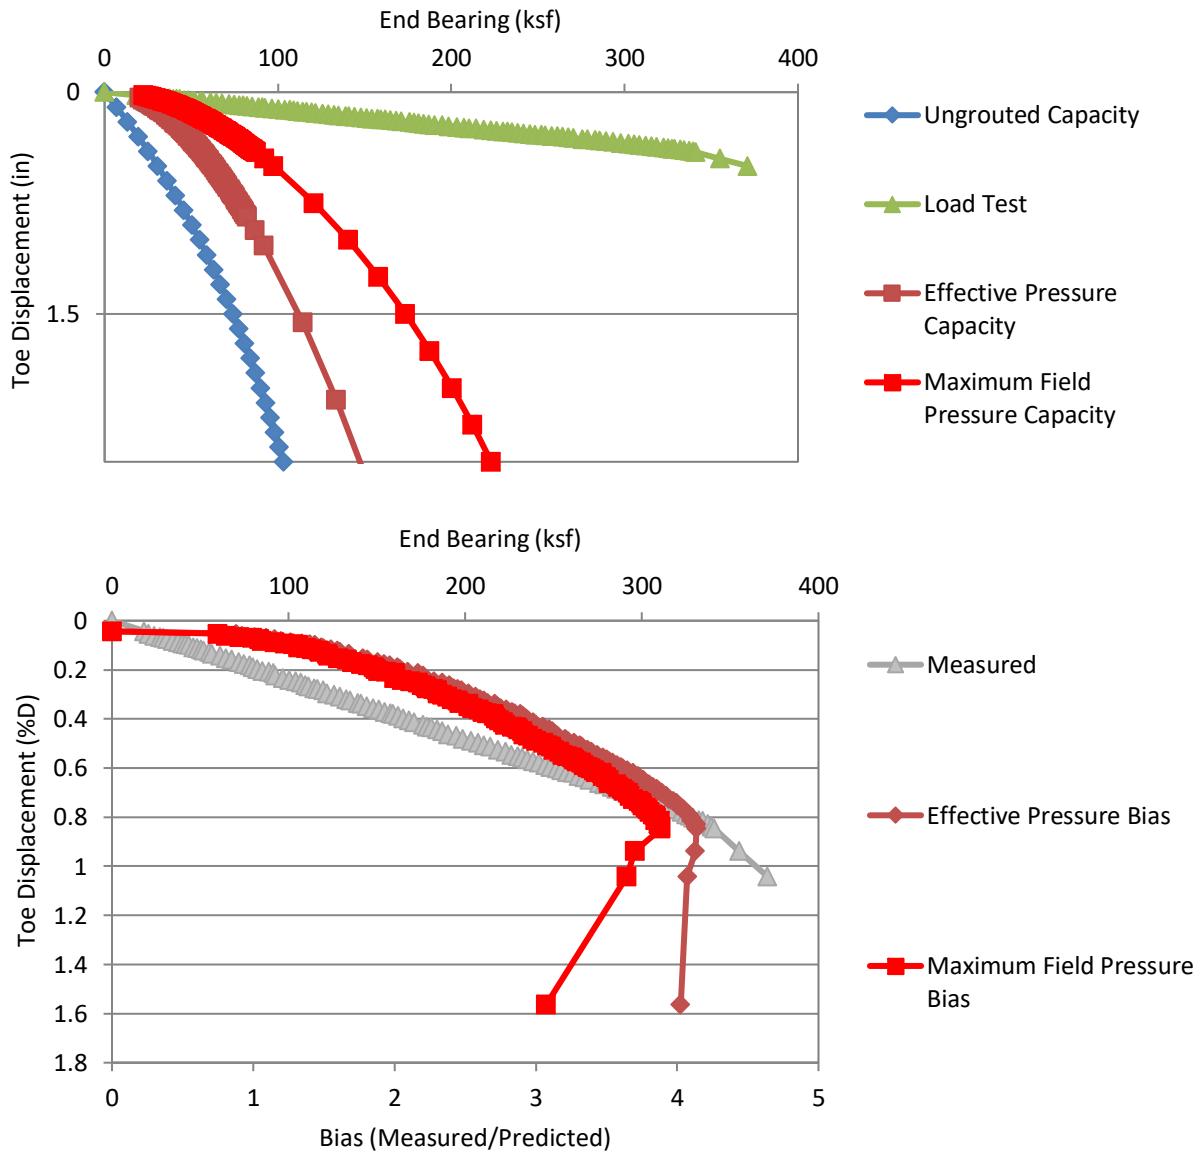
Figure 4.64 Data set 21 predicted/design and load test response (top); bias vs disp. (bottom).

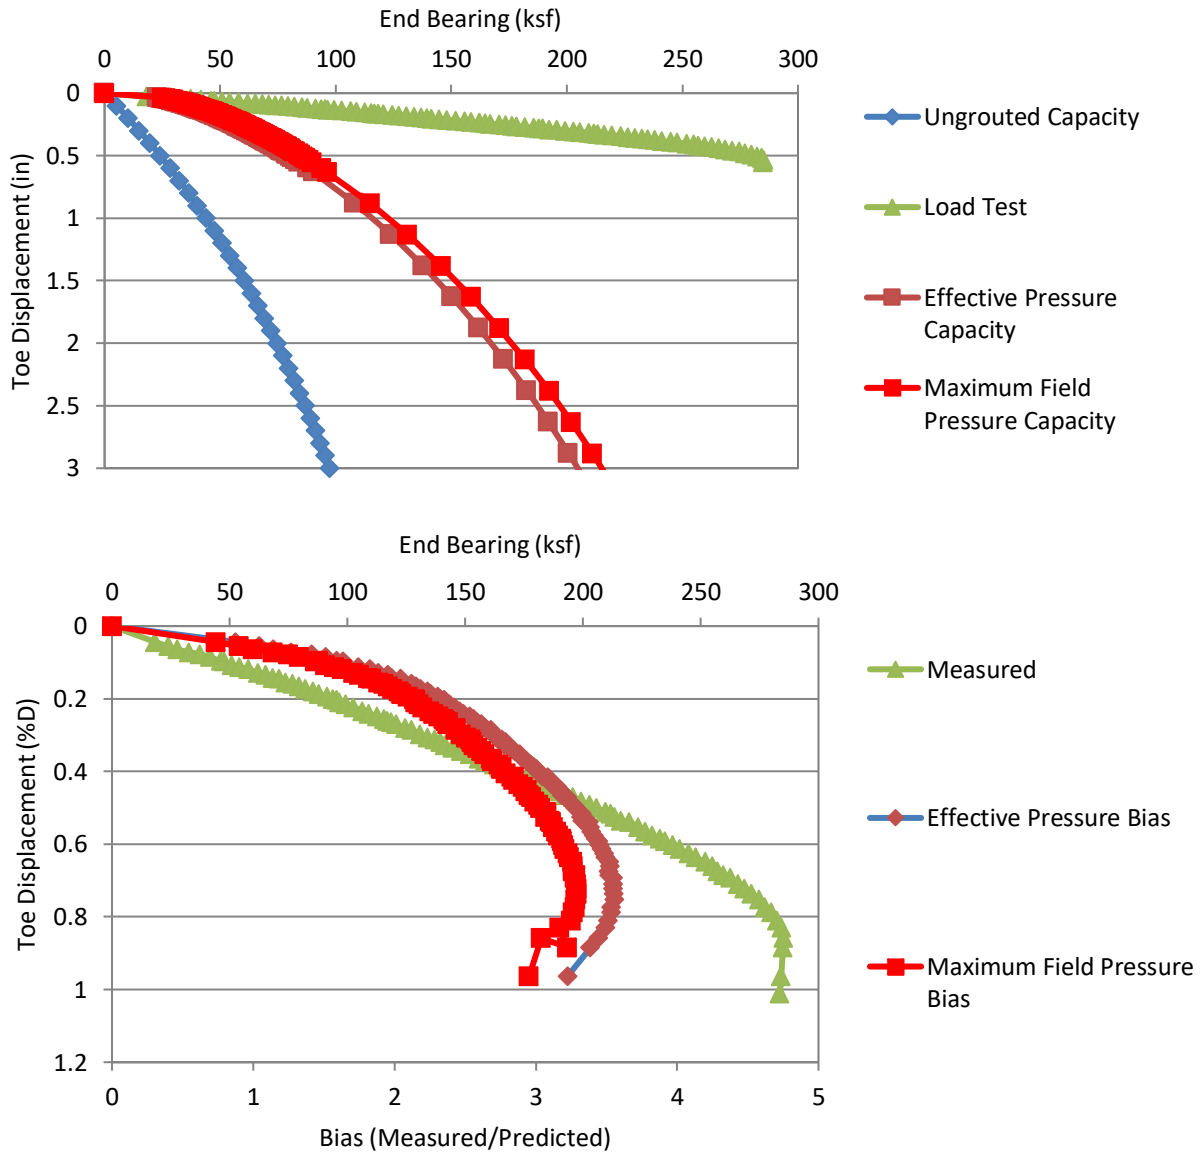
Figure 4.69 Data set 23 predicted/design and load test response (top); bias vs disp. (bottom).

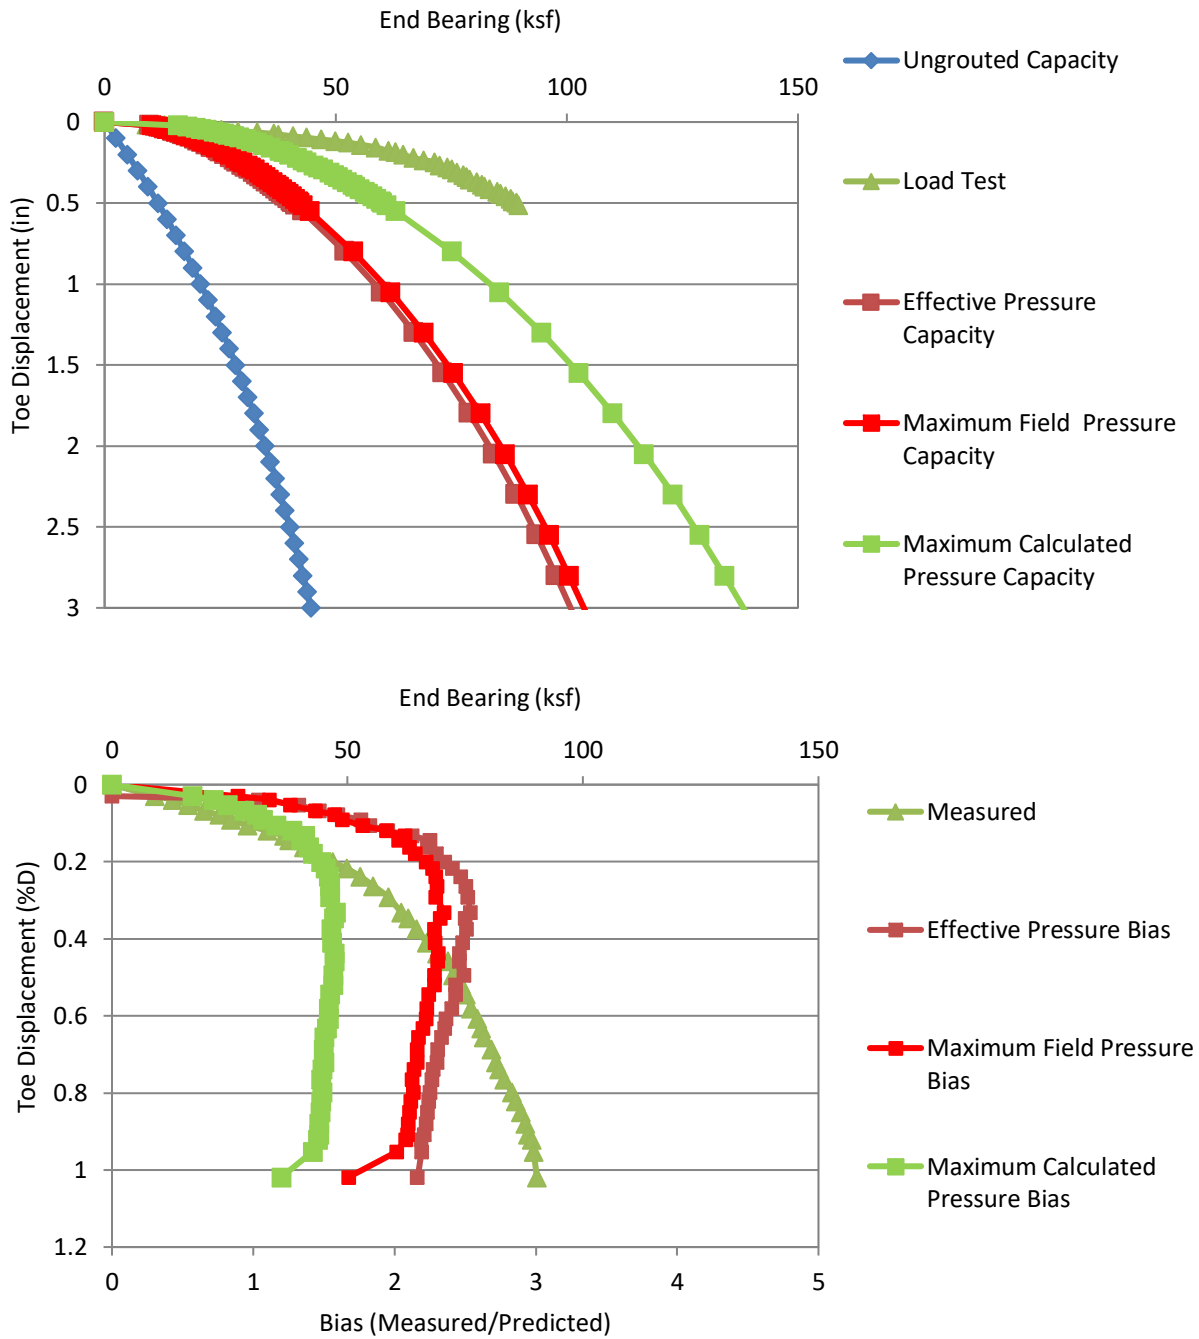
Figure 4.81 Data set 27 predicted/design and load test response (top); bias vs disp. (bottom).

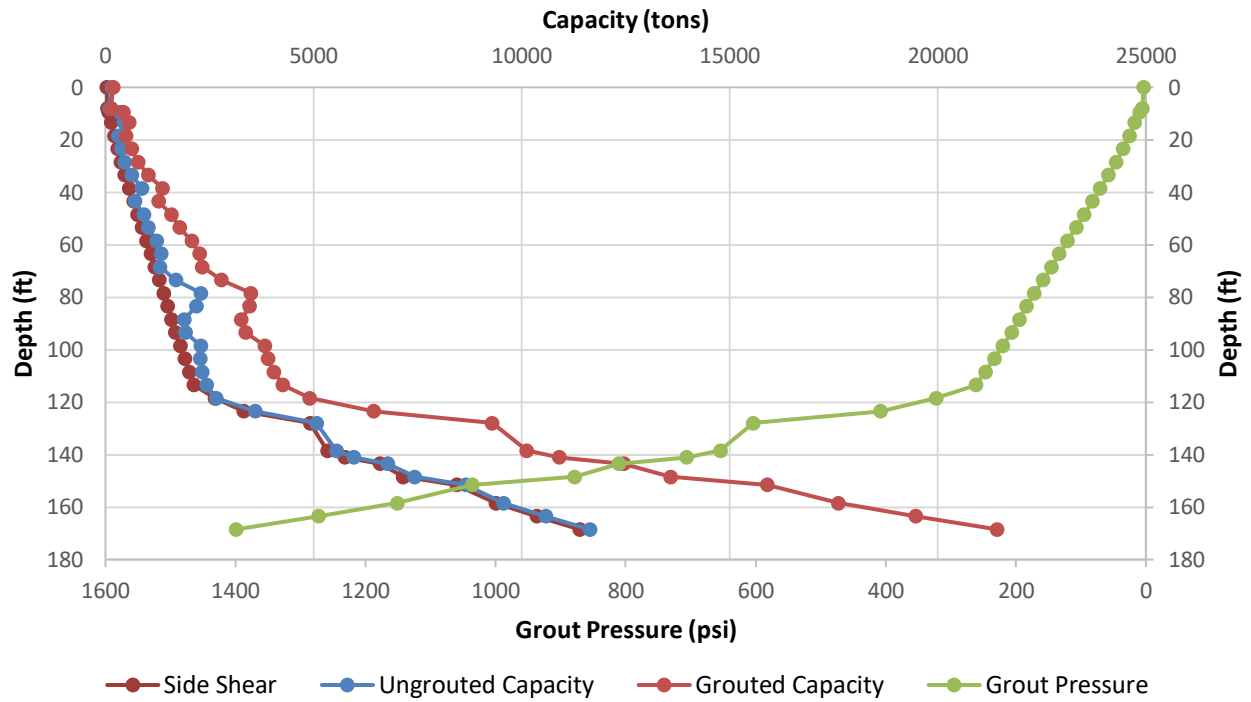
Figure 4.82 Data set 28 design curves.

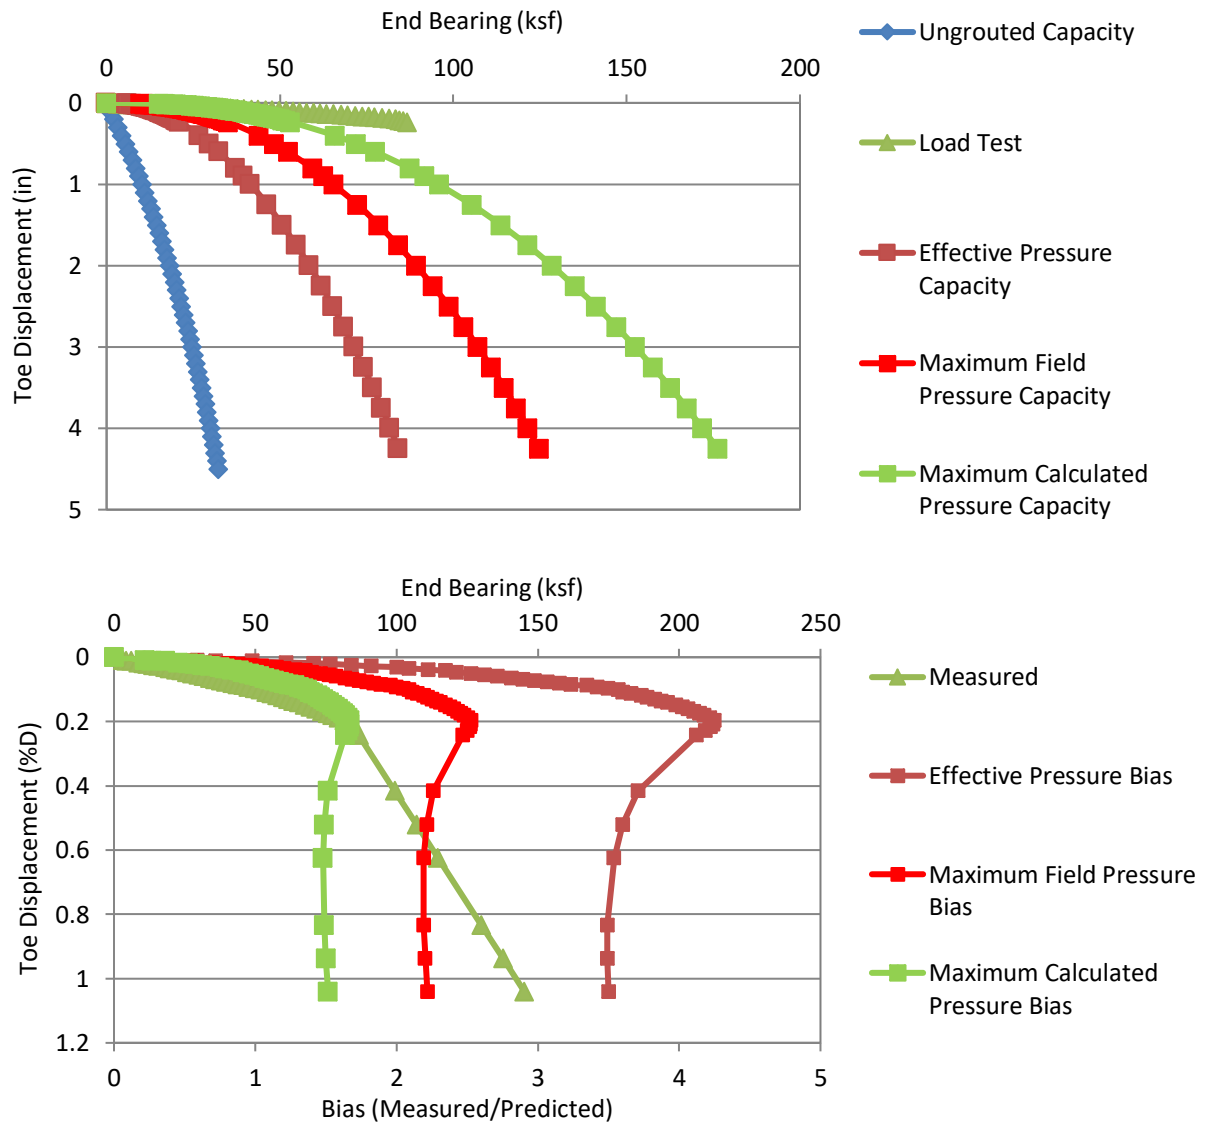
Figure 4.90 Data set 30 predicted/design and load test response (top); bias vs disp. (bottom).

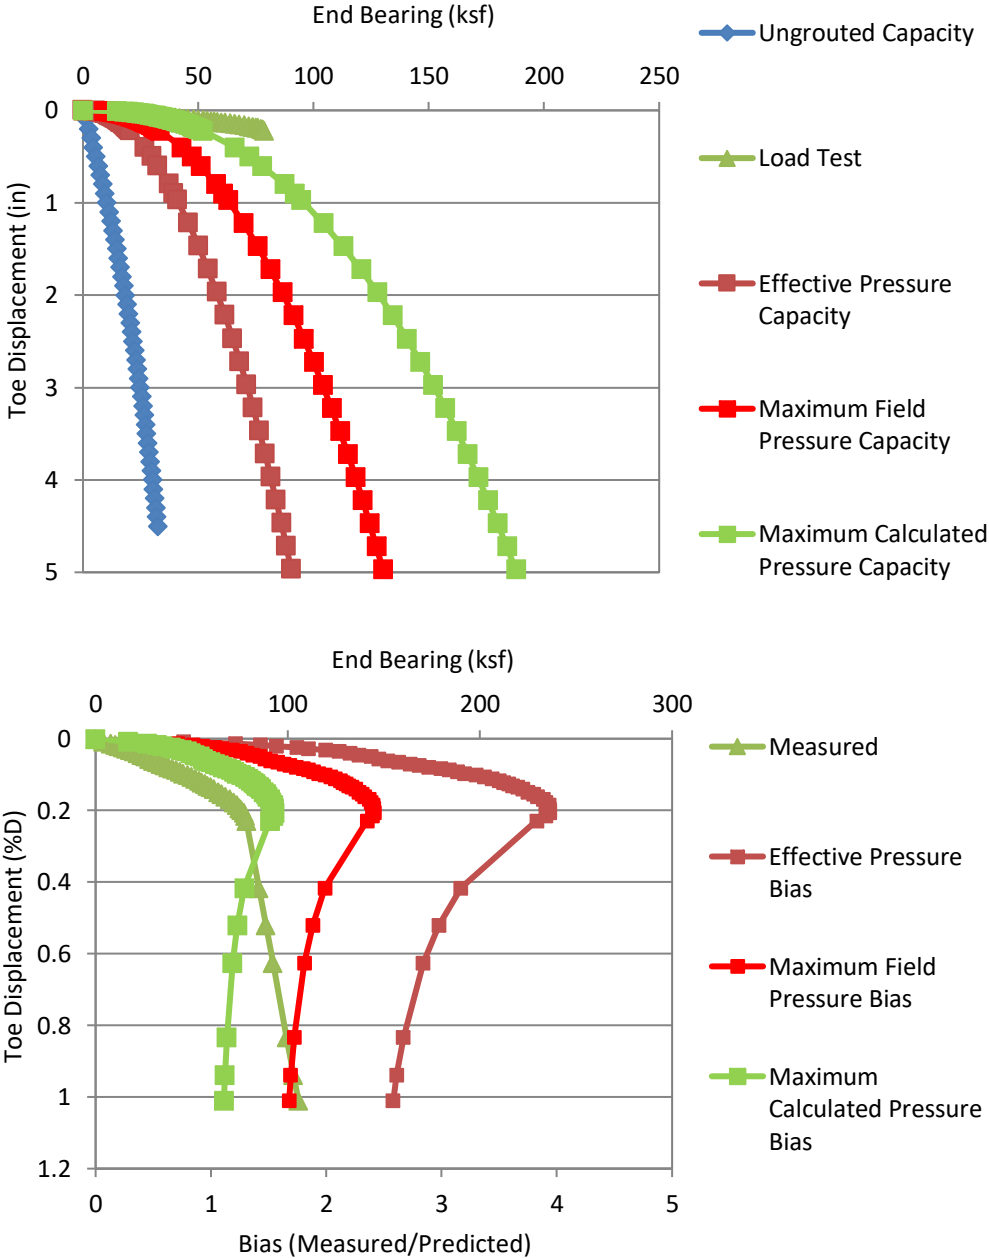
Figure 4.93 Data set 31 Predicted/design and load test response (top); bias vs disp. (bottom)

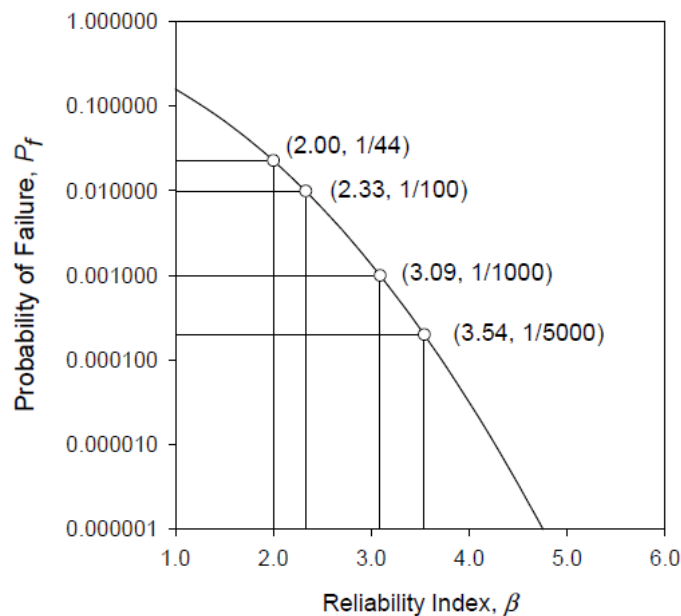
Figure 5.1 Reliability index vs probability of failure (Allen, 2005).

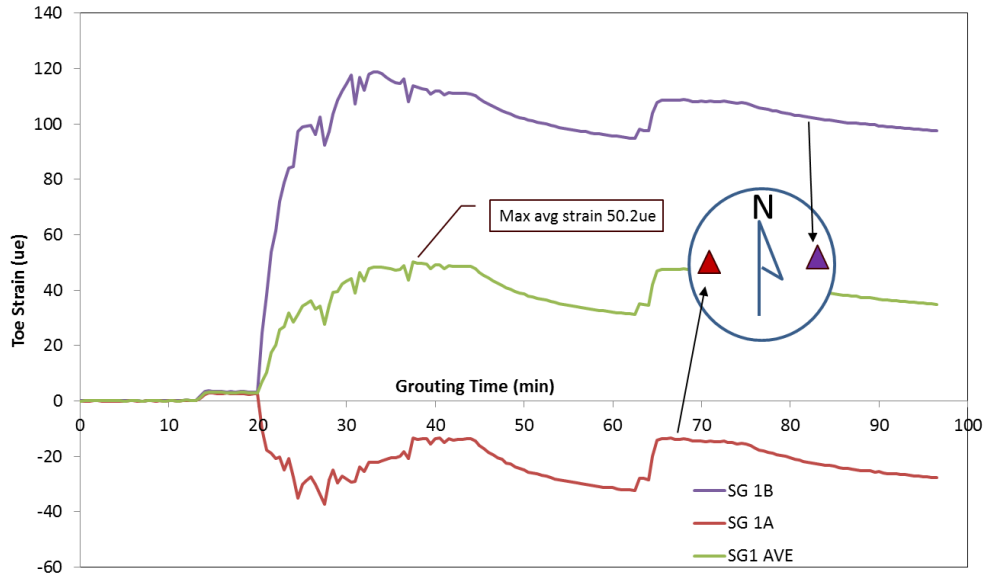
Figure 5.9 Eccentric grout bulb formation noted by strain gauges.

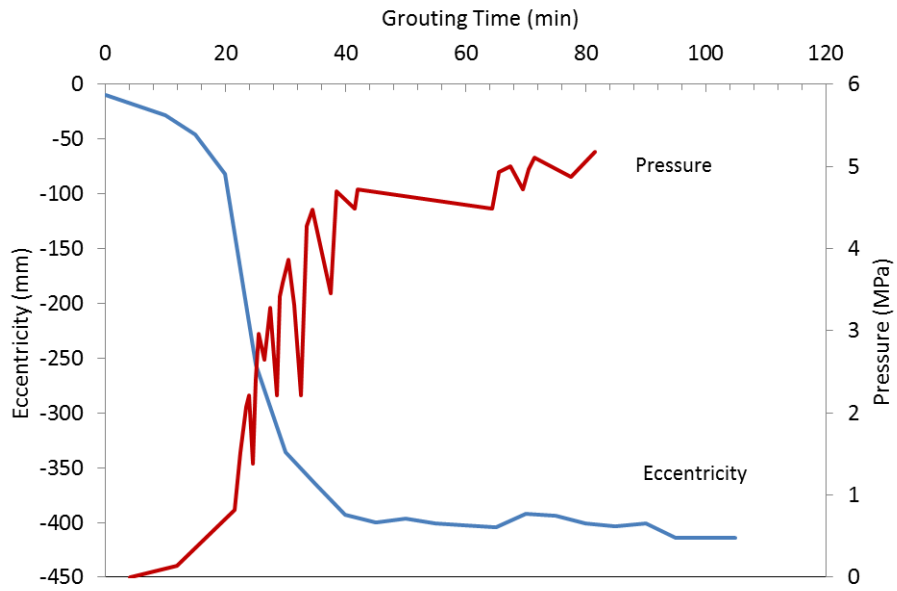
Figure 5.10 Eccentricity as a function of grouting time.

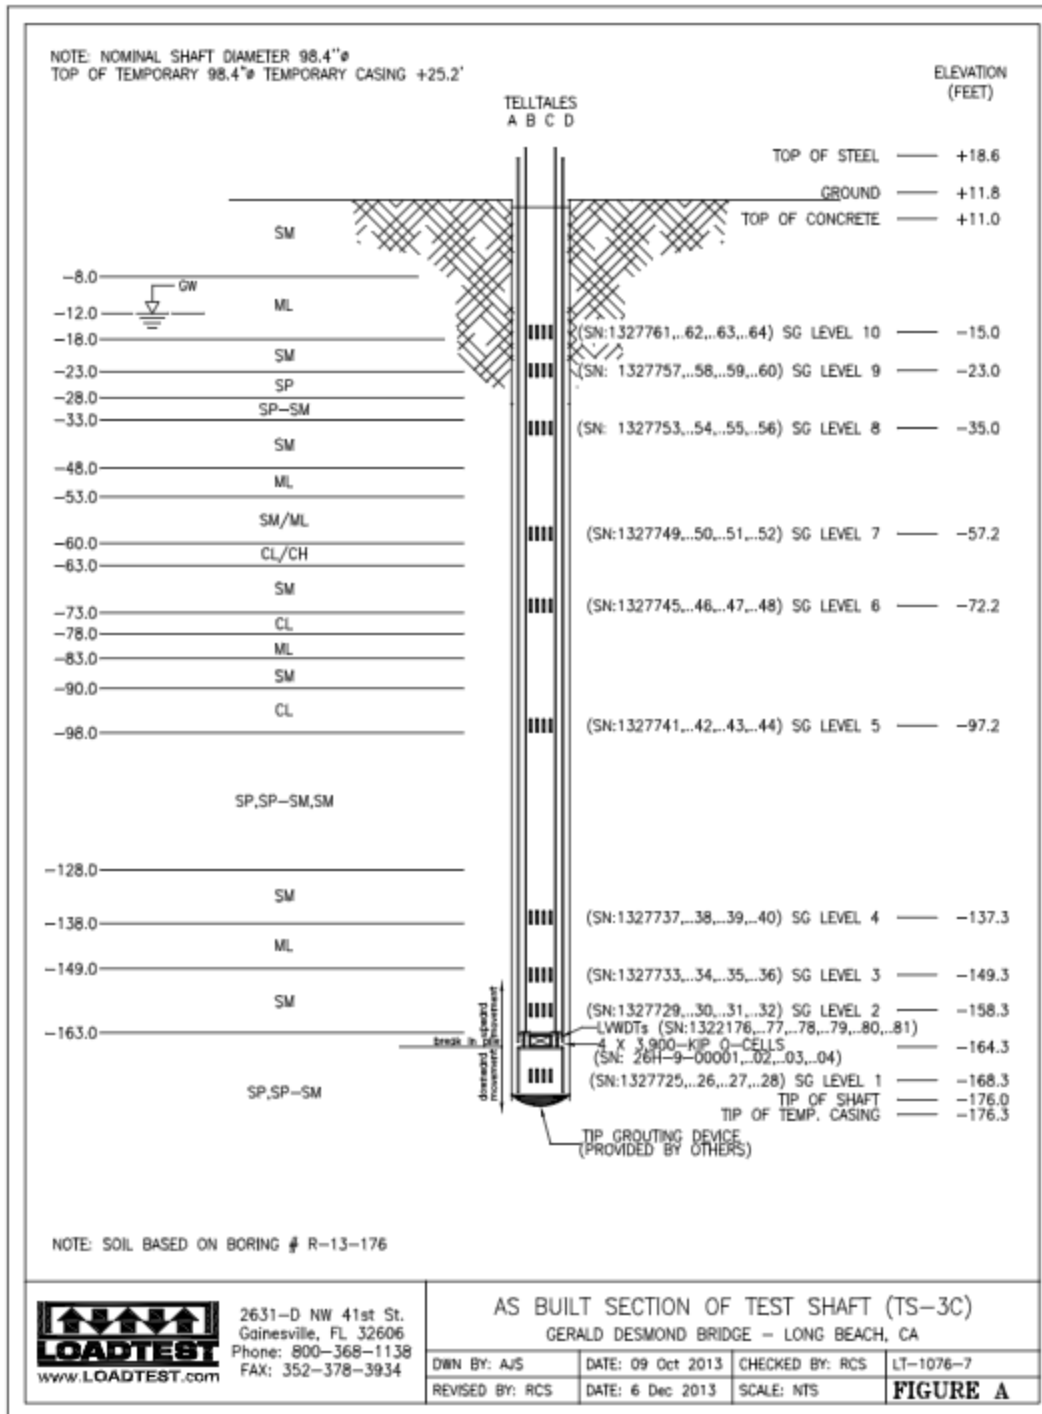
Figure A.6 Data set 6 soil information

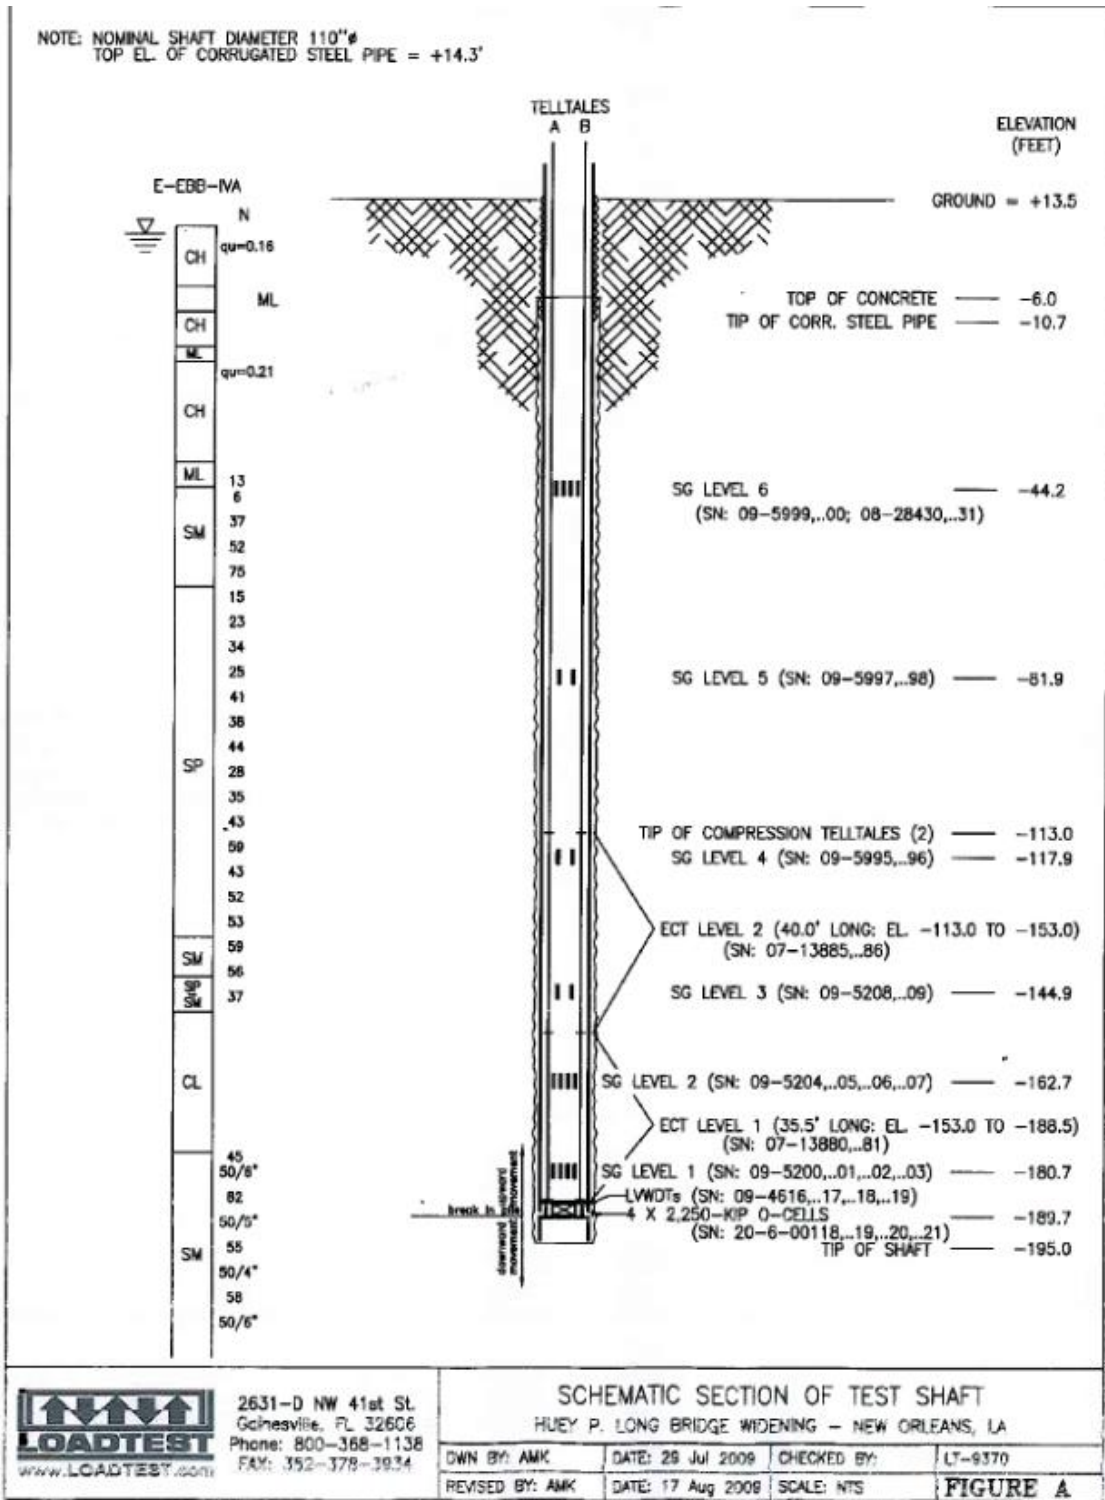
Figure A.7 Data set 7 soil information

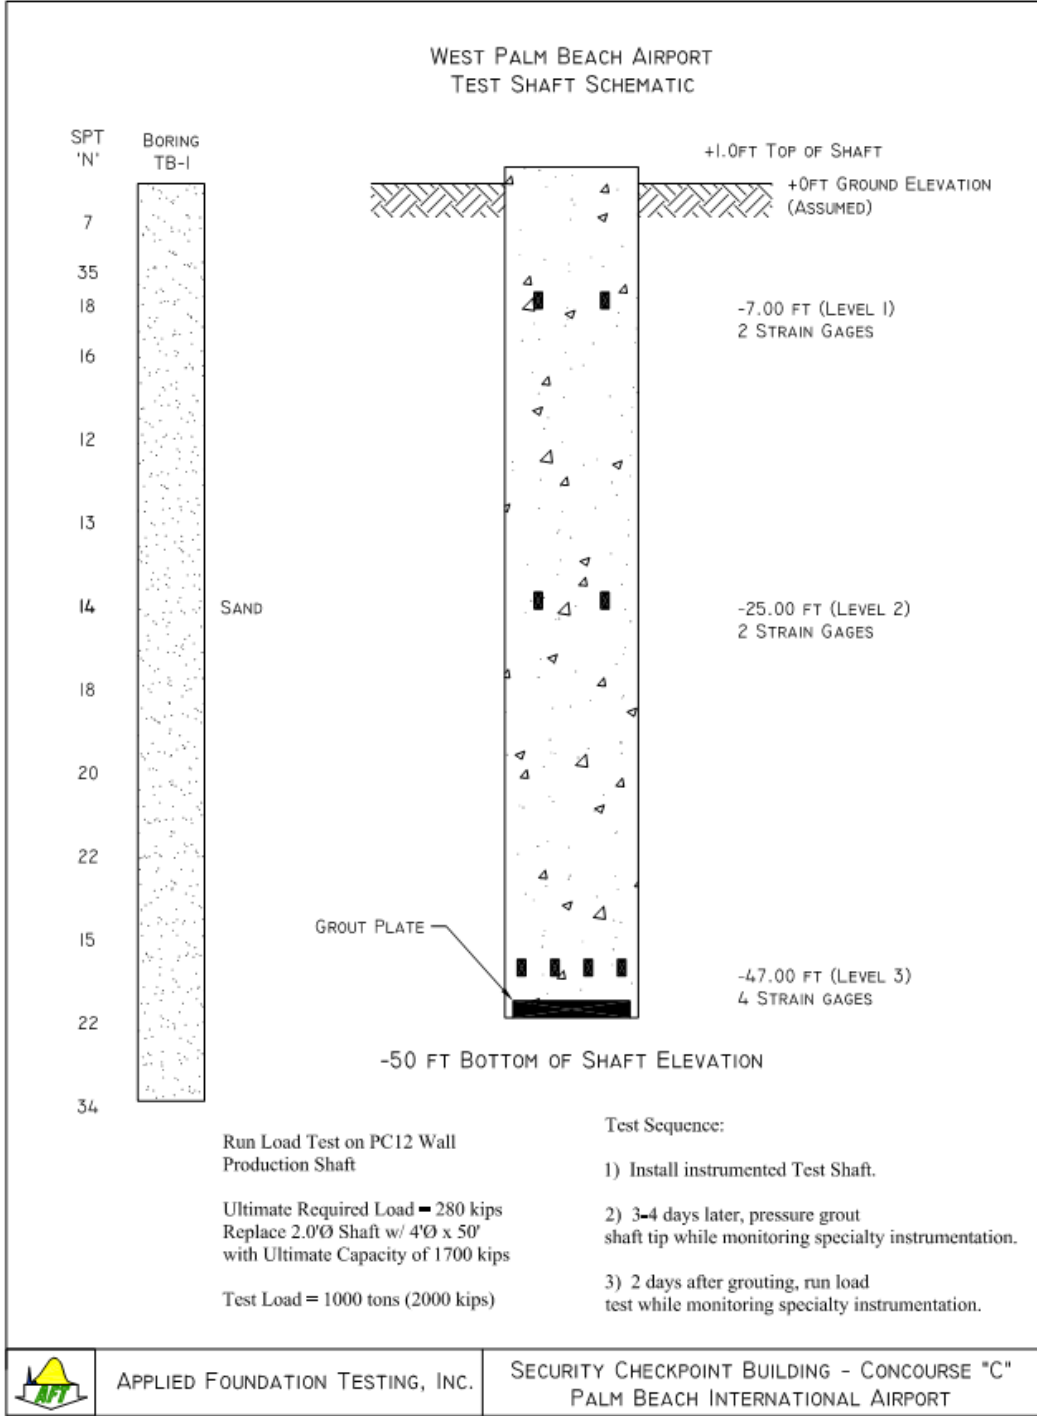
Figure A.17 Data set 17 soil information

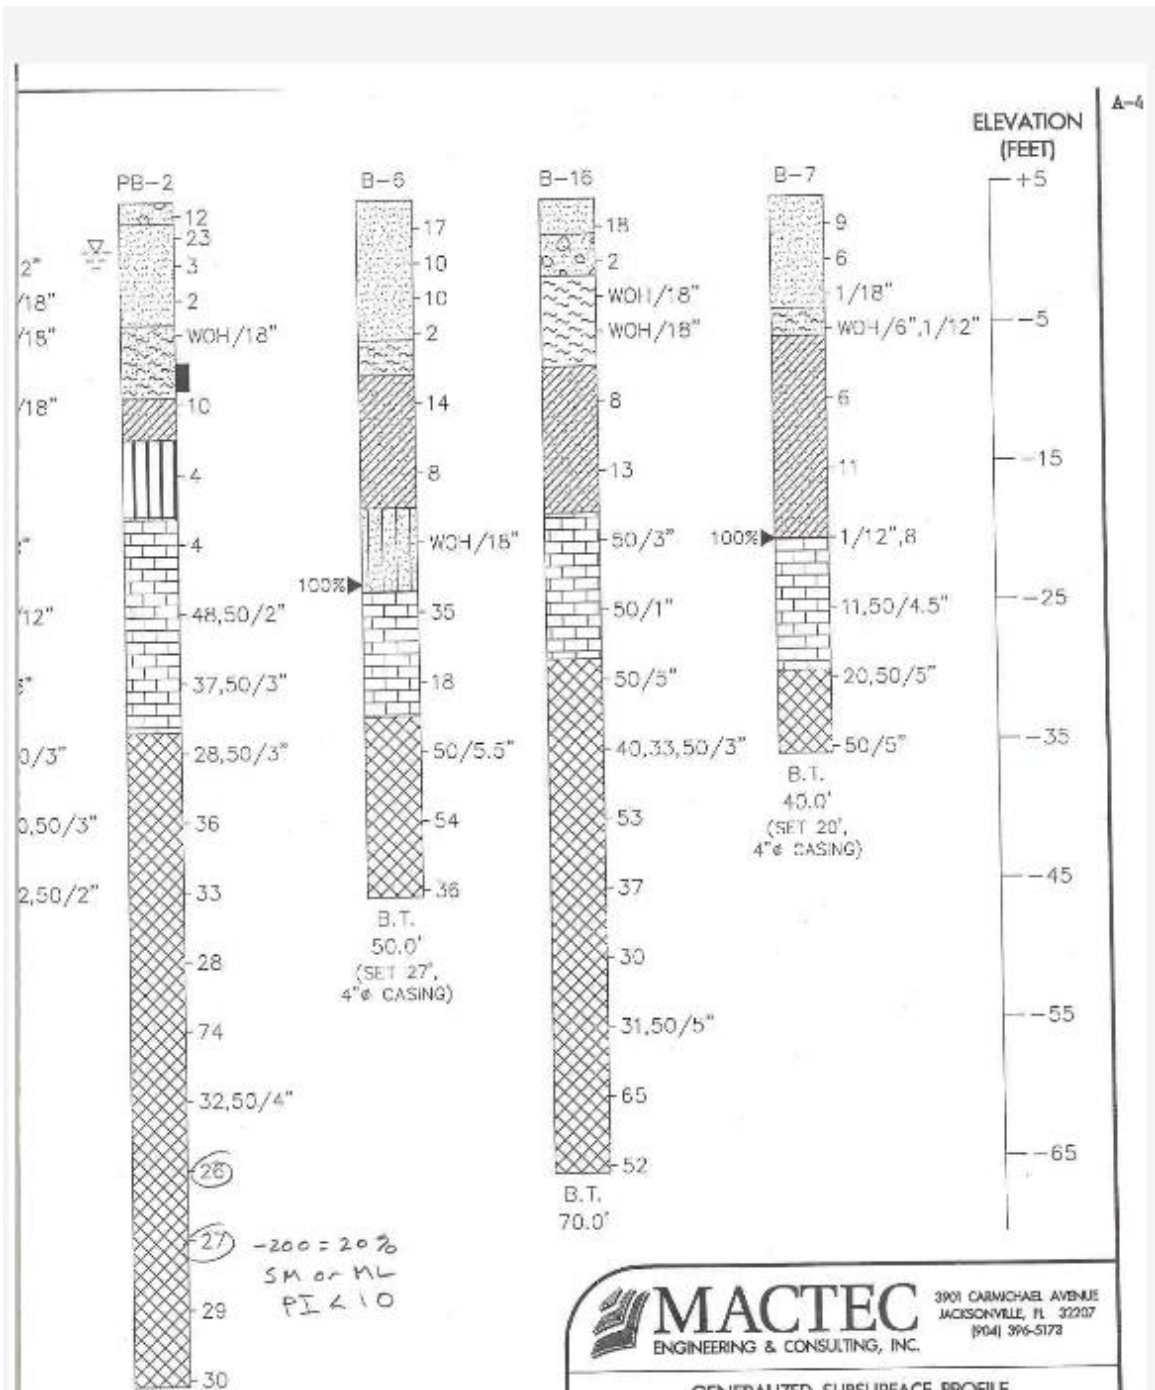
Figure A.29b Data set 29 soil information

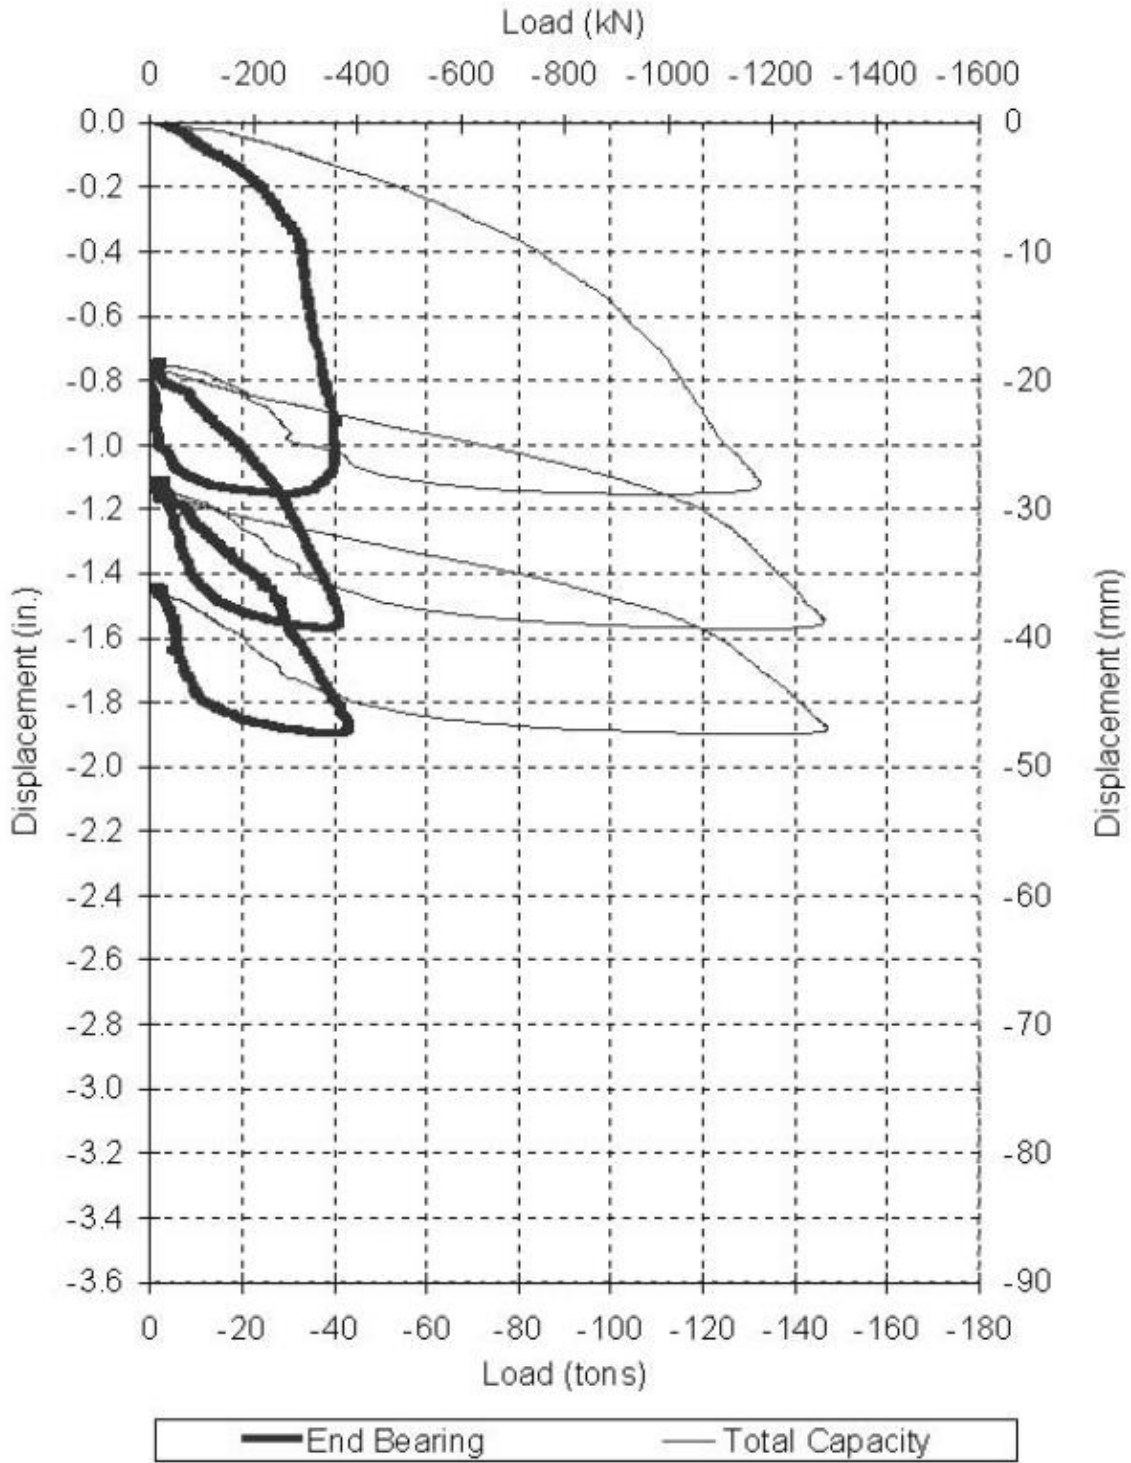
Figure B.11 Data set 11 load test results

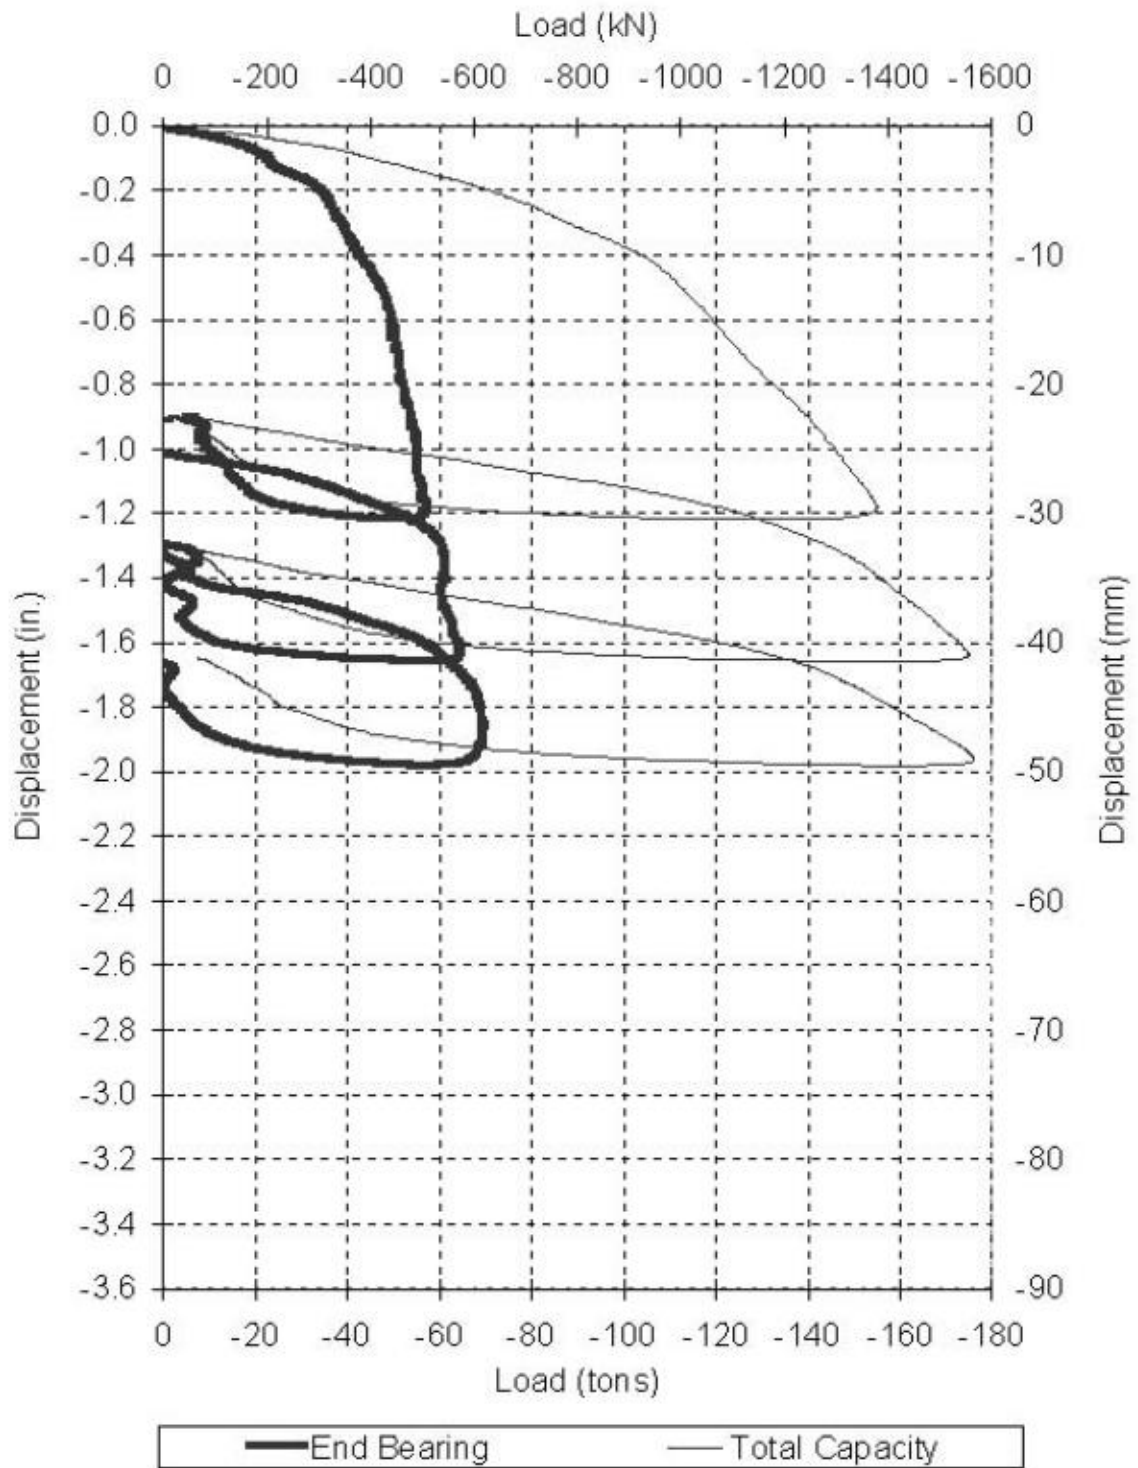
Figure B.12 Data set 12 load test results
