**LOAD AND RESISTANCE FACTOR DESIGN (LRFD) RESISTANCE
FACTORS FOR TIP GROUTED DRILLED SHAFTS**

BDV25-977-37

FINAL REPORT

September 2019

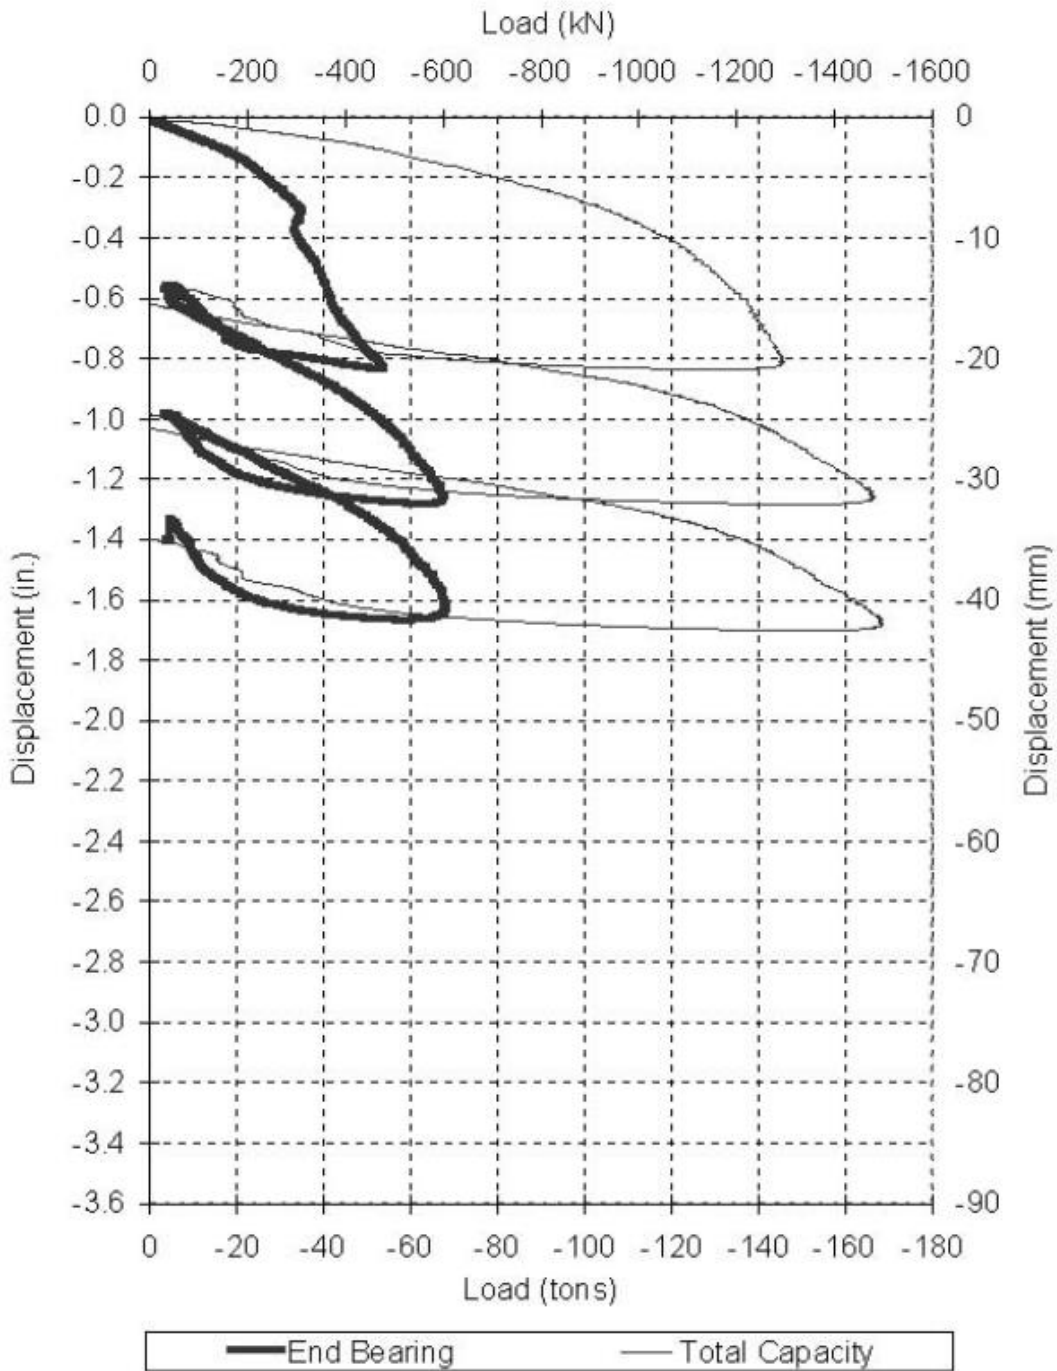
Figure B.13 Data set 13 load test results

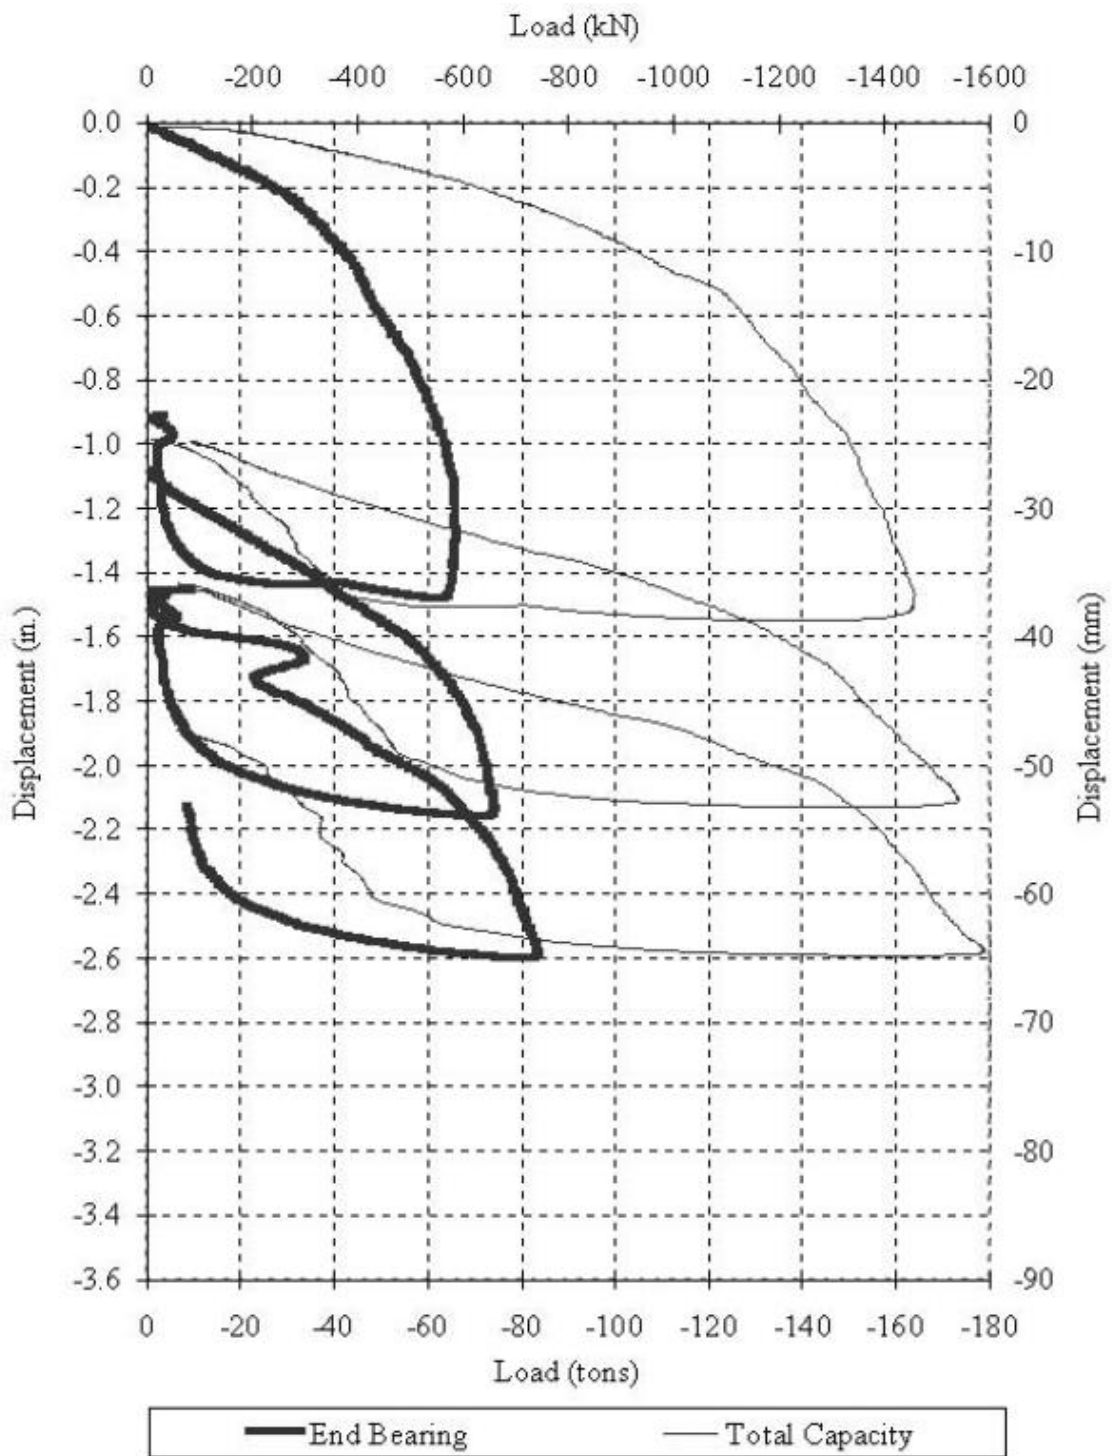
Figure B.15 Data set 15 load test results

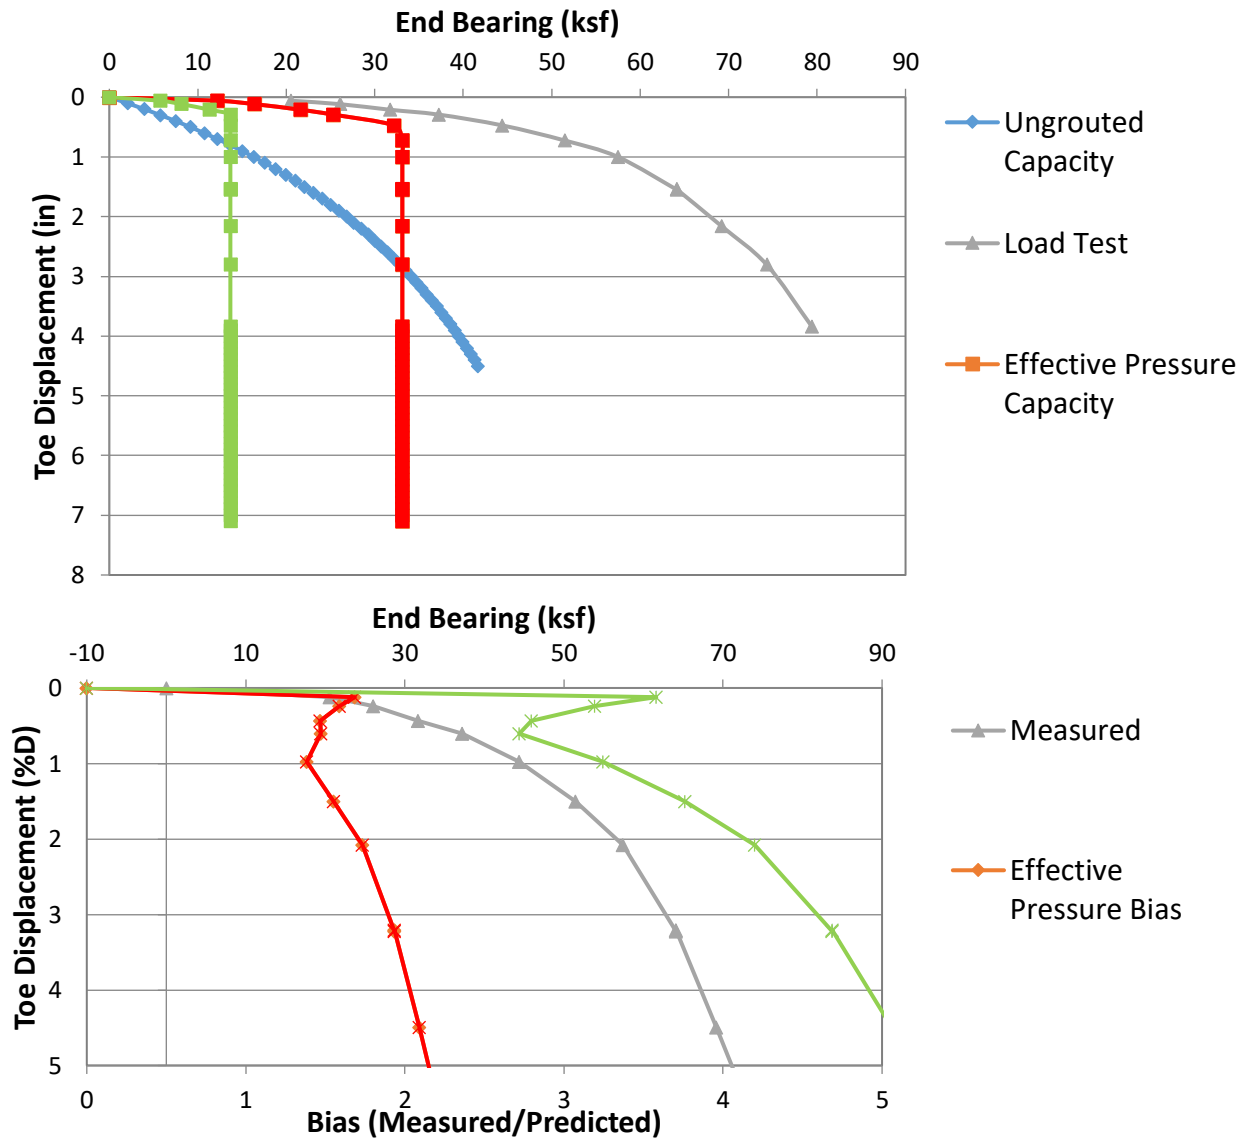
Figure C.8 Data set 8 predicted/design and load test response (top); bias vs disp. (bottom)
