Evaluation of W-Beam Guardrail Terminal Post in Sleeve

Prepared by: Texas A&M Transportation Institute
Texas A&M University System
College Station, TX 77843

Date: October 2019

Report #: 4000(183) (TTI Report No. 611011-1)

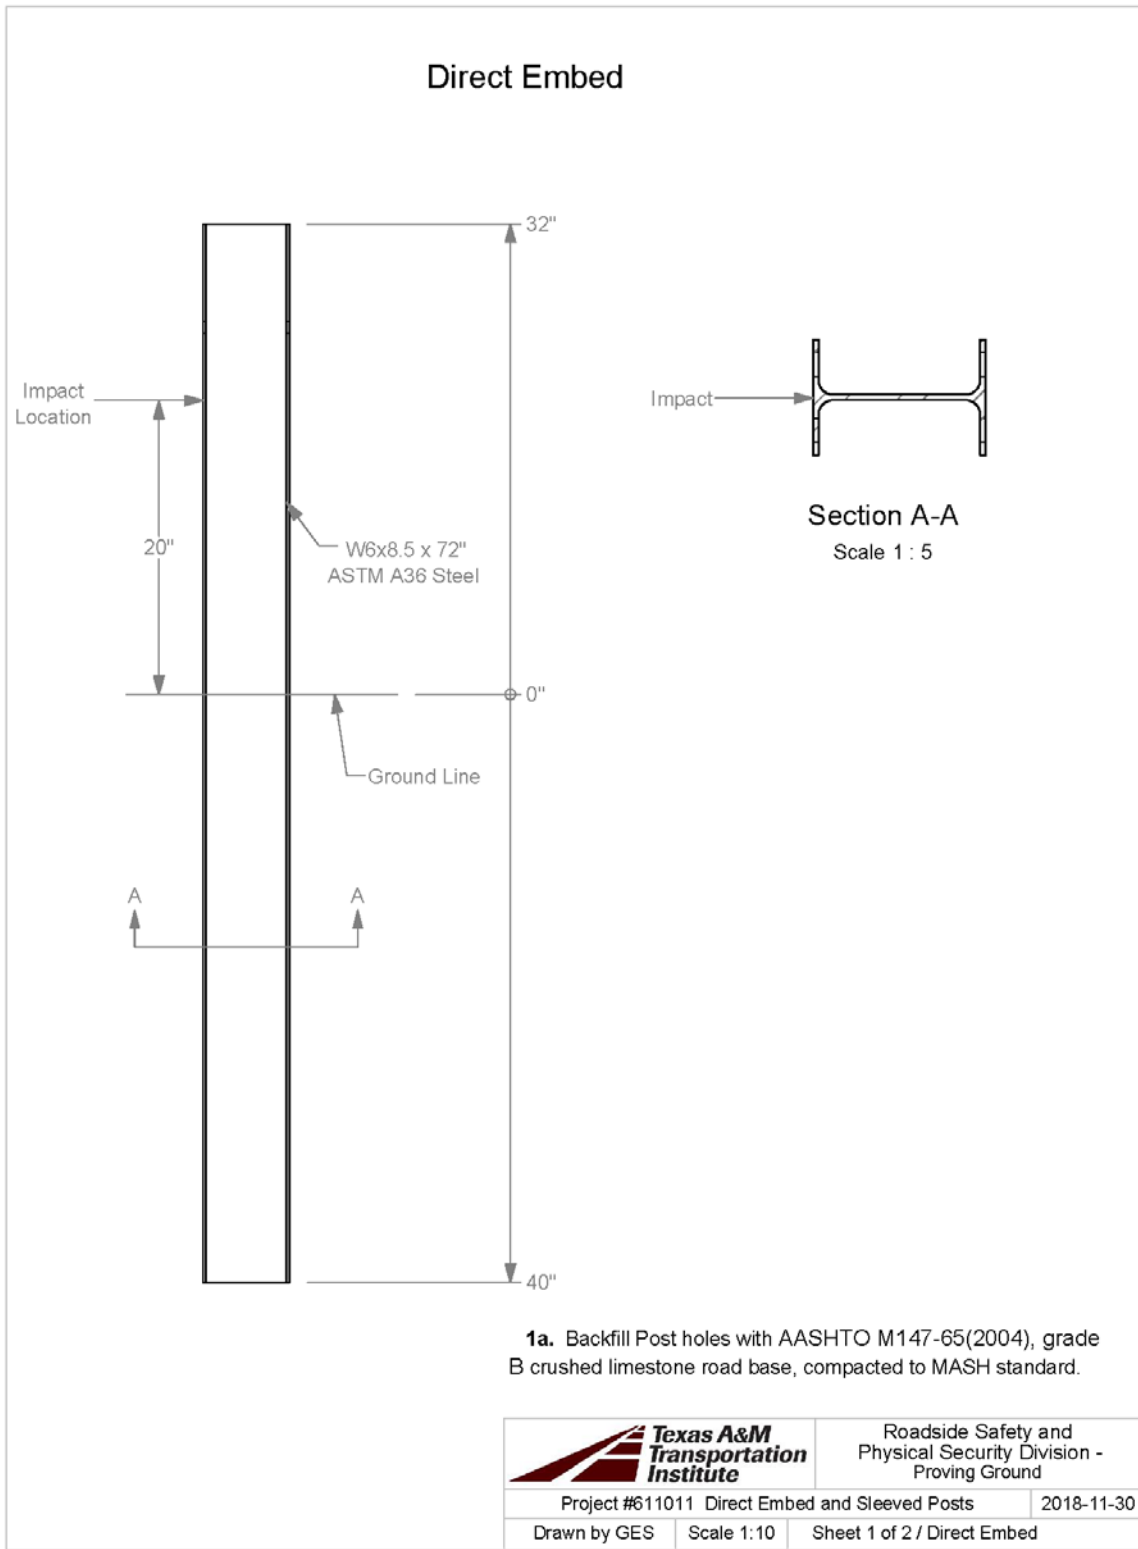
Figure 3.1. Details of Direct Embedded Posts.

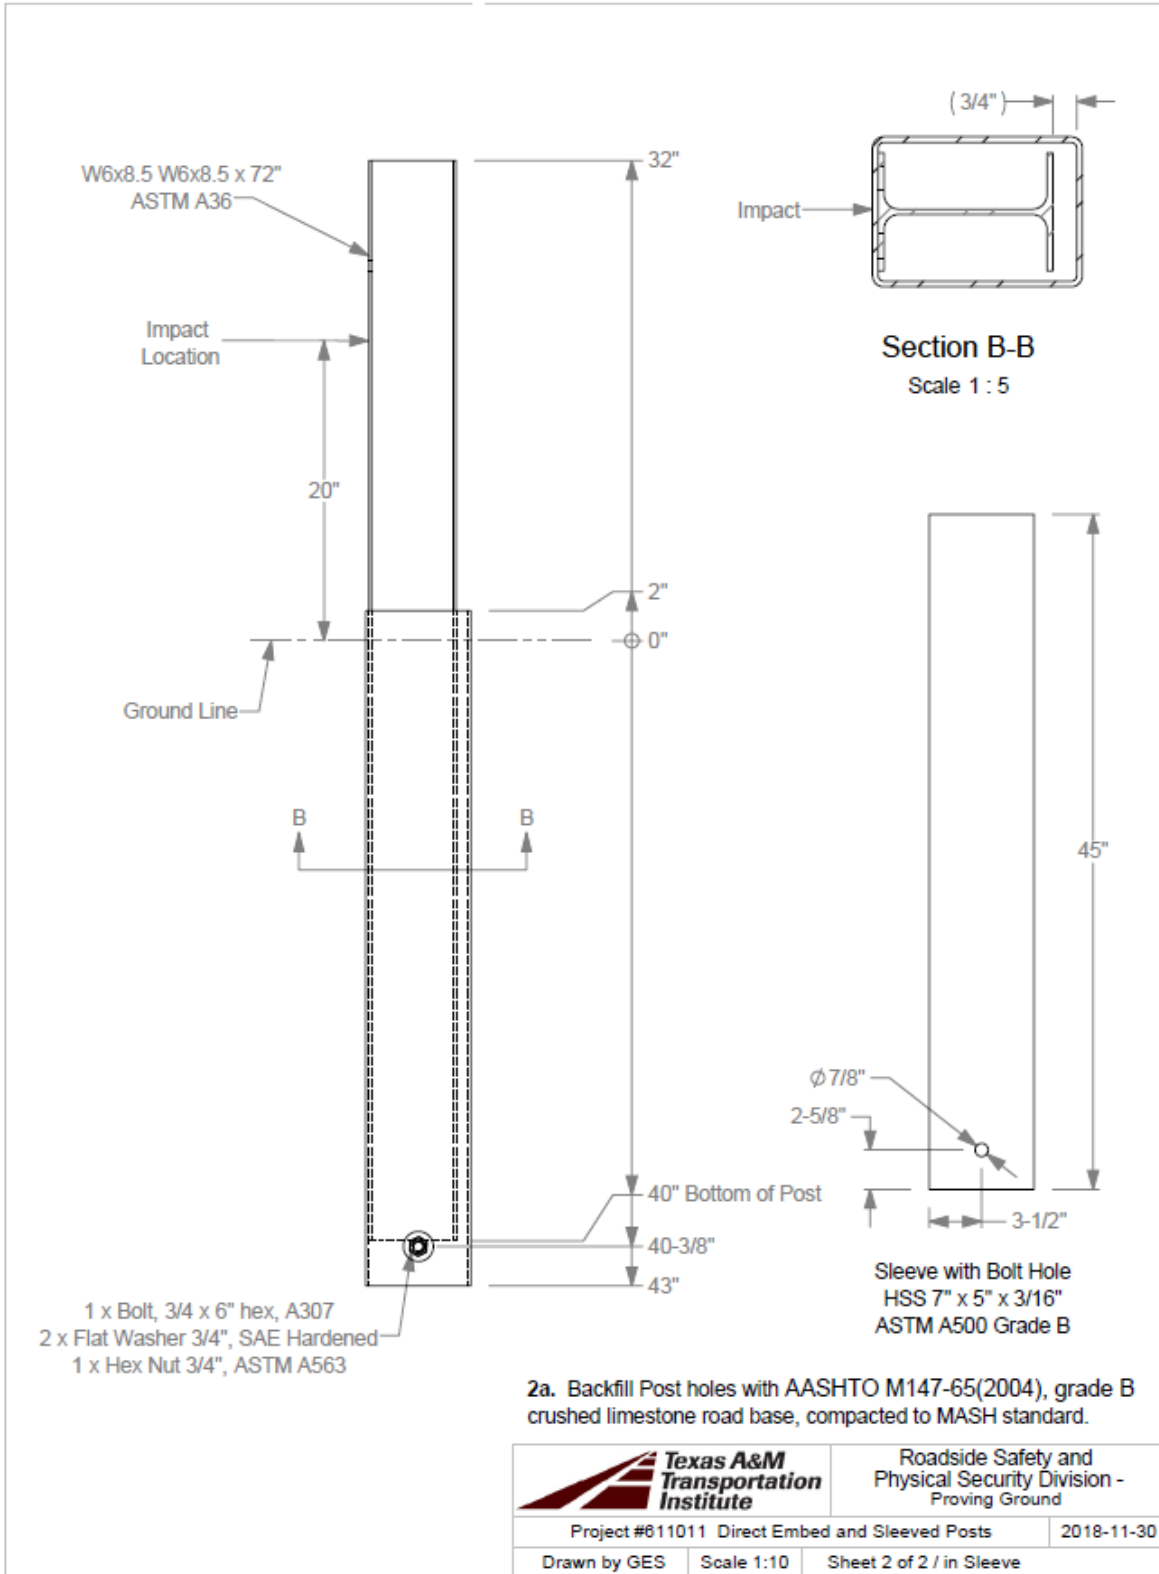
Figure 3.2. Details of Posts in Steel Sleeve.

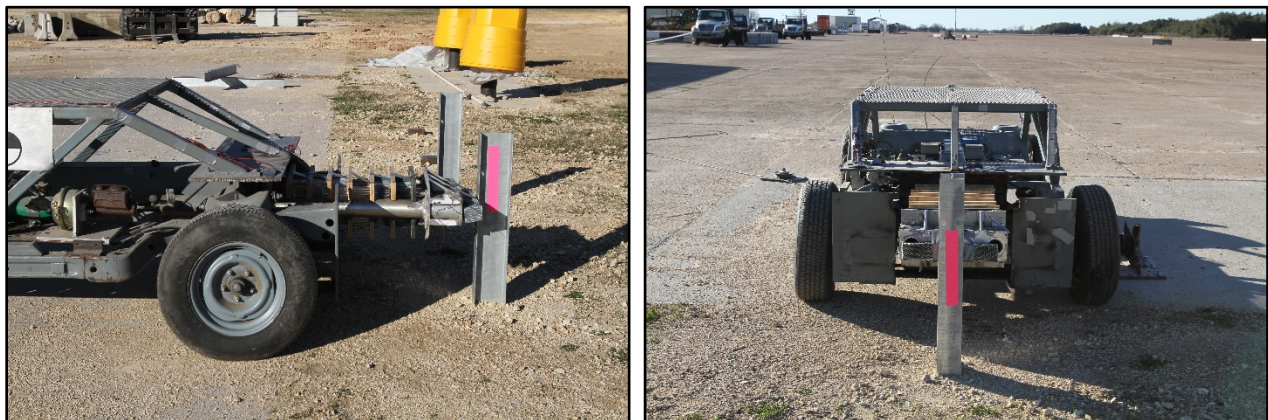
Figure 3.3. Post/Bogie Test Vehicle Geometrics for Test Nos. 611011-B1-B4.

Figures 3.3 and 3.4 show the bogie test vehicle used for the impact tests. The vehicle's test inertia weight was 1856 lb, and its gross static weight was 1856 lb. Frontal crush of the aluminum honeycomb nose of the bogie simulates the crush of an actual vehicle. The crushable nose configuration is ten stages of cartridges of expendable aluminum honeycomb material of differing densities placed in a sliding nose mechanism. After a test, the honeycomb material is replaced and the bogie is reused. A sketch of the honeycomb configuration used for the pendulum bogie is shown in Appendix A.

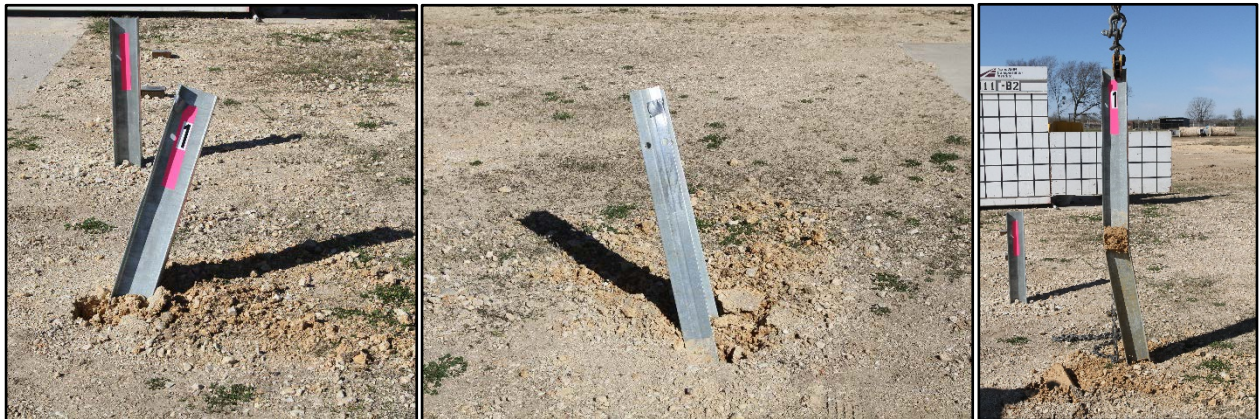
Figure 3.5. Direct Embedded Post after Test No. 611011-B1.

The bogie impacted the direct embedded post at 90° while traveling at a speed of 20.9 mi/h. The direct embedded post was pushed toward the field side 5.0 inches at grade and was leaning 73° toward the field side. Maximum stroke on the honeycomb nose was 6.5 inches. Figures 3.5 and 3.6 show the post and bogie, respectively, after the test. Acceleration-time, force-time, and force-displacement curves are provided in Figures 3.7 through 3.9, respectively.

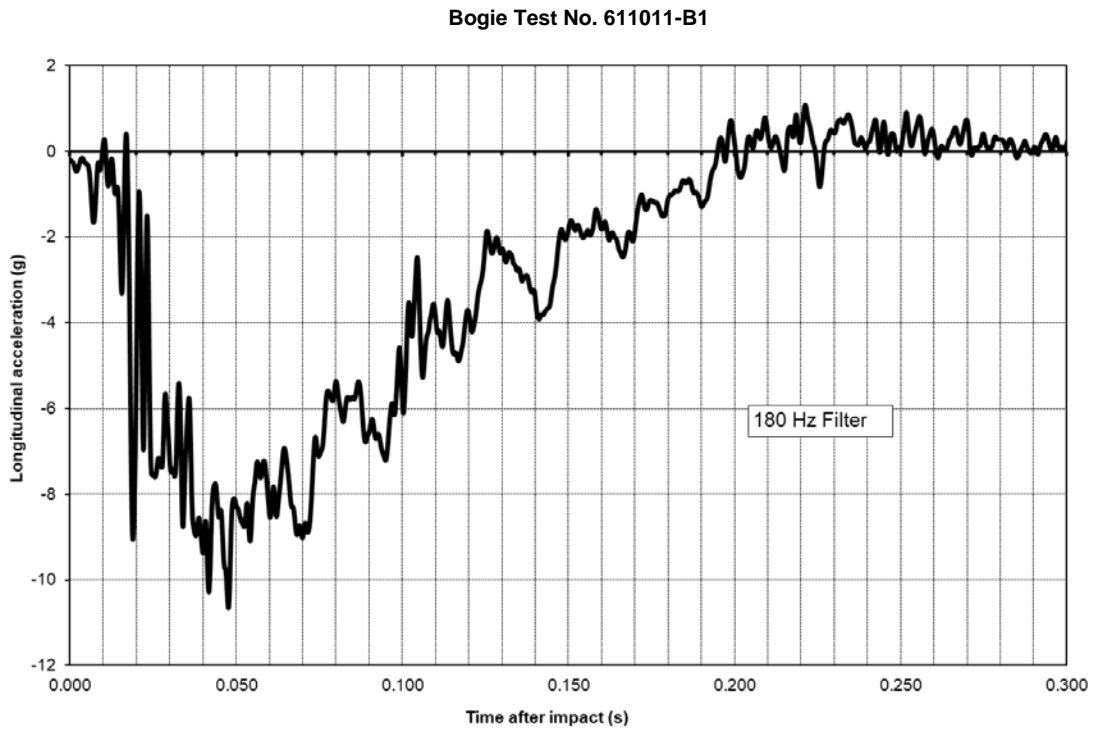
Figure 3.7. Longitudinal Acceleration for Test No. 611011-B1.

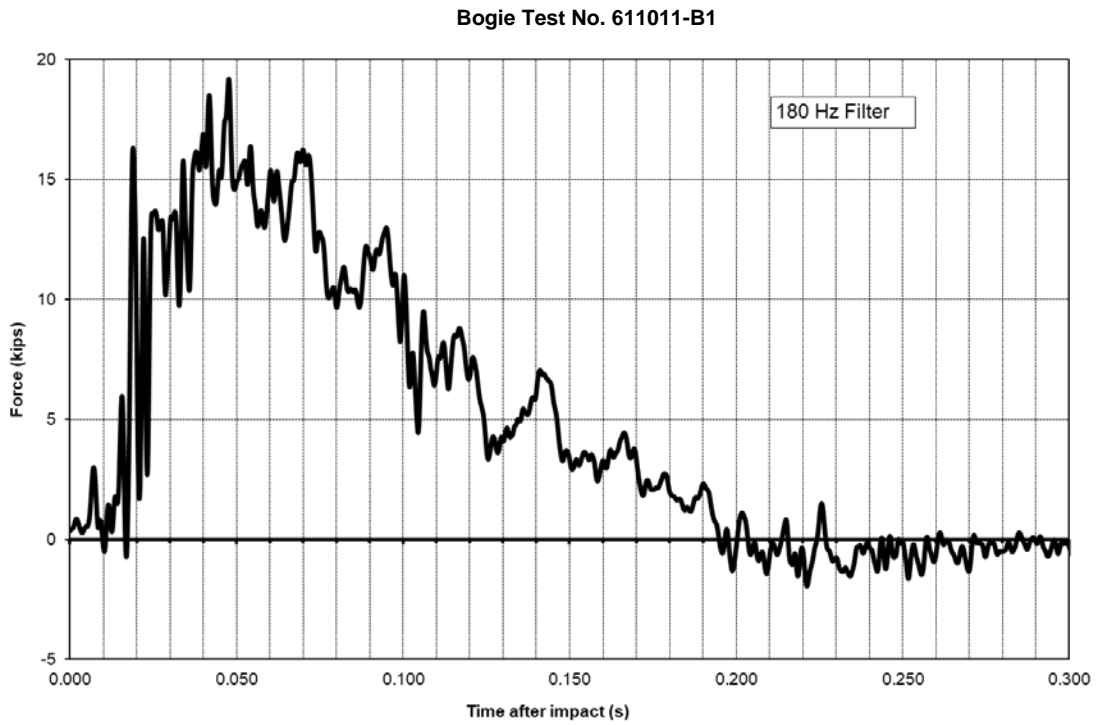
Figure 3.8. Force for Test No. 611011-B1.

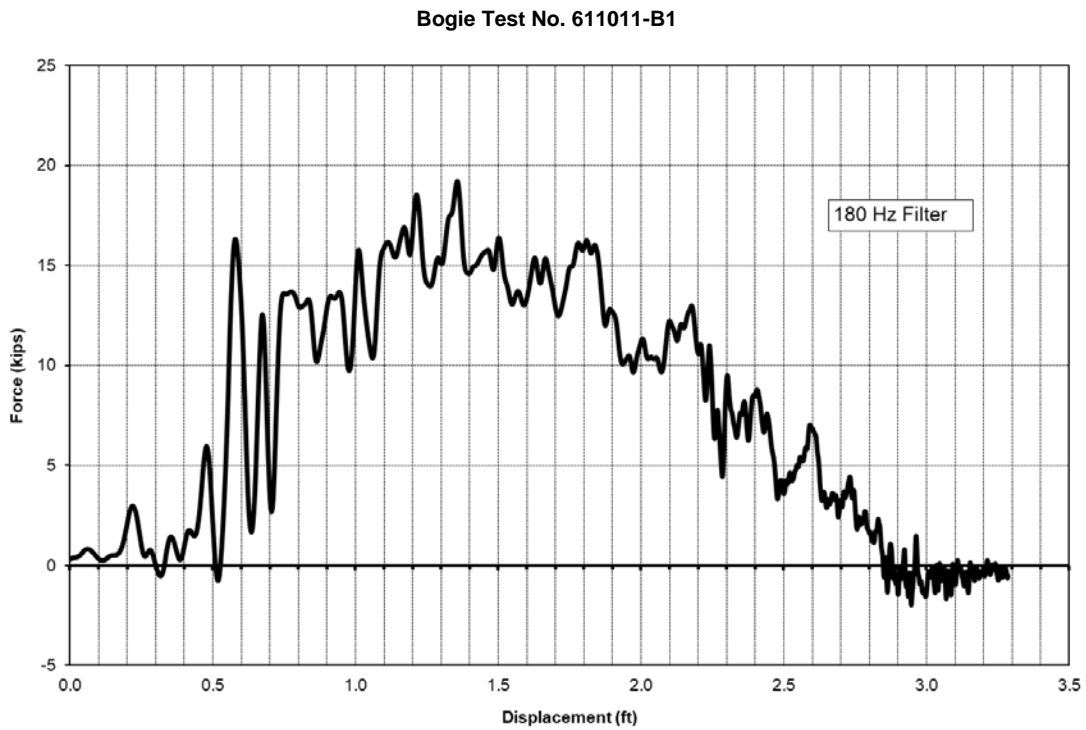
Figure 3.9. Displacement vs Force for Test No. 611011-B1.

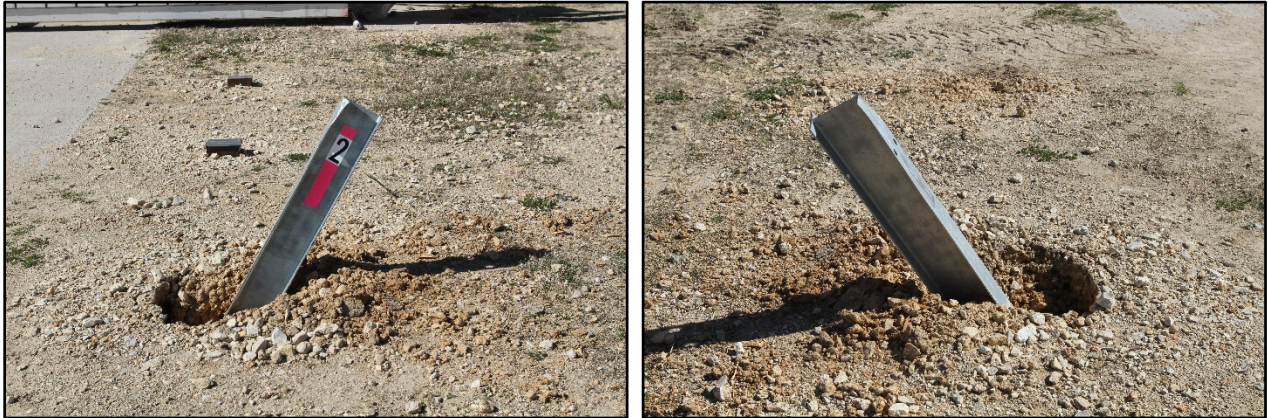
Figure 3.10. Direct Embedded Post after Test No. 611011-B2.

The bogie impacted the direct embedded post at 90° while traveling at a speed of 26.0 mi/h. The direct embedded post was pushed toward the field side 12.5 inches at grade and was leaning 59° toward the field side. Maximum stroke on the honeycomb nose was 5.5 inches. Figures 3.10 and 3.11 show the post and bogie, respectively, after the test. Acceleration-time, force-time, and force-displacement curves are provided in Figures 3.12 through 3.14.

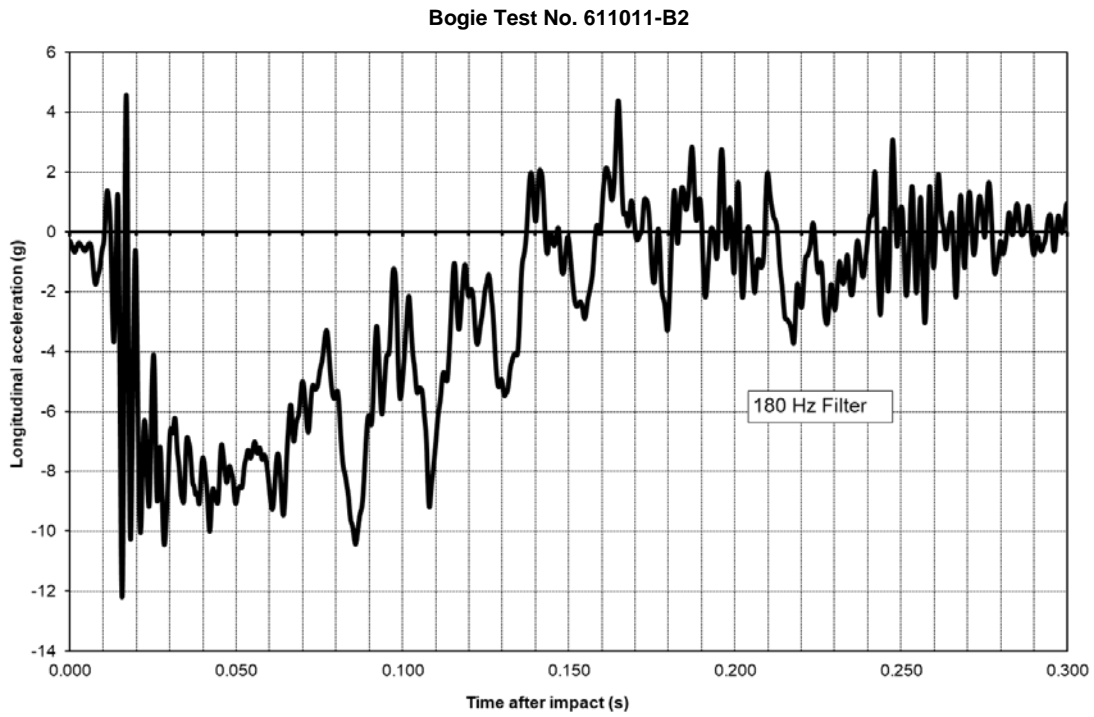
Figure 3.12. Longitudinal Acceleration for Test No. 611011-B2.

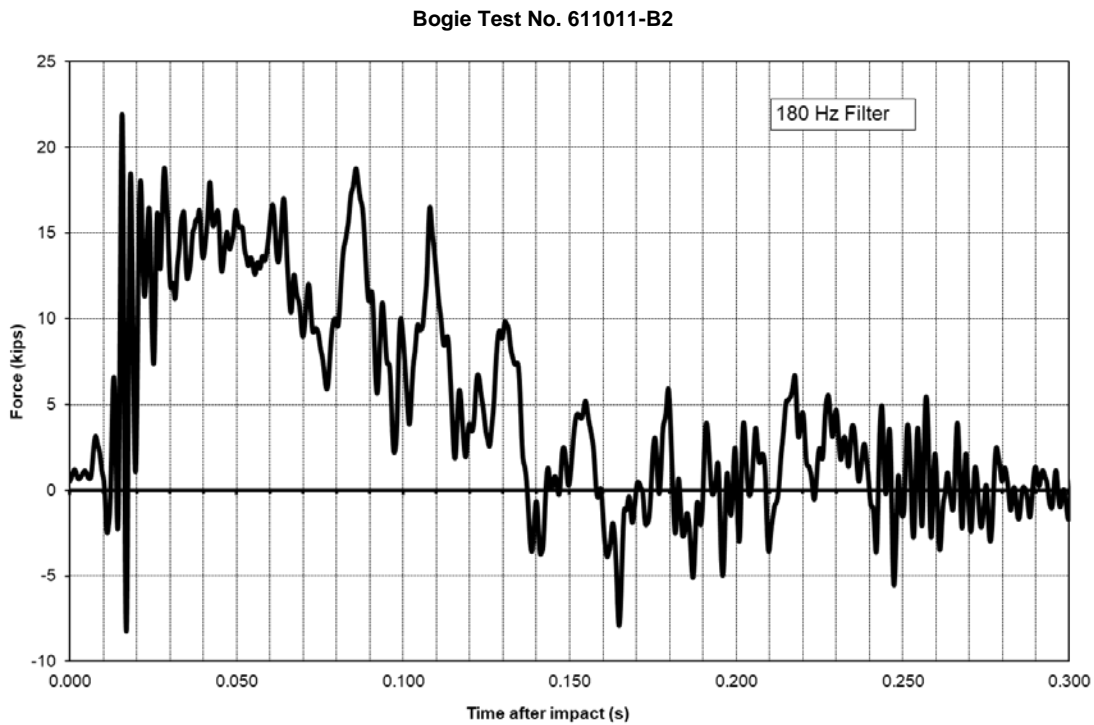
Figure 3.13. Force for Test No. 611011-B2.

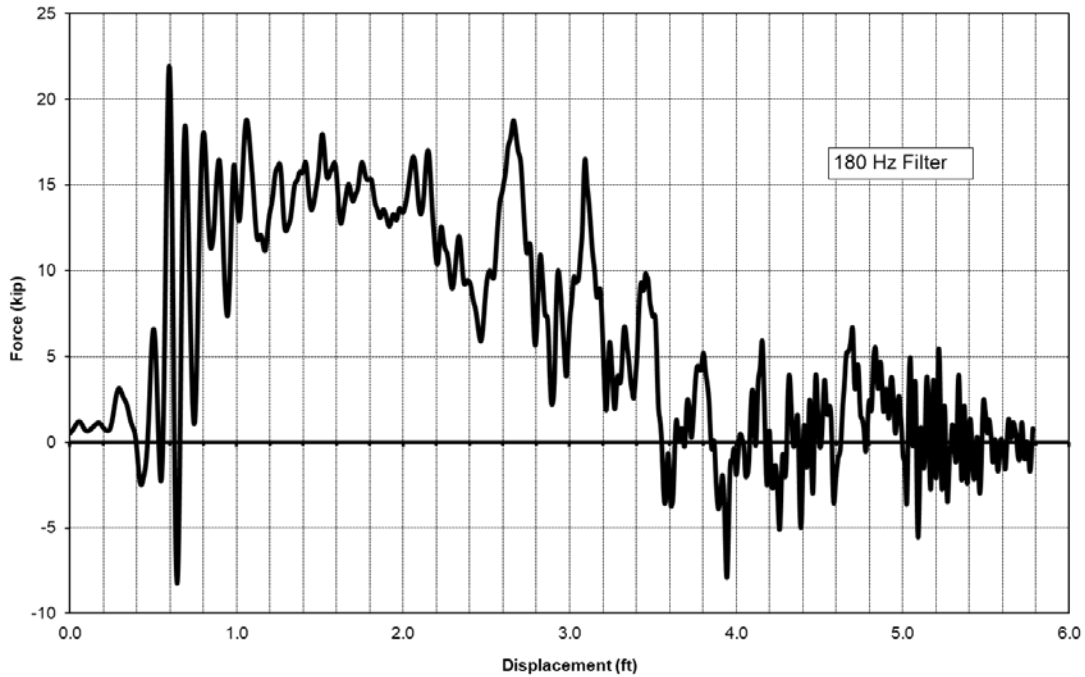
Figure 3.14. Force vs Displacement for Test No. 611011-B2.

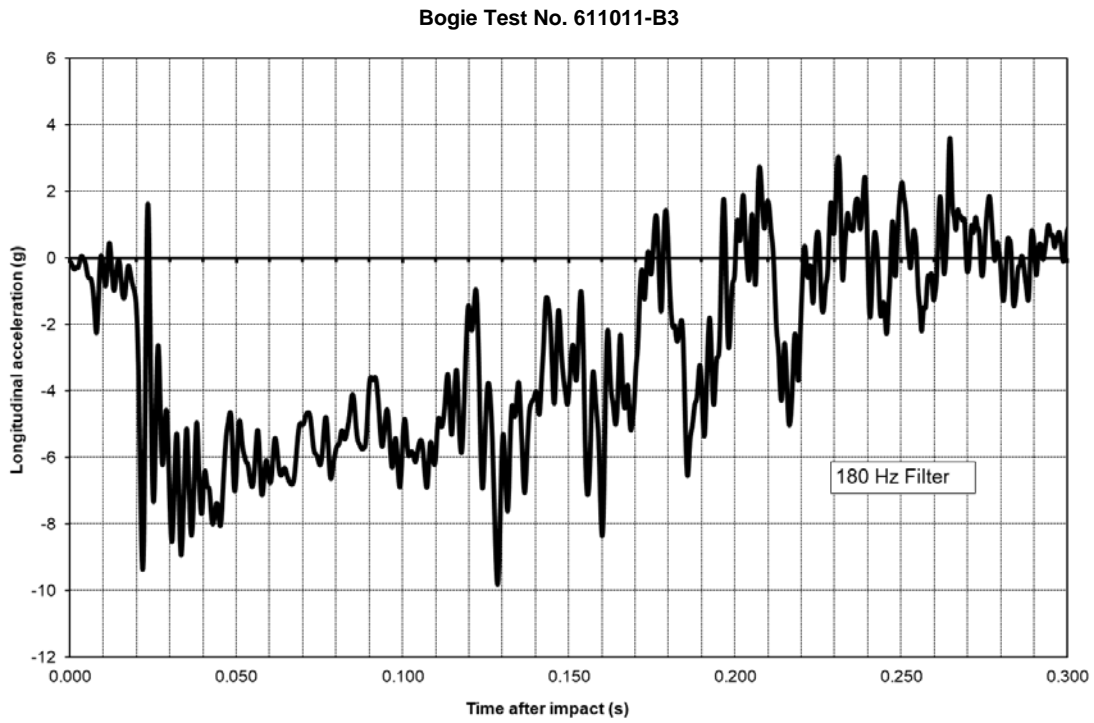
Figure 3.17. Longitudinal Acceleration for Test No. 611011-B3.

The bogie impacted the post installed in a sleeve at 90° while traveling at a speed of 20.9 mi/h. The direct embedded post (and sleeve) was pushed toward the field side 13.0 inches at grade and was leaning 63° toward the field side. Maximum stroke on the honeycomb nose was 5.25 inches. Figures 3.15 and 3.16 show the post and bogie, respectively, after the test. Acceleration-time, force-time, and force-displacement curves are provided in Figures 3.17 through 3.19.

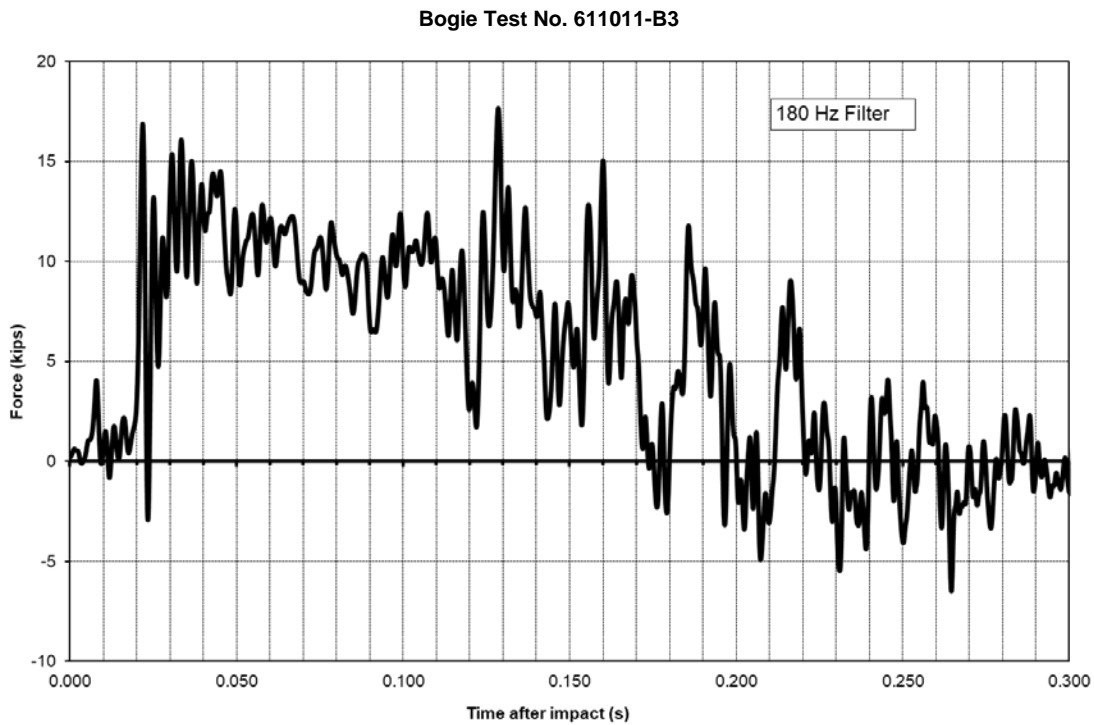
Figure 3.18. Force for Test No. 611011-B3.

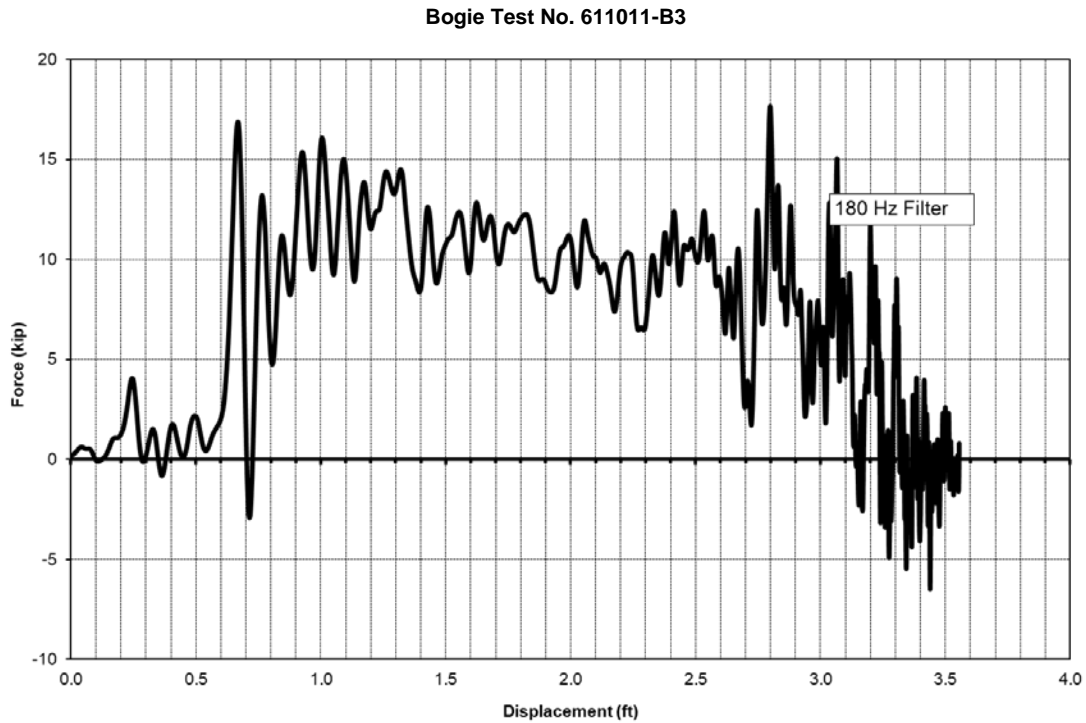
Figure 3.19. Force vs Displacement for Test No. 611011-B3.

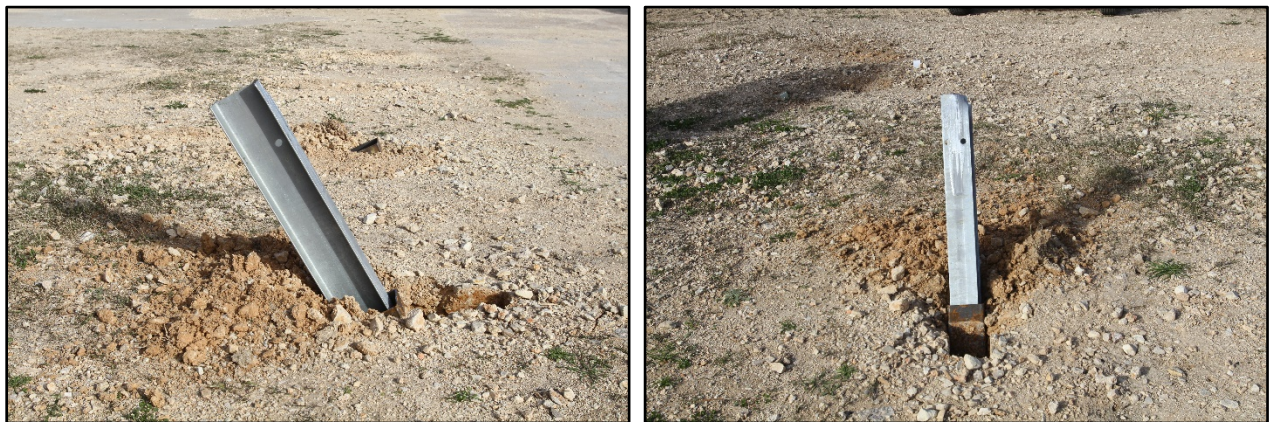
Figure 3.20. Post in Steel Sleeve after Test No. 611011-B4.

The bogie impacted the post installed in a sleeve at 90° while traveling at a speed of 25.1 mi/h. The direct embedded post (and sleeve) was pushed toward the field side 3.0 inches at grade and was leaning 60° toward the field side. Maximum stroke on the honeycomb nose was 6.0 inches. Figures 3.20 and 3.21 show the post and bogie, respectively, after the test. Acceleration-time, force-time, and force-displacement curves are provided in Figures 3.22 through 3.24.

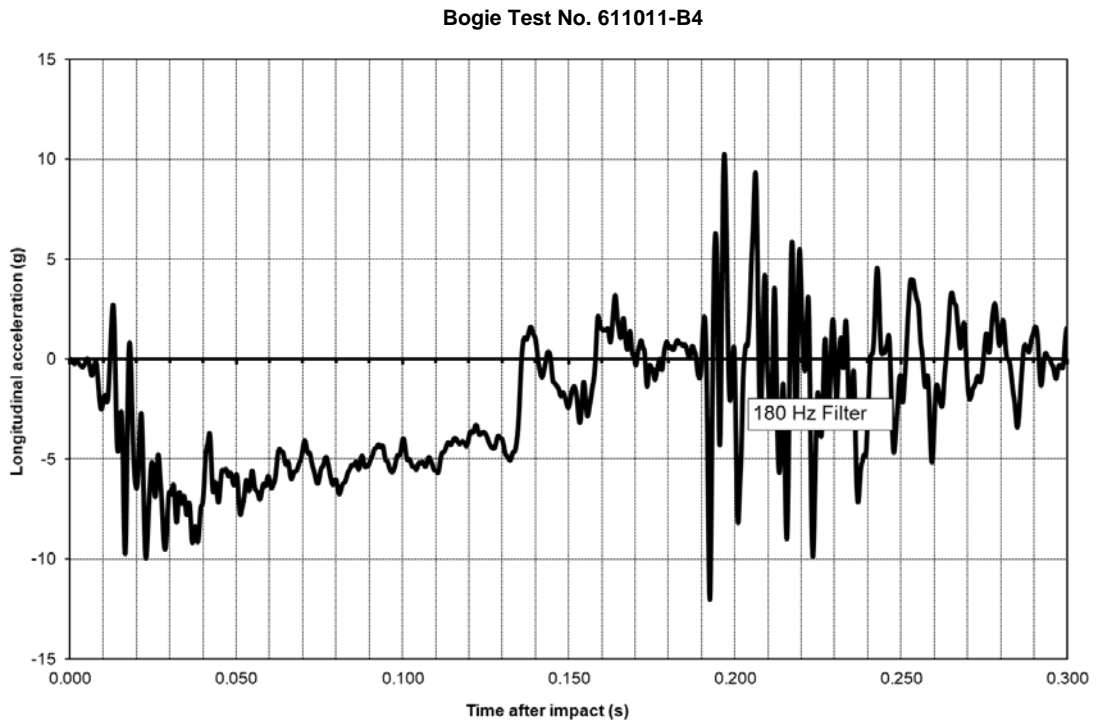
Figure 3.22. Longitudinal Acceleration for Test No. 611011-B4.

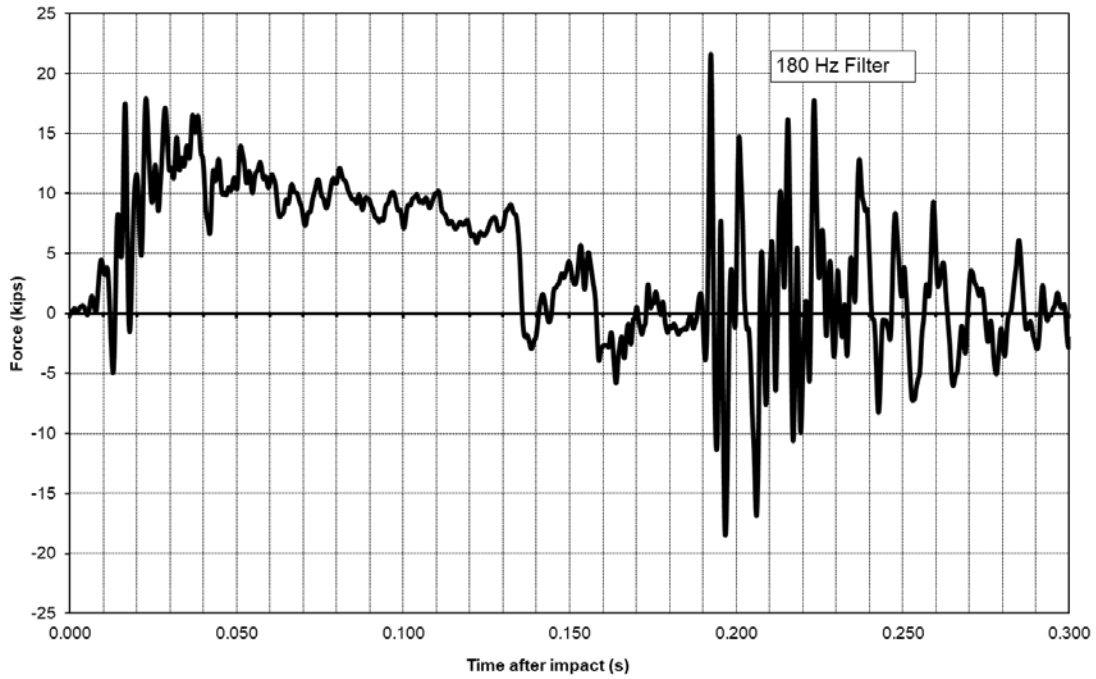
Figure 3.23. Force for Test No. 611011-B4.

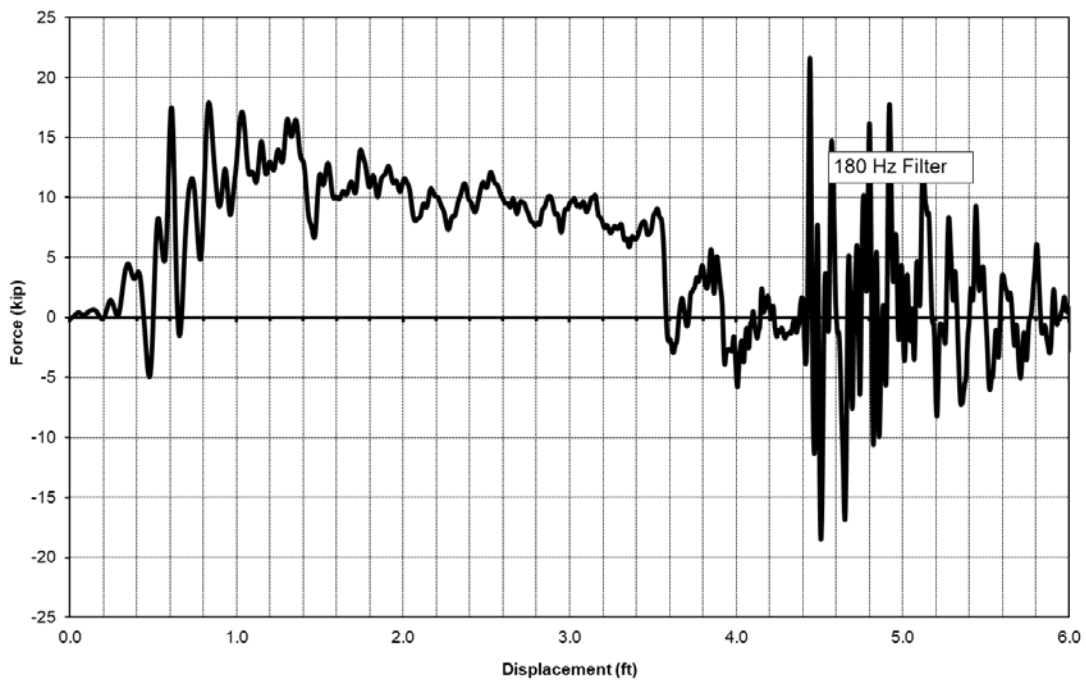
Figure 3.24. Force vs Displacement for Test No. 611011-B4.

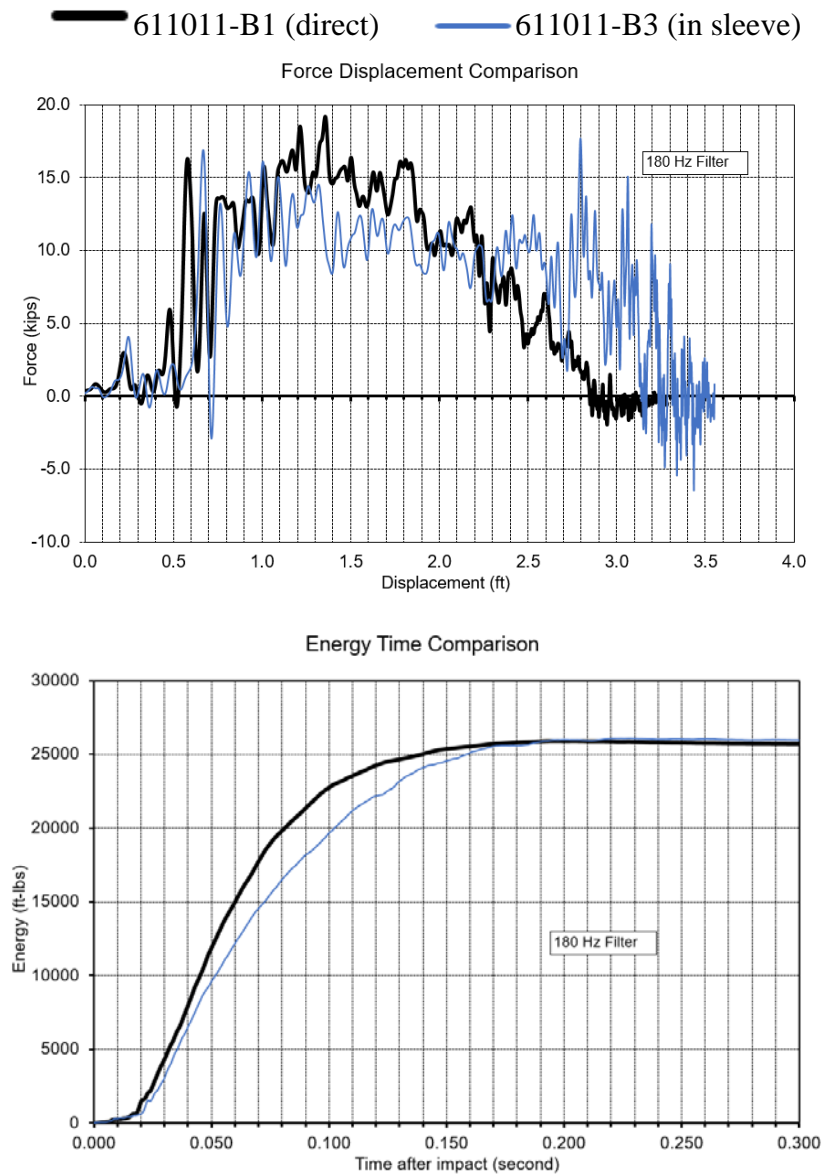
Figure 3.25. Force-Displacement and Energy-Time Comparisons of Posts with 21 mi/h Impact.

Comparisons of the force-displacement and energy-time responses of the direct-embedded and in-sleeve posts, for the target impact speeds of 21 mi/h and 25 mi/h, are shown in Figures 3.25 and 3.26, respectively. The response of both post types is very similar for both impact speeds. Due to the similarities in the bogie impact testing, the researchers proceeded with performing *MASH* Test 3-35, details of which are described in the following chapters. Figure 3.27 shows the deformed posts after the bogie testing. Directly embedded posts were more deformed, closer to the ground level, while the posts in sleeves had much less deformation.

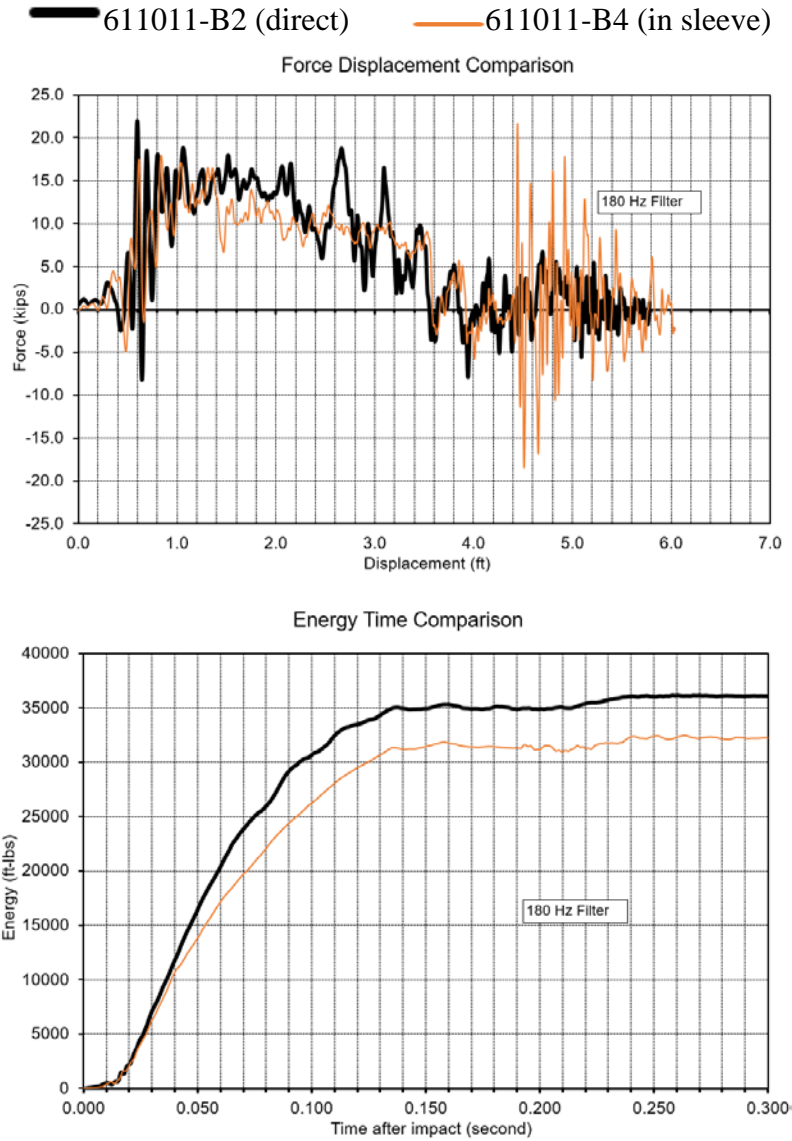
Figure 3.26. Force-Displacement and Energy-Time Comparisons of Posts with 25 mi/h Impact.

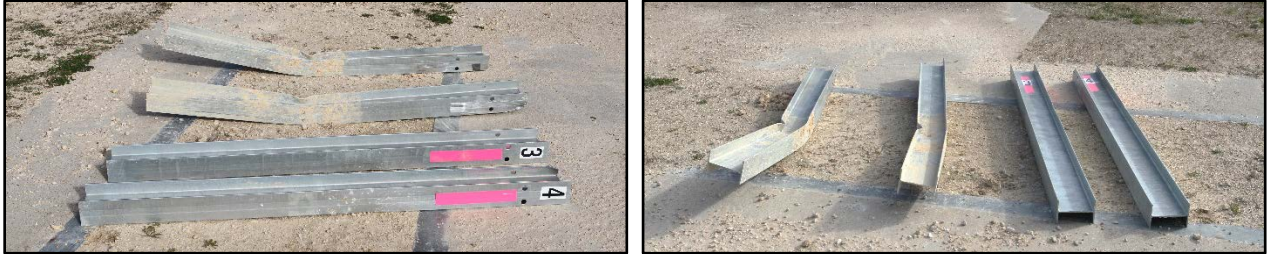
Figure 3.27. Comparison of Posts after Test Nos. 611011-B1-B4.

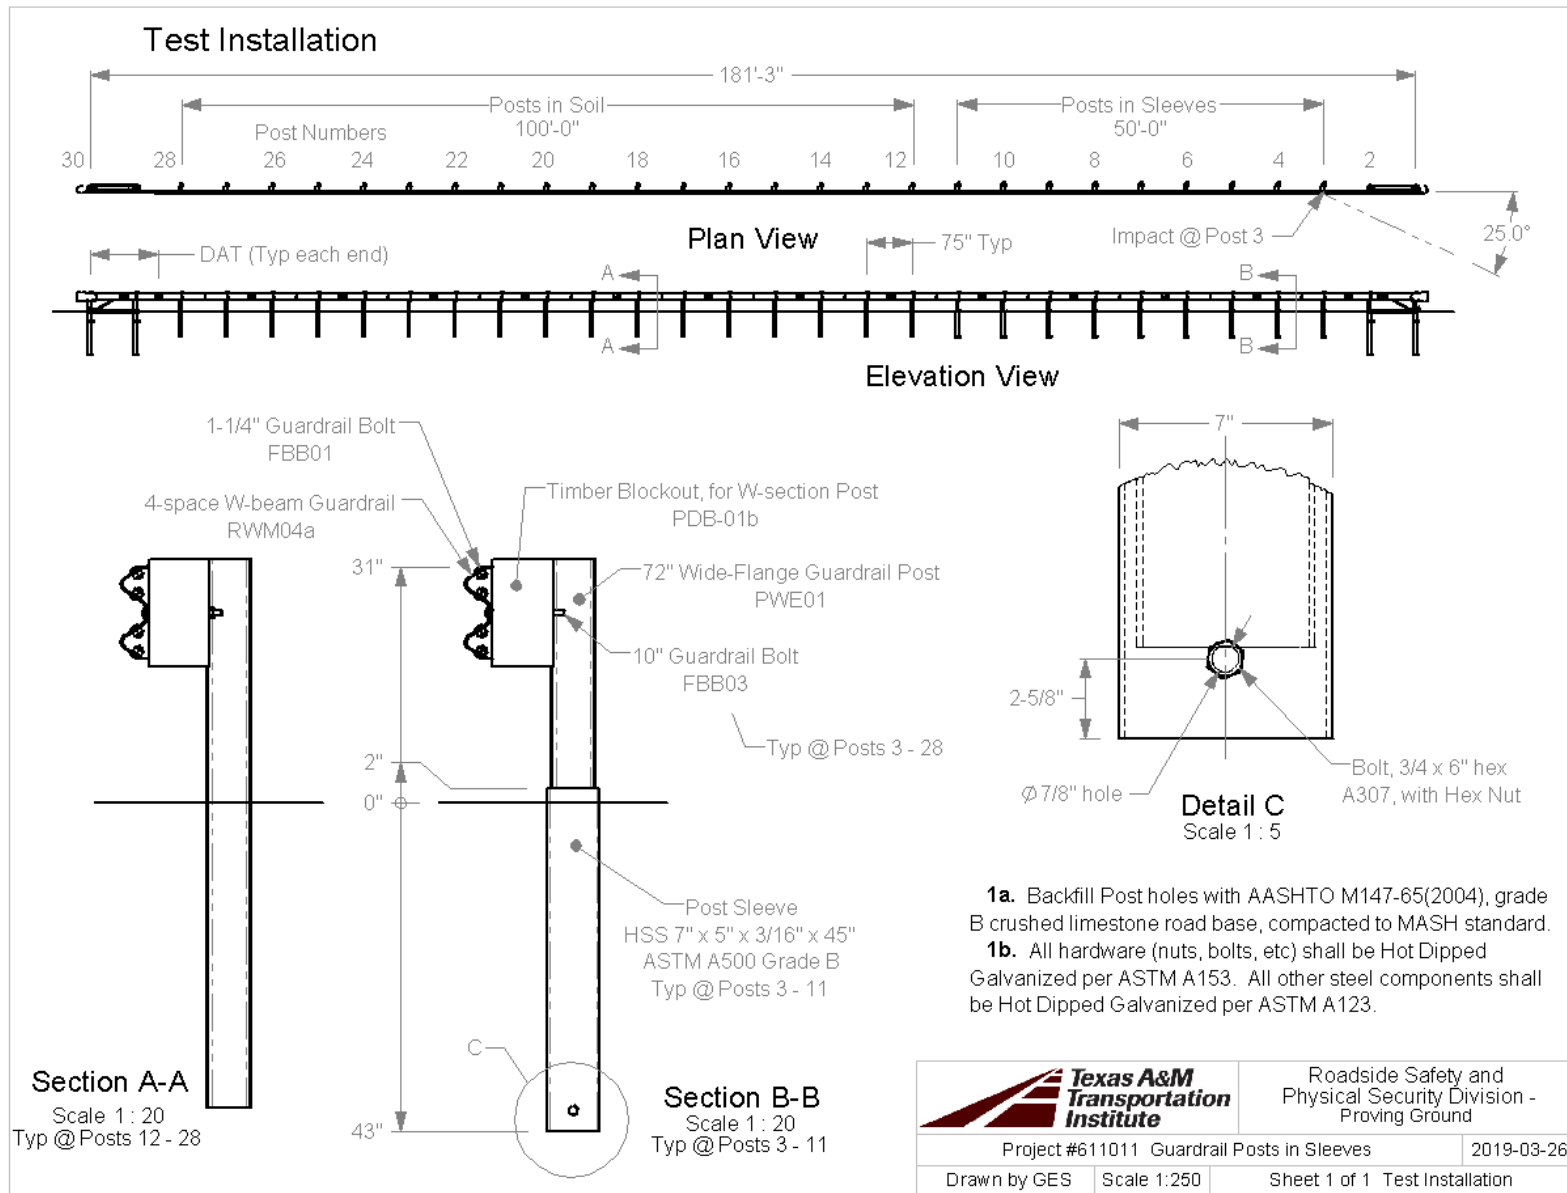
Figure 4.1. Details of 31-inch Guardrail Terminal with Steel Posts in Steel Sleeves.

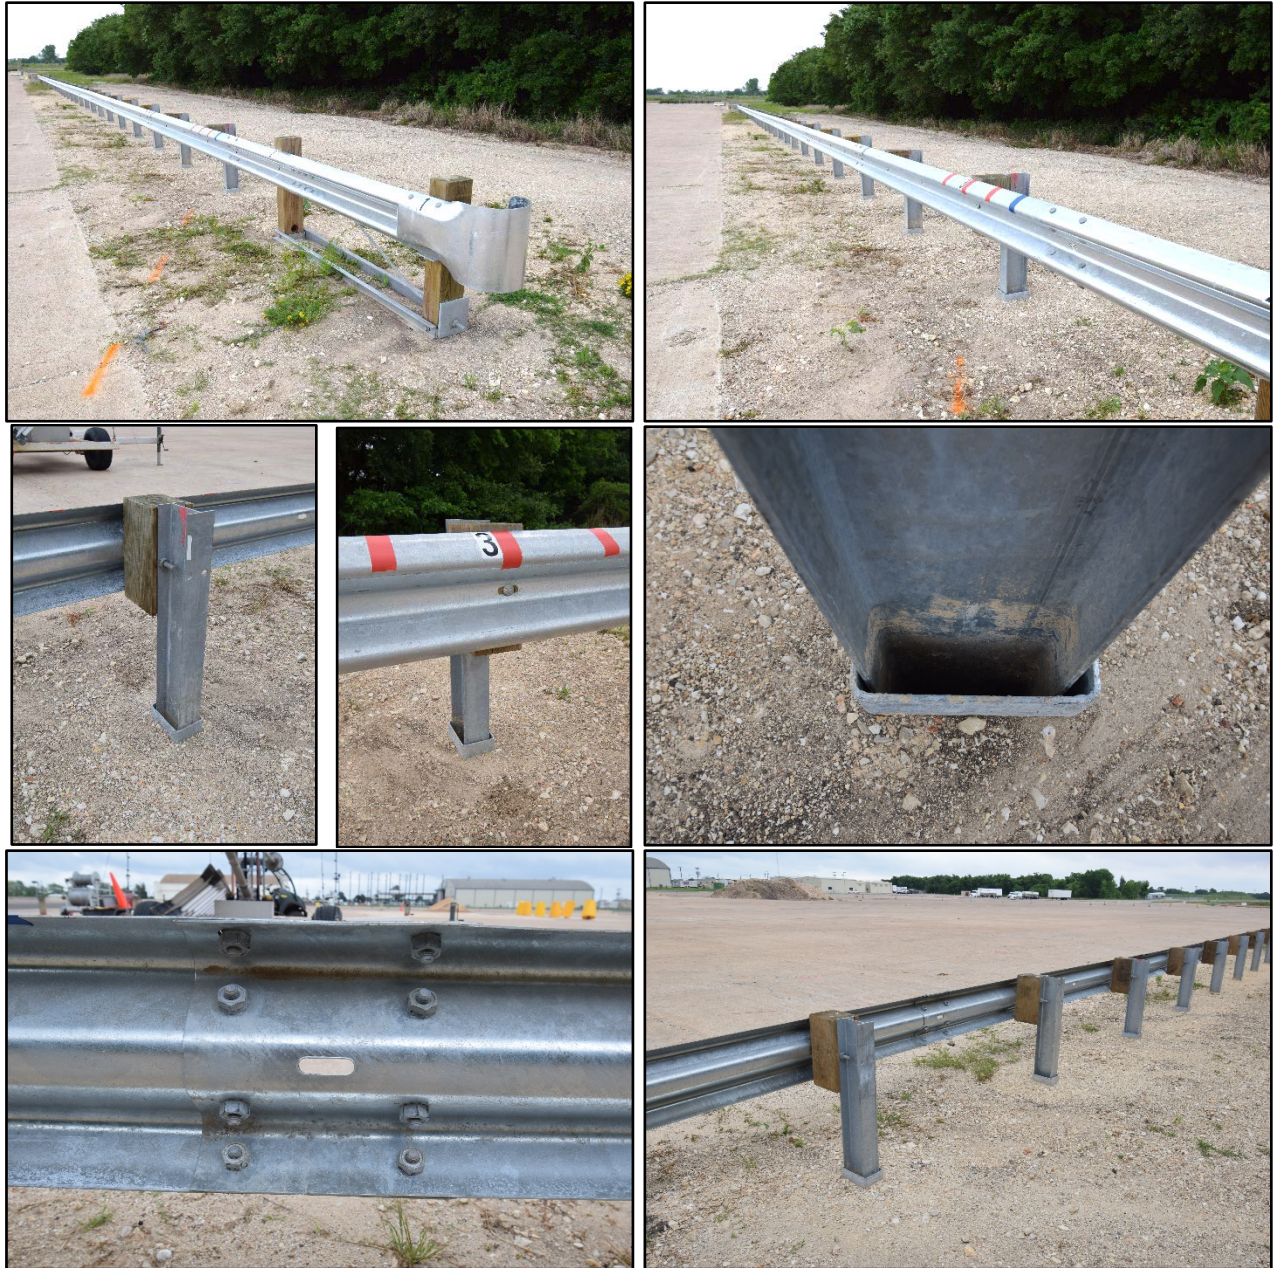
Figure 4.2. 31-inch Guardrail Terminal with Steel Posts in Steel Sleeves prior to Testing.

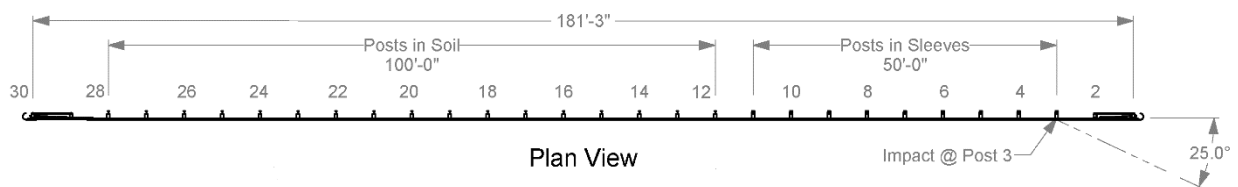
Figure 5.1. Target CIP for *MASH* Test 3-35 on the Terminal.

MASH Test 3-35 was performed on the 31-inch W-beam guardrail terminal with steel posts in steel sleeves. The target impact point for *MASH* Test 3-35 was determined using the information provided in *MASH* Section 2.2.2, Section 2.2.2.2, and Figure 2-3A. The beginning of length of need of the terminal and target impact point was at post 3, and is shown in Figure 5.1.
