Evaluation of W-Beam Guardrail Terminal Post in Sleeve

Prepared by: Texas A&M Transportation Institute
Texas A&M University System
College Station, TX 77843

Date: October 2019

Report #: 4000(183) (TTI Report No. 611011-1)

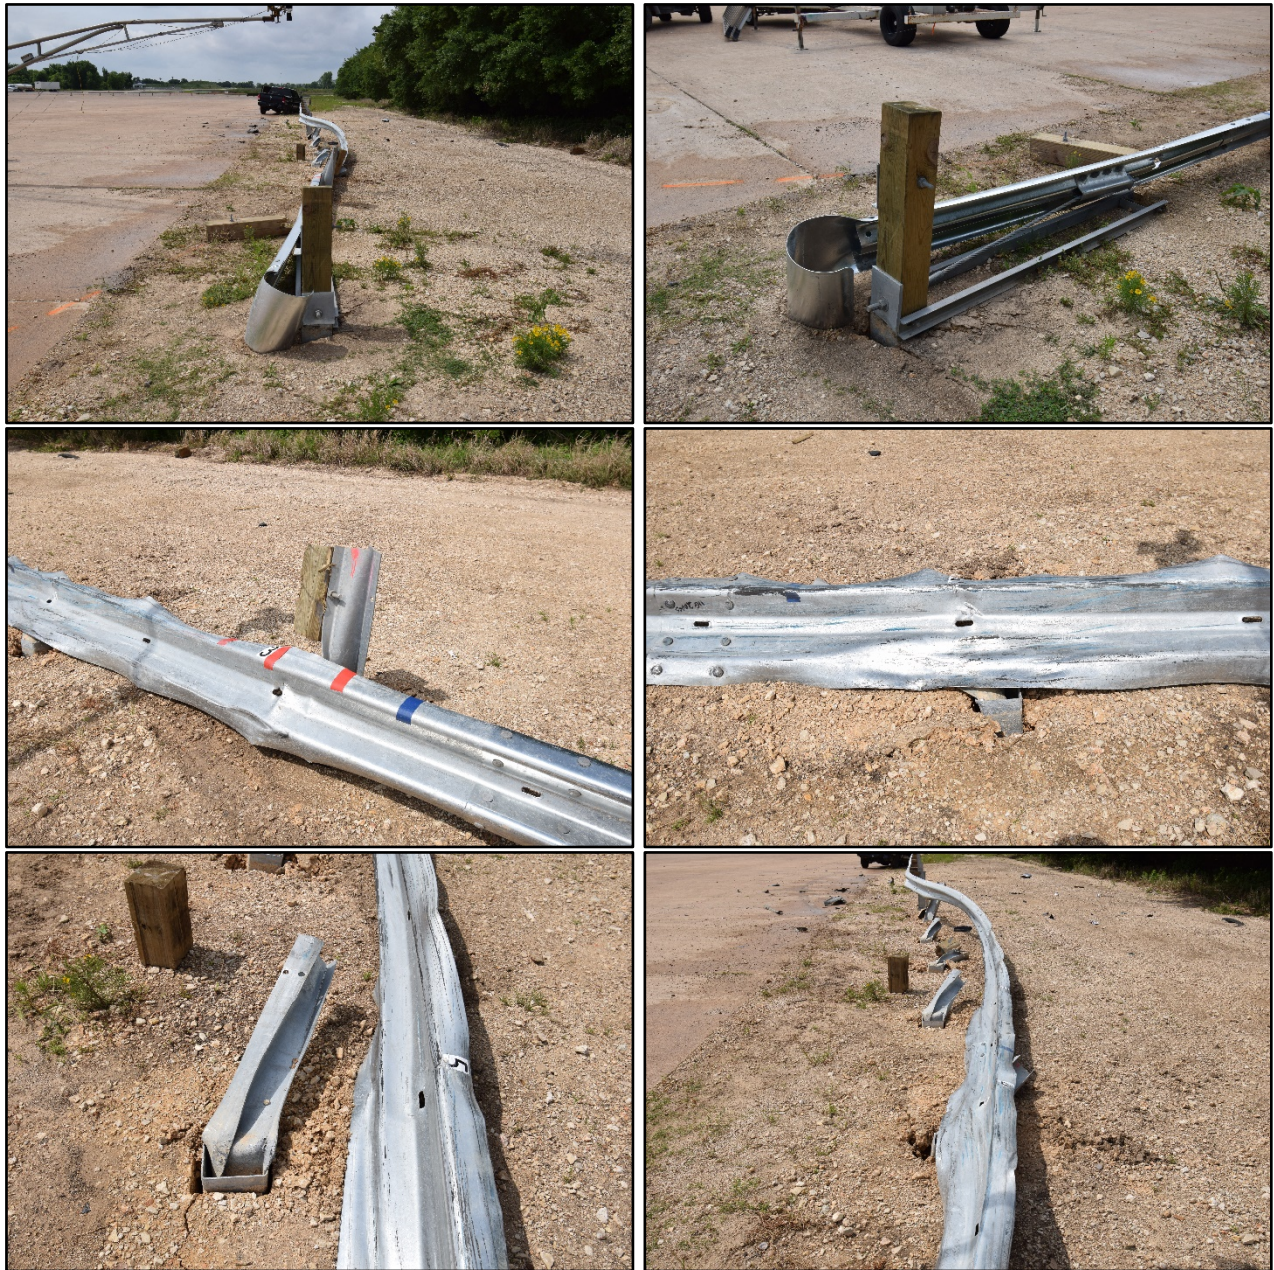
Figure 7.3 shows the damage to the guardrail and the DAT terminal. Post 1 was leaning downstream at 85°. Post 2 broke off at grade. Post 3 rotated 95° clockwise and was leaning

toward the field side at 85°. Posts 4 through 7 were leaning back at approximately 0-10°, and post 8 was leaning downstream at 53°. The blockouts were missing from posts 4, 5, 7, and 8, and the rail released from posts 1 through 9. Figure 7.4 shows movement of some of the sleeves. Working width* was 54.9 inches, and height of working width was 54.0 inches. Maximum dynamic deflection during the test was 48.5 inches. The maximum permanent deflection was 41.1 inches, located 2 feet downstream of the original post 6 location.

Figure 7.3. Terminal after Test No. 611011-1.

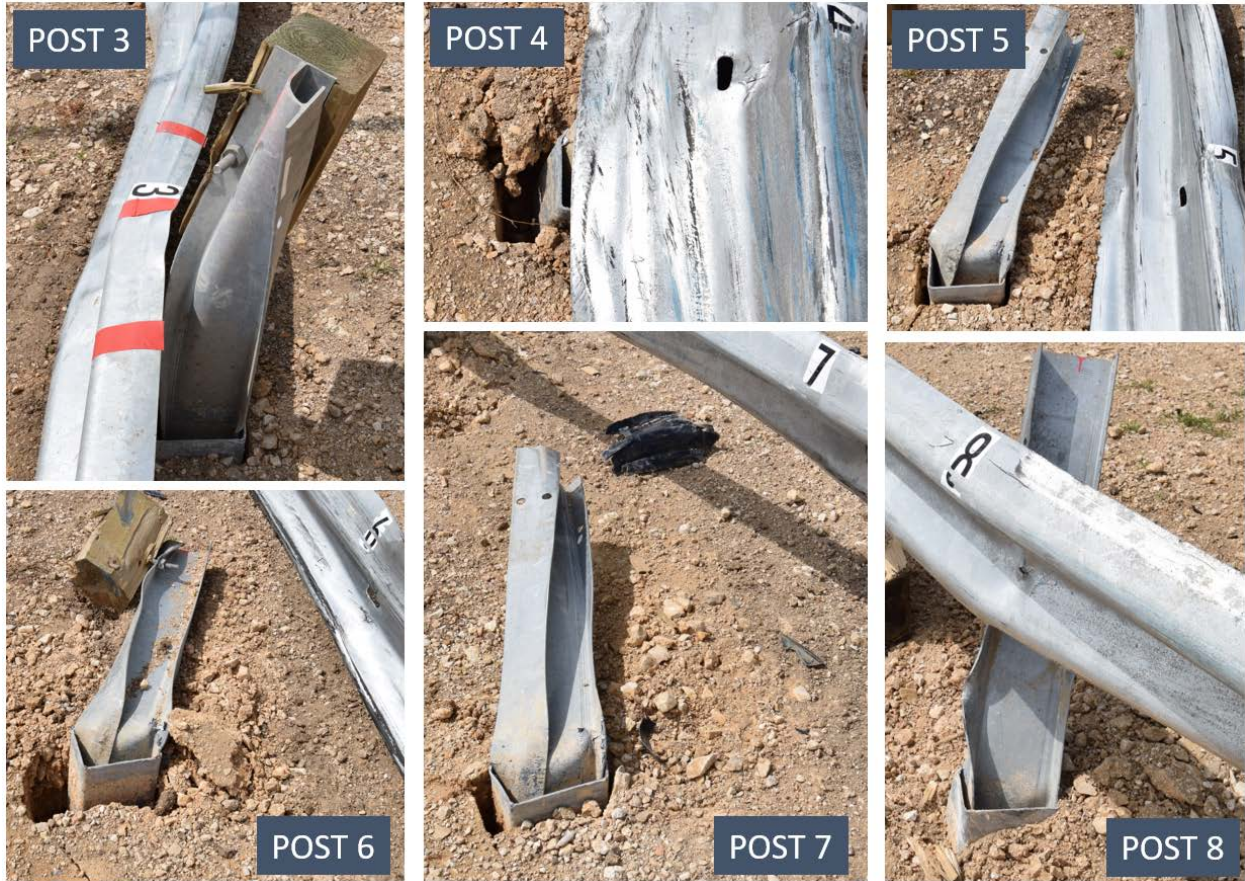
Figure 7.4. Movement of Some of the Sleeves after Test No. 611011-1.

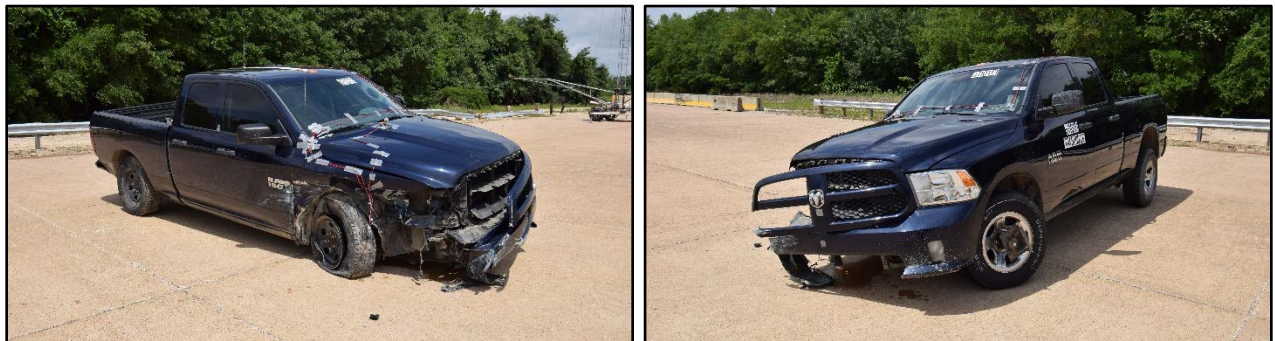
Figure 7.5 shows the damage sustained by the vehicle. The front bumper, grill, right front tire and rim, right lower A-arm, right front fender, right front door, right rear exterior bed, and rear bumper were damaged. Maximum exterior crush to the vehicle was 7.0 inches in the side plane at the right front corner at bumper height. No occupant compartment deformation or intrusion was observed. Figure 7.6 shows the interior of the vehicle. Tables E.3 and E.4 in Appendix E1 provide exterior crush and occupant compartment measurements.

Figure 7.5. Test Vehicle after Test No. 611011-1.

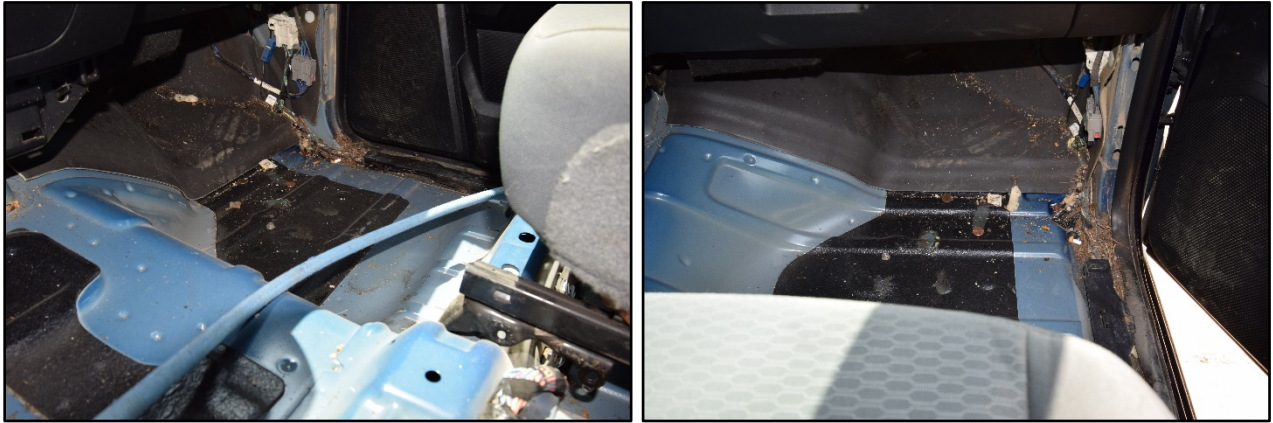
Figure 7.6. Front Impact-Side Interior of Test Vehicle after Test No. 611011-1.

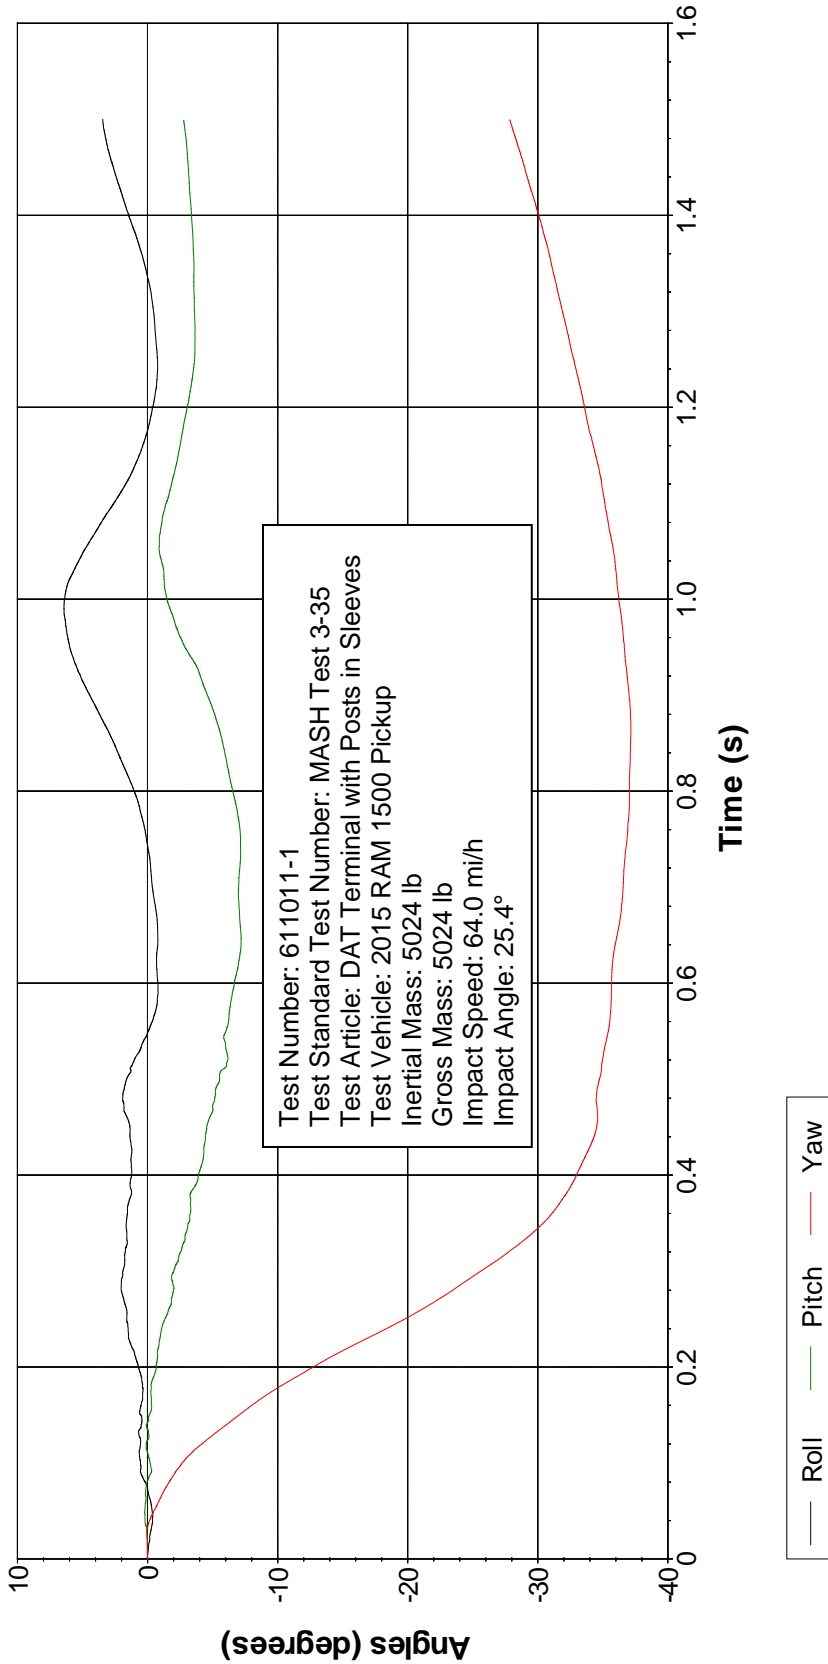
Figure E.3. Vehicle Angular Displacements for Test No. 611011-1.

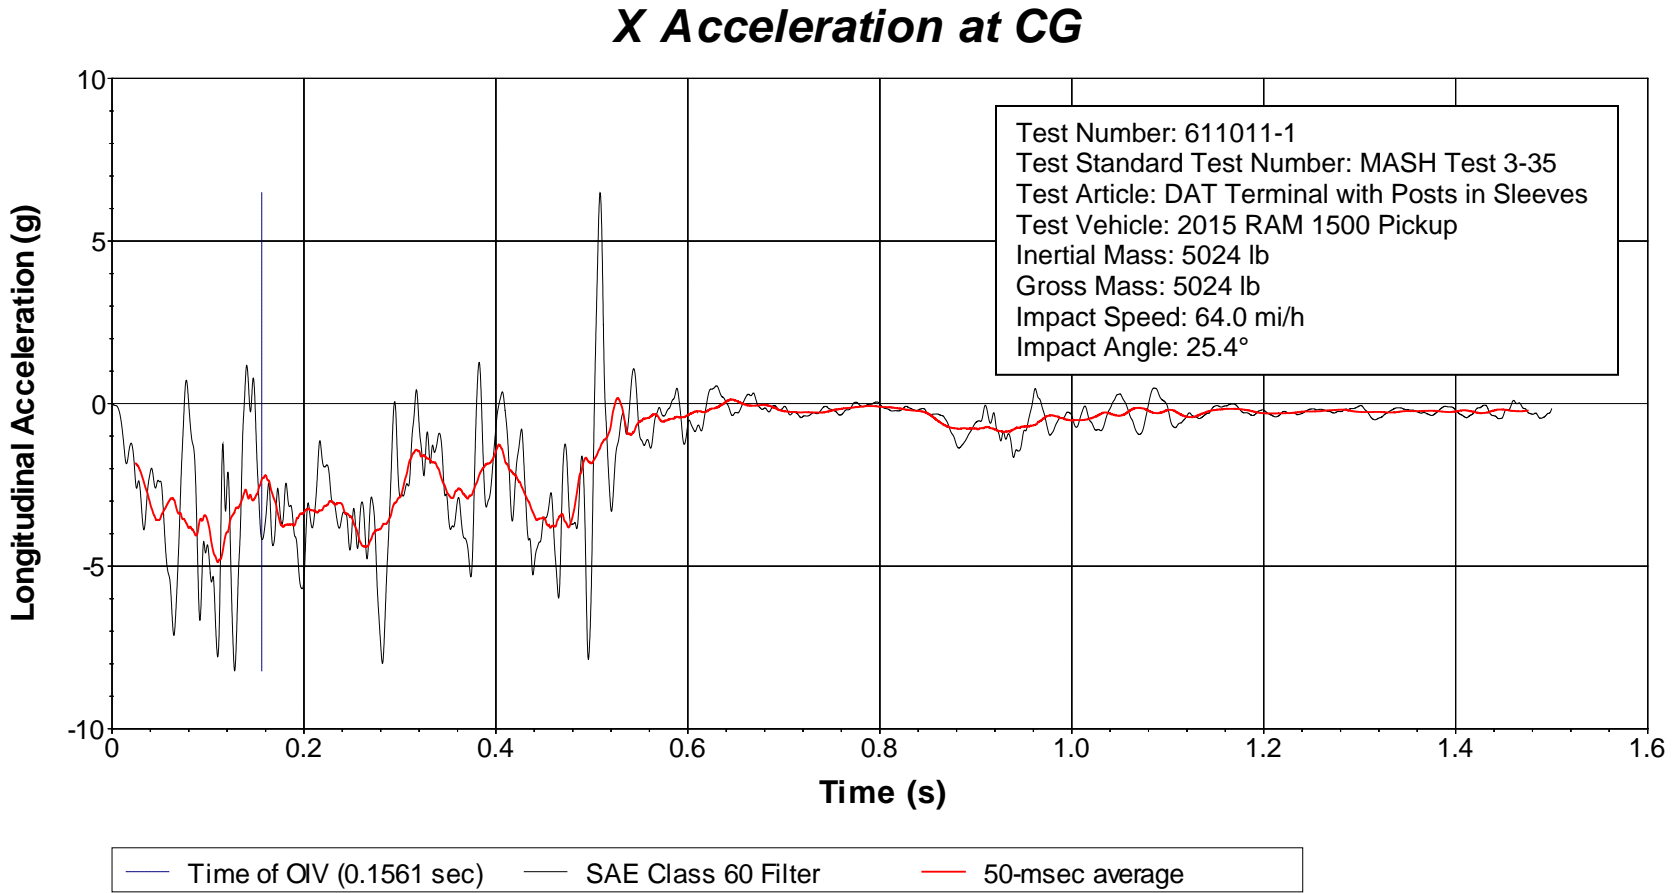
Figure E.4. Vehicle Longitudinal Accelerometer Trace for Test No. 611011-1 (Accelerometer Located at Center of Gravity).

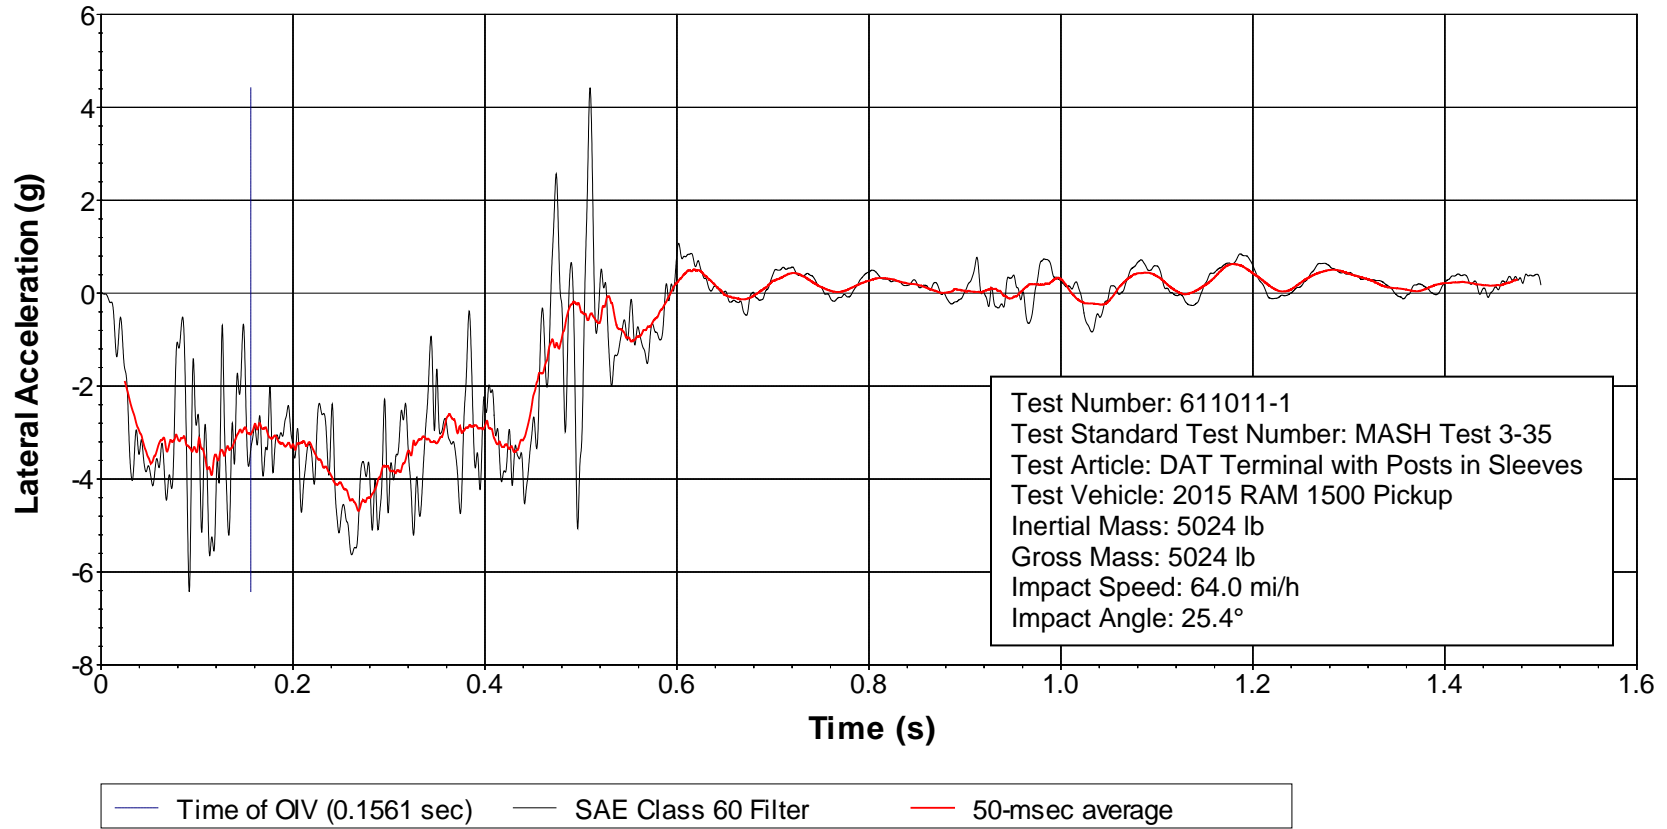
Figure E.5. Vehicle Lateral Accelerometer Trace for Test No. 611011-1 (Accelerometer Located at Center of Gravity).

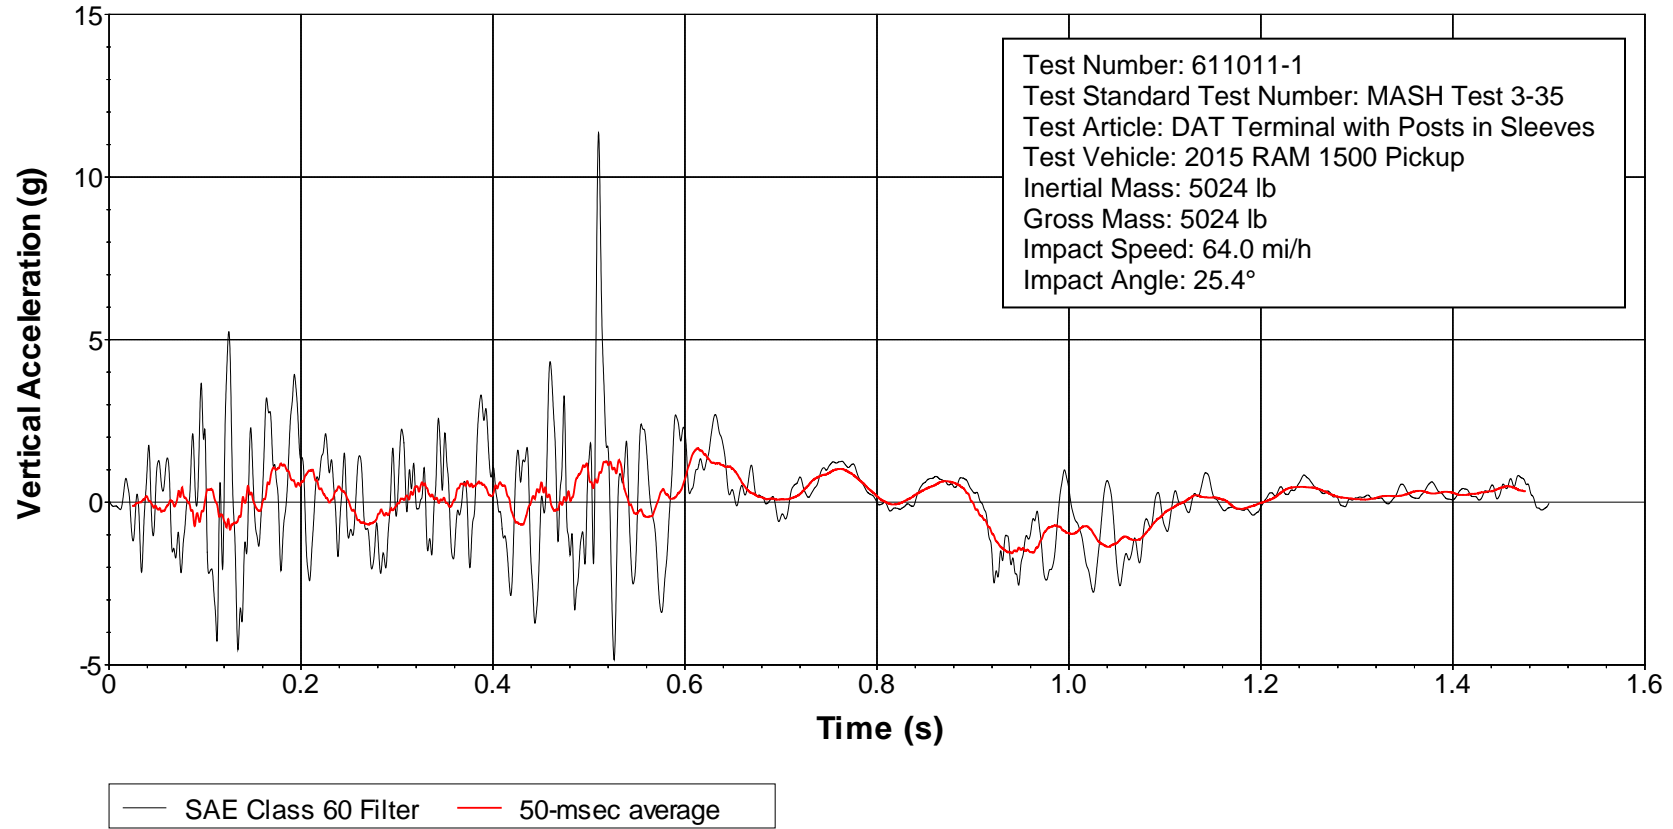
Figure E.6. Vehicle Vertical Accelerometer Trace for Test No. 611011-1 (Accelerometer Located at Center of Gravity).
