Evaluate ODOT's Current Berm Compaction Process for Cost Effective Alternatives

The Ohio Department of Transportation,
Office of Statewide Planning & Research

State Job Number 135496

Final Report

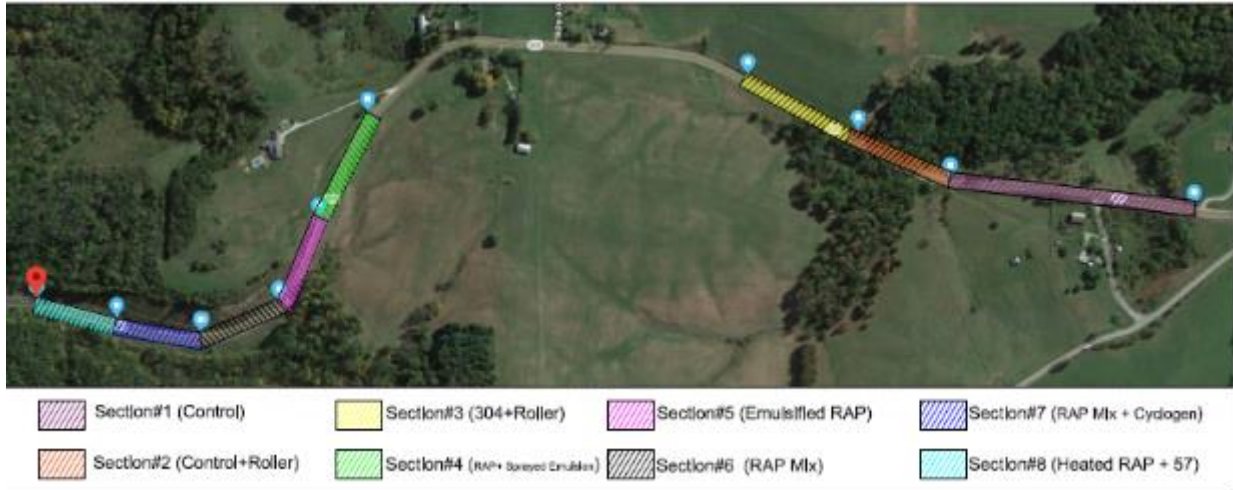
Figure 1. Layout of test section on SR 800 in ODOT Monroe County

- Section 8: The berm was established using the same method and equipment as in Section 2 but using RAP mix with No. 57 aggregates produced using Bagela BA10000 recycler. The No. 57 aggregates was added after RAP is heated and was mixed with RAP at a proportion of 3 parts RAP to 1 part No. 57 (3:1).

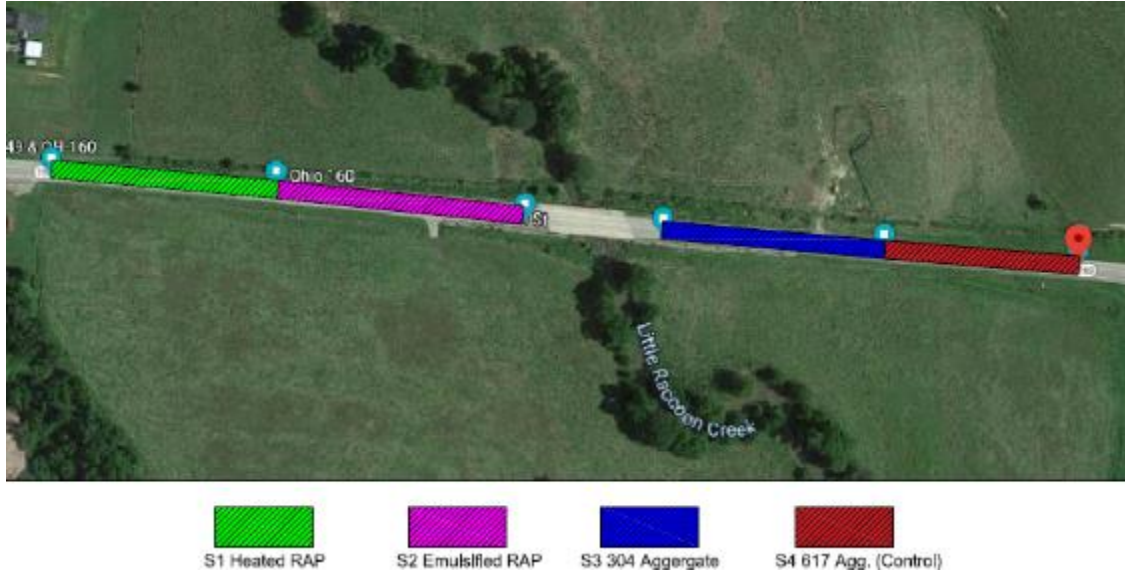
Figure 2. Layout of test section on SR 160 in ODOT Vinton County

Four berm test sections were also constructed on October 22nd, 2018 on SR 160 in ODOT Vinton County to evaluate the different alternative materials and methods for the establishing berms. Figure 2 provides the layout for the constructed test sections in Vinton County. The constructed test sections were:

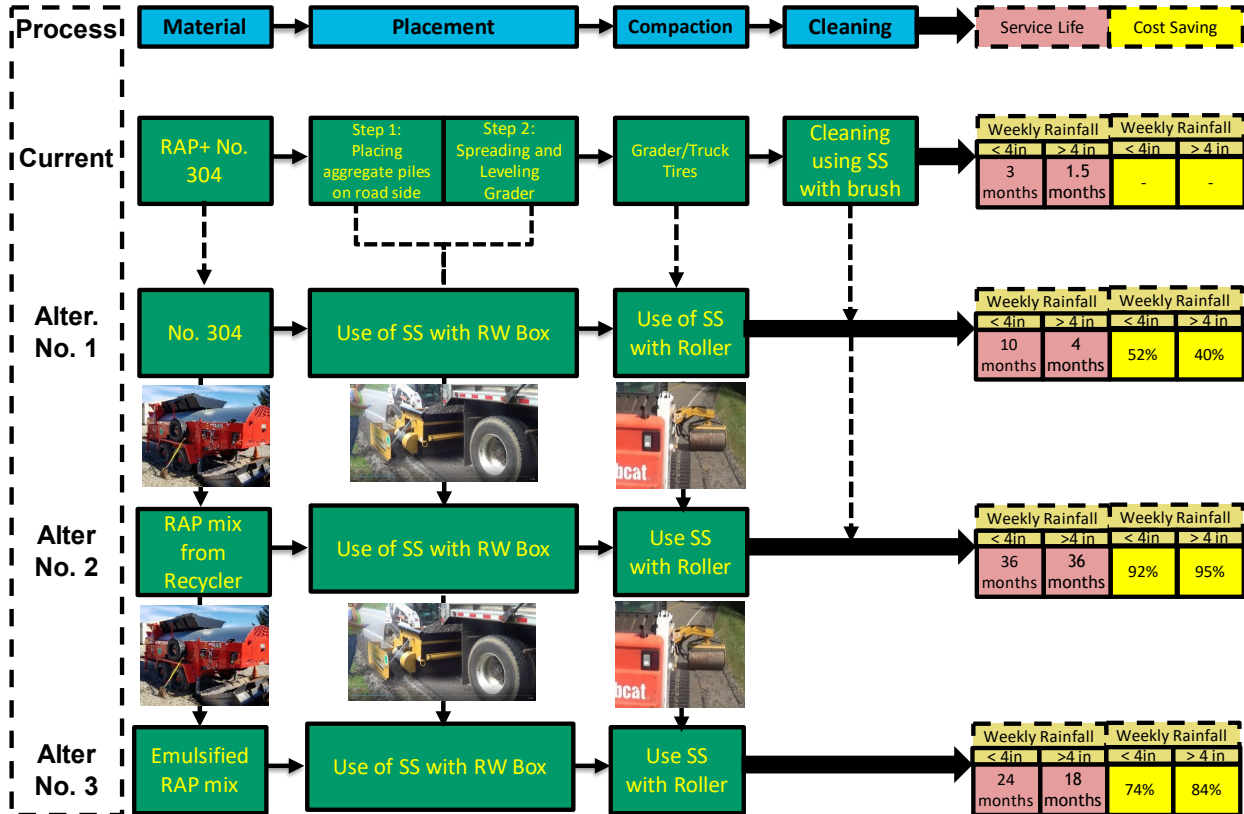
Figure 3. Recommended alternatives materials/methods for establishing berms

- Figure 3 provides the alternatives that are recommended to be used when establishing or repairing berms. A decision tree is also provided in Figure 4 to be used for the selection of berm material.
- Continue to monitor the performance of berm sections constructed in this study to validate the conclusions made in this report.
- The use of emulsified RAP mix was found to significantly improve the performance and service life of berms, and significantly reduce their cost. Future research should explore methods to efficiently produce such mixes.
- Future research should evaluate the performance and service life of patches installed using the RAP mixes produced using the asphalt recycler.

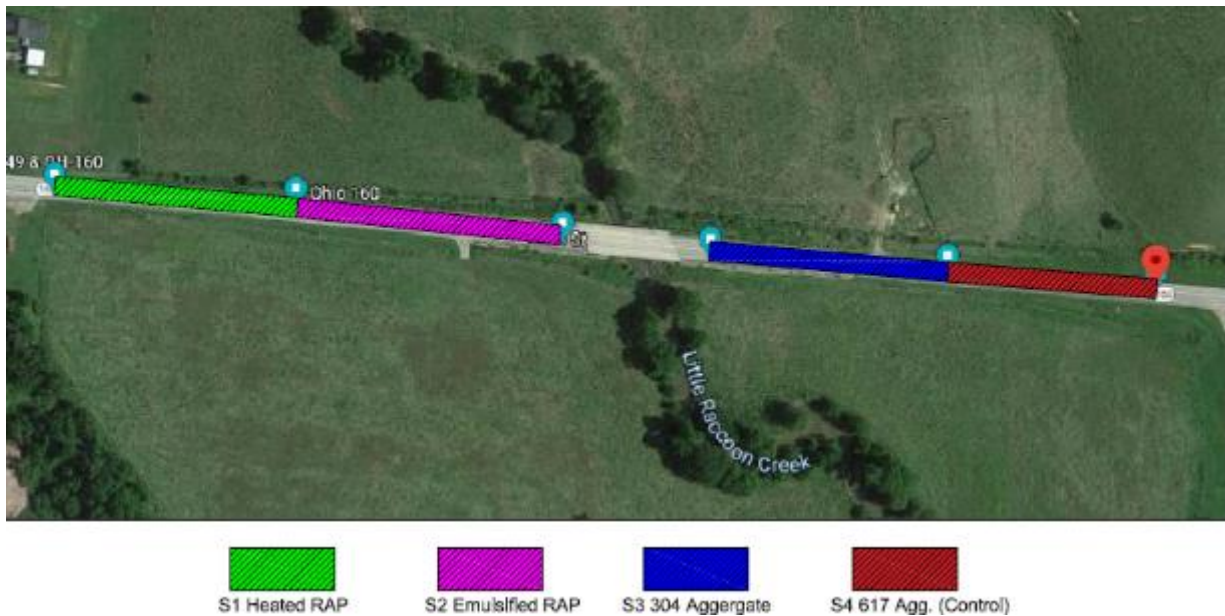
Figure A.3 Layout of test section on SR 160 in ODOT Vinton County

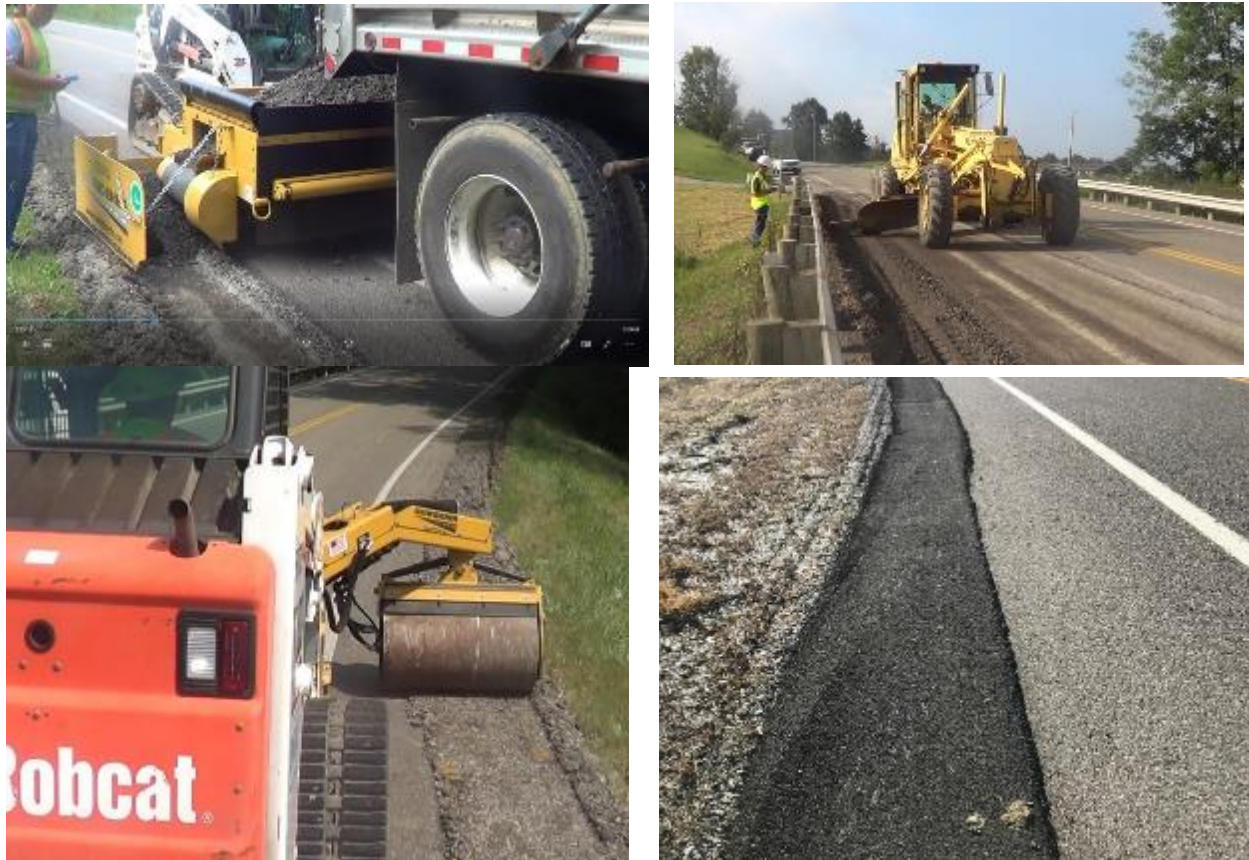
Figure A.4 Pictures taken during construction of berm test section in Monroe County

For each test section, the following information and data were recorded during the berm placement and compaction: exact location of each test section, time and date of compaction, berm material type and volume used, climatic conditions, equipment used for placing and compacting the berm, duration of berm placement and compaction, and number of workers in maintenance crew involved in berm construction. Prior to constructing the berm, the stiffness of existing materials was evaluated using the Light Falling Weight Deflectometer (LWD). LWD was also used during compaction to determine the number passes needed by offset vibratory roller to achieve the optimum stiffness for unbound granular materials. Based on that it was determined that three passes of the offset vibratory roller was needed for unbound aggregate material. LWD was also conducted to determine the stiffness of berms after completion of compaction. Videos and photographs were also taken to document the berm compaction and placement process. Figure A.4

presents some of the pictures taken during construction of test sections. All available information regarding the cost of constructing berm test sections were also obtained for use in the cost analyses conducted in this study.

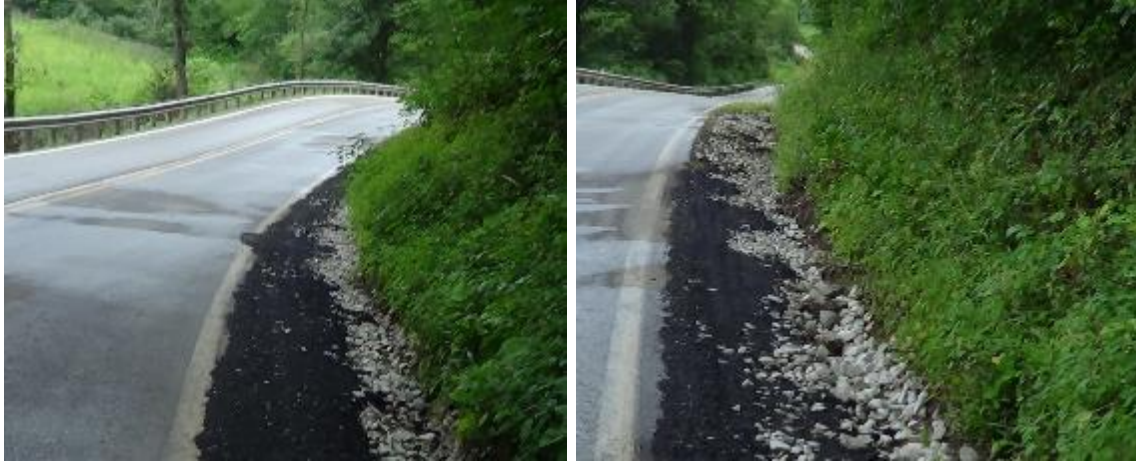
Figure A.5 Picture of repairs on SR 148

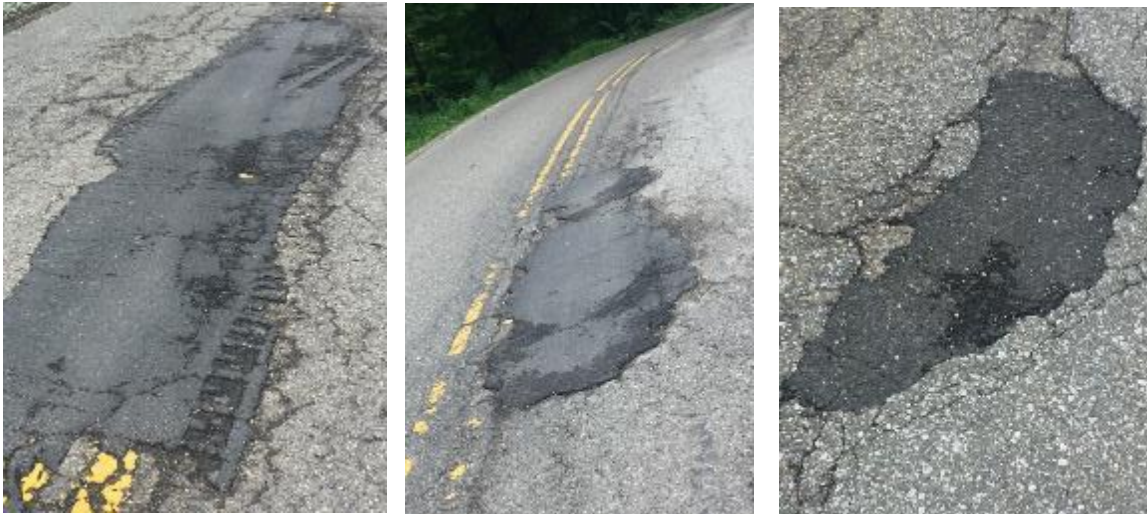
Figure A.5 Picture of repairs on SR 255

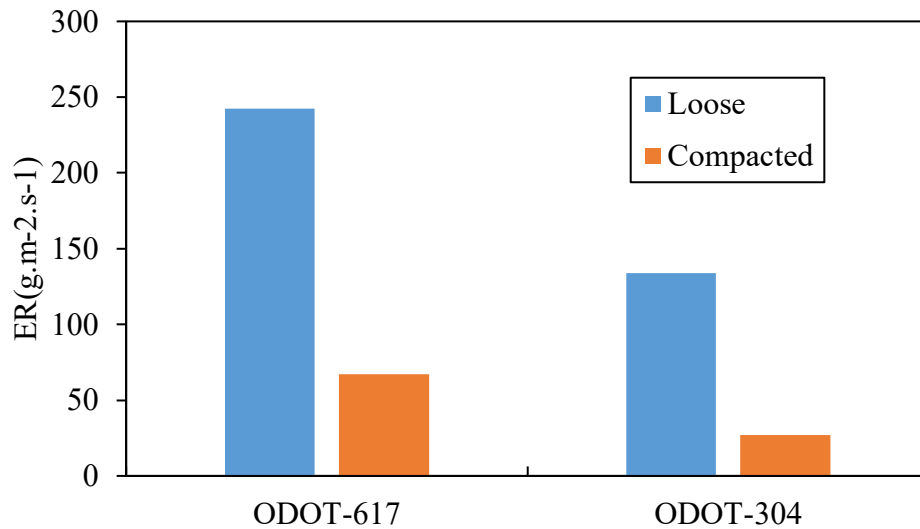
The erodibility of two different types of unbound aggregate materials (ODOT Item No. 617 and ODOT Item 304) that can be used by ODOT as berm materials was evaluated at different compaction level using the turbulent flow erodibility test. Figure B.1 presents the results of the average erodibility ratio (ER) that was obtained from conducted tests. It is noted that the lower the ER value the better the resistance of the materials to erosion. It is clear that the erosion resistance of ODOT No. 304 material was much better than ODOT No. 617 material. In addition, the effect of compaction on the erodibility of both aggregates is significant. Such that the compacting the materials to their maximum density obtained in a standard proctor results in decreasing the ER value and increasing the erodibility resistance. The improvement was more significant in the ODOT No. 304 aggregates.

Figure B.1 Erodibility of unbound berm materials

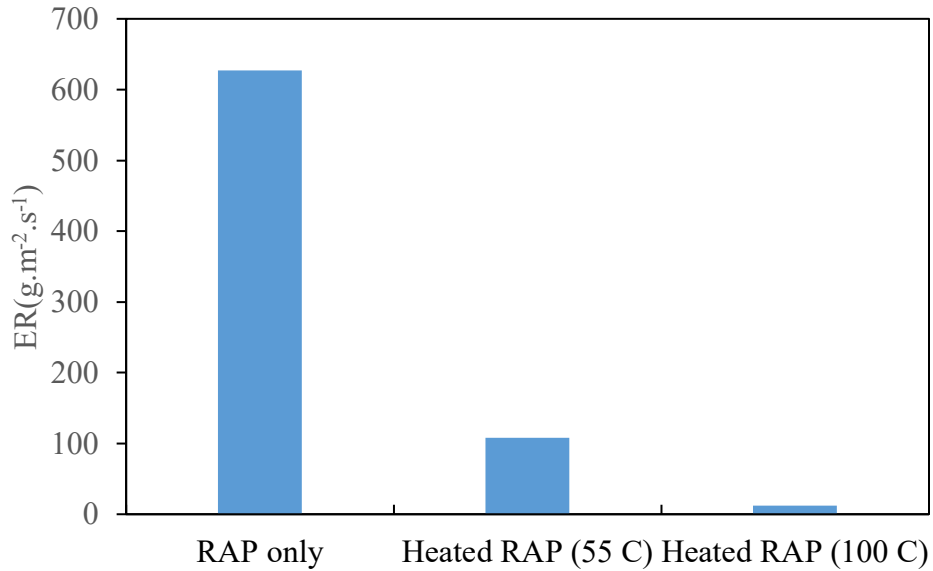
The use of heated RAP material was one of the alternatives identified in Phase 1 to improve the performance and service life of berm materials. Erodibility tests were conducted on RAP materials that were unheated as well as heated to two different temperatures and then compacted to determine the minimum heating temperature to be used in the field. The temperatures used were 55°C and 100°C. Figure B.2 presents the ER ratio for the RAP material heated to different temperatures. It is clear that the unheated RAP material has much higher ER value and thus significantly lower resistance to erosion than ODOT No. 617 and ODOT No. 304 materials. This suggested that unheated RAP materials should not be used for berm. Heating the materials to 55°C will improve the erosion resistance significantly; however, the best resistance to erosion will be achieved at a temperature of 100°C. This result suggest that compaction temperature of heated RAP material should be at least 100°C.

Figure B.2 Erodibility of heated RAP material

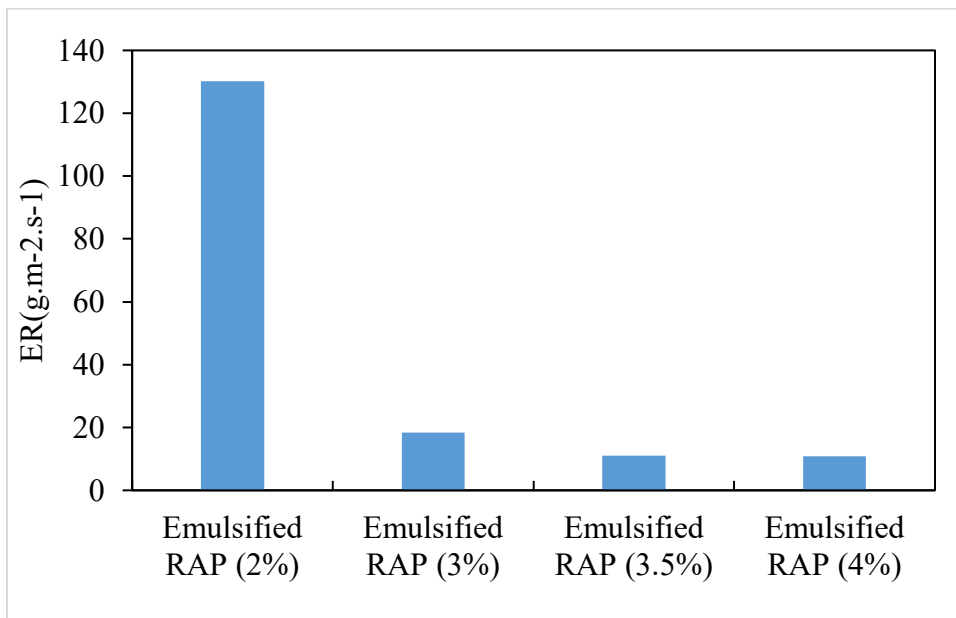
Phase 2 of this study also explored the use of emulsified RAP material for berm. Emulsified RAP materials are RAP materials that are mixed with an emulsion to form a mixture after curing. RAP materials obtained from ODOT county garages were mixed with four different emulsion contents: 2%, 3, 3.5%, and 4%. Emulsified RAP mixes were compacted and tested. Figure B.3 presents the ER ratio for the emulsified RAP mixes prepared using different emulsion contents. It is clear that increasing the emulsion have improved the RAP material resistance to erosion significantly, particularly when the emulsion content is more than 3%. Based on the results, the optimum emulsion content is between 3 and 3.5%.

Figure B.3 Erodibility of Emulsified RAP material

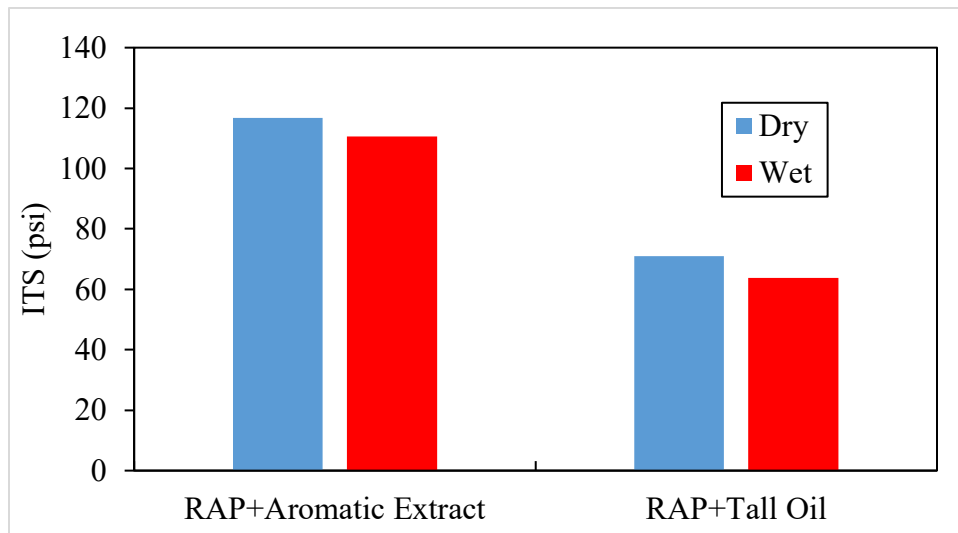
Indirect tensile strength (IDT) tests were conducted on dry and wet conditioned samples of the RAP mixes with two different rejuvenators at 25°C. Figure B.4 presents the average ITS values for tested samples. It is noted that the average ITS value for the dry samples of the RAP mix with aromatic extract rejuvenator was higher than 100 psi, which is the value recommended for mixes with acceptable tensile strength. However, RAP mix with tall oil rejuvenator had an average ITS value less than 100 psi for dry samples. This indicates that the tall oil has significantly softened the RAP mix, which might suggest it affects its cracking resistance. The wet conditioning resulted in lowering the ITS values of the samples of both mixes. However, the decrease in the ITS was slightly more in the mix with the tall oil rejuvenator. The tensile strength ratio (TSR), the ratio between average indirect tensile strengths of the wet conditioned samples to that of the dry samples, was computed. The average TSR values for the considered mixes are shown from Figure B.5. It is noted that all mixes exceeded the TSR limit set by ODOT at 80%, which indicates adequate resistance to freezing and thawing and thus, good durability. Based on the obtained results the aromatic extract rejuvenator was selected to be used in the RAP mixes for the field test section.

Figure B.4 ITS test results for RAP mixes

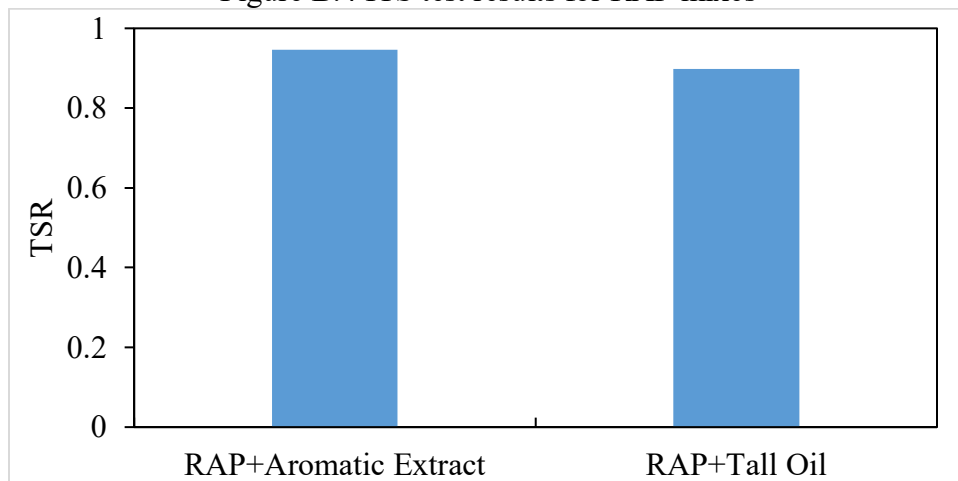
Figure B.5 TSR of RAP mixes

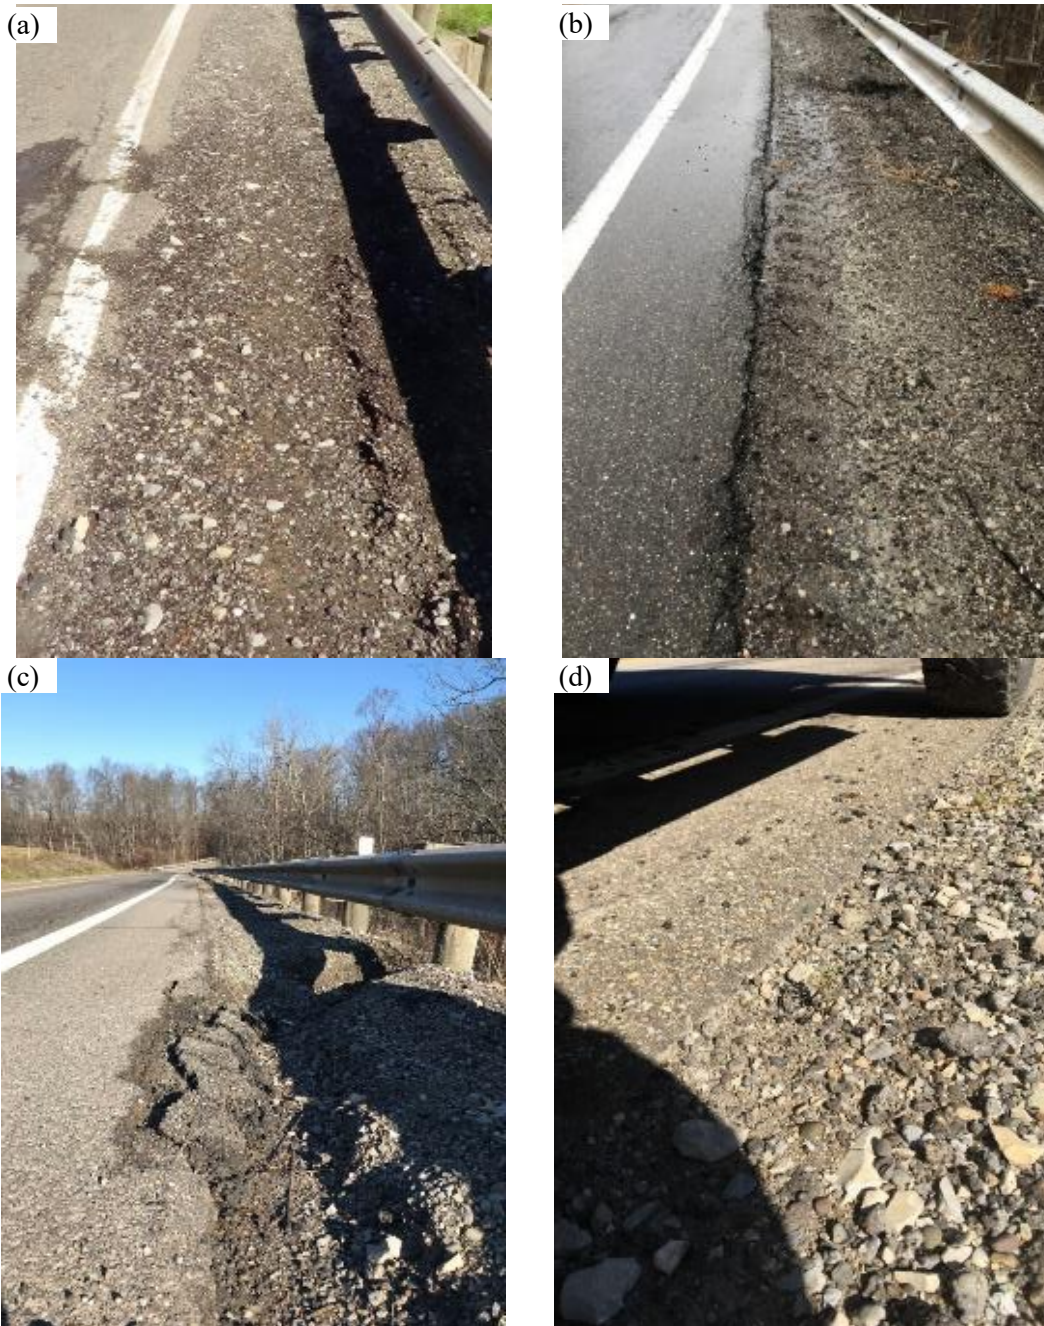
Figure B.8 Pictures from section one evaluation after: a. One month b. Four months b. Four months (Failed section) c. One year

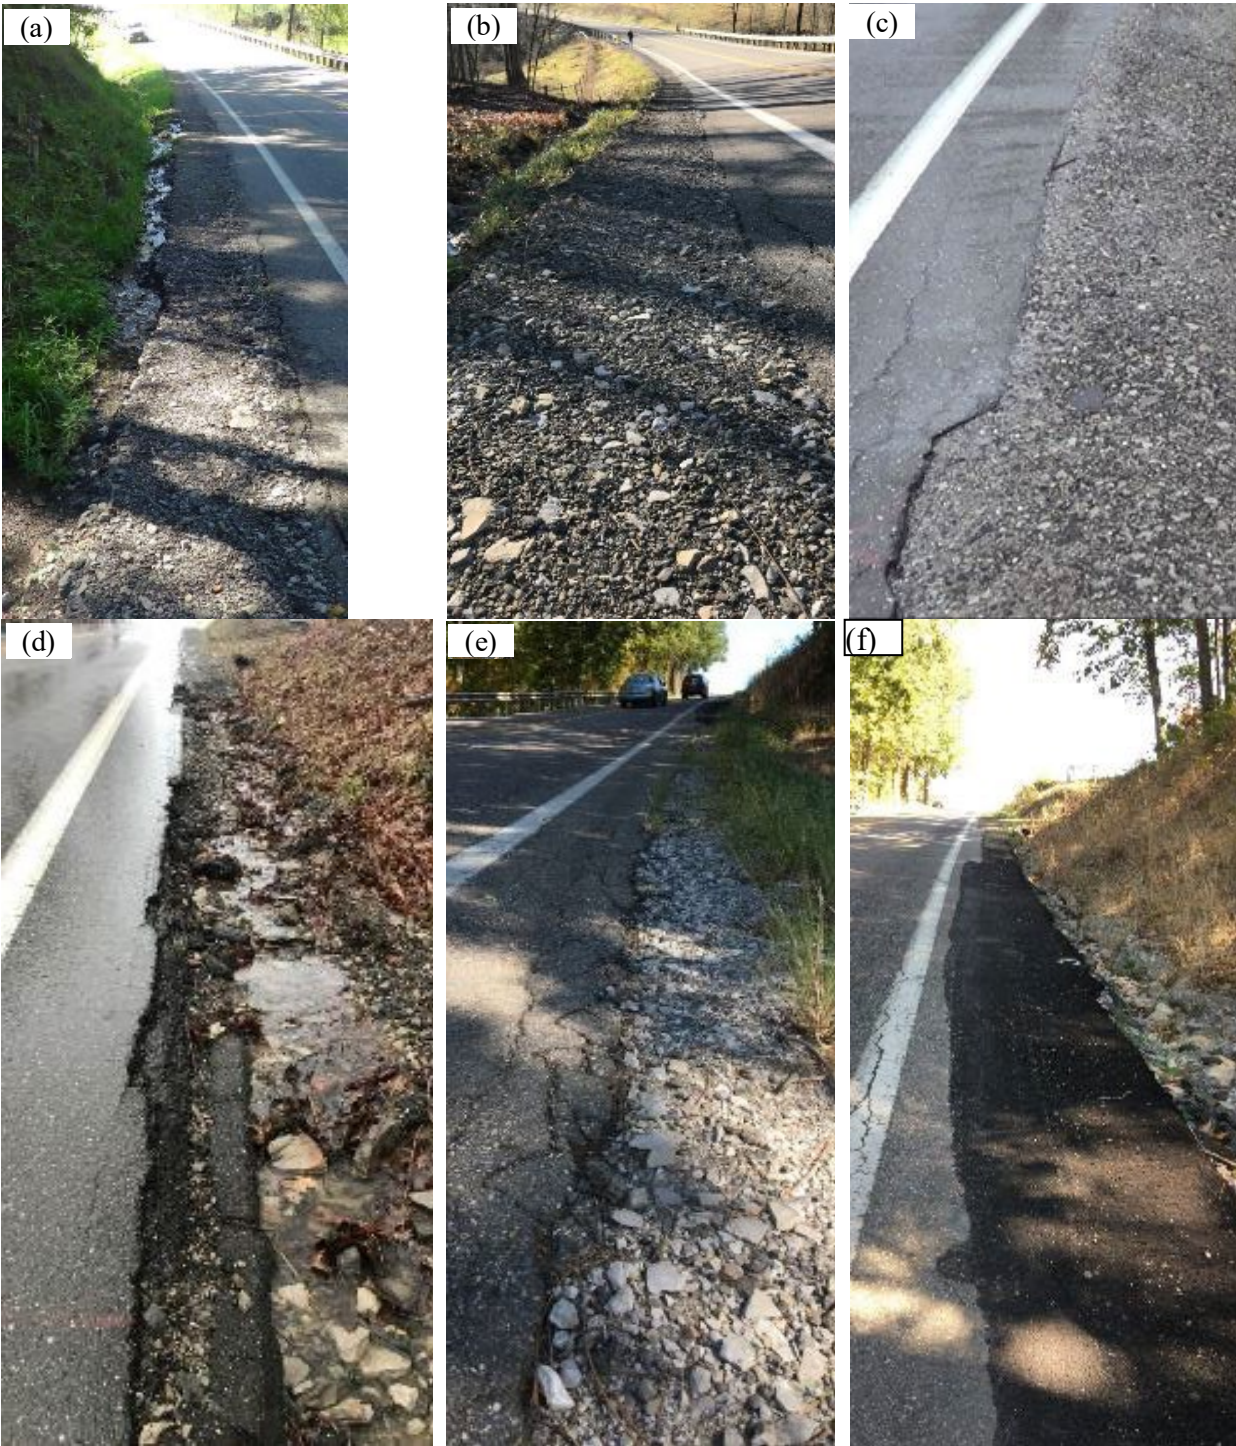
that may cause erosion. It is worth noting that grade changed within the second part of section two from negative to positive indicating that this part was placed on a valley, Figure B.10. The failed part of berm section 2 was repaired using the heated RAP. It is noted that after three months of service the repaired part had no erosion or any damage, Figure B.9f. After one year, the berm materials became very loose and the drop-off along the edge increased and reached up to 1.5 inches. Additionally, pavement edges were broken due to lack of lateral support. The service life for this section was estimated to be about seven months.

Figure B.9 Pictures from section two evaluation after: a. One month b. Four months c. Six months (first part of section) d. Six months (second part of section) e. One year f. 3 months (Repaired part

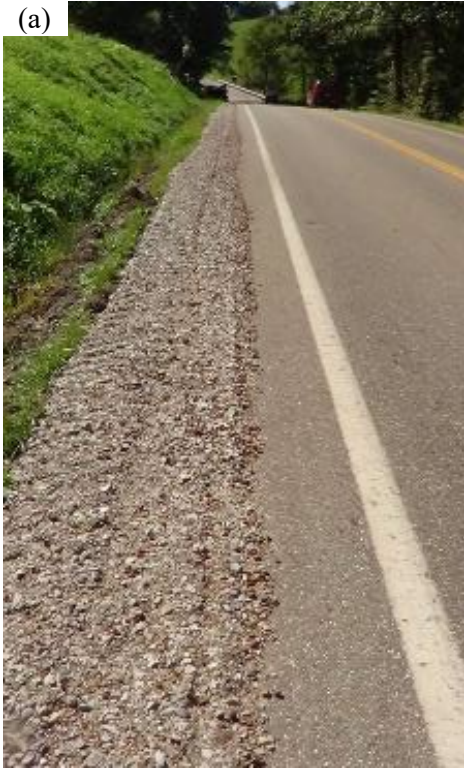
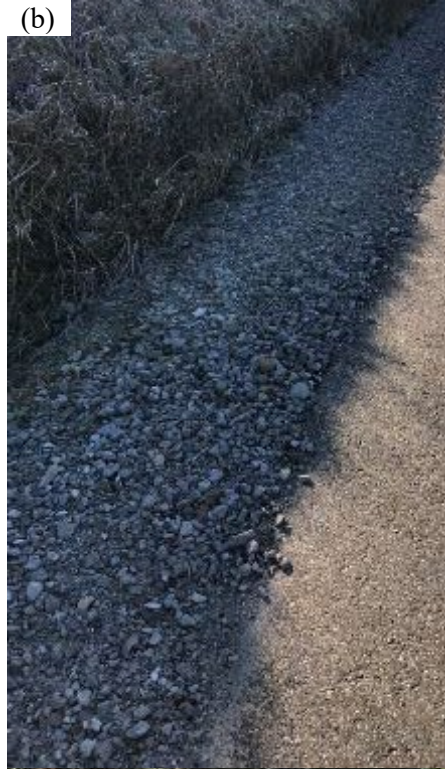
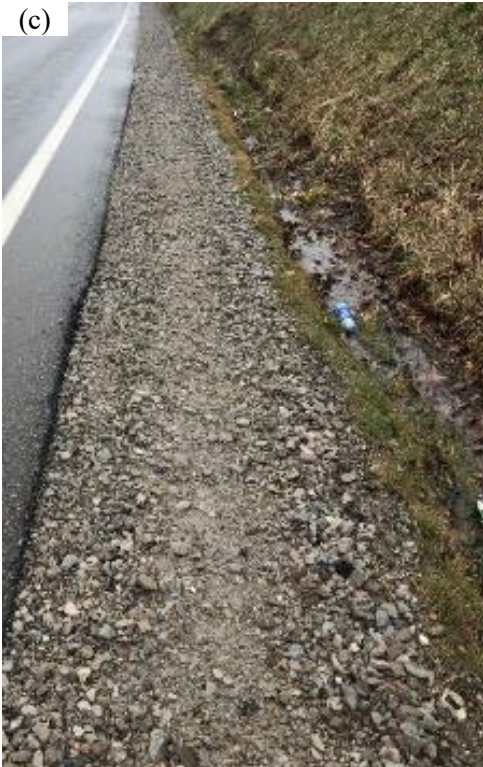
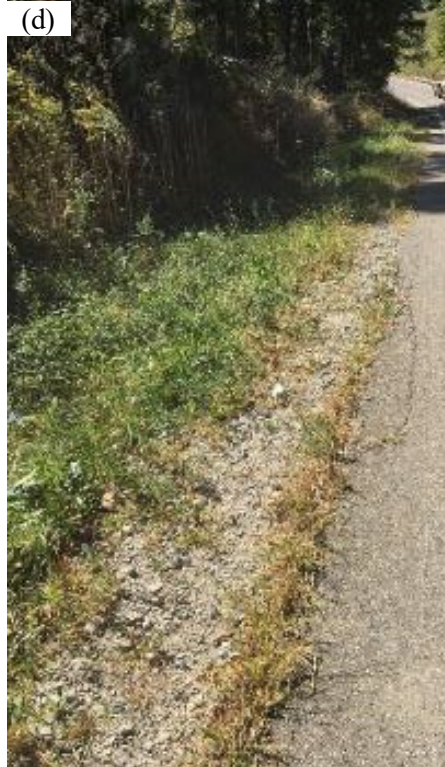
Figure B.11 Pictures from section three evaluations after: a. One month b. Four months b. Seven months four months c. one year

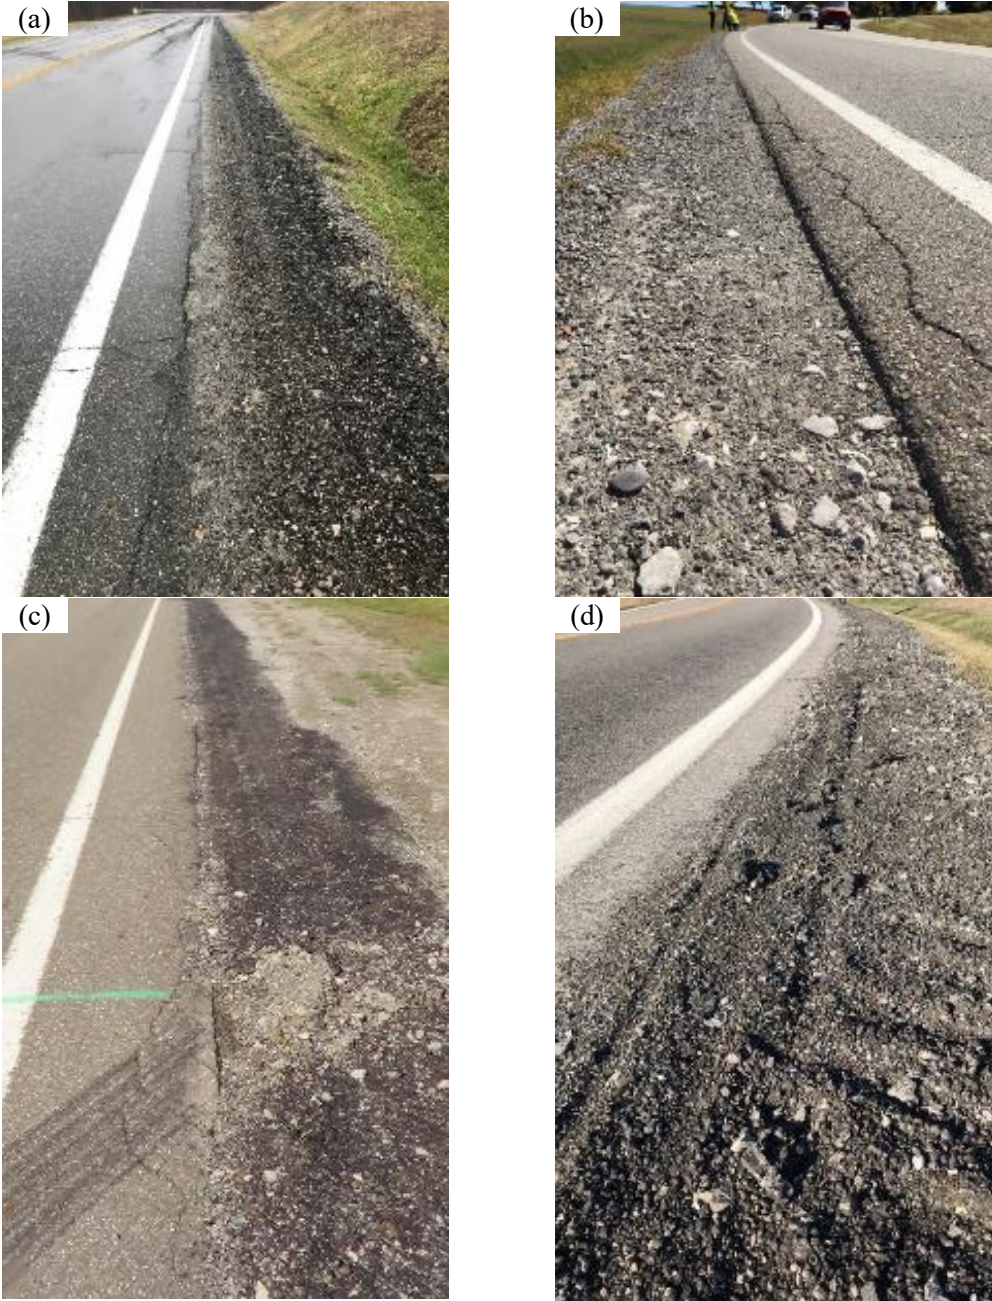
This section did not have any erosion or drop-off after one month. In addition, the berm material seemed to be stiffer than it was directly after the construction. There were no apparent differences in the performance between the wet and dry compacted parts of the section. The materials were loose and soft after four months of construction, Figure B.12b. In addition, some of the loose materials started to migrate towards the sideways of the section. A drop-off of up to 0.25 inches was observed in some spots of the berm. After one year, the berm material became looser, which resulted in some erosion and increase in the depth of the drop-off along the edge, which was found to be on average about 0.5 inches along the section but reached up to 2.0 inches in few locations. In addition, cracks developed along the pavement edges, which was caused by lack of support from the berm. The service life for this section was estimated to be one year.

Figure B.12 Pictures from section four evaluations after: a. One month b. Four months b. Seven months four months c. One year

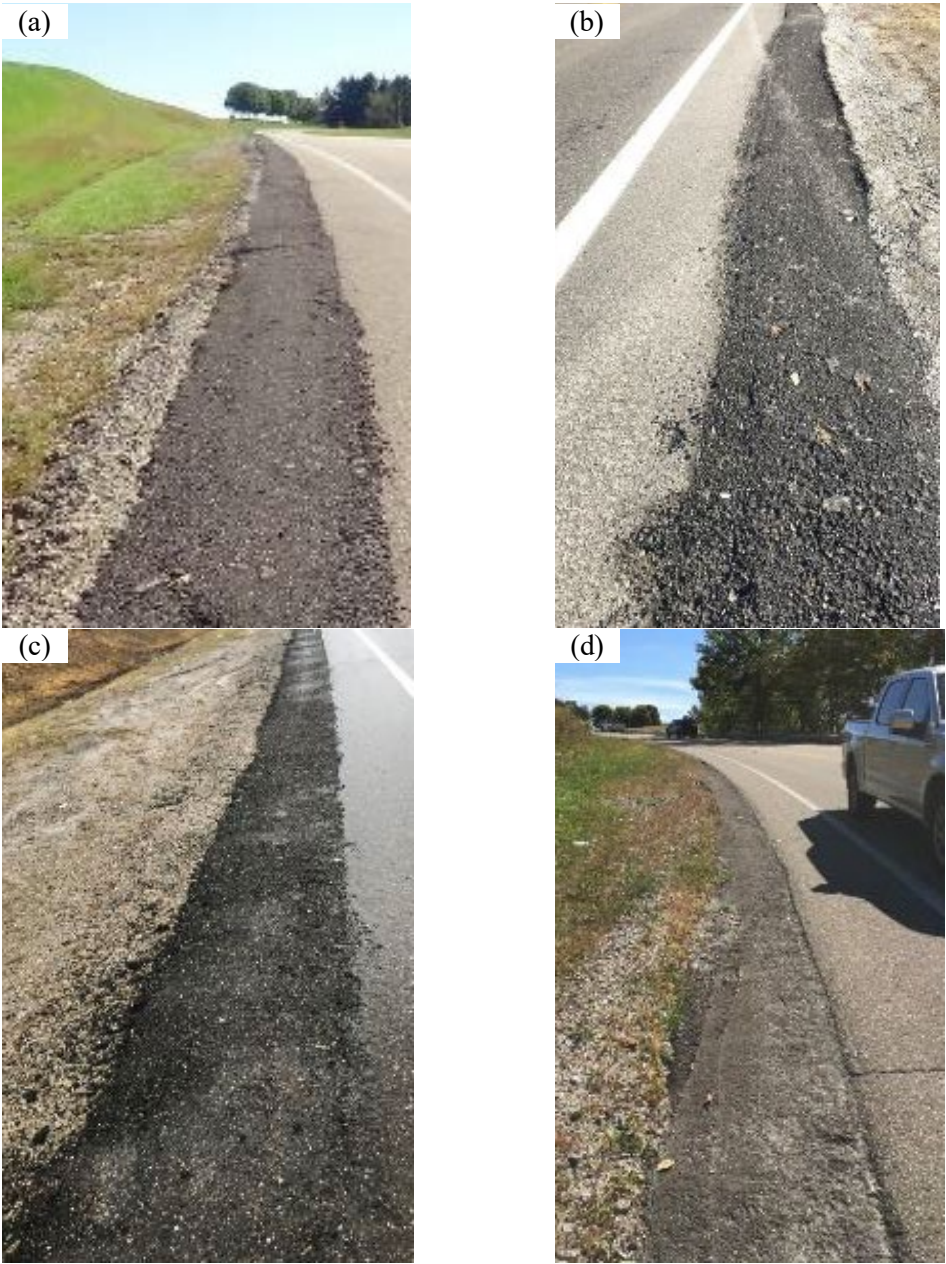
first four test sections. Based on the evaluation done, the service life for this section is estimated to be at least 2 years.

Figure B.13 Pictures from section five evaluations after: a. One month b. Four months b. Seven months four months c. One year

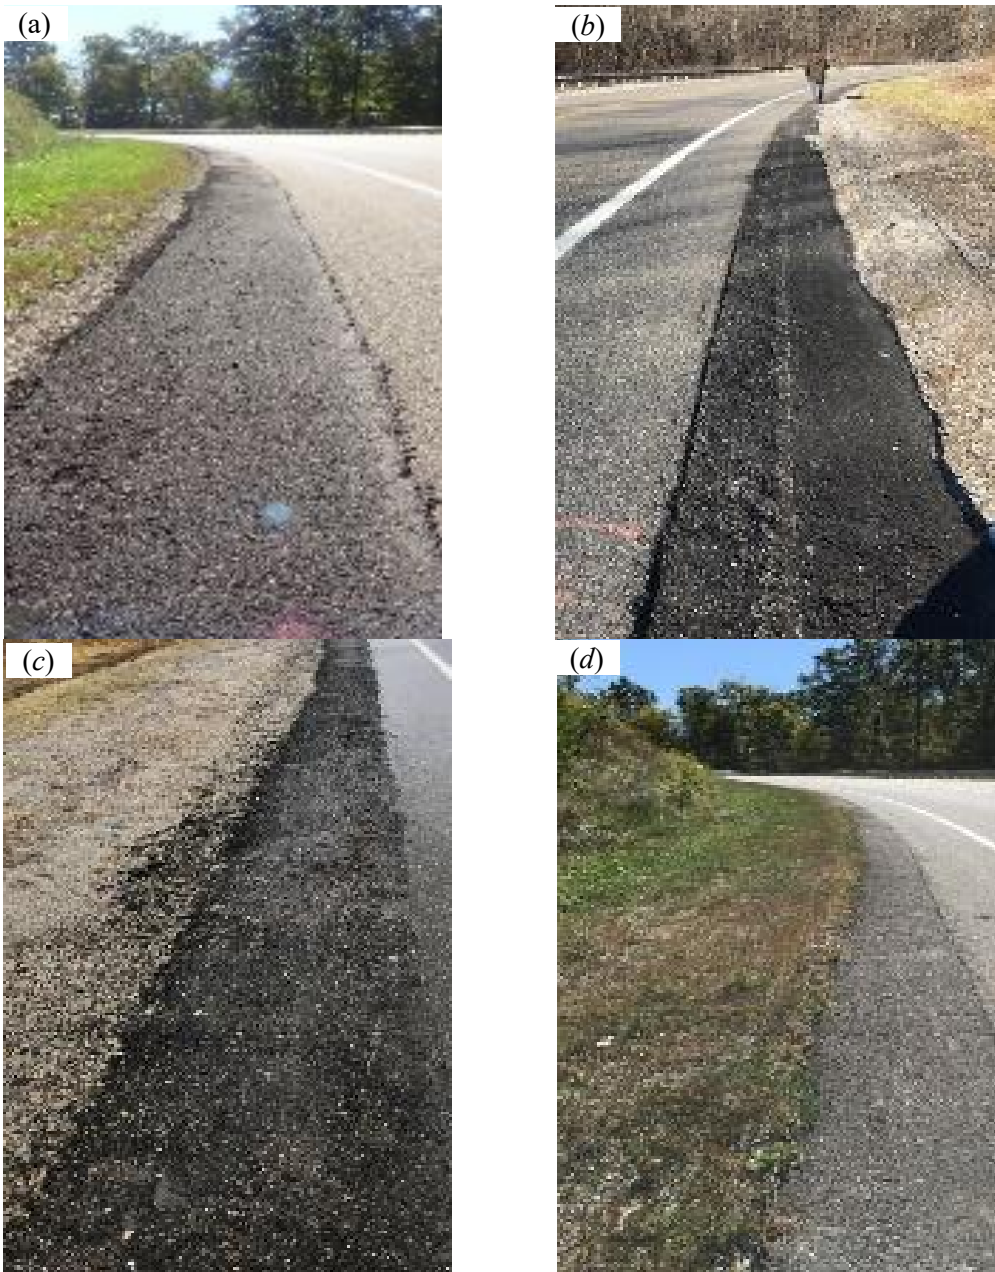
found to be more durable than sections 6 and 8. There was low level raveling in the section 6 after one year of service. Based on evaluation done on this test section, it is estimated that the service life will be more than three years.

Figure B.14 Pictures from section six evaluations: a. One month b. Four months c. one year

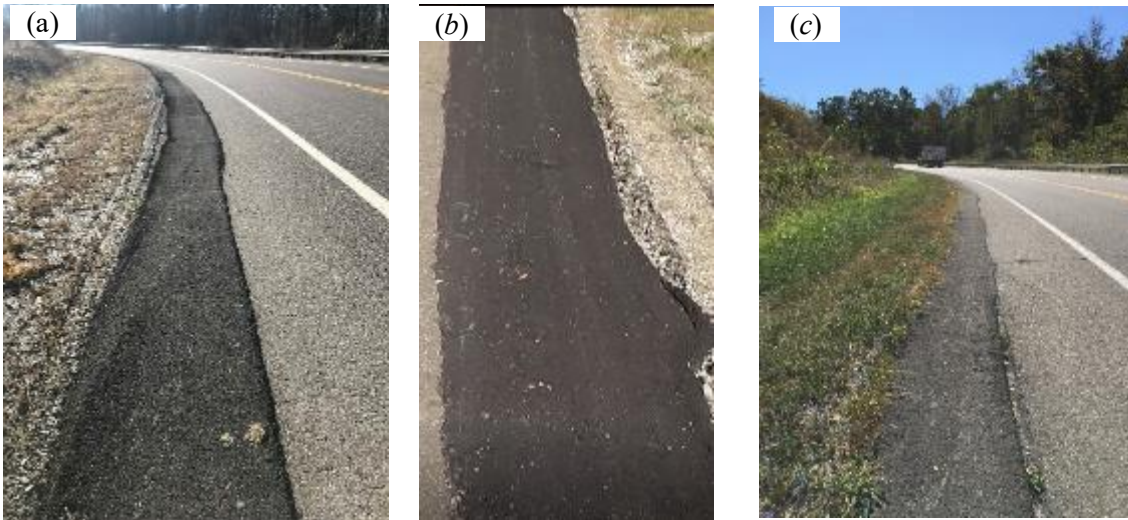
There was a low-level erosion after one year of service, which results in drop-off less than 0.25 inches in some segments in this section. This section seemed to be less durable than sections six and seven, as shown in Figure B.16. Some of aggregates have started stripping out from the berm after one year of service, but this did not affect the performance. It is estimated that the service life of this section to be less than three years.

Figure B.15 Pictures from section seven evaluations: a. One month b. Four months c. One year

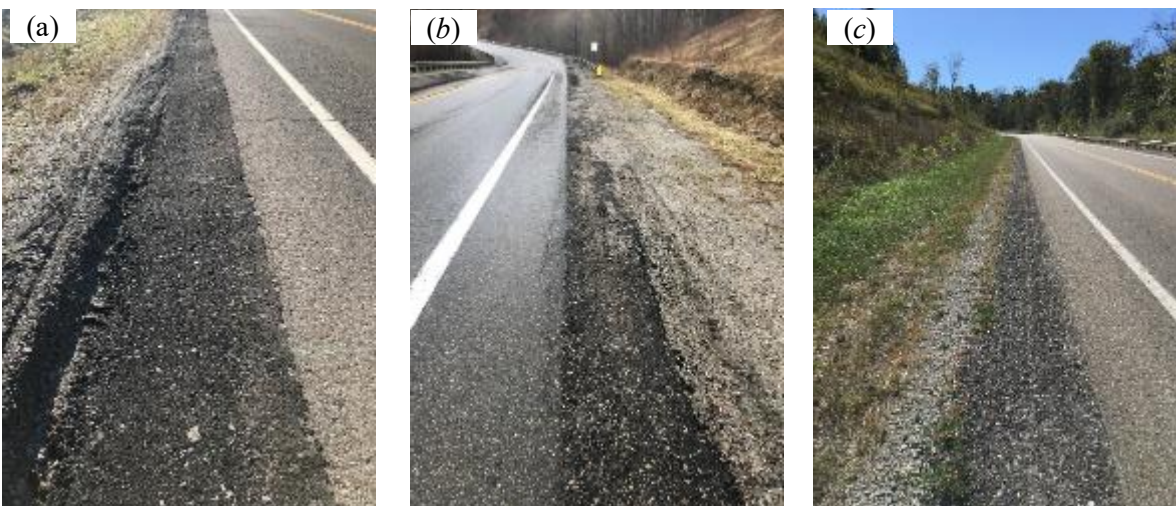
Figure B.16 Pictures from section eight evaluations: a. One month b. Four months c. One year

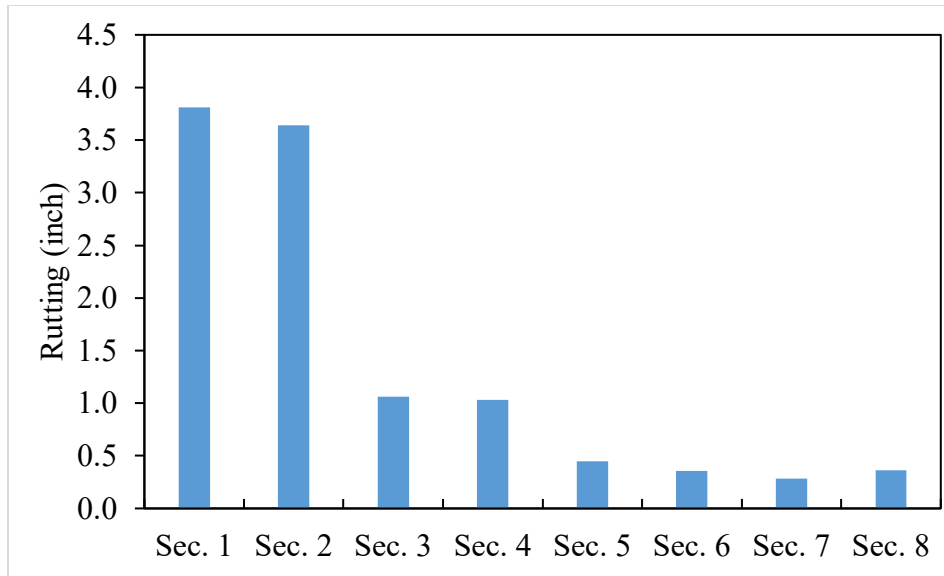
As rutting due to heavy truck traffic is a concern for test sections in ODOT Monroe County, the rutting was predicted for 5 years of service life. To achieve this, the LWD modulus was used to determine the vertical strains that will develop in the different test section due to truck traffic with maximum axle load of 34 kips. The computed vertical strain was used to compute the rutting. Figure B.22 presents the computed rutting in the berm test sections. It is clear that sections with current berm materials will result in rutting more than 3 inches. The use of ODOT No. 304 compacted using the offset vibratory roller will reduce the rutting to less than 1 inch. Finally, using emulsified RAP mixes or heated RAP mixes will result in rutting less than 0.5 inch. The lowest rutting will develop in the section with heated RAP mix that includes rejuvenator.

Figure B.22 Predicted rutting values for Monroe test section

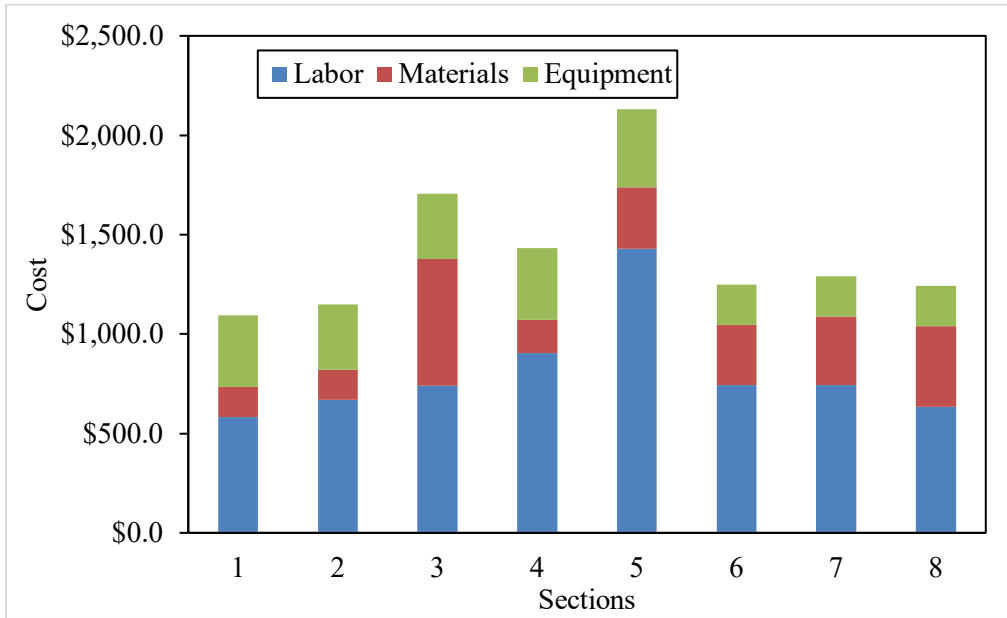
Figure B.23 Cost of construction for Monroe test section

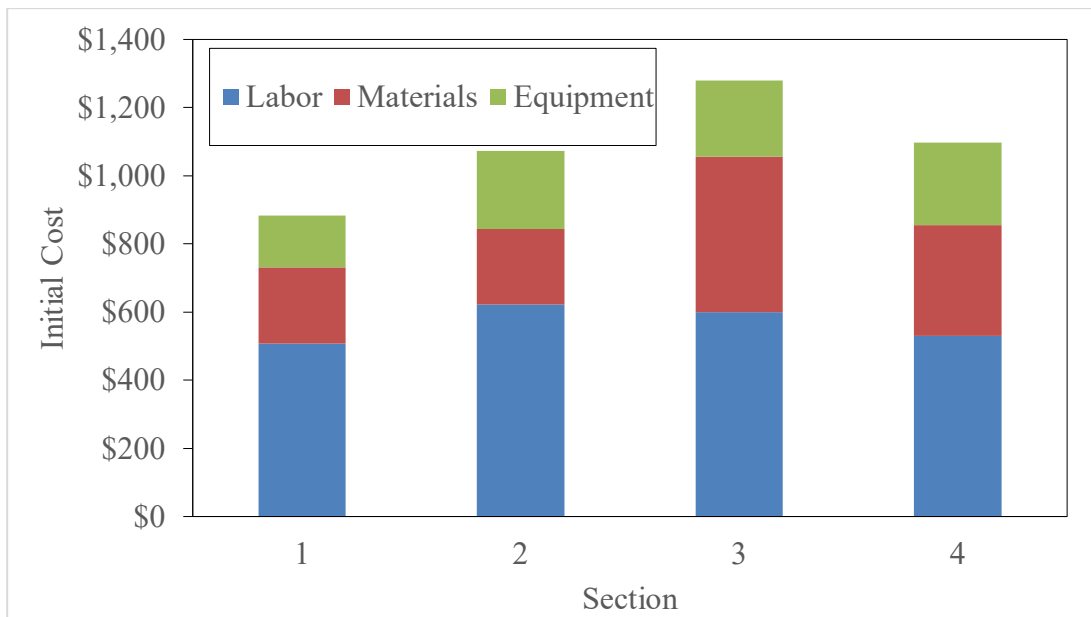
Figure B.24 Cost of construction for Vinton test section
