# Greensburg Vehicle and Pedestrian Study

South Main Street between West Otterman and Pittsburgh Street

## FINAL RESEARCH REPORT

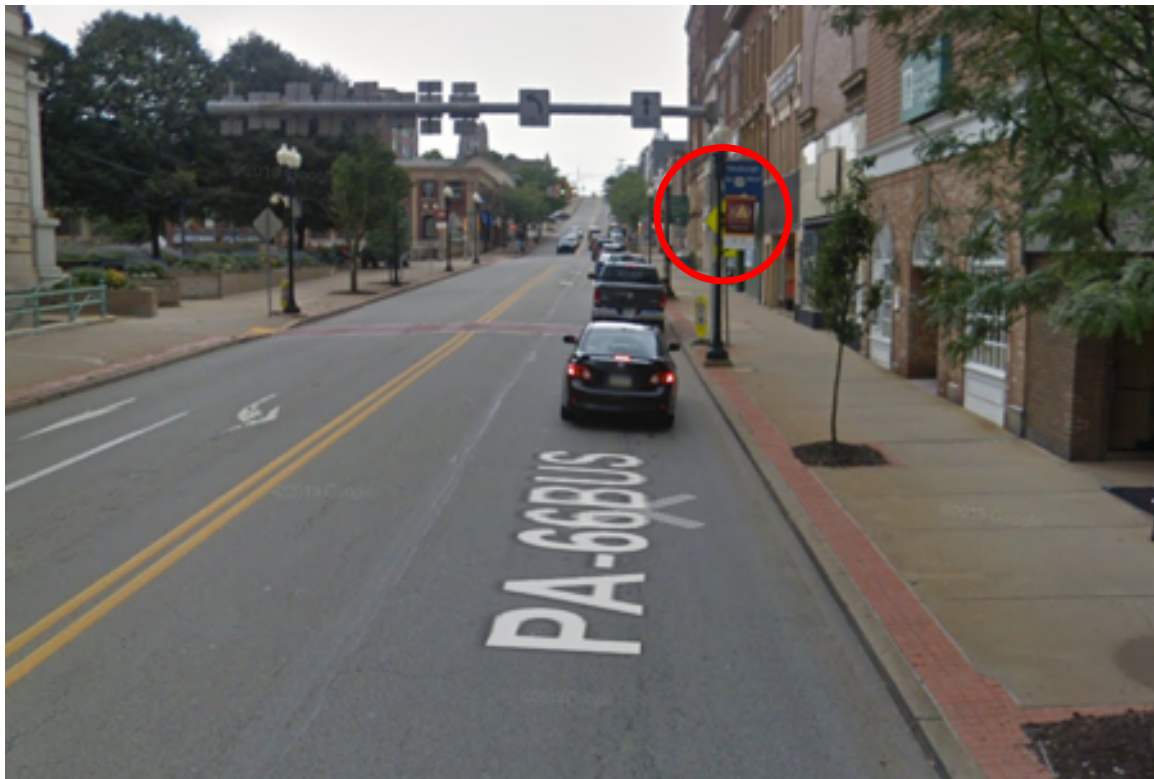
When event posters are present on the streetlamp in front of the crosswalk from the southbound direction as in the figure below, visibility of the yield sign for large vehicles with a high seating position is greatly reduced.

**FIGURE 2.** Event posters reduce visibility to the ‘yield to pedestrians’ sign

This negatively affects the probability that large trucks will yield to pedestrians when necessary and could therefore lead to safety hazards. Even without the banner, the crossing marker is partially obscured by the streetlamp’s pole.

General upkeep and modification of a few key components may be enough to make a noticeable improvement on pedestrian safety, crosswalk utilization, and motorist compliance in the study area. First, banners should not be hung on the streetlamps directly in front of the line of sight of the crosswalk sign. This type of banner placement obscures visibility of the crossing sign and limits awareness of the crossing location for motorists unfamiliar with the area. Also, in its current condition, the paint outline of the midblock crosswalk is relatively faded in color and chipped off intermittently along its length (See Figure 8). Repainting the outline of the crosswalk with a fresh white coat will improve visibility in overcast and dark conditions for minimal cost. This may itself cause a large improvement in crosswalk utilization and motorist yielding.

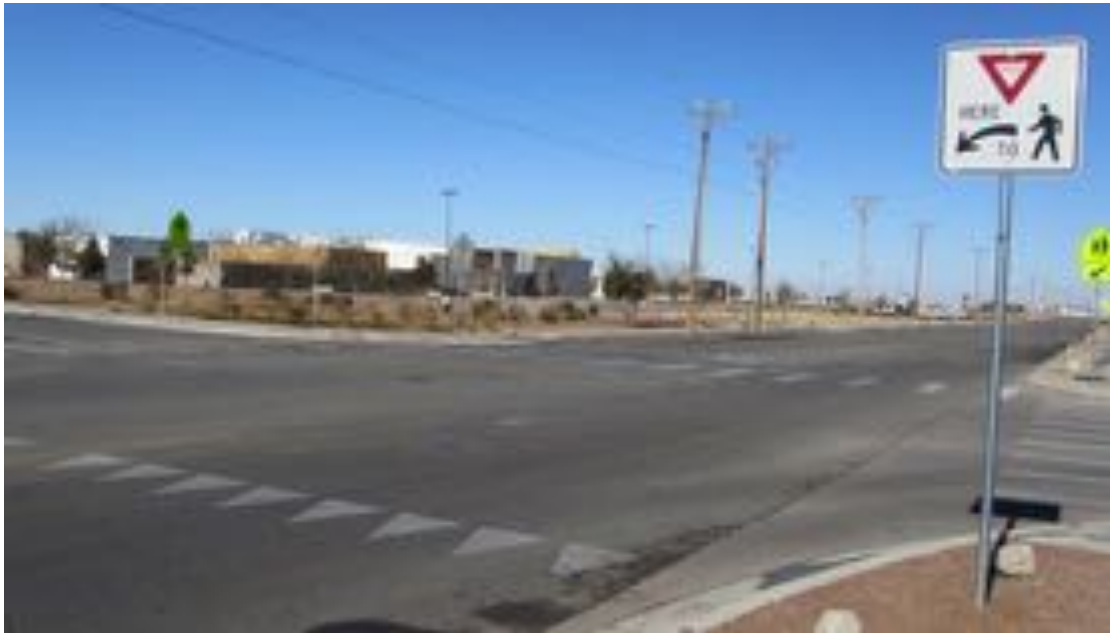
The current signage in the study area could be improved markedly by the addition of two new signs and road markings constituting an advance yield area (see Figure 3). Studies performed by the DOT indicated that advance yield signs and stop markings placed 20-50 feet from the crossing location are a relatively inexpensive and effective means of improving the safety of pedestrians at uncontrolled crossing locations.

**FIGURE 3.** Example of recommended advance yield markings.

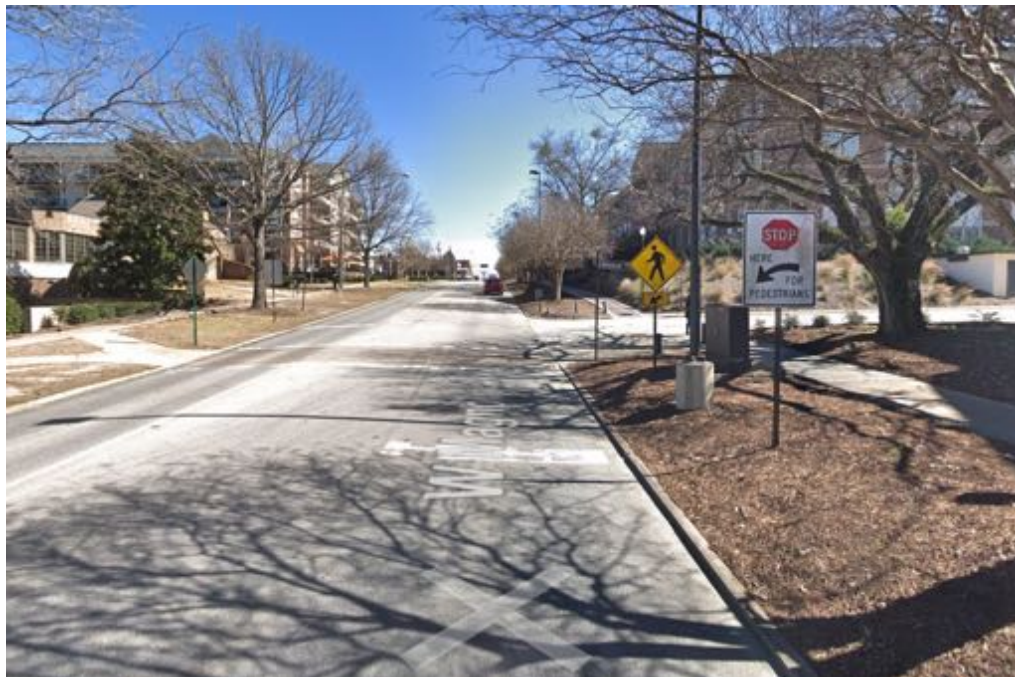
Advanced yield markings placed 20 – 50 feet in front of a crosswalk in either direction as shown in the figure below have been observed to reduce the probability of pedestrian and vehicle conflicts by as much as 25%. And given the current visibility problem, it is highly likely that the installation of advanced yield markings will increase the percentage of motor vehicles that yield to pedestrians in general.

**FIGURE 5.** Another example of the usage of advanced yield markings to improve safety.

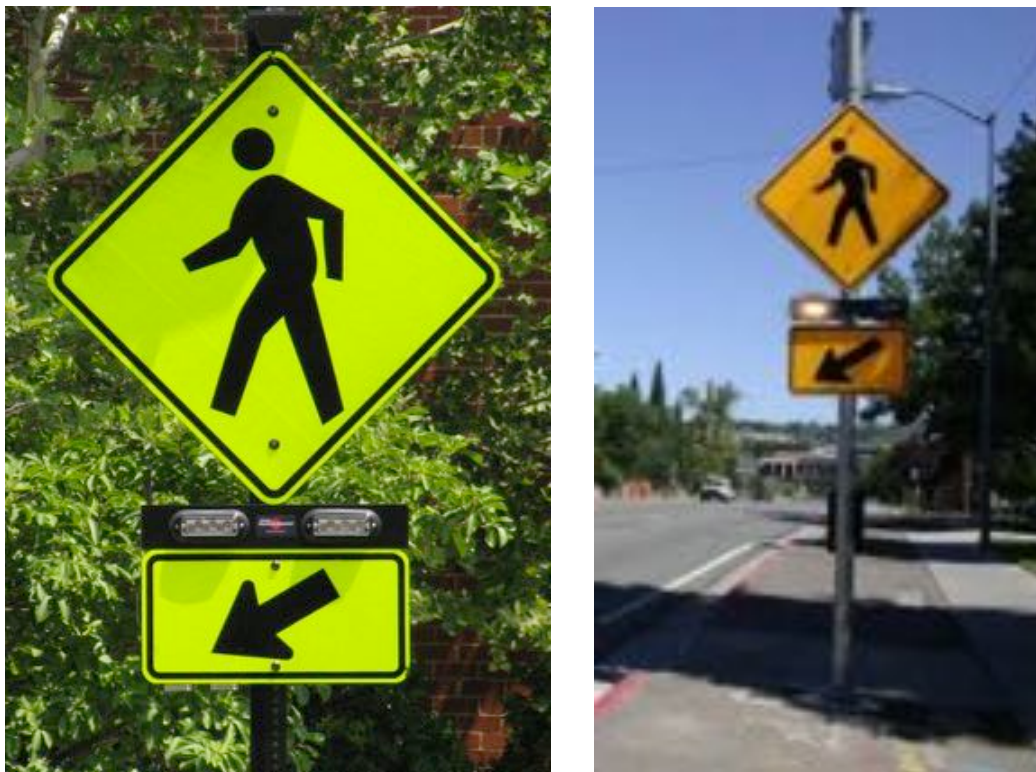
Rectangular Rapid Flash Beacons are a relatively new, yet incredibly effective, means of increasing vehicle yielding, crosswalk utilization, and general crosswalk visibility (see Figure 6). RRFBs are installed below existing crosswalk signs and are either actuated automatically by passive radio-wave pedestrian detectors or by nearby buttons mounted on existing light-poles or other infrastructure. The two lights activate in an irregular pattern that is extremely effective in capturing the attention of passing motorists and ensuring they yield to pedestrians.

**FIGURE 5.** Two examples of RRFB deployments.

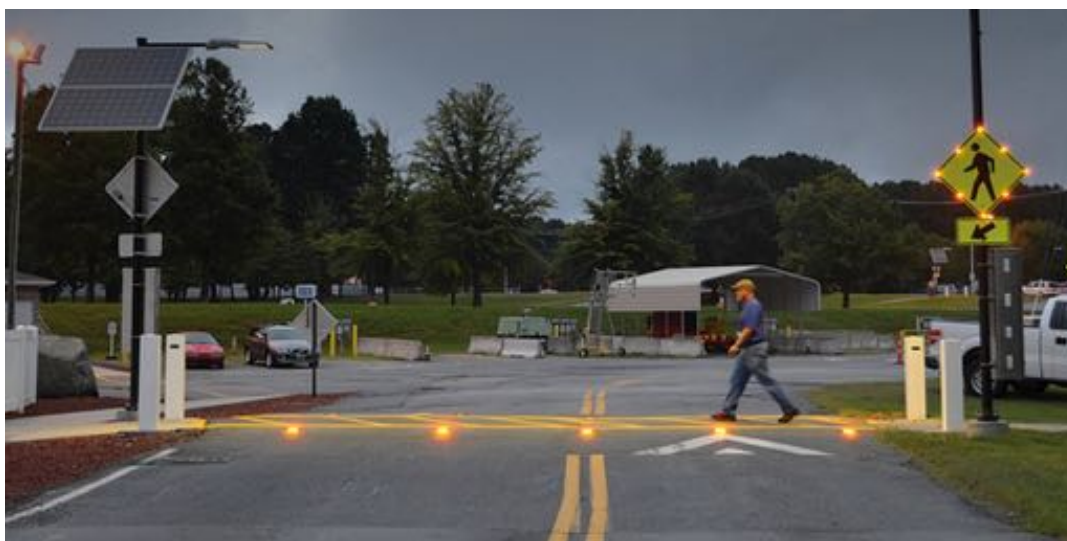
Current lighting conditions are relatively good, but further improvements can still be made. Lighting of pedestrians crossing the crosswalk appears to be adequate, but perception of the crosswalk location and compliance to yielding laws are still of concern. Installing in-street LED lighting along the crosswalk distinctly illuminates the crosswalk area and signals to drivers the legitimacy of the location (see Figure 6). Combined with advance yield markings, the system would maximally convey the location and necessity of yielding at the crossing.

**FIGURE 6.** Example of in-pavement lighting.

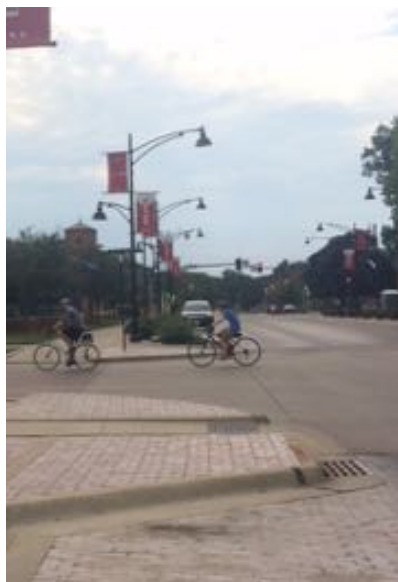
Because of the large width of the road at the crossing location, additional lighting may be necessary to fully illuminate pedestrians near the middle of the crossing. In-pavement lighting would solve this problem while still maintaining the uniform look of the streetlamps along Main Street. The other option to address this concern would be to install an overhanging light on either side of the crosswalk as shown in Figure 7.

**FIGURE 7.** Example of overhead lighting.

This option tends to be cheaper than in-pavement lighting, but it is slightly less effective at illumination across the entire width of the crosswalk. Also, it may not make financial sense to install an entirely different type of streetlamp where they already exist. PEDSAFE pricing estimates obtained from past projects are detailed below.

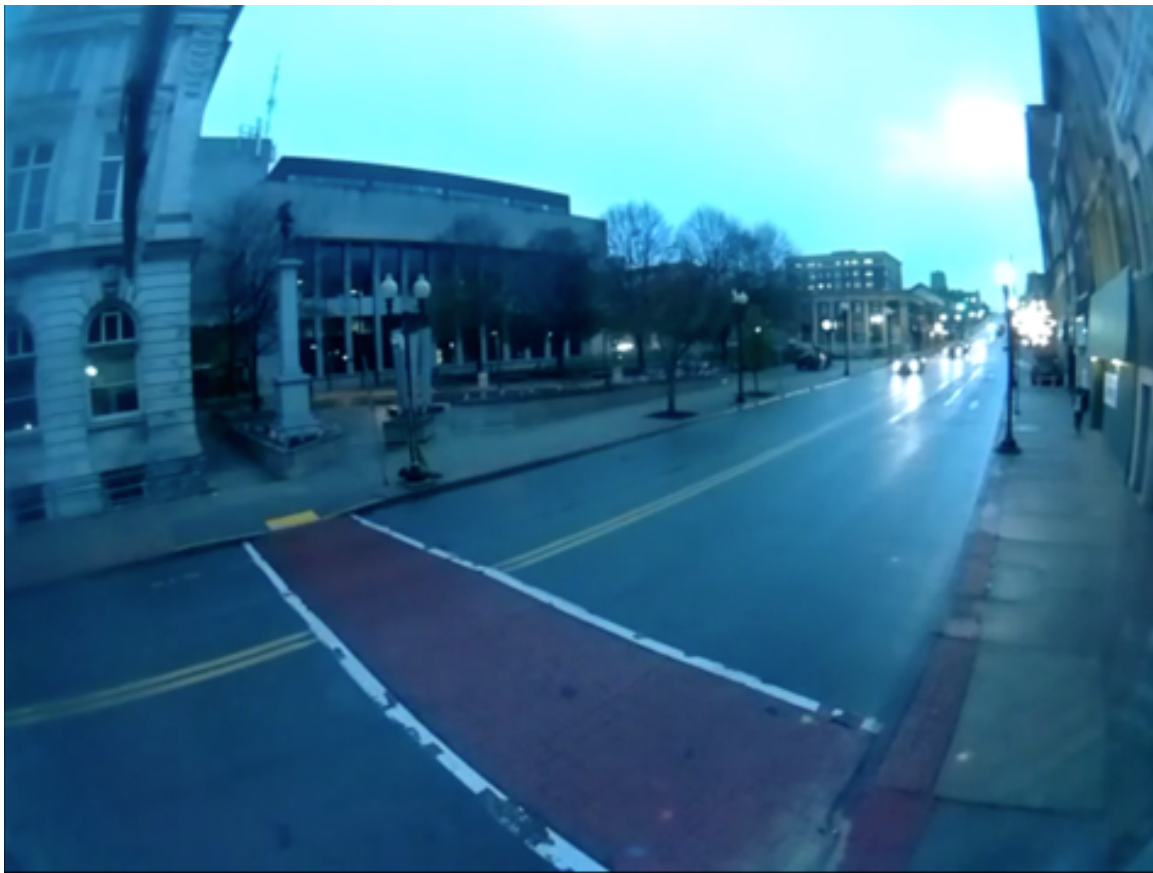
**FIGURE 8.** Crosswalk paint at the time of the data collection was chipped and faded.
